**File 1012 : Development ECO Checklist No.: 4**

ECO Checklist the Construction of Bulk Services for the Preekstoel Beach Lifestyle Estate on Portion 2 of Erf 599 and Erf 1028, Still Bay East, Western Cape

ECO Checklist for Civils Construction

# ECO CHECKLIST # 4

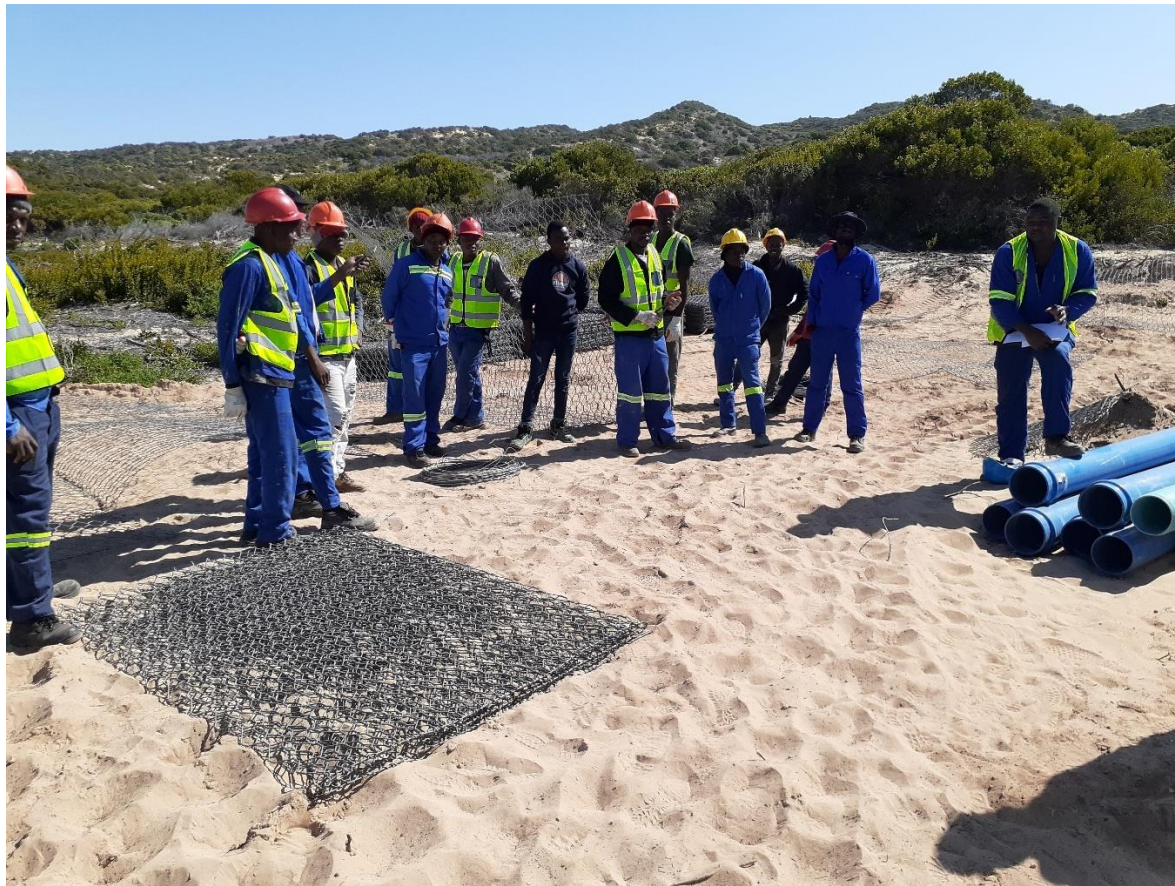
**Photo 1:** The induction of MSE Civils staff (construction of gabions) on site.

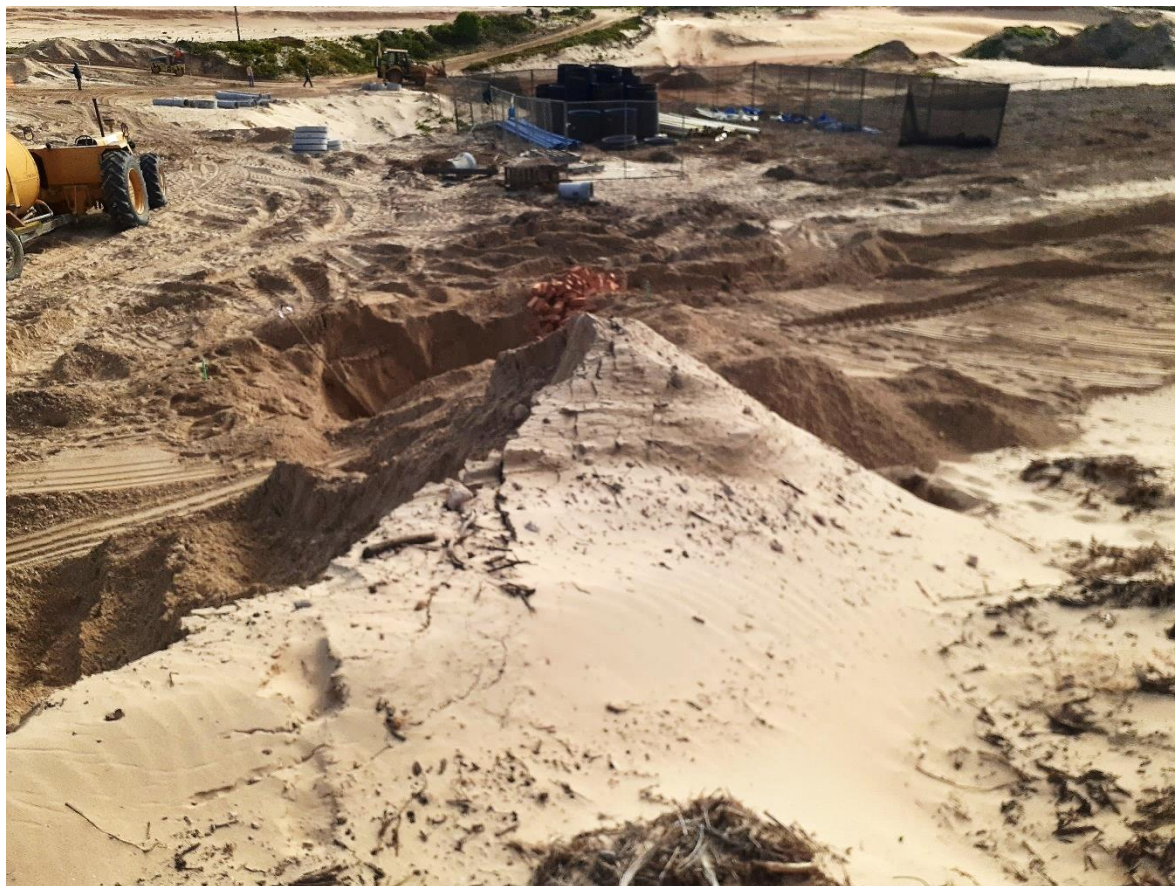
ENVIRONMENTAL ASPECTS (PROJECT ACTIVITY)	REQUIRED ACTIONS	TARGET AND RESPONSIBILITY	COMPLIANCE	ECO COMMENTS
Undertake <b>construction of Municipal Services</b> without adversely affecting the environment, including the gravel entrance road across the site to the Nature Reserve.	2. The contractor must point out the site office and the holding yard.	To be sanctioned by the ECO and site agent before installation of services takes place.	C	A small container has been placed near the entrance of the site to act as a temporary site office, eating area, placement of toilet and waste bin, and 3 larger storage containers have been placed within the storage yard for the duration of the services contract. A smaller storage yard has been put up near Phase I site ( <b>Photo 2</b> ).

**Photo 2:** The temporary storage of construction materials on site.

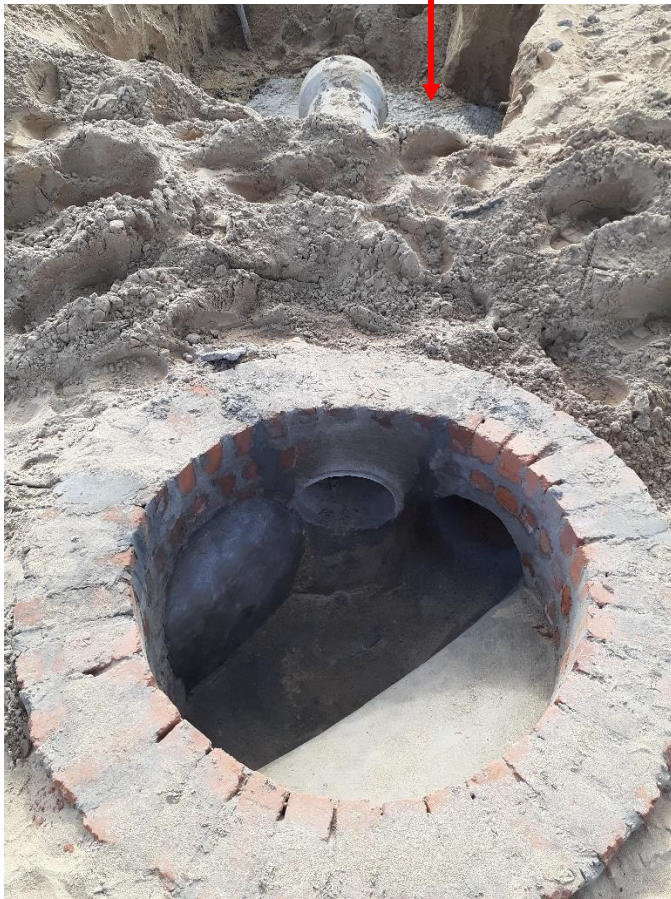
6. Concrete mixing must be restricted to a designated area on site and cement residues to be removed from site as soon as possible. At least one wastewater catch pits must be constructed for the capture of concrete residues from cleaning of the cement mixer. Residues are to be removed from site from time to time.	ECO to monitor compliance. Contractor to remove cement residues from each logical phase of construction.	C	Concrete and mortar are being used during the current phase of works on site for the foundations of the sewer manholes and brickwork within manholes ( <b>Photo 3</b> ). No concrete waste is being generated on site.

**Photo 3:** The use of concrete (red arrow) and brickwork on site for stormwater drainage.

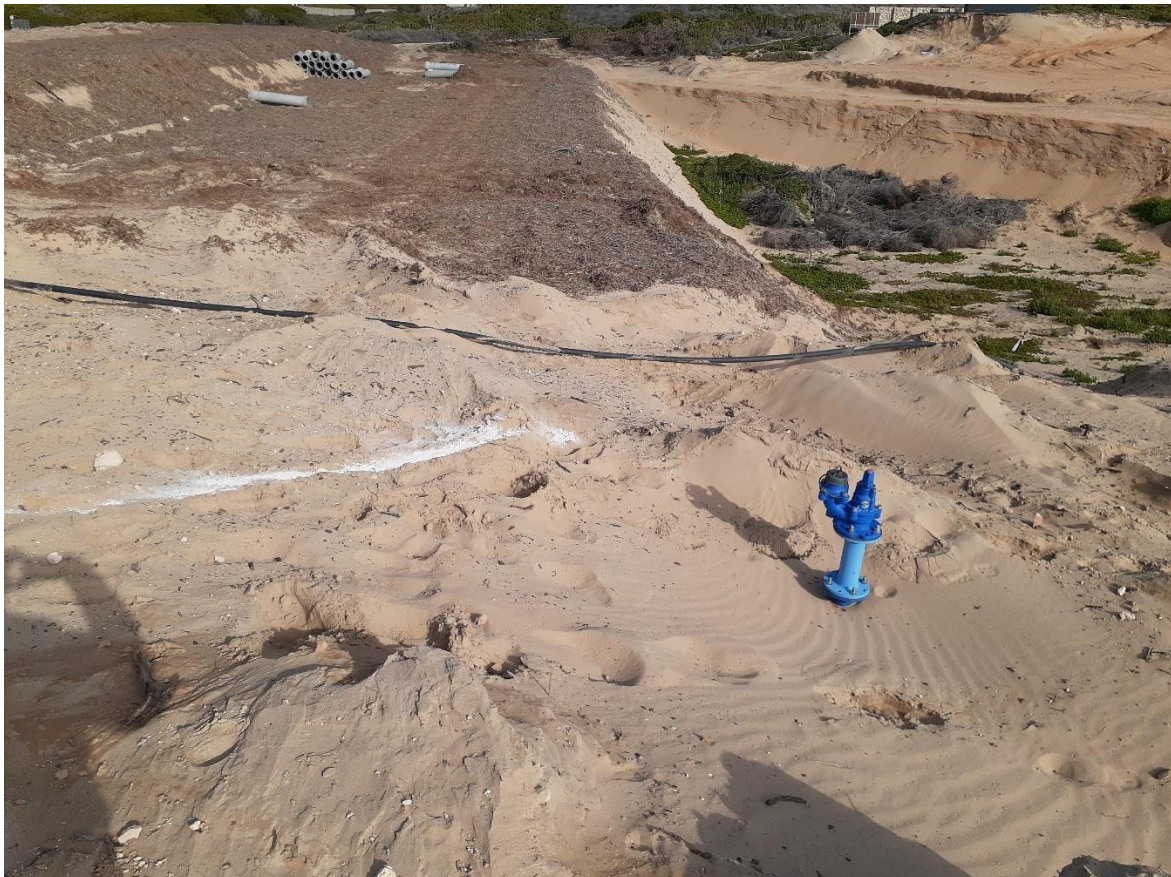
Institute measures for <b>stormwater management to prevent erosion</b> , damage to property and pollution of the environment.	1. Stormwater measures are not required during the installation of services phase of construction. Should a heavy downpour of rain occur the Site Agent must ensure that stormwater is contained on the property.	RE/Site Agent to monitor adequate storage of stormwater after moderate rainstorms and during the wet winter period (Construction Phase).	C	Deep ponding of stormwater on site must be prevented and measures to keep the stormwater on the site must be undertaken by the Site Agent. No heavy rainstorms have occurred on site during the winter period so far. Stormwater pipes are being connected to the small stormwater detention pond to the west of the site ( <b>Photo 4</b> ).
<b>F.2.3 Soil</b>				
<b>Prevent soil erosion</b>	1. The whole site has been de-grubbed of alien vegetation. Once the various building platforms have been completed it will be necessary to spread the wood chips over the stabilized platforms on site to prevent wind erosion.	ECO to monitor site clearing and site preparation and check for any erosion that may take place.	C	The whole site has been cleared of all alien vegetation and de-grubbed. The phase 1 building platforms have been prepared and the wood chips spread over them. Municipal services are currently being installed within and along the roads ( <b>Photos 4 and 5</b> ). No major wind erosion has currently been noticed on site.

**Photo 4:** Potable water pipelines and pressure release valves are being installed. Note the small stormwater detention pond in top right corner of photo.

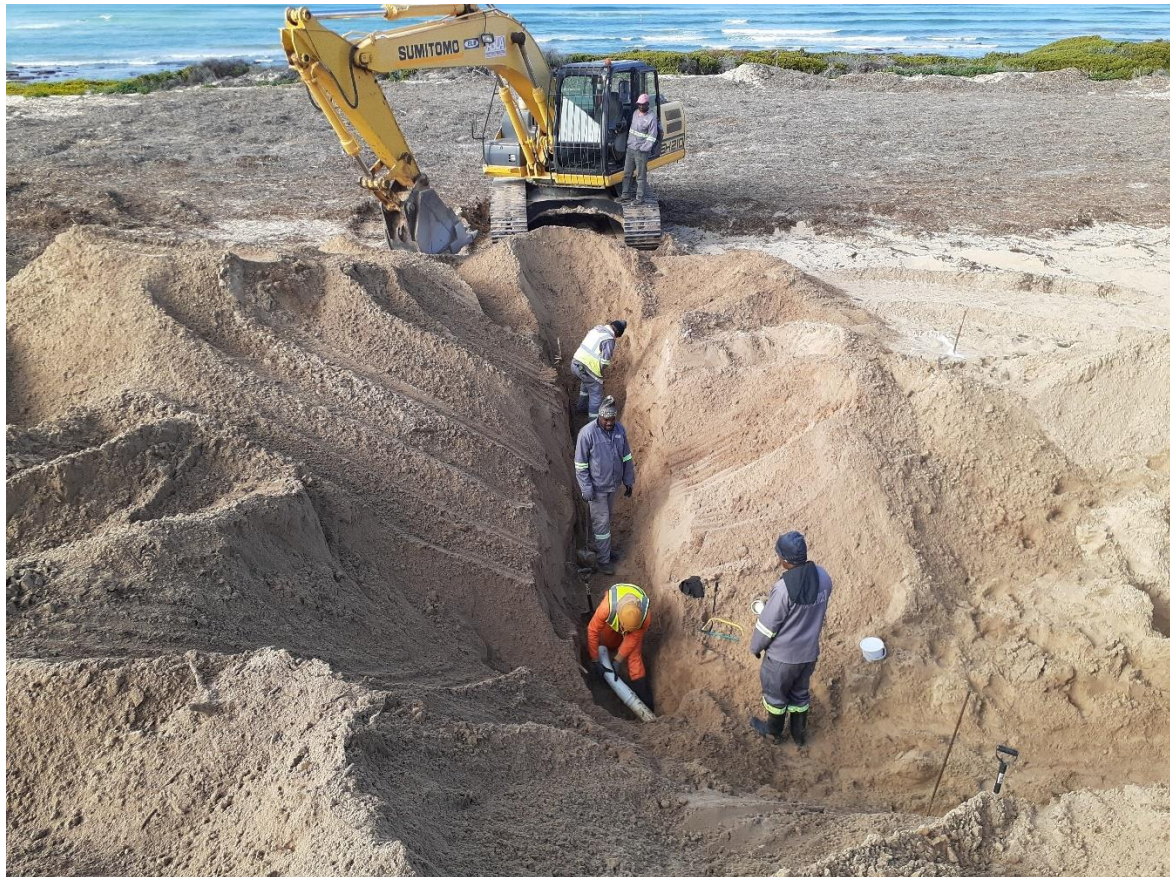
**Photo 5:** The laying of sewage pipes to individual erven.

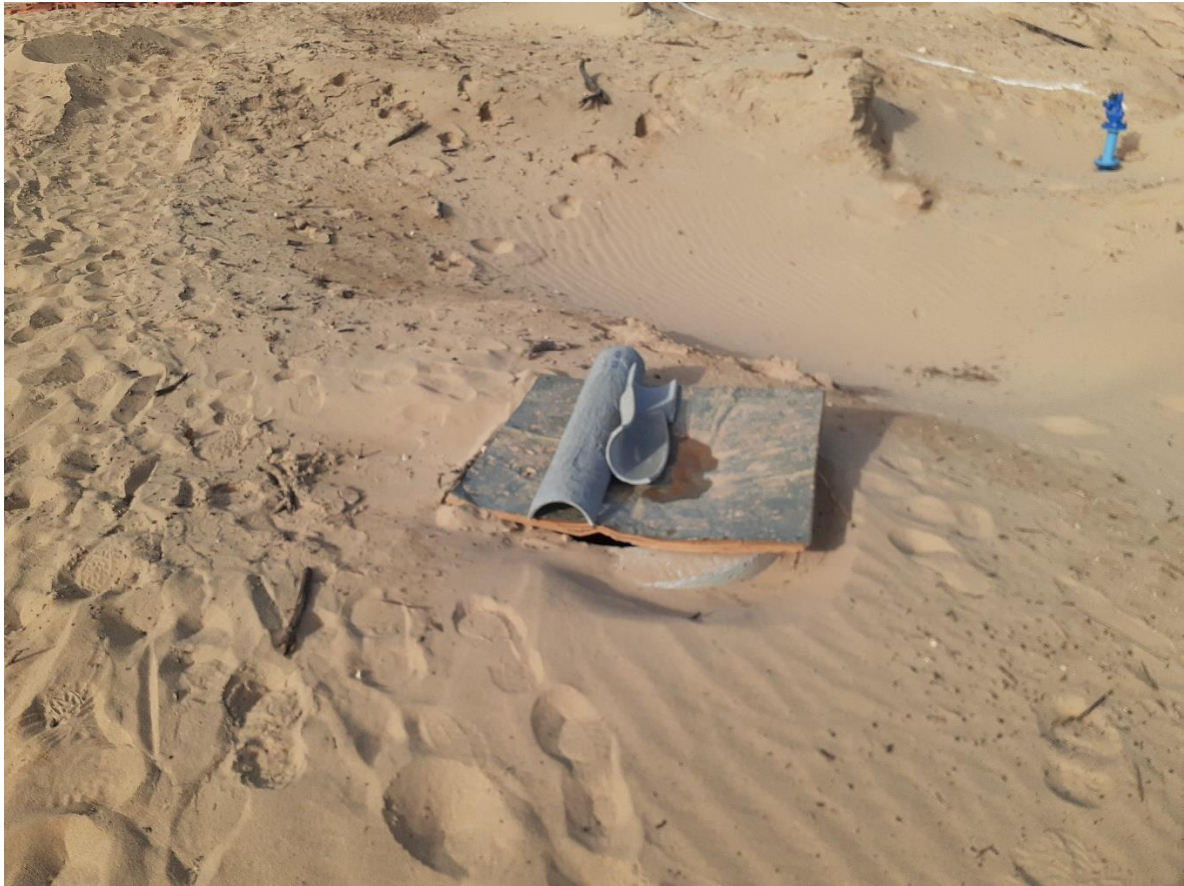
To prevent injury to construction staff (and the public).	Stakes with danger tape should be place around open manholes. Those manholes without proper lids should also be staked with danger tape	Site Agent and ECO to check on compliance during the various phases of the development of the site.	NC	Stakes and danger tape must be placed around manholes that are open or that have wooden lids to warn staff of open manholes ( <b>Photo 7 and 8</b> ).

**Photo 7:** The manhole must have stakes around it and danger tape around the stakes.

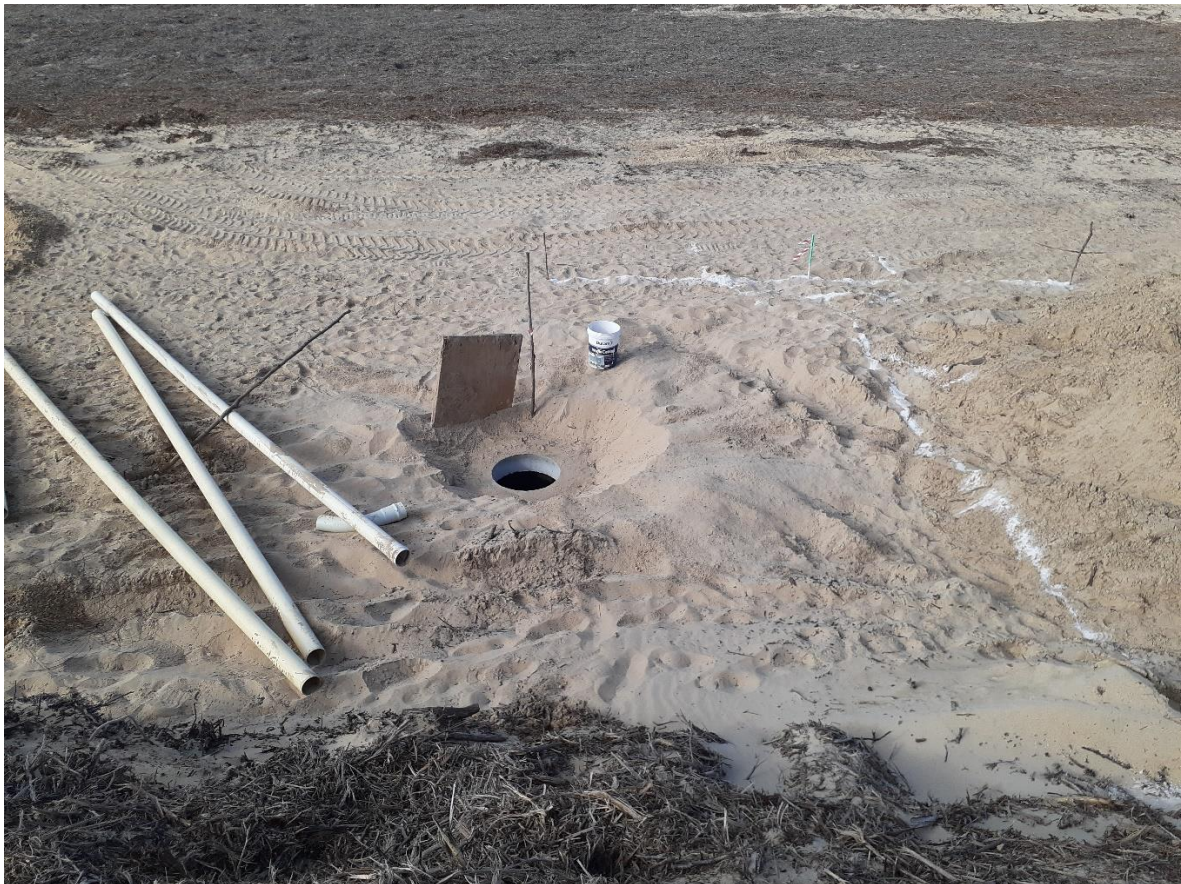
**Photo 8:** Open manholes must be demarcated with stakes and danger tape. Sand should also be prevented from entering sewage manhole.
