**File 1012 : Development ECO Checklist No.: 5**

ECO Checklist the Construction of Bulk Services for the Preekstoel Beach Lifestyle Estate on Portion 2 of Erf 599 and Erf 1028, Still Bay East, Western Cape

# ECO CHECKLIST # 5

## PREEKSTOEL BEACH LIFESTYLE ESTATE, STILL BAY EAST, WESTERN CAPE

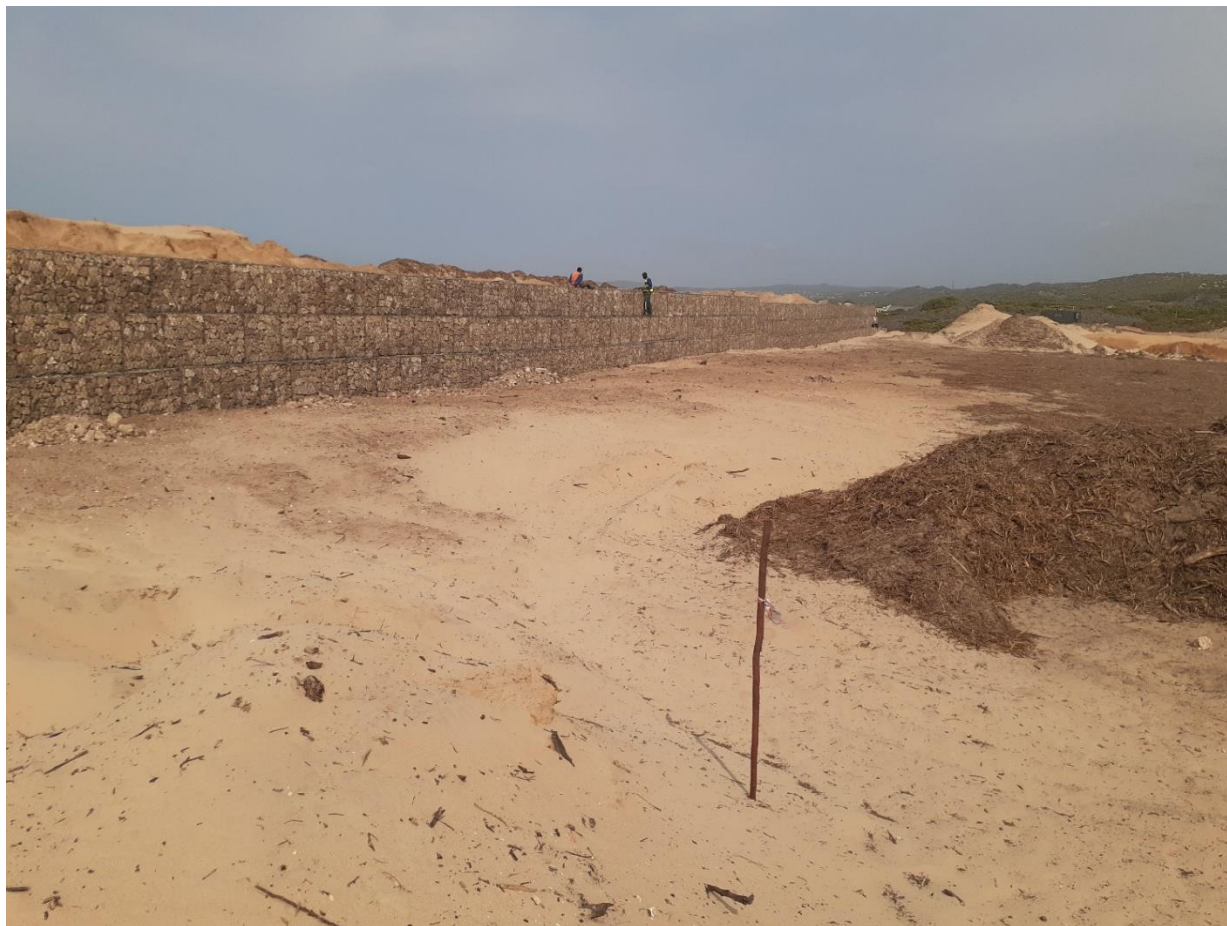
2. Contractors to be fully informed by the ECO as to their environmental contractual obligations. Induction of staff must take place.	ECO is to undertake the induction of staff and to monitor environmental contractual obligations of contractors on ongoing basis for the duration of the project.	C	A site hand over meeting was held with ASLA construction on 20 July 2022 during which the contractor was made aware of their environmental obligations. Environmental Awareness Posters have been provided to the Contractors. The induction of ASLA staff was undertaken on 4 August 2022. The induction of MSE Civils took place on 8 September 2022. This team will be responsible for the construction of gabions ( <b>Photo 1</b> ).

**Photo 1:** The construction of gabions is progressing well.

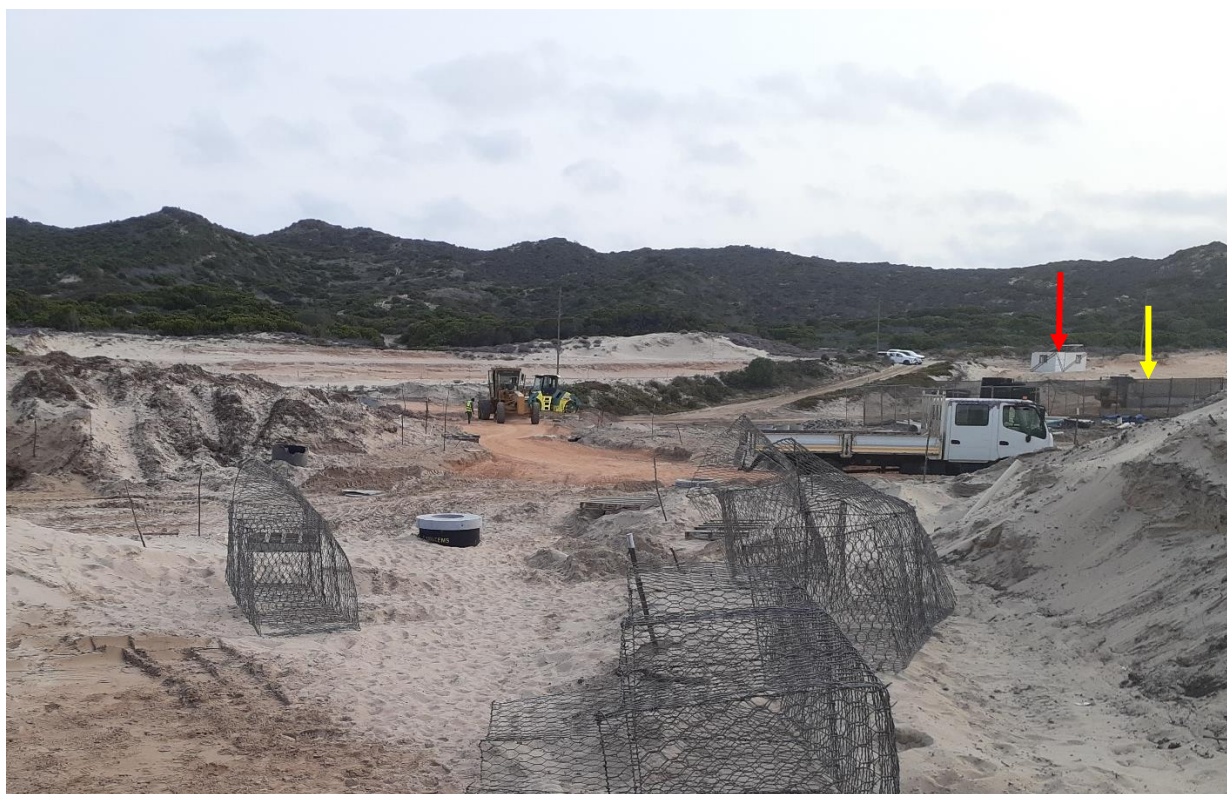
**Photo 2:** The containers (red arrow) have been replaced near the large detention pond. The yellow arrow indicates the temporary storage yard.

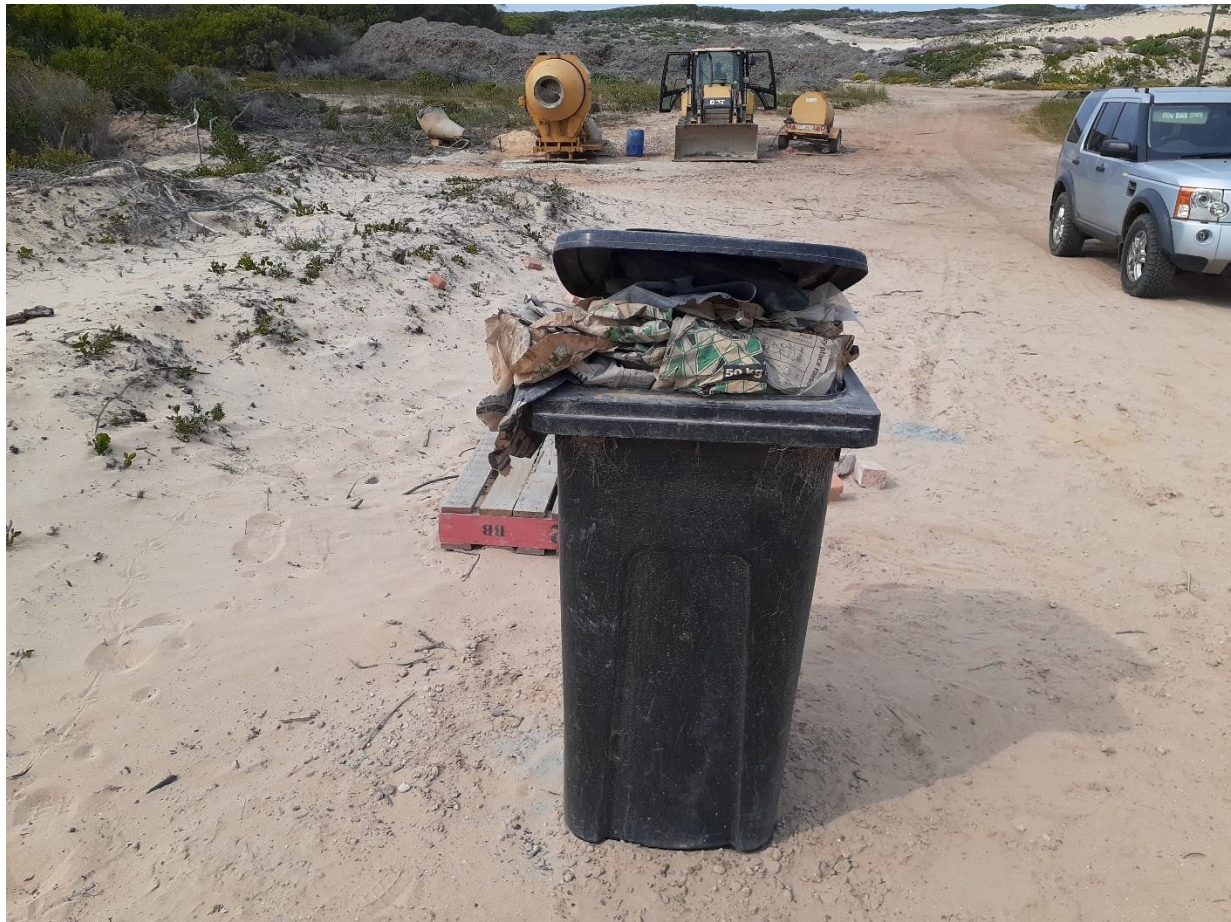
ENVIRONMENTAL ASPECTS (PROJECT ACTIVITY)	REQUIRED ACTIONS	TARGET AND RESPONSIBILITY	COMPLIANCE	ECO COMMENTS
<b>Storage of construction materials on site and concrete mixing areas</b> (cont.)	waste disposal facility. The burning of solid waste and paper on site will not be allowed. Recyclable waste (e.g. paper, glass, tin, plastic) should be recycled if possible.			bags are lying around on site. This area needs to be tidied up ( <b>Photos 3 and 4</b> ). The second dustbin must be placed near small container used for storing small tools. This bin is also full and needs to be emptied every week.

**Photo 3:** The full dustbins must be cleared every week..

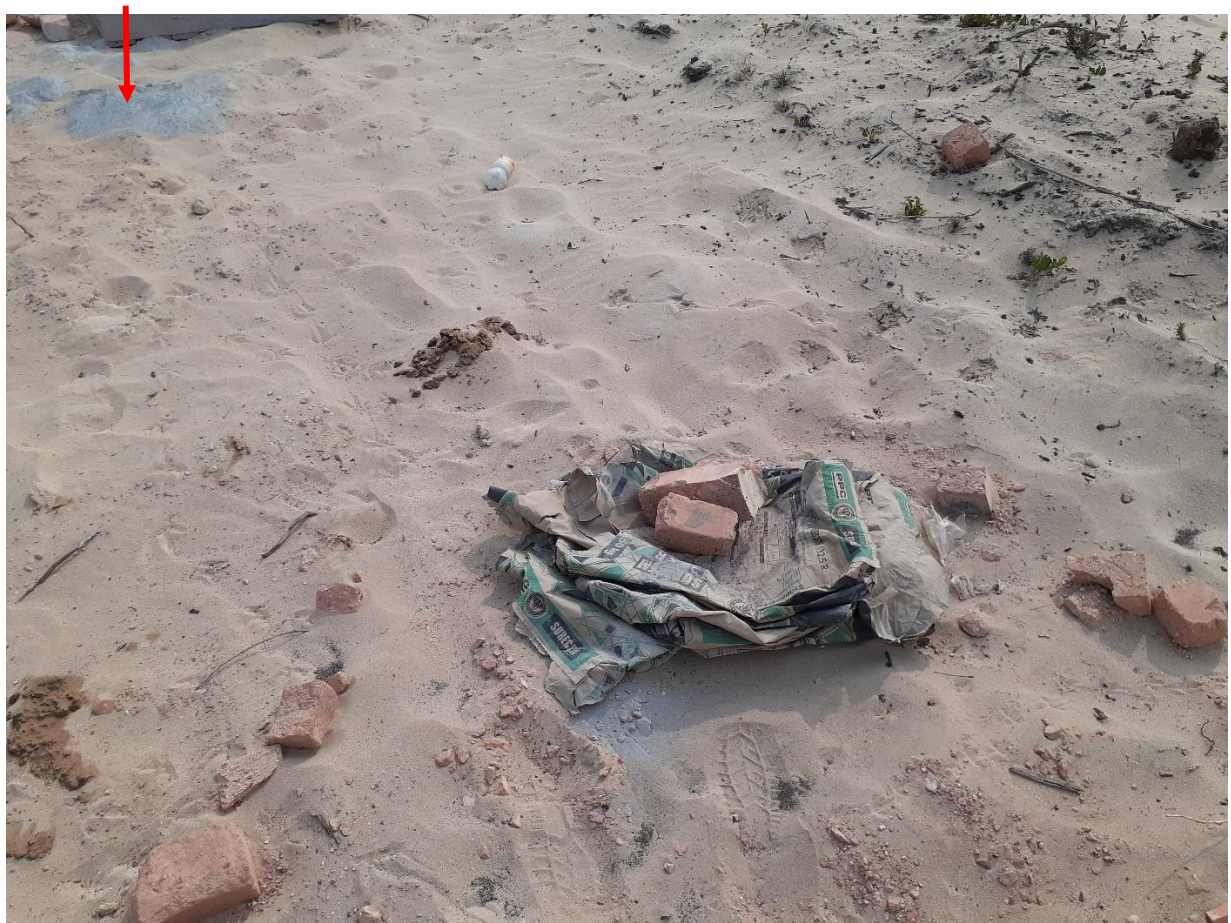
6. Concrete mixing must be restricted to a designated area on site and cement residues to be removed from site as soon as possible. At least one wastewater catch pits must be constructed for the capture of concrete residues from cleaning of the cement mixer. Residues are to be removed from site from time to time.	ECO to monitor compliance. Contractor to remove cement residues from each logical phase of construction.	PC	Concrete and mortar are being used during the current phase of works on site for the foundations of the sewer manholes and brickwork within manholes. No concrete waste is being generated on site. Cement power spills must be picked up ( <b>Photo 4</b> )

**Photo 4:** Cement packets must be placed in dustbins. Cement powder spills must be picked up (arrow). Plastic wrapping is also to be picked up.

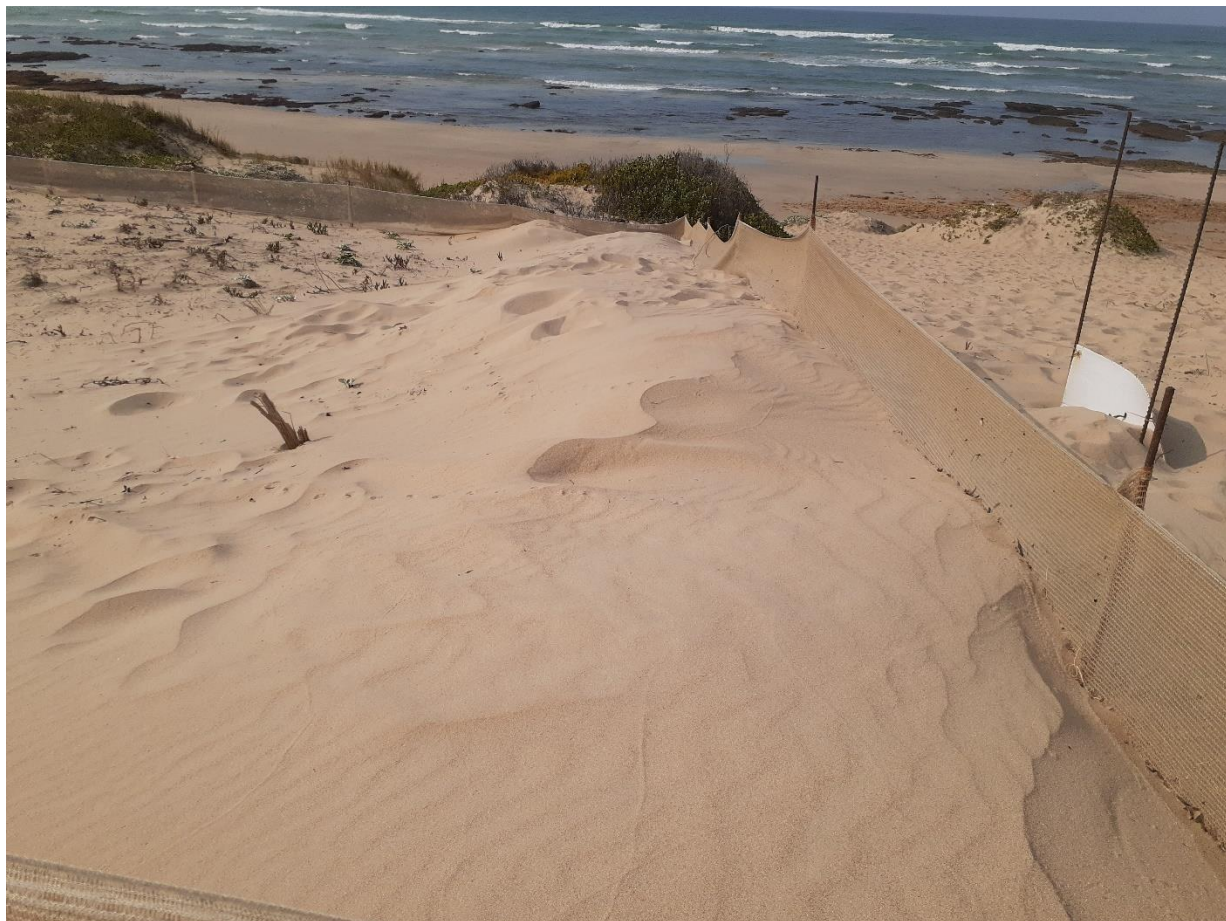
**Photo 5:** Windblown sand has accumulated to the west end of the dune rehabilitation area.

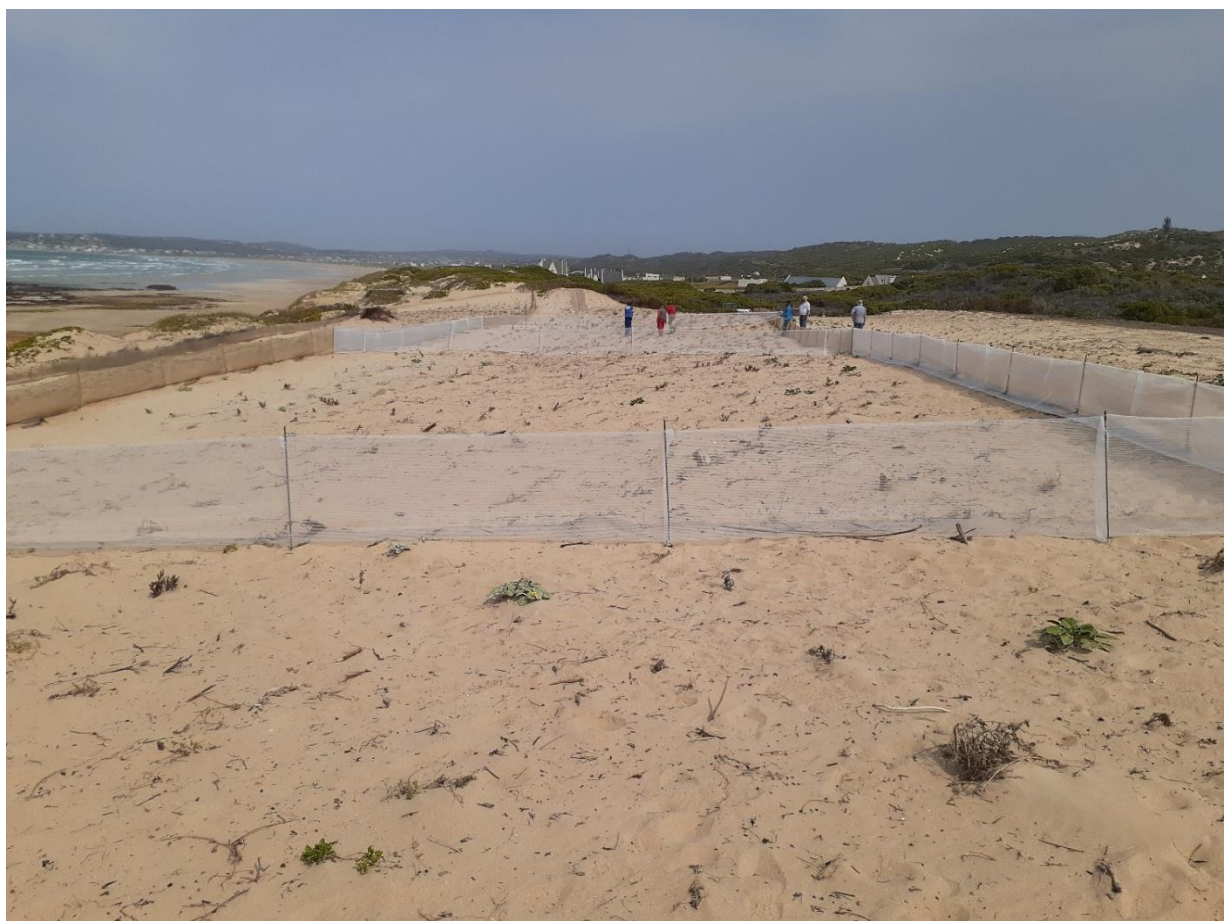
**Photo 6:** New internal netting has been erected within the rehabilitation area to prevent windblown sand. Note the growth of locally planted strand plants.

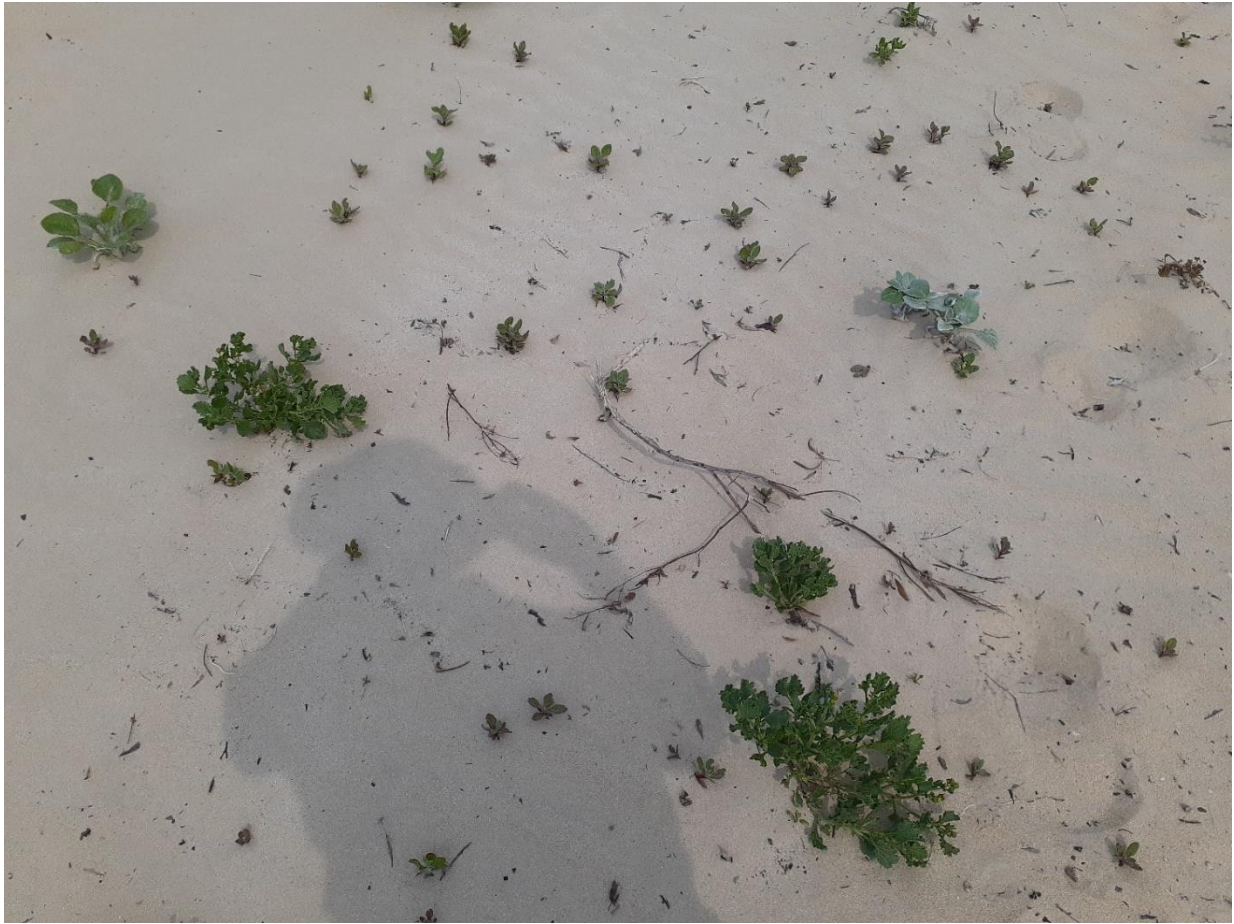
3. If significant wind erosion of the property takes place despite the use of wood chips, it may be necessary to use specially made netting erected at right angles to the prevailing winds.	Anti-erosion measures to be discussed with and approved by the RE in consultation with the ECO if and when necessary	<b>C</b>	No significant erosion has been noticed on site as yet. Some windblown sand was noted on the dune area ( <b>Photo 5</b> ). Internal netting on the dune rehabilitation area to prevent wind blown sand accumulation has been installed ( <b>Photo 6</b> ).
<b>Rehabilitate</b> all areas where <b>soil erosion</b> has taken place	1. The badly eroded frontal dune system has been reshaped by moving sand from the accumulation of sand in the backdune area into the blow-outs	Since the brushwood fences did not trap any significant amounts of sand in the period November 2021 to August 2022, the dune rehabilitation specialist (Deon van Eeden) and the ECO decided to replace the windblown sand accumulated in the back dune area into the blowouts. Once the bulk earthworks were completed indigenous strand plants, which were removed before earthworks, were planted over the replaced sand.	<b>C</b>	The back-dune area of the frontal dune system has grown in size (by at least 2m vertically over a period of about 20-50 years) by rooikrans trapping windblown sand off the beach and from prolonged blow-outs. The sand from the backdune area was moved back towards the beach to get a stable, low angle dune front. The stable dune area was planted with strand plants ( <b>Photo 6</b> ). Shade netting rows have been erected to prevent wind erosion. The transplanted plants are being irrigated. The seeds (mainly bitou) broadcast over the site have started germinating ( <b>Photo 7</b> ).

**Photo 7:** A large number of the seeds broadcast over the rehabilitation area have started germinating (mainly bitou seedlings).

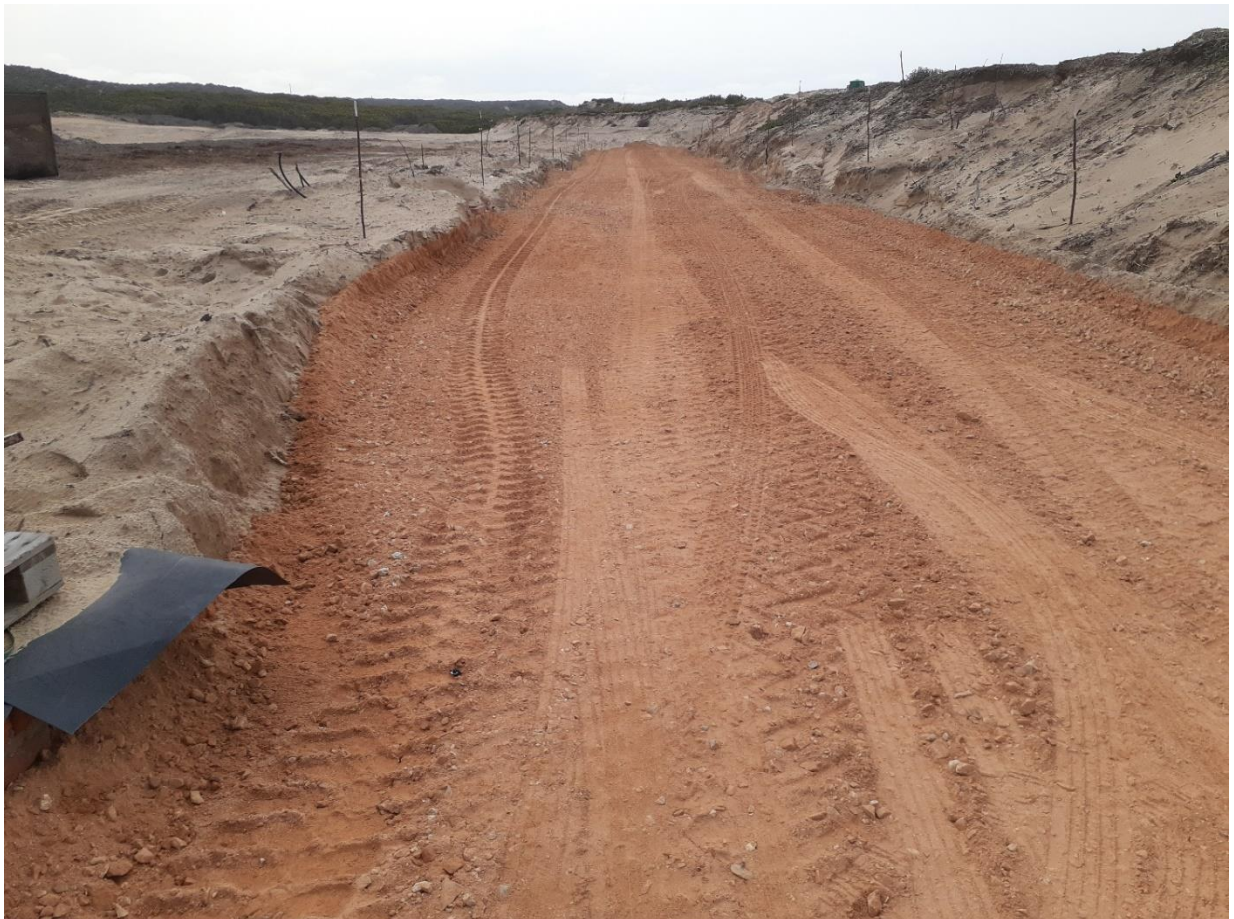
**Photo 8:** Internal roads are being constructed for Phase 1 of the development. G5 material is being spread and compacted.

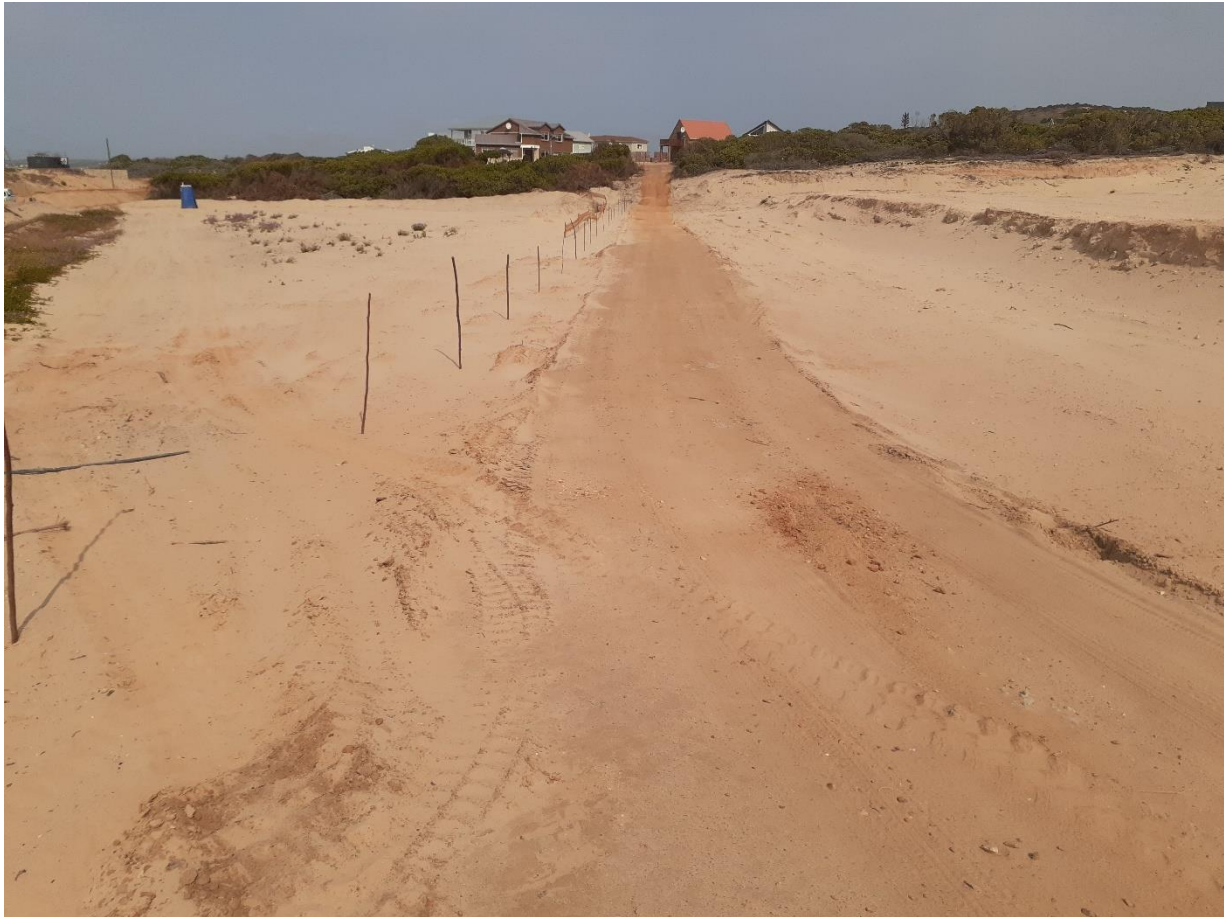
4. Road surfaces may cause dust pollution during their construction phase.	ECO to monitor and advise on the use of water to wet surfaces to prevent dust or to advise on alternative dust suppression measures	<b>C</b>	The gravel access road is in use and is being kept moist. The construction of roads has begun with the spreading of G5 material and compaction ( <b>Photo 8</b> ). A temporary access road has been constructed for CapeNature staff, whilst the access road to the development is being constructed ( <b>Photo 9</b> ).

**Photo 9:** A temporary road has been constructed for access of CapeNature staff and the public. The access road to the development is currently being constructed (access road in the top left hand corner of the photo).

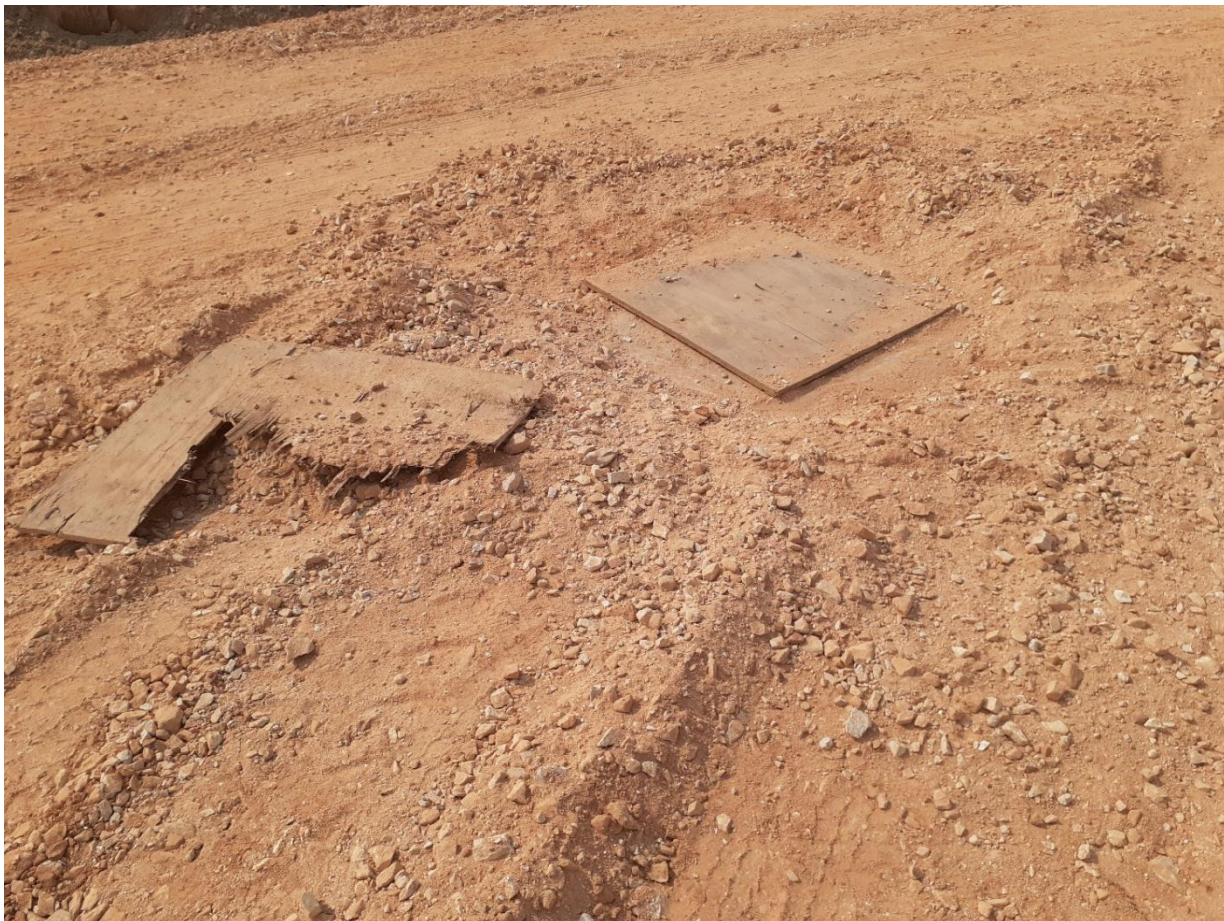
**Photo 10:** The manhole must have stakes around it and danger tape around the stakes.

<b>To prevent injury to construction staff</b> (and the public).	Stakes with danger tape should be place around open manholes. Those manholes without proper lids should also be staked with danger tape	Site Agent and ECO to check on compliance during the various phases of the development of the site.	NC	Stakes and danger tape must be placed around manholes that are open or that have wooden lids to warn staff of open manholes ( <b>Photo 10</b> ).
