**File 1012 : Development ECO Checklist No.: 6**

ECO Checklist the Construction of Bulk Services for the Preekstoel Beach Lifestyle Estate on Portion 2 of Erf 599 and Erf 1028, Still Bay East, Western Cape

**REPORT** ECO Checklist for Civils Construction

## PREEKSTOEL BEACH LIFESTYLE ESTATE, STILL BAY EAST, WESTERN CAPE

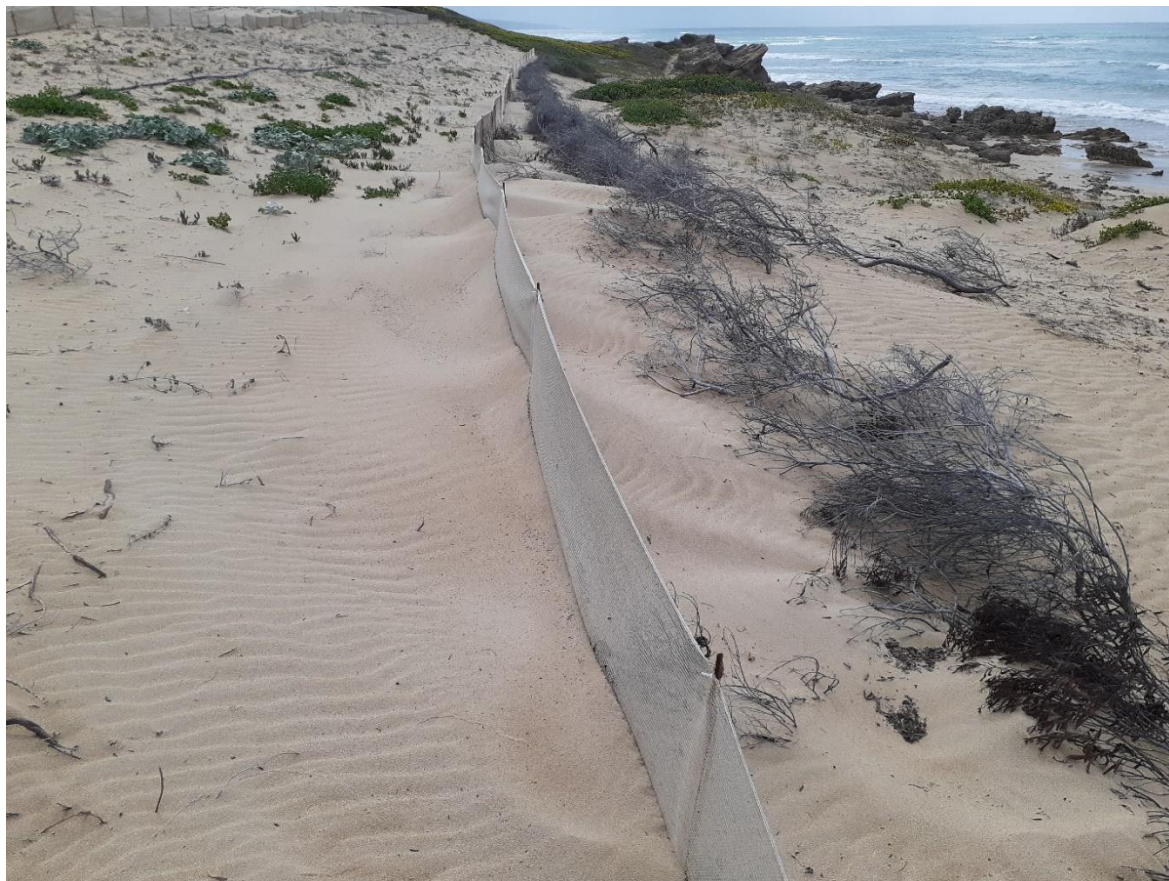
**Photo 1:** Windblown sand off the beach is accumulating just behind the hummocky dunes.

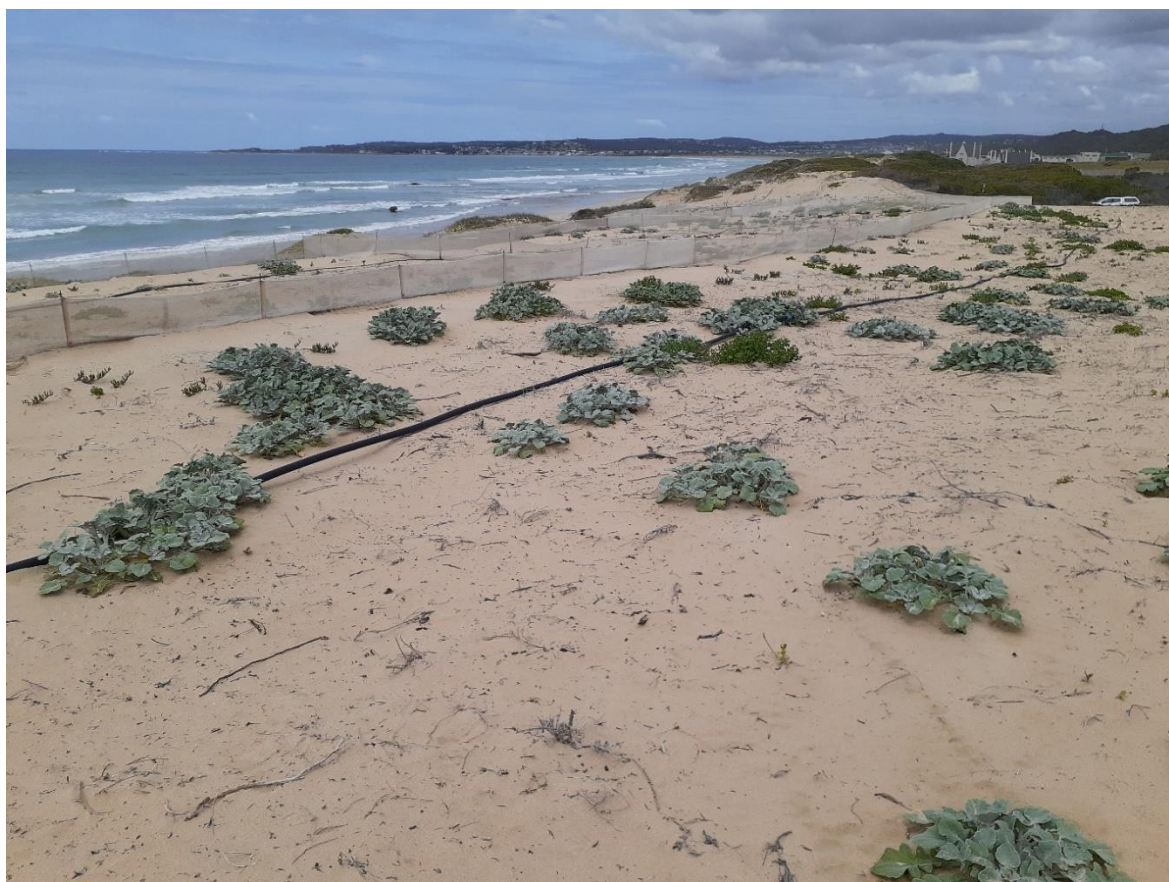
**Photo 2:** The pioneer strand plants are growing well on the rehabilitated dunes. More climax plants will be planted next year in between the strand plants. Once the climax plants have taken, these strand plants will be transplanted behind the hummocky dunes.

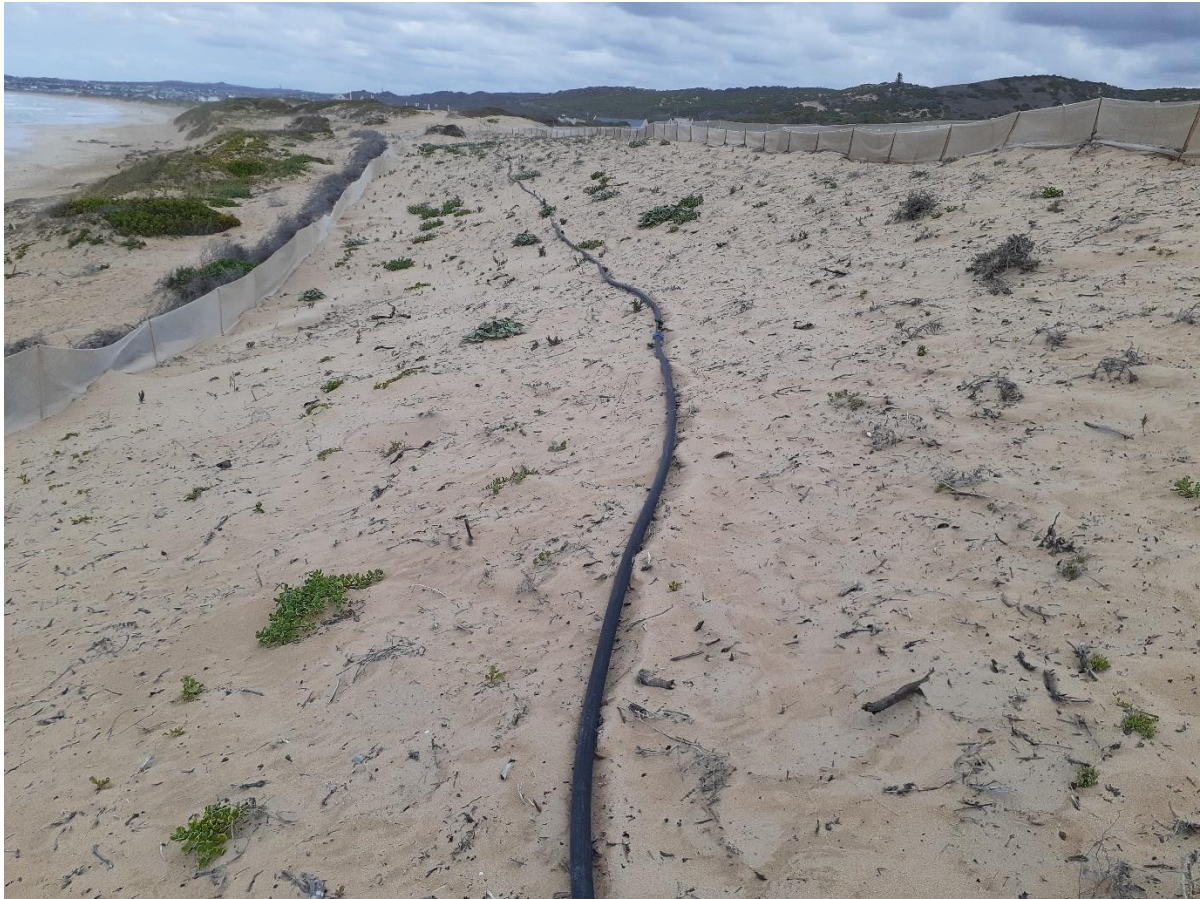
ENVIRONMENTAL ASPECTS (PROJECT ACTIVITY)	REQUIRED ACTIONS	TARGET AND RESPONSIBILITY	COMPLIANCE	ECO COMMENTS
<b>Prevent soil erosion</b>	3. If significant wind erosion of the property takes place despite the use of wood chips, it may be necessary to use specially made netting erected at right angles to the prevailing winds.	Anti-erosion measures to be discussed with and approved by the RE in consultation with the ECO if and when necessary	C	No significant erosion has been noticed on site as yet. Some windblown sand was noted on the dune area ( <b>Photo 1</b> ). Internal netting on the dune area has been installed in the rehabilitation area to prevent wind-blown sand.
<b>Rehabilitate</b> all areas where <b>soil erosion</b> has taken place	1. The badly eroded frontal dune system has been reshaped by moving sand from the accumulation of sand in the backdune area into the blow-outs	Since the brushwood fences did not trap any significant amounts of sand in the period November 2021 to August 2022, the dune rehabilitation specialist (Deon van Eeden) and the ECO decided to replace the windblown sand accumulated in the back dune area into the blowouts. Once the bulk earthworks were completed, indigenous strand plants, which were removed before earthworks, were planted over the replaced sand.	C	The back-dune area of the frontal dune system had grown in size (by at least 2m vertically over a period of about 20-50 years) by rooikrans trapping windblown sand off the beach and from prolonged blow-outs. The sand from the backdune area was moved back towards the beach to get a stable, low angle dune front. The stable dune area was planted with strand plants, which are growing well ( <b>Photo 2</b> ). Shade netting rows have been erected to prevent wind erosion. The transplanted plants are being irrigated with a dedicated irrigation system ( <b>Photo 3</b> ).

**Photo 3:** A temporary irrigation system has been installed on the rehabilitated dune system.

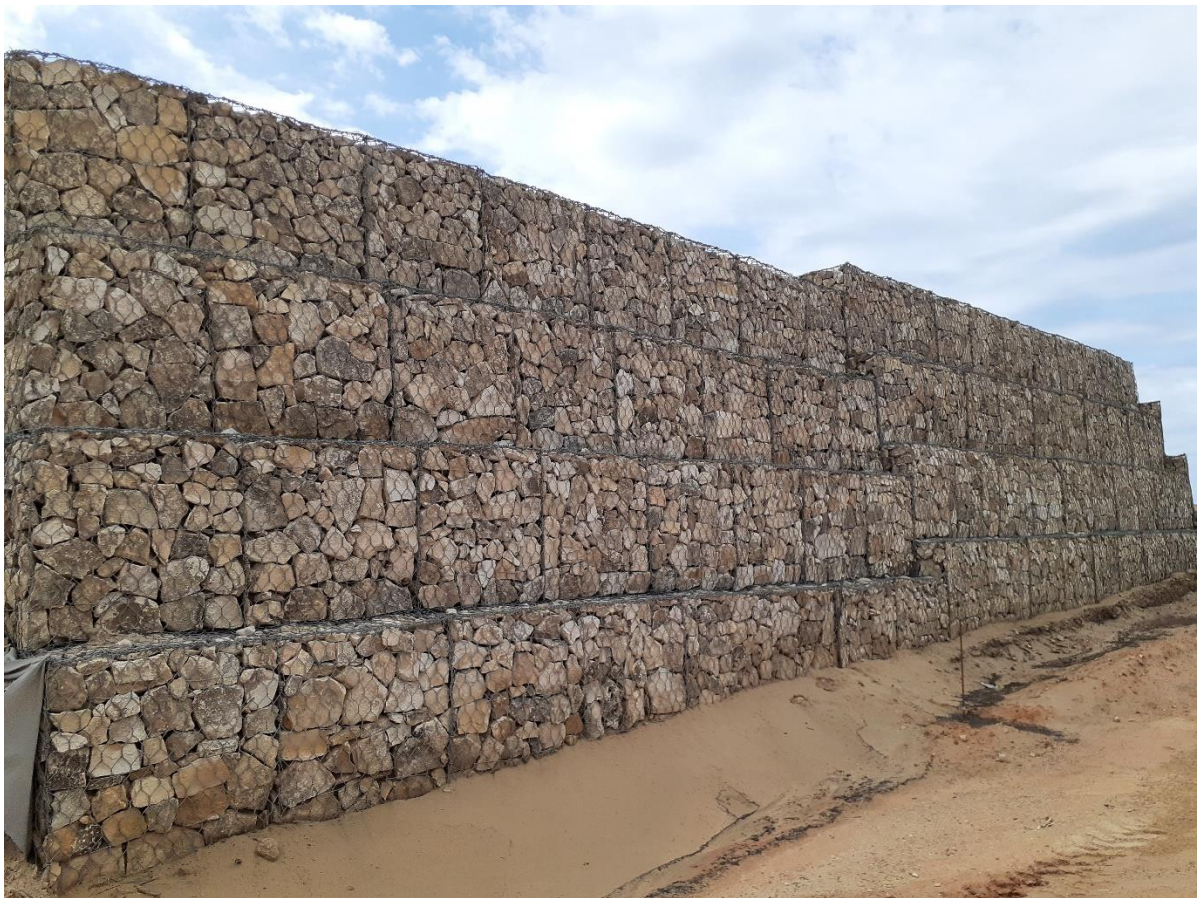
**Photo 4:** The gabion retaining walls have been completed for the first phase of the project.

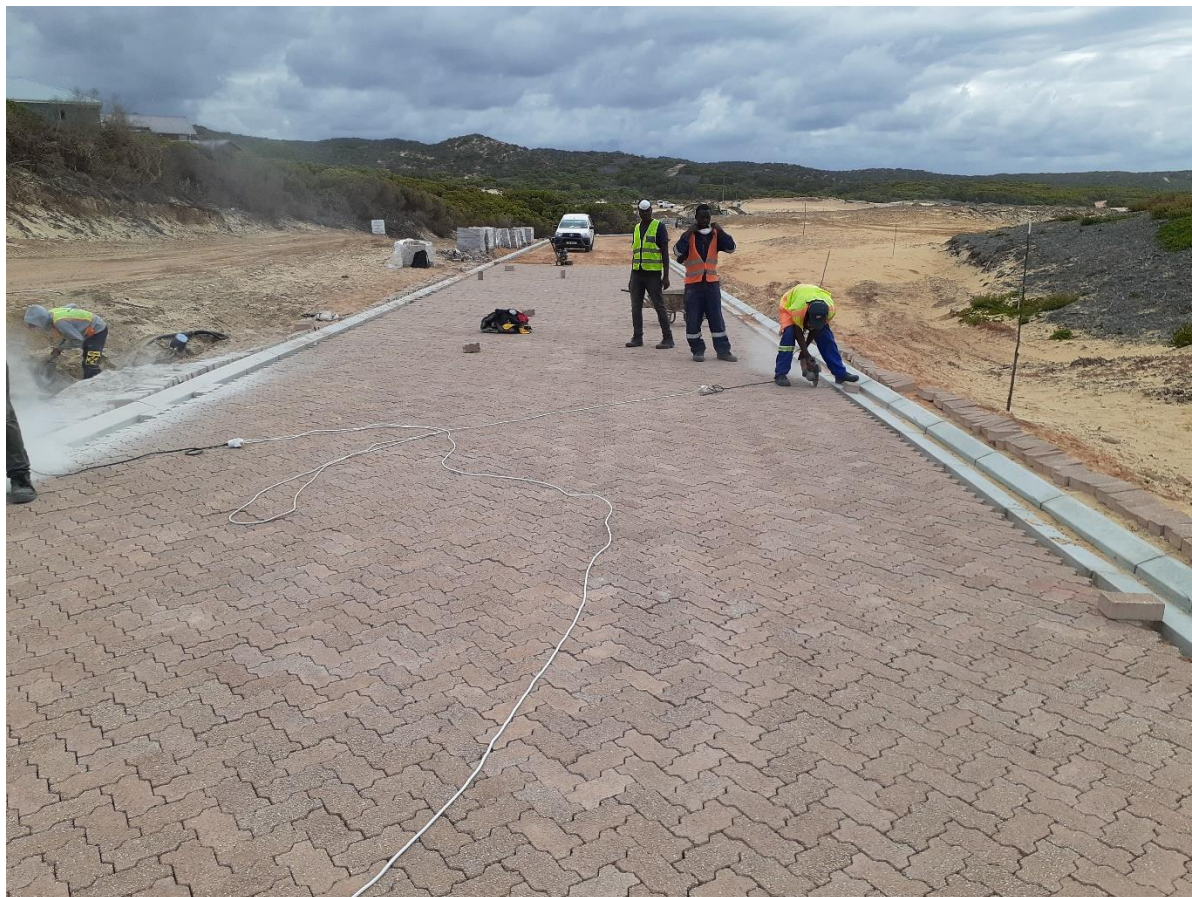
4. All fuels, oils and hydrocarbon products (e.g. tars) kept in tins and drums must be stored in a suitably bunded area to prevent pollution in case of spills or leakages.	ECO to monitor compliance for duration of contract.	<b>C</b>	Whilst oils and grease products are presently kept on site, no incidents of spills have been recorded. Tar will probably not be used on site for the construction of the roads. Roads for Phase 1 are currently being paved with concrete interlocking blocks ( <b>Photo 5 and 6</b> ).

**Photo 5:** The entrance road is currently being paved. The temporary access road is seen to the left of the paved entrance road.

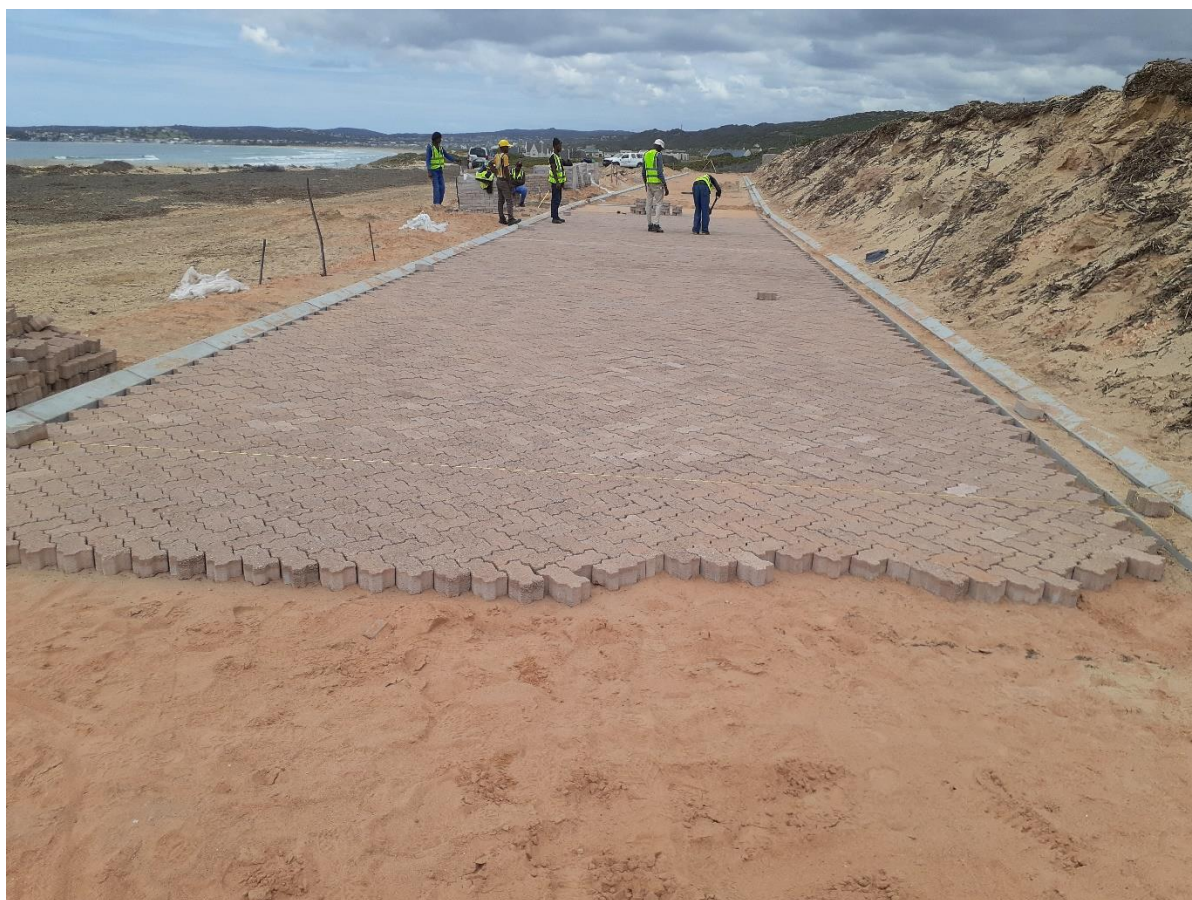
**Photo 6:** Paving of the internal roads are also being undertaken.

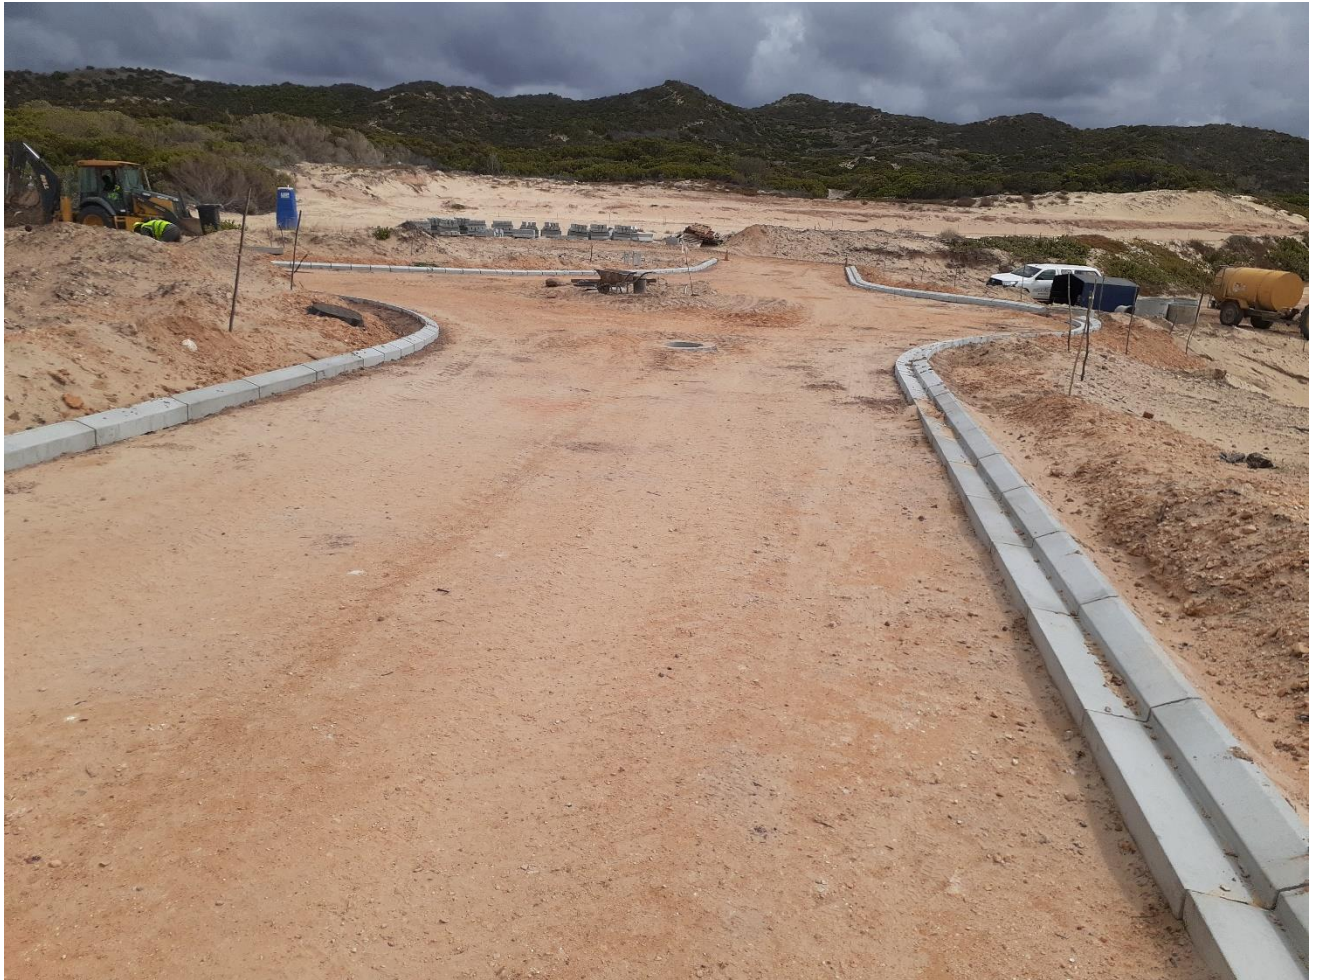
ENVIRONMENTAL ASPECTS (PROJECT ACTIVITY)	REQUIRED ACTIONS	TARGET AND RESPONSIBILITY	COMPLIANCE	ECO COMMENTS
To <b>prevent injury to construction staff</b> (and the public).	Stakes with danger tape should be place around open manholes. Those manholes without proper lids should also be staked with danger tape	Site Agent and ECO to check on compliance during the various phases of the development of the site.	P/C	A drum with danger tape around the drum should be placed over any open manholes when construction for the day is complete to prevent injury of the public accessing the site ( <b>Photo 7</b> ).
<b>F.3.3 Security</b>				
<b>Minimise security risk</b> during the construction phase	1. The contractor(s) will be responsible for the security of their construction sites and the conduct of their personnel for the duration of the services and building contracts.	The contractor and developer will need to monitor security issues.	C	No breaches of security risks have been noted on site. It was learnt that diesel was stolen from the tanks within the Municipal caravan and camping area. Asla was informed about this incident.

**Photo 7:** The open manhole (red arrow) should be covered and demarcated with danger tape each evening after work to prevent members of the public injuring themselves. Once the paving has been completed, the manhole cover can be fixed in place.
