File 1012 : Development ECO Checklist No.: 7

ECO Checklist the Construction of Bulk Services for the Preekstoel Beach Lifestyle Estate on Portion 2 of Erf 599 and Erf 1028, Still Bay East, Western Cape

ECO Checklist for Civils Construction

ECO CHECKLIST # 7

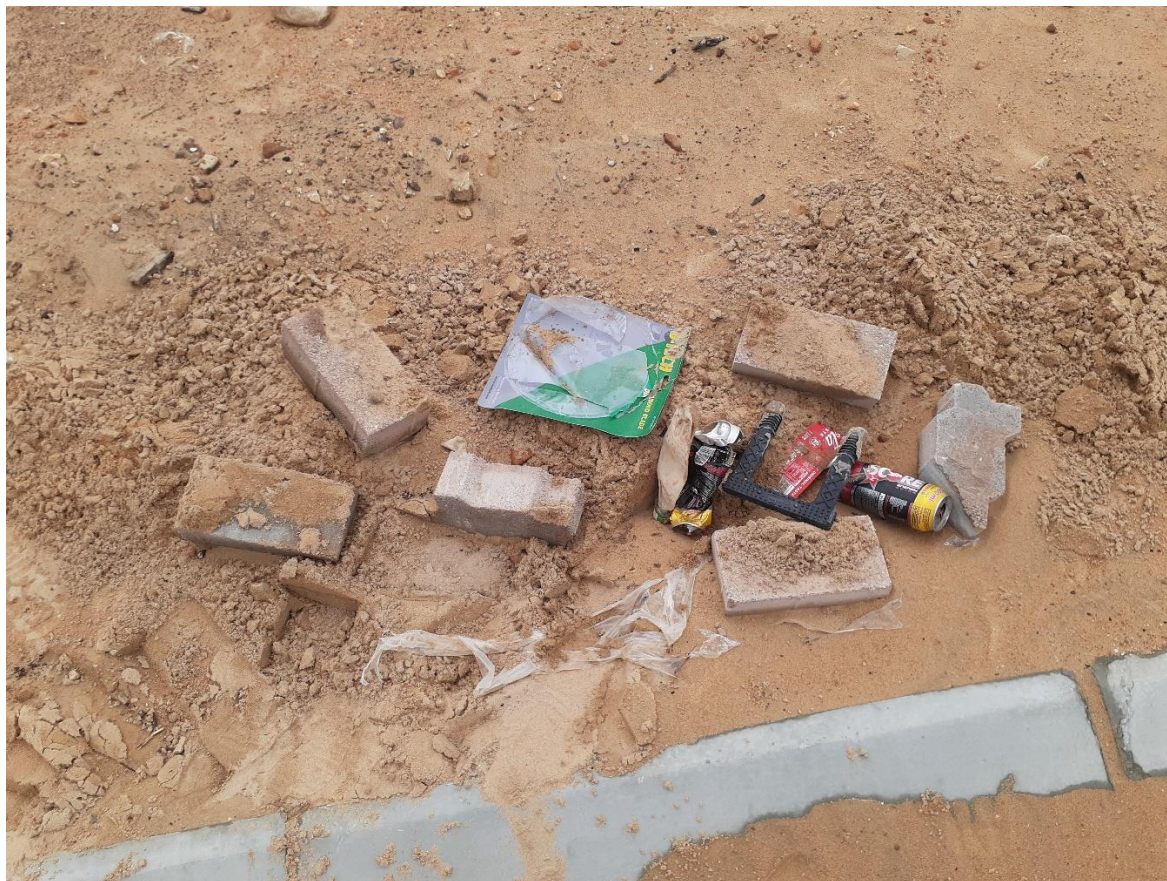
Photo 1: Plastic bottles, tins and packaging were scattered over the site, primarily by the paving crews.

ENVIRONMENTAL ASPECTS (PROJECT ACTIVITY)	REQUIRED ACTIONS	TARGET AND RESPONSIBILITY	COMPLIANCE	ECO COMMENTS
Storage of construction materials on site and concrete mixing areas (cont.)	waste disposal facility. The burning of solid waste and paper on site will not be allowed. Recyclable waste (e.g. paper, glass, tin, plastic) should be recycled if possible.			bottles and tins) lying around on site (Photo 1). Plastic bags had been given to the two paving teams working on site to fill with plastic wrapping removed from the paving bricks (Photo 2). The site foreman was informed to remove all litter from site before they closed down for the Xmas recess.

7. All parked mechanical vehicles must have a drip tray present to prevent spillage of oils and fuels.	ECO checked all construction vehicles and none of them were leaking oils or diesel.	C	The paving teams were informed about using drip trays beneath their petrol generators. Drip trays were being used beneath generators being used for cutting the paving (Photo 3).
Prevent possible negative impacts of construction personnel on the environment	1. Contractors will be responsible for the conduct of their personnel on site, as it pertains to trespassing, littering, and unacceptable social behaviour.	Contractor responsible for social management. ECO to monitor for duration of contract.	PC	All staff were observed within the construction area. Some littering was noticed on site (cooldrink bottles and tins, bread plastic bags and plastic wrapping of paving blocks) (Photo 1).

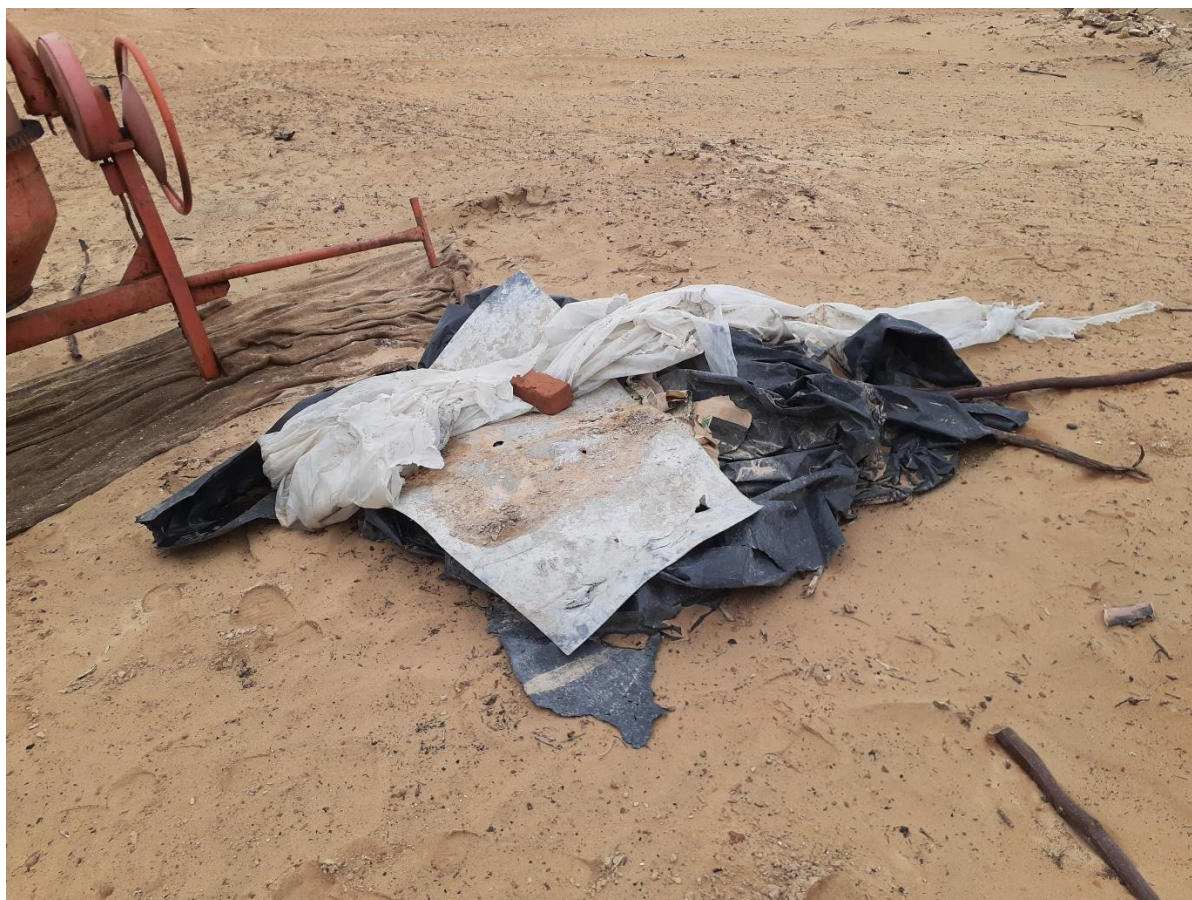
Photo 2: Plastic wrapping from the paving bricks were scattered around the site. The foreman on site was told to pick up all was and dispose of it at the Municipal waste disposal facility.

2. ECO must inform construction personnel of environmental rules to apply during construction period.	ECO to meet with contractor prior to commencement of construction in new areas to inform workers of the sensitivities of the site and how they should conduct themselves.	PC	The ECO met with the Contractor on 4 August 2022. The environmental awareness information was provided to the Contractor, and staff were inducted. The two paving teams were informed (17 November) about littering and that the plastic wrapping around the paving bricks were to be picked up and put into plastic bags for disposal (Photo 2).

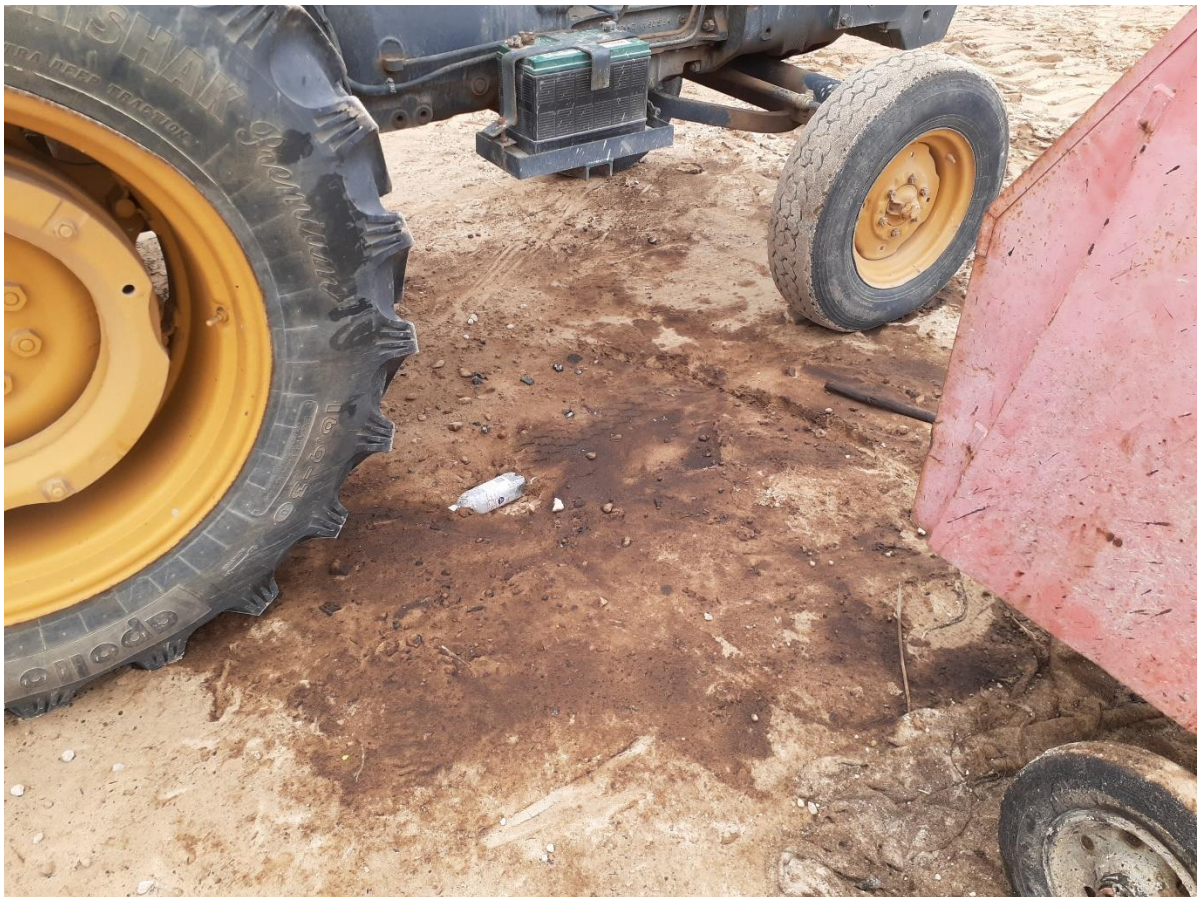
2. Prevent cement, bitumen, fuel and other hazardous material spills or clear such accidental spills as soon as possible. All hydrocarbon spills are to be addressed immediately to prevent seeping into the ground.	ECO and site agent to monitor for the duration of the contract period.	NC	Only diesel, oils and grease are being used on site. A diesel spill was recoded on site.

3. Refuelling may take place on site, provided adequate drip trays, spill absorbent material and fire fighting equipment are at hand	ECO and site agent to monitor for the duration of the contract period.	NC	Construction vehicles are filled by a mobile diesel bowser. One diesel spills was recorded on site.

Photo 4: A large diesel spill beneath the tractor was noted on the site. The foreman was informed to pick up the contaminated sand and dispose of it at the Municipal waste disposal facility.

2. All servicing of vehicles must have a drip tray to prevent accidental spillage of oils and fuels. Similarly, any stationary concrete mixers, dumpers, compressors or generators must have drip trays under them at all times, whether they are working or not.	ECO to monitor for duration of contract.	NC	Whilst driptrays are on site, there was a diesel spill beneath the tractor. The foreman was informed to remove the saturated sand from site and dispose of it at the Municipal waste facility.

ENVIRONMENTAL ASPECTS (PROJECT ACTIVITY)	REQUIRED ACTIONS	TARGET AND RESPONSIBILITY	COMPLIANCE	ECO COMMENTS
Prevent pollution/ contamination of soil	3. All vehicles, equipment, fuel and petroleum services and tanks must be maintained in a good condition that prevents leakages and potential contamination of soil.	ECO to monitor for duration of contract.	NC	All vehicles except for the tractor were in good working condition. The saturated sand will be picked up and disposed of at the Municipal waste disposal facility.

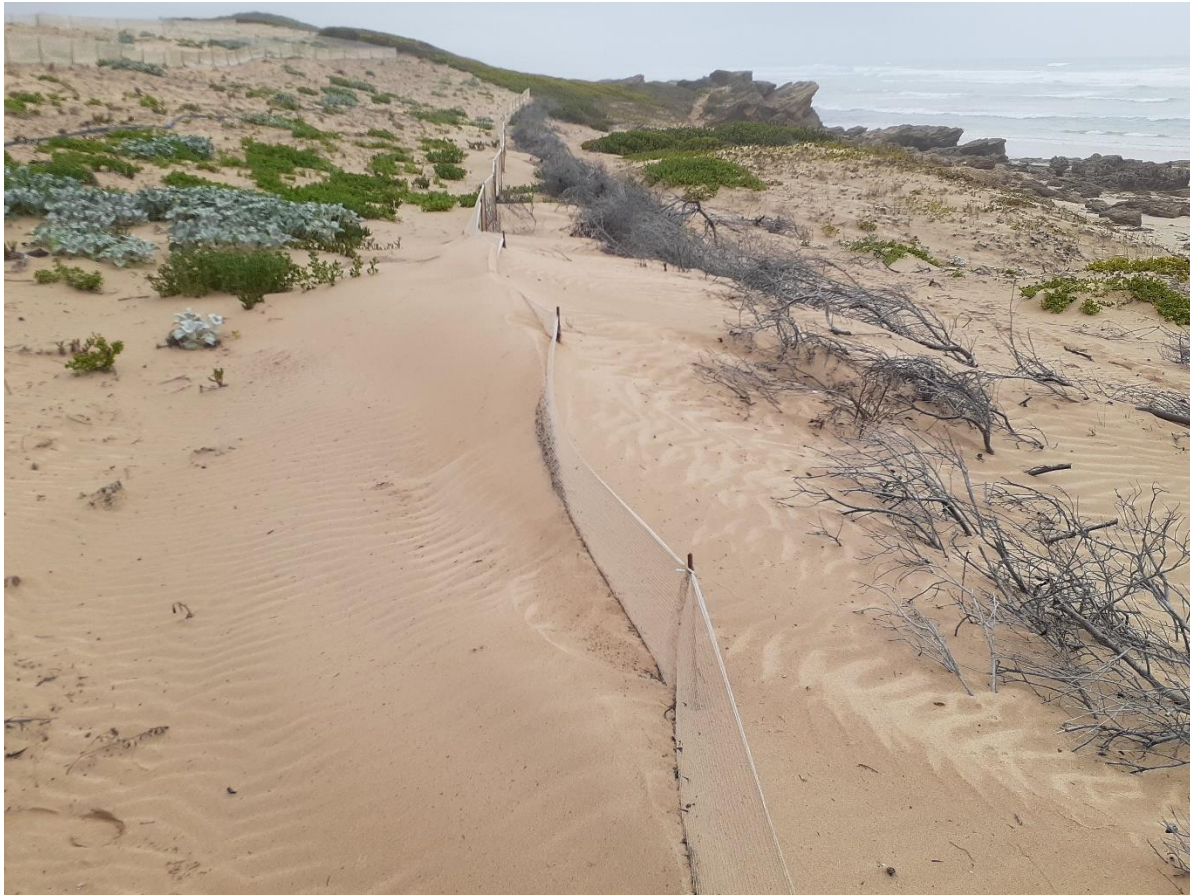
Photo 5: Dune sand has been blown off the beach and been trapped by the netting on the frontal dune system.

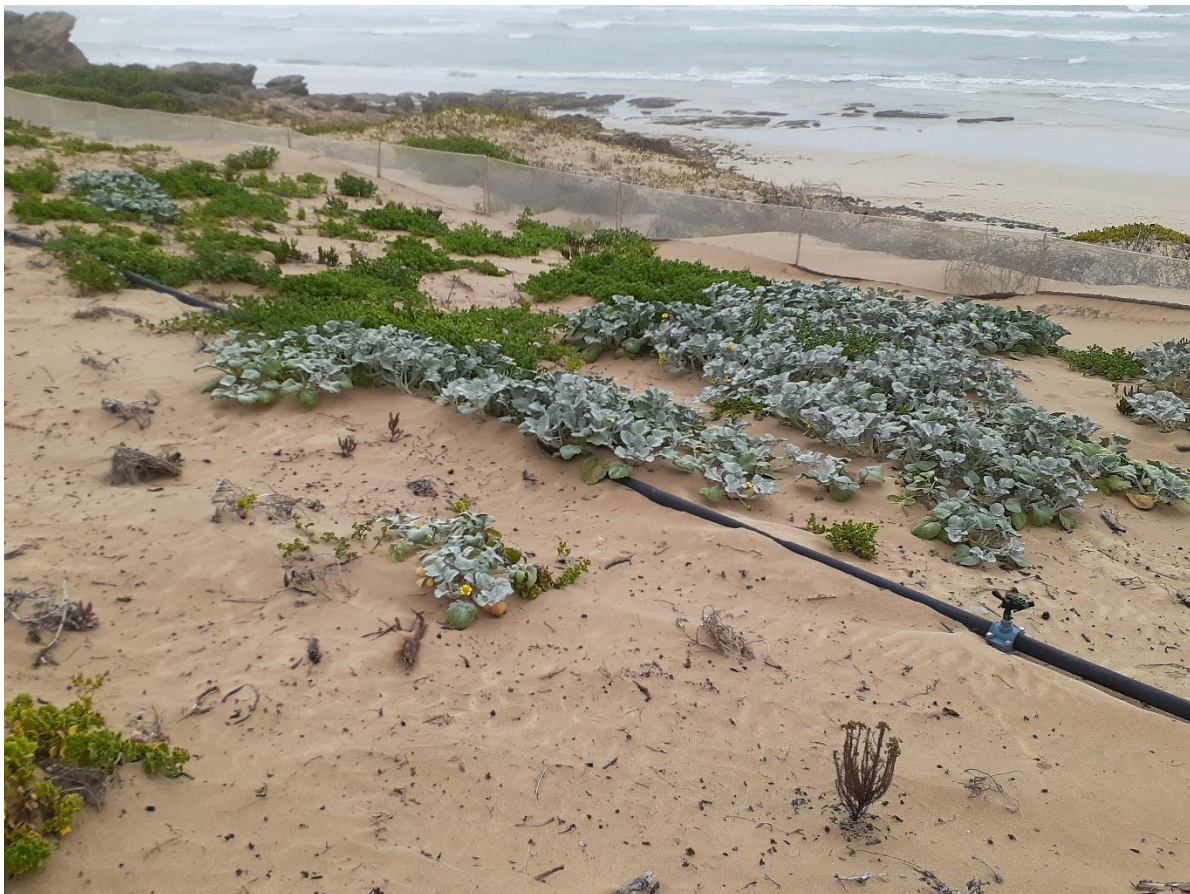
Photo 6: The strand plants are growing well between the netting on the frontal dune system.

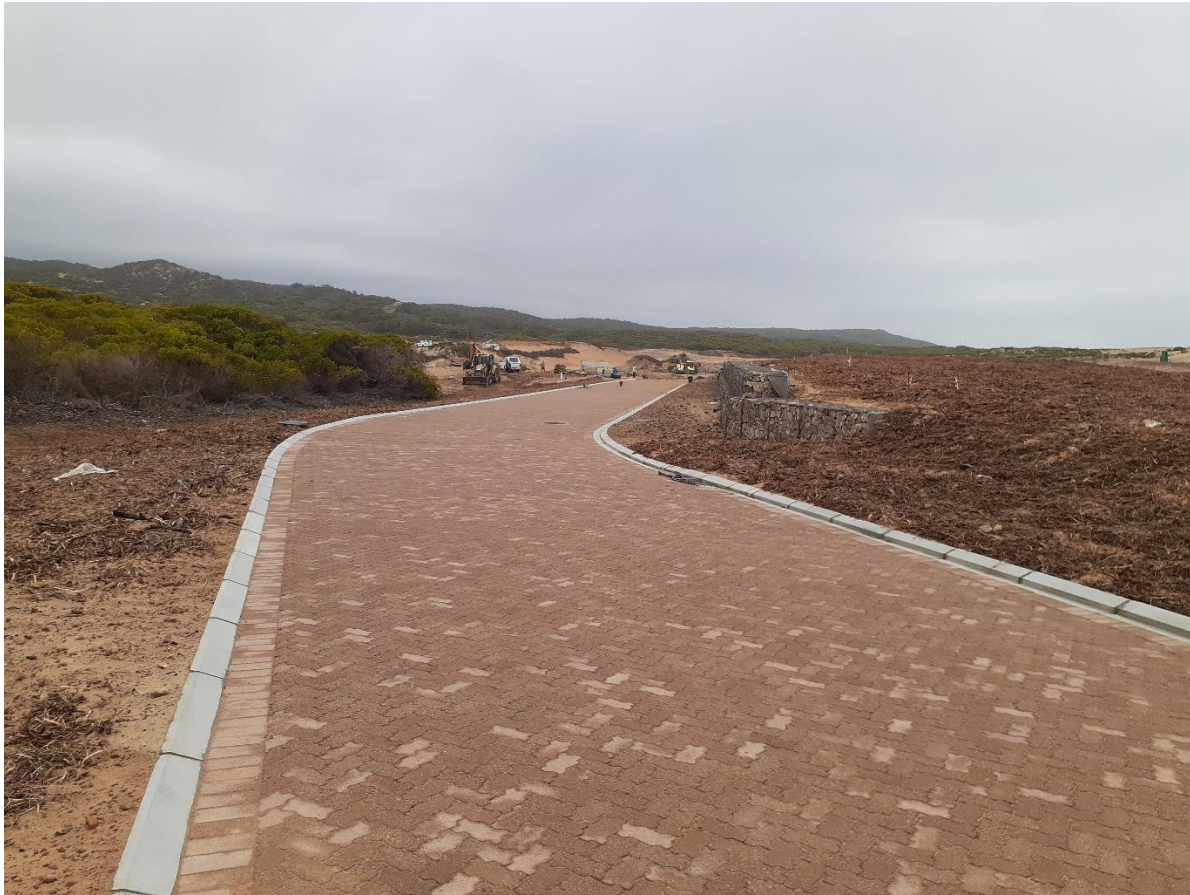
Photo 7: The paving of the roads for the first phase will be completed by the close for the Xmas break.

4. All fuels, oils and hydrocarbon products (e.g. tars) kept in tins and drums must be stored in a suitably bunded area to prevent pollution in case of spills or leakages.	ECO to monitor compliance for duration of contract.	C	Whilst oils and grease products are presently kept on site, no incidents of spills were noted, except for the diesel spill. Tar will not be used on site for the construction of the roads. The paving of the roads will be completed by the end of the week (Photo 7 and 8).

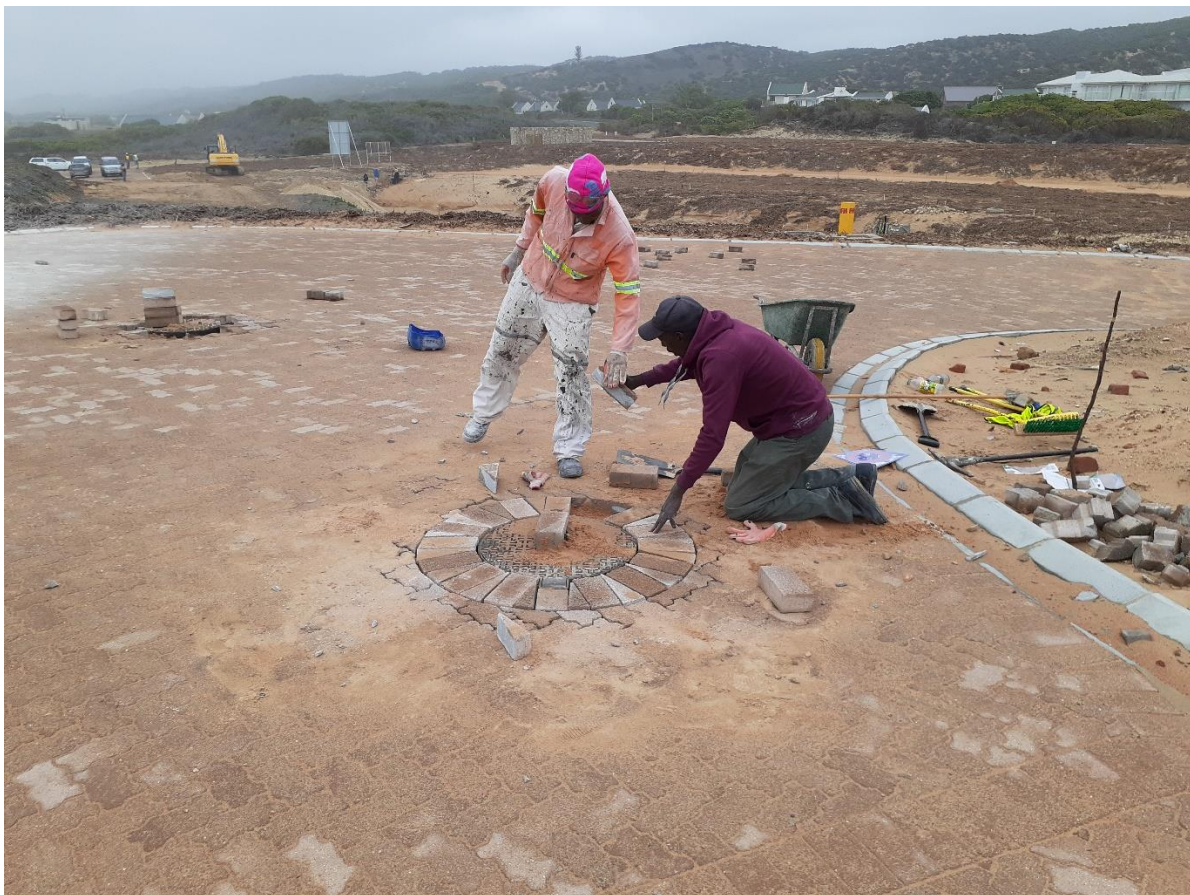
Photo 8: The manholes were all in place and the final paving was being undertaken around such manholes.
