**ECO CHECKLIST FOR THE BULK EARTHWORKS, DUNE
REHABILITATION AND THE CONSTRUCTION OF BULK
SERVICES FOR THE PREEKSTOEL BEACH LIFESTYLE
ESTATE ON PORTION 2 OF ERF 599 AND ERF 1028,
STILL BAY EAST, WESTERN CAPE**

File 1012 : ECO Checklist No.: 1

Date: 27 March 2022

ECO Checklist for Civils Construction

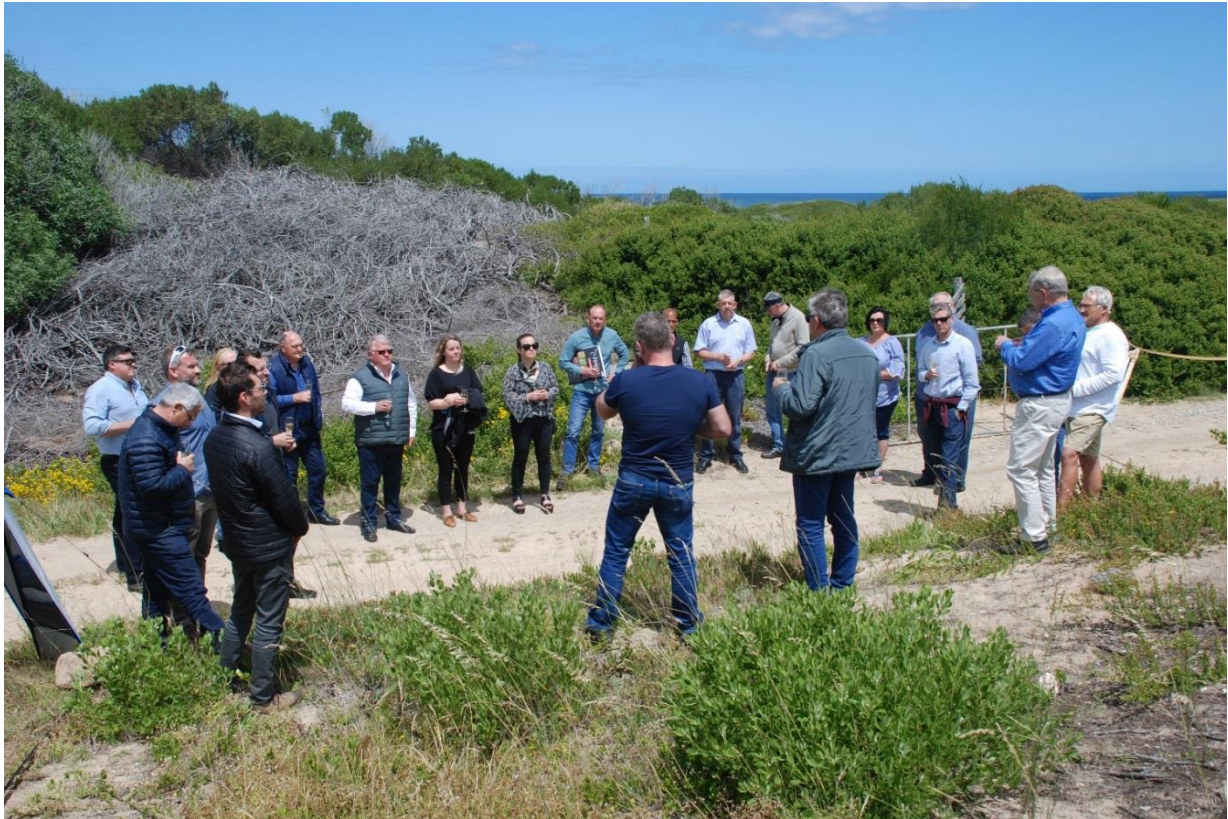
Photo 1: The site handover was held with the ASLA construction on 2 November 2021 at which the contractor was made aware of their environmental obligations.

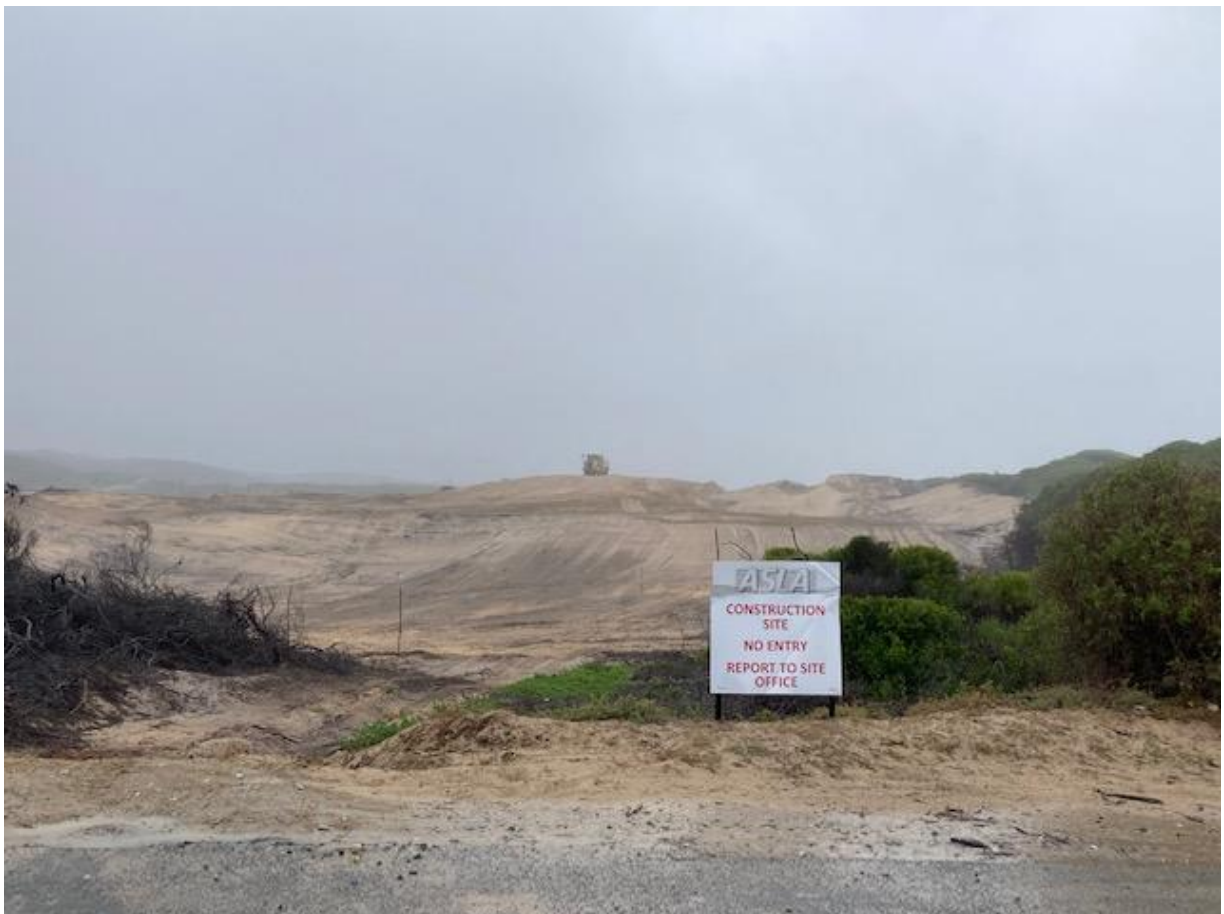
Photo 2: The notice board indicates that the public wishing to get to the Geelkrans Nature Reserve are to report to the site office (small container on site). The original board has been replaced with a larger sign board.

4. Appropriate signage that indicates the contact details of the Implementing Agent, Contractor, RE (or RE's representative) and ECO must be provided on site. Given that access across the site must remain open during the day, appropriate signage must be erected on the entrance gate warning visitors to the Nature Reserve about the movement of heavy construction vehicles.	The contractor's Notice Board has been erected at the entrance to the construction site. The signboard warning the public of heavy moving traffic is to be placed in the center of the entrance gate to the site.	PC	The contractor's Notice Board still needs to be placed at the entrance to the construction site. A signboard informing visitors to the nature reserve that they must report to the site office has been placed on the fence to the north of the entrance gate (Photo 2). It was suggested that this sign should be put in the middle of the gate. CapeNature are designing a sign board to be put up at the entrance to the construction site (arising from meeting with the Re on 24 March 2022).

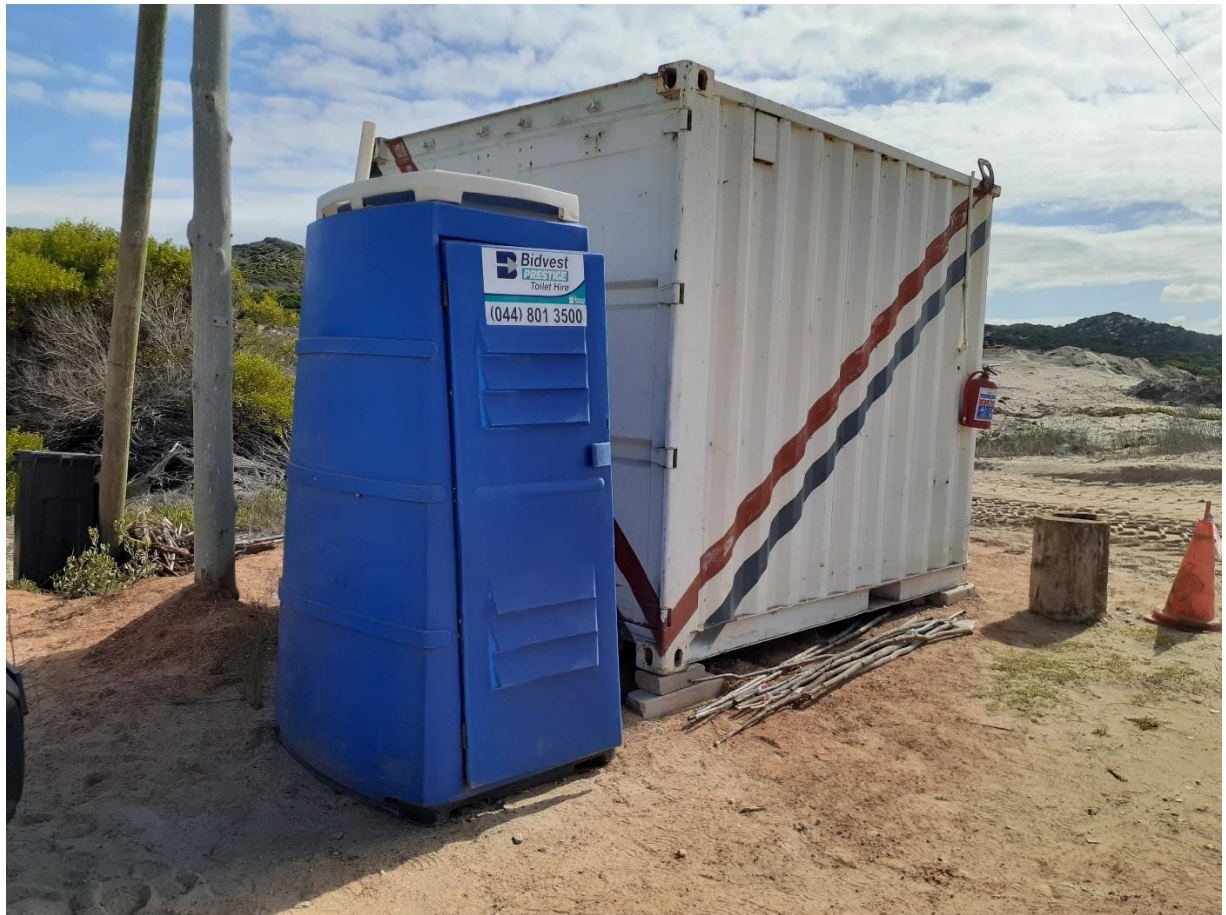
Photo 3: Temporary site office (container), mobile toilet and lidded dustbin are place on site within the out of work area.

2. The contractor must point out the site office.	To be sanctioned by the ECO and site agent before bulk earthworks commences.	C	Only a small container has been placed on the property to act as a temporary site office for the duration of the bulk earthworks (Photo 3).

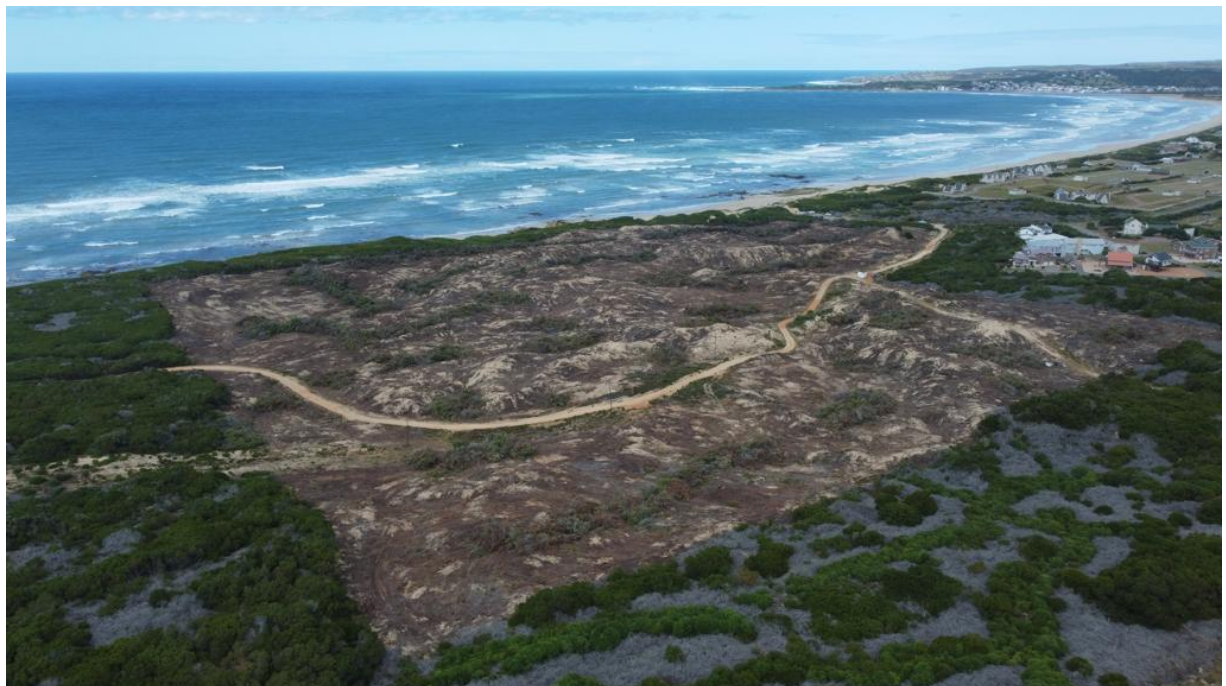
Photo 4: Cleared brushwood and mulch understorey have been put into windrows ready for chipping.

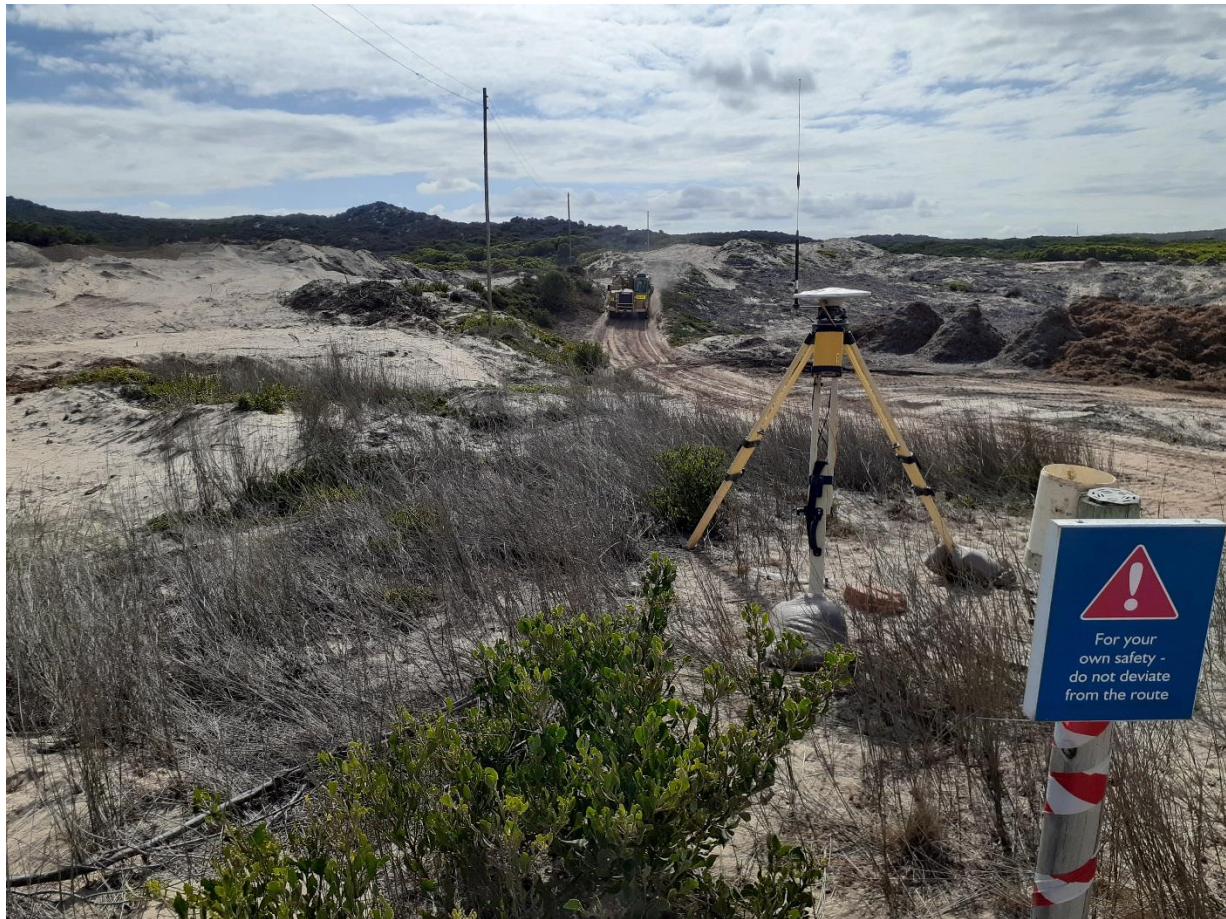
Photo 5: Wood chips heaps place on the de-grubbed site (top right corner of photo. Note the heavy scraper on the haul road.

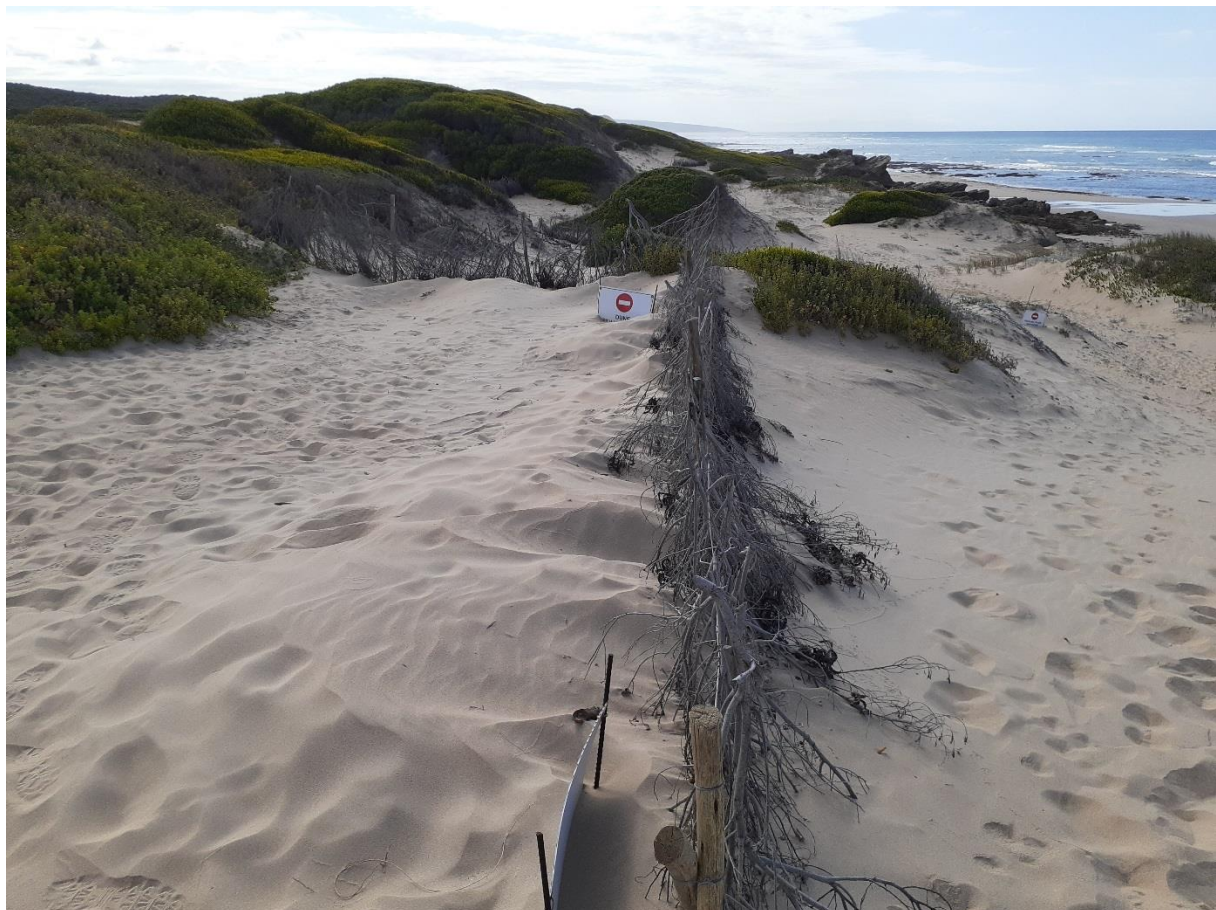
Photo 6: Example of a brushwood fences that have trapped windblow sand off the beach and frontal dune.

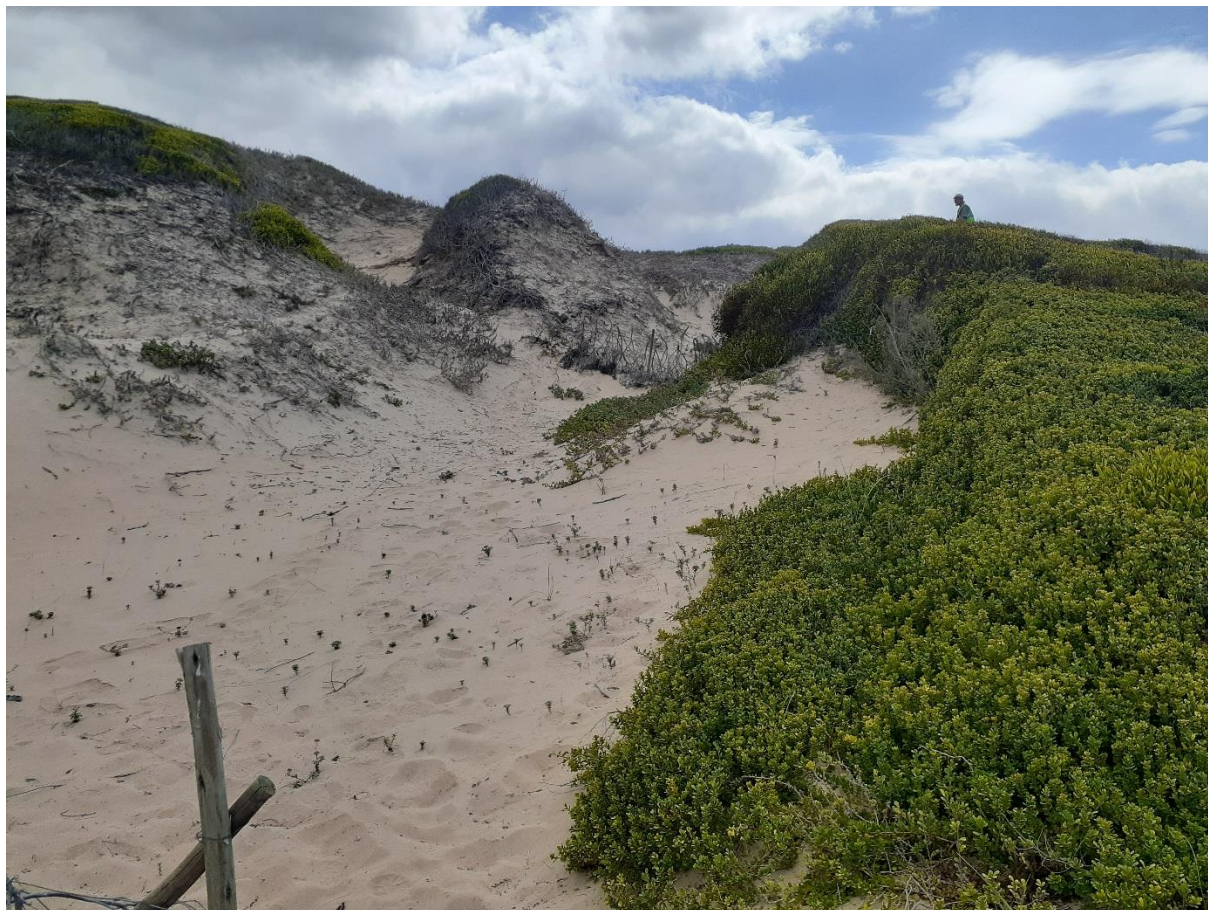
Photo 7: Shows the large blow-outs on the back dune area. Note the stable low angle of the backdune area.

ENVIRONMENTAL ASPECTS (PROJECT ACTIVITY)	REQUIRED ACTIONS	TARGET AND RESPONSIBILITY	COMPLIANCE	ECO COMMENTS
Rehabilitate all areas where soil erosion has taken place	1. The badly eroded frontal dune system must be rehabilitated by trapping windblown sand using brushwood fences placed at strategic points	If the brushwood fences (Photo 7) take too long in trapping sand moved off the beach by wind, sand harvested from the interior of the property can be used to fill in blowouts (Photo 8) and reshape dunes. The ECO and the specialist dune rehabilitation company, VULA, will be responsible for such rehabilitation.	C	The back-dune area of the frontal dune system has grown in size (by at least 2m over a period of about 20 years) by rooikrans trapping windblown sand off the beach and from prolonged blow-outs. It is envisaged to mechanically drag such sand back towards the beach to get a stable, low angle dune front, which will be rehabilitated with locally indigenous strandveld plants. Shade netting rows will be used for long term trapping of sand off the beach and prevent erosion of the newly formed back-dune.

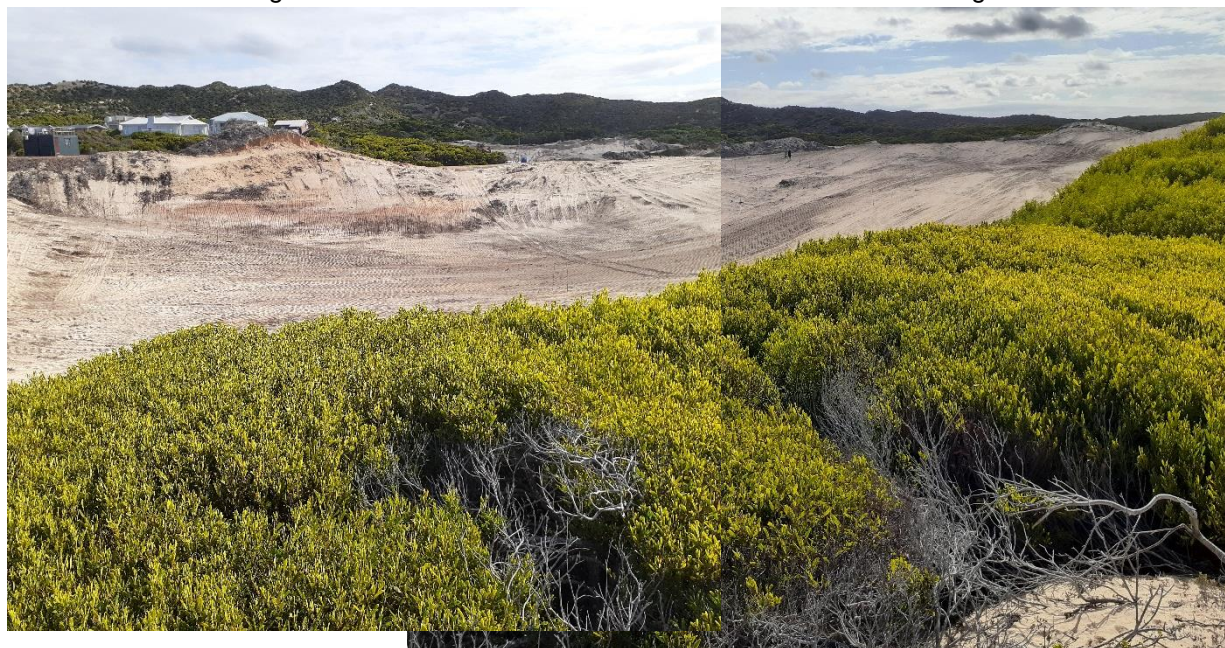
Photo 8: The entire site has been de-grubbed

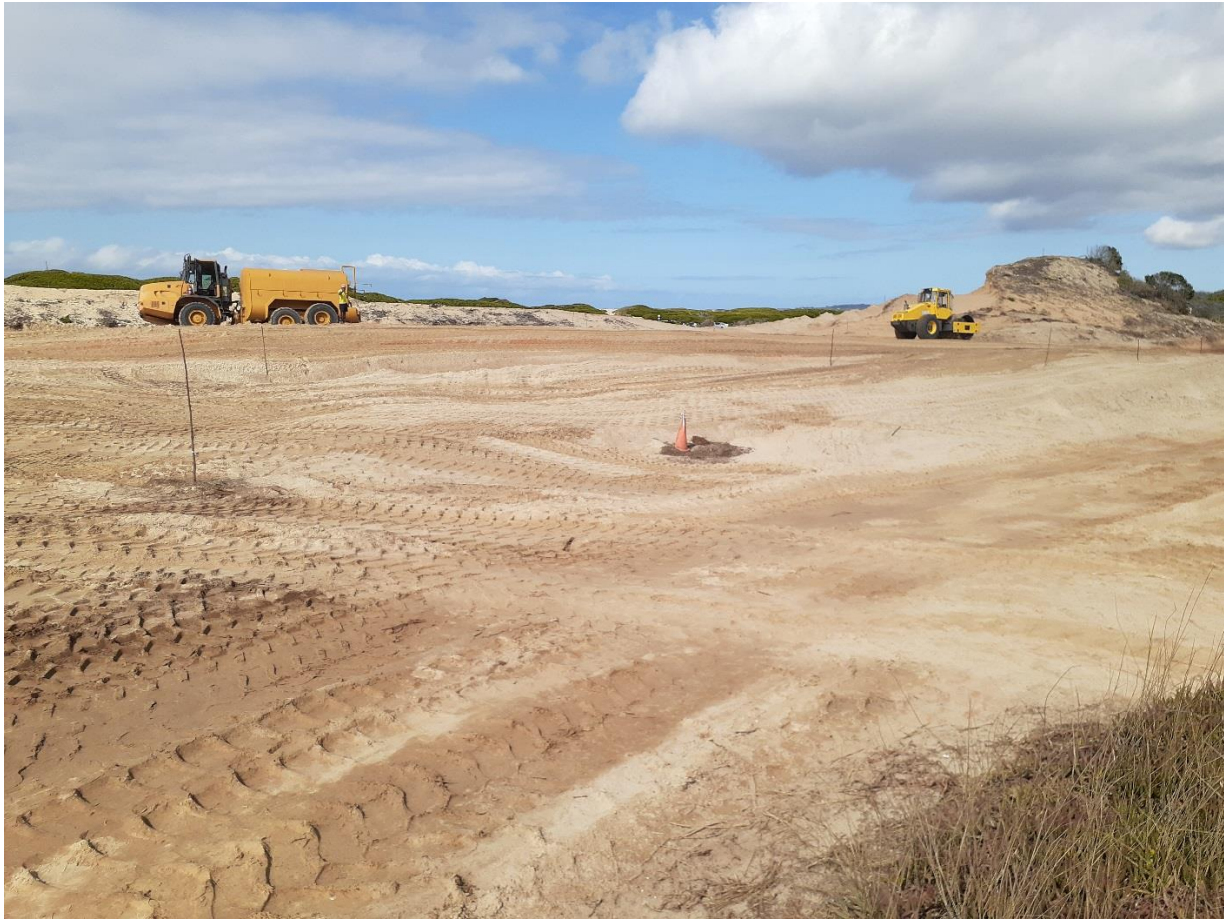
Photo 9: Phase 1 platforms are presently being constructed.
