GEOTECHNICAL REPORT

FOR THE PROPOSED RESIDENTIAL DEVELOPMENT ON THE SUBDIVISION OF ERF 19374 GEORGE

1 July 2022

Revision 0

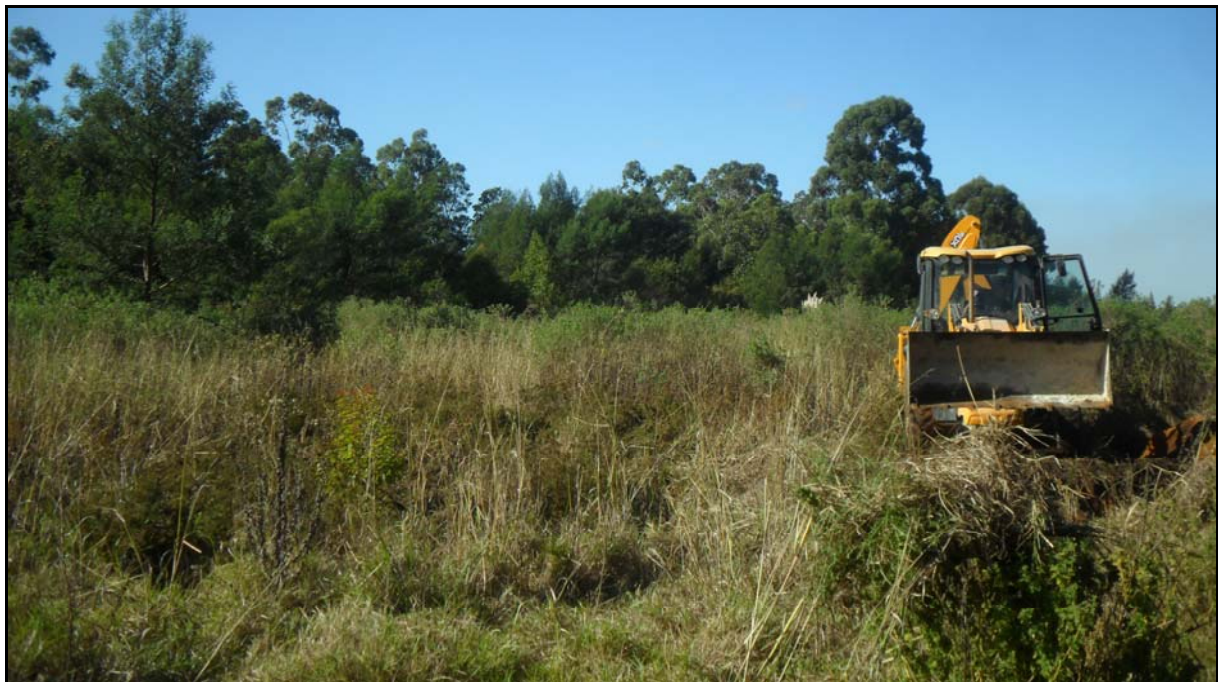
Figure 3: View of the typical terrain and vegetation on the central part of site

The site was situated just north of the residential area of Heather Park in George. At the time of the investigation the site was vacant and was easily accessible via the existing municipal roads leading to the southern and eastern boundaries of the site (see **Figure 2**). The vegetation consisted of long grass and medium sized bushes and some large trees along the western and eastern boundaries (**Figure 3**). The topography was described as very gentle but becoming steep along the western boundary, which falls downward towards the Malgas River which runs along this boundary, flowing in a southerly direction.

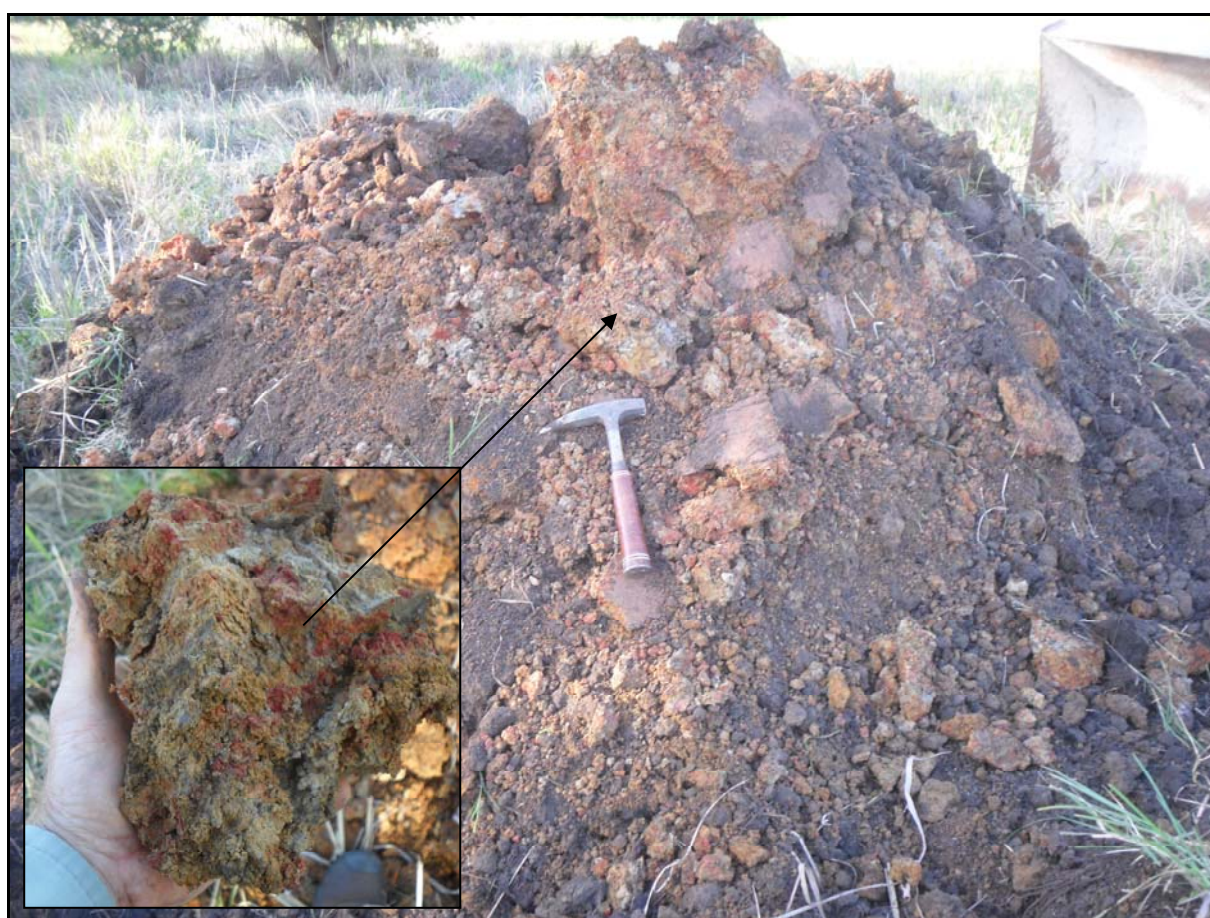
Figure 5: Active residual clay extracted from test pits

sandy matrix), which was then underlain by clayey sandy gravelly residual soil derived from the complete weathering of the underlying feldspathic sandstone or hornfels. The underlying rock was only encountered in a few of the pits. The general soil profile was recorded as follows:

- 0-500mm: Moist to very moist, dark brown, soft to firm, intact, clayey silt with abundant roots (topsoil).
- 500-900mm: Moist, light brown, medium dense, intact, silty fine sand, colluvium.
- 900-1100mm: dark red orange, medium dense, pinholed & voided, clay & sandy gravel (ferricrete), pedogenic.
- 1100-2000mm: Moist, mottled light brown & dark red orange, stiff, micro-shattered & slickensided, silty clay with scattered gravel & cobbles, residual (completely weathered feldspathic sandstone – see **Figure 5**).
- >2000mm: Blotched grey & red orange, highly to completely weathered, highly fractured, soft rock, feldspathic sandstone/hornfels.

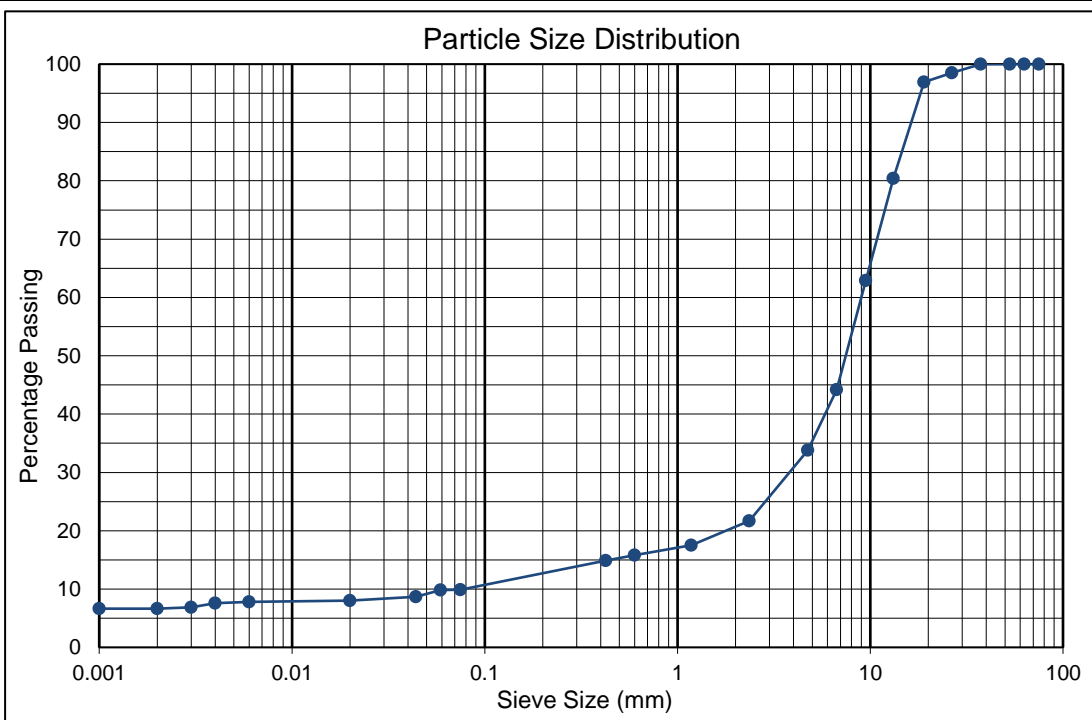
Sample Position (SV)	TP 1 - Layer 3
Depth (mm):	700 - 1200
Sample No.:	83973
Materials Description	In-Situ Dark Red Orange Well Graded Gravel with Silt and Sand Existing
Soil Type	
Classification

Liquid Limit (%)	44
Plasticity Index (%)	16
Linear Shrinkage (%)	8
Moisture Content (%)	12.1

% Clay	7
% Silt	3
% Sand	10
% Gravel	80

Unified Soil Classification	GW-GM
AASHTO Soil Classification	A-2-7

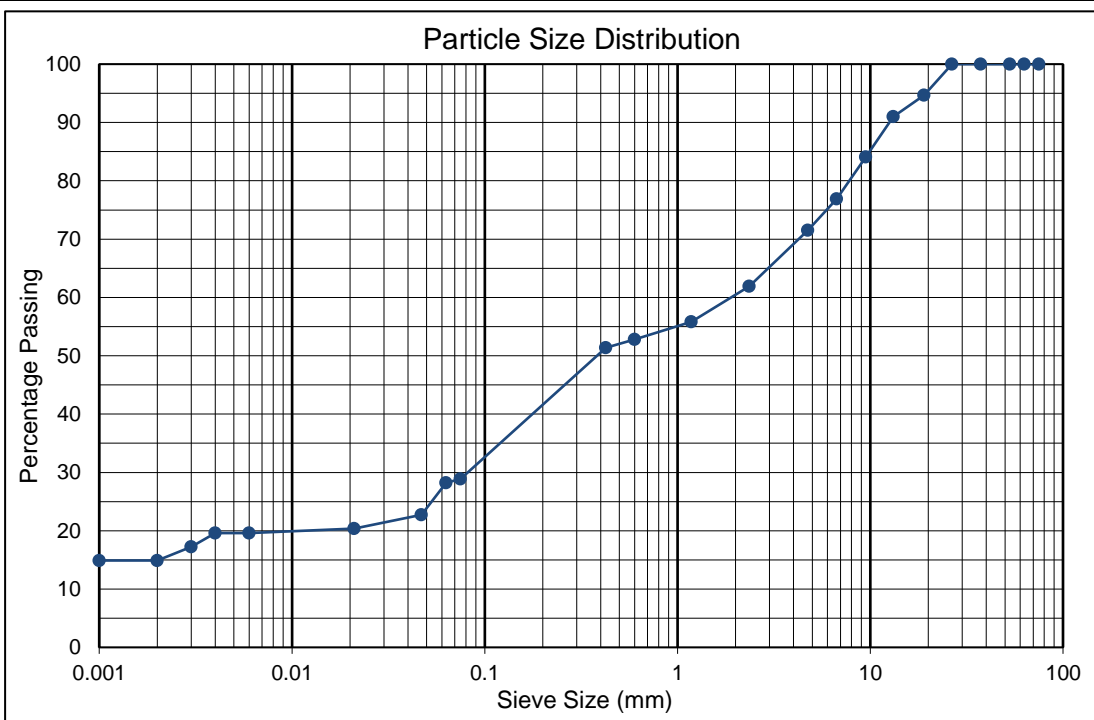
Sample Position (SV)	TP 3 - Layer 3
Depth (mm):	500 - 1000
Sample No.:	83974
Materials Description	In-Situ
Source	Light Brown - Light Yellow Orange
Colour	Silty/Clayey Gravel with Sand
Soil Type	Existing
Classification

Liquid Limit (%)	24
Plasticity Index (%)	4
Linear Shrinkage (%)	2
Moisture Content (%)	8.2

% Clay	15
% Silt	12
% Sand	33
% Gravel	40

Unified Soil Classification	GM-GC
AASHTO Soil Classification	A-2-4

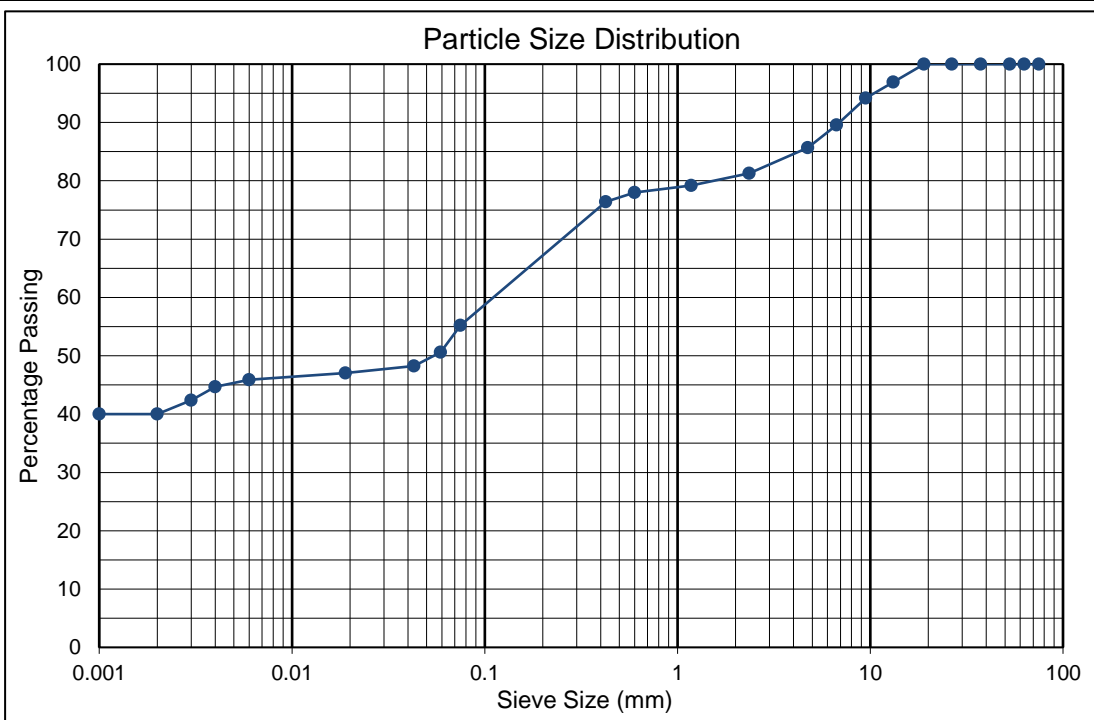
Liquid Limit (%)	70
Plasticity Index (%)	26
Linear Shrinkage (%)	13
Moisture Content (%)	33.8

% Clay	40
% Silt	11
% Sand	30
% Gravel	19

Unified Soil Classification	MH
AASHTO Soil Classification	A-7-5

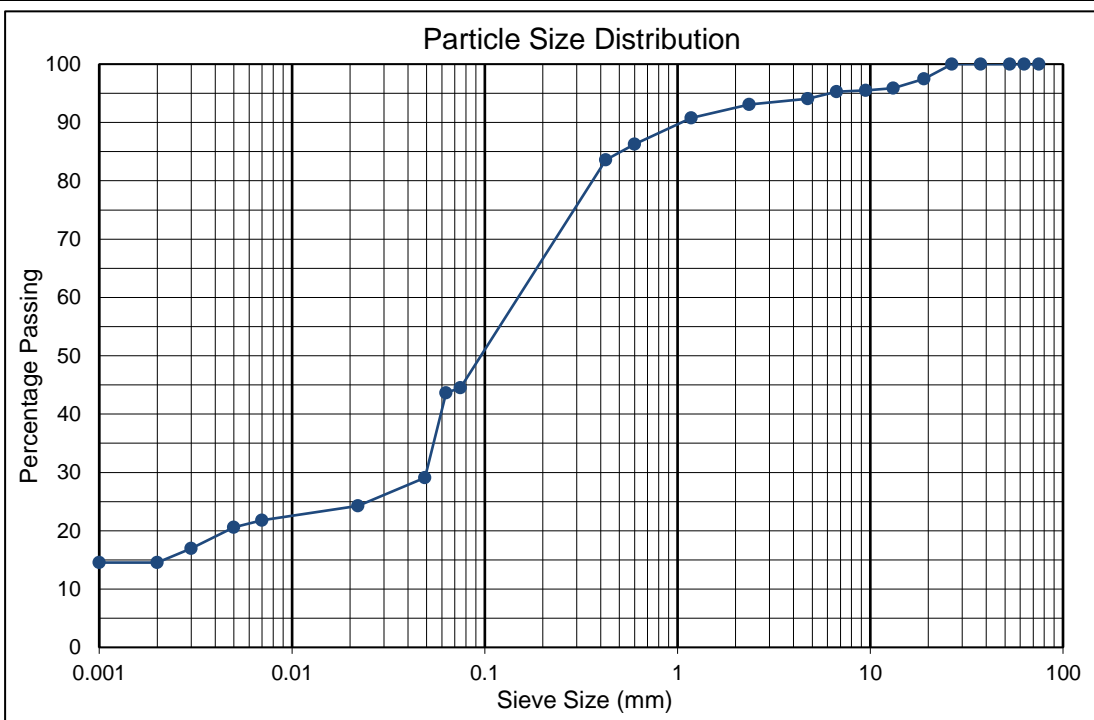
Liquid Limit (%)	21
Plasticity Index (%)	5
Linear Shrinkage (%)	3
Moisture Content (%)	17.2

% Clay	15
% Silt	25
% Sand	52
% Gravel	8

Unified Soil Classification	SM-SC
AASHTO Soil Classification	A-4

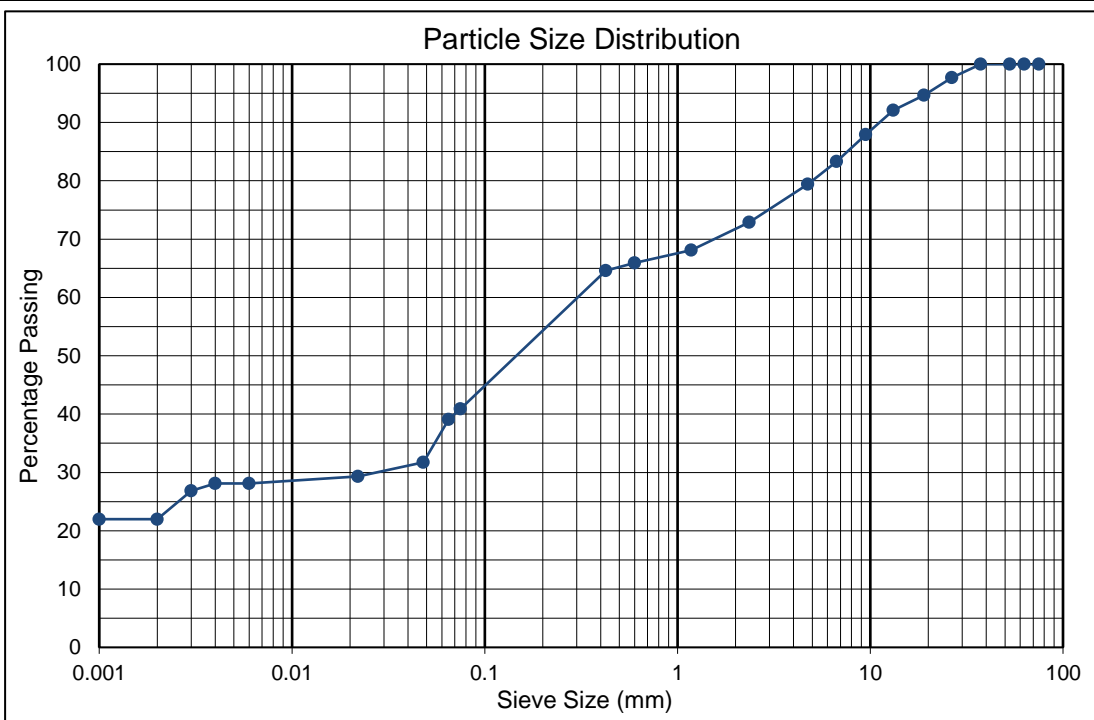
Liquid Limit (%)	23
Plasticity Index (%)	4
Linear Shrinkage (%)	2
Moisture Content (%)	10.5

% Clay	22
% Silt	15
% Sand	34
% Gravel	29

Unified Soil Classification	SM-SC
AASHTO Soil Classification	A-4

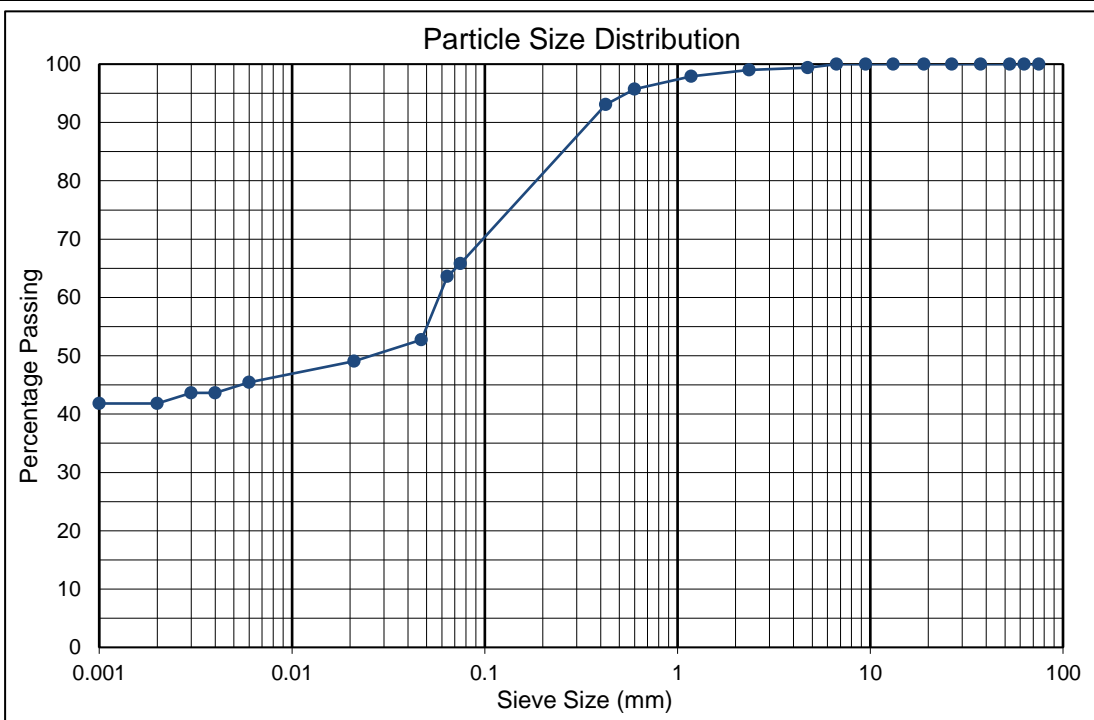
Liquid Limit (%)	50
Plasticity Index (%)	25
Linear Shrinkage (%)	13
Moisture Content (%)	23.0

% Clay	42
% Silt	19
% Sand	38
% Gravel	1

Unified Soil Classification	CL
AASHTO Soil Classification	A-7-6

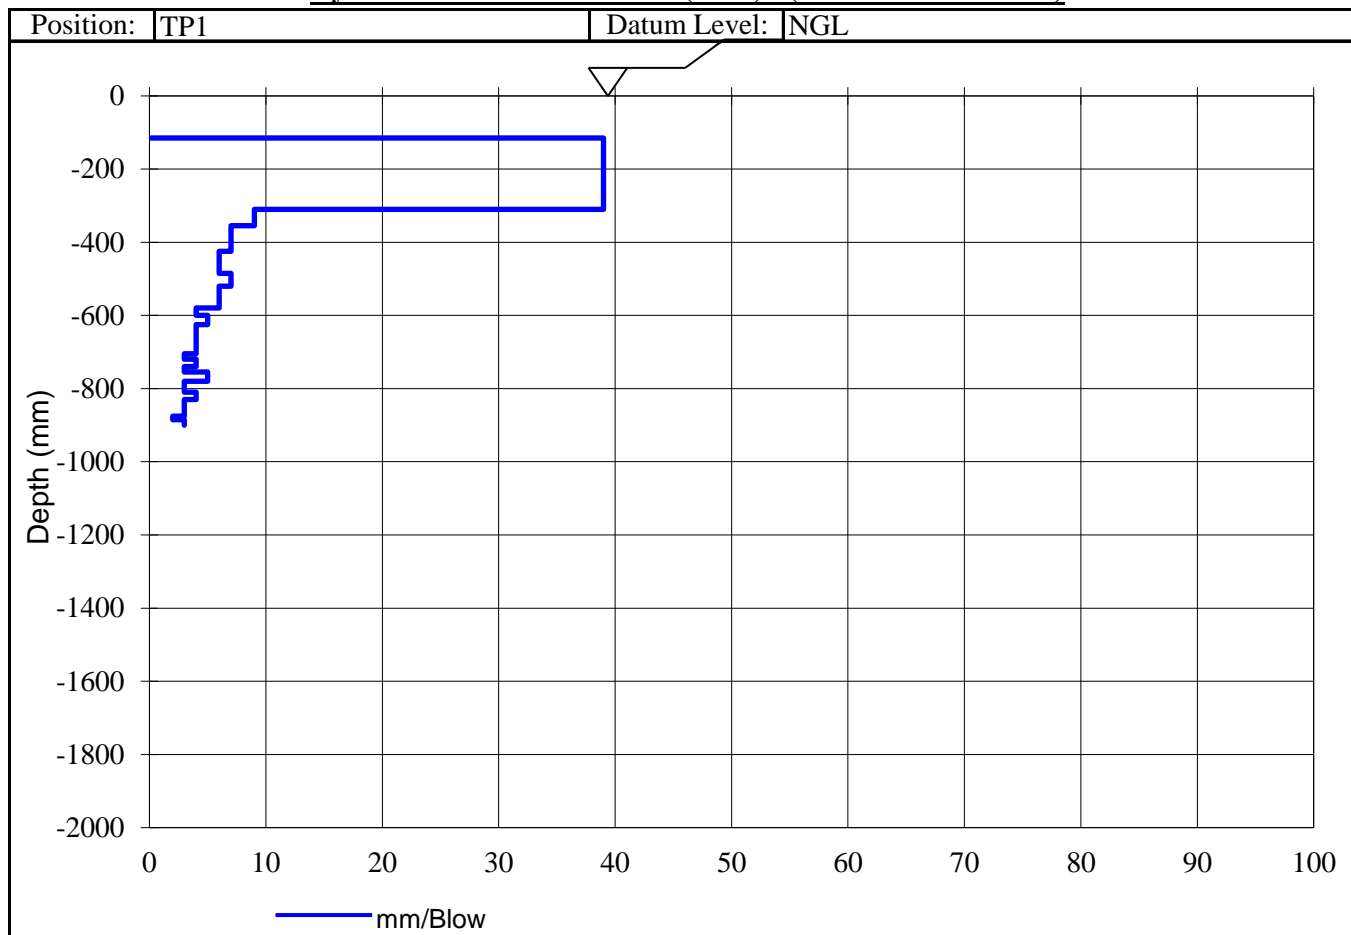
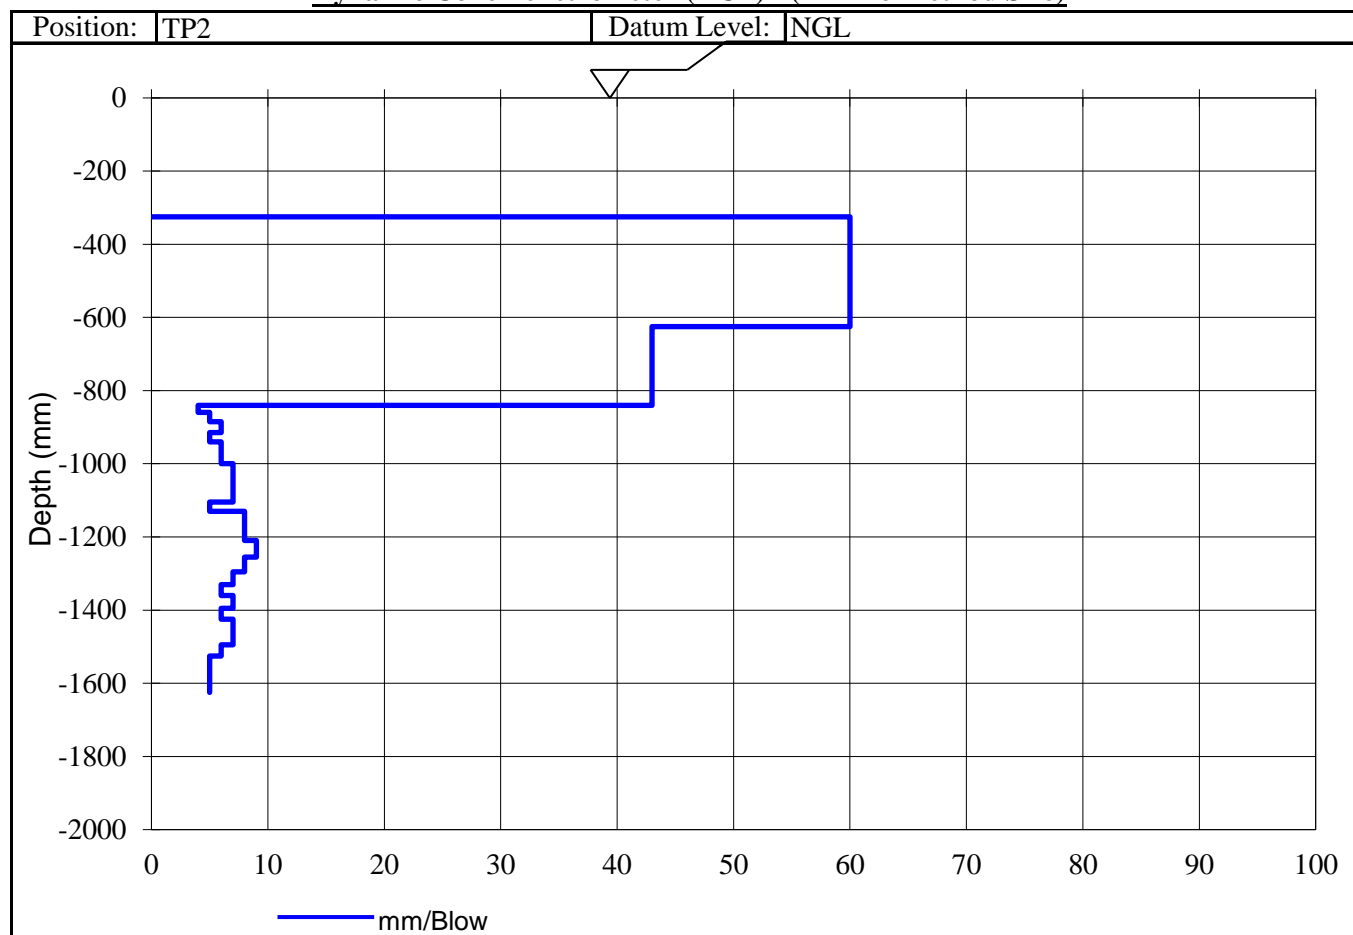
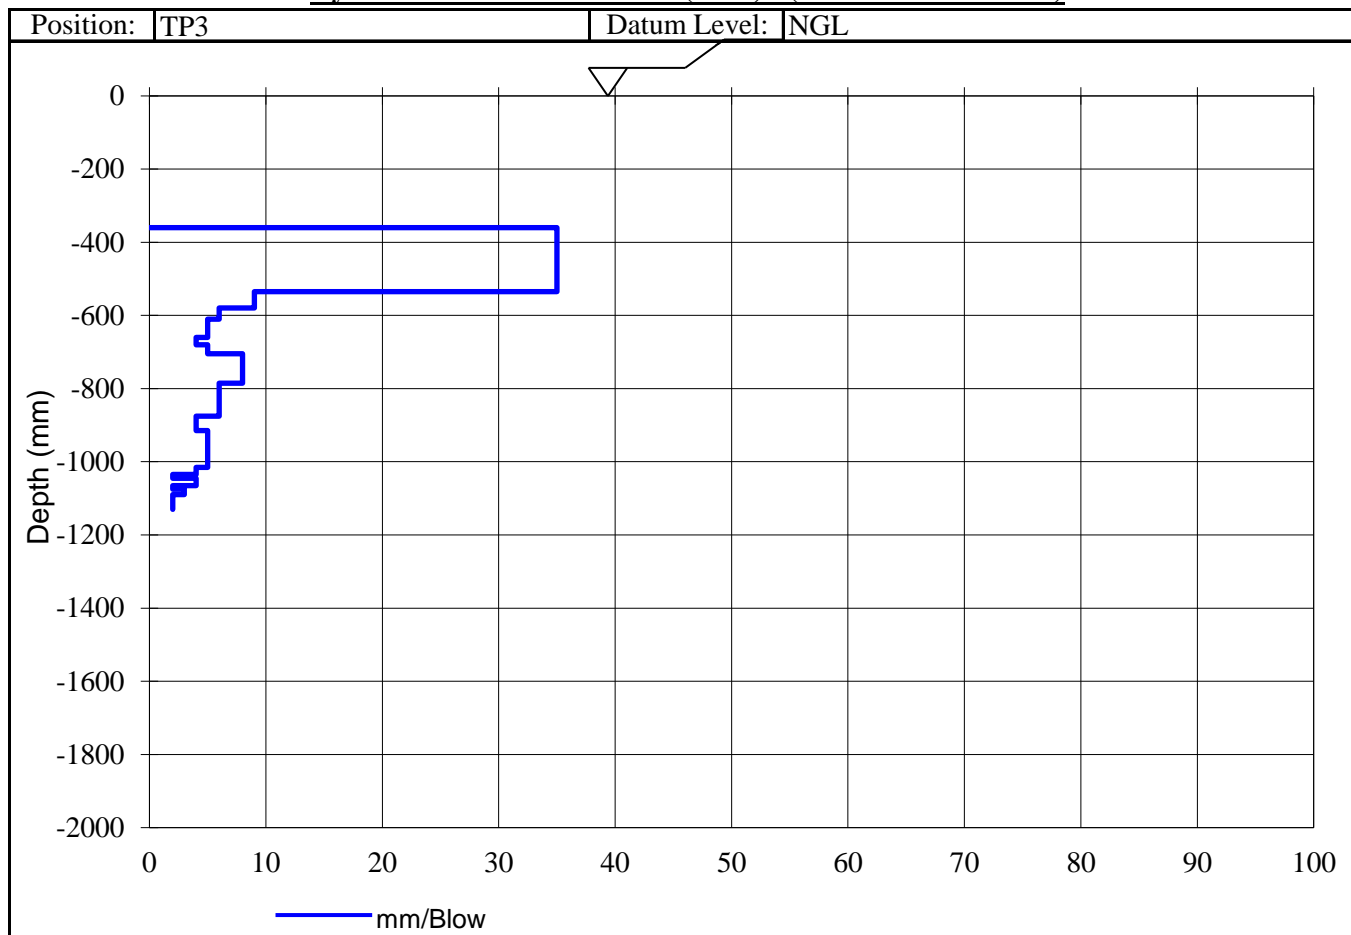
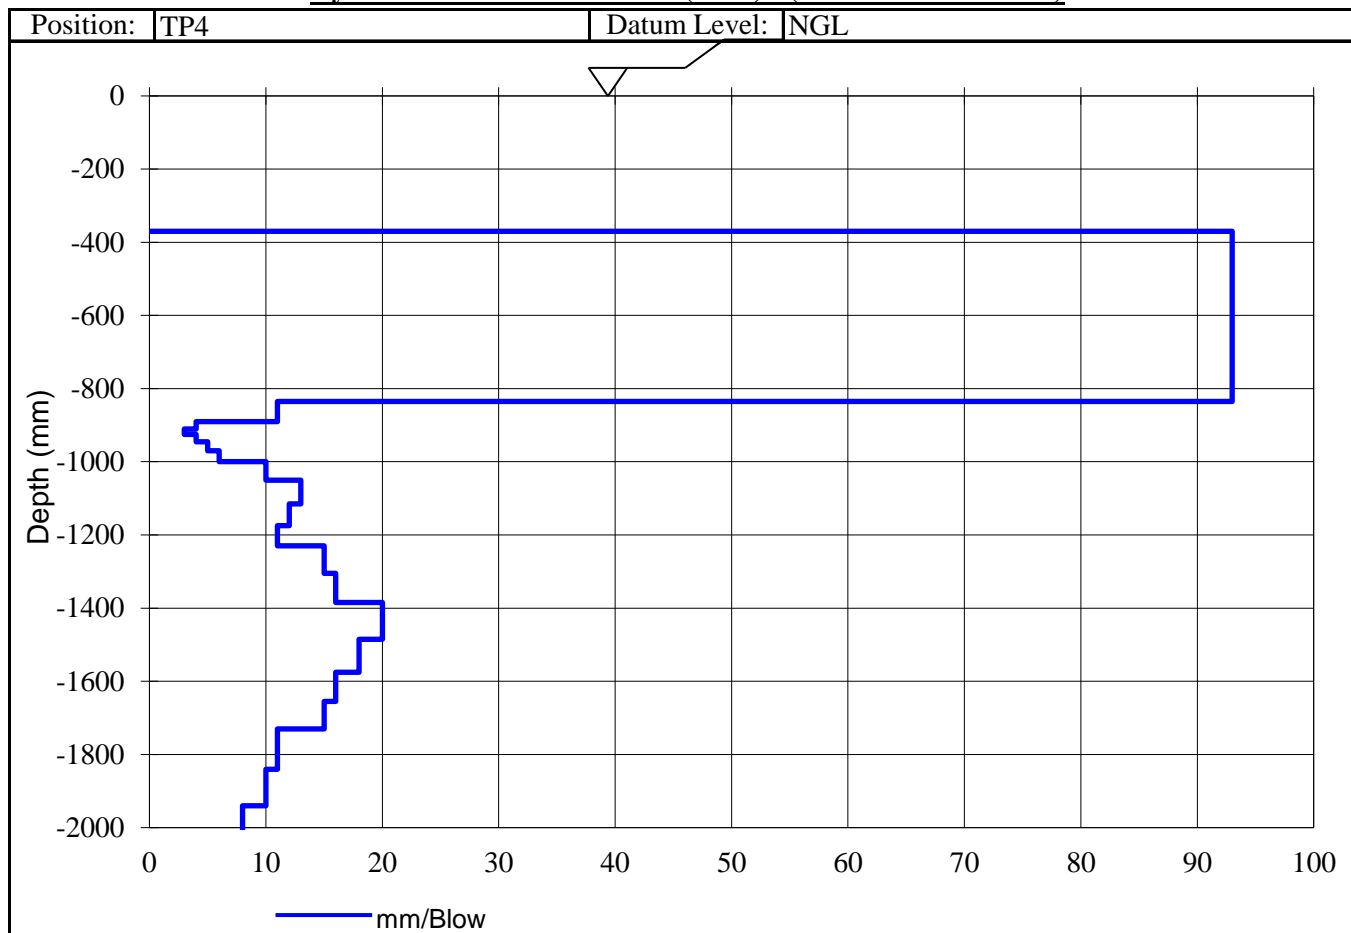
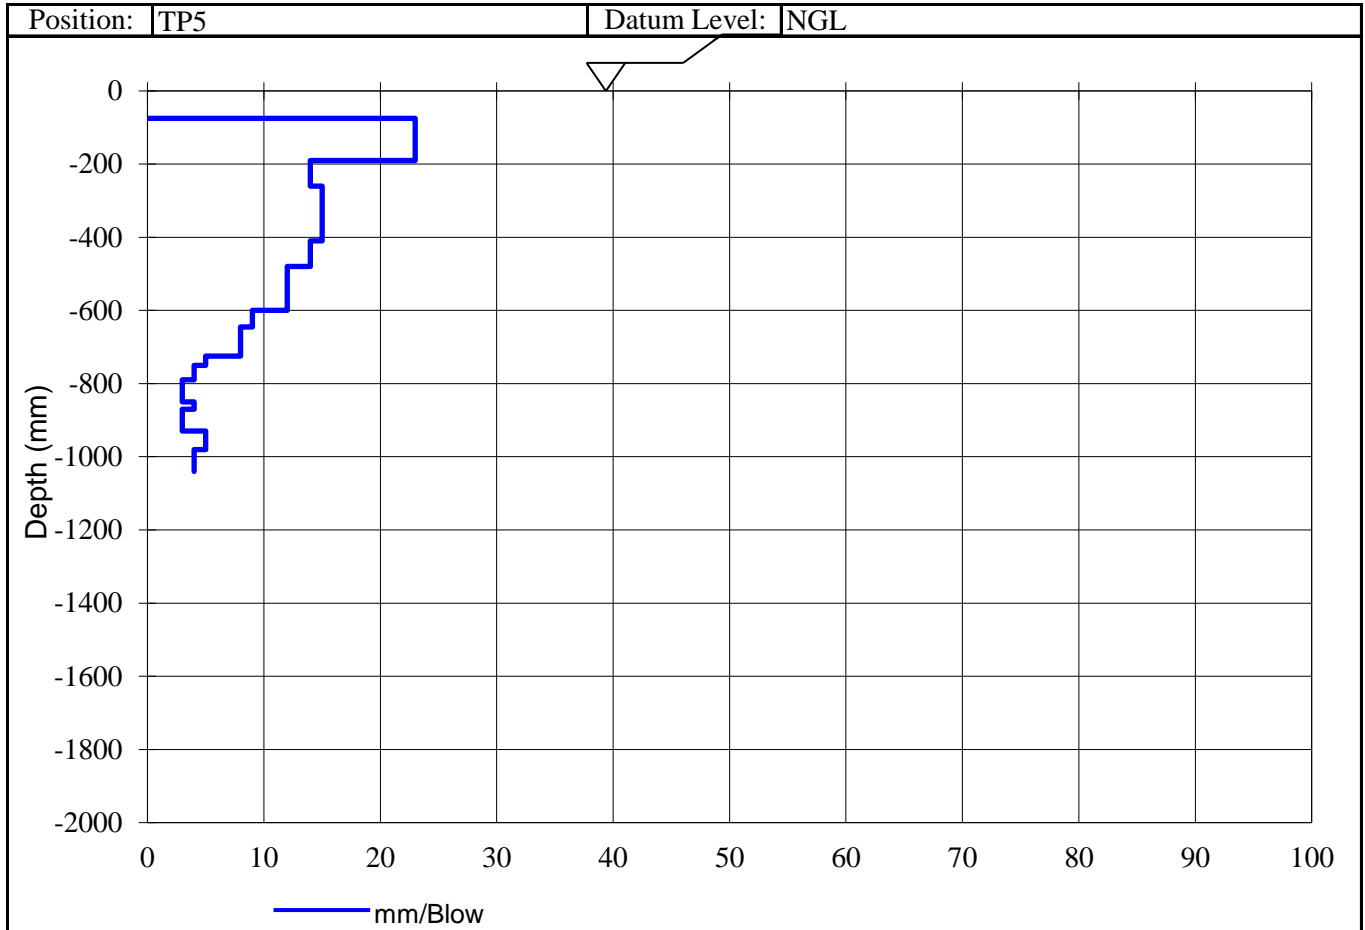
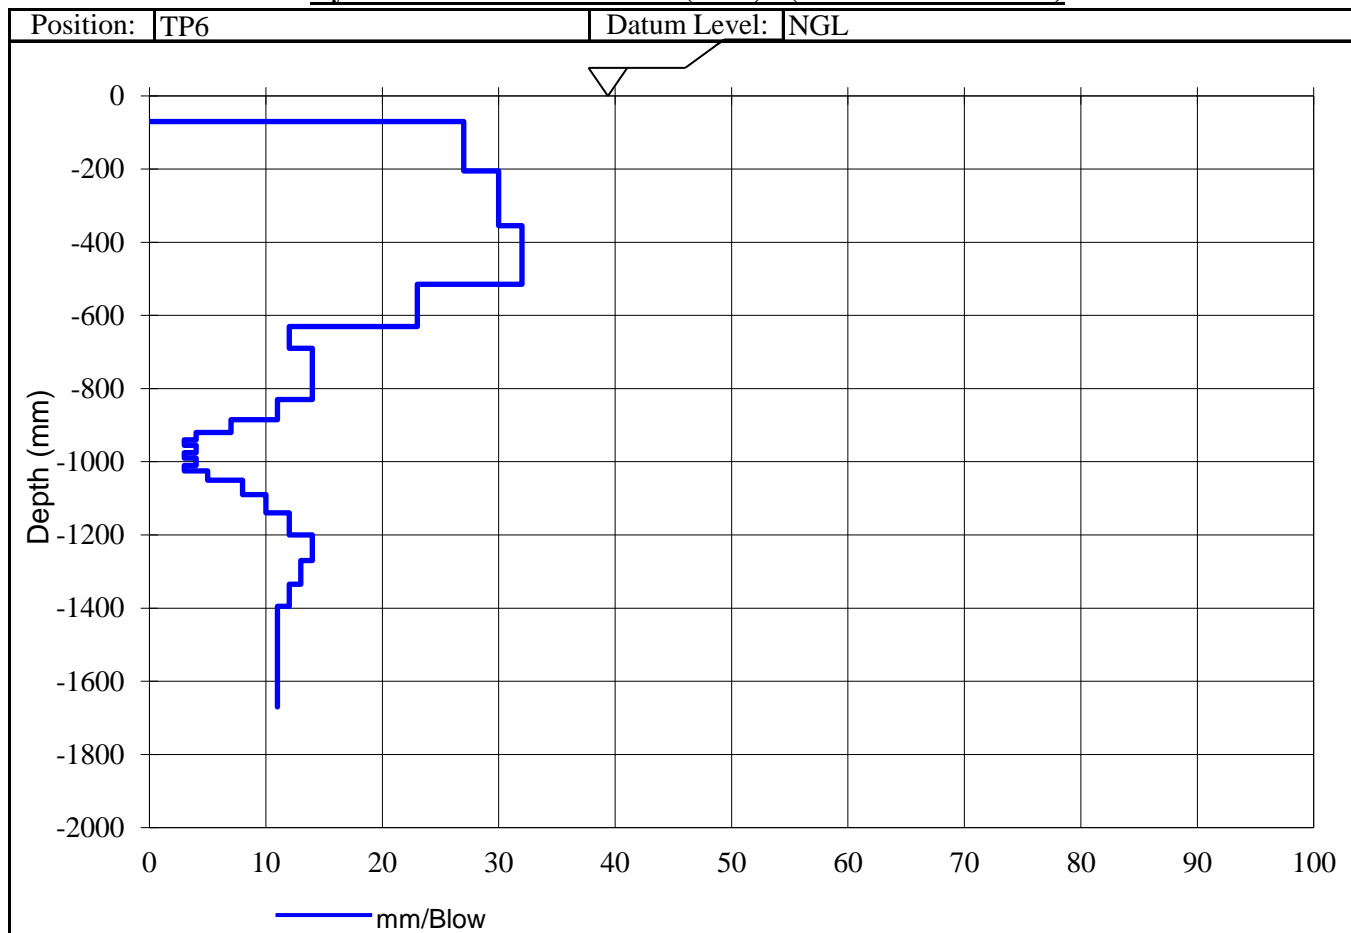
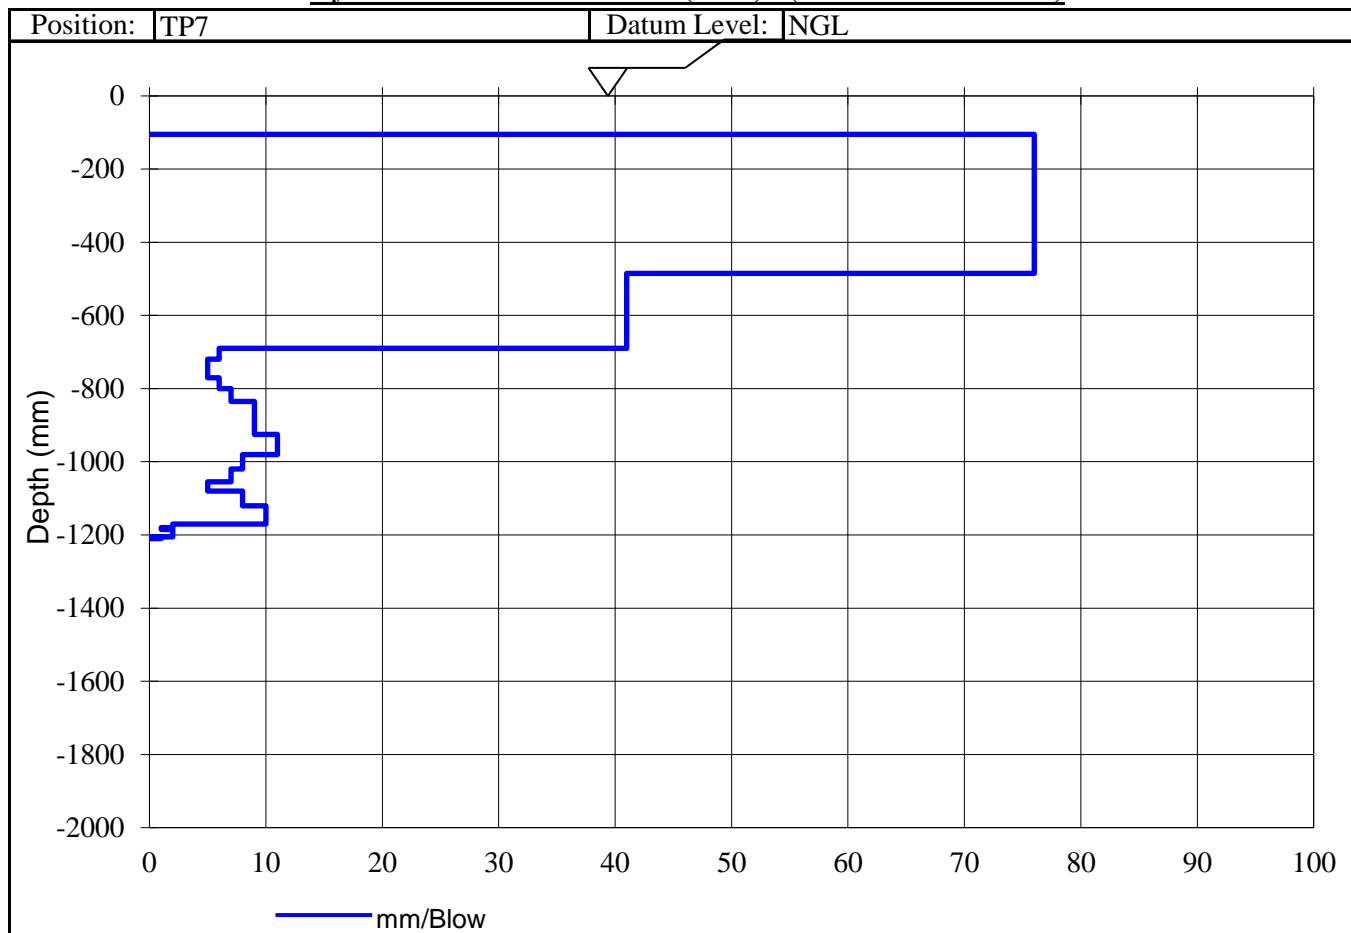
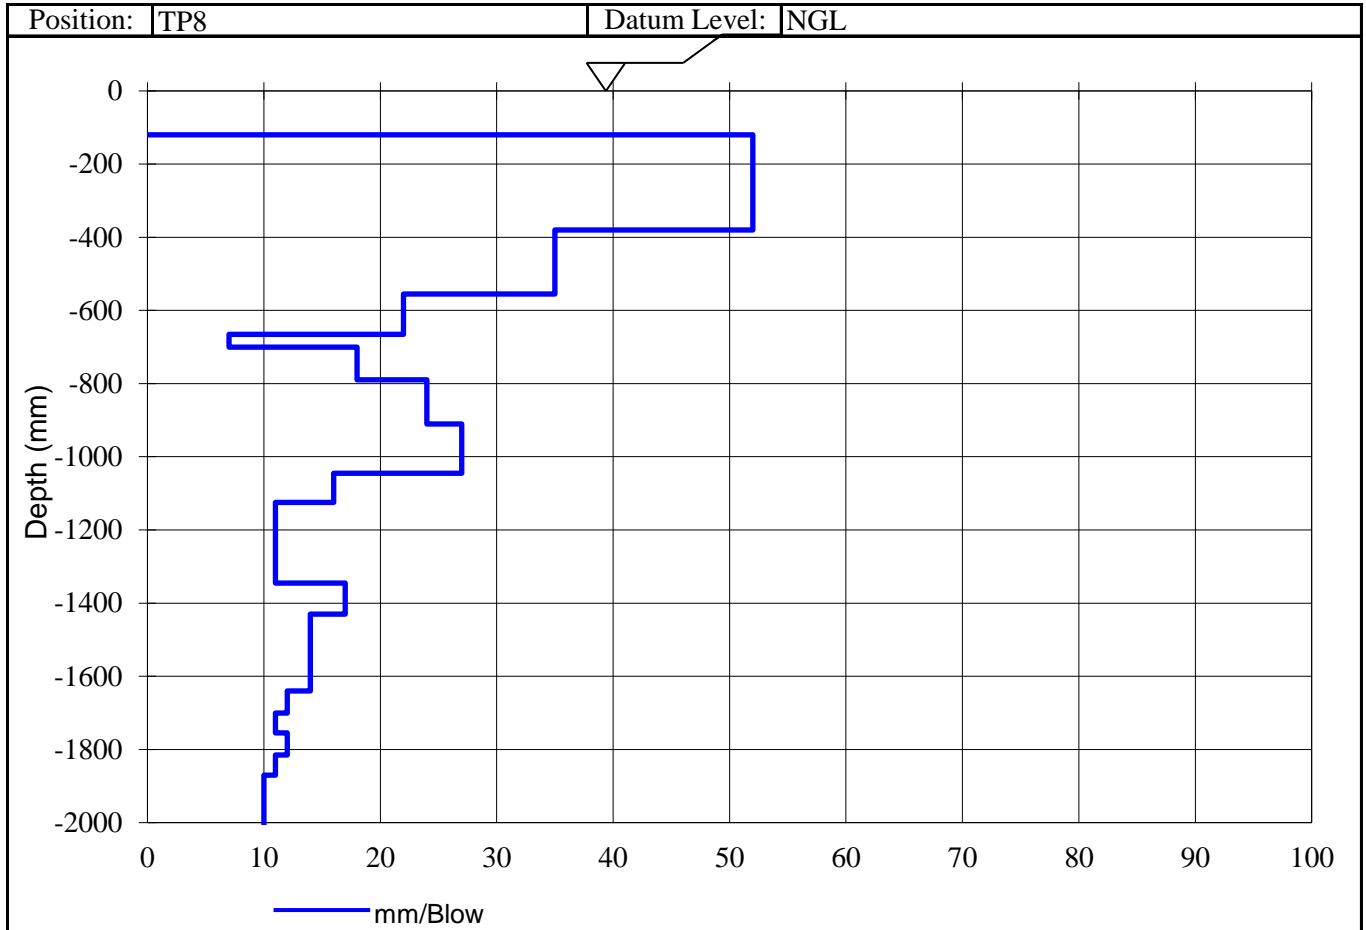
TEST REPORT**Dynamic Cone Penetrometer (DCP) - (TMH 6 Method ST6)**

The DCP tests indicated a generally loose/soft soils in the upper 0.8m, which broadly correlated to the transported horizons, but the tests consistently improved below this depth to medium dense or dense consistency. The tests indicated allowable bearing capacities in the range of 125-150kPa below a nominal founding depth of 0.8m.
