Proposed Eagle Creek Housing Development on RE 47, 187 and 188 of Farm 220 Vyf Brakke Fontein, Mossel Bay, Western Cape.

Aquatic Biodiversity Assessment.

Prepared For: PW Steinberg
Author: Dr. J.M. Dabrowski
Confluent Environmental Pty (Ltd)
7 St. Johns Street,
Dormehls Drift,
George, 6529
SACNASP: Pr. Sci. Nat. (Water Resources – 114084)
Date: 4 June 2025
Version: Draft Final

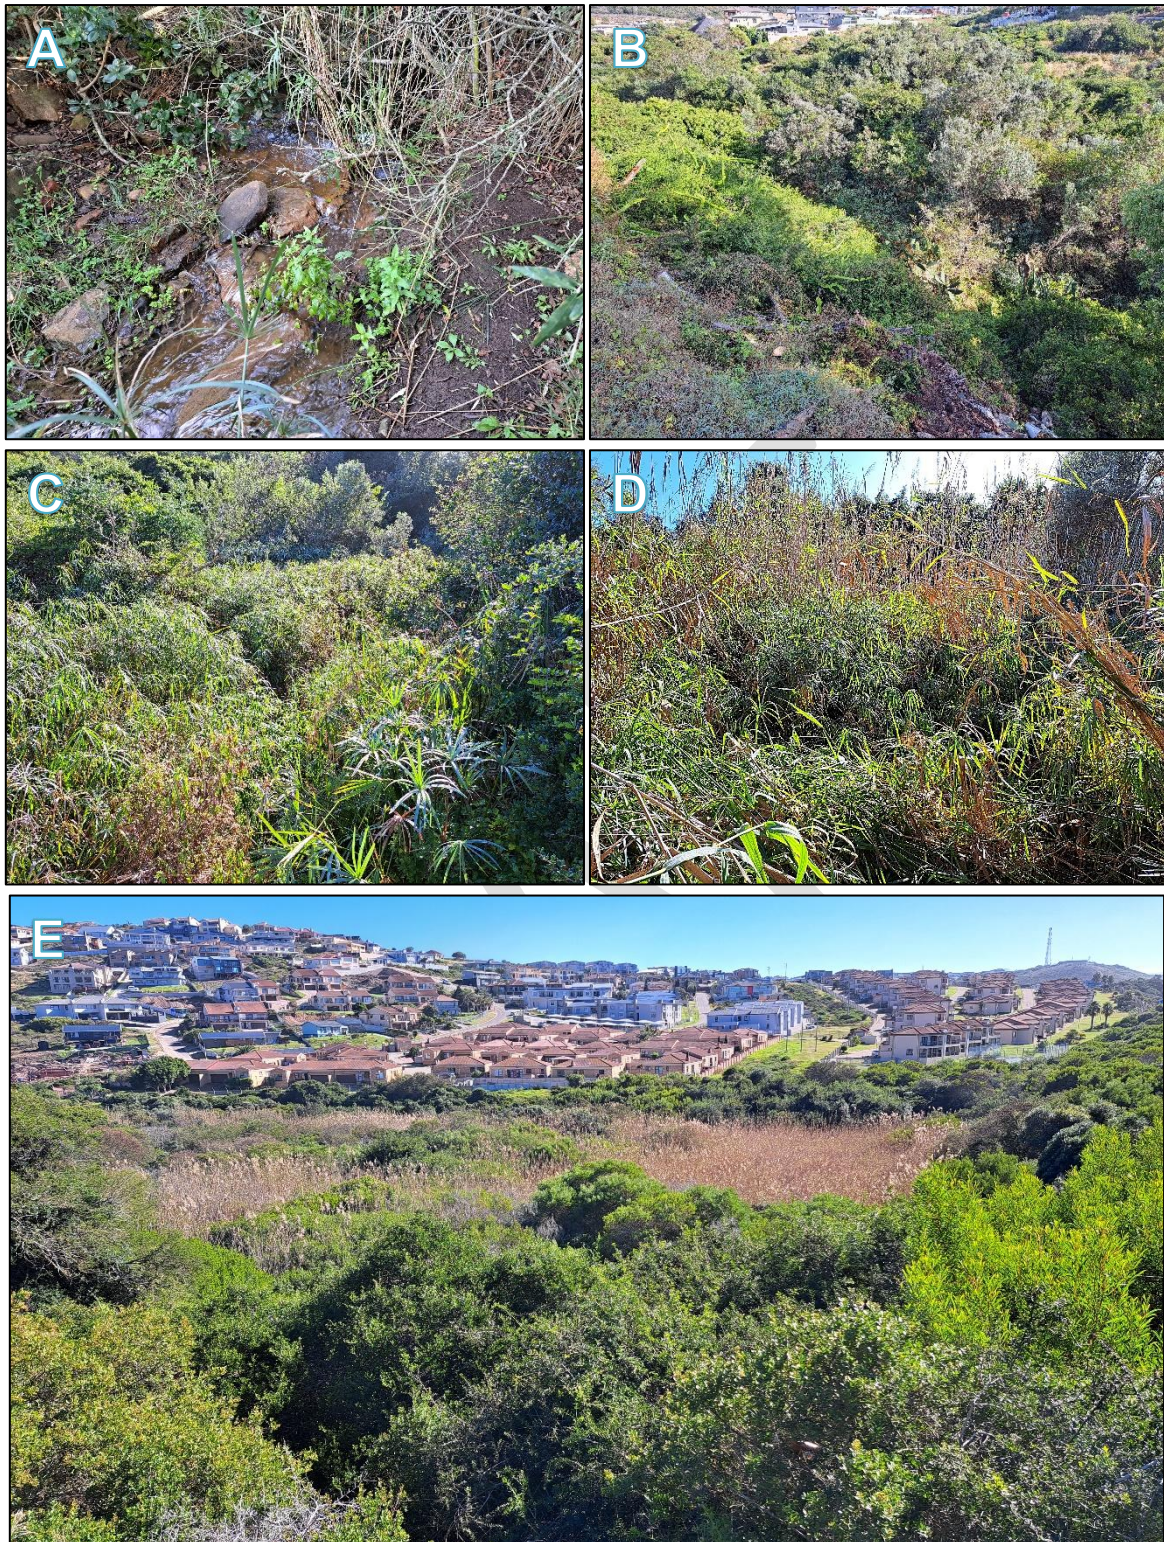
Figure 5: Photographs illustrating the narrow active channel of the river (A); steep embankment and riparian thicket vegetation along the valley bottom (B); a patch of *Cyperus textilis* in the wetland (C); patch of *Phragmites australis* in the wetland (D); and a view of the wetland as it broadens towards the N2 showing *P. australis* reed-bed.

approximately 300 m eastwards, the channel is confined immediately to the south by a very steep embankment (approximately 4 – 5 m high), which also forms the southern extent of the macro-channel). The upper reach of the watercourse immediately below the dam is consistent with a narrow non-perennial river (stream), fringed by a relatively wide riparian zone consisting of thicket species, namely *Olea exasperate*, *Carissa bispinosa* and *Searsia spp.* (Figure 6). There is no wetland vegetation on this embankment and vegetation is characterised by a mixture of indigenous and invasive terrestrial shrubs and trees (Figure 5).

As the channel approaches the N2 highway, the gradient of the southern embankment becomes more gentle, and the river grades into a channelled-valley bottom wetland (Figure 6). The active channel widens and is bordered by wetland habitat, characterised by dense reed beds consisting of *Cyperus textilis*, *Arundo donnx* and *Phragmites australis*. Analysis of historical imagery indicates that the wetland area immediately south of the active channel was historically cultivated (Figure 7) and at various times in the past was crossed by various road crossings. Construction of the N2 highway resulted in infilling across the watercourse, causing impedance of higher flows, and increased inundation and saturation of the banks adjacent to the channel – enhancing wetland habitat. It also appears as if the eastern most extent of the wetland (where it widens noticeably against the N2 highway) was associated with an area of disturbance (possibly an excavation), which allowed water to extend beyond its natural course (Figure 8). The delineated extent of the riparian zone and wetland is much narrower than mapped by CSiR (2018) and is mapped in Figure 6. There are other indicators of wetland vegetation (reed beds of *A. Donnx*) outside of the delineated area indicated in Figure 6, but these are all associated with stormwater outlets that discharge stormwater from the main access road, overland towards the direction of the wetland and are not considered as natural wetland areas.

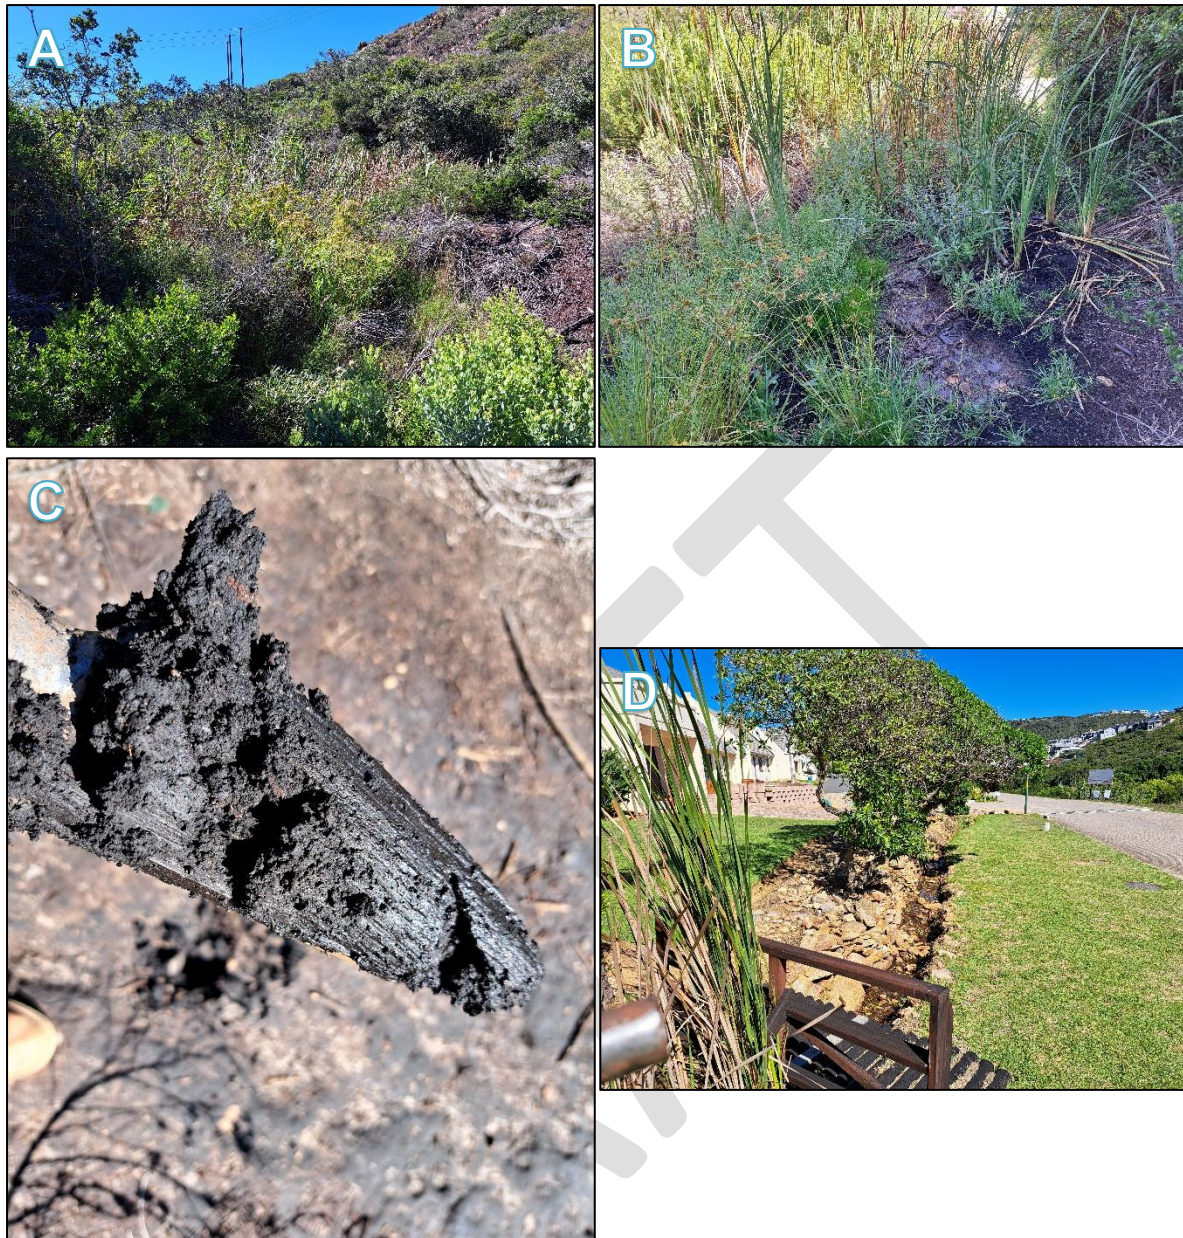
Figure 9: Photographs of the seep wetland showing the berm and area of inundation characterised by *P. australis* (A); surface flow and wetland vegetation (B); saturated organic soil within the wetland area (C) and; a stormwater channel into which some surface flow from the wetland is diverted (D).

A seep wetland was identified on the Remainder of Portion 47 of Farm 220, south of the access road into the development area. The wetland originates from a spring that discharges from the mountain side. The spring has been contained by a berm which creates a small, inundated area that is vegetated by wetland plant species that include *P. australis* and *C. textilis* (Figure 9). Surface and sub-surface water however seeps below the berm and down towards the road, which concentrates flow towards a culvert and ultimately discharges as a narrow stream into the channelled valley bottom wetland below. Some of the surface flow is directed into a stormwater channel running south of the access road. The spring is likely to be permanent and has led to the development of a highly organic saturated soil layer above the road.

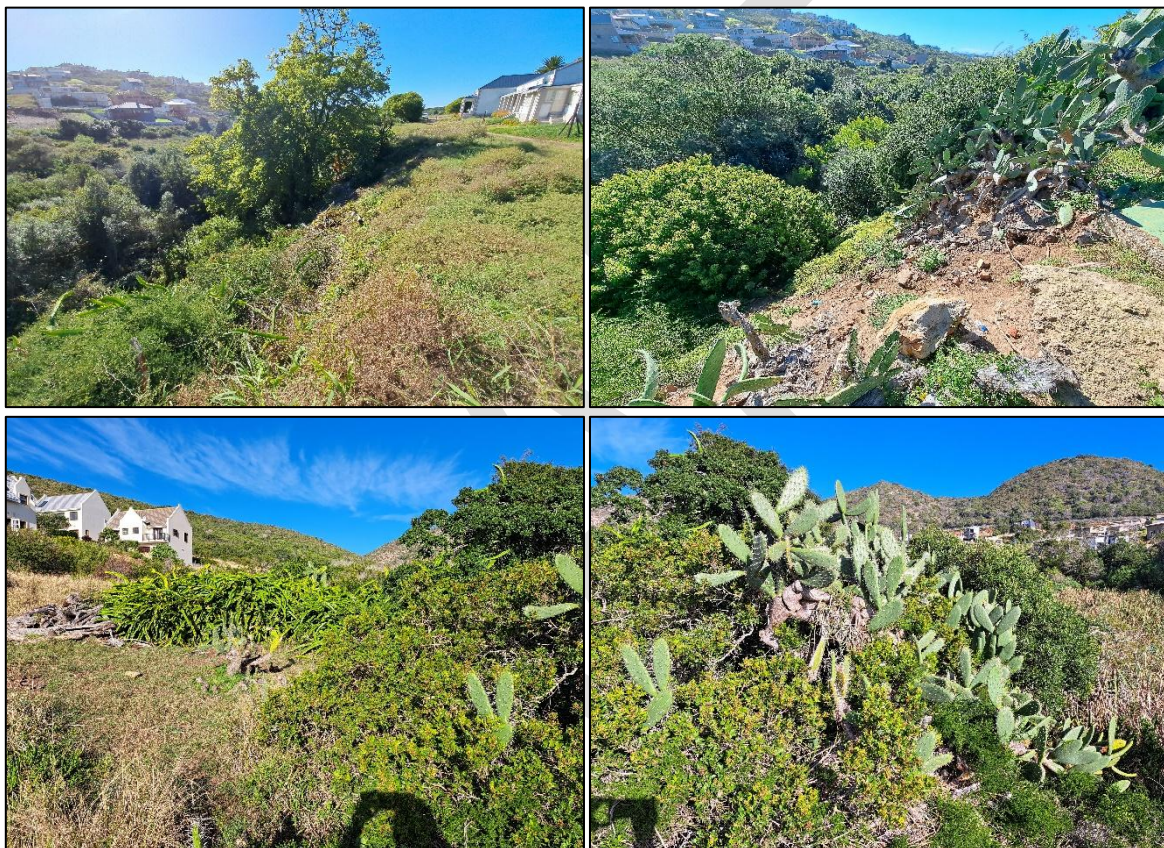
Figure 10: Photographs of the site showing the steep embankment and invasion by *Hylocereus undatus* and *Opuntia engelmannii*.

- Numerous exotic invasive species were observed along the river embankments, including *Hylocereus undatus* (Dragon Fruit) and *Opuntia engelmannii* (Prickly Pear). These have the potential to invade and spread throughout the riparian area and must be actively controlled and removed from the site;
- Active revegetation of bare exposed banks with indigenous vegetation is recommended; and
- Strict rules must be implemented and enforced which forbid dumping of waste and garden refuse within the buffer zone.
