Upgrading of Stormwater Infrastructure, Rosemoor, George, Western Cape.

Aquatic Biodiversity – Specialist Assessment

Author: James Dabrowski (PhD)
Confluent Environmental Pty (Ltd)
7 St. Johns Street,
Dormehlsdrift,
George, 6529

Date: 23 July 2025

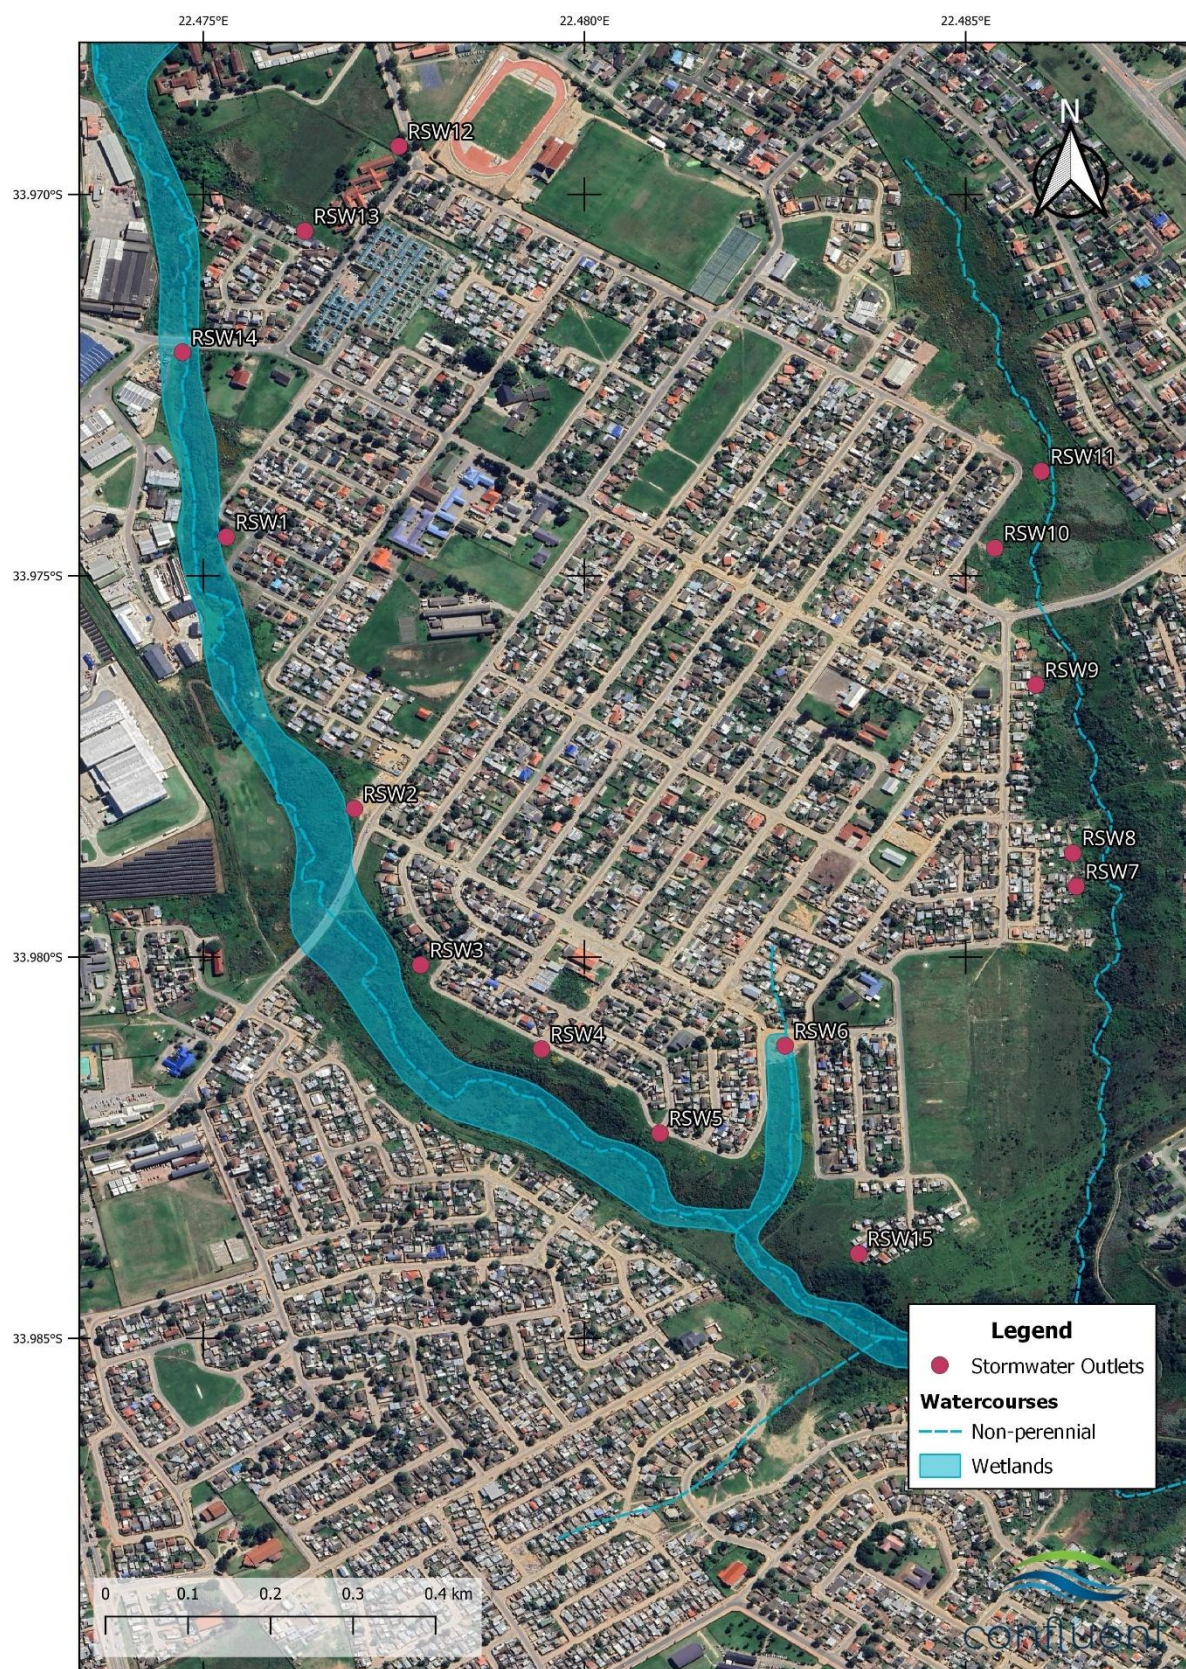
Figure 2: Map showing the stormwater outlets in relation to mapped watercourses.

The Meul River originates from the industrial centre of George and passes through a combination of formal residential areas and informal settlements (with poor access to water and sanitation services). Sewage spills from blocked manholes and failing pump stations frequently result in sewage spills into both rivers, which has resulted in closure of recreational activities at Ballots Bay (where the Meul River discharges into the sea). Stormwater outlets (labelled RSW1 to RSW5) will be upgraded at five locations in the upper catchment area of the river. The majority of these outlets are located on relatively steep slopes that drain towards nearby watercourses (Figure 2).

Watercourses affected by the upgrades include the upper most reaches of the Meul River and an eastern tributary that meets the Meul River below RSW4. The length of the upper Meul River is mapped as an unchannelled valley bottom wetland (Figure 2). These systems are typically located along low gradient, valley bottoms, which favours diffuse flow and hence the lack of a distinct channel. The site visit revealed a prominent, incised channel with steep, vertical banks, ranging between 2 to 3 m high and is therefore not consistent with the diagnostic features of an unchannelled valley bottom wetland (Figure 8). It is possible that the watercourse was originally a very narrow unchannelled valley bottom wetland that has become severely incised (and modified) over time. While a clear, narrow, linear length of drainage can

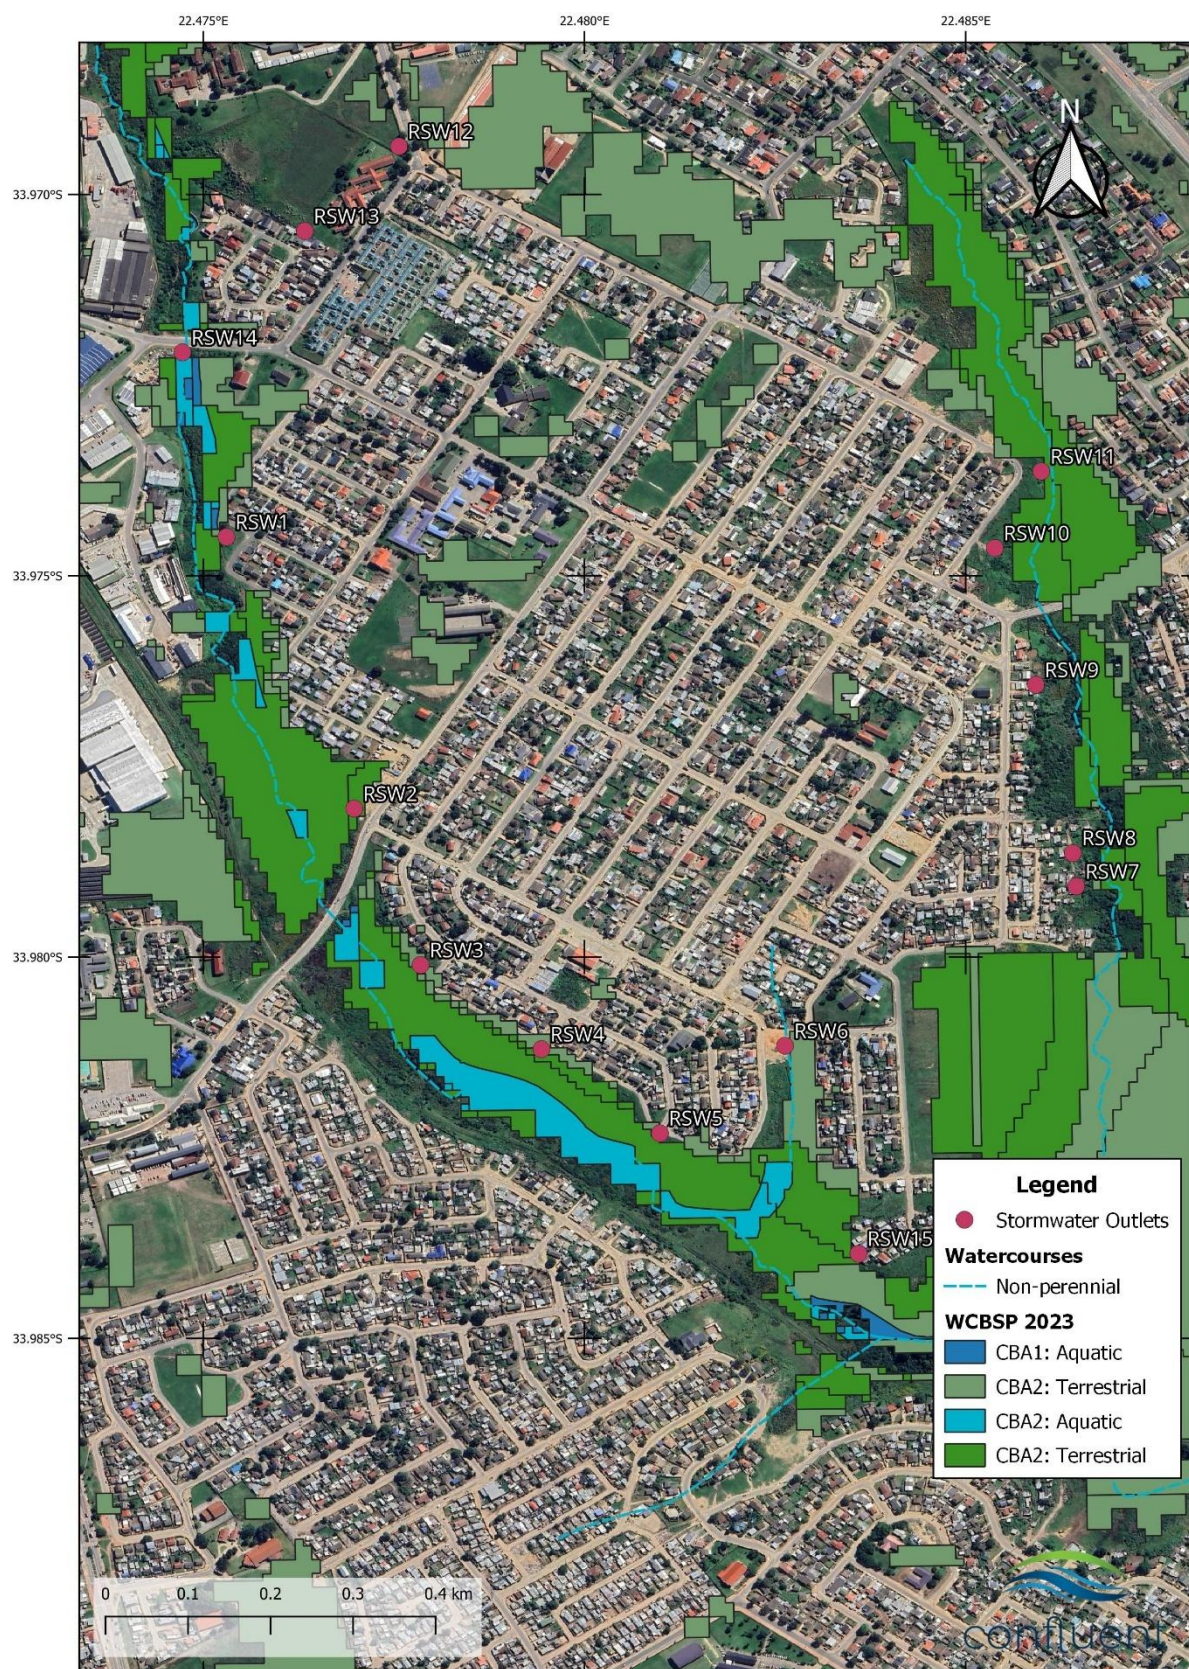
Figure 4: Location of the stormwater outlets in relation to the Western Cape Biodiversity Spatial Plan.

With the exception of RSW14 fall within or immediately adjacent to terrestrial CBA2 areas (Figure 4). These are considered as degraded areas that are required in order to meet biodiversity targets and have been assigned as CBA status due to the presence of the critically endangered Garden Granite Fynbos vegetation type. Small patches of the wetland along the Meul River have been assigned as aquatic CBA2. Aquatic CBA2 areas are degraded watercourses that are required in order to meet biodiversity targets for species, ecosystems or ecological processes and infrastructure (Table 1).

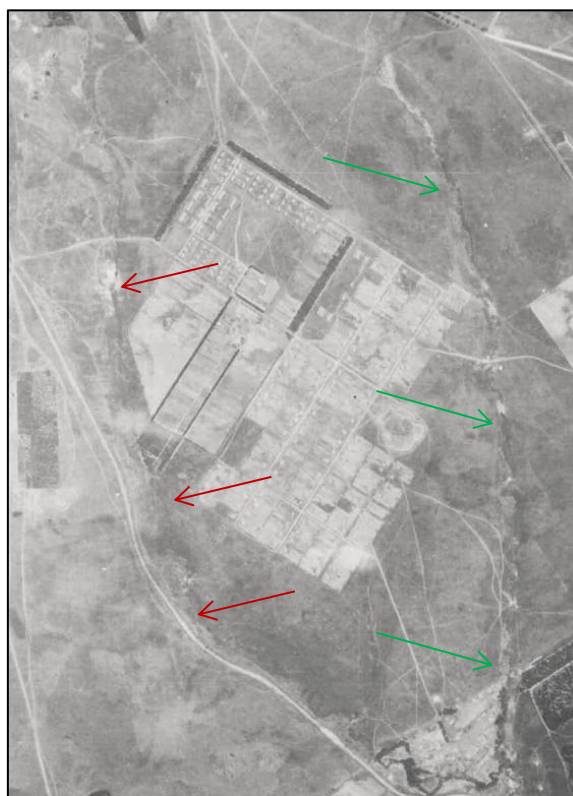
be observed in historical imagery it cannot be confirmed with any certainty whether the drainage was an unchannelled wetland or a channelled non-perennial stream.

Figure 7: Historical aerial image (1936) indicating poorly defined drainage lines (indicated by red arrows) associated with the Meul River (red arrows) and its eastern tributary (green arrows).

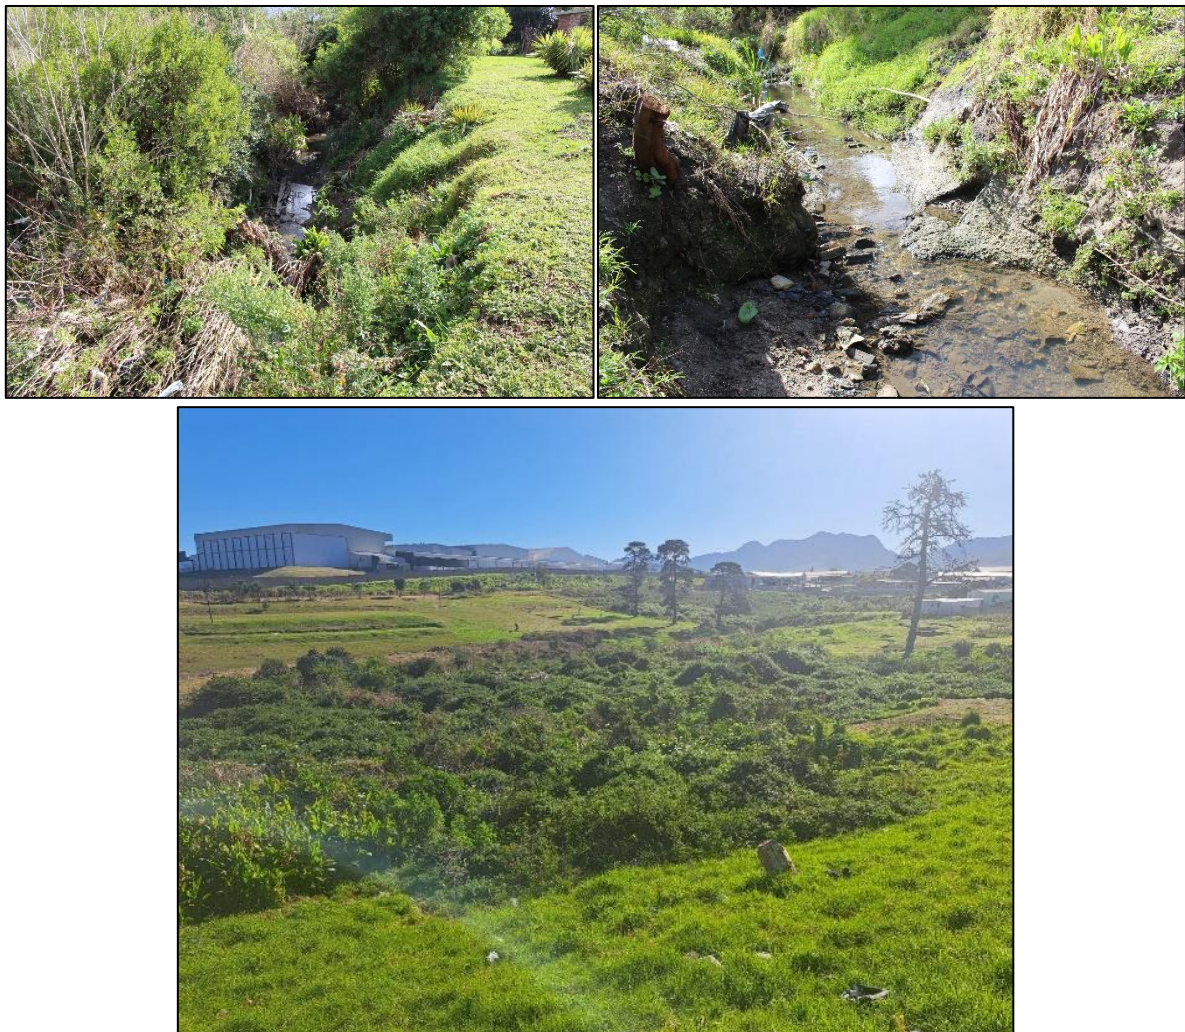
Wetland vegetation (dominated by *Cliffortia odorata* in the more seasonally saturated interior and *Nidorella ivifolia* on the drier temporarily saturated margins) is located along the valley slopes adjacent to the banks of the channel (but not along the valley bottom) and is consistent with a hillslope seep wetland (Figure 8). The wetland extends along the entire length of the river reach – on both sides of the channel. The eastern tributary is mapped as a non-perennial drainage line, but the site visit confirmed the presence of a seep wetland along the adjacent slopes – similar to the seep wetland along the Meul River. The formation of seep wetlands along the gentle slopes of valleys is consistent with the soil type in George (i.e. a coarsely textured A horizon overlying a relatively impervious clay enriched B horizon). The seep wetland features are sustained primarily by lateral sub-surface flow which is prevented from penetrating the deeper impervious B horizon and expresses near the surface as it travels down the relatively gentle slopes. The gentle slopes allow water to be retained in the soil profile for an extended period of time, leading to seasonally saturated conditions and the establishment of wetland vegetation. Further downstream (far below project area of interest below the N2 highway), the gradient of these slopes becomes steeper and water is retained in the soil profile for a shorter duration, and wetland habitat is replaced by woody vegetation typical of a riverine riparian zone. The most likely original reference configuration of the aquatic features is a seep wetland which would have historically fed a non-perennial river channel abutting the wetland. Over time this channel has become severely modified due to stormwater inputs from the urban catchment area. Alien invasive species are not prolific within the seep wetland but do occur throughout and, amongst others, include *Cenchrus clandestinus* (kikuyu grass), *Solanum mauritanium*, *Acaia mearnsii* and *Rubus sp.*. In some areas, where invasion is more dense, the woody structure contributes to confining high flows to the channel,

Figure 8: Photographs showing the steeply incised riverine channel of the Meul River (top right and left) and a section of the wetland seep along the slopes of the river (bottom).

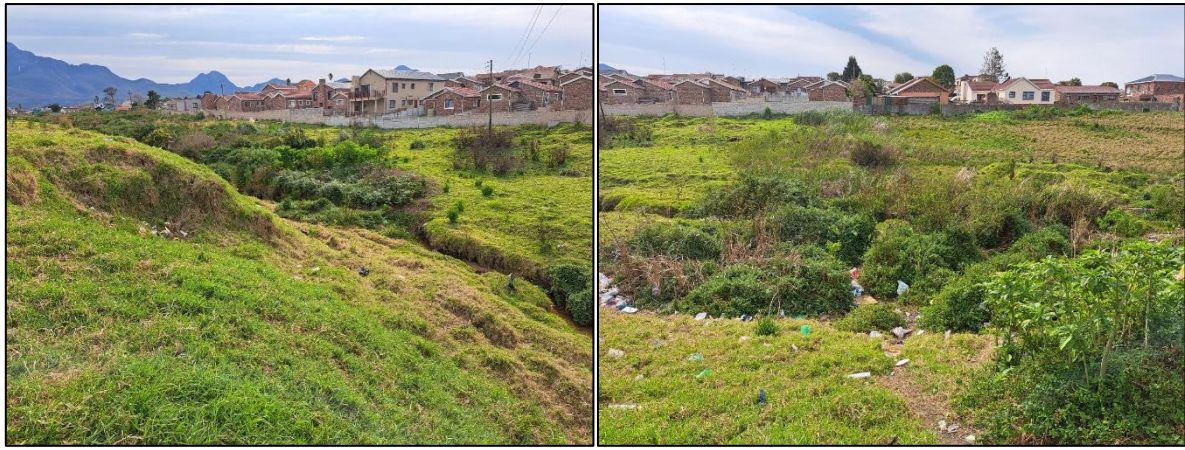
Figure 9: Photographs showing wetland vegetation along the length of the eastern tributary of the Meul River.

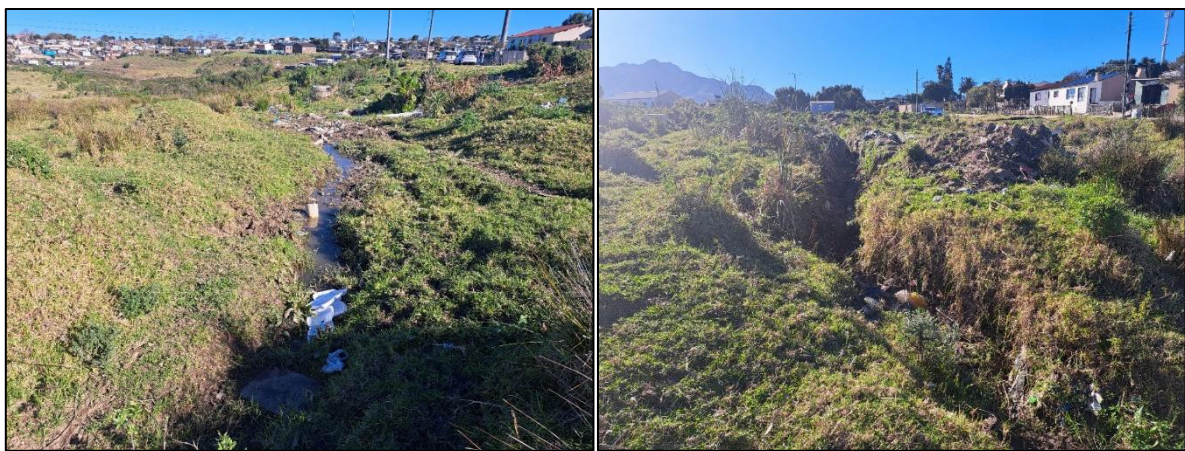
RSW4 discharges onto a gently sloping plain that has been mapped as an unchannelled valley bottom wetland (Figure 10). The upper section of this mapped area overlies a flat area with no valley (or valley-bottom) and is therefore not consistent with a valley-bottom wetland. An obvious valley only forms closer to the confluence with the Meul River. The upper flat area is heavily transformed and clearly receives high volumes of stormwater from the outlet which has created an incised channel that extends all the way down into the valley. Wetland vegetation has colonised sections of the channel (mainly *Typha capensis*).

*Figure 10: Photographs below RSW4 illustrating the incised channel below the outlet showing signs of soil saturation and colonisation by wetland plants (*T. capensis*).*

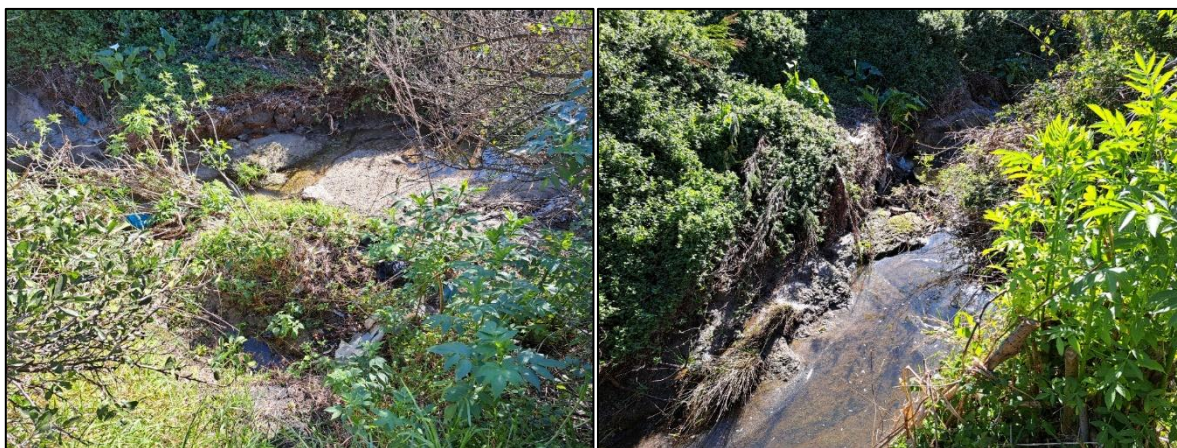
The exact location of the existing stormwater outlet could not be located in the field. The river along the reach is heavily incised and the wetland seep was confined to a narrow band along the slope. Wetland vegetation is dominated by *C. odorata* and *N. ivifolia* along the drier outer margins. The invasive *C. clandestinus* is relatively abundant throughout the site.

Figure 12: Photographs showing the incised channel of the Meul River.

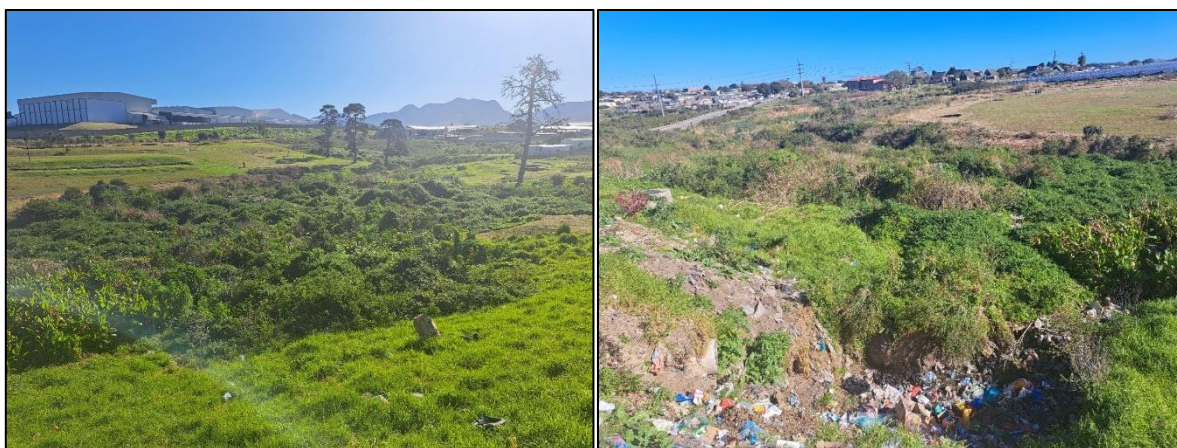
RSW2 is located at the top of a relatively wide, gently sloping valley. The wetland seep is located along the slopes (up to 50 m in width) and is dominated by *C. odorata* and invaded by *C. clandestinus* on the margins (Figure 13). The outlet of the existing stormwater pipe discharges relatively high up onto the unprotected slope and has caused a significant erosion gulley that extends into wetland seep vegetation along the banks. Significant quantities of solid waste and litter have been dumped into the erosion gulley, which acts as source of solid waste pollution to the wetland and Meul River.

Figure 13: Photographs showing the wetland seep along the slopes (left) and the deep erosion gulley below the RSW2 stormwater outlet.

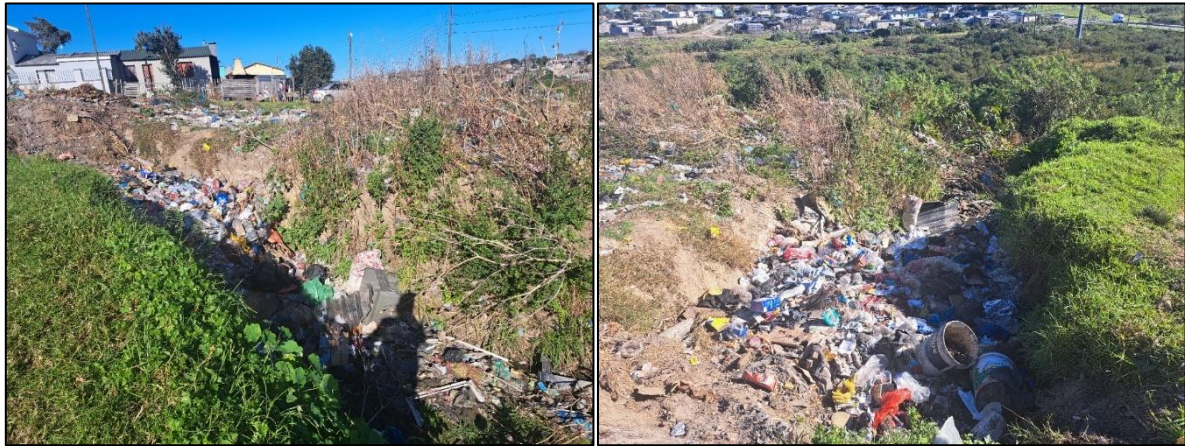
RSW3 is very similar to RSW2. The valley is slightly more confined and slopes are slightly steeper. Wetland seep vegetation also lines these slopes but shows a more distinct saturation zonation, with *N. ivifolia* dominating the upper steeper slopes (where soil saturation is more temporary) and *C. odorata* dominating the gentler, lower slopes where saturation is more prolonged and seasonal. Similar to RSW2, the outlet discharges onto the slope and has caused a significant erosion gulley below the outlet (Figure 14). Very high quantities of solid waste and litter have been dumped into the gulley. Significant quantities of solid waste and litter have been dumped into the erosion gulley, which acts as source of solid waste pollution to the wetland and Meul River.

Figure 14: Photographs showing the erosion gulley below RSW3.

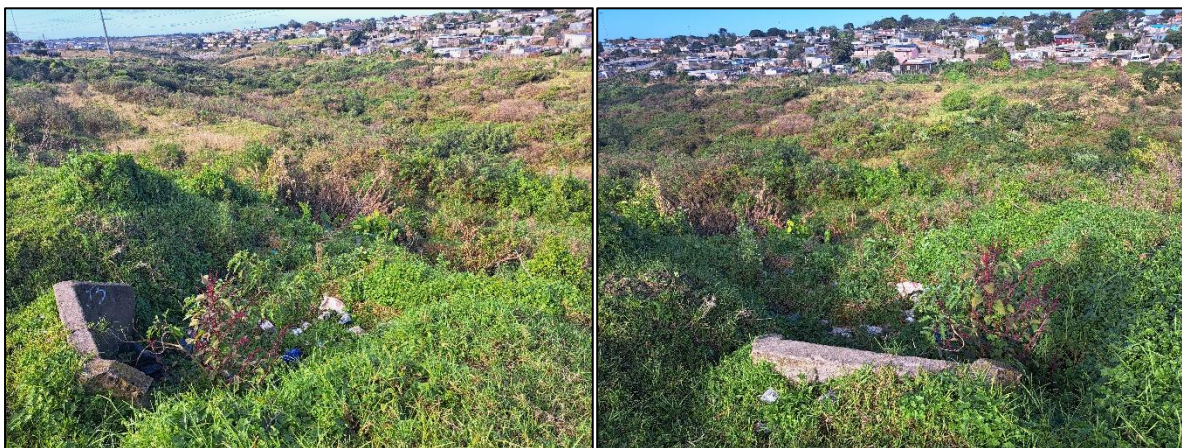
RSW4 is located outside of the delineated area of the wetland. It discharges onto a steep slope that is well vegetated and no obvious erosion was visible (Figure 15). Minor quantities of litter were observed at the outlet.

Figure 15: Photographs showing well vegetated slopes below RSW4.

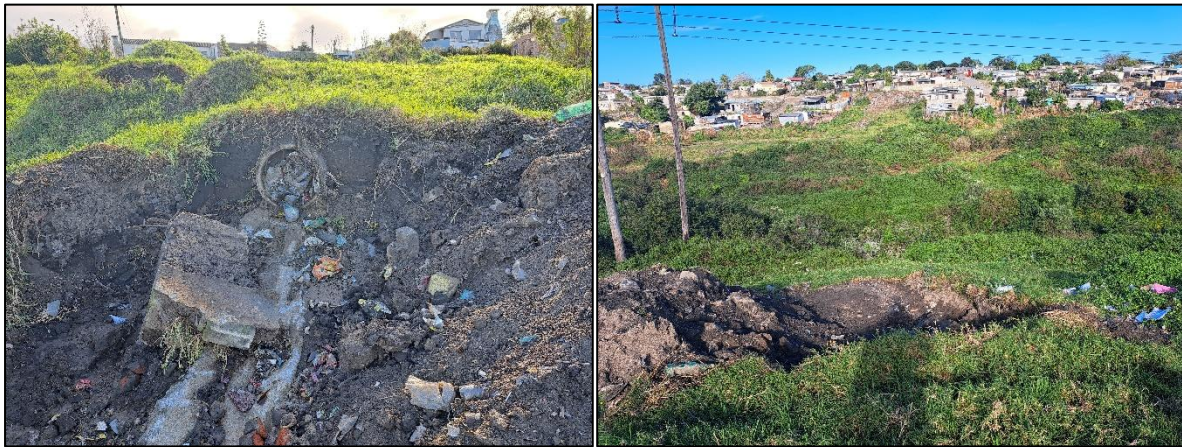
RSW5 is also located outside of the delineated wetland area. The outlet pipe was blocked with litter and the headwall had been demolished. An excavation below the outlet was visible, presumably in an effort to maintain or repair the outlet. No erosion was visible below the outlet.

Figure 16: Photographs of RSW5 showing the blocked outlet pipe, demolished headwall and excavation.

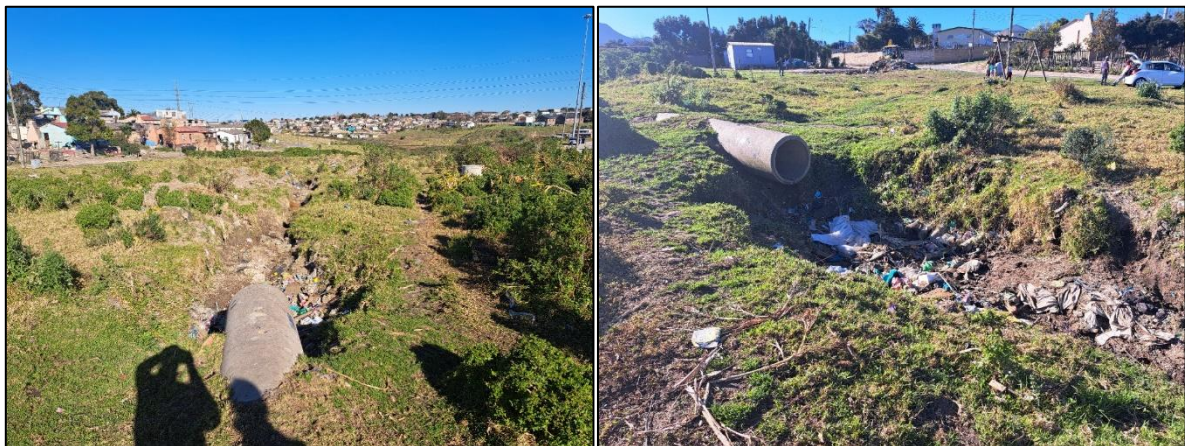
As described above, RSW6 discharges onto a gently sloping plain that ultimately drains down towards the Meul River. The outlet is not located within a watercourse. Stormwater discharge has led to the formation of a narrow, incised channel that leads down to the river (Figure 17). Wetland vegetation has colonised this channel (mainly *Typha capensis*) and as with other stormwater outlets, levels of litter and dumping were high.

Figure 17: Photographs showing the RSW6 stormwater outlet.

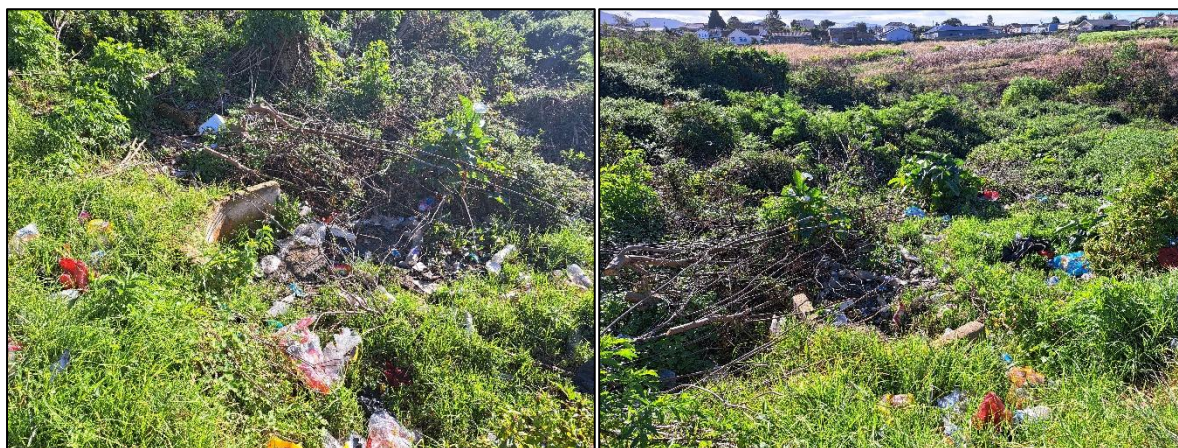
RSW10 discharges into wetland seep habitat (dominated by *C. odorata*) lining the edge of the eastern tributary of the Meul River. The outlet is at a relatively low elevation and there were no obvious signs of erosion towards the nearby wetland. Significant quantities of solid waste and litter have been dumped into the erosion gulley, which acts as source of solid waste pollution to the wetland and Meul River.

Figure 18: Photographs showing the RSW10 outlet.

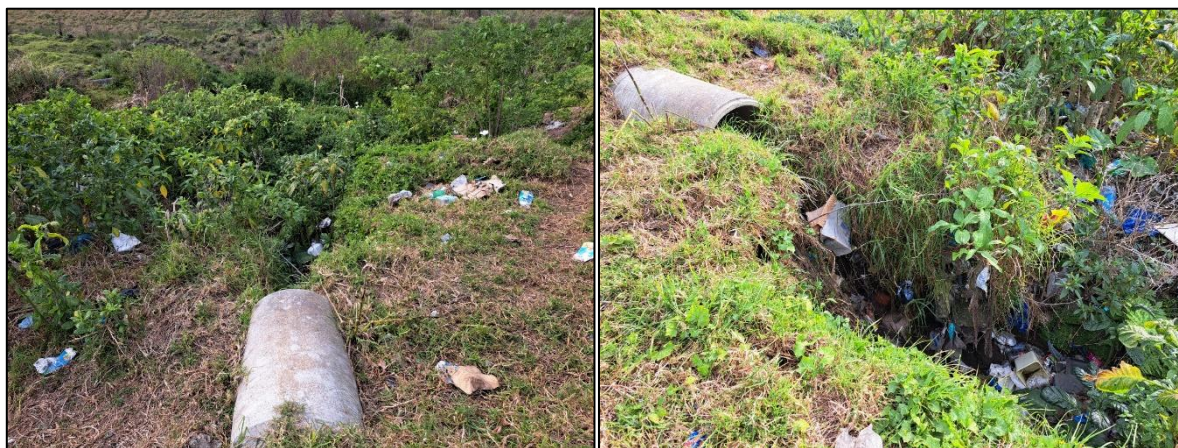
RSW11 discharges into wetland seep habitat lining the edge of the eastern tributary of the Meul River. In contrast to other stormwater outlets included in this assessment, it discharges at a comparatively lower elevation on a more gentle slope. Thus, while an erosion gulley was present at the outlet, its width and depth is not as severe as at other sites (e.g. RSW2 and RSW3) - Figure 19.

Figure 19: Photograph showing the RSW11 stormwater outlet.

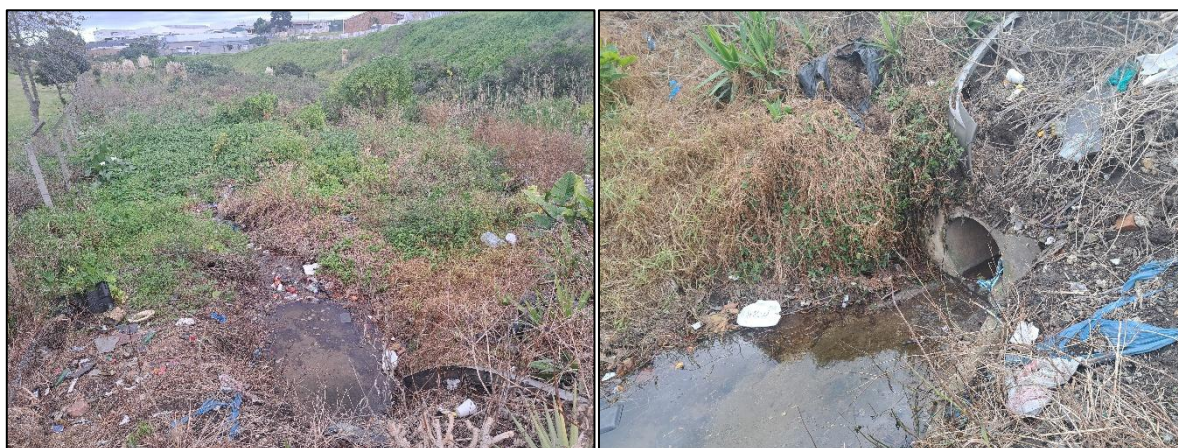
RSW14 discharges onto the top of the eastern bank of the Meul River downstream of where Grens Street crosses the river. While high quantities of litter were evident, the discharge has not caused any serious erosion of the embankment (Figure 20).

Figure 20: Photograph showing the RSW14 stormwater outlet
