# Botanical Impact Assessment

## Proposed upgrading of Moordkuil Pump Station, Mossel Bay

11 September 2025

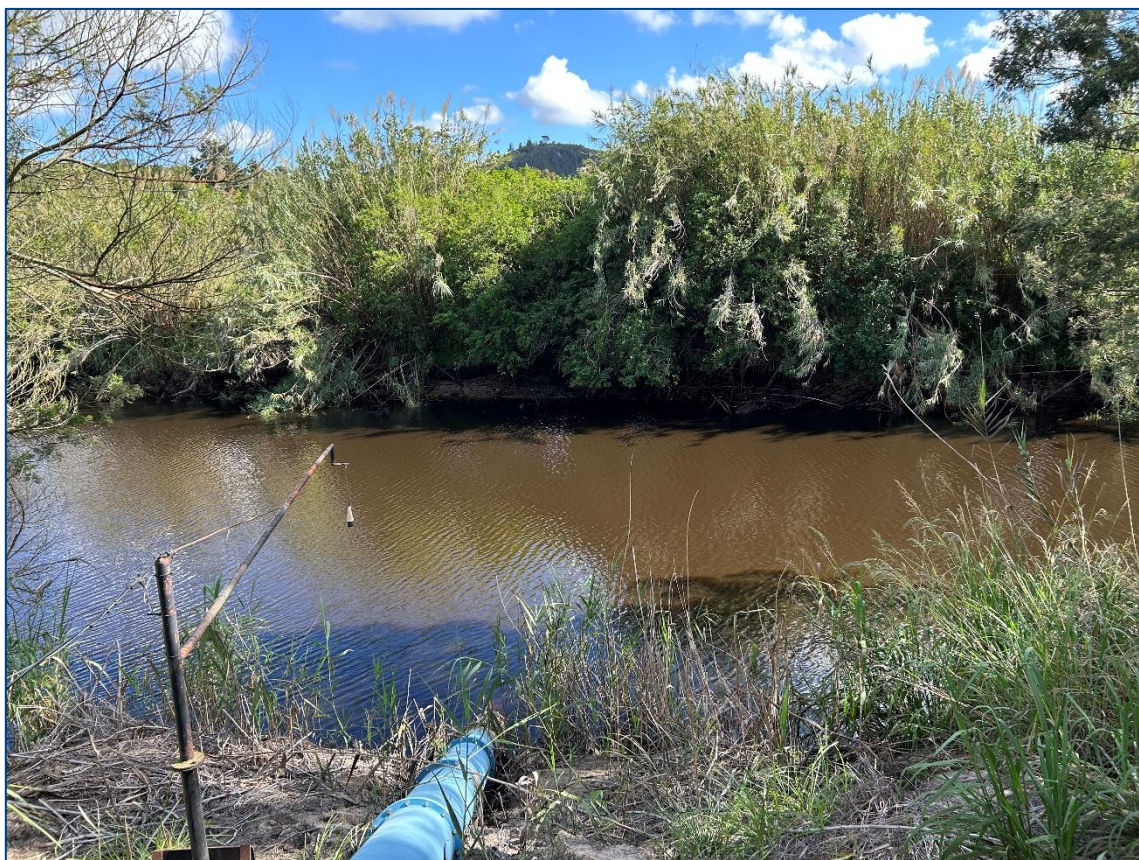
**Figure 4-2: Moordkuil River with one of the water abstraction pipes.**

According to CapeFarmMapper, the pump station is located on the edge of a NFEPA estuarine wetland associated with the Moordkuil River (**Figures 4-1 & 4-2**). The National Freshwater Ecosystem Priority Areas (NFEPA) project provides strategic spatial priorities for conserving South Africa's freshwater ecosystems and supports sustainable use of water resources. These priority areas are commonly referred to as NFEPA's. One of the site camp options is also located next to a non-perennial watercourse coming from the Klipheuwel Dam. The above wetland and watercourse have been included in the Western Cape biodiversity network.

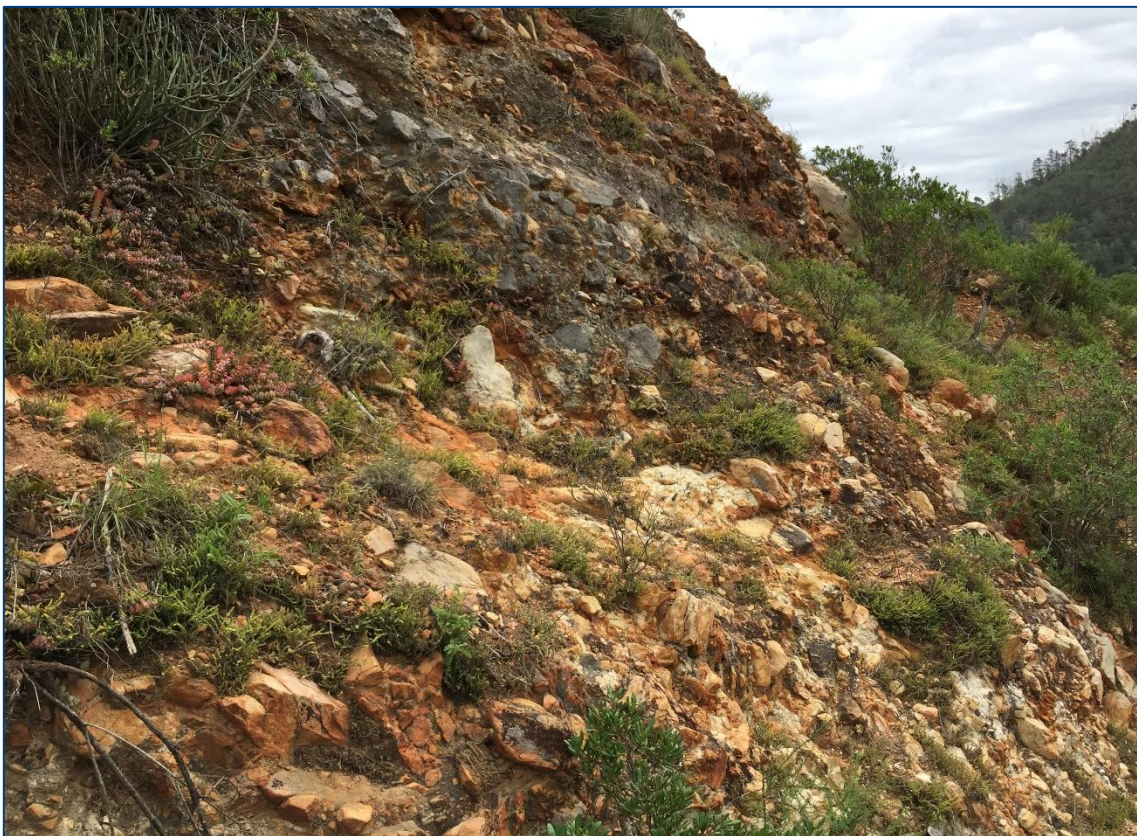
**Figure 4-3: Exposed Enon conglomerate on a 'koppie' north of the site.**

According to the 3422 AA Mossel Bay 1:50 000 geological map, the site lies on the boundary between alluvium and Enon Formation (conglomerate, breccia & sandstone) (**Figure 4-3**). The latter belongs to the Uitenhage Group (Jurassic to Cretaceous age) of sediments. The cobblestones found in the Enon conglomerate originate from the Table Mountain Group sandstones (Viljoen, 1993). Enon conglomerate is an important source of stone aggregate, which is mined at several quarries found in the area (Viljoen, 1993). The latter typically supports Albany thicket and renosterveld in the Mossel Bay area.

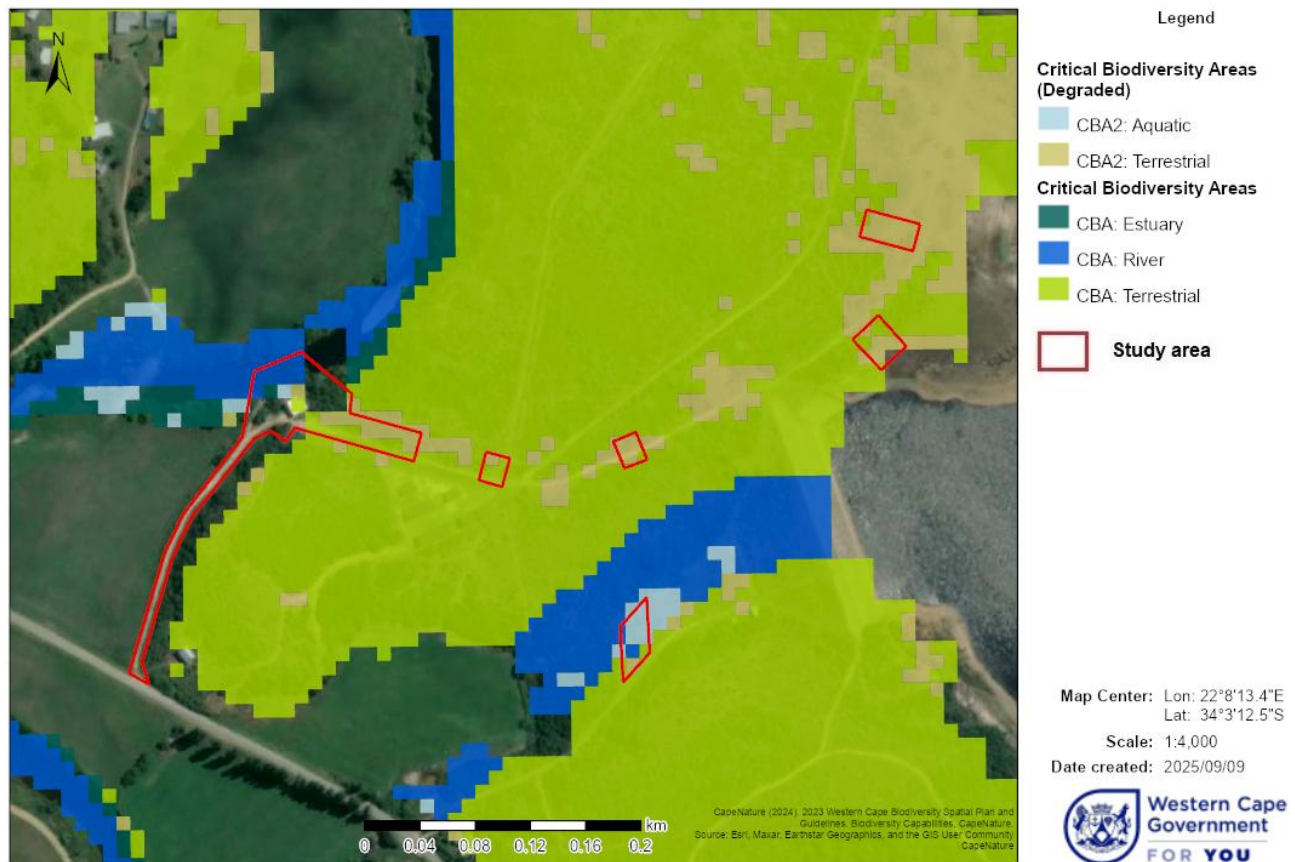
**Figure 4-5: Extract of the Western Cape biodiversity network map.**

A large part of the project area falls inside the Western Cape biodiversity network. The pipeline route and two of the camp site options fall inside a terrestrial critical biodiversity area (CBA) and degraded critical biodiversity areas (CBA2) (**Figure 4-5**). The pumpstation itself and camp site option below the dam wall encroach on aquatic (river) CBA's and degraded aquatic CBA's. Reasons for the mapped units include the presence of a climate adaption corridor, ecological processes (FEPA river corridor), threatened vegetation type (albeit the wrong type), threatened vertebrate habitat (bontebok), estuary (Klein Brak Estuary), river types (ephemeral upper foothill river & permanent lower foothill river), wetland types (channelled & unchannelled valley bottom wetlands) and water resource protection (Southern Coastal Belt). It was previously noted that most of the intact vegetation in the Mossel Bay interior is found on the steeper hill slopes. These areas are thus considered of great value in the biodiversity network. The CBA2's correspond with transformed areas, such as pastures and roads. The Moordkuil River has

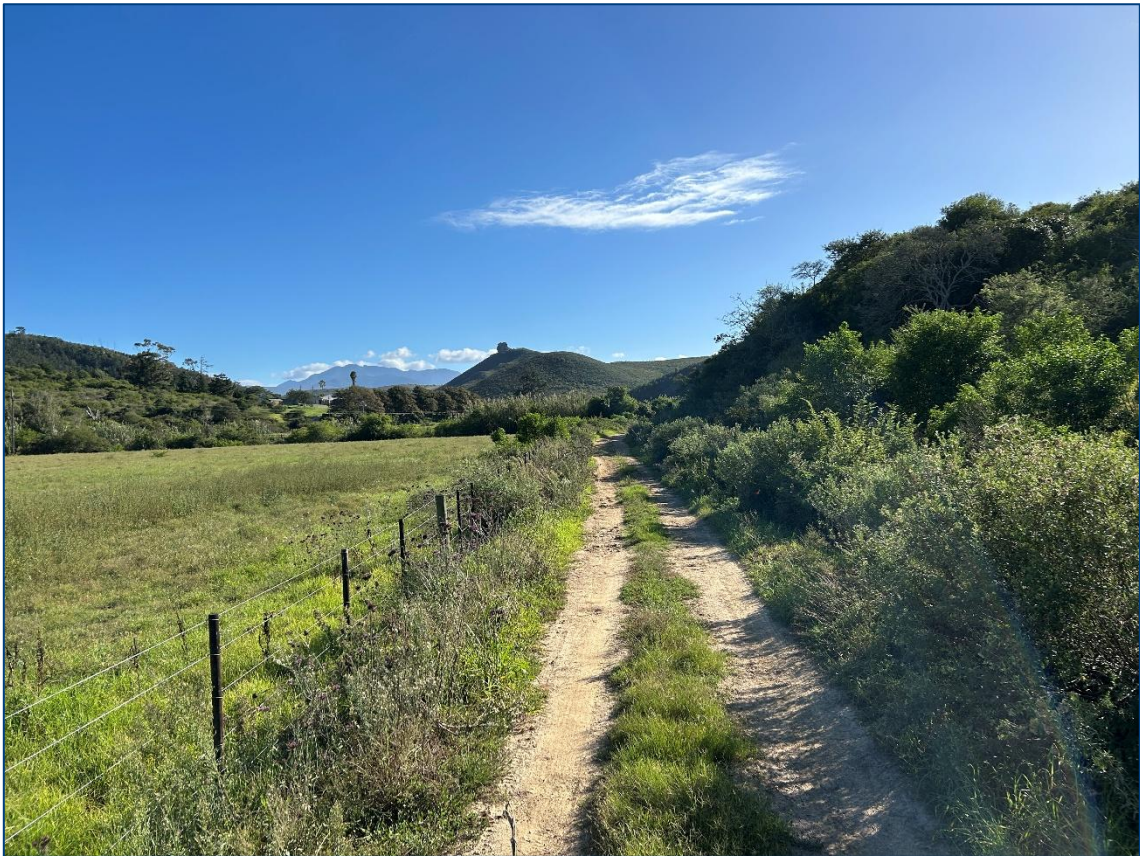
**Figure 5-1: Access road to the pump station, fringed by a pasture and degraded thicket/thicket regrowth.**

The site (Moordkuil Pump Station & access road) lies inside transformed or degraded thicket (**Figures 5-1 to 5-5**). The vegetation changes into senescent renosterveld further up the hill slope along the route for the rising main. A large patch of good quality Albany thicket was noted on the southern side of the bypassing farm road (**Figure 5-6**). The vegetation directly adjacent to the existing infrastructure and access road is quite degraded with a notable presence of weeds and aliens, such as *Acacia mearnsii*, *Nicotiana glauca*, *Solanum mauritianum* and *Verbena bonariensis*. Patches of thicket on the edges of the project footprint are populated by typical thicket species, such as *Sideroxylon inerme*, *Grewia occidentalis*, *Searsia pallens*, *Euclea undulata* and *Azima tetracantha*. Disturbances noted include the presence of farm roads, water pump infrastructure, pastures, fence lines, remains of demolished buildings and alien species. There is also a small solar plant located next to the rising main route.

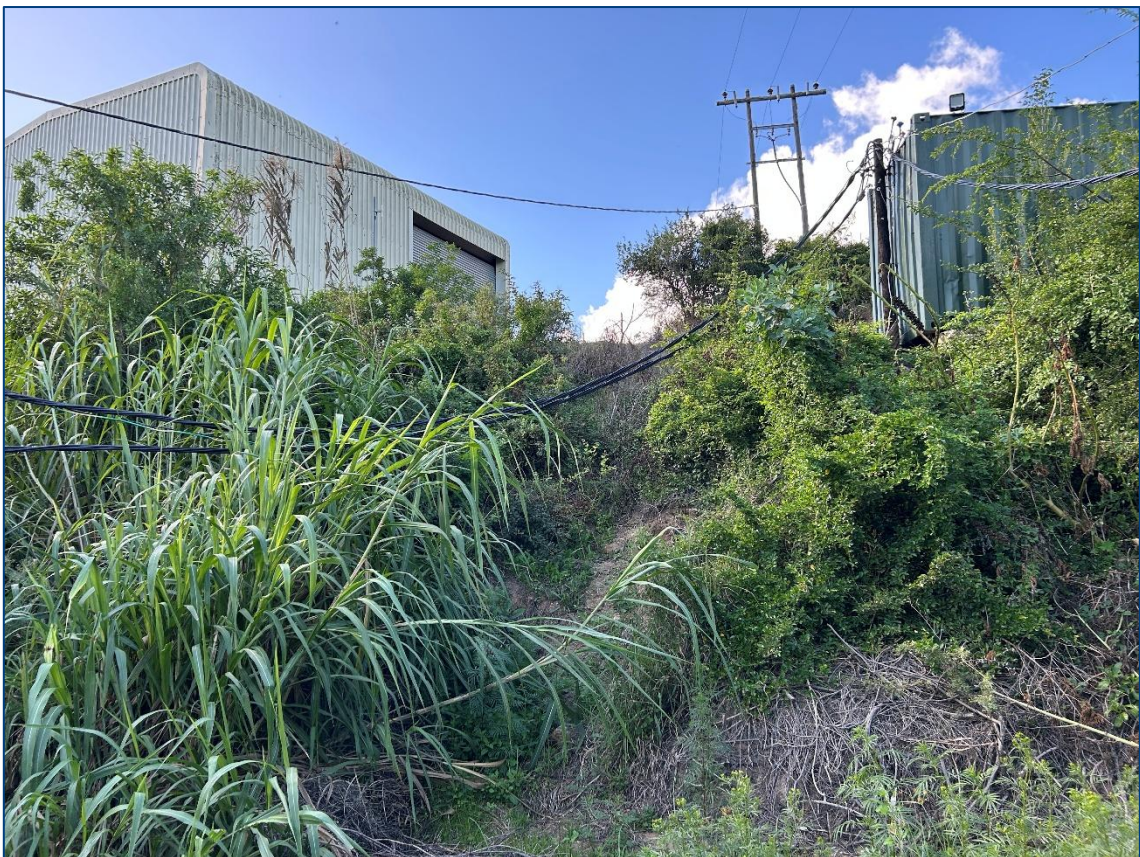
**Figure 5-2: Embankment on western side of pump station, covered by pioneer shrubs and reeds.**

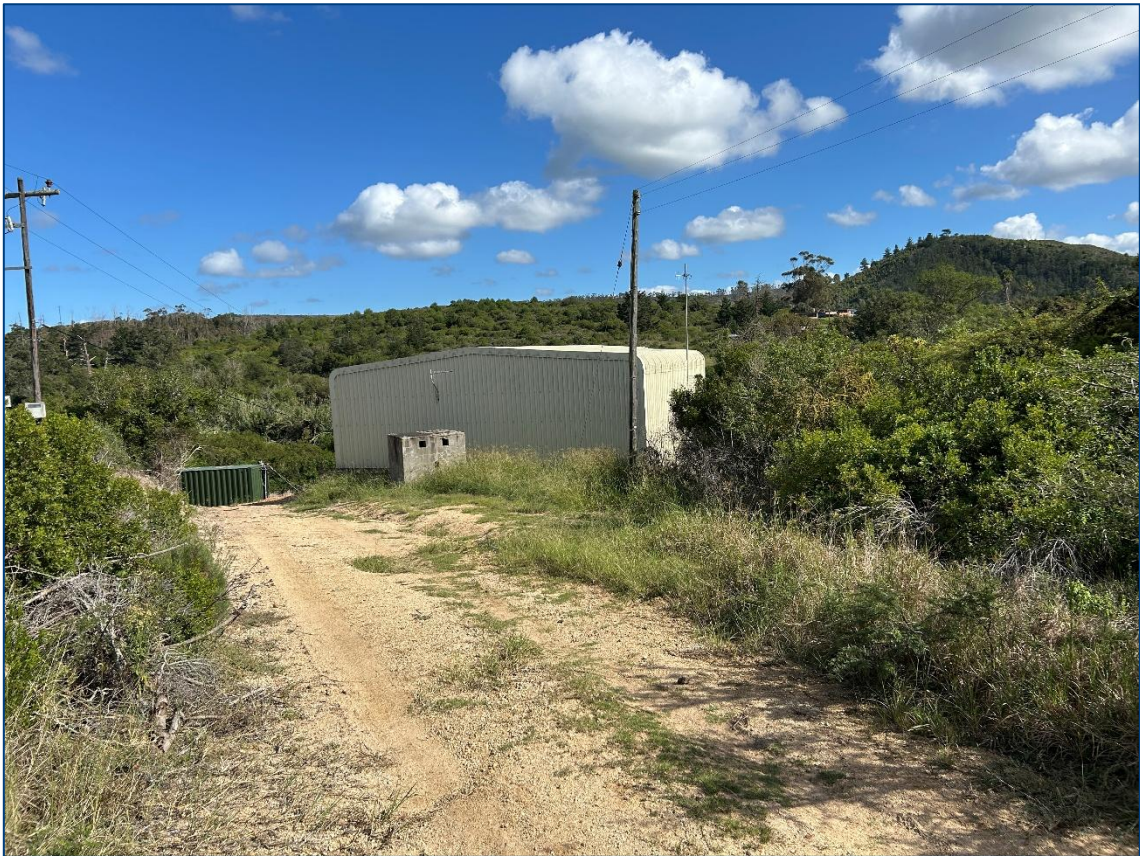
**Figure 5-3: Thicket on eastern side of pump station and position of temporary access to construction site.**

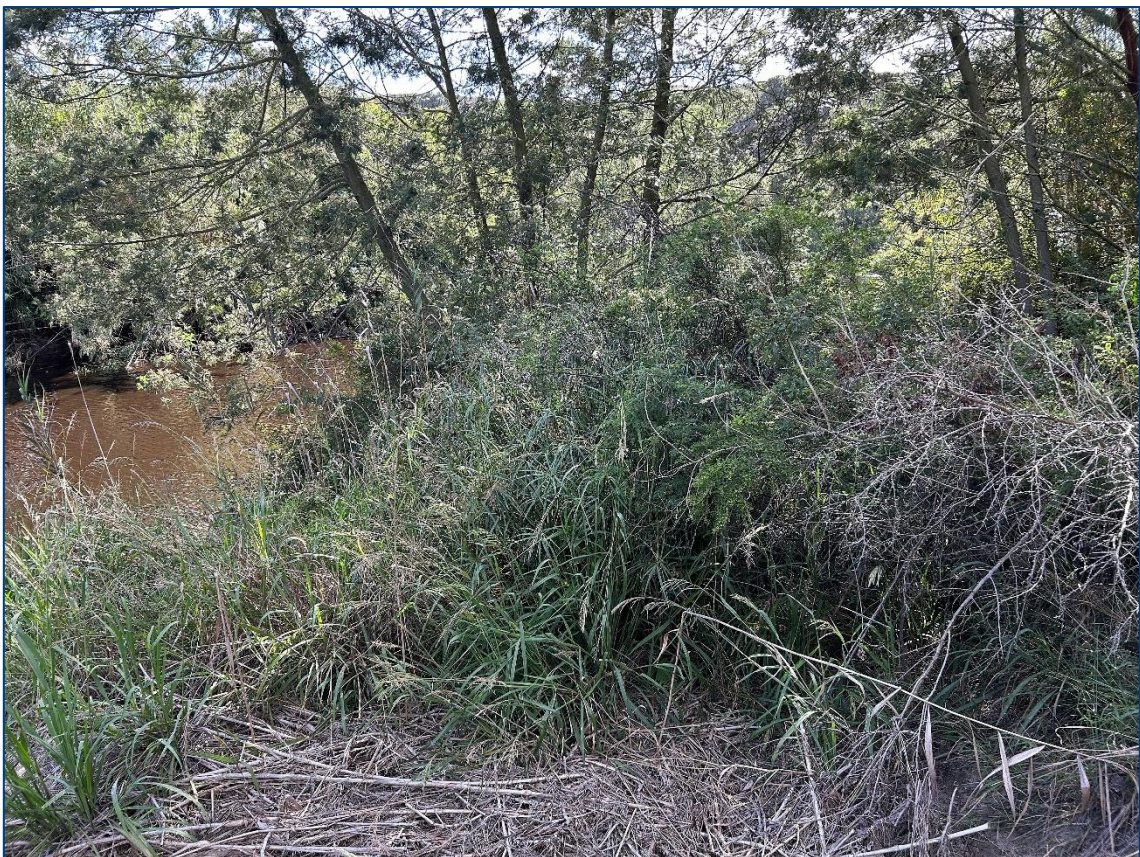
**Figure 5-4: Degraded vegetation on eastern side of pump station.**

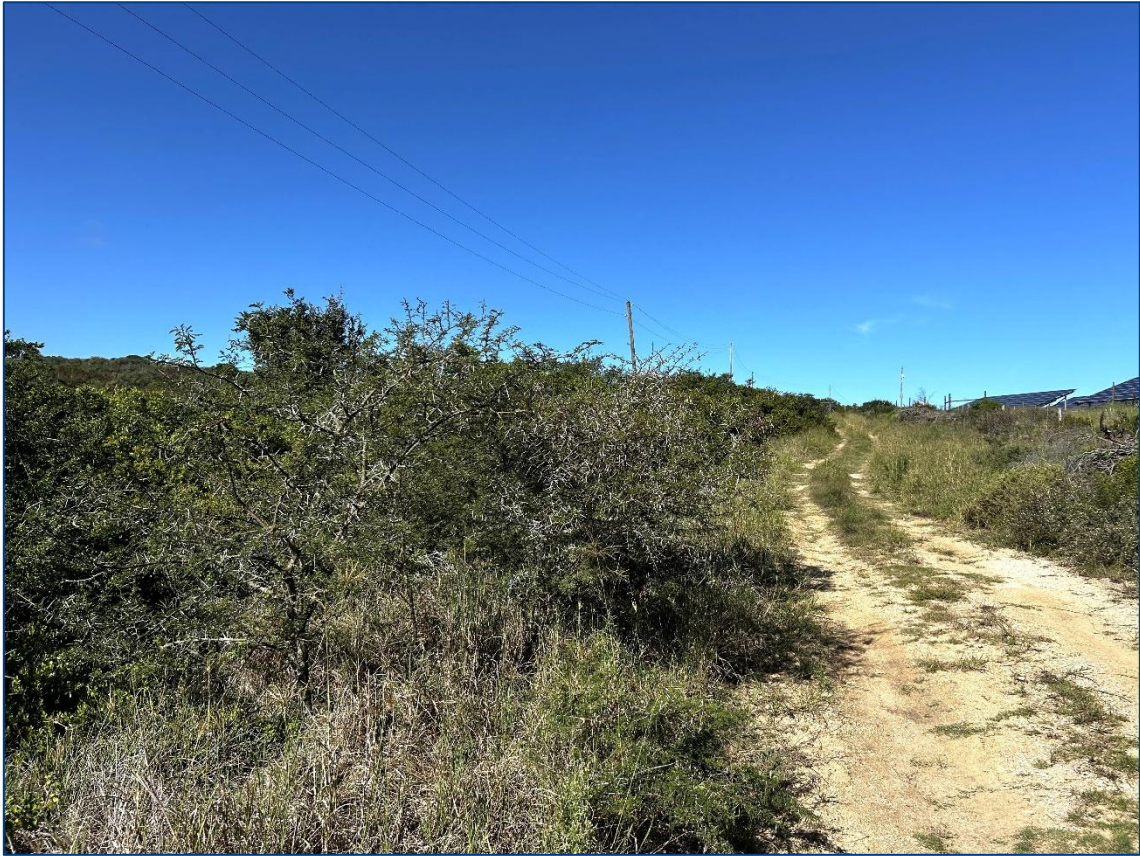
**Figure 5-5: Route for rising main, fringed by *Vachellia karroo*, *Searsia pallens*, *S. rehmanniana*, *Euclea undulata* and *Athanasia trifurcata*.**

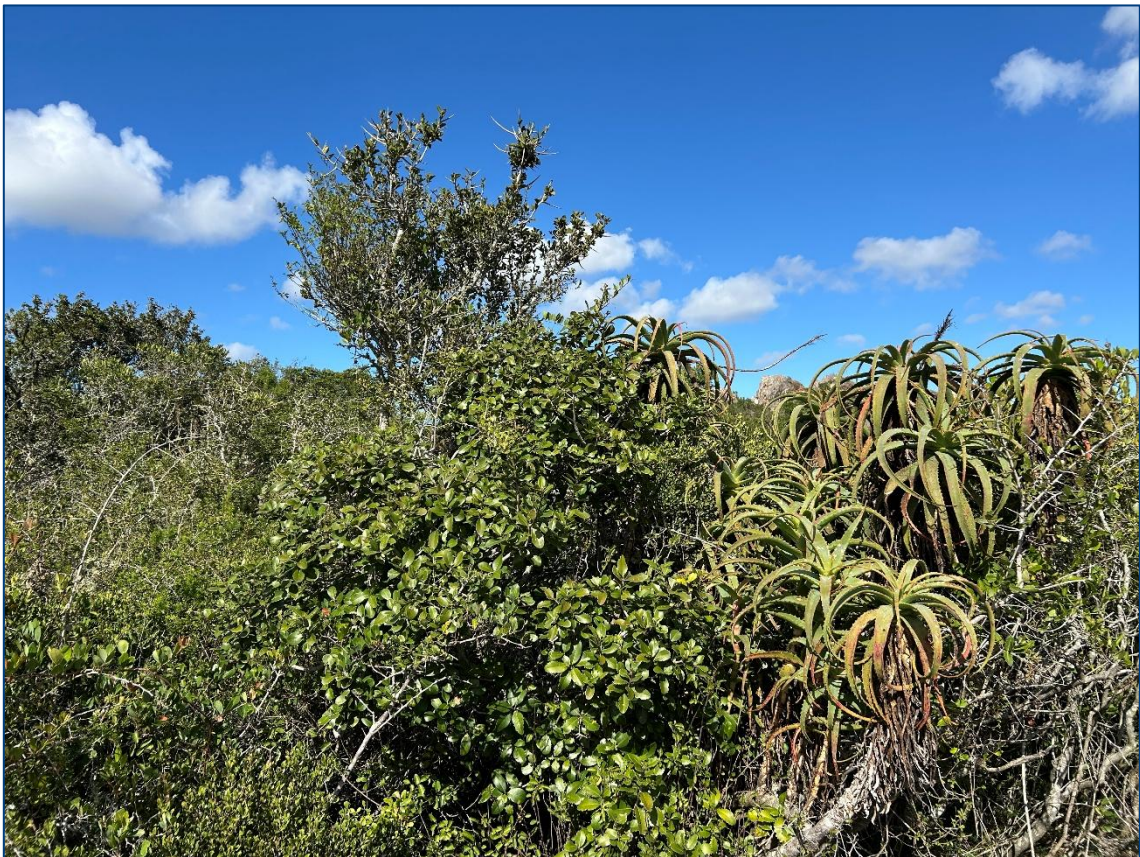
**Figure 5-6: Good quality thicket with *Aloe arborescens* on the southern side of pump station site.**

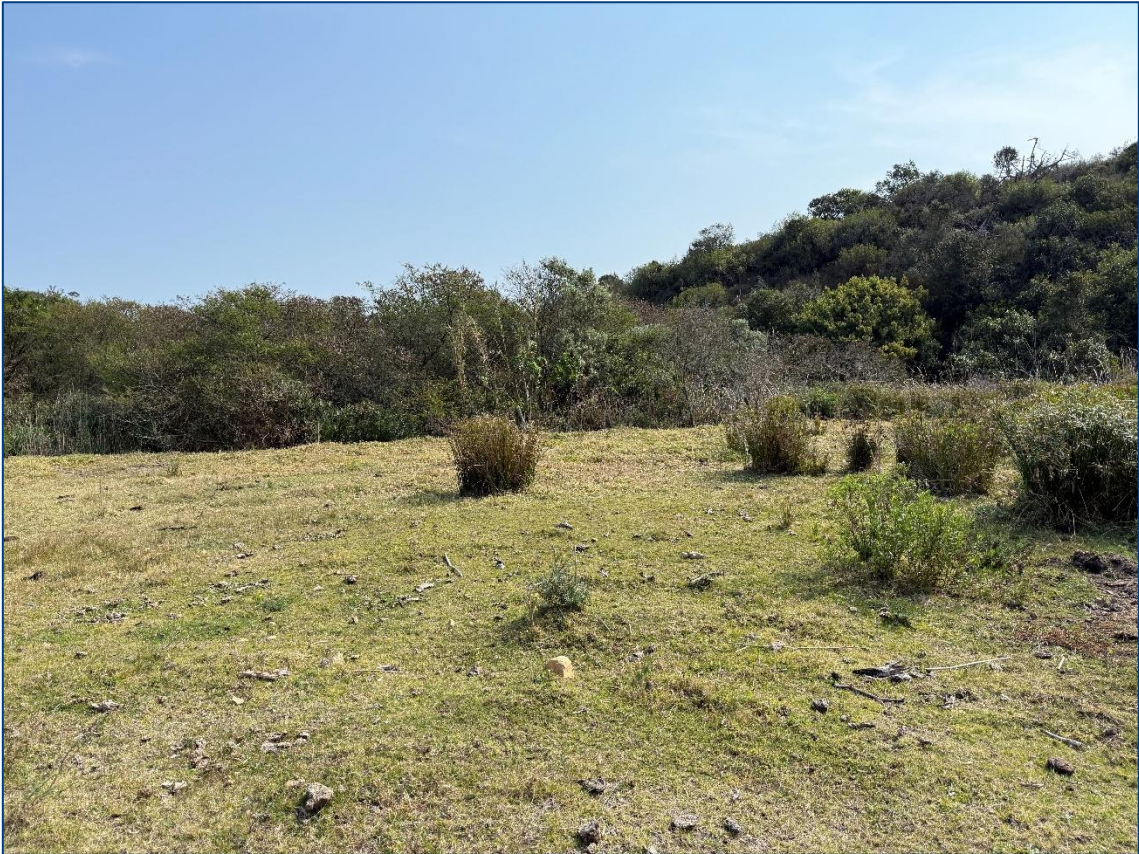
**Figure 5-7: Site camp option 1, below the Klipheuvel Dam wall (34° 03' 17" S; 22° 08' 17" E).**

Transformed or disturbed areas were selected for the site camp options (**Figures 5-7 to 5-9**). Site camp option 1 (below dam wall) is mainly covered by grasses, weeds and pioneer shrubs, such as *Cenchrus clandestinus*, *Stenotaphrum secundatum*, *Juncus acutus*, *Cyperus textilis*, *Nidorella ivifolia*, *Senecio rosmarinifolius* and *Vachellia karroo*. It also lies in close to a watercourse with *Cyperus textilis* and *Typha capensis*. Site camp options 2 and 3, which contain scattered thicket/renosterveld elements or regrowth, are more diverse. Indigenous species recorded here include *Dicerothamnus rhinocerotis*, *Oedera genistifolia*, *Scolopia zeyheri*, *Searsia pallens*, *Ruschia tenella* and *Cotyledon orbiculata*. Site camp option 3 also contains the remains of demolished farm buildings. The botanical attributes of the study area are presented in **Figure 5-10**.

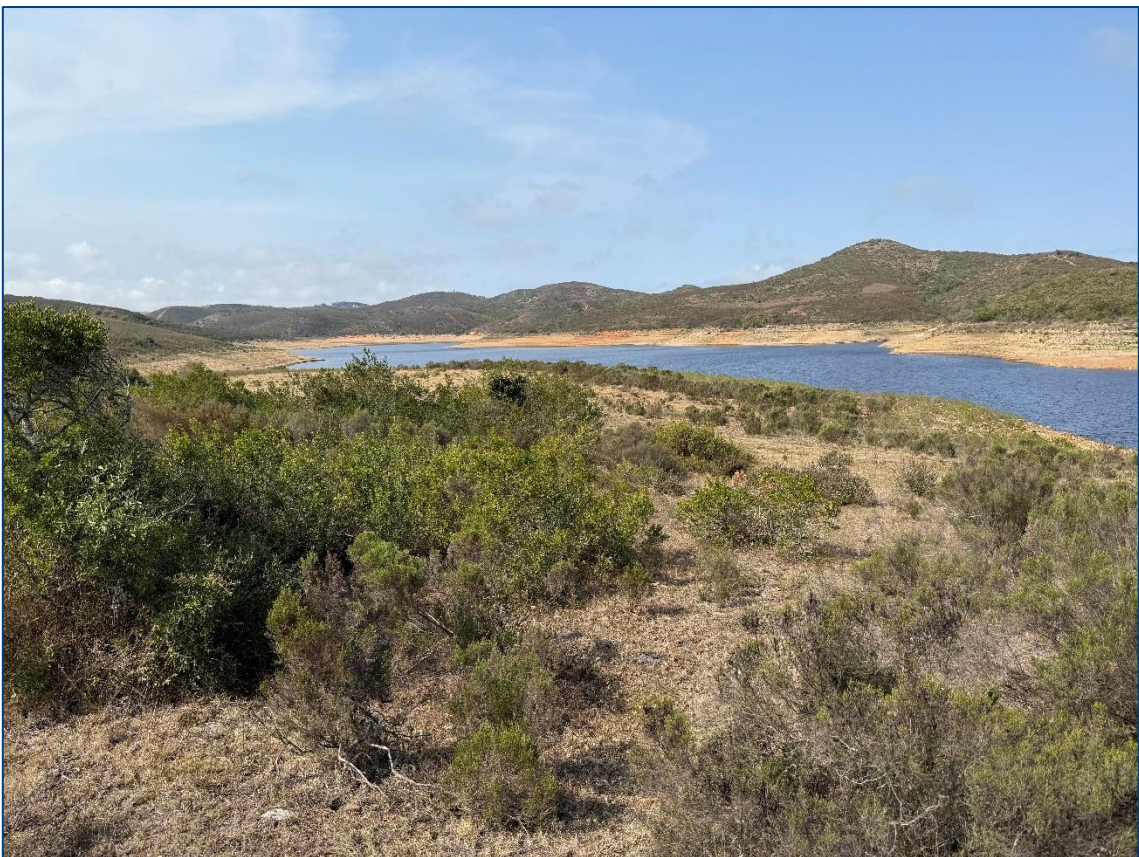
**Figure 5-8: Site camp option 2, above Klipheuvel Dam (34° 03' 10" S; 22° 08' 23.5" E).**

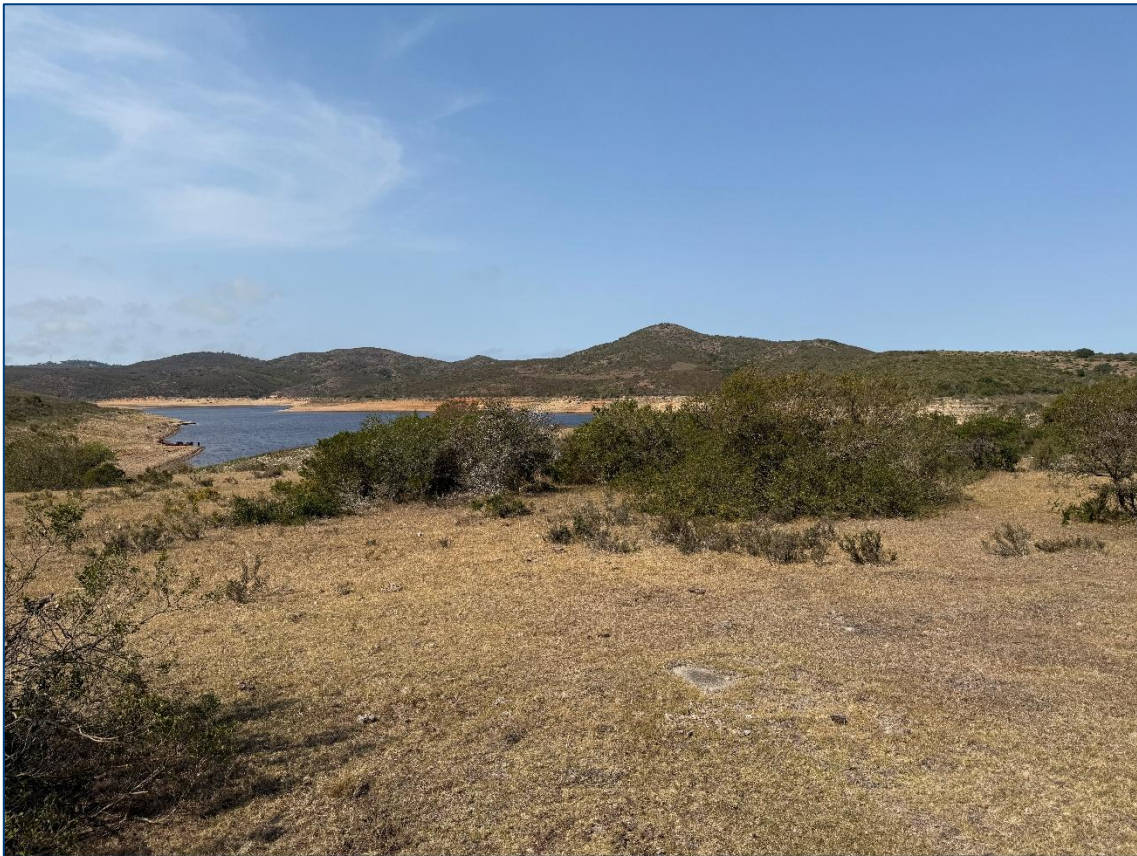
**Figure 5-9: Site camp option 3 (34° 03' 07.5" S; 22° 08' 24" E).**

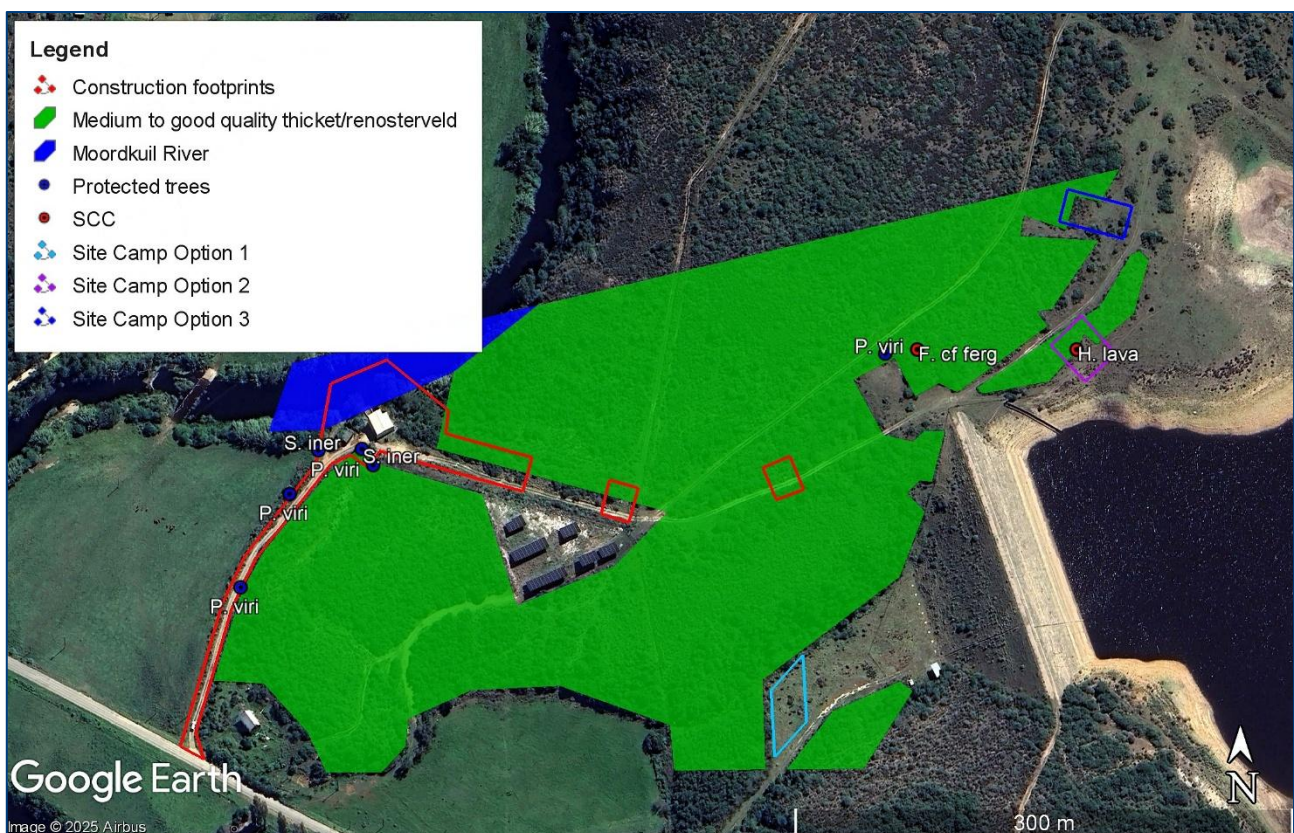
**Figure 5-10: Botanical attributes of the project area. The untuned areas inside the project footprint are transformed or highly degraded.**
