Engineering Geological Report

Township Establishment on
Erf 266 and the Remainder of Erf 21
Riversdale

Title:	Township Establishment: Erf 266 and RE/21, Riversdale
Project No:	TG-21-039

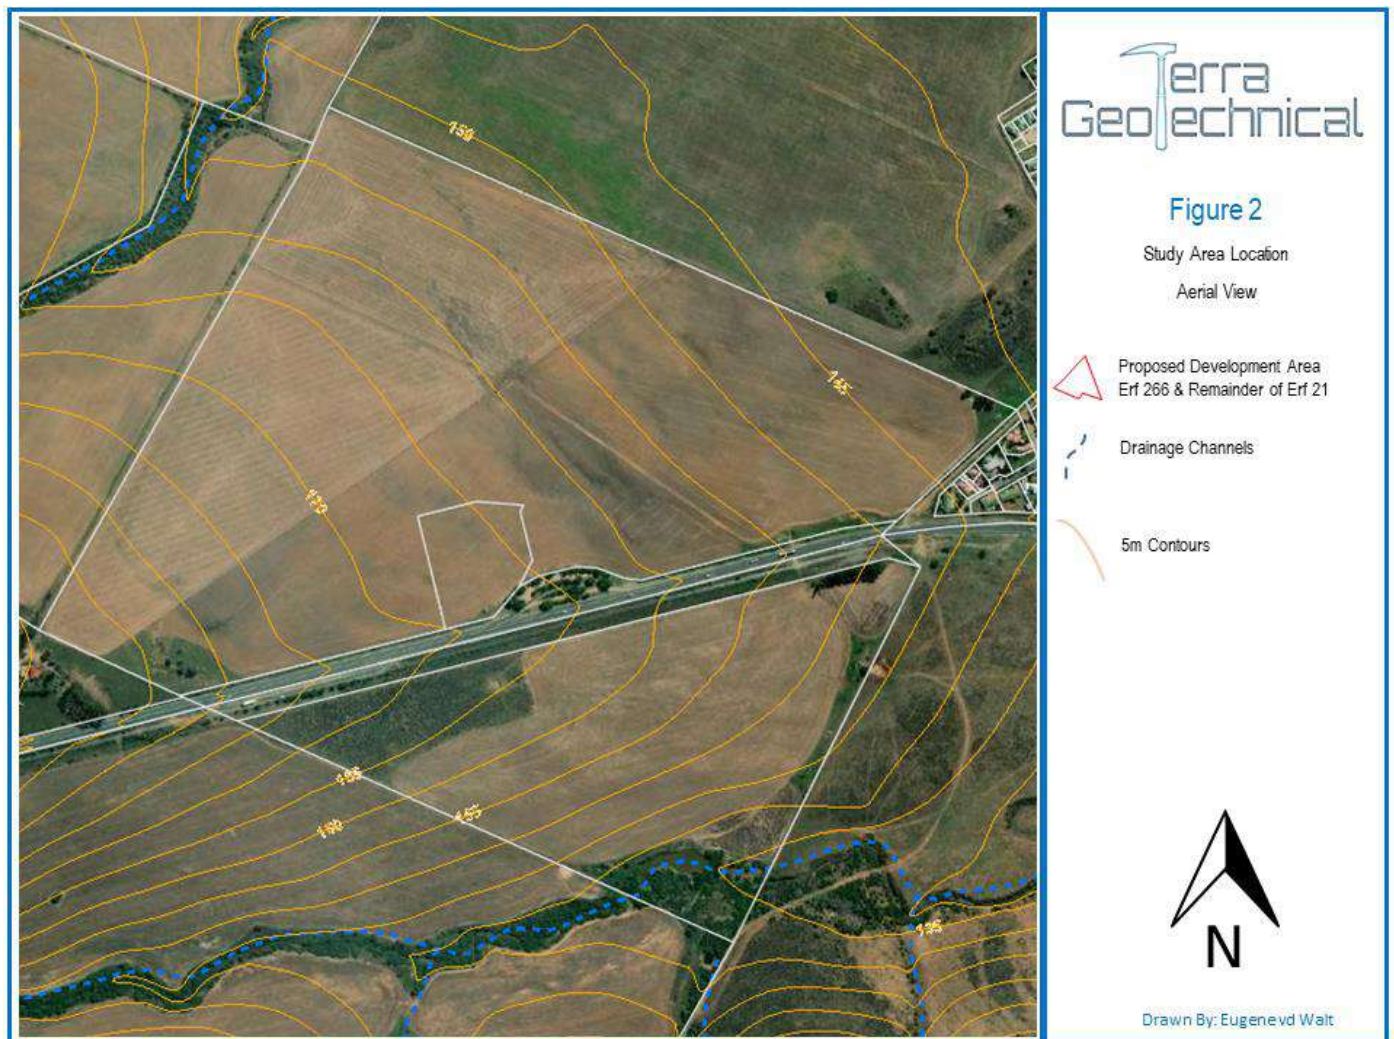
Figure 2 below visually depicts the current site conditions. The site is currently undeveloped and seen to be utilized for farming activities. The image shows the 5m contour lines indicating a drop in elevation from west to east. Various non-perennial drainage channels occur around the site, but none are identified to traverse the site. On the upper western portion, the site is approximately 190 m above mean sea level, and at its lowest point on the east, the site is approximately 140 m above mean sea level.

The site is seen to host gentle slopes of between 1 and 3 degrees
