SITE SENSITIVITY VERIFICATION REPORT

PROPOSED REMOVAL AND REPLACEMENT OF THE EXISTING ROAD AND CULVERT INFRASTRUCTURE LOCATED ALONG DIVISION ROAD (DR) 1791 KM 1.59, STOFPAD ROAD, CROSSING FARMS 591, FARM 586 AND FARM 306 ON PORTION 22 WITTEDRIFT, BITOU LOCAL MUNICIPALITY, GARDEN ROUTE DISTRICT

Applicant:	Western Cape Government Department of Infrastructure: Transport Infrastructure Branch			
	·			
Environmental Consultant:	· ·			
	Author: Madeleine Knoetze (EAPASA: 2021/3230)			
	Assisted by: Jessica Gossman (Candidate EAPASA:			
	2022/6154)			
SES Reference Number:	CT6/SSVR/03/25			
DEADP Reference:	TBC			
Date:	2025/03

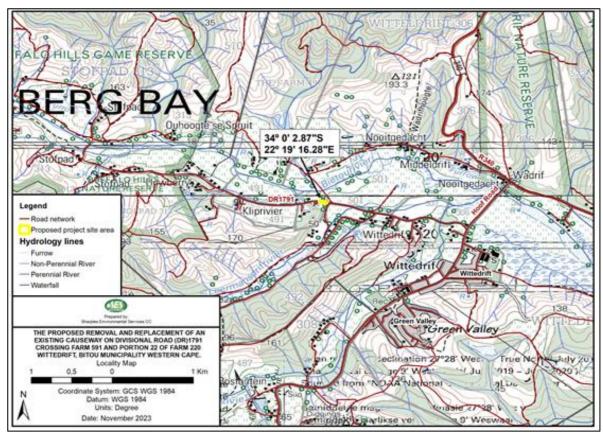
Figure 1: Locality map of the proposed infrastructure works along DR1791, Wittedrift.

The existing causeway sees its starting coordinates at 34° 0'2.76"S 23°19'15.90"E, its end coordinates at 34° 0'2.87"S 23°19'16.50"E and is located within a road reserve with a width of 20 m. In order to effectively re-establish and upgrade the existing causeway, it is required that a bypass be installed north of the existing road, and the bypass will be 4 m in width. Only approximately 2.5 m of the proposed bypass will be located outside of the existing road reserve.

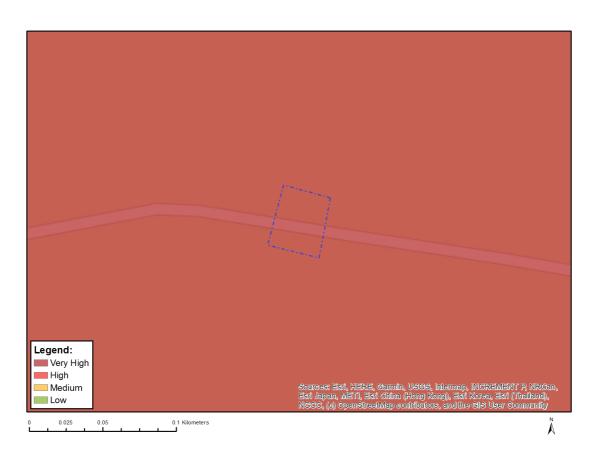
Figure 5. Relative Aquatic Biodiversity Theme Sensitivity Map

Sensitivity rating	Feature(s) for DR1791
Very High	FEPA Subcatchment
Very High	SWSA (SW) _Outeniqua

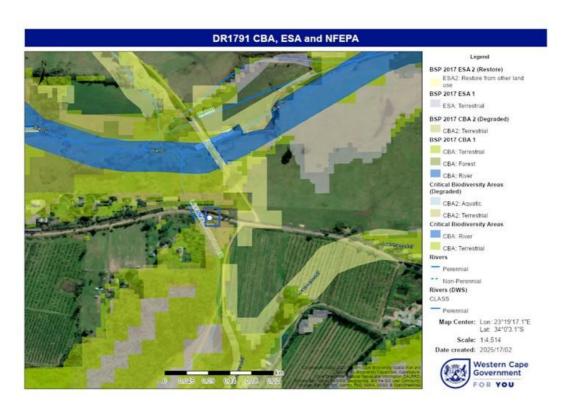
Figure 6. Aquatic biodiversity map, Western Cape Biodiversity Spatial Plan 2017, (Cape Farm Mapper, 2025).

Based on the desktop study of the site the construction will take place within the watercourse of the perennial Leermansdrift River (a tributary of the Bitou River watercourse, that is mapped as a critical biodiversity area). It is required that an aquatic assessment be undertaken based on the desktop study as well as the screening tool findings as the site sensitivity is classified as being very high as the sensitivity falls within the Freshwater Ecosystem Priority Area(s) as well as the Outeniqua Strategic Water Source Area(s).

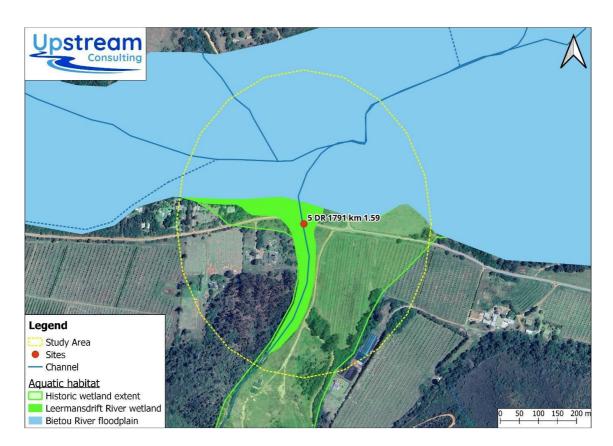
Figure 7. The delineated aquatic habitat within the 500m radius

The specialist verified that the site location does not fall within the Strategic Water Source Areas, and that two watercourses have been identified within the 500 meter study area radius. The hydrogeomorphic units are HGM16 – Leermansdrift River that is channelled valley bottom wetland and HGM17- Bietou River, that is regarded as a floodplain wetland system. The specialist noted that Leermansdrift River will be impacted on directly and the Bietou River will be impacted on indirectly. And concluded that the site will need a full impact assessment.

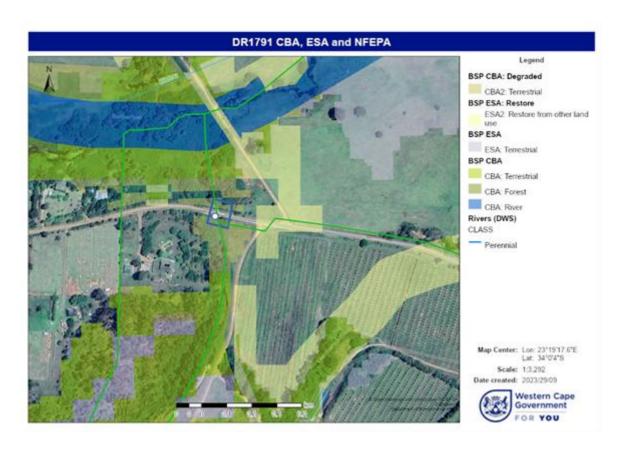
Figure 12. Critical Biodiversity Areas and rivers , Western Cape Biodiversity Spatial Plan (2017).

The site is located within an area with an Ecological Threat Status of Endangered see Figure 13 and is mapped as terrestrial Critical Biodiversity Area 2 (CBA2) as well as ESA2 as seen on Figure 12. This site's vegetation type is Garden Route Shale Fynbos and has an Ecosystem Threat Status of Endangered. This site is located within a National Protected Area Expansion Strategy (NPAES) area and within the Garden Route National Park buffer area.

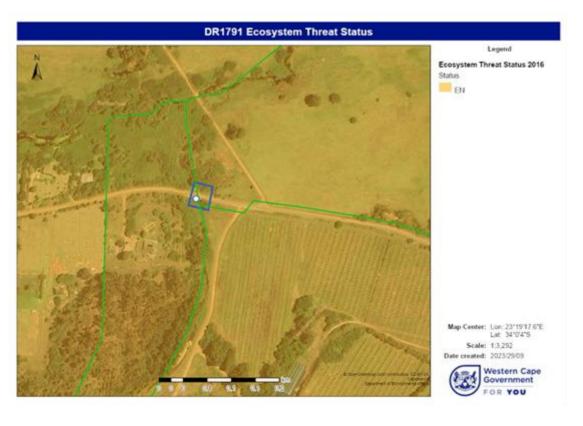
Figure 13. Ecological Threat Status of the proposed development site (WCBSP, 2017).

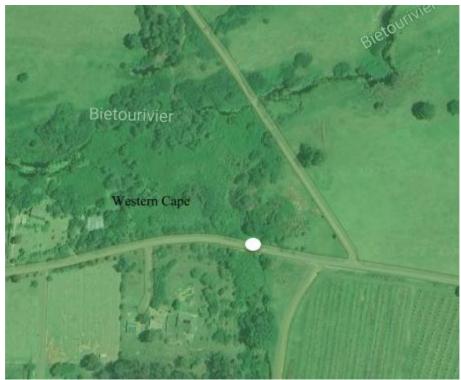
Figure 16. SAHRIS PalaeoSensitivity Map for the proposed removal and repair project

Based on desktop observation and sourced images from the South African Heritage Resources Information System (SAHRIS,2023), the site appears to have no features of palaeontological significance and regarding the nature of the already disturbed area is to replace and repair existing infrastructure, the likelihood of interacting with fossils can be considered low. However, should remains be found, further information and procedures will be included in the Environmental Management Programme (EMPr) to minimise risk and disturbance. Heritage Western Cape will be included as a Stakeholder as part of the Public Participation Processes.
