# Heritage Statement

**PROPOSED REMOVAL AND REPLACEMENT OF THE EXISTING  
ROAD AND CULVERT INFRASTRUCTURE LOCATED ALONG  
DIVISION ROAD (DR) 1791 KM 1.59, STOPPAD ROAD, CROSSING  
FARMS 591, FARM 586 AND FARM 306 ON PORTION 22  
WITTEDRIFT, BITOU LOCAL MUNICIPALITY, GARDEN ROUTE  
DISTRICT**

### BRIEF PALAEOONTOLOGICAL IMPACT STATEMENT

**NEW CAUSEWAY – LEERMANSDRIFTRIVIER – SITE 5 DR1791 km 1.59**

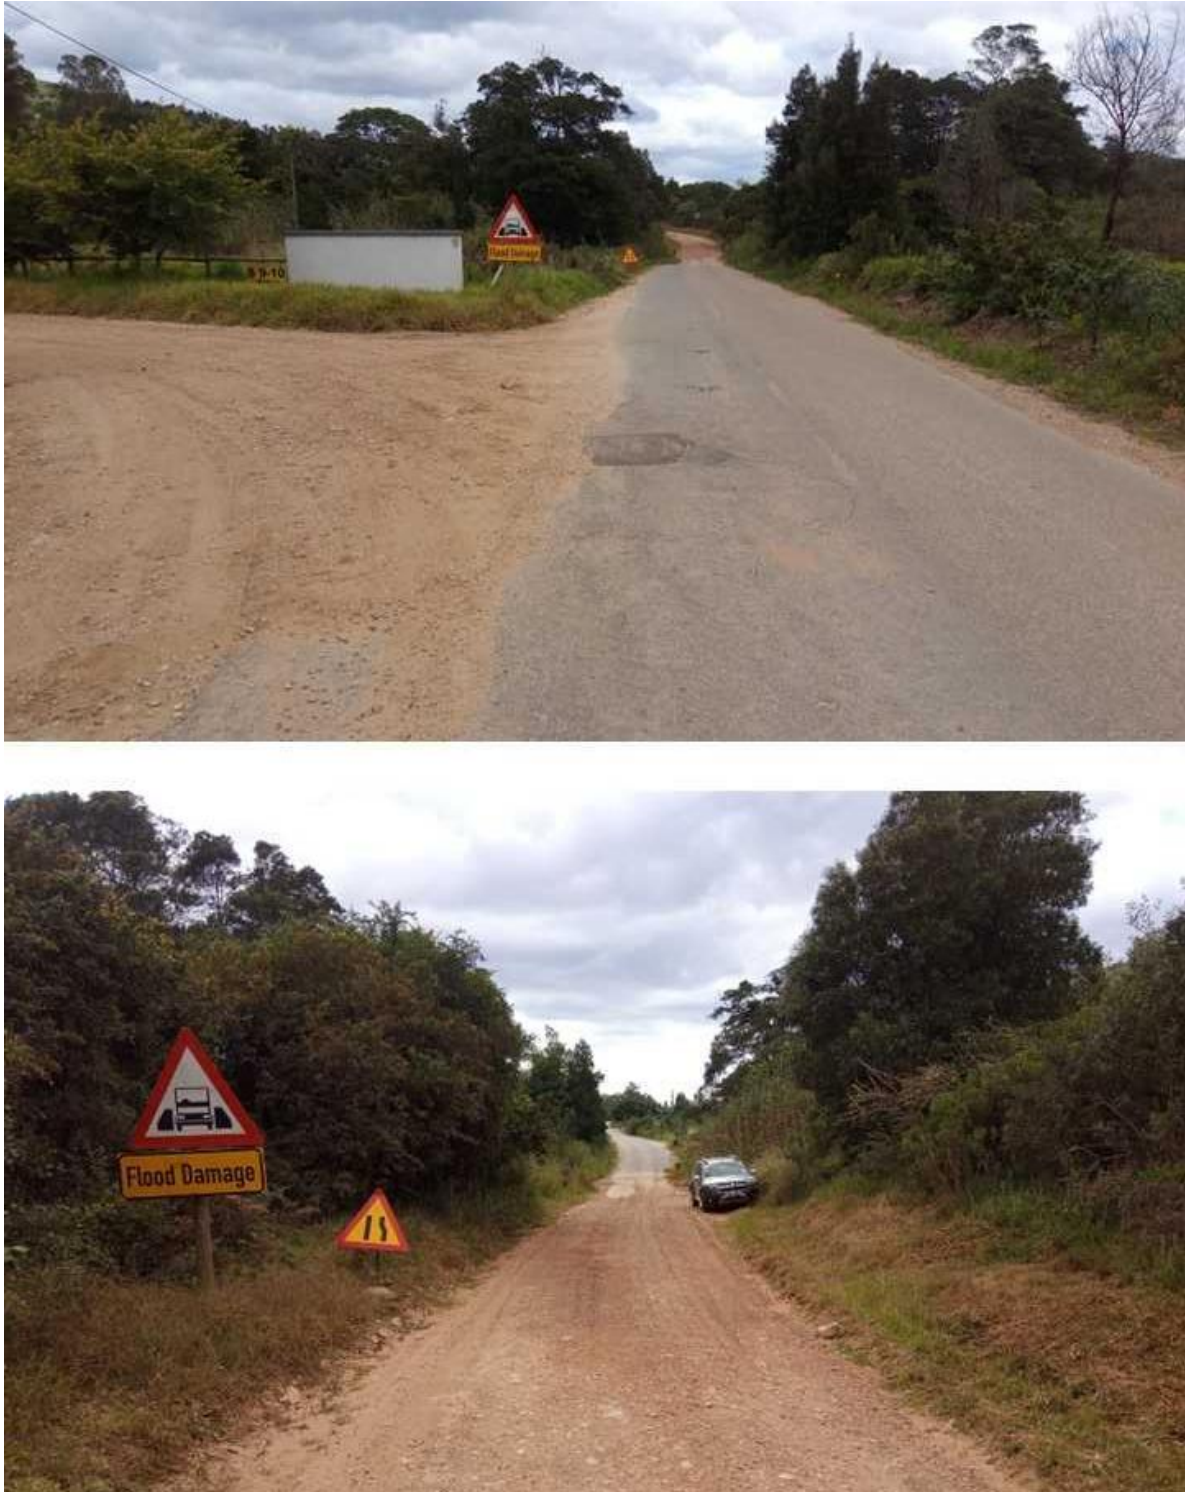
as well as by water damage during flooding. The reason for the proposed activity is to repair the road and causeway that were damaged during flooding in 2023. The immediate surroundings are overgrown. Examples of site 5, damage to transport infrastructure, and the immediate surroundings are shown in Figures 4 and 5.

Figure 4. Site 5 and immediate surroundings viewed from the East (top) and viewed from the West (bottom).

An independent site inspection of Site 5 was conducted on 8 February 2024 by means of a foot survey that covered the footprint of the proposed activity. Archaeological visibility was moderate to good and adequate for the purpose of this report. Examples of the studied area are shown above in Figures 4 and 5.

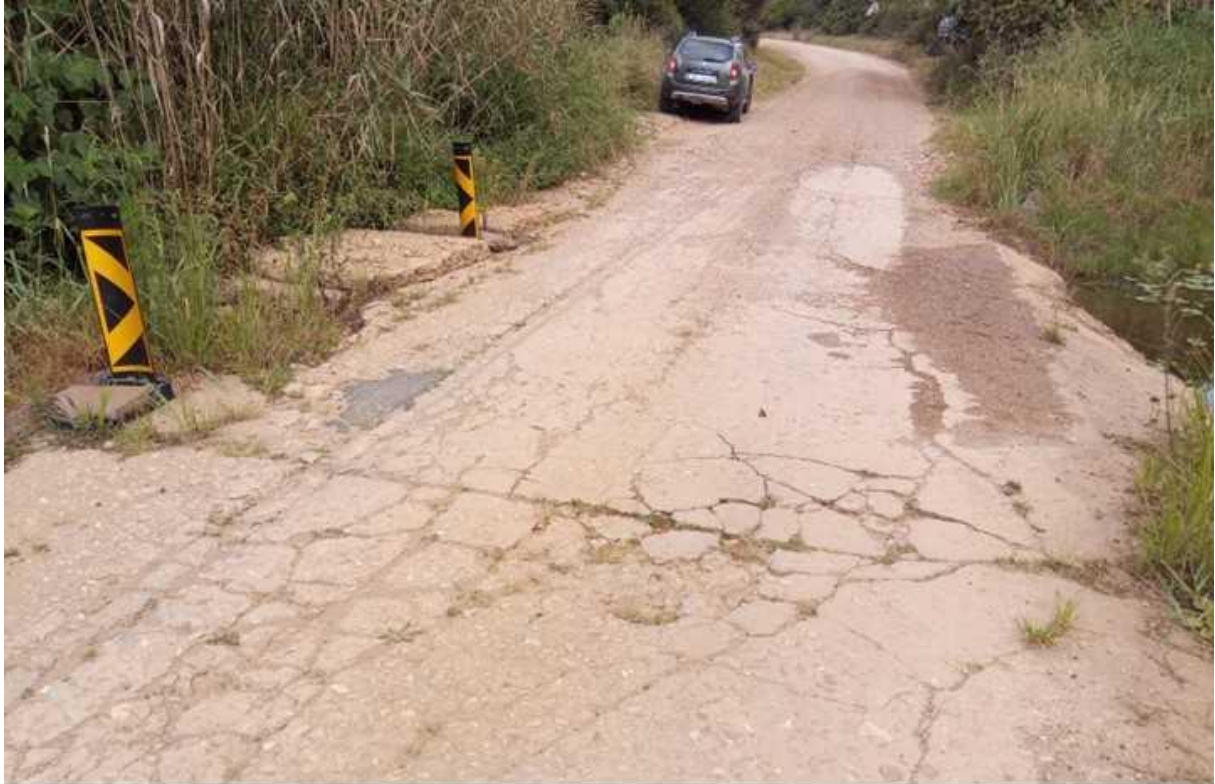
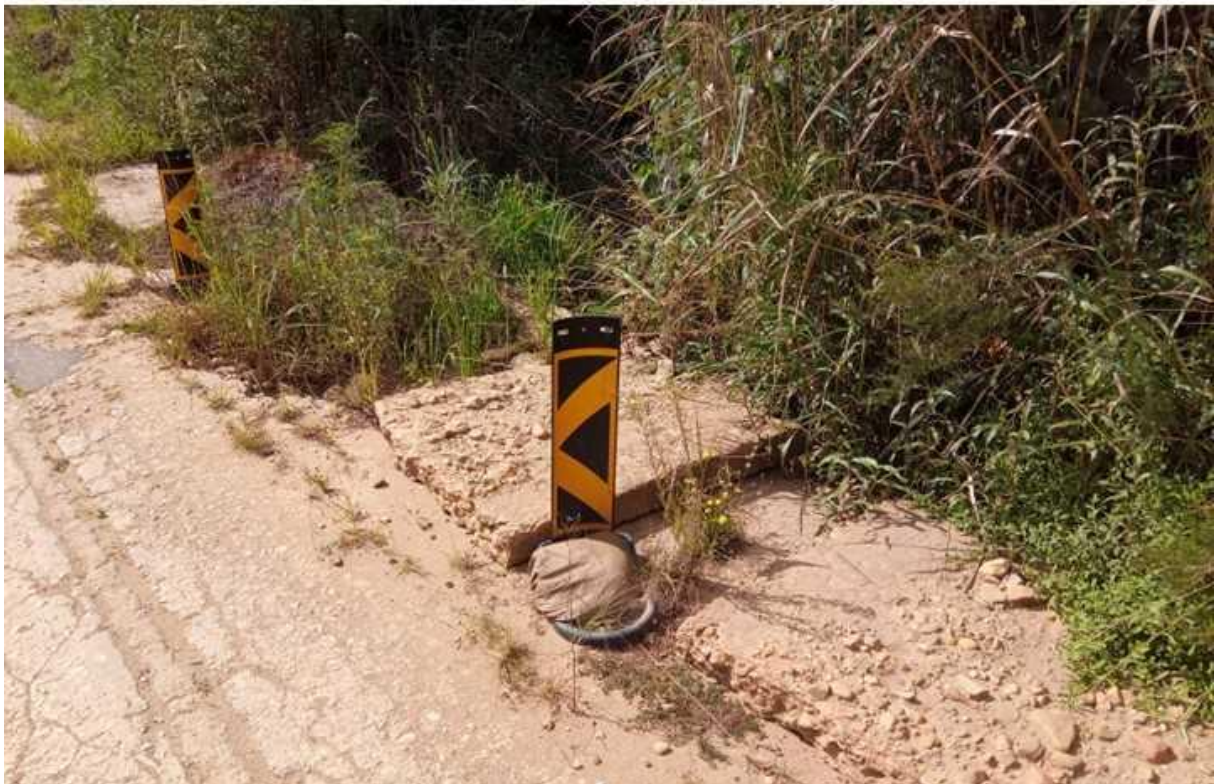
Figure 5. Site 5 showing damage to causeway.

The road and causeway at Site 5 are likely older than 60 years but are damaged and do not have any structural features of heritage value. Given the existing transport infrastructure at Site 5, any archaeological or palaeontological resources that may have occurred in the affected area are disturbed and compromised by human-related activities and imported sediments. No archaeological or heritage resources of colonial or pre-colonial origin were identified within the study area or in its immediate vicinity. No intact fossil-bearing sediments were seen.

The proposed repair works will “Replace existing causeway with new but much bigger openings; provide inlet and outlet apron slab and wing walls; raise road about 600 mm estimated - temporary deviation road downstream bypass will be 4 m wide and 55 m long. The information suggests that the bypass extends approximately 2.5 m beyond the road reserve, which represents an area of approximately 68 m<sup>2</sup>. The total development footprint of the bypass road will be ca. 385 m<sup>2</sup> “(from SES).

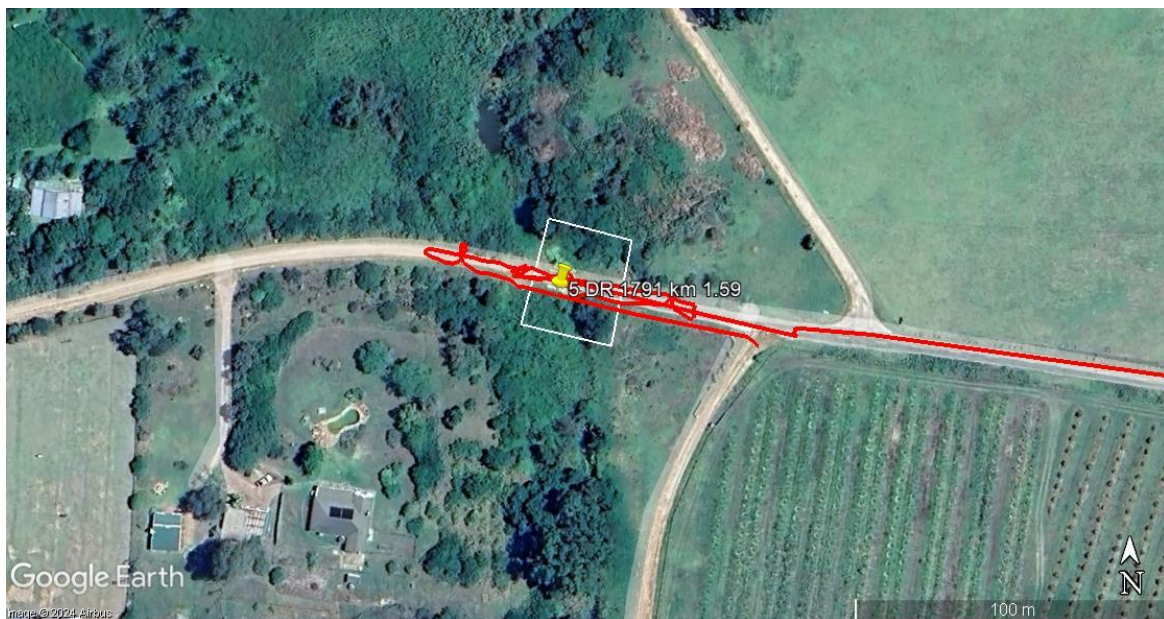
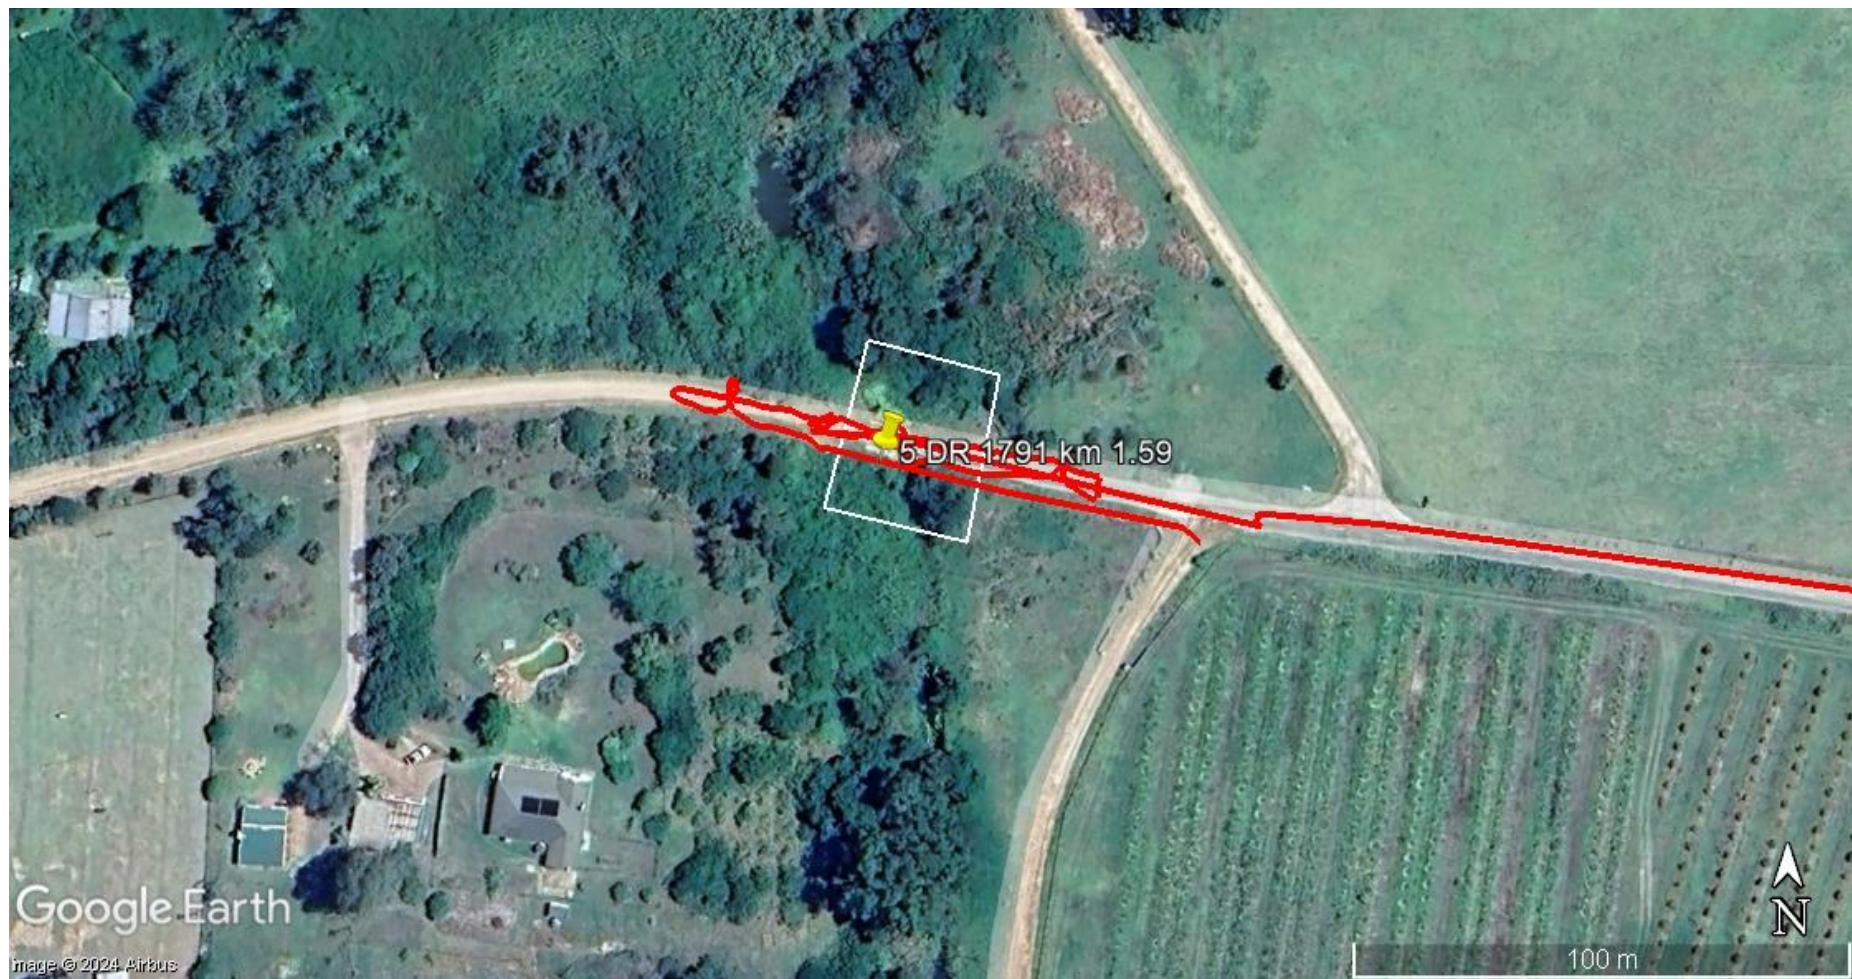
Survey tracks and observations were fixed with a handheld Garmin Etrex 30x GPS to record the investigated area (Figure 7). A high quality, comprehensive digital photographic record was made with a DooGee S86 mobile phone, including location data for photographs. All GPS and photographic data are available on request.

Figure 7: Study area (yellow marker and white rectangle) with GPS-fixed survey tracks (red lines). (A4 version below).
