ECO CHECKLIST FOR THE CONSTRUCTION OF THE PACKAGE SEWAGE PLANT AND HOUSES ON THE PREEKSTOEL BEACH ESTATE, STILL BAY EAST, WESTERN CAPE

File 1012 : Construction ECO Checklist No.: 7

Date: 24 October 2024

ECO CHECKLIST # 7

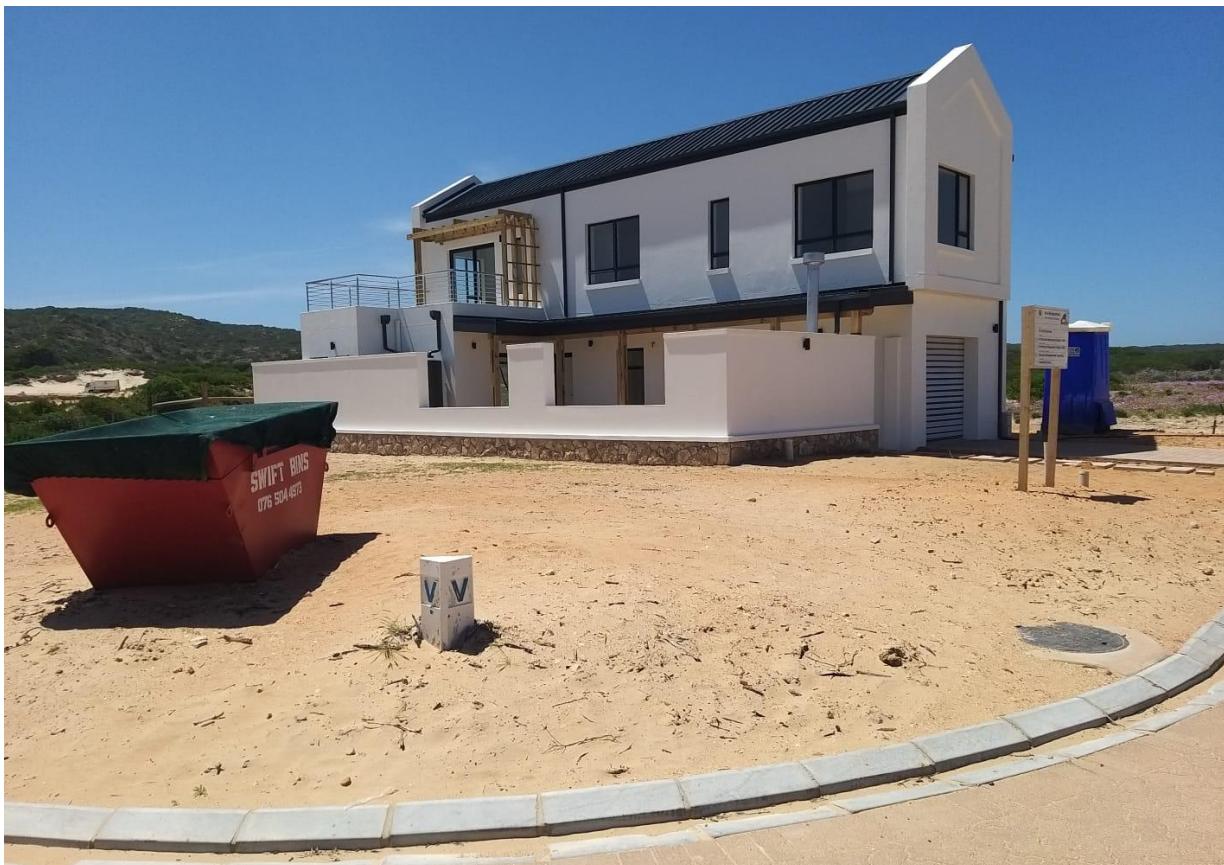
Photo 1: A waste skip is being used for the temporary storage of builder's rubble and general waste on Stand Erf 2382. The toilet was still on site for the small building team that were in the throws of completing the house.

Storage of construction materials, concrete mixing areas, rubble storage and litter management on	1. Construction material (precast concrete components of the package sewage plant, concrete and mortar raw materials) must be stored in	Area for construction material has been designated by the Site Agent and to be in secured area out of the way of access routes. ECO to monitor compliance.	C	The storage areas have been vetted by the Site Agent and ECO and are out of the way. These storage areas are in a neat and tidy state (Photo 1).

5. Chemical toilets must be used on site and must be emptied and sanitized regularly. There must be 1 toilet per 15 staff.	Construction supervisors are responsible for the provision of chemical toilets, the provision of toilet paper, soap and water	C	Each construction site has its own toilet on site (refer to Photos 1 and 3). Toilets are serviced each week.

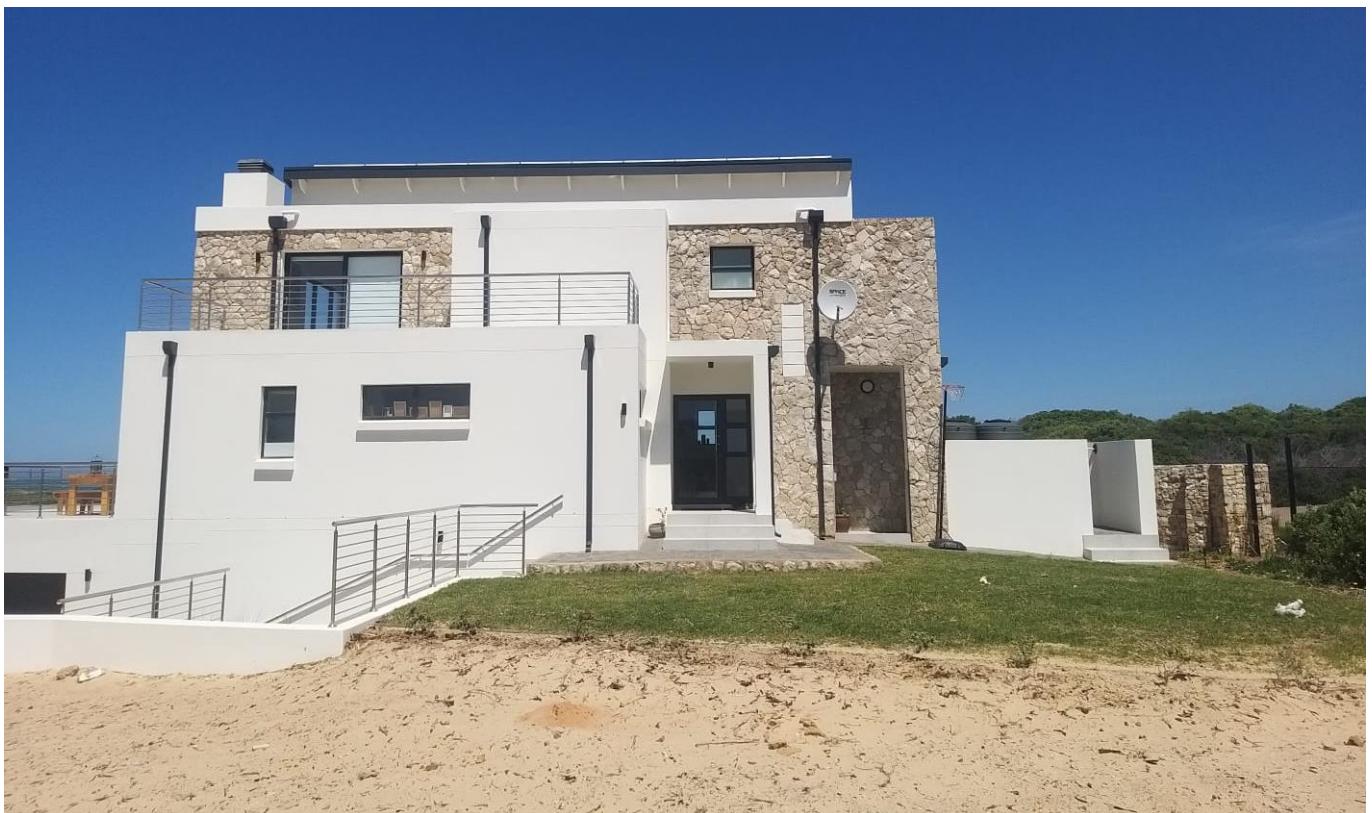
Photo 2: The construction of the house on Erf 2457 has been completed and some landscaping has been undertaken. The house was occupied.

2. Contractor to store building rubble in a suitable designated area, with rubble removed from site on a weekly basis.	The area for any building rubble storage to be designated by the Site Agent. Contractor to remove any builder's rubble on weekly basis. ECO to monitor compliance.	C	Building rubble is being generated on two of the houses being built on Erven 2382 and 2421. Such waste is removed from site weekly in a skip. Building waste from the two erven building sites is stored in a skip which is covered with shade netting (Photo 1). The house on Erf 2457 has been completed and is occupied (Photo 2). The first floor deck of the house on Erf 2421 was being prepared for casting the concrete (Photo 3).

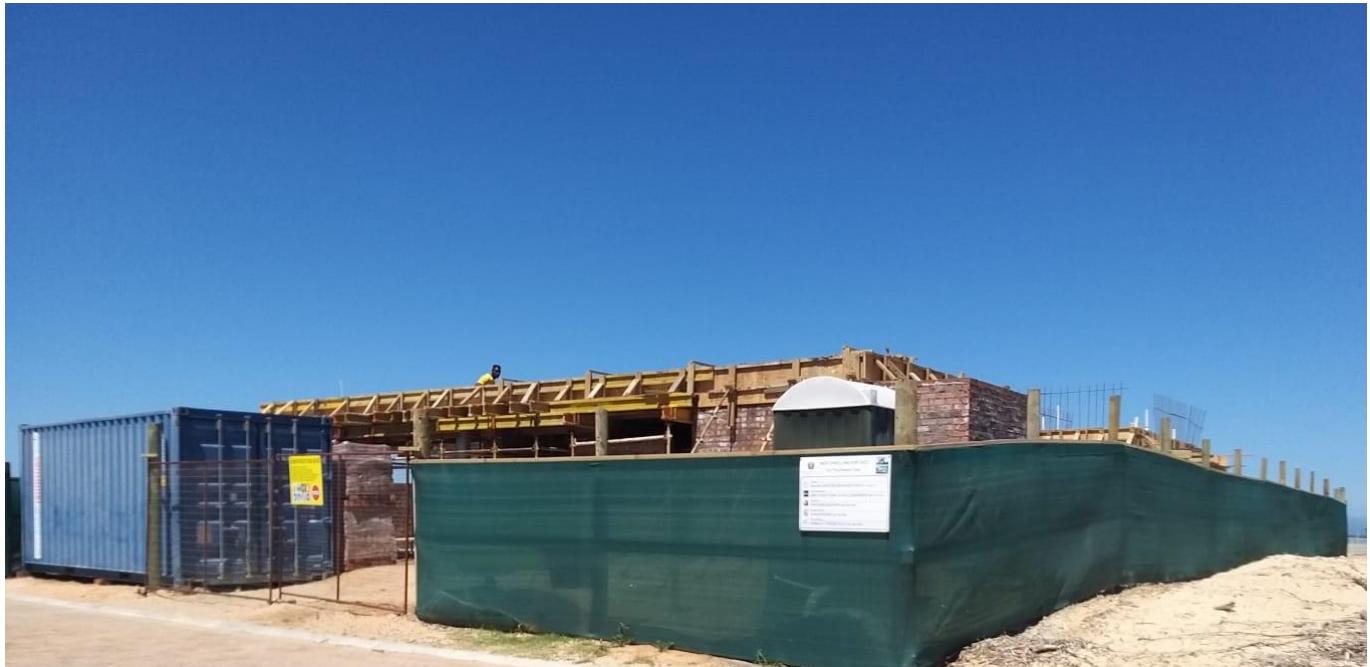
Photo 3: The first floor deck of the house being built on Erf 2421 has been prepared for casting the concrete. The site has a toilet and a skip on site for builder's rubble. The chemical toilet is also visible on site. The site was in a neat and tidy condition.

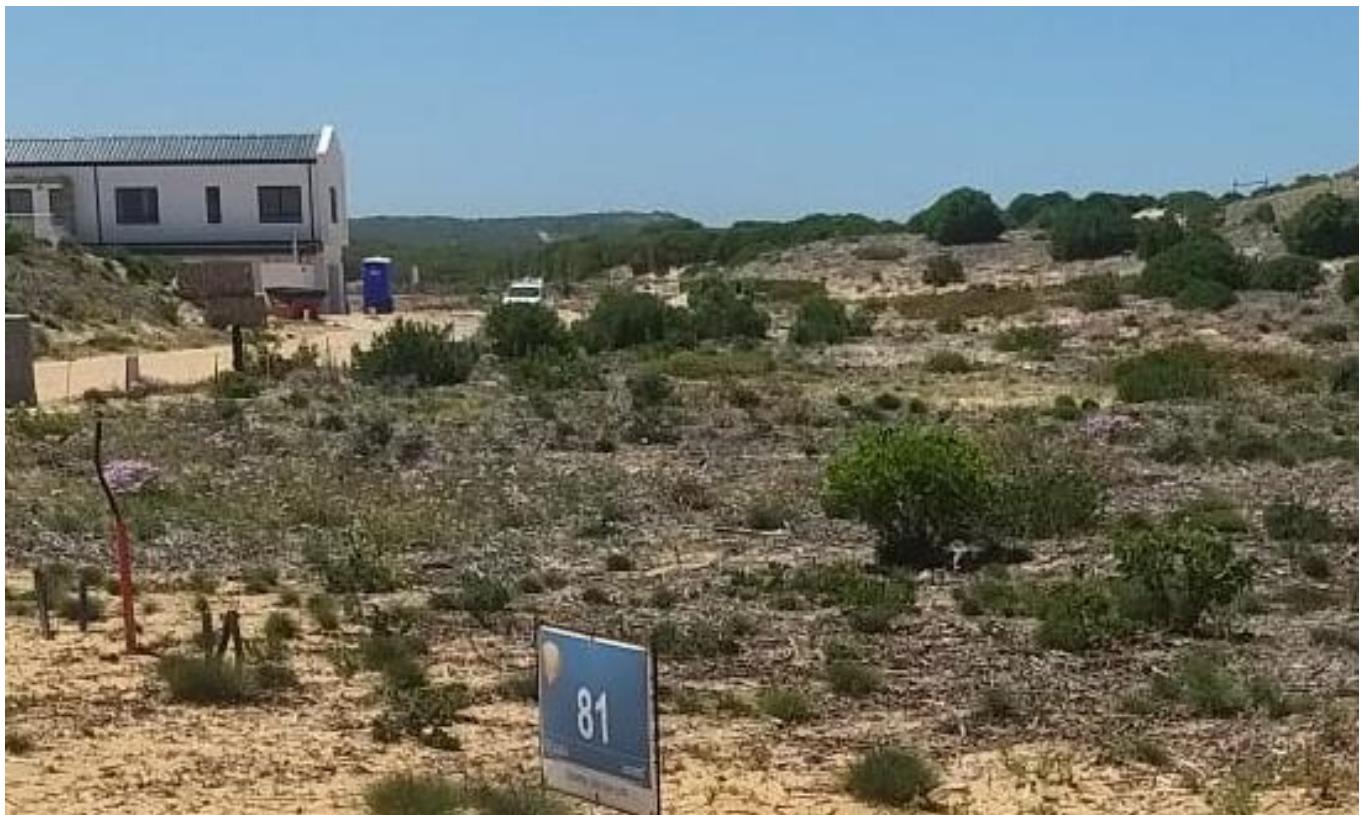
Photo 4: The exotic, invasive rooikrans (*Acacia cyclops*) has been removed from erven 2460 to 2467. Some locally indigenous Blombos Strandveld species have germinated on site, including a sedge species and various grasses.

ENVIRONMENTAL ASPECTS (PROJECT ACTIVITY)	REQUIRED ACTIONS	TARGET AND RESPONSIBILITY	COMPLIANCE	ECO COMMENTS
		(e.g. foliar spraying with an appropriate herbicide).		for the developer (refer to Photos 4 and 5).
Minimise disturbance to fauna	1. Contractors must not harm or disturb any wildlife, especially snakes, tortoises, buck, hares and birds.	Construction Supervisor and Site Agent to monitor. The contractors must report all incidents of harm to any fauna to the site agent who will report such incidents to the authorities.	C	No incidences of wildlife were noted on site.
E.2.2 Water				
Institute measures to minimise ground water pollution during construction phases of project.	1. No pollution of surface or ground water may occur due to any activity on the property. The relevant requirements of the National Water Act, 1998 (Act No. 36 of 1998) must be complied with at all times	The Construction Supervisor and Site Agent must monitor the use of oils, diesel and other hydrocarbons on site.	C	No incidents of any hydrocarbon spills have been noted or reported.

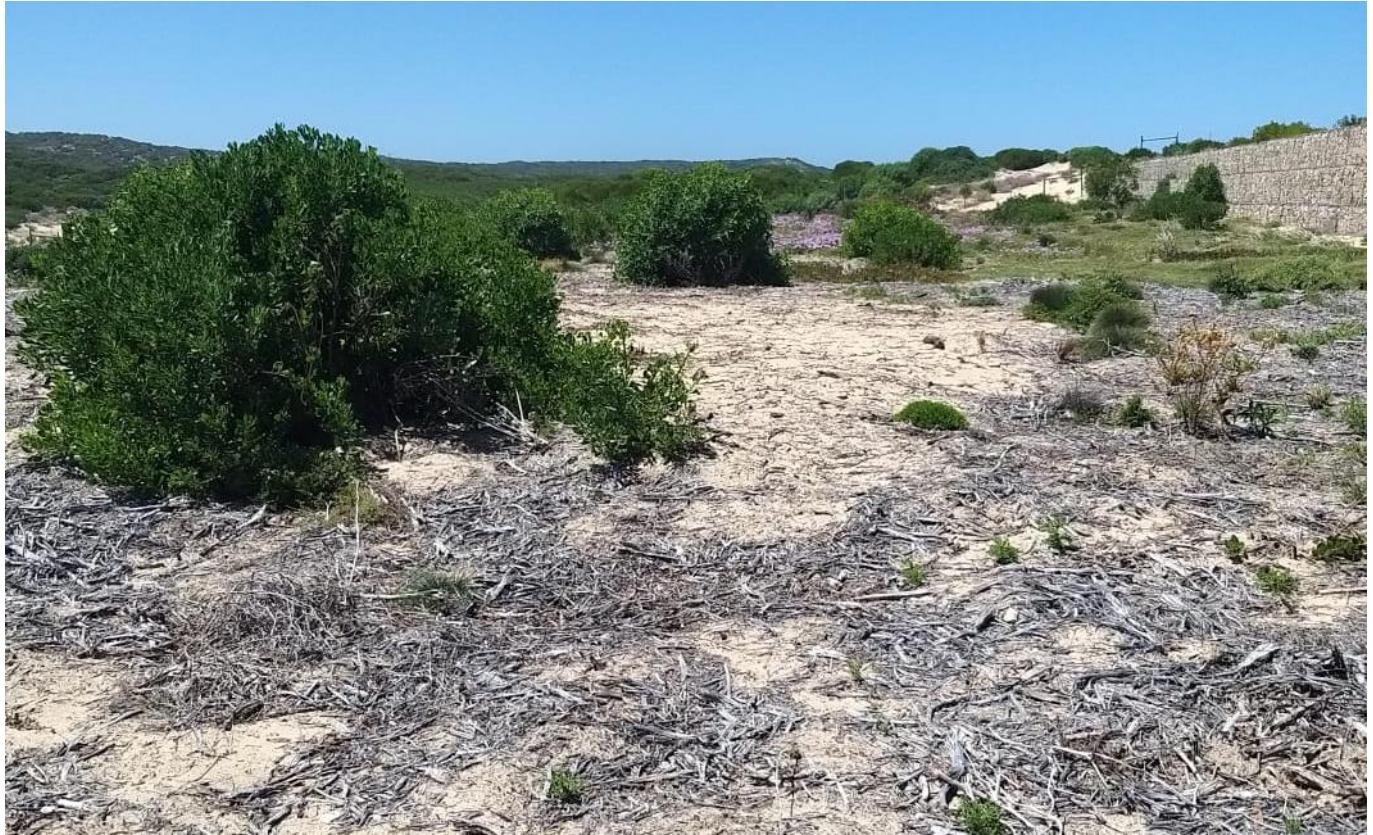
Photo 5: A dedicated team of gardeners has been employed to physically remove the rooikrans and manatoka seedlings that are proliferating on the erven 2423 to 2727 within the development area. Seedlings of Blombos Strandveld species have grown on site.

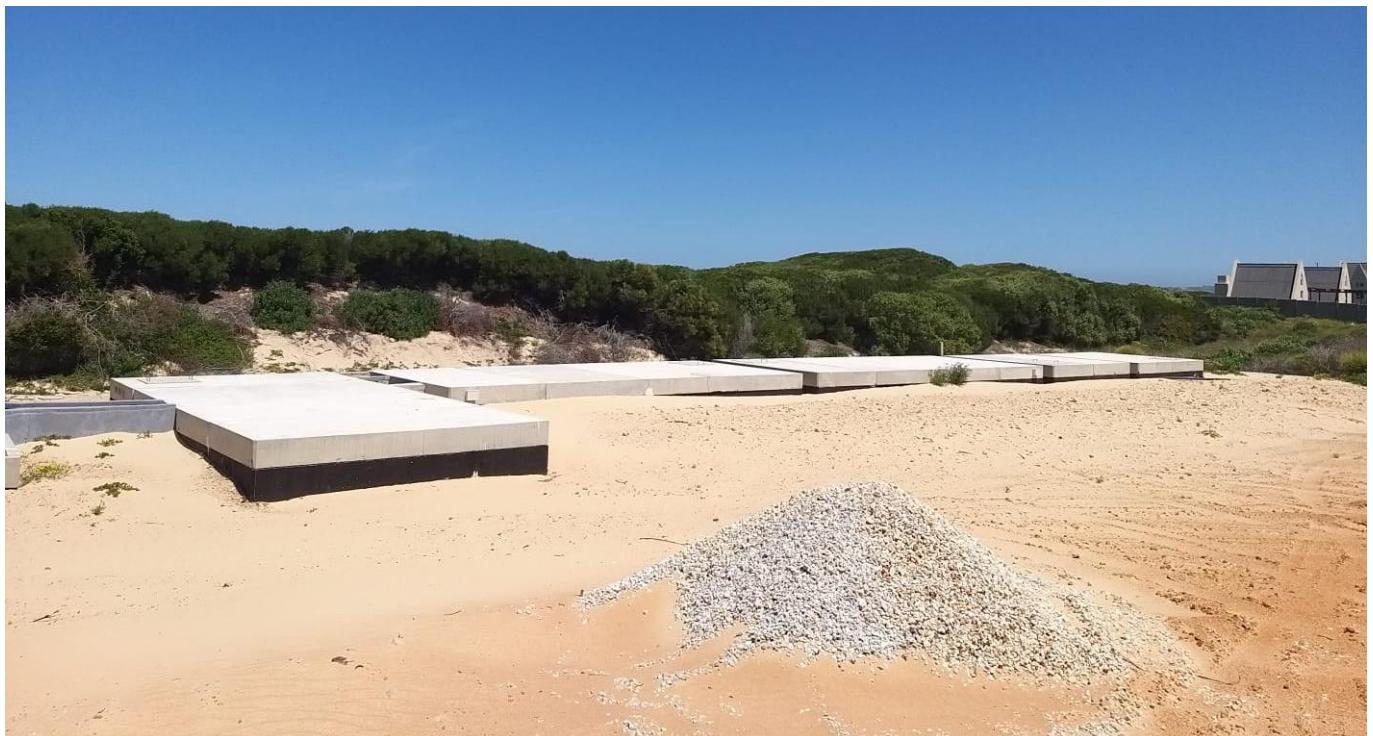
Photo 6: The final lids have been placed onto the various tanks of the package sewage plant.

ENVIRONMENTAL ASPECTS (PROJECT ACTIVITY)	REQUIRED ACTIONS	TARGET AND RESPONSIBILITY	COMPLIANCE	ECO COMMENTS
E.2.3 Soil				
Rehabilitate all areas where soil erosion has taken place	<ol style="list-style-type: none"> 1. Institute soil protection and soil rehabilitation measures on site where erosion has taken place with the use of wood chips. Shade netting could be used in areas where windblown open sandy areas are located. 2. Eroded areas will need to be backfilled and compacted 3. Plant locally indigenous Strandveld plants over the private open space areas to stabilize exposed sandy areas. The above planting should only take place after the first good rains of the winter season. 	<p>To be planned and facilitated by the Site Agent and Construction Supervisor where necessary.</p>	C	No significant erosion of the development site has been noted.
Prevent pollution/contamination of soil	<ol style="list-style-type: none"> 1. Prevent cement powder spills and clear such accidental spills as soon as possible as cement powder has a high alkalinity pH rating that can contaminate and affect both soil and water pH dramatically. All hydrocarbon spills are to be addressed immediately to prevent seeping into the ground. 2. All fuels, oils and hydrocarbon products kept in tins and drums must be stored in a suitably bunded area to prevent pollution in case of spills or leakages. 	<p>Site Agent and Construction Supervisor to monitor for duration of contract. Contractor to inform Site Agent of such spills.</p> <p>Special measures are to be implemented for any hydrocarbon fuel spills. An Oil Spill kit must be kept on site in case of a hydrocarbon spill.</p> <p>Site Agent to monitor compliance for duration of contract.</p>	C	<p>No cement powder spills were noted on site. The large crane used to lift the pre-cast concrete components of the package sewage plant into position did not require refueling. The last of the pre-cast concrete panels were delivered to site on 13 March 2024. These panels were placed by the crane on the package sewage plant on Thursday and Friday 14 and 15 March. The final lids were placed onto the package sewage plant during October once the required pipework had been installed (Photo 6).</p> <p>No incidents of spills have been noted.</p>
