ECO CHECKLIST FOR THE CONSTRUCTION OF HOUSES ON THE PREEKSTOEL BEACH ESTATE, STILL BAY EAST, WESTERN CAPE

File 1012 : Construction ECO Checklist No.: 9

Date: 3 July 2025

ECO Checklist the Construction of the Sewage Package Plant and Housing on the Preekstoel Beach Estate, Still Bay East, Western Cape

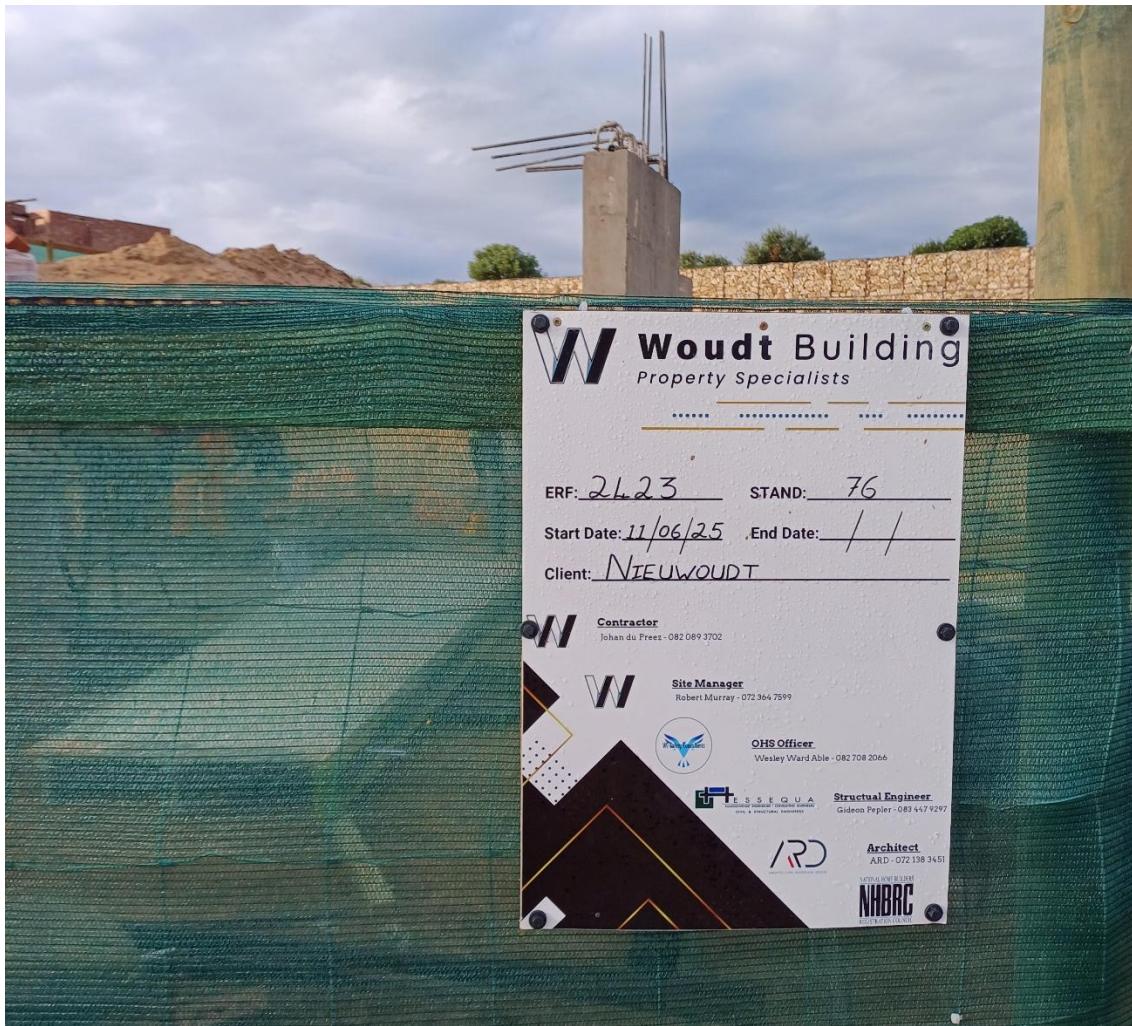
Photo 1: Woudt Building is currently building the house on Erf 2423.

3. Appropriate signage indicating the main contractor, Consulting Civil Engineers, Electrical Engineers, Landscape Architect, Environmental Assessment Practitioner and ECO (with contact details) must be erected on site.	The contractor's Notice Board is to be placed near the entrance to the development site. The Notice Board is to have the ECO's telephone No. on it.	C	The Main Contractor's Notice Board is placed near the entrance to the development's construction site and the telephone No. of the ECO is on the notice board. The FluidCo's construction notice board for the Package Sewage Plant's site complies with the necessary site safety regulations. The Tretsom notice board is on the shade cloth fence, as are Woudt Building (Photos 1, 2 & 3).

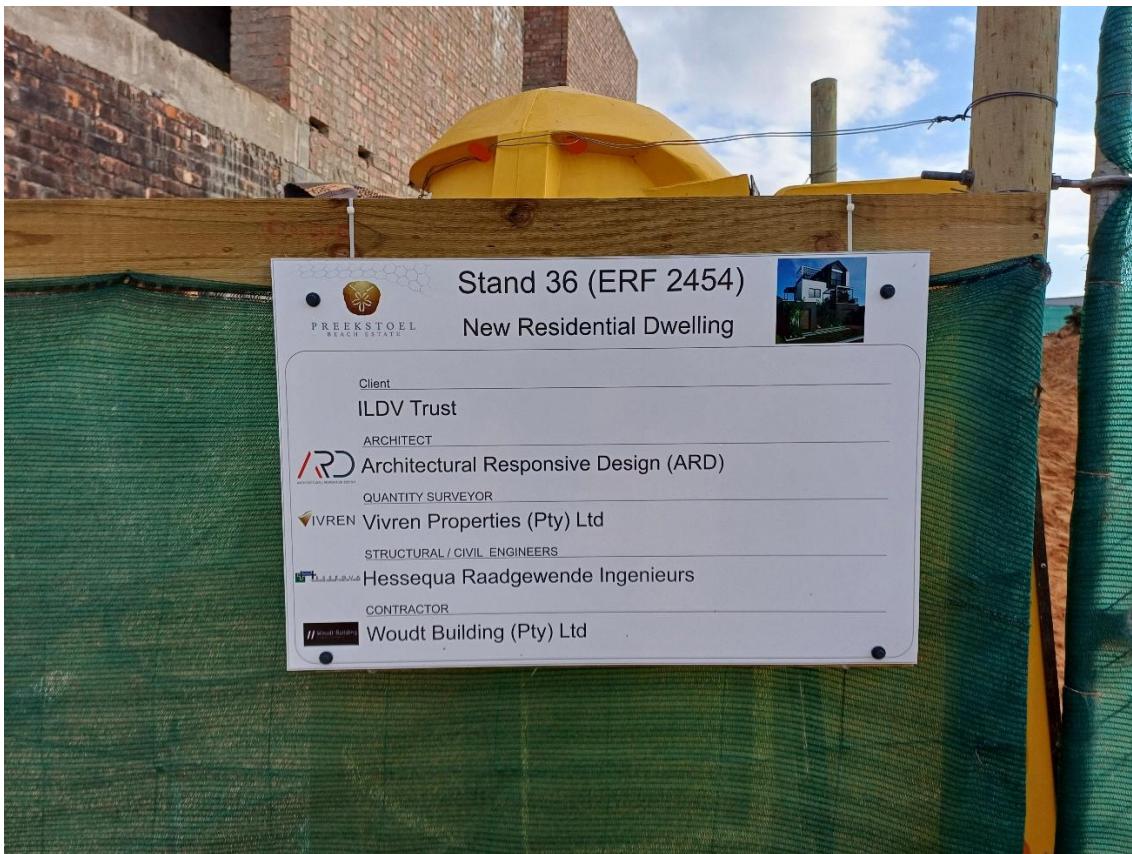
Photo 2: Woudt Building is currently building the house on Erf 2454.

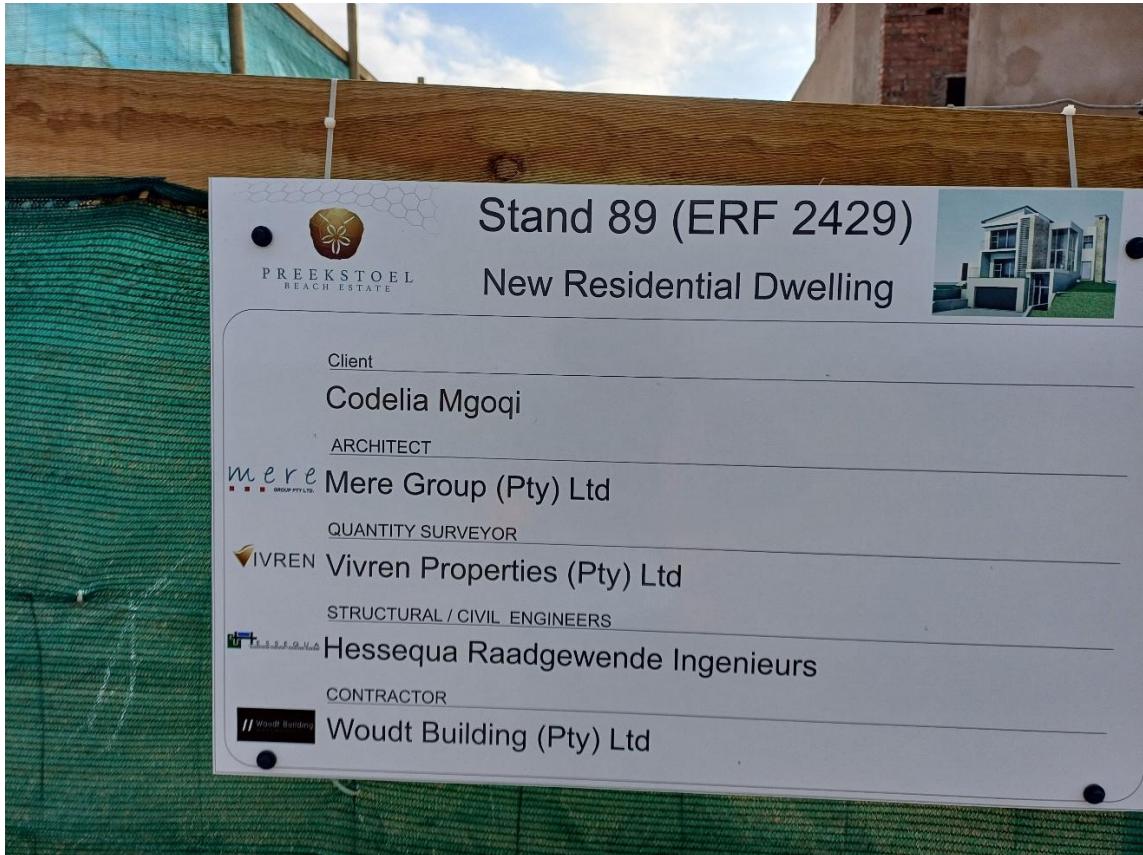
Photo 3: Woudt Building is currently building the house on Erf 2429.

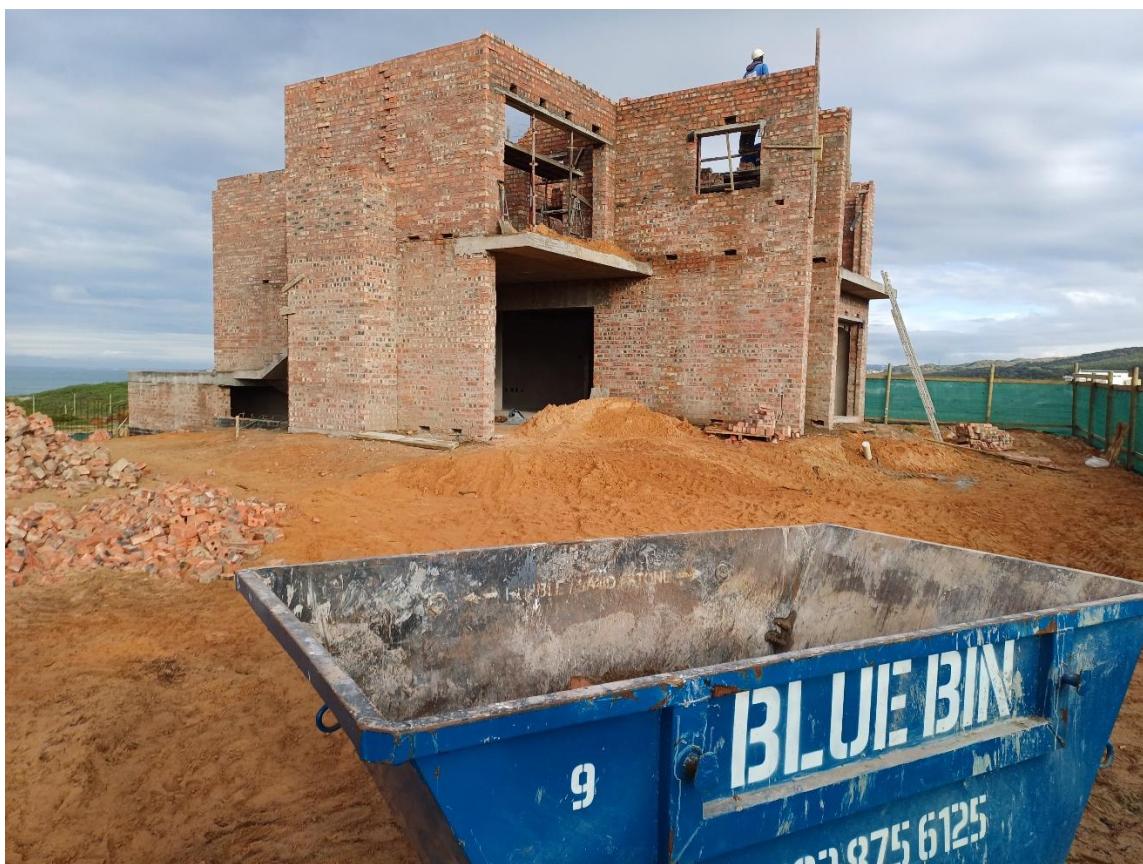
Photo 4: The contractors all make use of skips for their waste. The skips are removed at least once per week .

2. Contractor to store building rubble in a suitable designated area, with rubble removed from site on a weekly basis.	The area for any building rubble storage to be designated by the Site Agent. Contractor to remove any builder's rubble on weekly basis. ECO to monitor compliance.	C	Building rubble is being generated on all of the building sites. Such waste is removed from site weekly in skips (Photo 4).

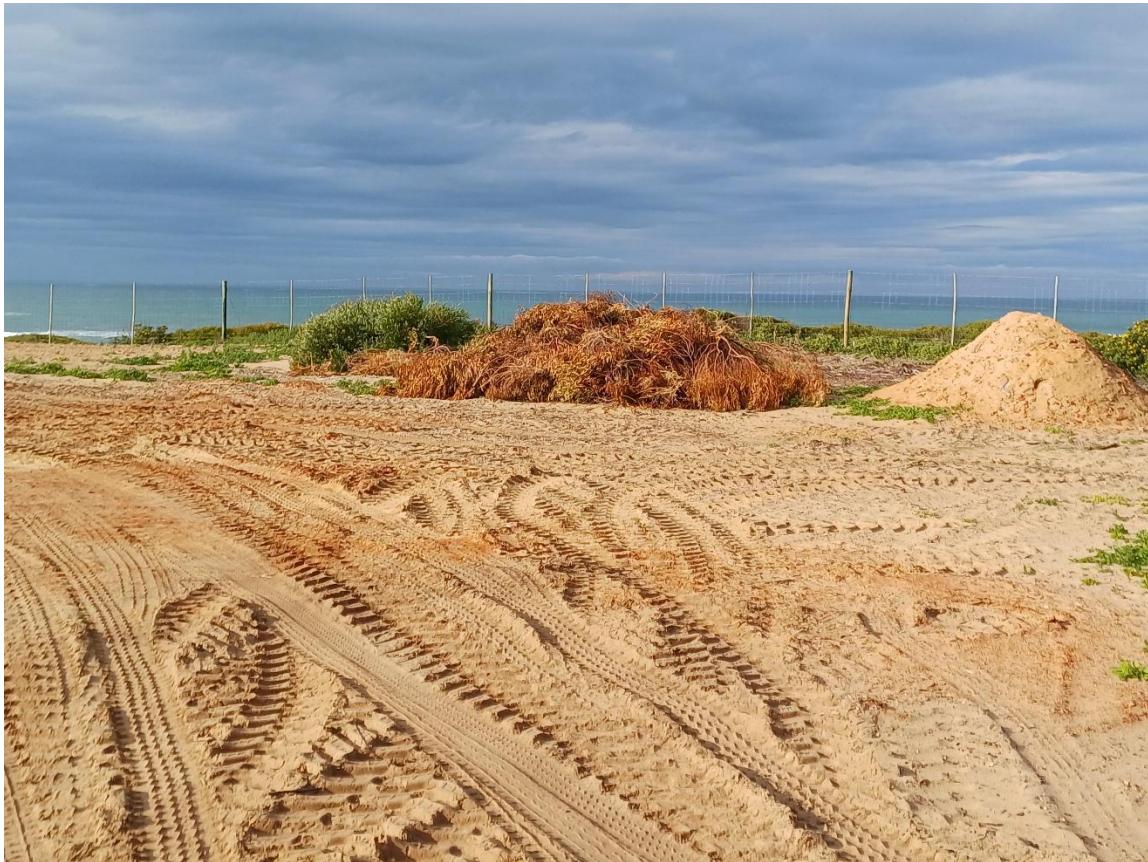
Photo 5: The growth of rooikrans seedlings are hand pulled regularly and removed from site.

ENVIRONMENTAL ASPECTS (PROJECT ACTIVITY)	REQUIRED ACTIONS	TARGET AND RESPONSIBILITY	COMPLIANCE	ECO COMMENTS
Alien plant management	1. Alien vegetation seedlings must be removed from the current building sites. Follow-up weeding will be required.	The Site Agent is to monitor the growth of rooikrans seedlings and take the appropriate measures to remove such seedlings from the building platforms (e.g. foliar spraying with an appropriate herbicide).	C	A number of rooikrans seedlings have already been noted on the site. Alien vegetation seedlings are currently being removed from the building platforms by a dedicated gardener for the developer on a regular basis (Photo 5).
Minimise disturbance to fauna	1. Contractors must not harm or disturb any wildlife, especially snakes, tortoises, buck, hares and birds.	Construction Supervisor and Site Agent to monitor. The contractors must report all incidents of harm to any fauna to the site agent who will report such incidents to the authorities.	C	No incidences of wildlife were noted on site.

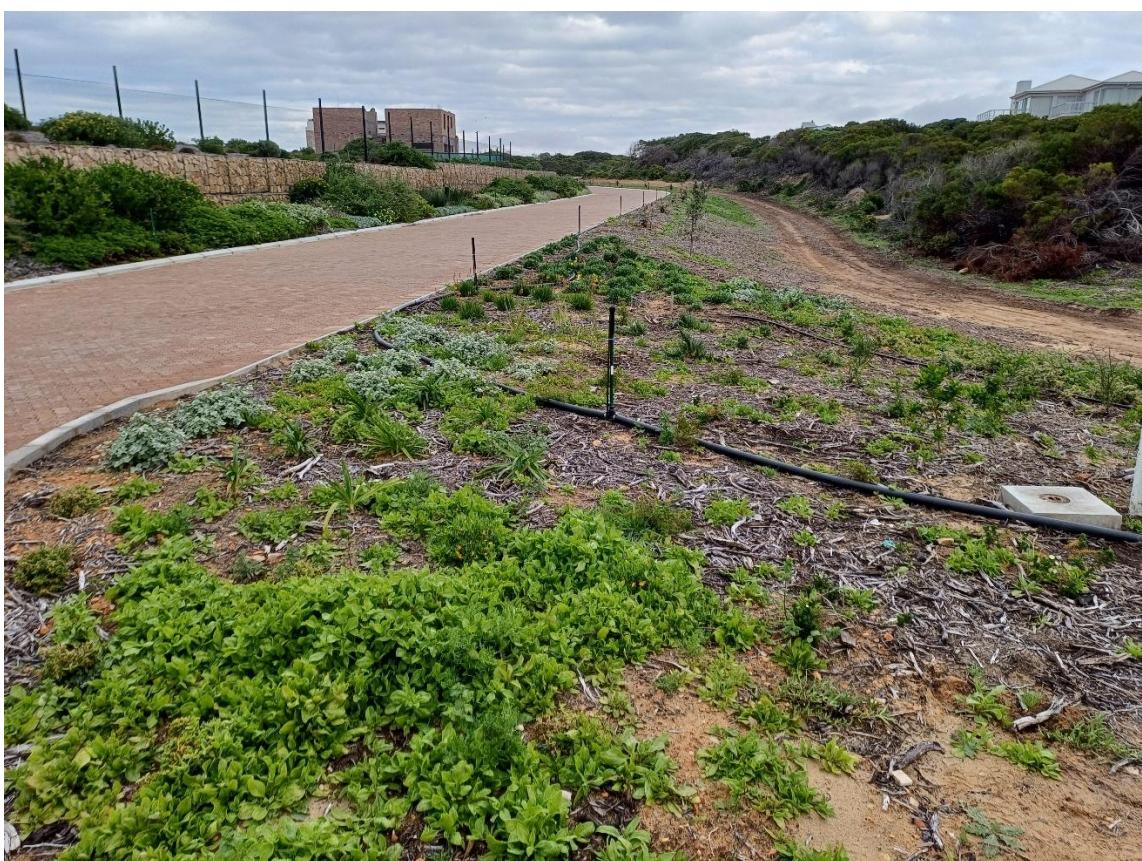
Photo 6: Blombos Strandveld species have been used in the landscaping along the entrance road into the Preekstoel Beach Estate. The contractors entrance road is noted on the right-hand side of the entrance road and landscaping strip. Once all construction has been completed the temporary road will also be landscaped. The access road and contractors road is on Municipal land.

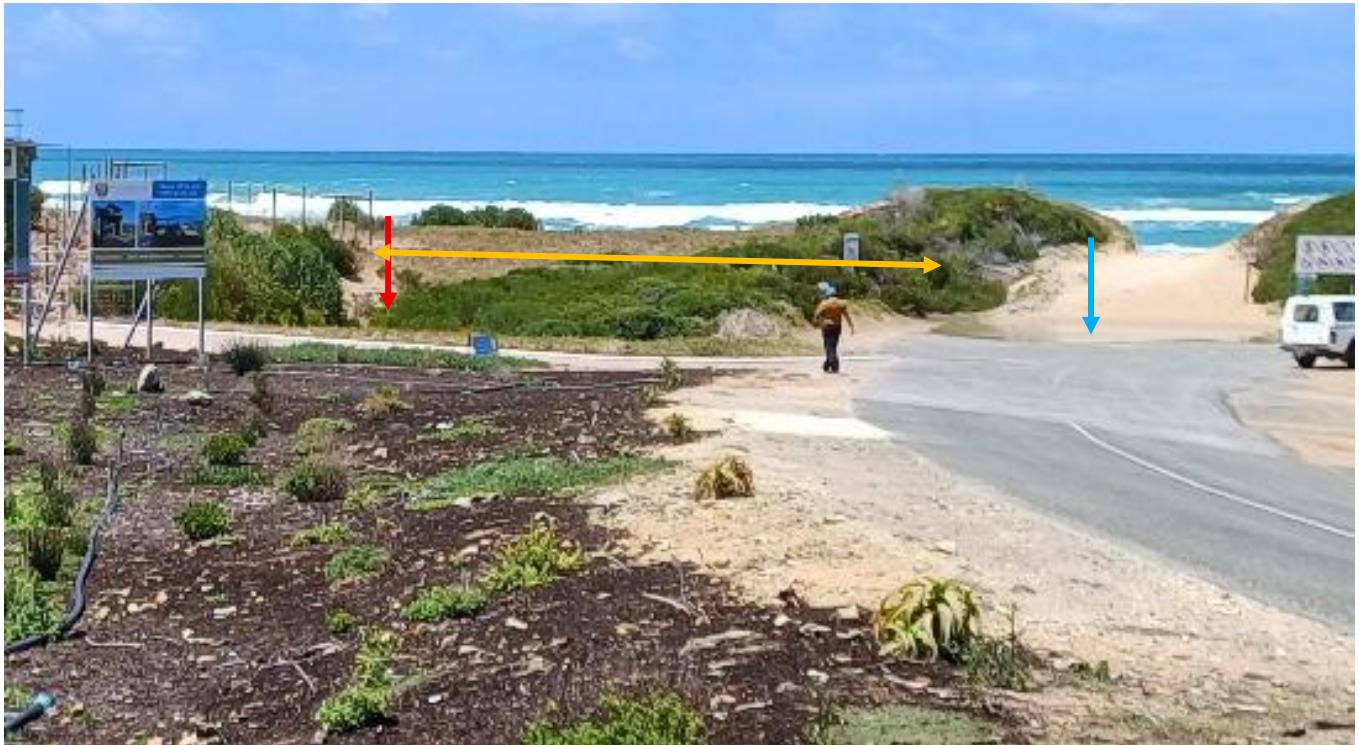
Photo 7a: The Provincial Road Reserve is depicted by the orange double-headed arrow. The mainly invasive, exotic rooikrans shrubs have now been removed (refer to Photo 7b). The blue arrow shows the accumulation of stormwater and the red arrow shows the deep erosion area in the lee side of the frontal dune.

E.2.2 Water				
Institute measures to minimise ground water pollution during construction phases of project.	1. No pollution of surface or ground water may occur due to any activity on the property. The relevant requirements of the National Water Act, 1998 (Act No. 36 of 1998) must be complied with at all times	The Construction Supervisor and Site Agent must monitor the use of oils, diesel and other hydrocarbons on site.	C	No incidents of any hydrocarbon spills have been noted or reported.
Institute measures for stormwater management to prevent erosion , damage to property and pollution of the environment.	1. Stormwater installation has been completed for the first phase of the development.	Construction Supervisor and Site Agent to monitor adequate storage of stormwater after moderate rainstorms and during the wet winter period (Construction Phase). Deep ponding of stormwater on site must be prevented and measures to keep the stormwater on the site must be undertaken by the Site Agent. Stormwater pipes have been connected to the small stormwater detention pond to the west of the site and the larger detention pond in the centre of the site.	C	No stormwater issues have been recorded on the construction sites. An irrigation pipe pulled out of a fitting on the reinstated dune causing some erosion. The Site Agent for Vivren Properties has been requested to repair the erosion that occurred.

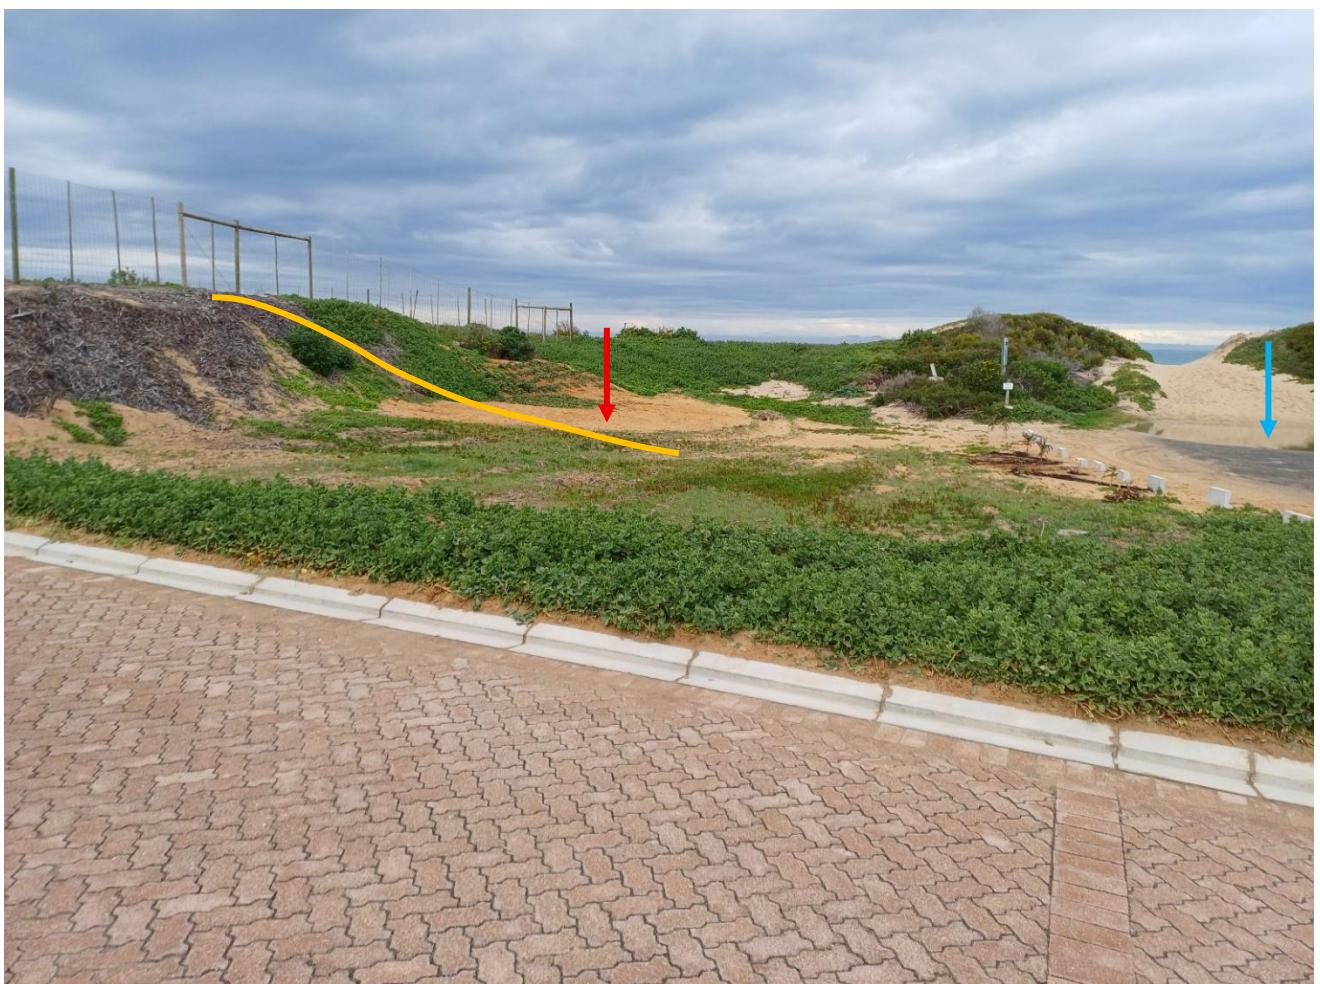
Photo 7b: The Provincial Road Reserve is from the western fence to the edge of the Preekstoel road. The red arrow shows where the deep erosion area of the lee side of the frontal dune has been filled with sand. The recommendation is to place sand fill between the terrace within Preekstoel Beach Estate and gently slope it towards the road. This area will then be landscaped with Blombos Strandveld plant species. Note the accumulation of stormwater at the foot of the dune (blue arrow). The old access road to the hotel site will be removed and landscaped.
