ECO CHECKLIST FOR THE CONSTRUCTION OF HOUSES ON THE PREEKSTOEL BEACH ESTATE, STILL BAY EAST, WESTERN CAPE

File 1012 : Construction ECO Checklist No.: 10

Date: 6 October 2025

ECO Checklist the Construction of the Sewage Package Plant and Housing on the Preekstoel Beach Estate, Still Bay East, Western Cape

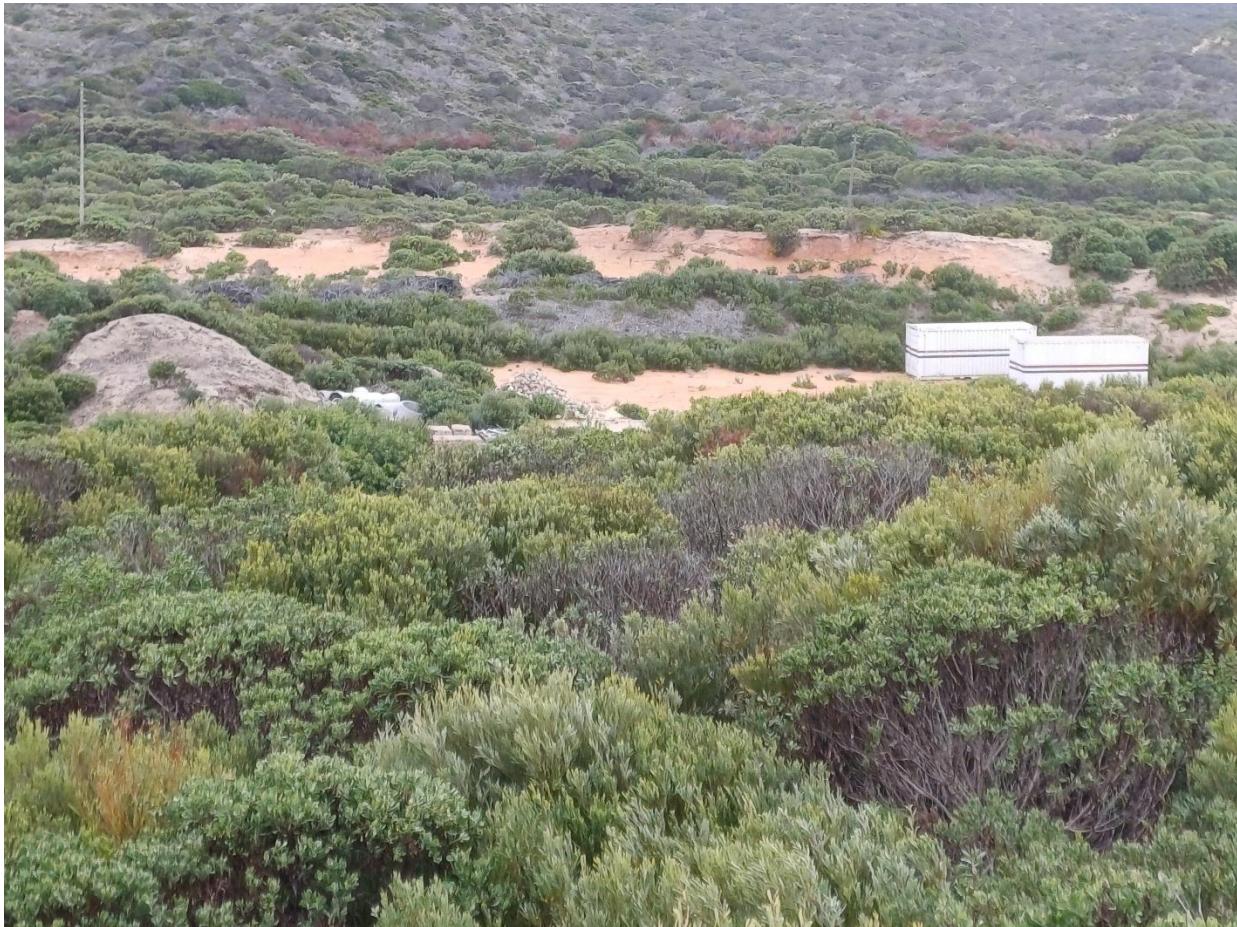
Photo 1: Van Schalkwyk Civils has made a start with their site yard, by placing two containers within the large stormwater detention pond within the central section of the development site. This yard must be fenced off.

ENVIRONMENTAL ASPECTS (PROJECT ACTIVITY)	REQUIRED ACTIONS	TARGET AND RESPONSIBILITY	COMPLIANCE	ECO COMMENTS
	4. Access across the site for the general public must remain open during the day. Signs warning visitors to the Nature Reserve about the movement of heavy construction vehicles must be placed on site.	The general public have access to the contractors temporary access over the site off the Preekstoel tar road.	C	Appropriate signage is on site.
Storage of construction materials, concrete mixing areas, rubble storage and litter management on all building sites	1. Construction material (precast concrete components of the package sewage plant) concrete and mortar raw materials and reinforcing steel must be stored in designated areas in a neat and orderly manner.	Area for construction material has been designated by the Site Agent and to be in secured area out of the way of access routes. ECO to monitor compliance. All building sites must be managed by each responsible contractor.	PC	The storage area for Woudt Building has been vetted by the Site Agent and ECO and is out of the way and being maintained in a neat and orderly manner. All the building sites are being managed in an orderly manner. All sites have their own waste skips. The Van Schalkwyk site yard is temporarily located within the large detention pond in the middle of the site (Photo 1). The site must be cordoned off with shade netting.

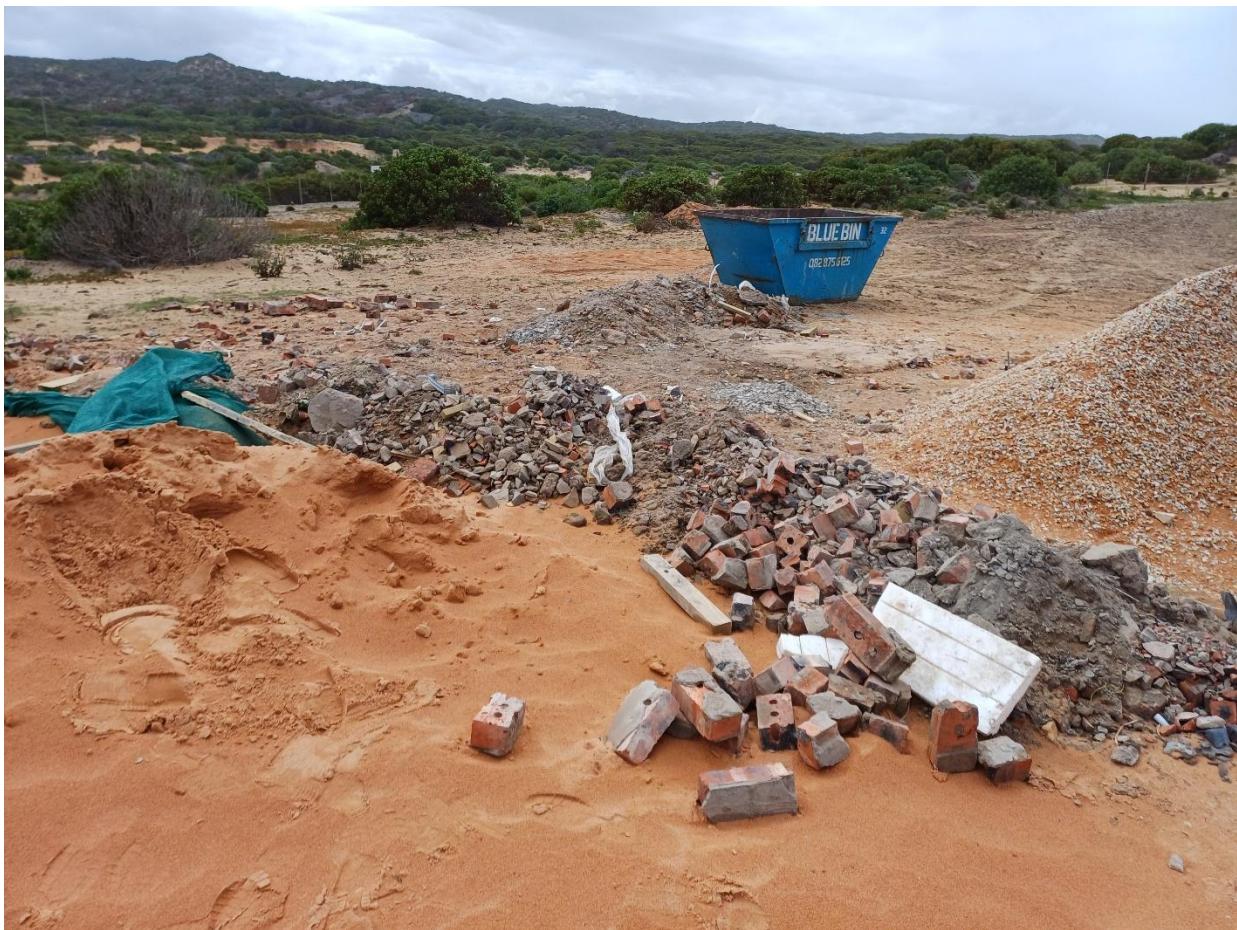
Photo 2: Building rubble just hap- hap- hazardously dumped on the neighbouring Erf. This is unacceptable and this Erf must be cleaned up as soon as possible.

2. Contractor to store building rubble in a suitable designated area, with rubble removed from site on a weekly basis.	The area for any building rubble storage to be designated by the Site Agent. Contractor to remove any builder's rubble on weekly basis. ECO to monitor compliance.	NC	Building rubble is being generated on all of the Woudt building sites. It would appear as though such waste, which is not being put into the skips, is not being removed from site weekly in skips (Photo 2).

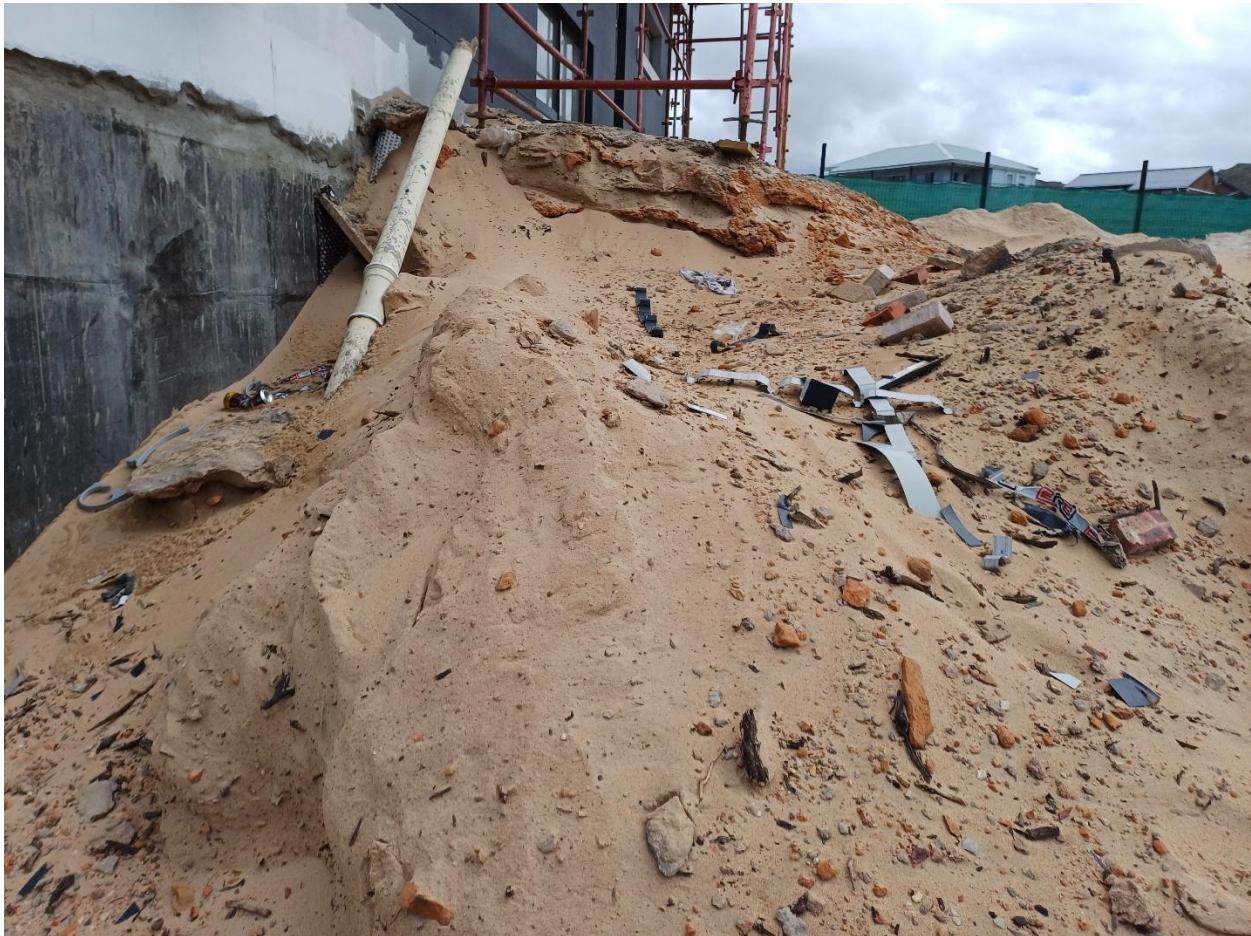
Photo 3: Litter and cut-off building material strewn over one of Woudt Building Contractor's sites.

3. The building contractor must indicate the dumping area for all spoil from the site. Trucks removing spoil must remain on designated access roads.	Site Agent to assess spoil dumping area, and to monitor condition of access roads.	NC	Waste skips are noted at all the current building sites, but a lot of builder's rubble and building litter is lying hap-hazardously on site (Photo 3). This site husbandry is not acceptable.

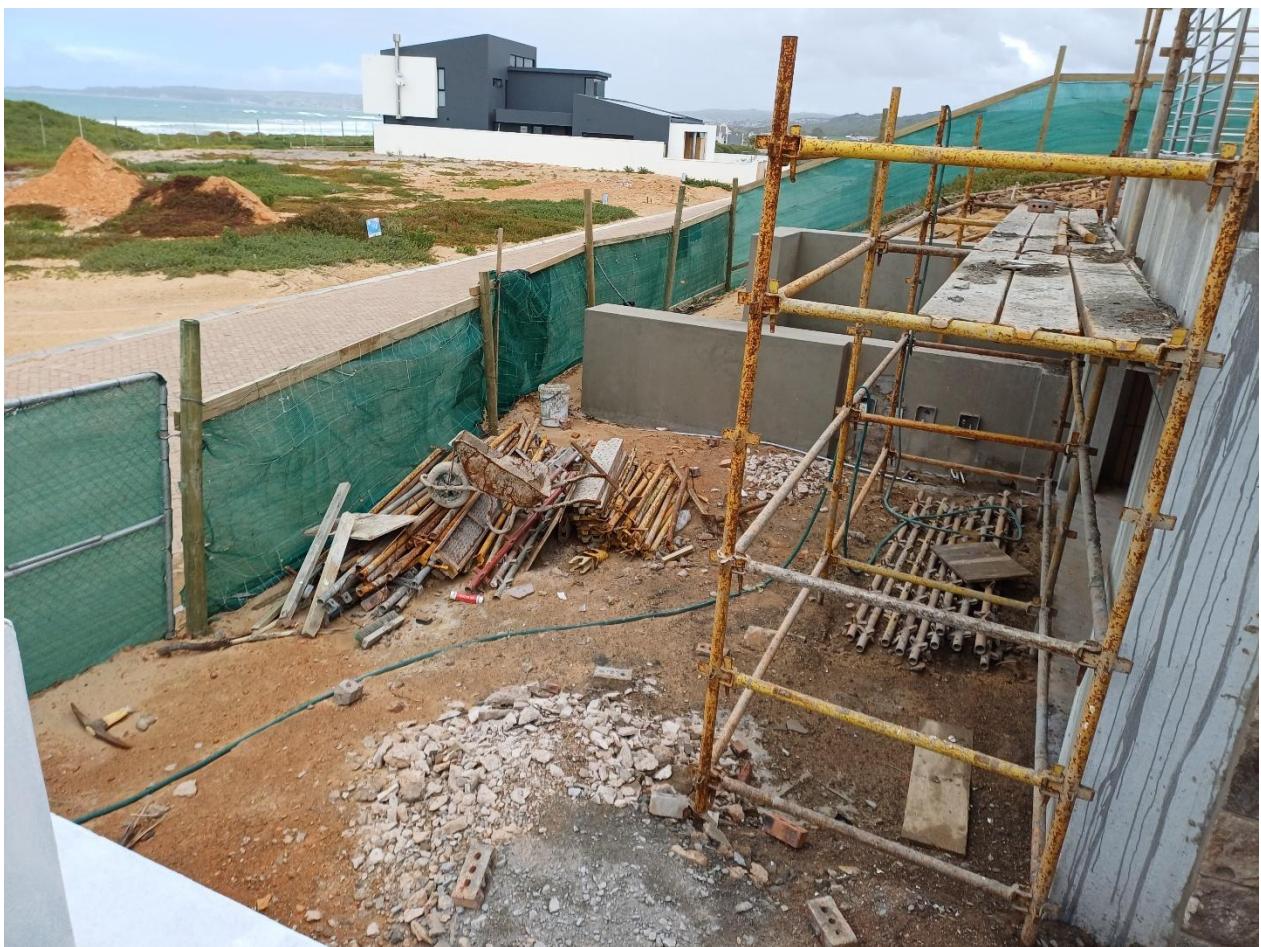
Photo 4: Builder's rubble, planks, a broken pick and scaffolding lying around one of Woudt Building's sites.

4. All other solid waste and litter to be kept in appropriate containers with lids and removed from the site on a weekly basis to a licensed waste disposal facility. The burning of solid waste and paper on site will not be allowed. Recyclable waste (e.g. paper, glass, tin, plastic) should be recycled if possible.	Contractor to remove solid waste on a weekly basis. Site Agent and ECO to monitor compliance. Waste skips are to be used where necessary on building sites.	NC	Litter, such as plastic wrapping on brick pallets, used cement bags and general domestic litter (plastic bags, lunch paper, cooldrink bottles) are noted lying around the building sites. The Woudt Building contractors must make sure that their site husbandry is vastly improved , i.e. neaten building sites (scaffolding, and place builder's rubble and general litter such as plastic covering of brick packs, cardboard, bottles etc.) into the skips (Photos 4 and 5).

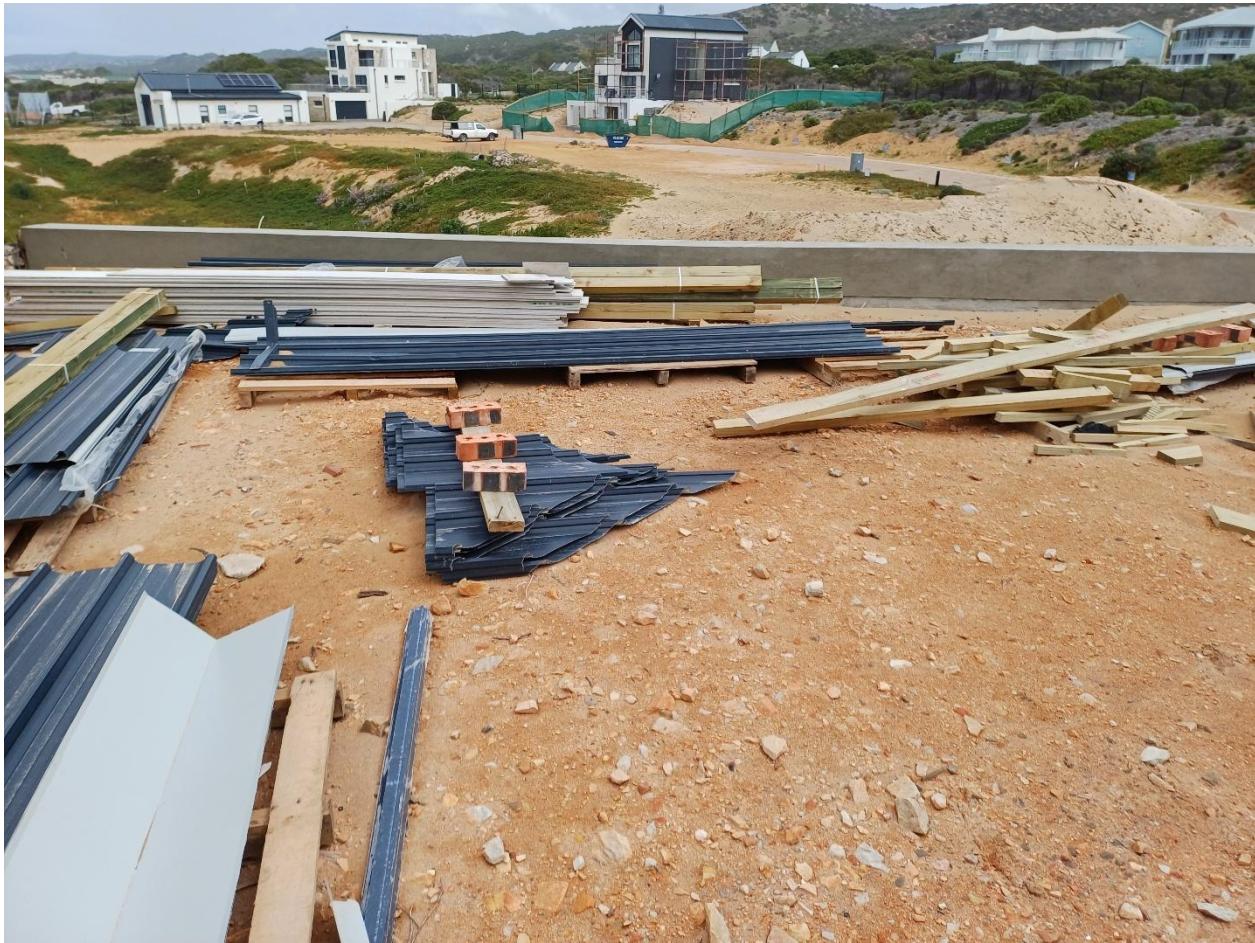
Photo 5: Whilst the metal roof sheeting is reasonably neatly stacked on site, cut-off roofing timber and bricks litter the site.

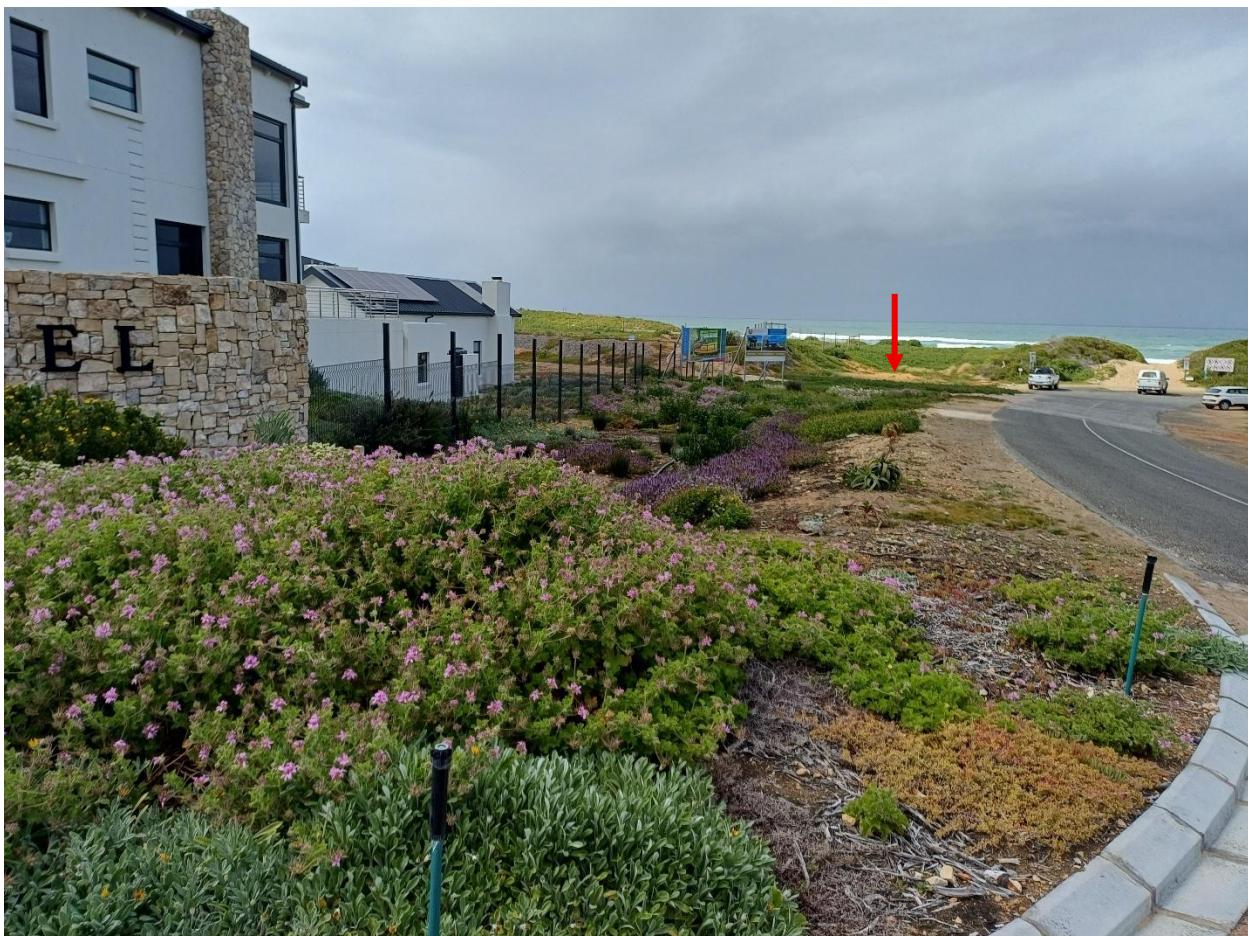
Photo 6: Blombos Strandveld species have been used in the landscaping along the Preekstoel Road. The section of road reserve at the end of the road (red arrow) should be landscaped with Blombos Strandveld species.
