ECO CHECKLIST FOR PHASE F CIVILS AND THE CONSTRUCTION OF HOUSES ON THE PREEKSTOEL BEACH ESTATE, STILL BAY EAST, WESTERN CAPE

File 1012 : Construction ECO Checklist No.: 11

Date: 7 November 2025

ECO Checklist the Construction of the Sewage Package Plant and Housing on the Preekstoel Beach Estate, Still Bay East, Western Cape

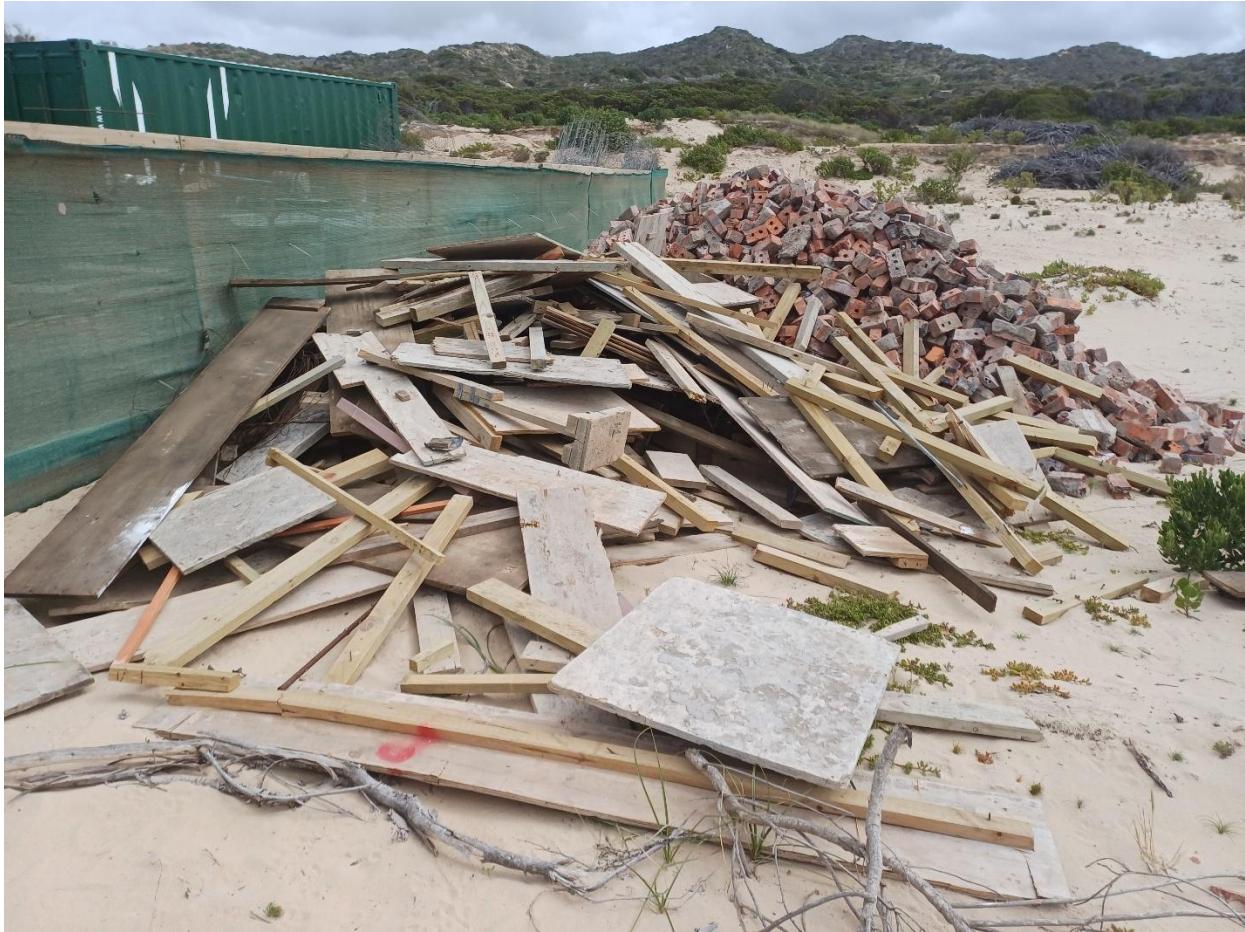
Photo 1: Whilst the clearing of their building sites, Woudt Building has just dumped their extraneous building waste on the east side of their building site yard. Woudt Building has been requested to remove such waste from the site.

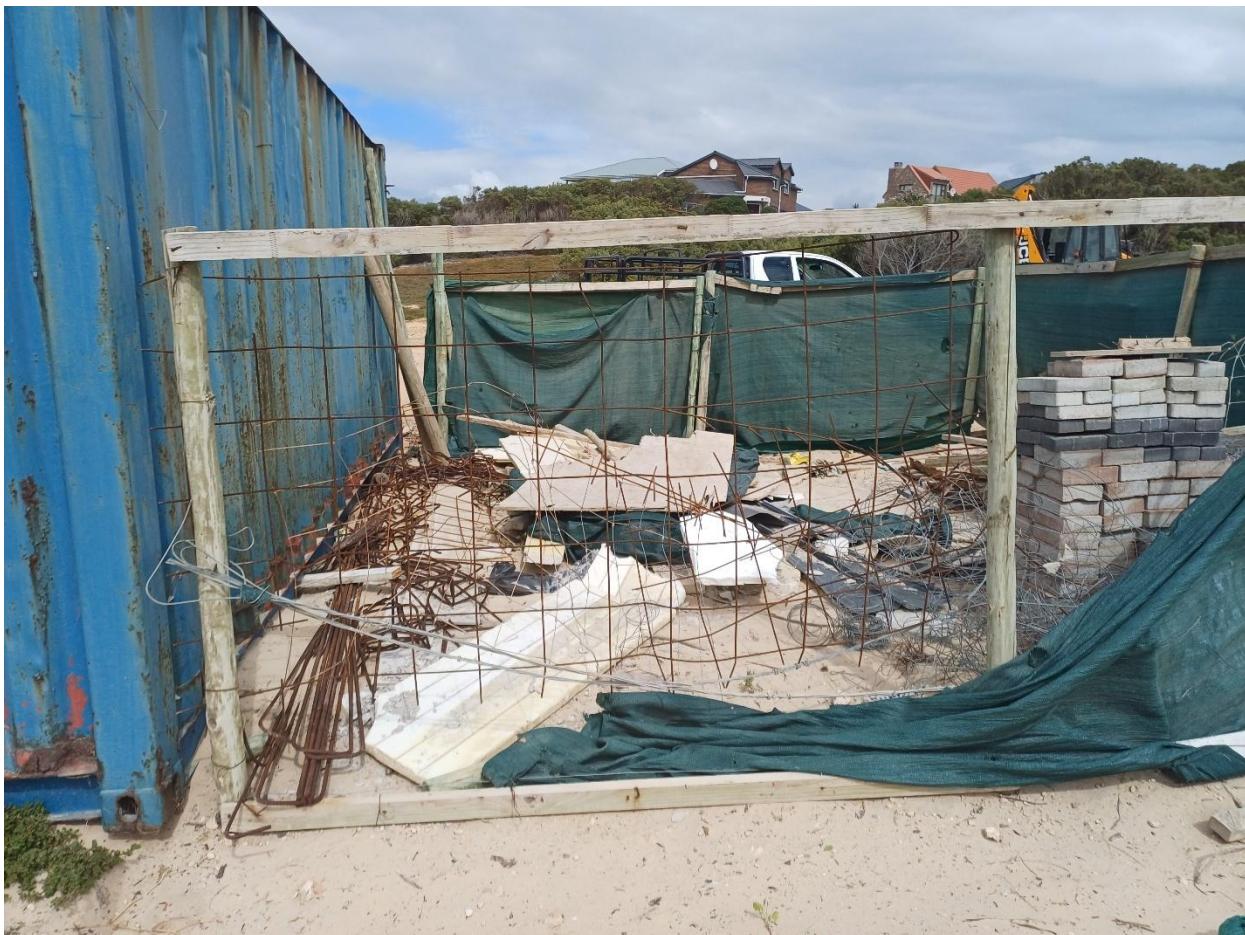
Photo 2: Hap-hazard storage of building materials in the Woudt Building site yard.

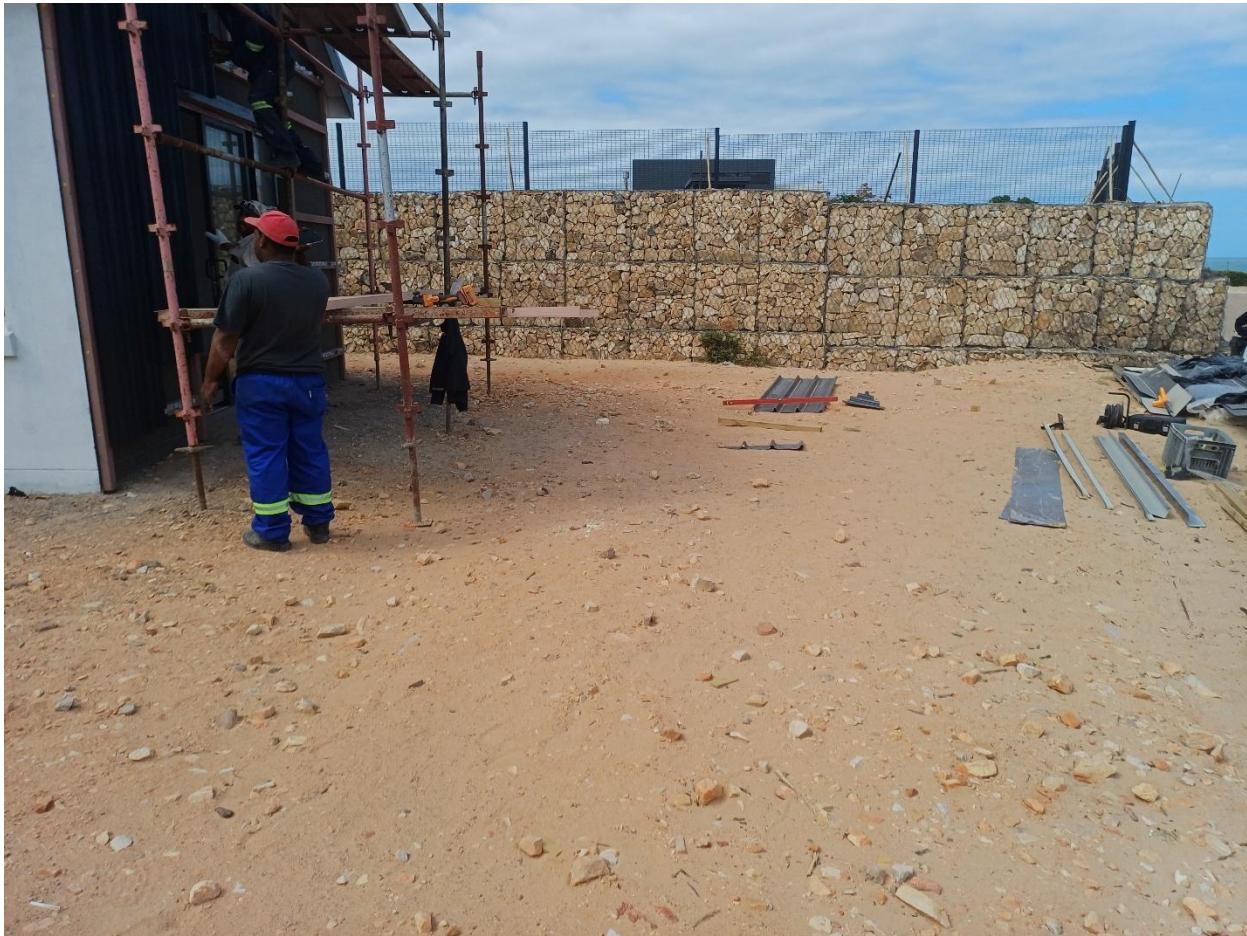
2. Contractor to store building rubble in a suitable designated area, with rubble removed from site on a weekly basis.	The area for any building rubble storage to be designated by the Site Agent. Contractor to remove any builder's rubble on weekly basis. ECO to monitor compliance.	C	Building rubble is being generated on all of the Woudt building sites. The building sites are clear of all rubble and extraneous building waste (Photos 3 and 4)

Photo 3: The Woudt Building site (76) has been cleared up.

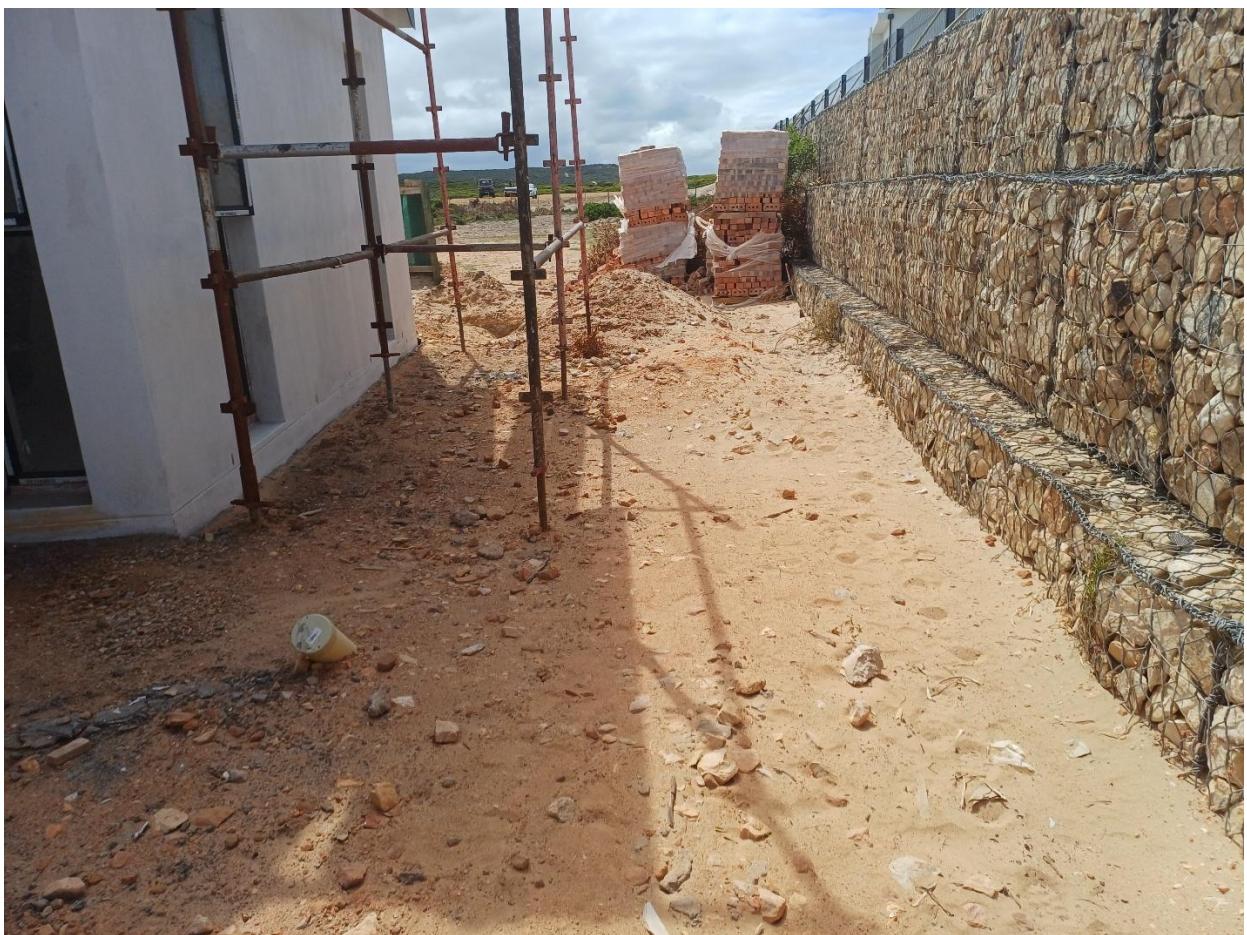
Photo 4: The Woudt Building's site has been cleared of builder's rubble.

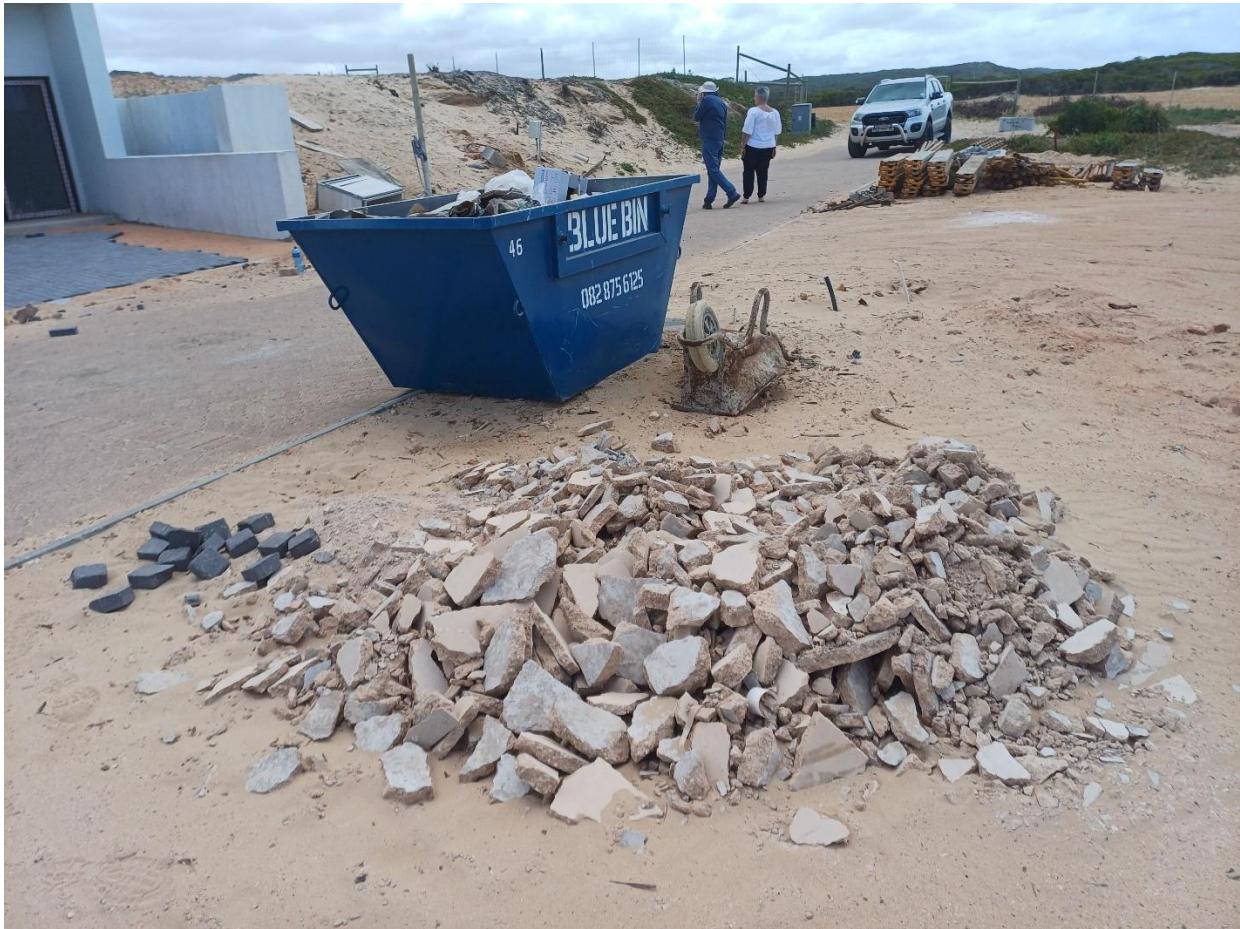
3. The building contractor must indicate the dumping area for all spoil from the site. Trucks removing spoil must remain on designated access roads.	Site Agent to assess spoil dumping area, and to monitor condition of access roads.	C	Waste skips are noted at all the current building sites, and must be emptied as soon as they are full (Photo 5). No litter was noted at the various building sites

Photo 5: The house on site 36 is currently being completed by Woudt Building and the site is being cleared of builders rubble and waste.

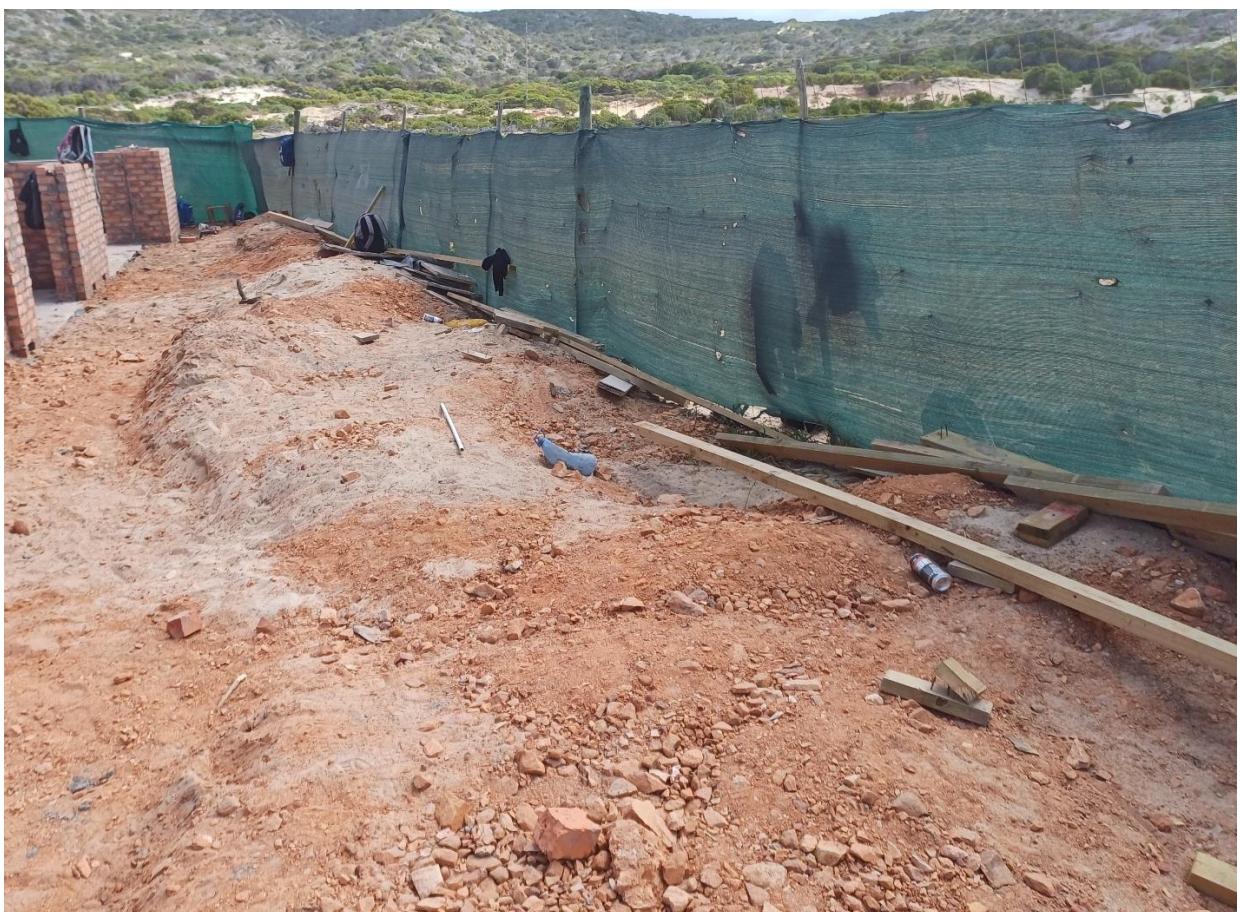
Photo 6: The minor amount of litter discarded on the Southshore building site was picked up after discussing littering with the site foreman on Thursday 6 November.

4. All other solid waste and litter to be kept in appropriate containers with lids and removed from the site on a weekly basis to a licensed waste disposal facility. The burning of solid waste and paper on site will not be allowed. Recyclable waste (e.g. paper, glass, tin, plastic) should be recycled if possible.	Contractor to remove solid waste on a weekly basis. Site Agent and ECO to monitor compliance. Waste skips are to be used where necessary on building sites.	PC	Litter, such as plastic wrapping on brick pallets, and general domestic litter (plastic bags, lunch paper, cooldrink tins) were noted on the Southshore building sites (Photo 6). The foreman on site, immediately designated someone to pick up such litter. The ECO suggested that tool box talks should be held regularly to ensure that staff did not litter the building sites.

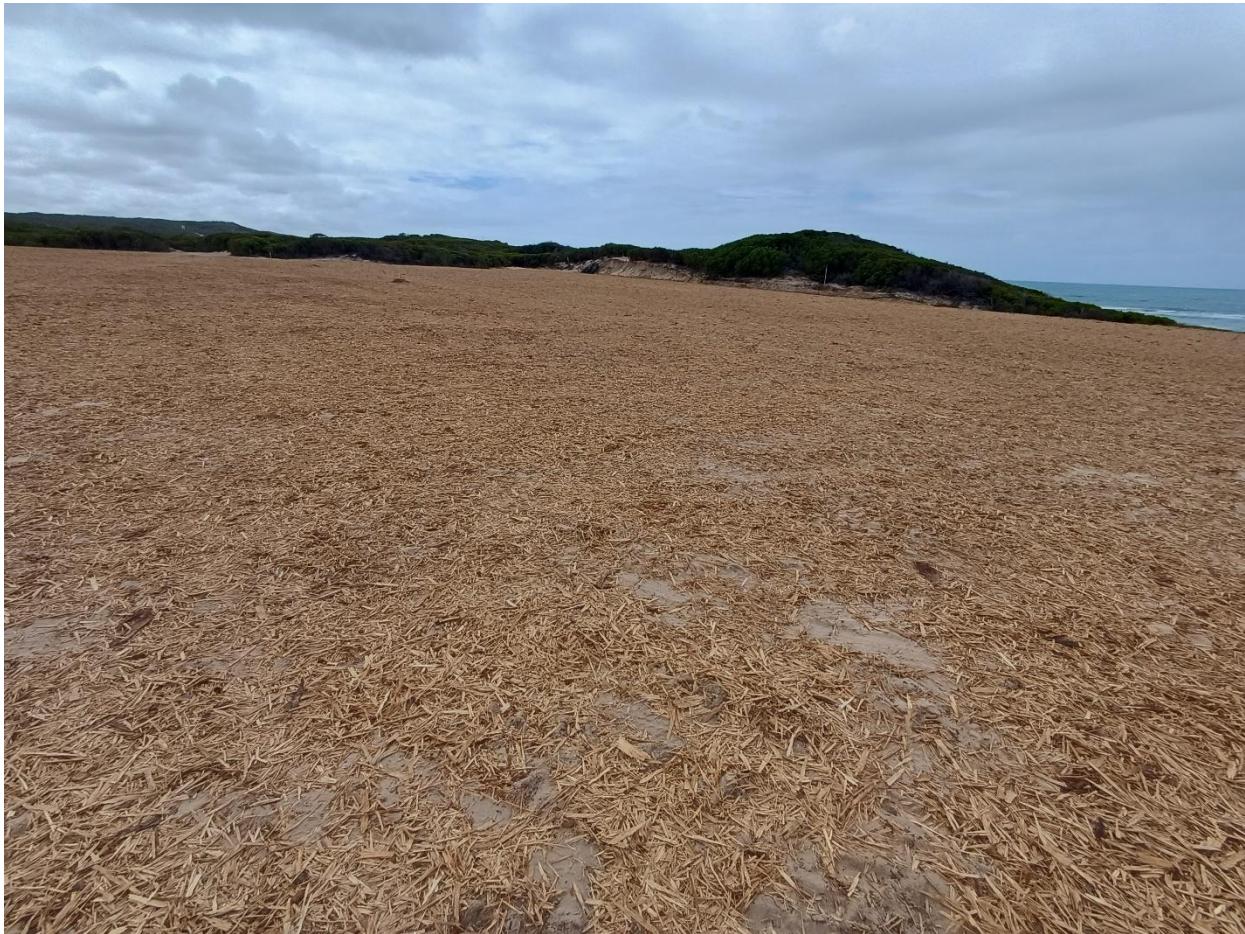
ENVIRONMENTAL ASPECTS (PROJECT ACTIVITY)	REQUIRED ACTIONS	TARGET AND RESPONSIBILITY	COMPLIANCE	ECO COMMENTS
E.2.1 Fauna and Flora				
There is no to little indigenous vegetation on site.	1. Mass earthworks were undertaken on site, where the nearly 100% of vegetation comprised rooikrans which was removed and stable building platforms have been constructed.	There should not be any issues with the removal of indigenous vegetation from building sites, as all sites were cleared of all vegetation to create stable building platforms.	C	Van Schalkwyk Construction removed alien vegetation that had grown back on the Phase F erven in order to undertake mass earthworks to provide stable platforms for the installation of roads, sewage, water and electrical reticulation, and construction of houses (Photos 7, 8 & 9). The bare sandy surfaces were covered with wood chips free of contamination (alien vegetation).

Photo 7: The building platform for Phase F has been completed and covered in wood chips to prevent wind erosion. The installation of roads, sewage pipes, stormwater, water and electrical reticulation will start in January 2026.

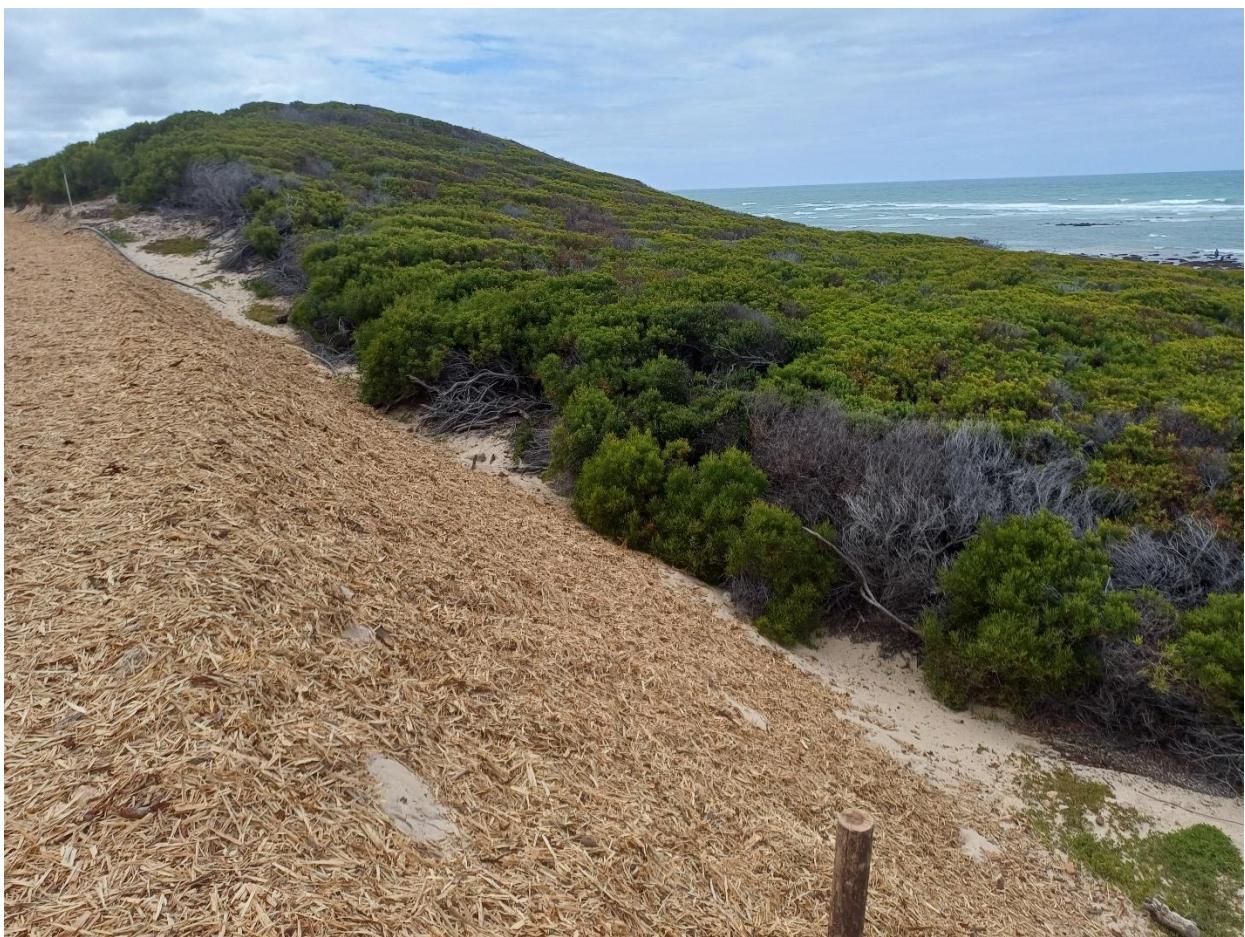
Photo 8: The southern edge of the stabilized building platform of Phase F has been completed. This sloped edge will be landscaped with Blombos Strandveld plants and Cape Seashore creepers.

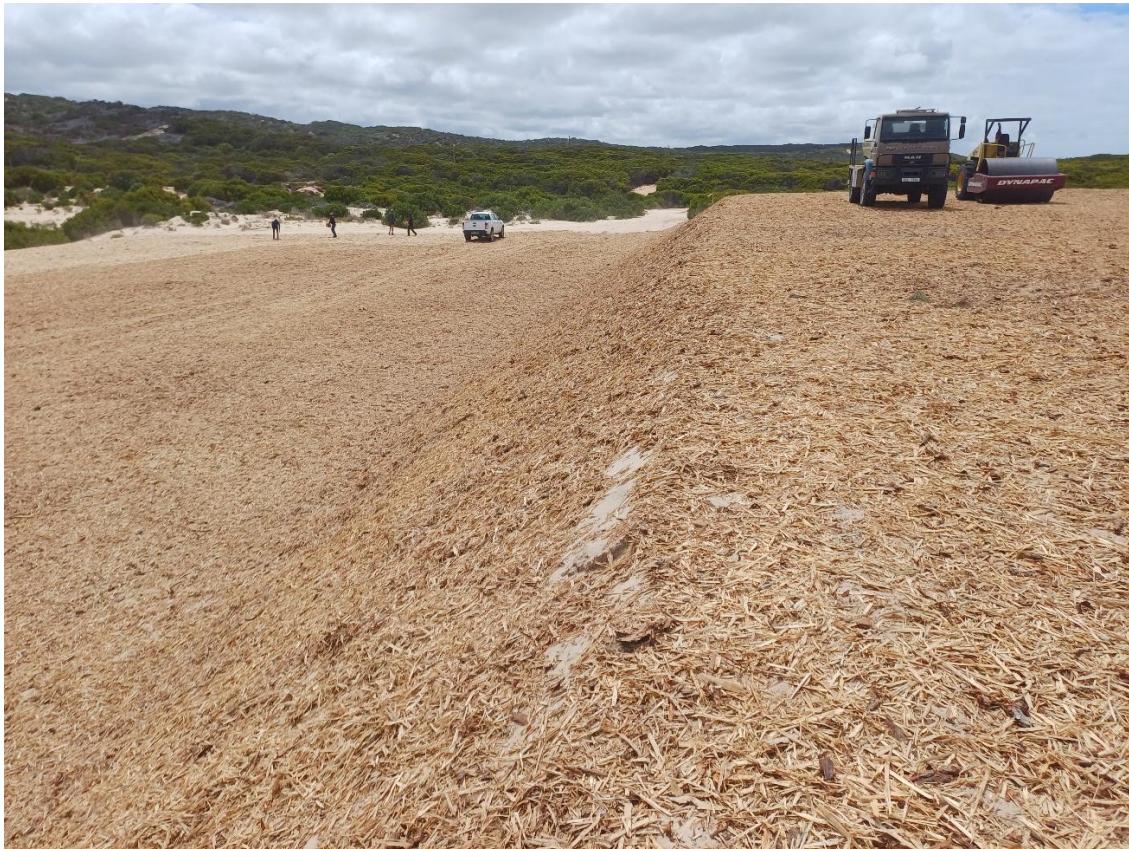
Photo 9: Shows the northern, lower platform of Phase F. The slope will be landscaped with Blombos Strandveld plants.

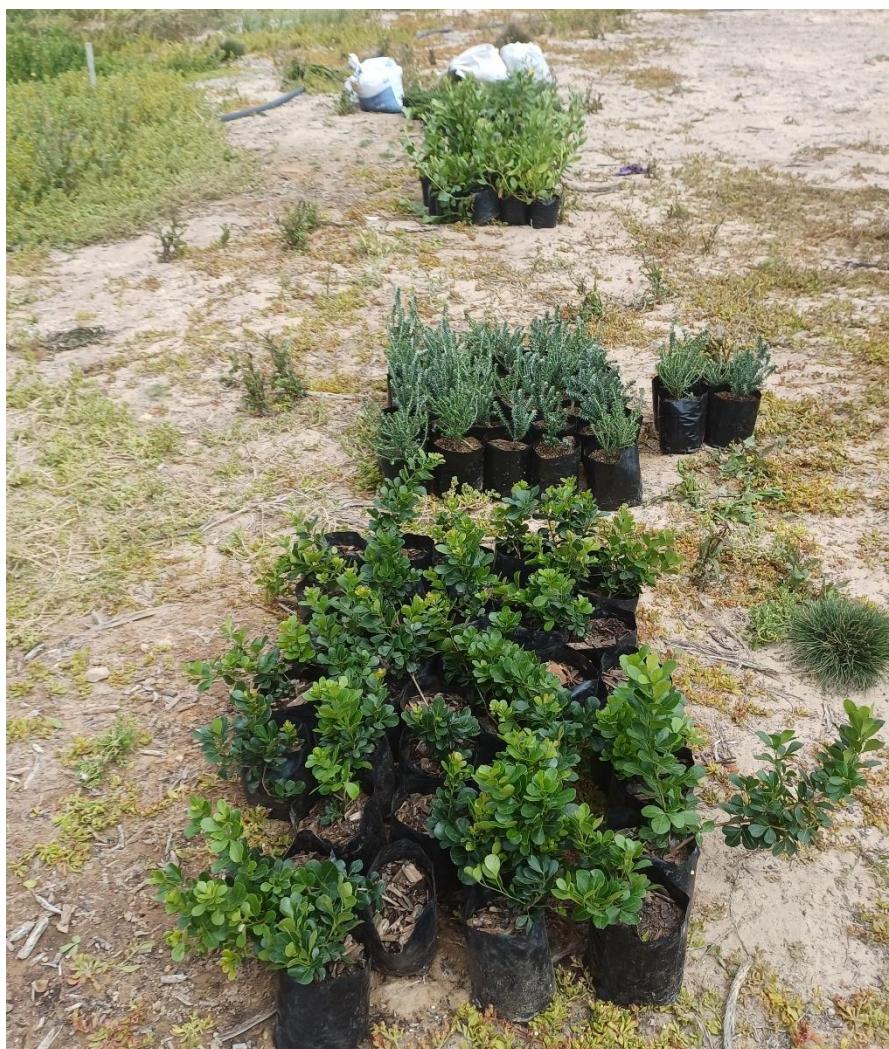
Photo 10: Shows the Blombos Strandveld climax plant species to be planted on the rehabilitated dune. 200 plants of each species, comprising Blombos, Bitou, Helichrysum and Crowberry species will be planted as a second phase of the frontal dune rehabilitation programme.

Add Blombos Strandveld climax plants onto the rehabilitated frontal dune	1. Climax Blombos Strandveld is to be planted amongst the pioneer indigenous creepers used to stabilise the frontal dune system and to prevent wind erosion.	Inus Brook from Galinha Farm and Gardens has been appointed to landscape the Preekstoel Beach Estate, and to add in climax species onto the rehabilitated frontal dune.	C	A start has been made with the planting of Blombos, Bitou, Helichrysum and Crowberry plants amongst the pioneer creepers on the rehabilitated dune (Photos 10, 11 & 12).
E.2.2 Water				
Institute measures to minimise ground water pollution during construction phases of project.	1. No pollution of surface or ground water may occur due to any activity on the property. The relevant requirements of the National Water Act, 1998 (Act No. 36 of 1998) must be complied with at all times	The Construction Supervisor and Site Agent must monitor the use of oils, diesel and other hydrocarbons on site.	C	No incidents of any hydrocarbon spills have been noted or reported.

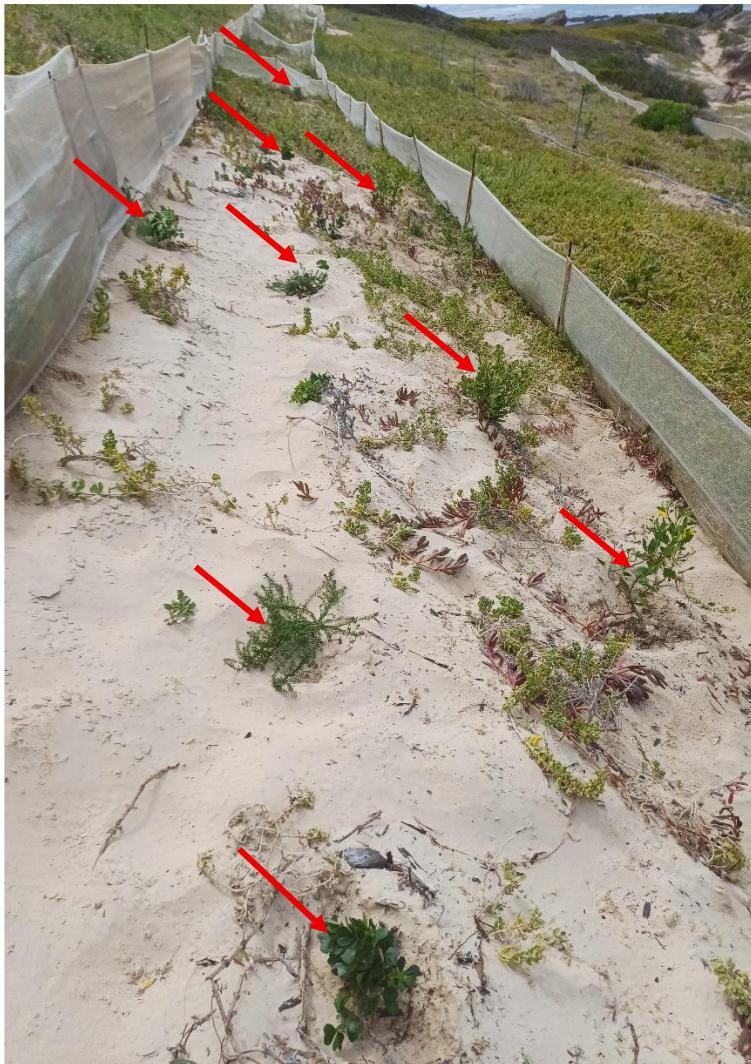
Photo 11: Shows the in-planting of Blombos Strandveld species on the frontal dune (red arrows).

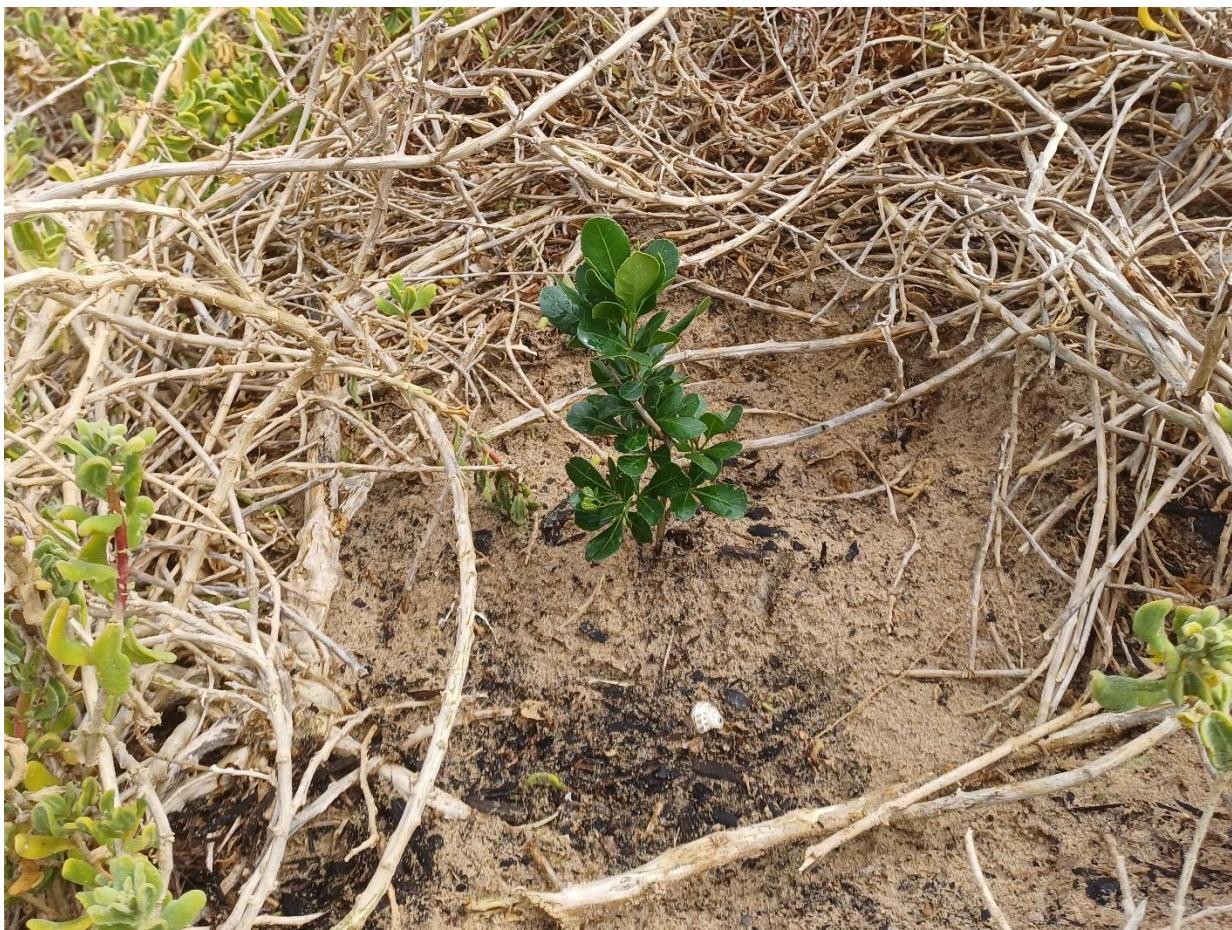
Photo 12: 200 Crowberry plants (*Sersea crenata*) have been planted on the frontal dune

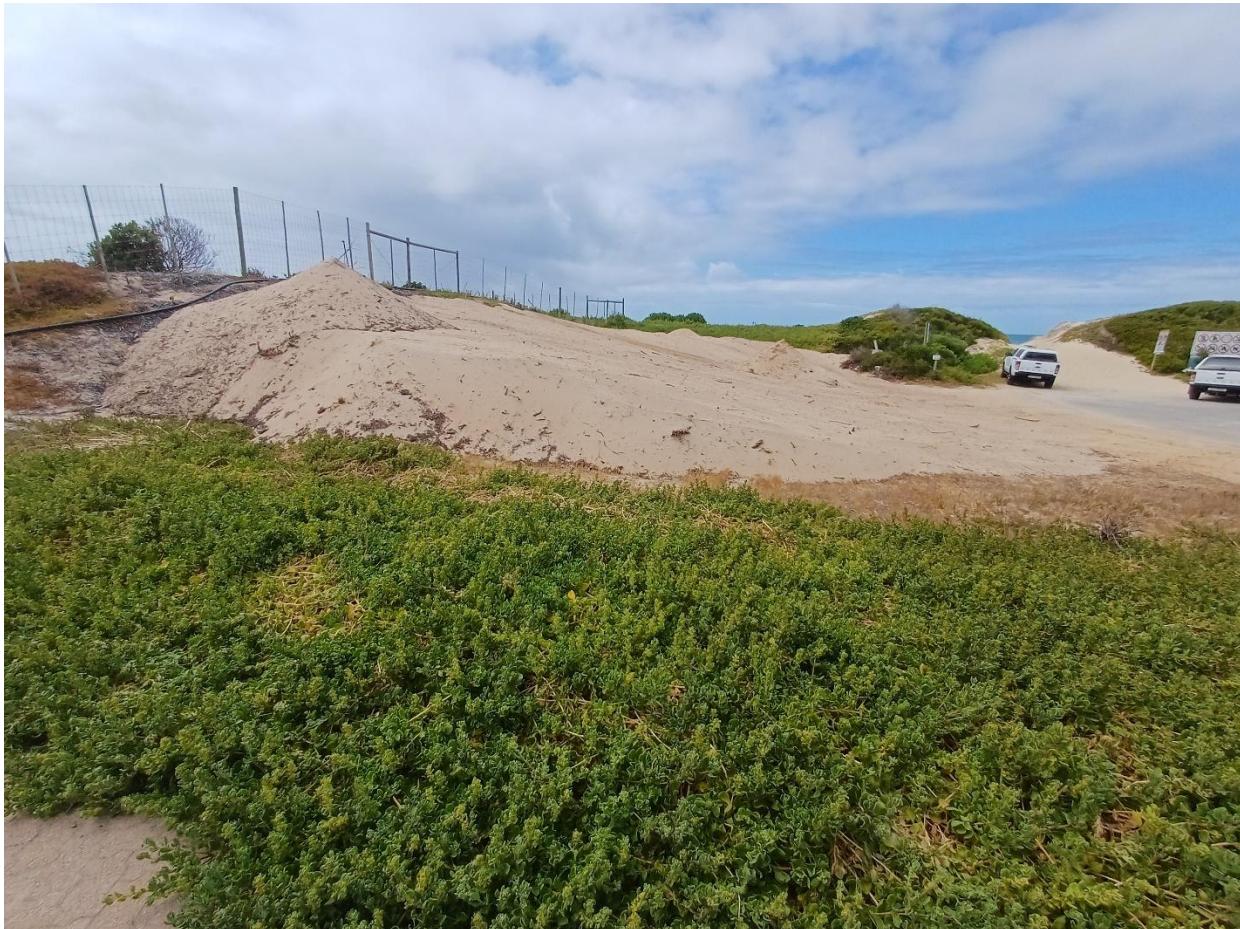
3. Plant locally indigenous Strandveld plants over the private open space areas to stabilize exposed sandy areas. The above planting should only take place after the first good rains of the winter season.	Landscape Architect and ECO to monitor and advise accordingly.	C	The left hand side of the entrance road has been planted with locally indigenous Blombos Strandveld species. An irrigation system has been put along the entrance road. In addition, the entrance off the Preekstoel road to the Estate has been landscaped. The road reserve between the old entrance to the hotel site and the frontal dune has been filled with sand and will also be landscaped (Photo 13). The District Roads Engineer will be informed in this regard.

Photo 13: The section of the road reserve at the end of the Preekstoel road has been filled with sand and will be landscaped with pioneer Cape seashore creepers and Blombos Strandveld plants species.
