**SERVICE STATION LOCATED ON PORTION 112 OF THE FARM
BUFFELSFONEIN 204/7 AS PART OF THE FUTURE HEROLDS BAY
COUNTRY ESTATE, GARDEN ROUTE MUNICIPALITY, WESTERN CAPE
PROVINCE**

ENVIRONMENTAL MANAGEMENT PLAN

**IN TERMS OF THE PETROLEUM PRODUCT SITE LICENSE ACT NO 120 OF 1977
UNDER THE REGULATIONS REGARDING PETROLEUM RETAIL & SITE LICENCES
(NO. R. 287 OF 27 MARCH 2006)**

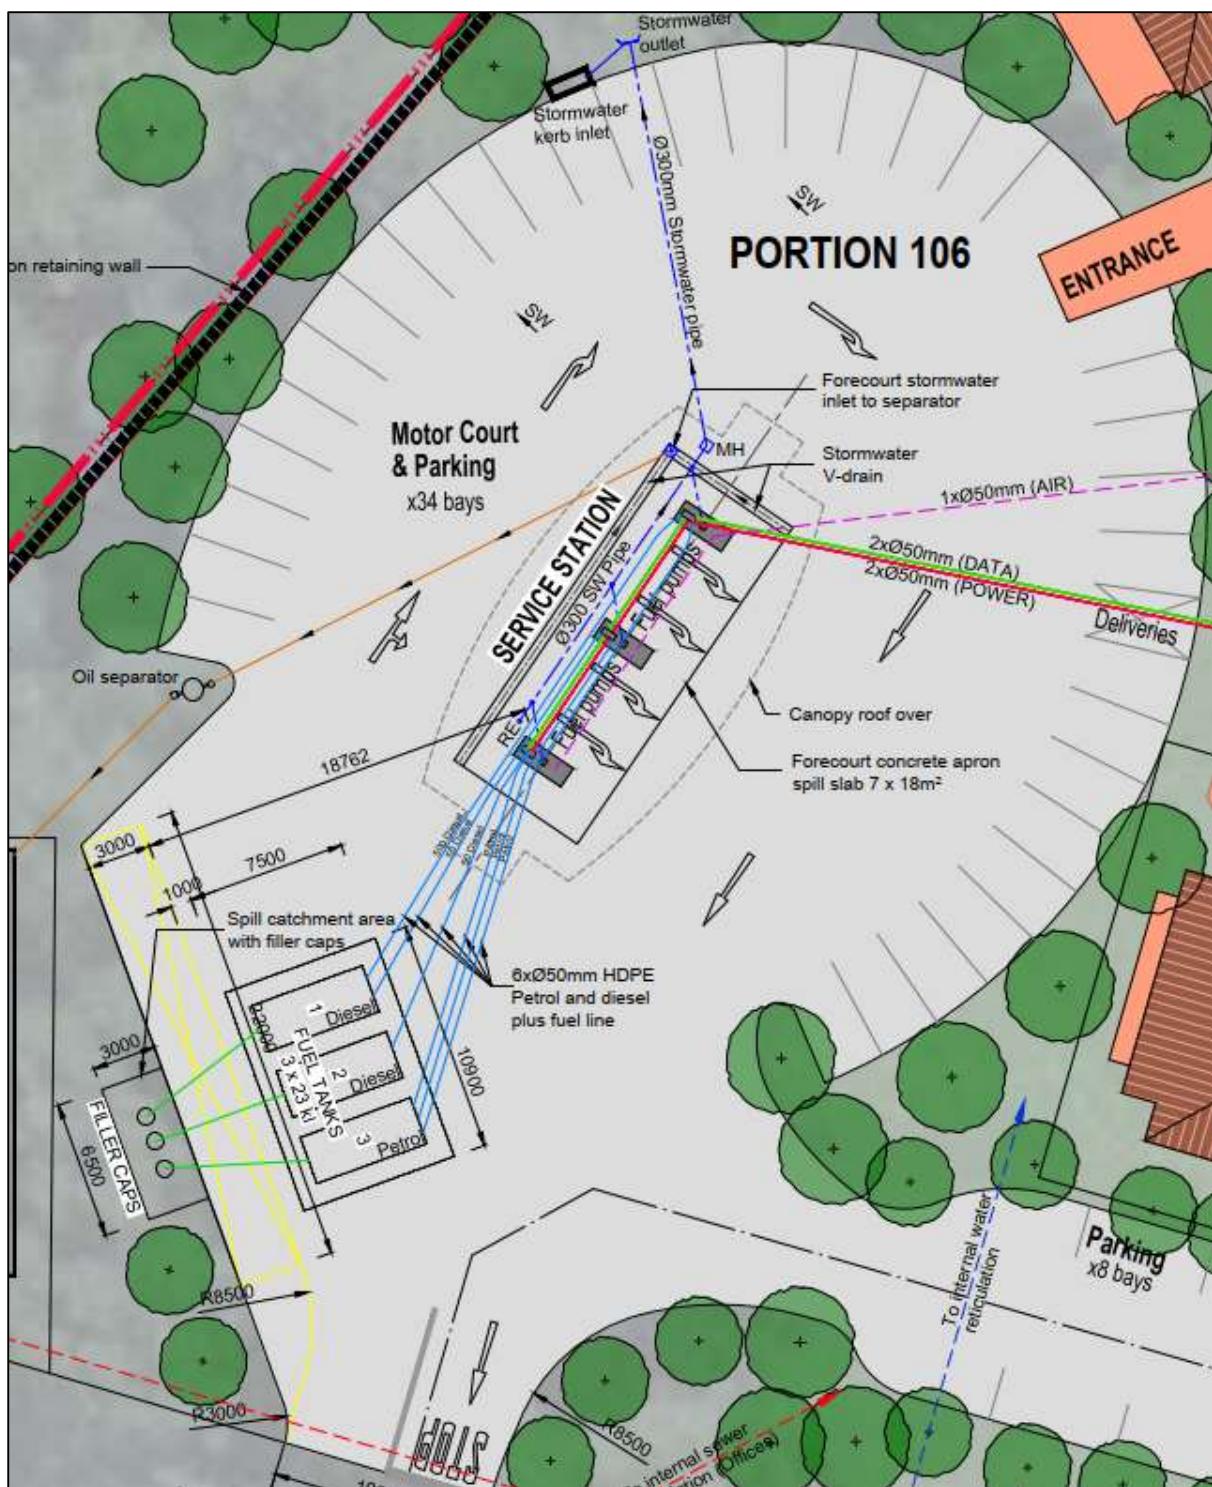
Figure 2: Site layout.

The proposed filling station is envisioned to be positioned in the southwestern corner of the development footprint area, adjacent to the Oubaai Main Road. A total of 69m³ storage capacity of fuel can be installed into 3 tanks, i.e., this will be split into 2 x 23 000l tanks for Diesel and 1 x 23 000l tank for Petrol.

The filling station area (footprint), in total, is approximately 1.5Ha.

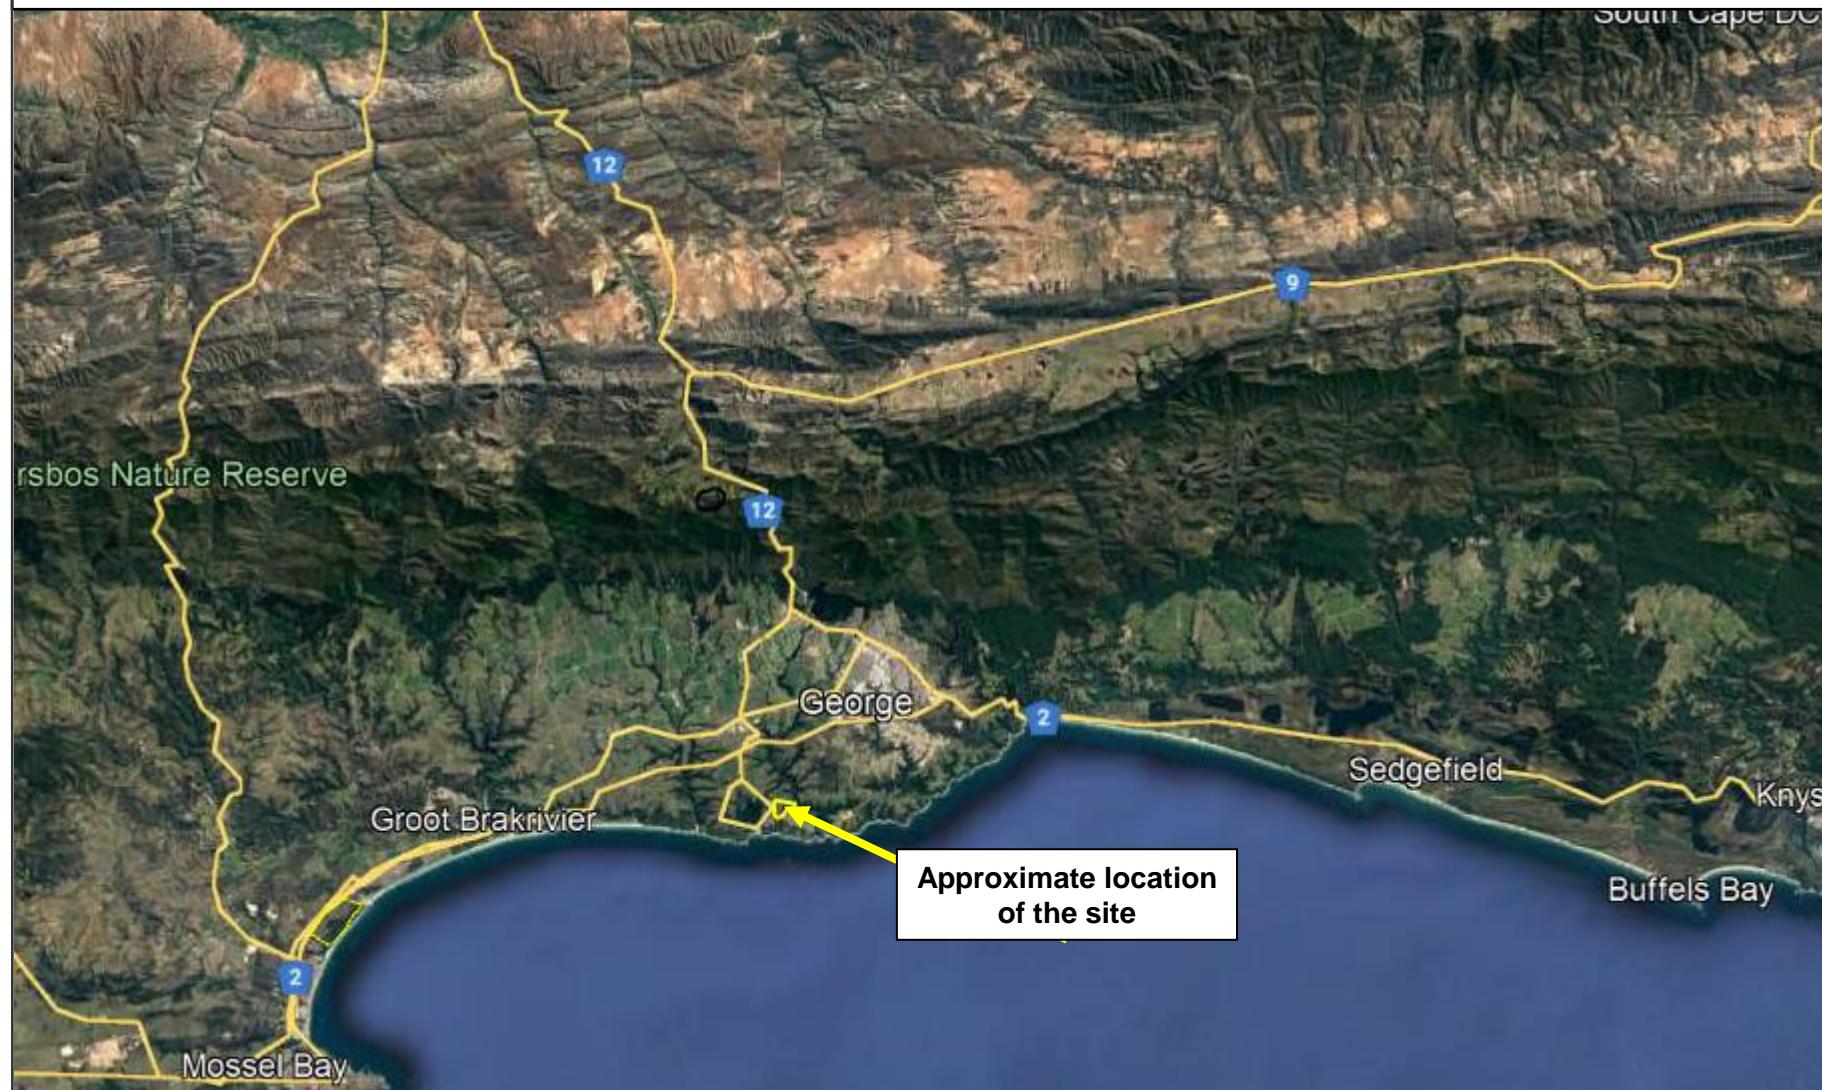
FIGURE 1: BOREHOLE PLACEMENT FOR THE FILLING STATION, HEROLDS BAY COUNTRY ESTATE ON PORTION 7 OF THE FARM.
BUFFELSFONTEIN 204, WESTERN CAPE

<p>Prevailing wind: Summer: Southeast Winter: Northwest</p> <p>GPS Coordinates: Latitude: 34° 2'44.39"S Longitude: 22°24'15.31"E</p>	<p>Prepared for: Herolds Bay Country Estate</p>		<p>Date: June 2022</p>

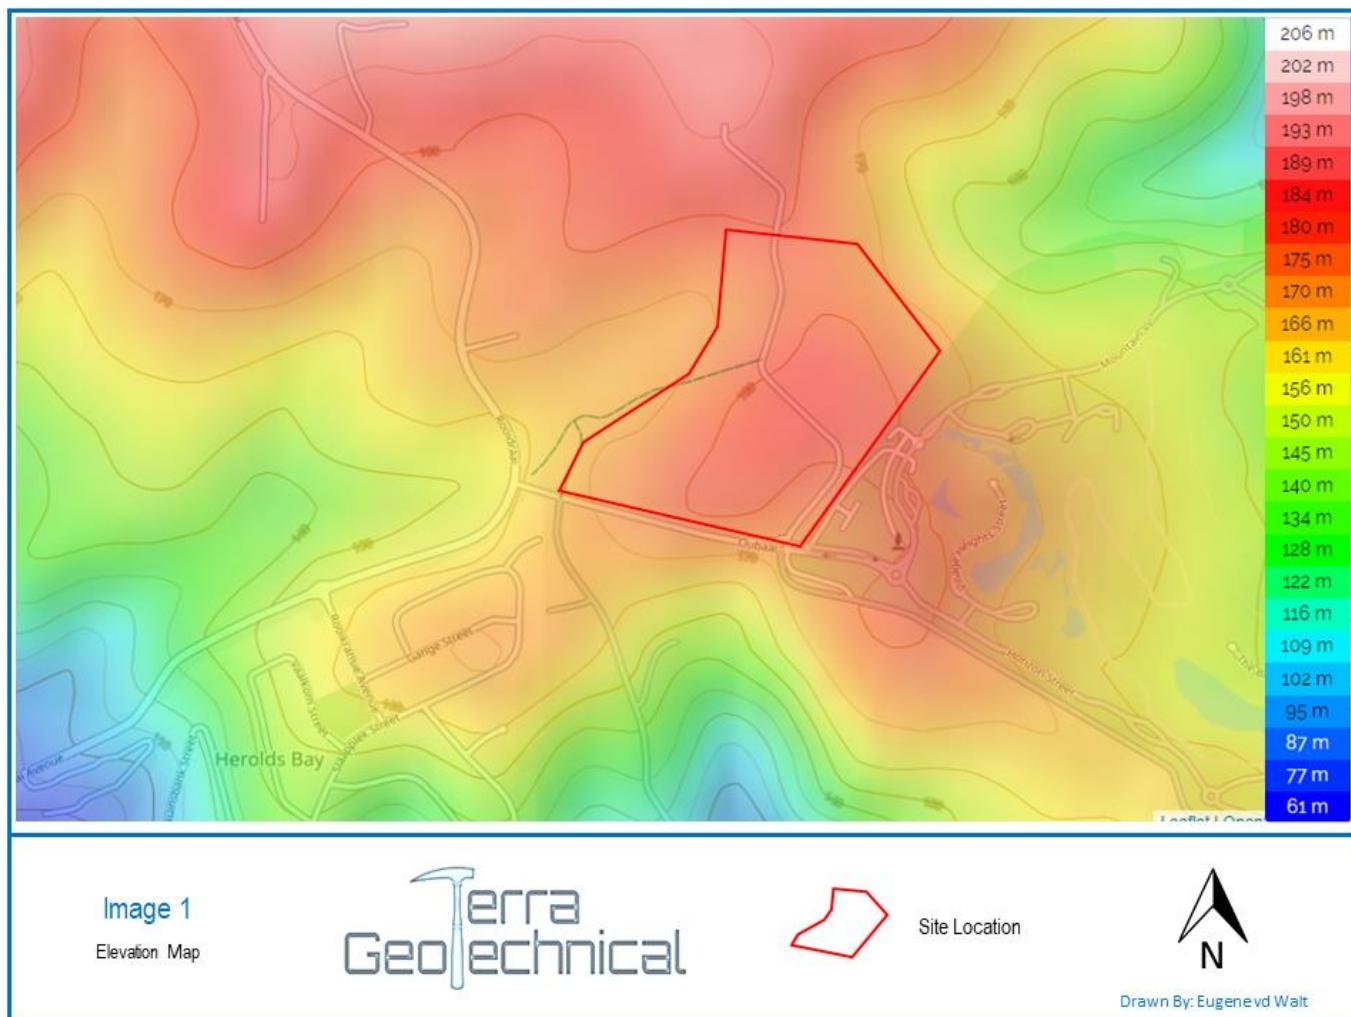
Image 1: Topography and elevation

The site is defined by a ridge type structure located within the south eastern portion of the site. This ridge structure is approximately 180 m above mean sea level. The remainder of the site is then characterized by gentle to moderate sloping side slopes, decreasing in elevation radially from the ridge. The site slopes are generally gently sloping (between 2 and 8°) across most of the site with isolated moderate slopes (up to 12°) in the south eastern corner.

The colour coded image below depicts the topographic nature of the study area, with the higher lying ridge type structures depicted by the red/white and the lower lying side slopes and valley structures depicted by the yellow/green colours. The site is located at an elevation of approximately 185 m above mean sea level.

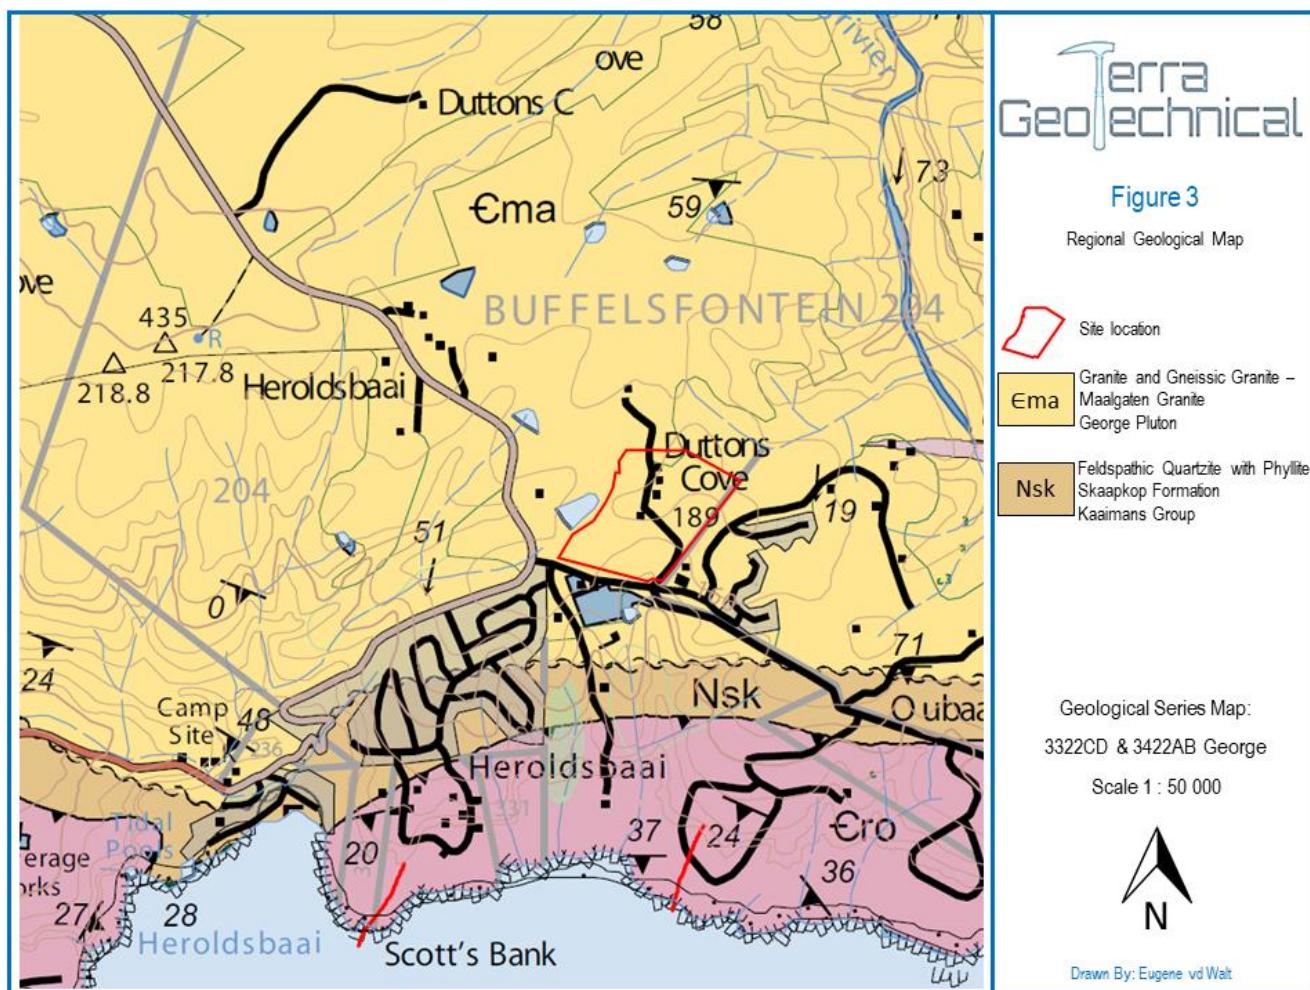
The regional geological setting of the study area (minus the surficial soil cover) is illustrated by Figure 3.

The study area does not reflect any risk for the formation of sinkholes or subsidence caused by the presence of water-soluble rocks (dolomite or limestone), and as such is not deemed "dolomitic land".

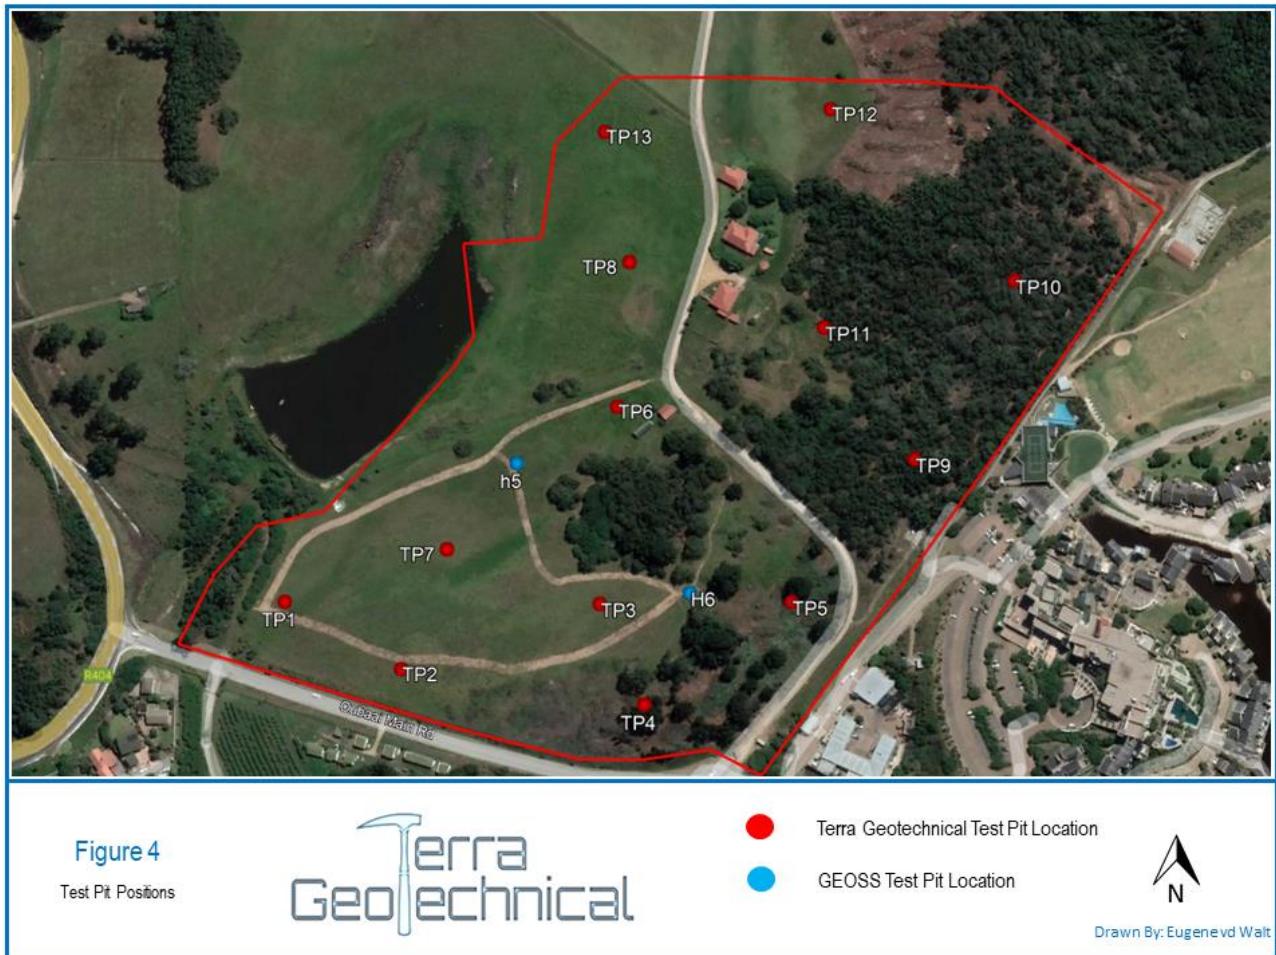
During the site investigation, a total of 13 test pits, numbered TP1 to TP13, were excavated across the site, by means of a TLB-type light mechanical excavator, at which time the exposed soil layers were profiled and samples extracted.

Figure 4 below depicts the test pit layout across the site. The red locations indicate the 13 test pits excavated during the investigation of Terra Geotechnical. Two additional test pits (in blue) are depicted. These are test pits performed during the prior investigation of GEOSS. These are purely utilized as additional data points.

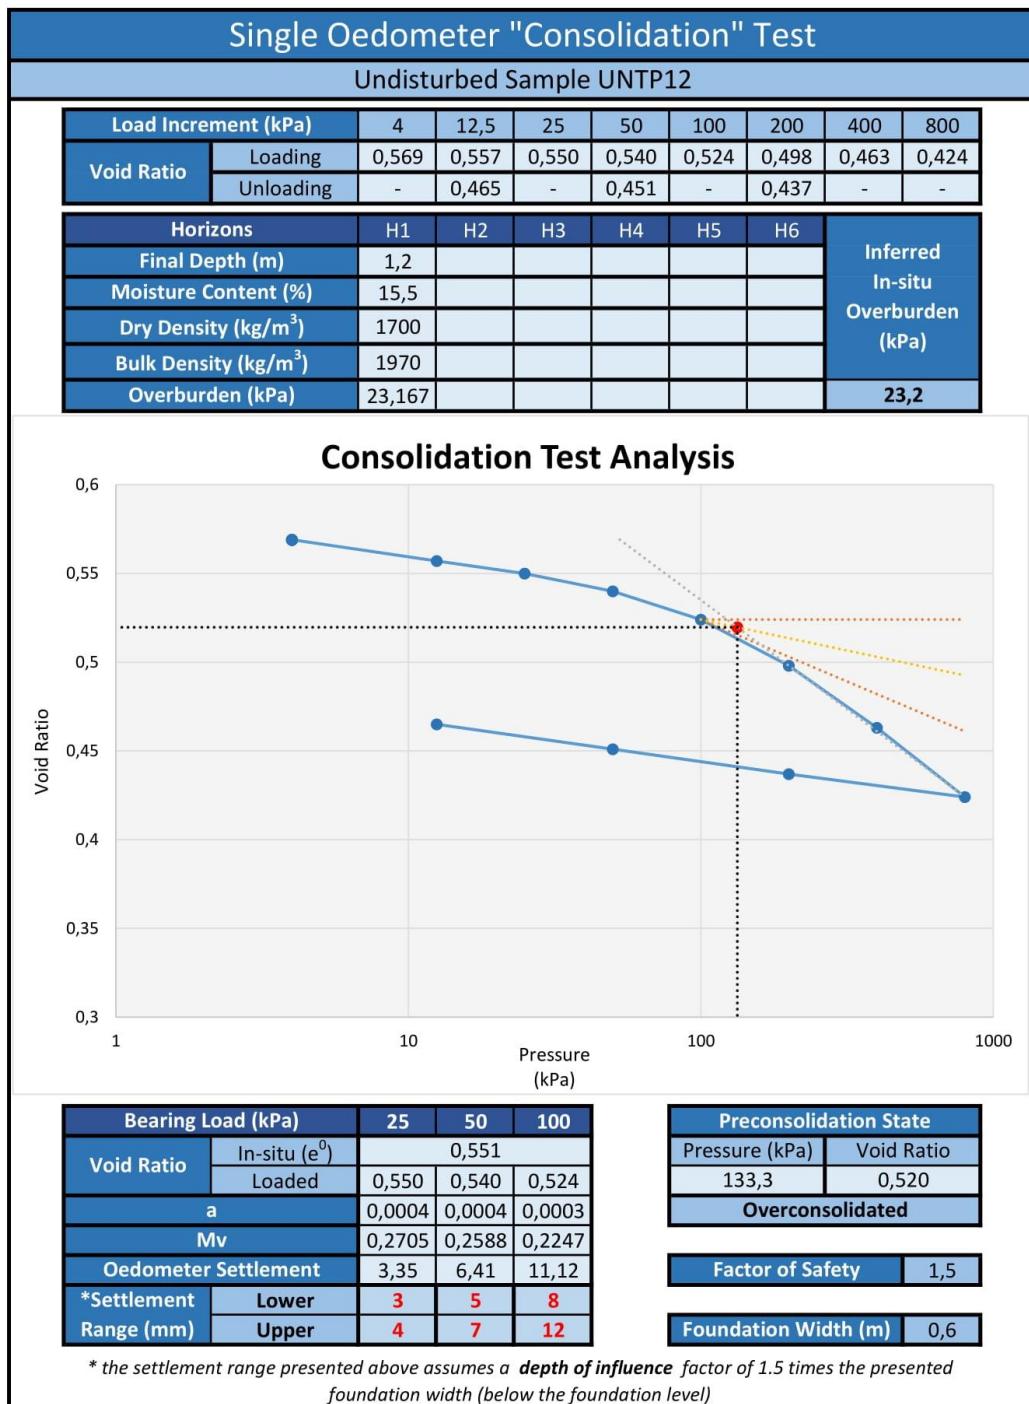
Oedometer Swell Test

Sample Detail		Initial	Final
Height	(mm)	20.3	19.0
Diameter	(mm)	63.5	63.5
Weight	(g)	126.4	132.2
Moisture	(%)	15.5	22.0
Dry Density	(Mg/m ³)	1.70	1.81
Bulk Density	(Mg/m ³)	1.97	2.20
Void Ratio		0.569	0.465
Particle Density	(Mg/m ³)		2.67
Disturbed/Undisturbed			Undisturbed
Remoulded Density	(Mg/m ³)		-

Project	Harolds Baai		
Sample	TP12		
Client	Terra Geotechnical	Test Method	BS1377 - 5: 1990
Jobfile	SWG00342	Test Date	25/05/2022
