# Heritage Statement

## **The Proposed Upgrading of the Herold's Bay Pump Station and Associated Rising Main as well as the Development of New Associated Infrastructure, Herold's Bay, George Municipality, Western Cape Province**

8 October 2023 – Revised 9 April 2024

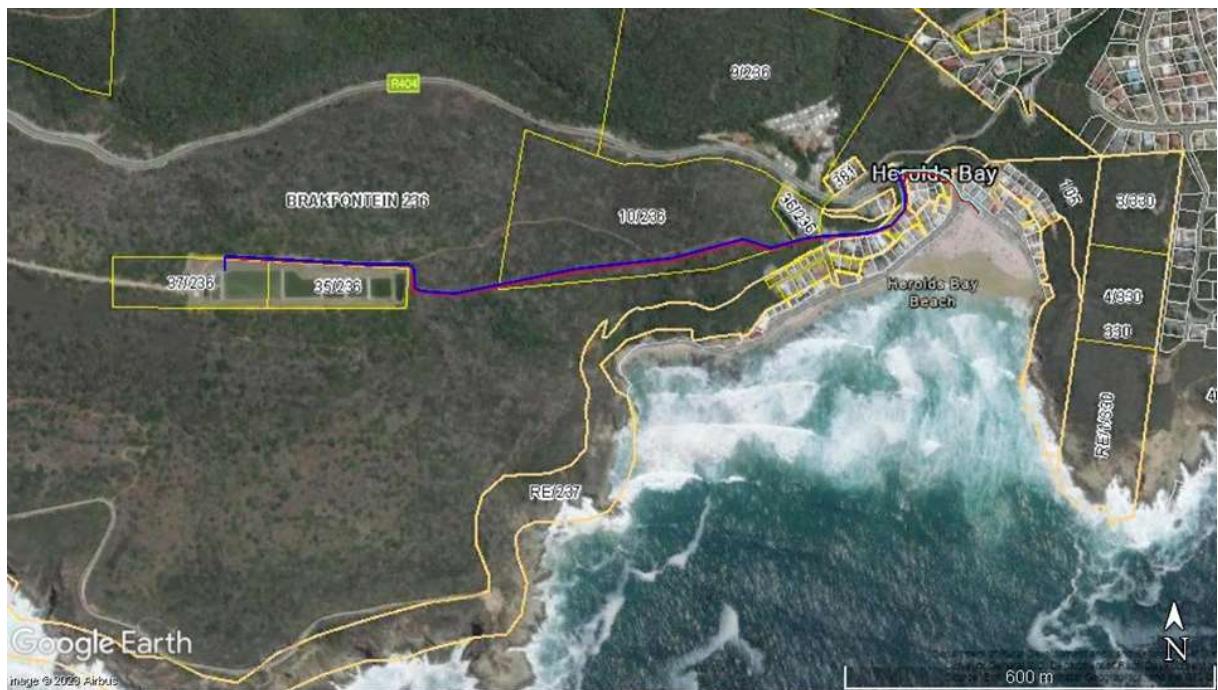
Figure 3. Area enlarged from Figure 1 showing study area (coloured lines), properties and developments. Courtesy of Cape Farm Mapper and Google Earth 2023. (A4 version below)

Figures 3 & 4 above show the affected properties and existing developments along the route. Starting at the Herold's Bay WWTW, the linear route falls within the previously disturbed portions of 37/236, 35/236, RE236 and 10/236. Apart from the WWTW, overhead transmission line and a vehicle track leading to a telecommunications mast, this part of the site is heavily overgrown with a mixture of indigenous and exotic vegetation. The route follows the existing sewer pipeline down the steep slope from the telecommunications mast to the top of Spekie Gericke Drive on RE/237 and Erf 110. From here, the route follows existing roads and sewer infrastructure along Spekie Gericke Drive, Skimmelkrans Lane and Sandstrand Avenue where it ends at the existing pump station on Erf RE/95. The new pump station will be built on Erf 116, which is currently an undeveloped erf already transformed and used as an informal car park.

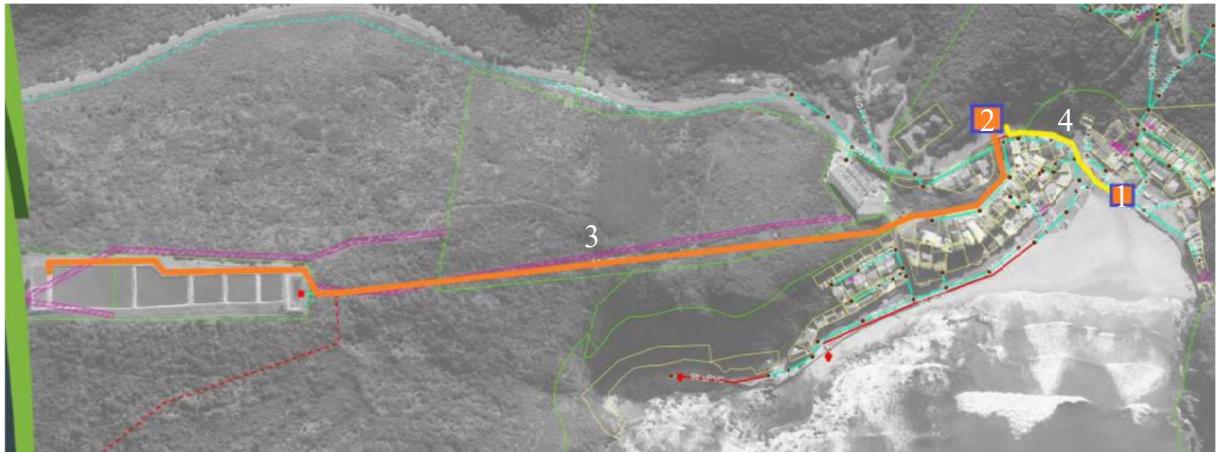
Figure 5: A conceptual layout plan of the proposed project. (after Bennet & Swanepoel 2023b, Pg 2, Figure 2)

“The project includes the following:

## 1. The upgrading of the existing Pump Station No. 1 (location 1 on figure 5)

2. Construction of a new pump station 4 including degritting and screening equipment (location 2 on figure 5)
3. Construction of a new 250mm diameter rising main parallel to the existing rising main from the new Pump Station 4 to the Herold's Bay WWTW's (orange line, see item 3 on figure 5)
4. Construction of a new rising main from the Herold's Bay Pump Station No. 1 to the new Herolds Bay pump station 4 (yellow line, see item 4 on figure 5)" (Bennet & Swanepoel 2023b, Pg 1 & 2).

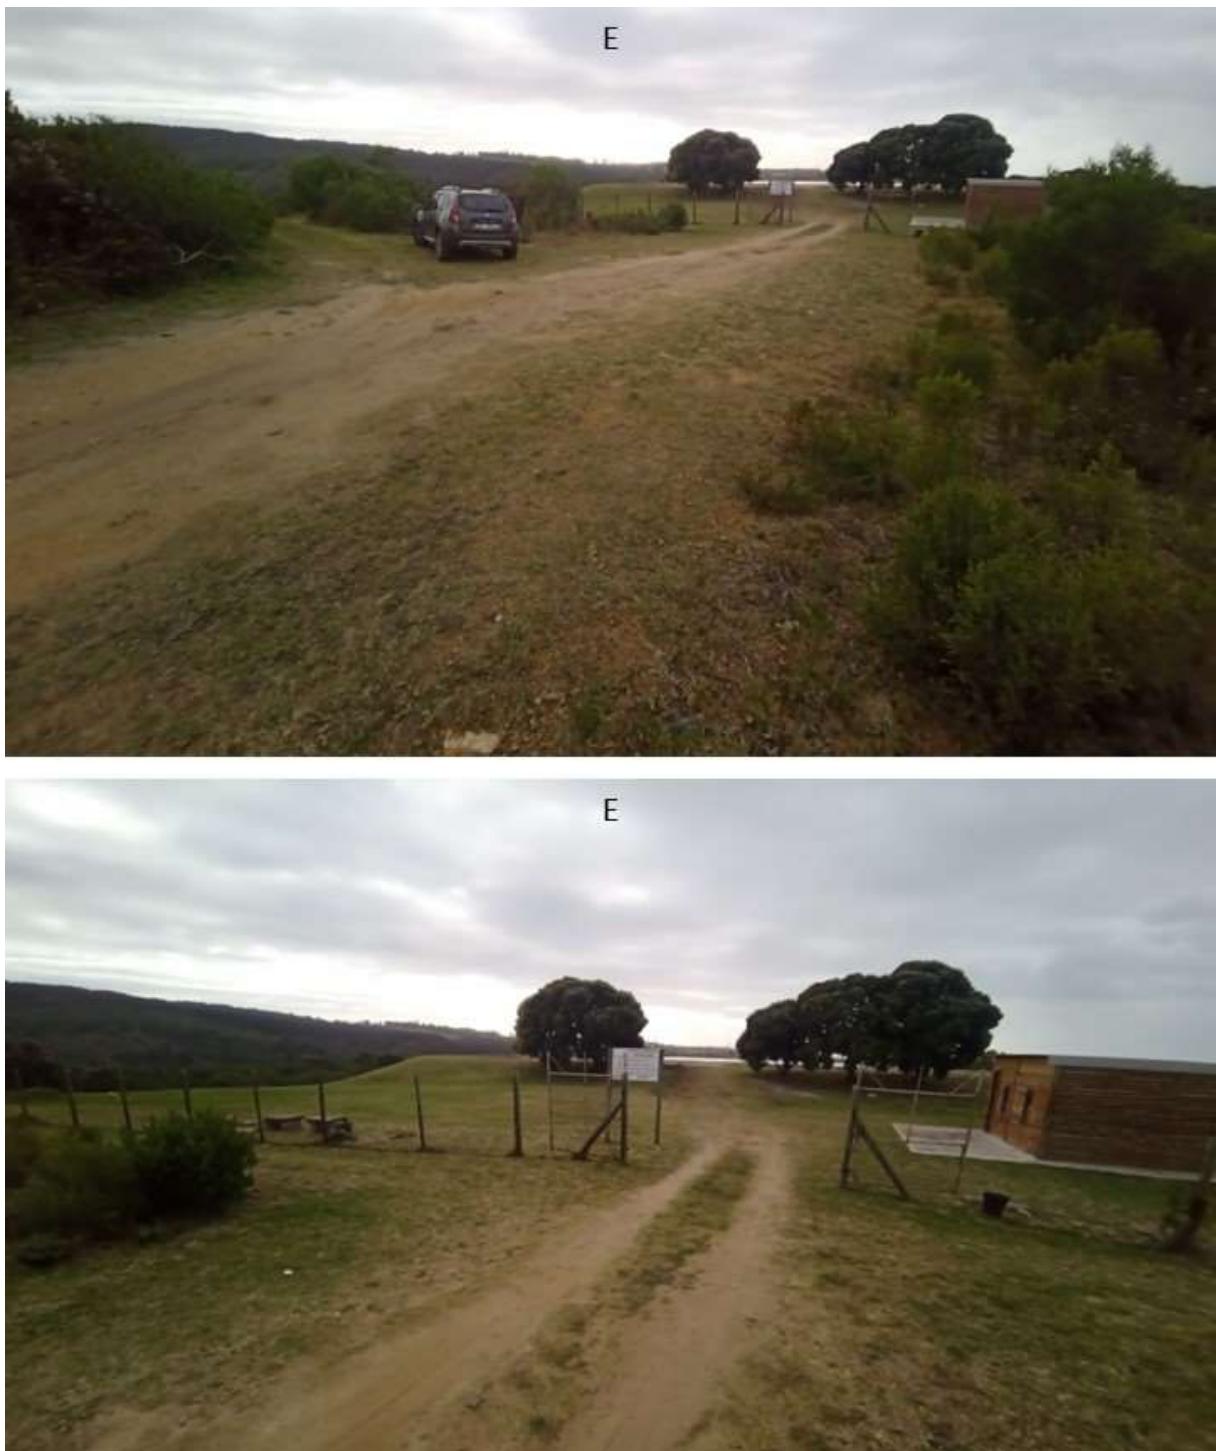
Figure 6. Western start point - Herold's Bay Wastewater Treatment Works (WWTW).

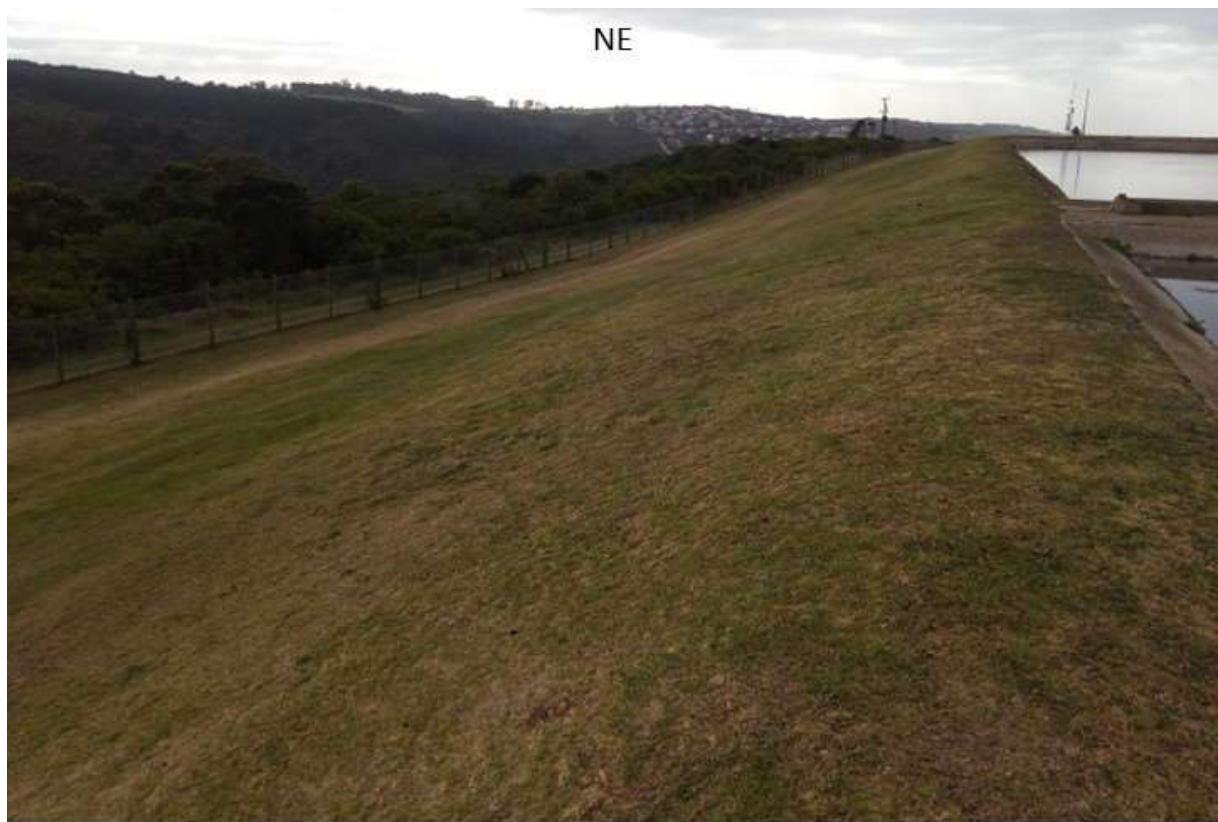
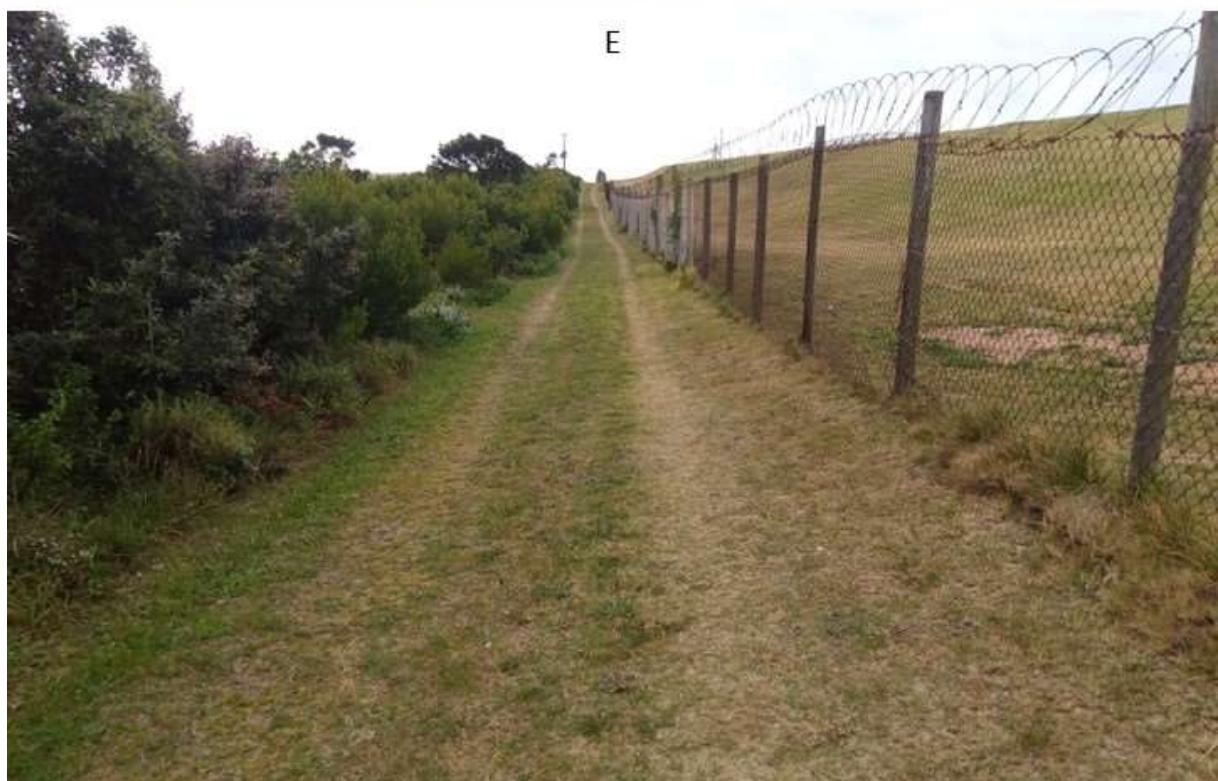
Figure 7. Herold's Bay WWTW and vehicle track. Note existing developments and dense vegetation & ground cover. High lying parts of Herold's Bay visible in background (top).

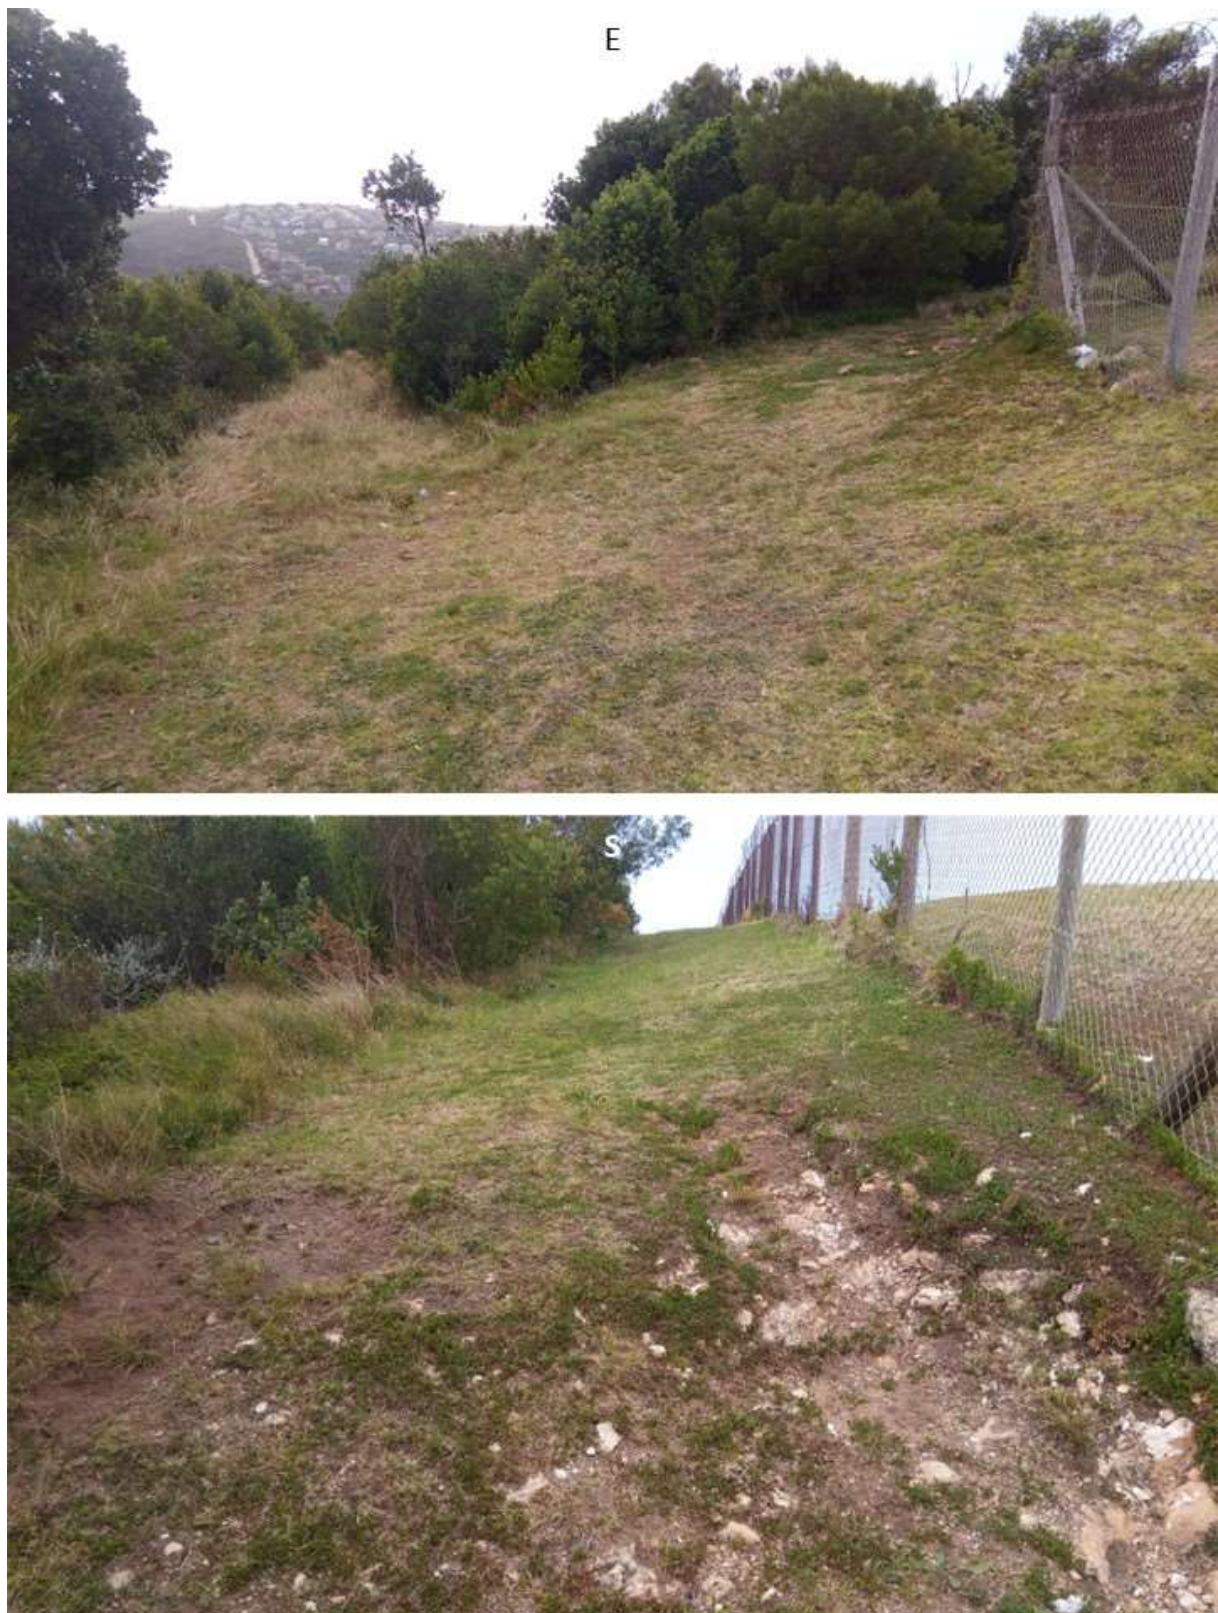
Figure 8. Previously developed area in the immediate surroundings of the Herold's Bay WWTW. Note existing developments and dense vegetation & ground cover. Vehicle track to telecommunications mast and the High lying parts of Herold's Bay visible in background (top).

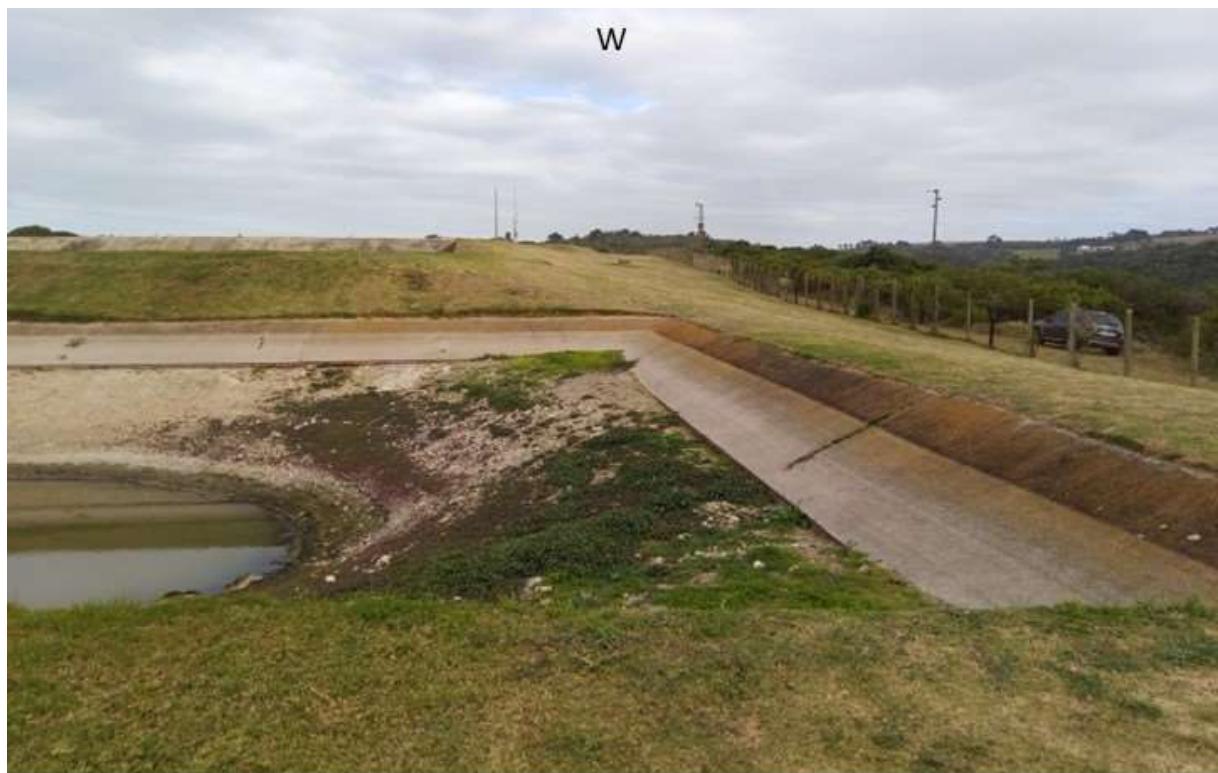
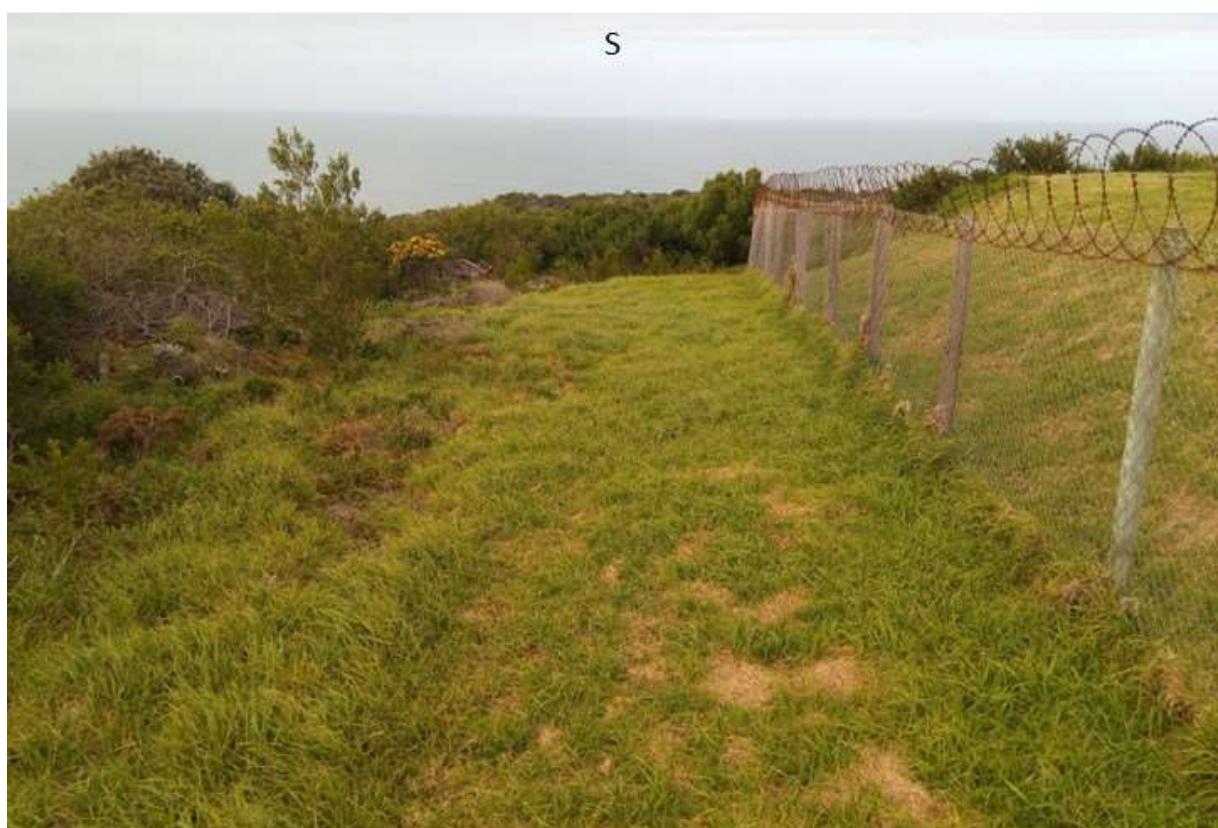
Figure 9. Previously developed area in the immediate surroundings of the Herold's Bay WWTW. Note existing developments and dense vegetation & ground cover.

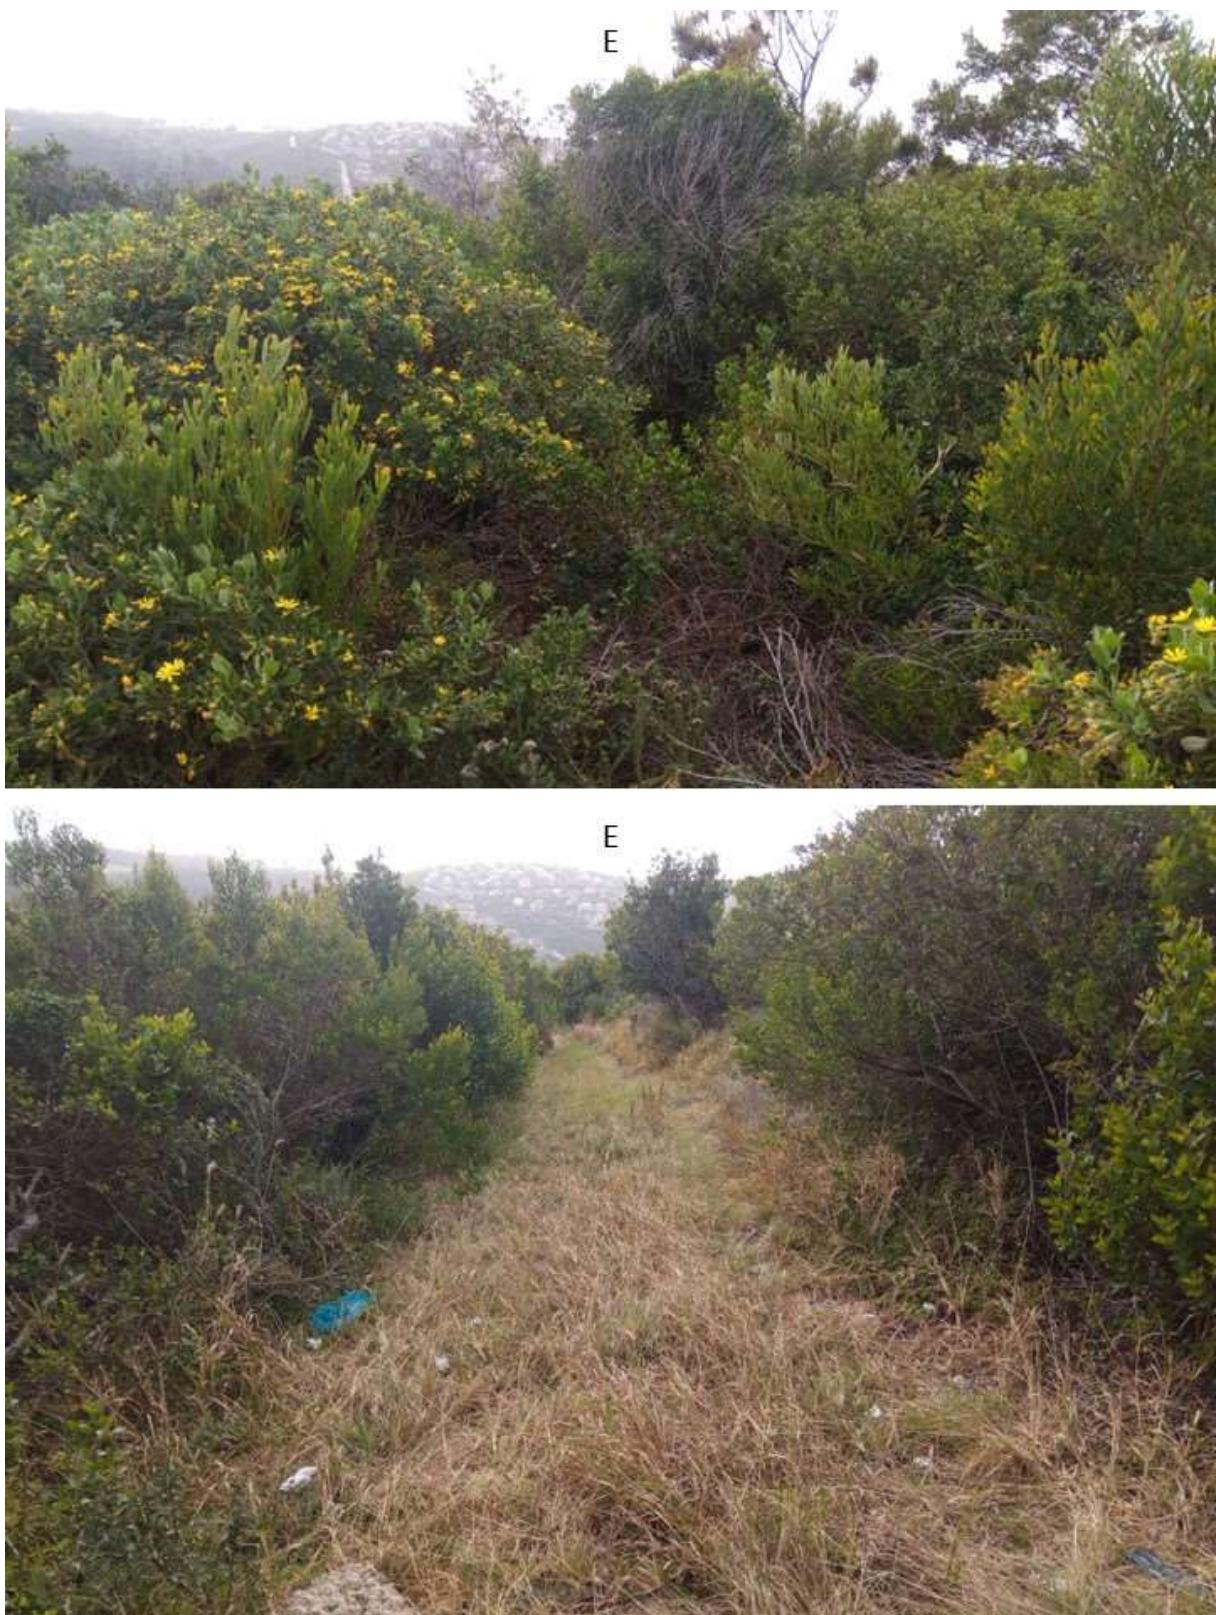
Figure 10. Area immediately east of the Herold's Bay WWTW showing dense vegetation cover and vehicle track to telecommunications maps. High lying parts of Herold's Bay visible in background.

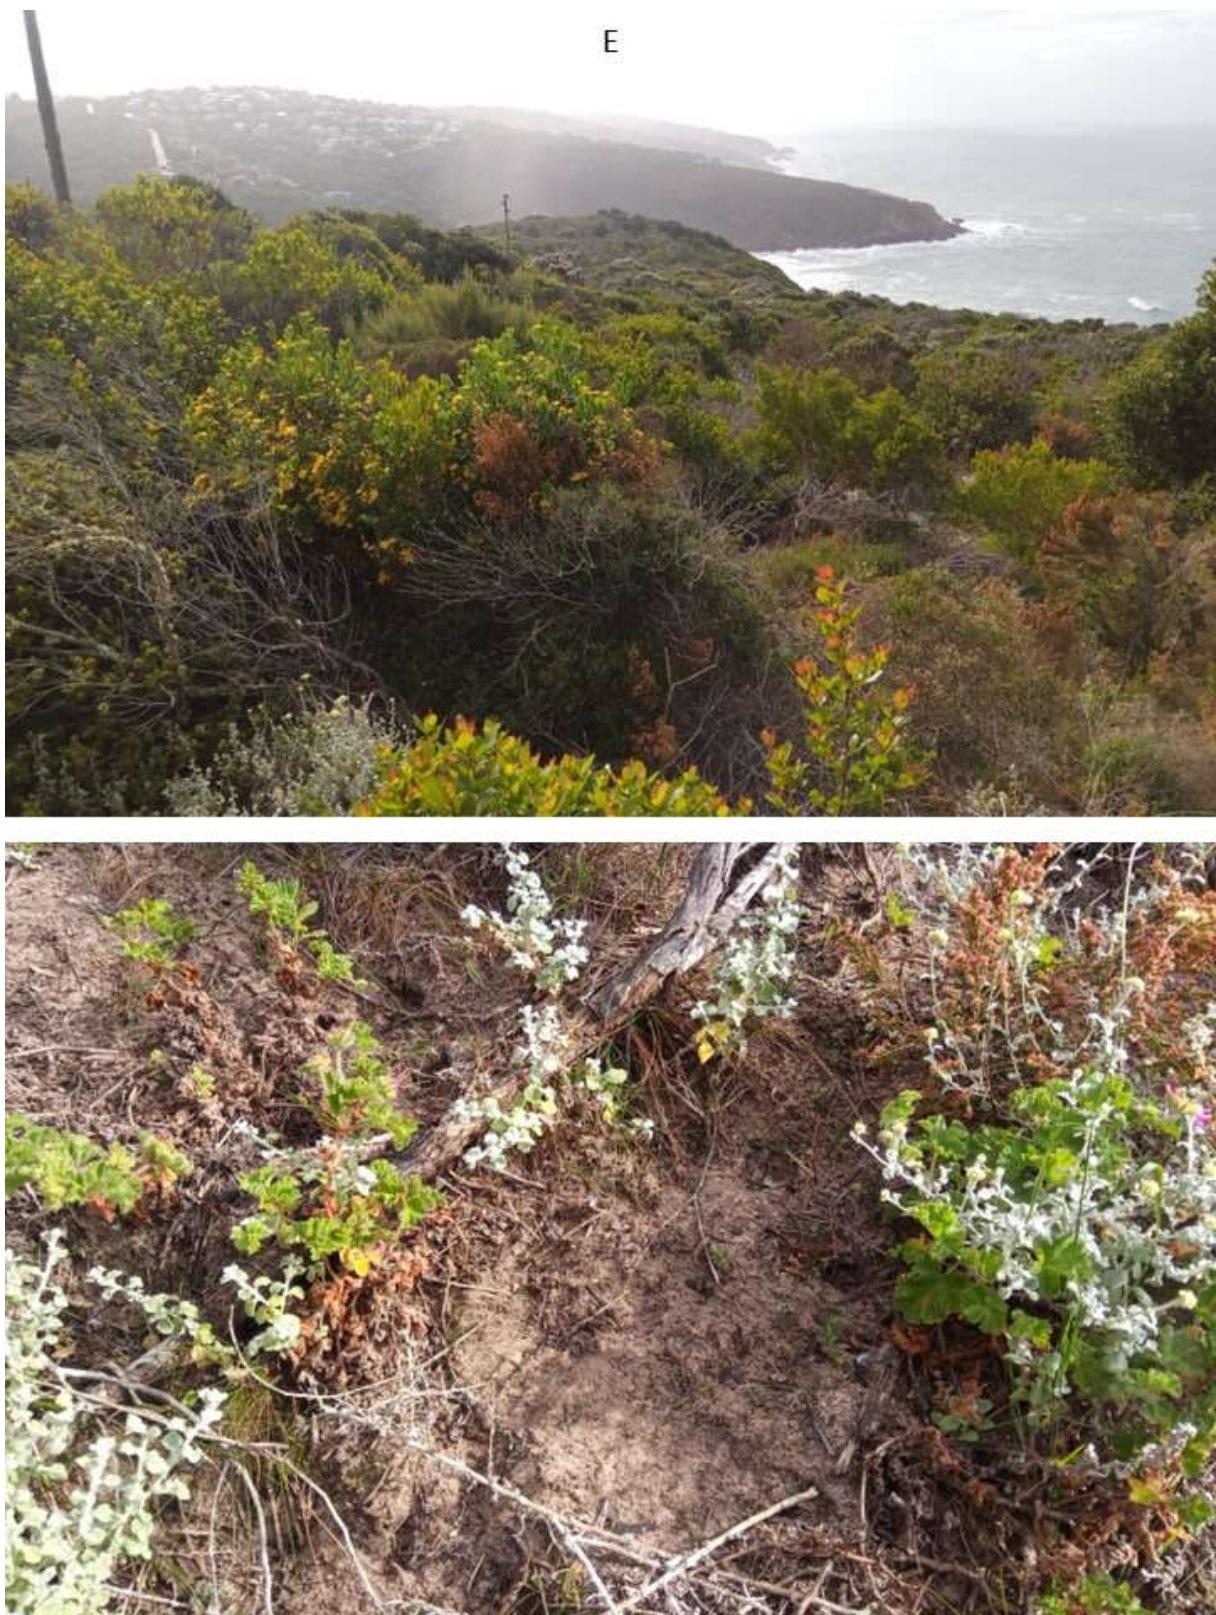
Figure 11. Overgrown stretch between the Herold's Bay WWTW and telecommunications mast. Patches of exposed dune sands are visible (bottom). High lying parts of Herold's Bay/Dutton's Cove visible in background (top).

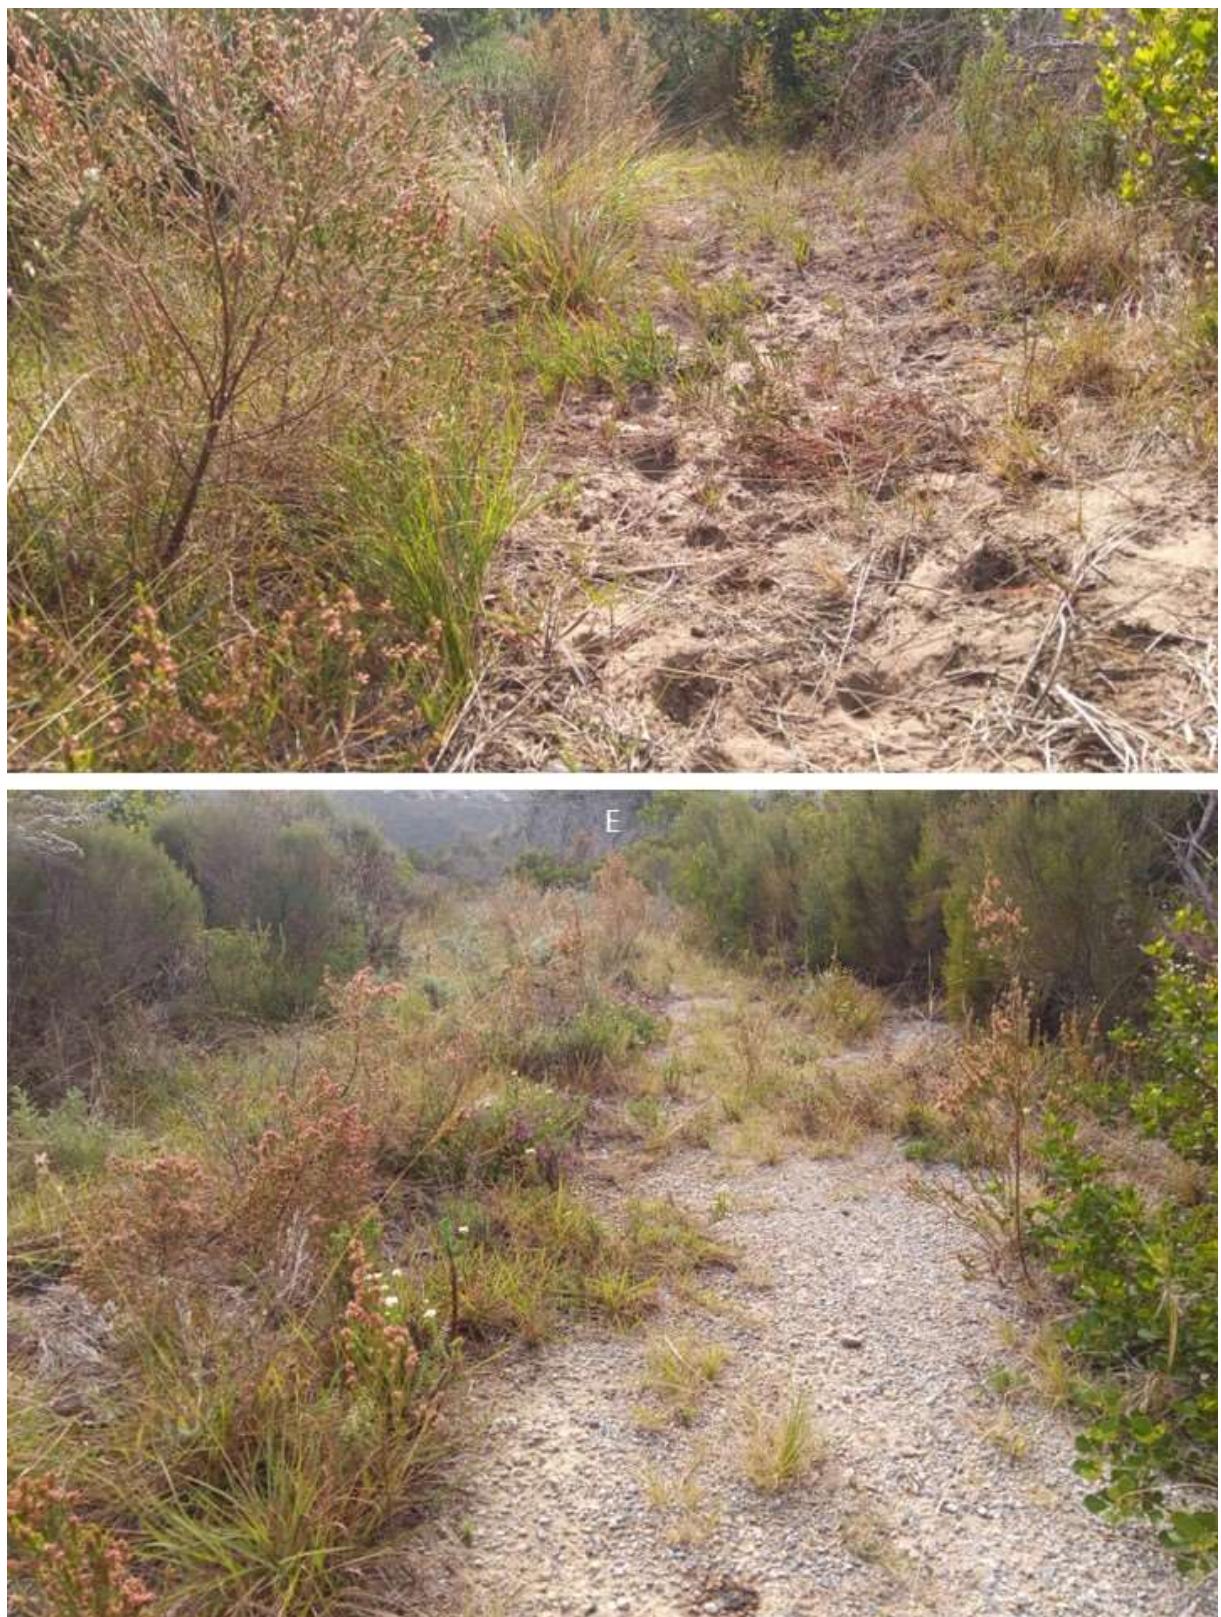
Figure 12. Exposed surfaces along vehicle track leading to the telecommunications mast showing imported gravels (bottom) and aeolian dune sands (top).

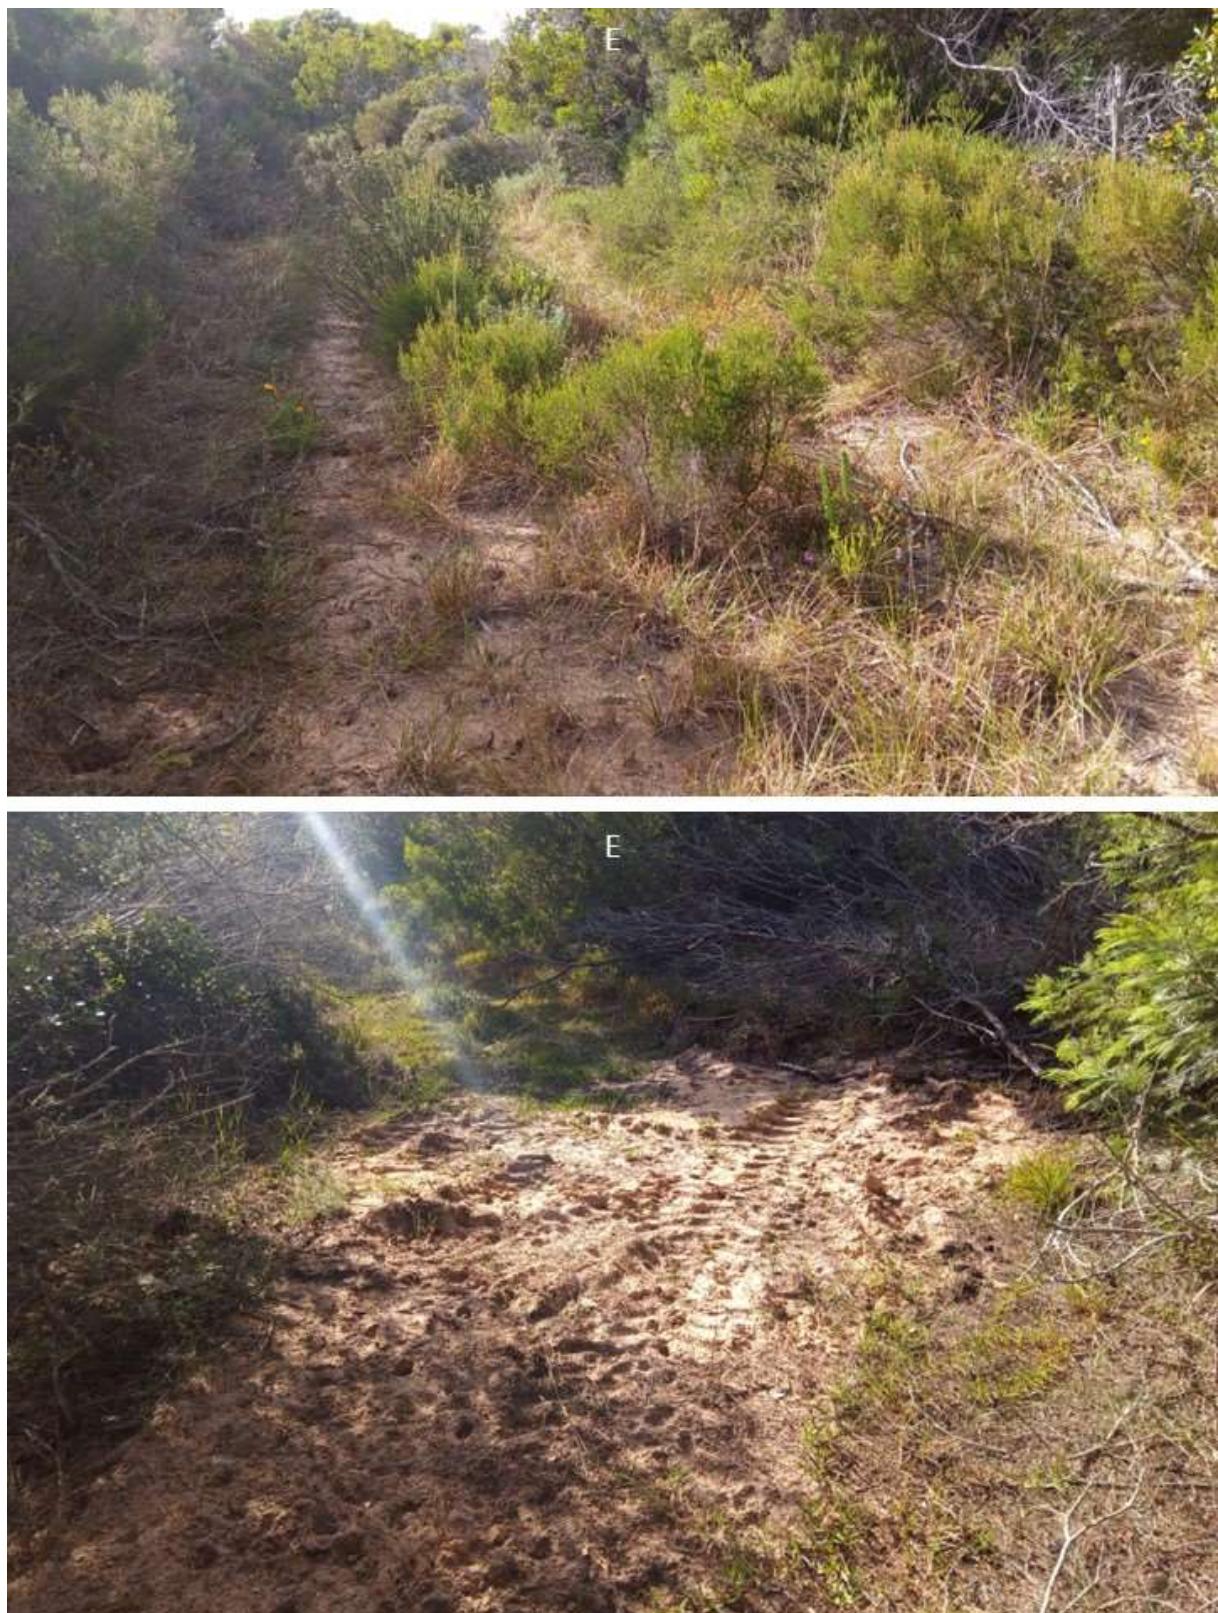
Figure 13. Exposed surfaces along vehicle track leading to the telecommunications mast showing sterile aeolian dune sands.

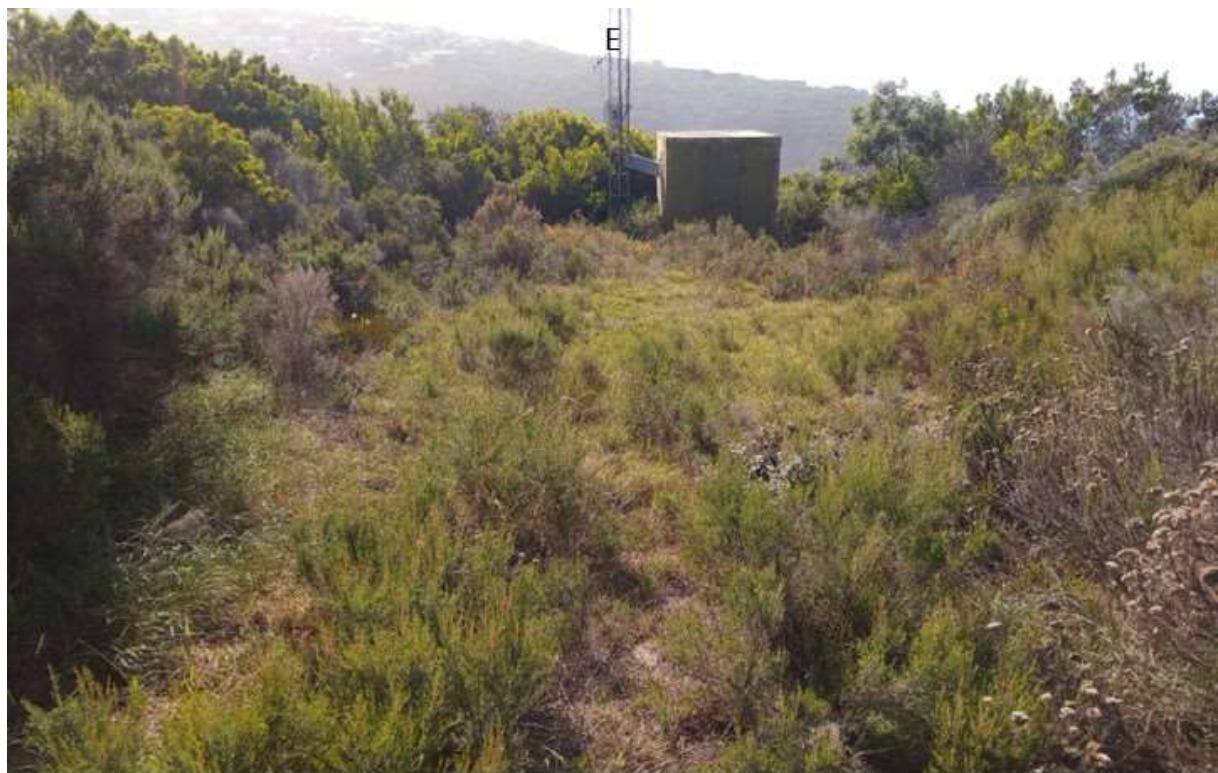
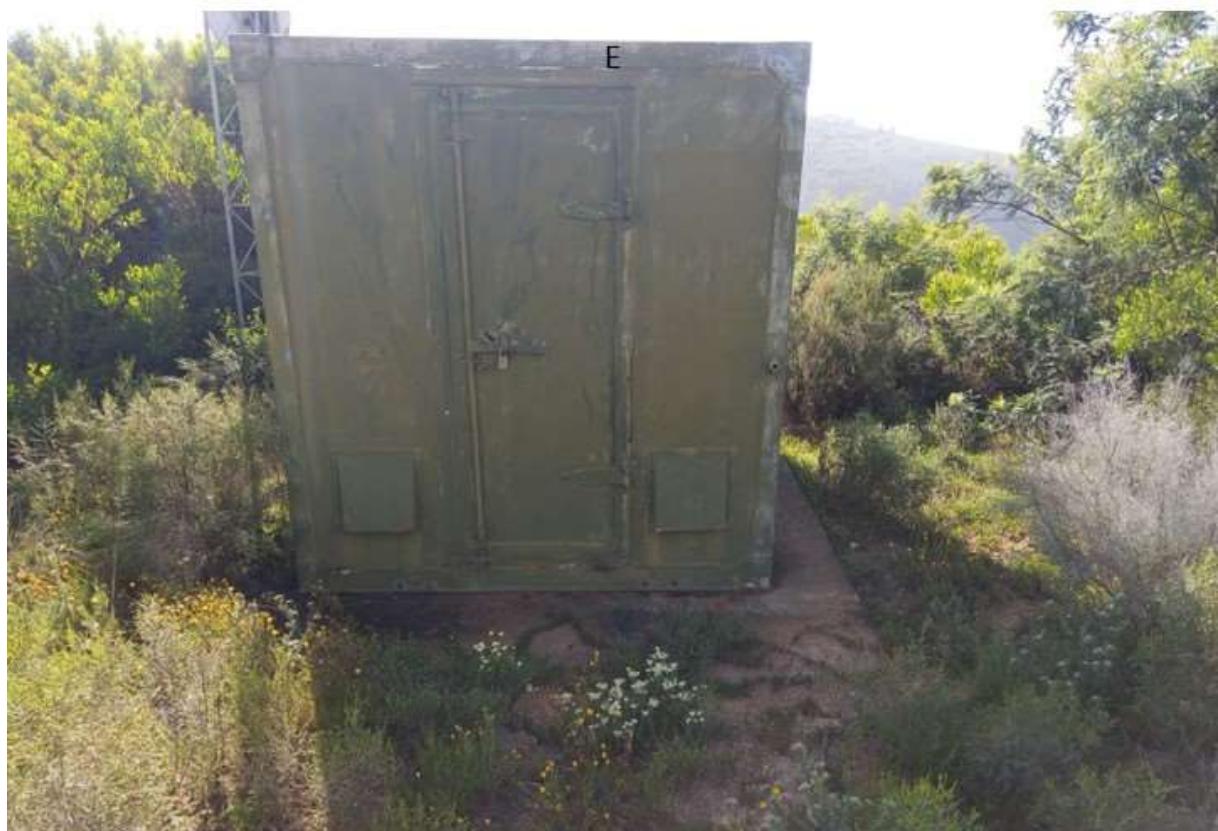
Figure 14. Exposed surfaces along vehicle track at the telecommunications mast (top) and showing concrete slab supporting structure/container for telecommunications equipment.

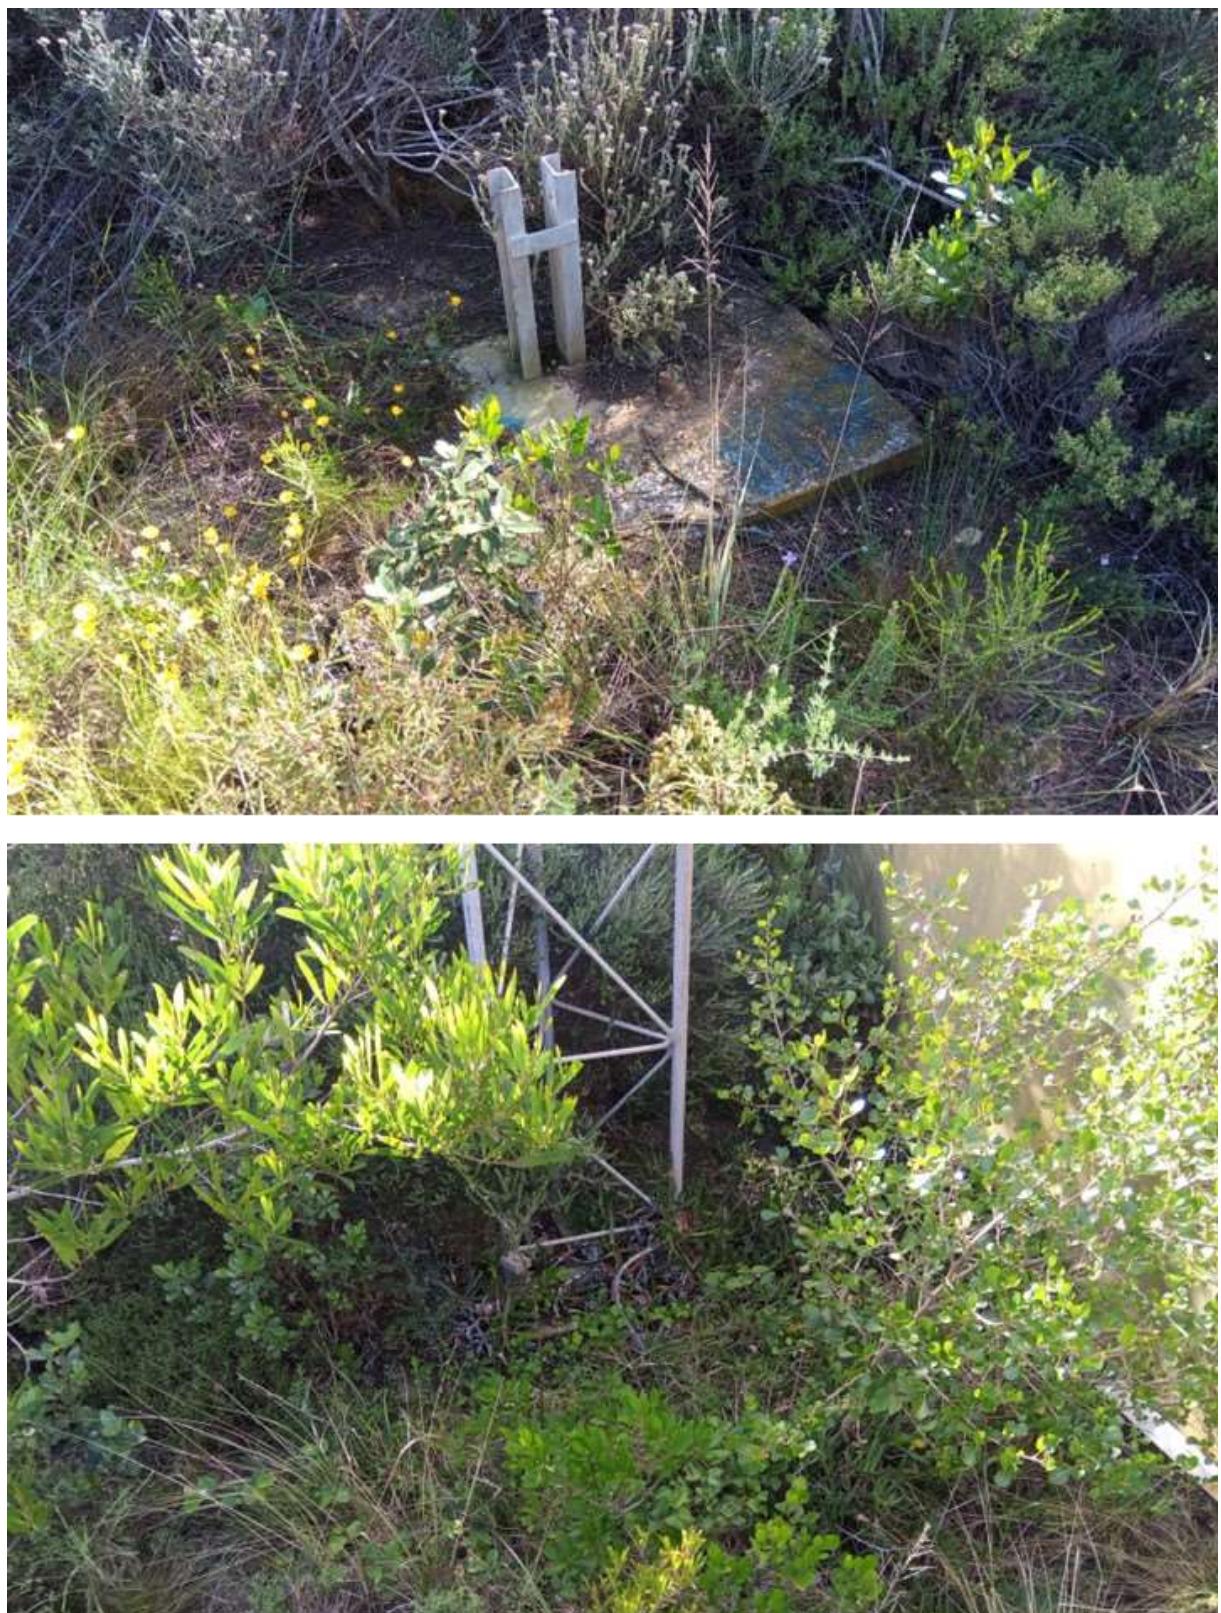
Figure 15. Concrete bases for telecommunications/other masts with the base of the current mast shown in bottom image. Area is densely overgrown.
