# Heritage Statement

## **The Proposed Upgrading of the Herold's Bay Pump Station and Associated Rising Main as well as the Development of New Associated Infrastructure, Herold's Bay, George Municipality, Western Cape Province**

8 October 2023 – Revised 9 April 2024

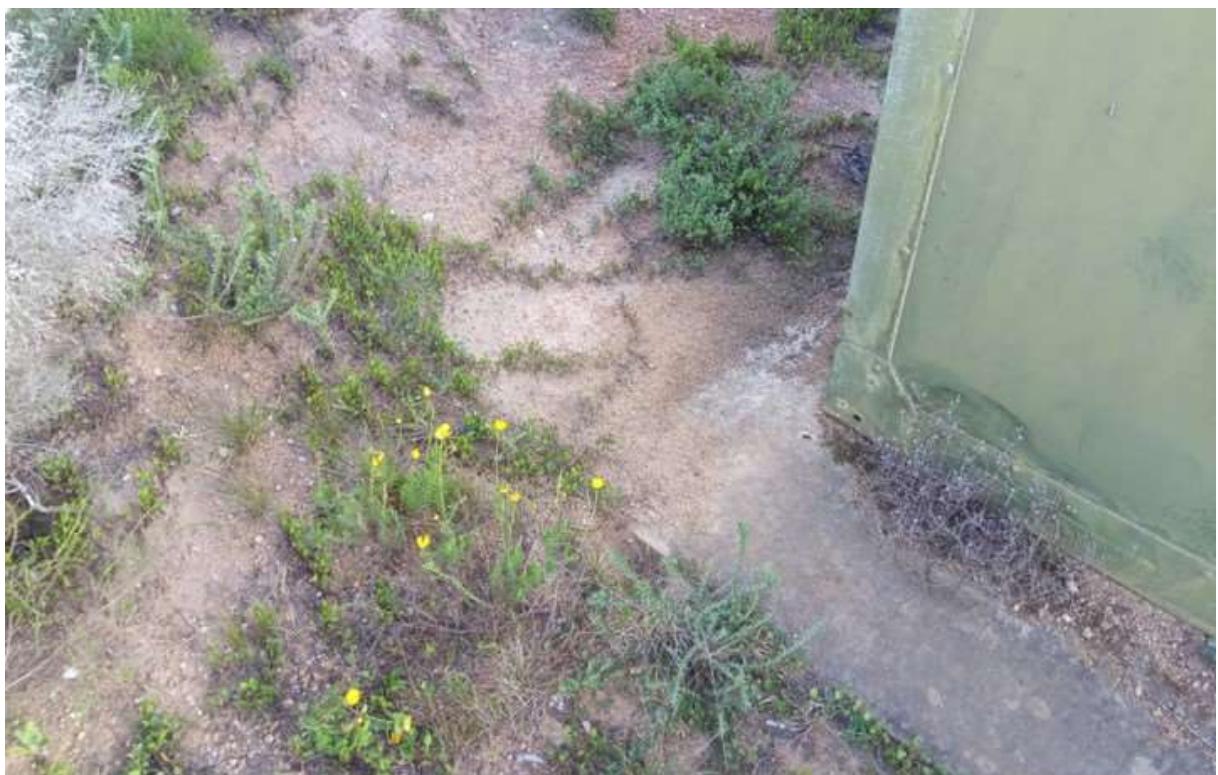
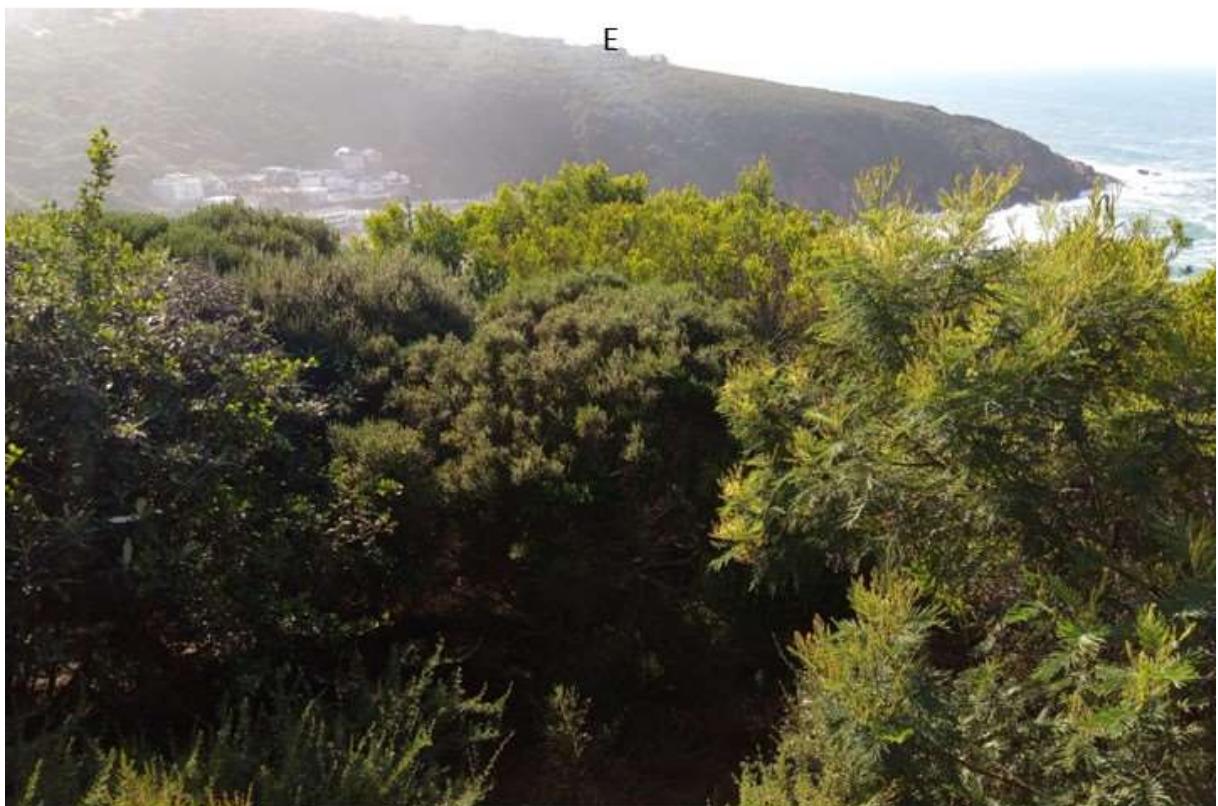
Figure 16. Concrete base of telecommunications structure/container (top) and dense vegetation on downslope to Spekie Gericke Drive (bottom). Eastern part of Herold's Bay visible in background (bottom).

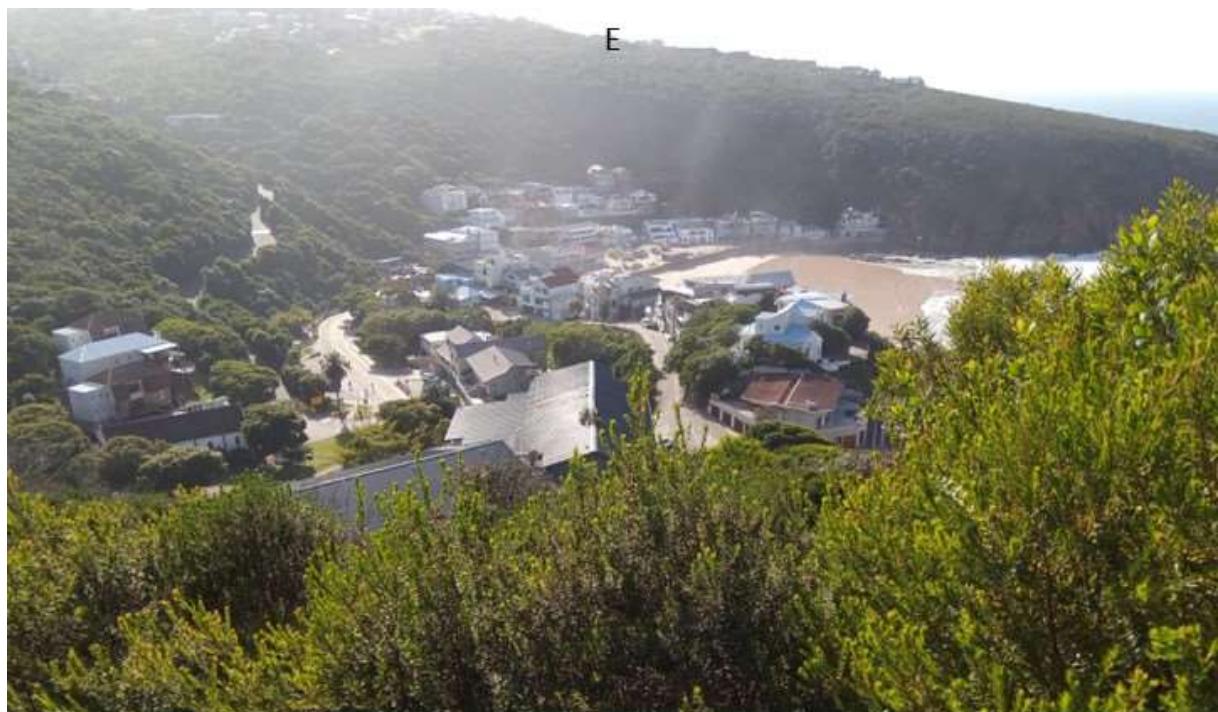
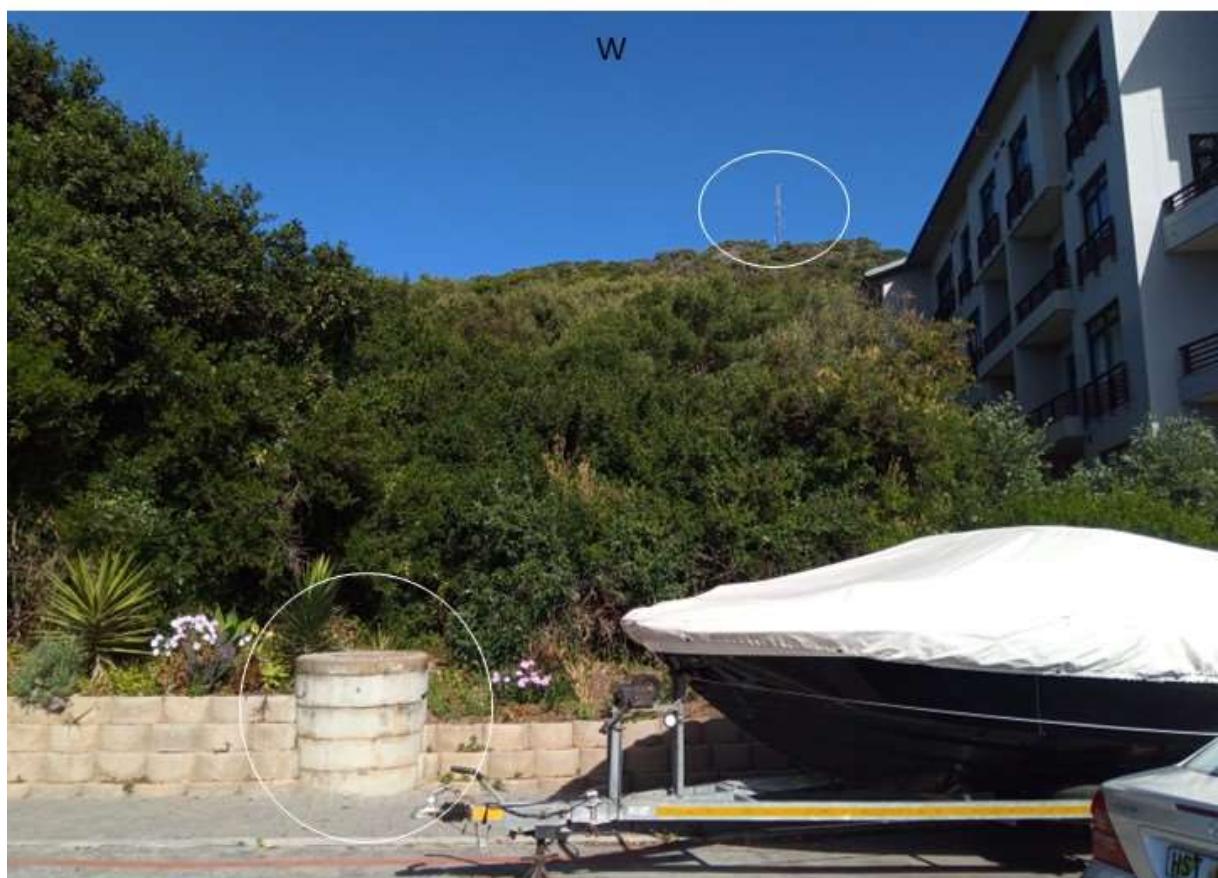
Figure 17. Looking down on Herold's Bay and along the pipeline route with Spekie Gericke Drive and Skimmelkraans Lane visible on the right and left respectively (Top). Looking up along the pipeline route towards the telecommunications mast (top ellipse) with the manhole (bottom ellipse) at the end or top of Spekie Gericke Drive (bottom). Note dense vegetation on steep slope.

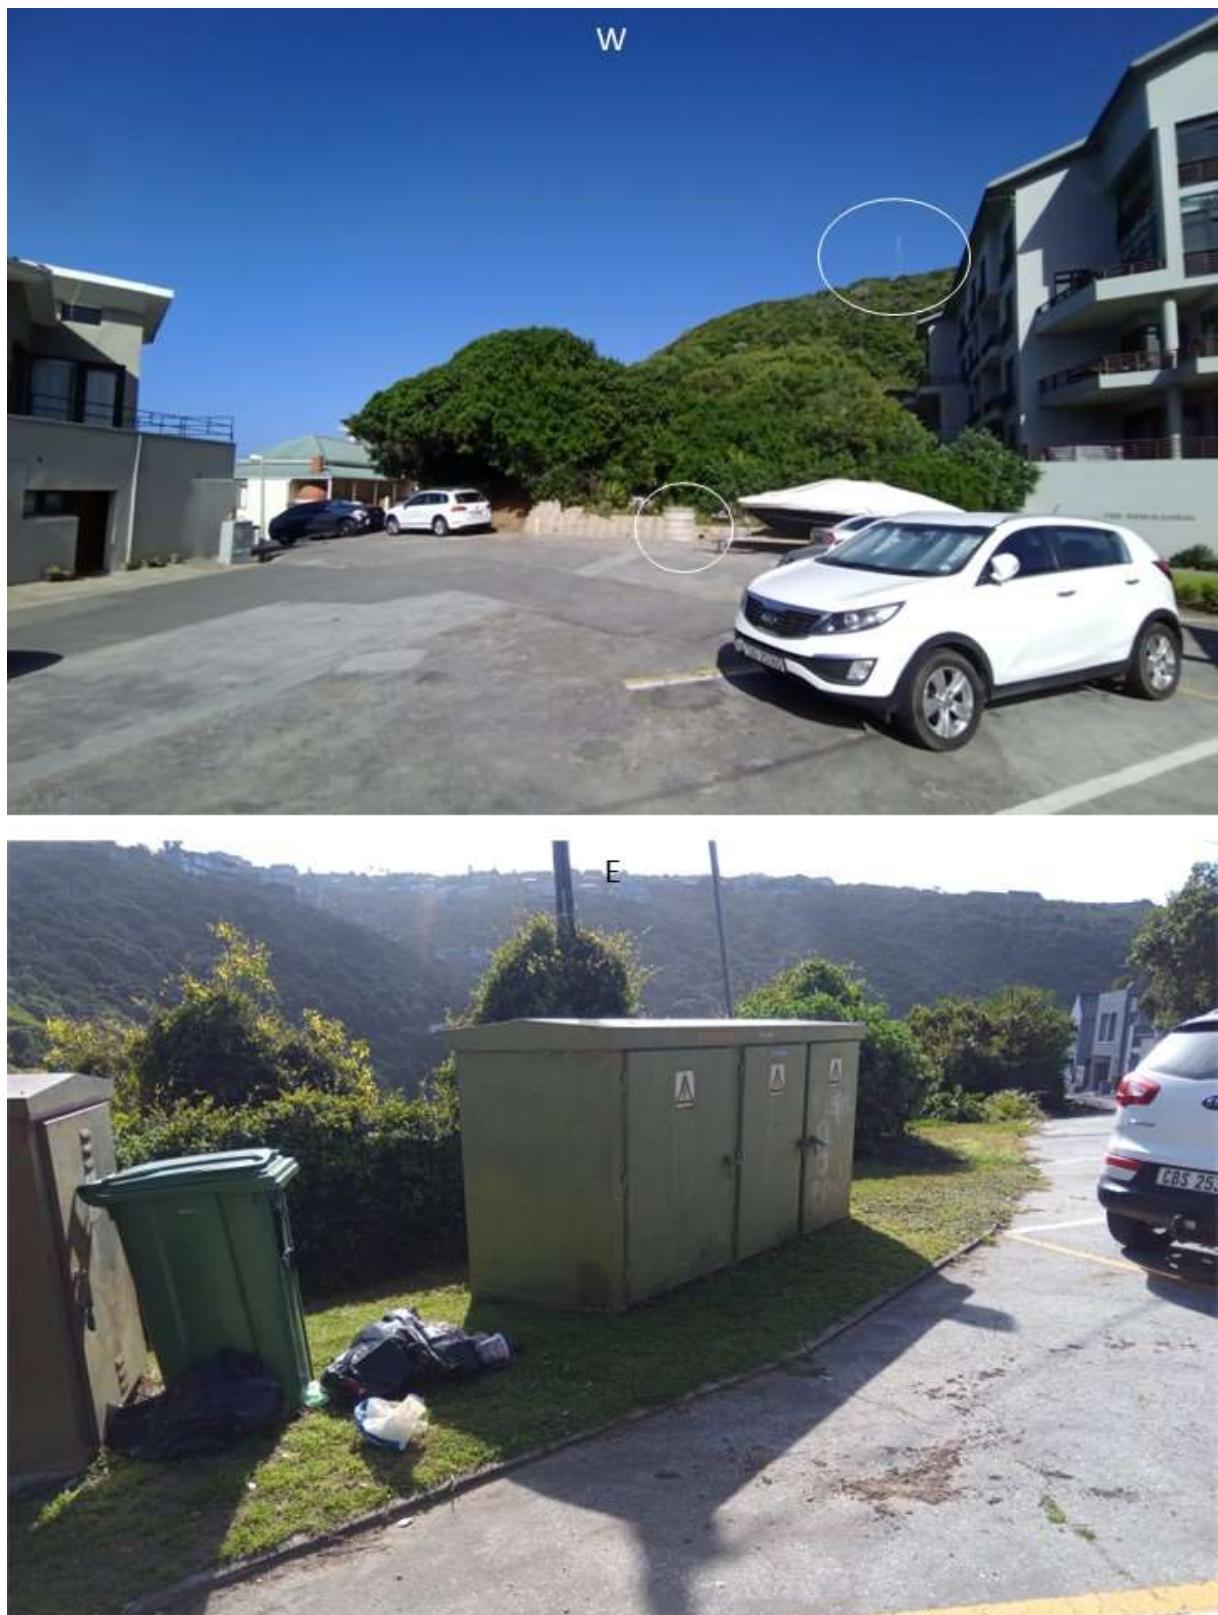
Figure 18. Top end of Spekie Gericke Drive showing manhole and telecommunications mast (white ellipses) and existing developments along sewer pipeline route.

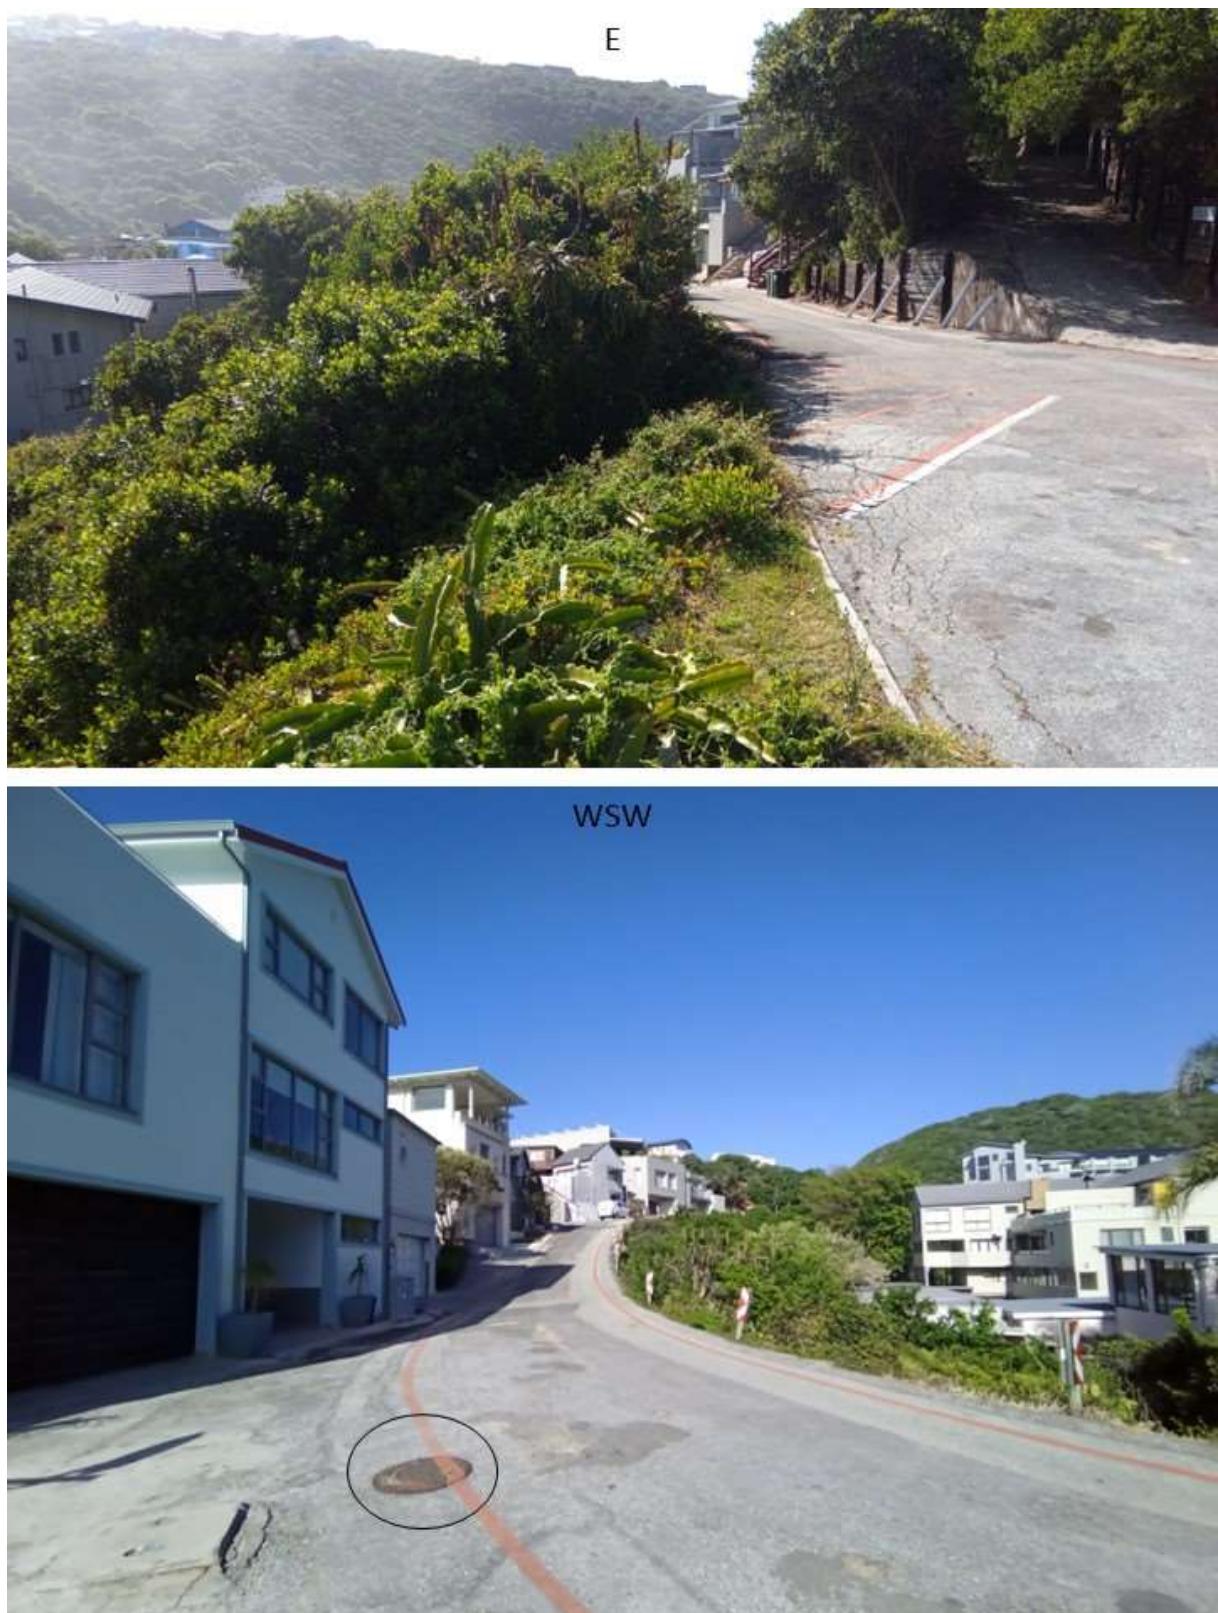
Figure 19. Looking down (top) and up (bottom) Spekie Gericke Drive and along the existing sewer pipeline route. Note existing developments and bulk services infrastructure including a manhole (ellipse, bottom).

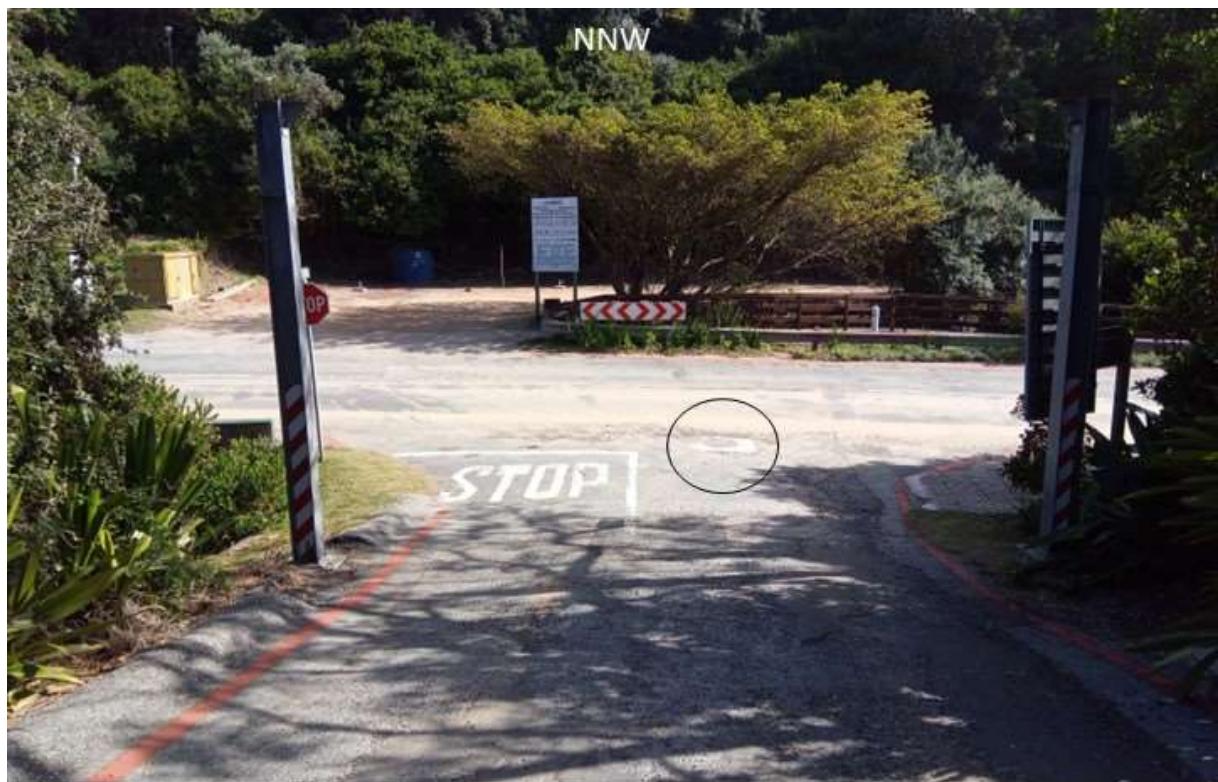
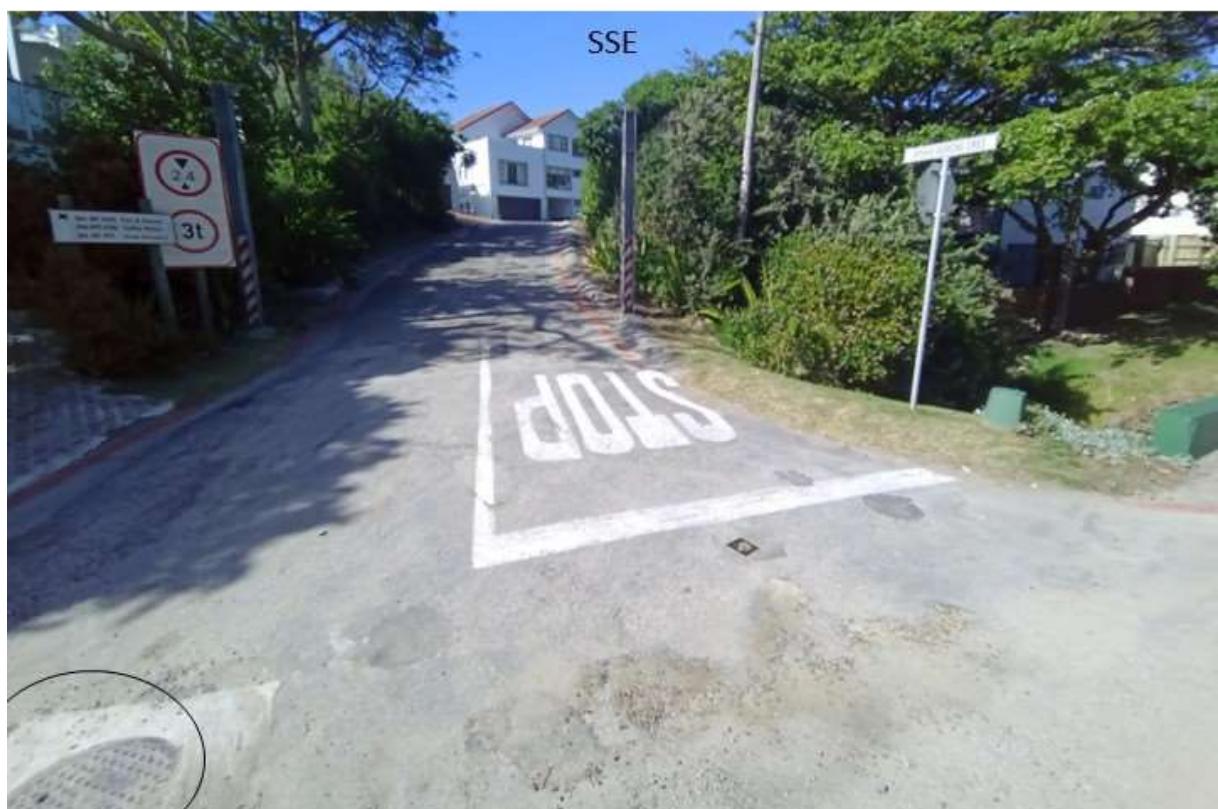
Figure 20. Intersection of Spekie Gericke Drive and Skimmelkranse Lane where the pipeline route turns to the east. Note existing developments and pipeline route (manholes in ellipses). The site for the new pump station on Erf 116 is north of Skimmelkranse Lane (top, see Figures 21 & 22).

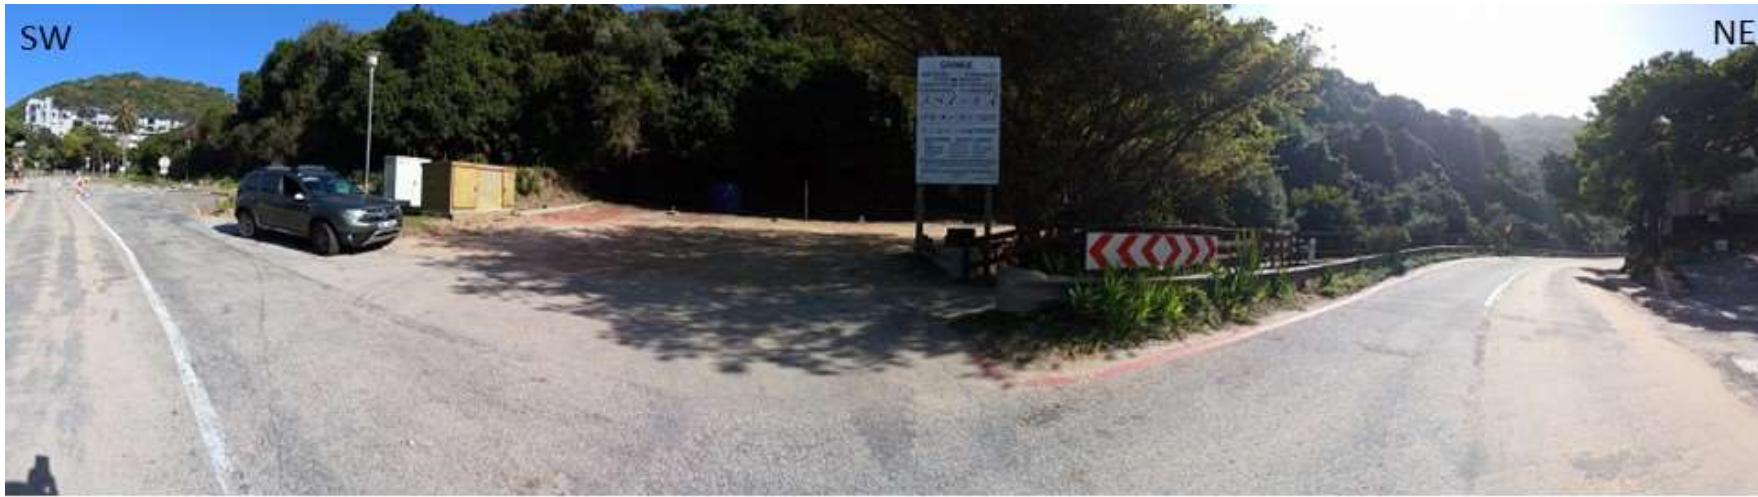
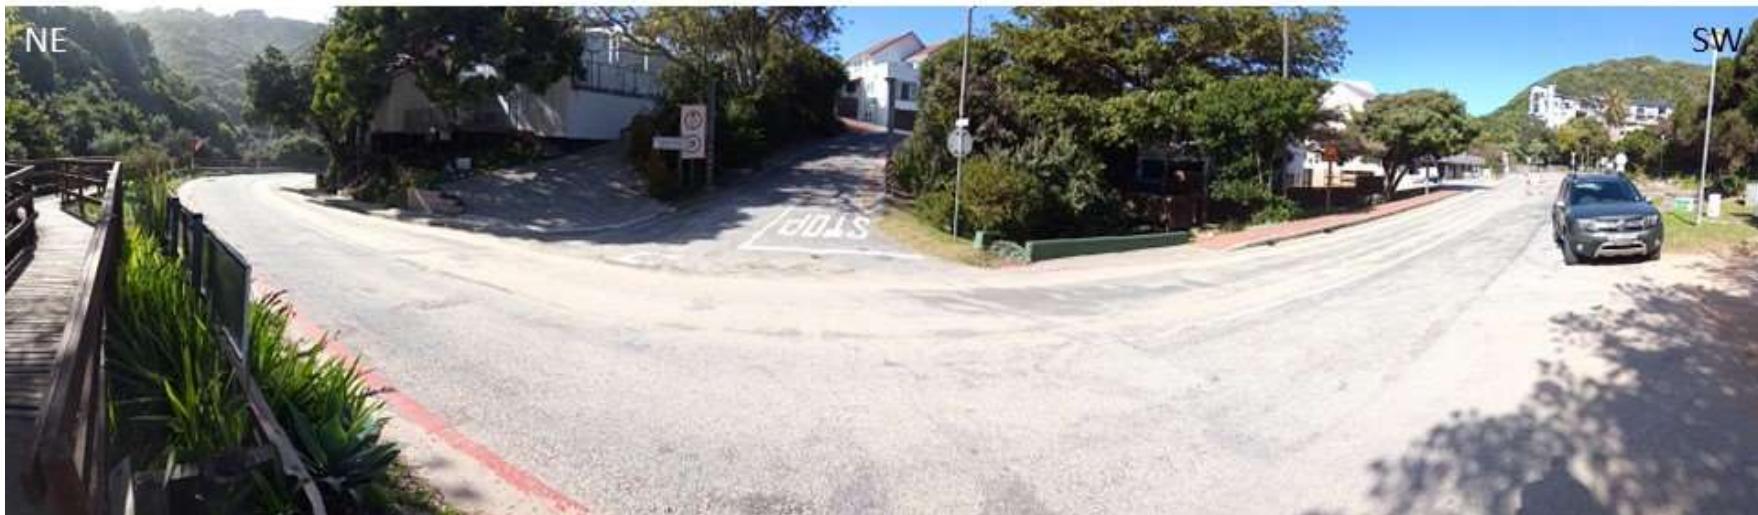
Figure 21. Panoramic views along Skimmelkraans Lane at the intersection with Spekie Gericke Drive. Erf 116 (site for new pump station – see Figure 22) is located in the middle of the top image and the bottom of Spekie Gericke Drive is in the middle of the bottom image. The sewer pipeline route turns right (top) and left (bottom) onto Skimmelkraans Lane towards Sandstrand Avenue.

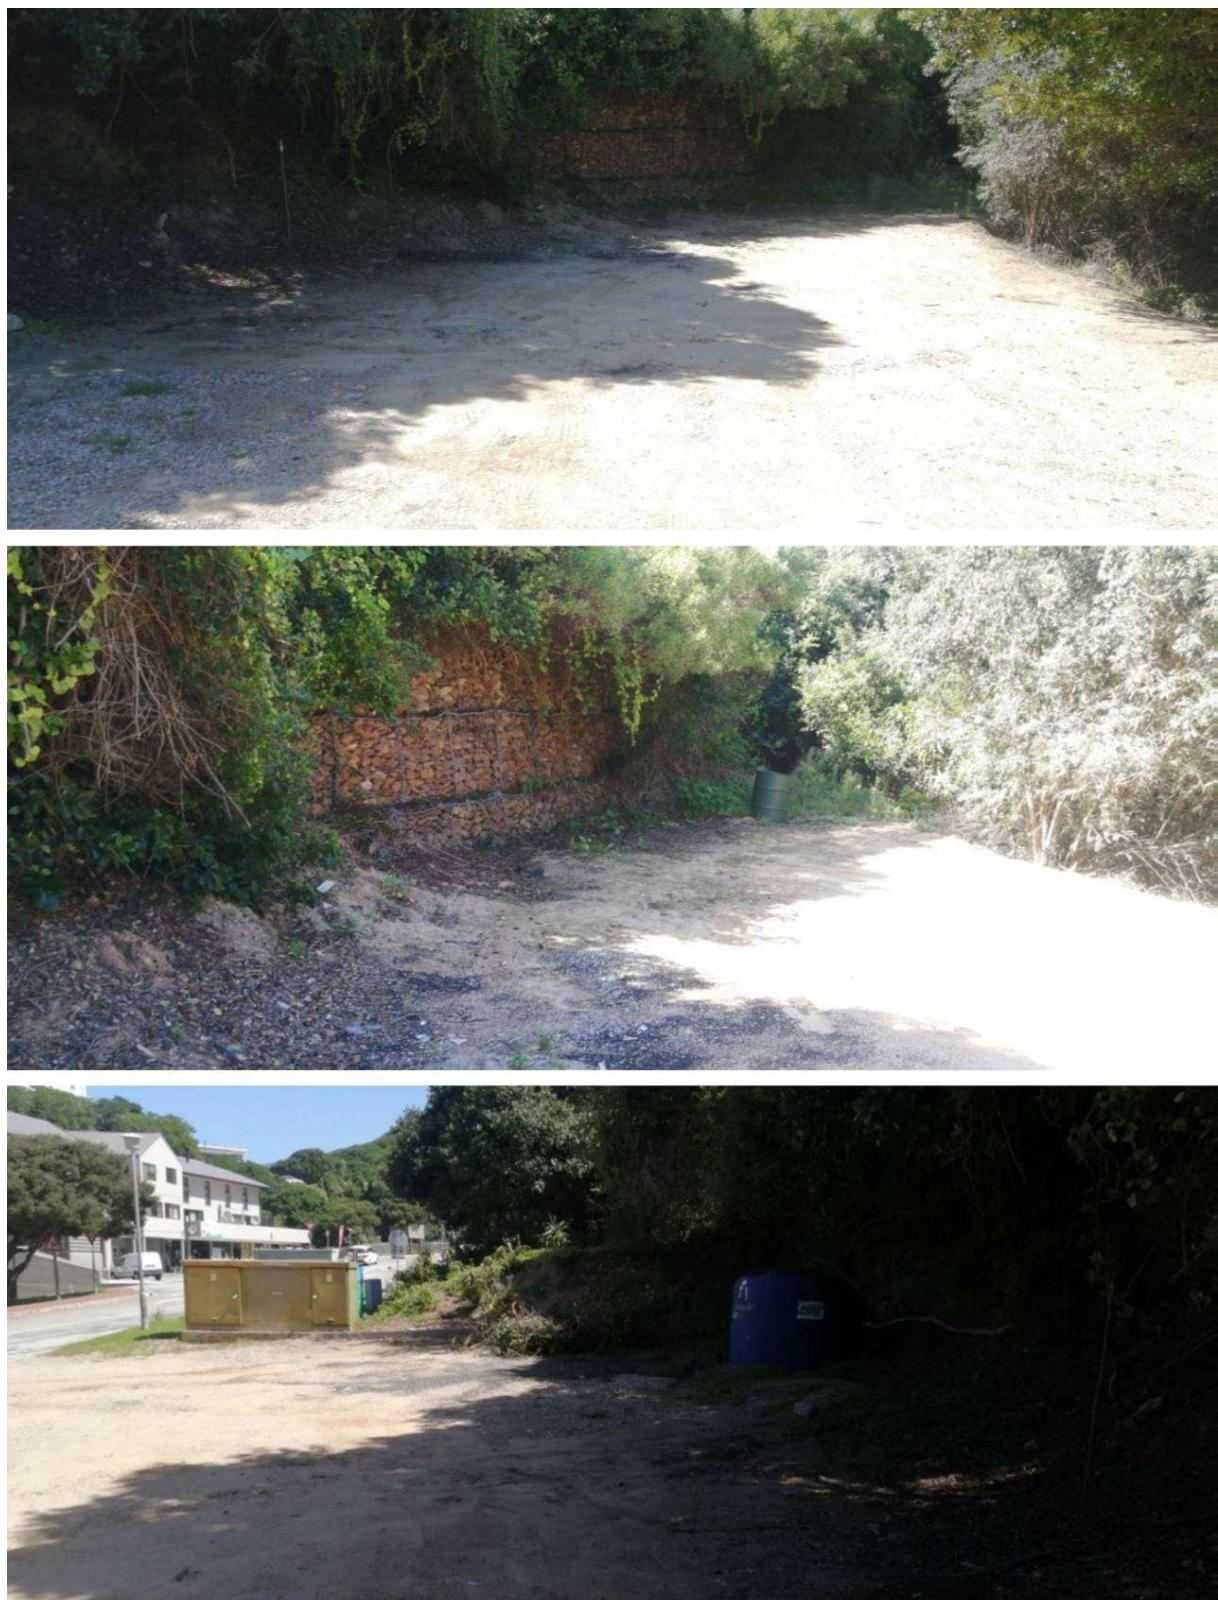
Figure 22. Proposed site for new pump station on Erf 116, Herold's Bay (after Bennet & Swanepoel 2023b, Pg. 8 & 9, Figures 9, 10 & 11). Note transformed state of property and existing developments and infrastructure.

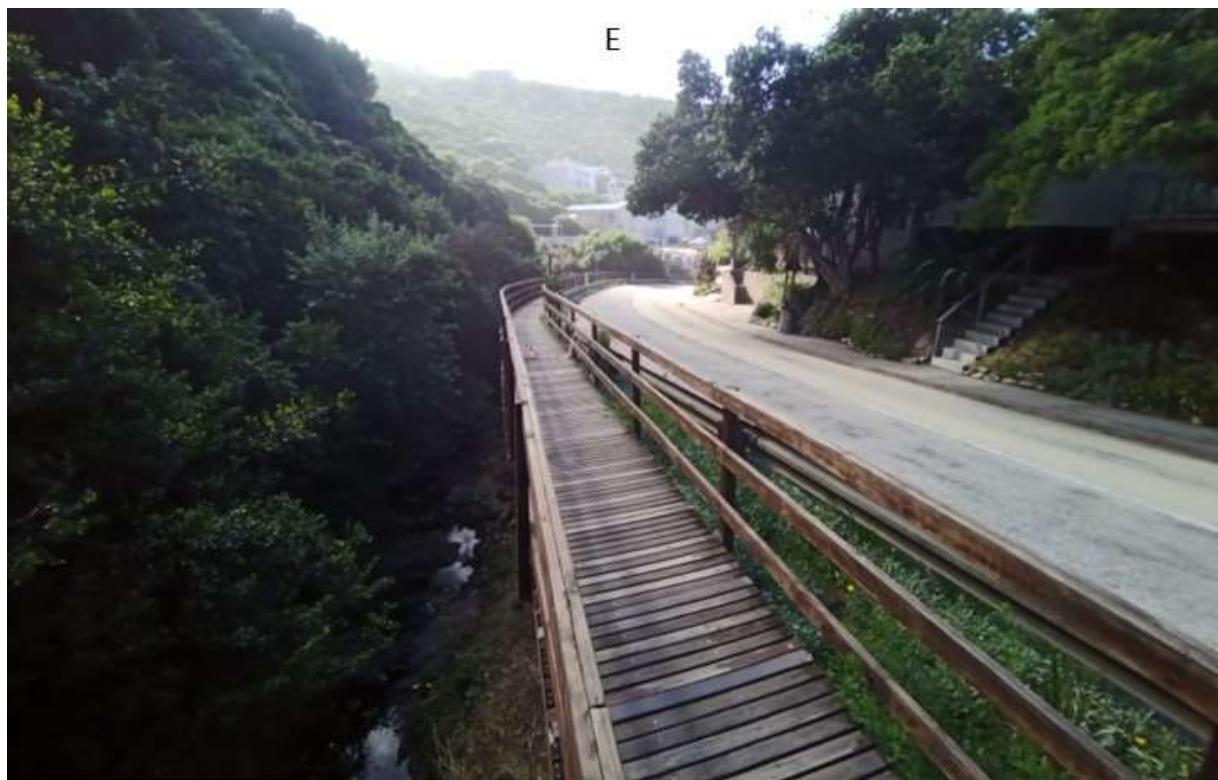
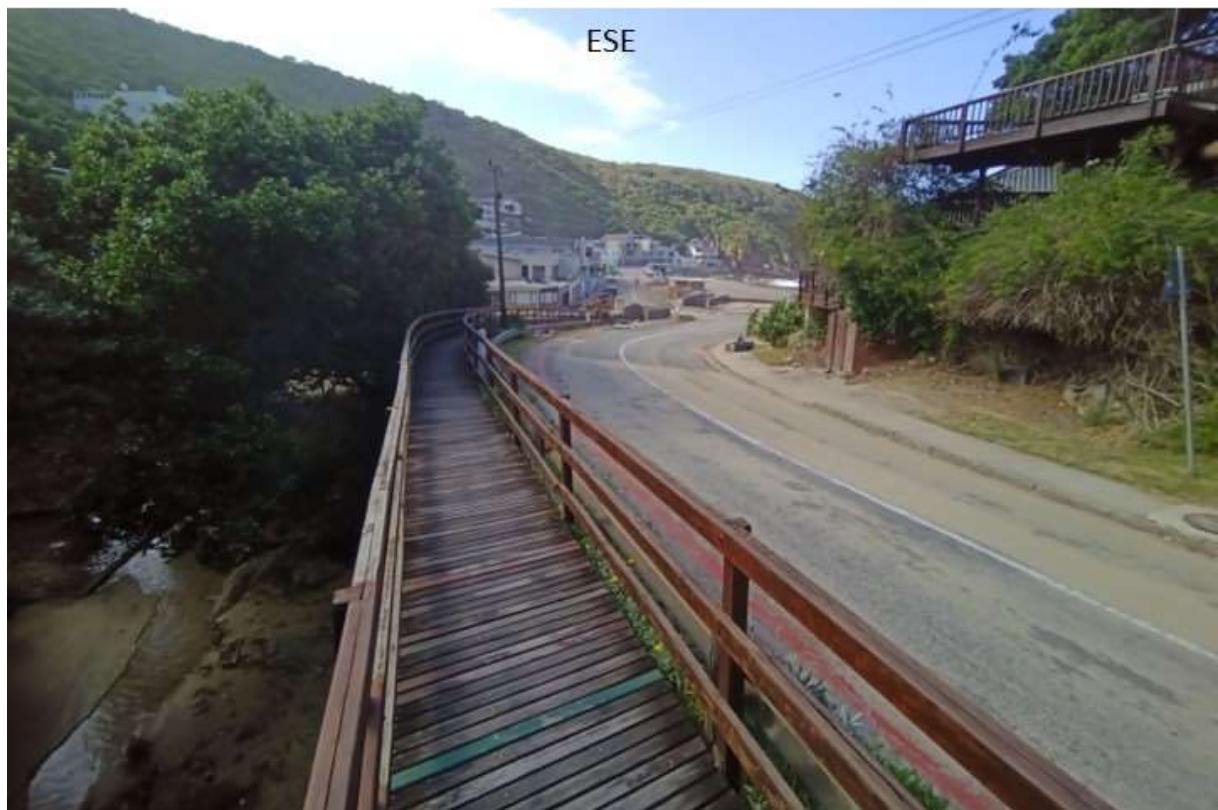
Figure 23. Views along Skimmelkrans Lane and existing sewer pipeline route. Note stream on left, existing developments and Sandstrand Avenue with existing pump station as well as Herold's Bay beach visible in the distance (bottom).

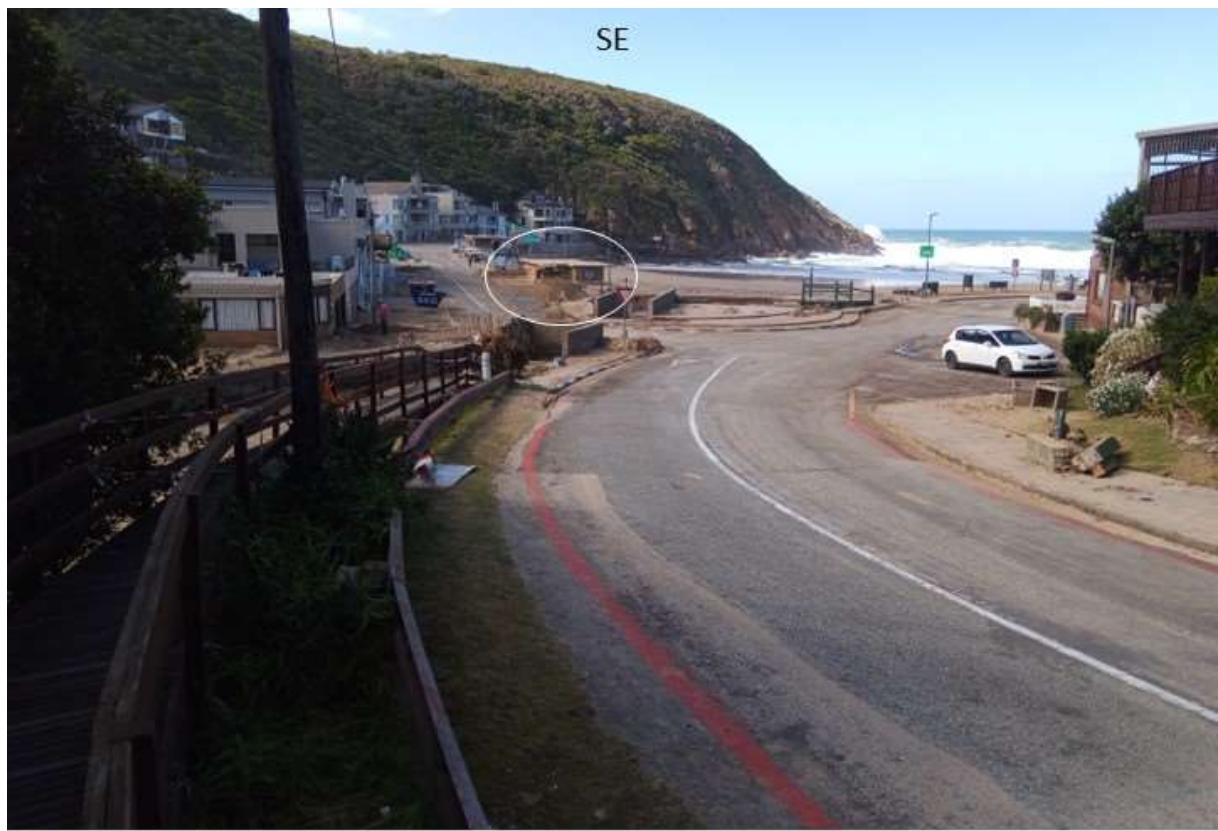
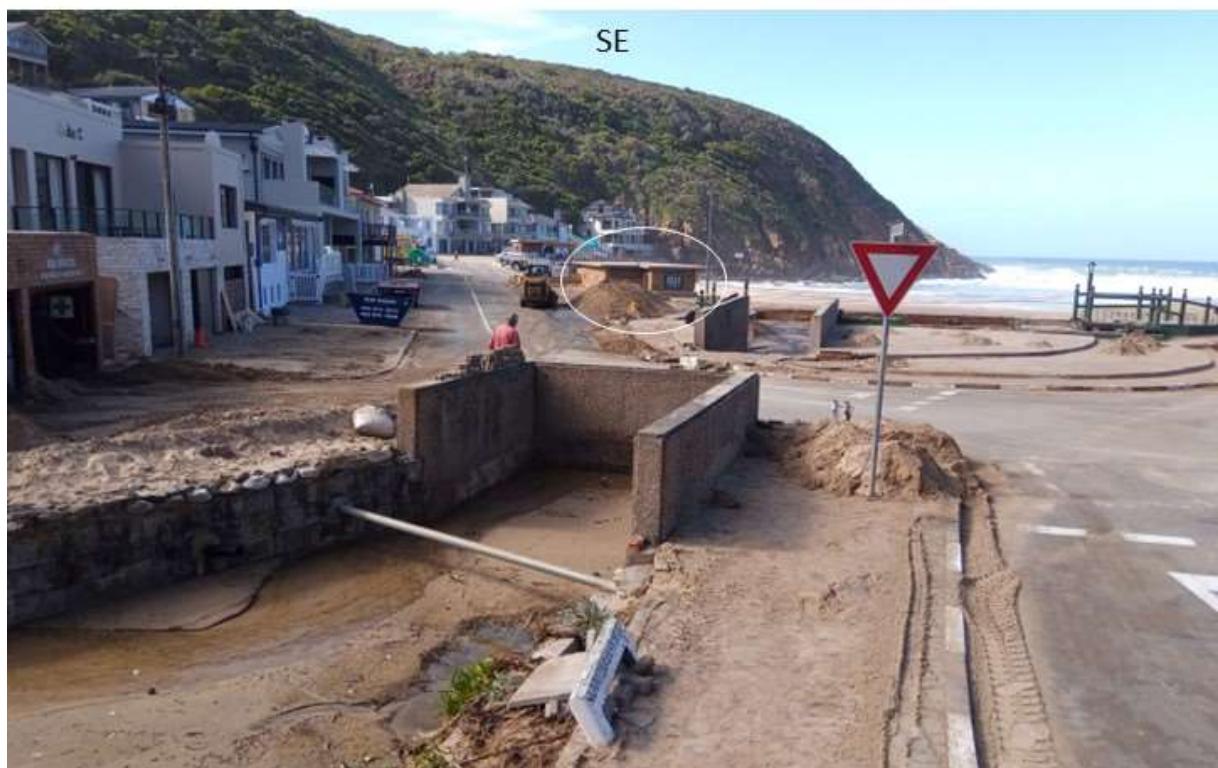
Figure 24. Views along Skimmelkrans Lane, Sandstrand Avenue and existing sewer pipeline route with pump station in white ellipse.

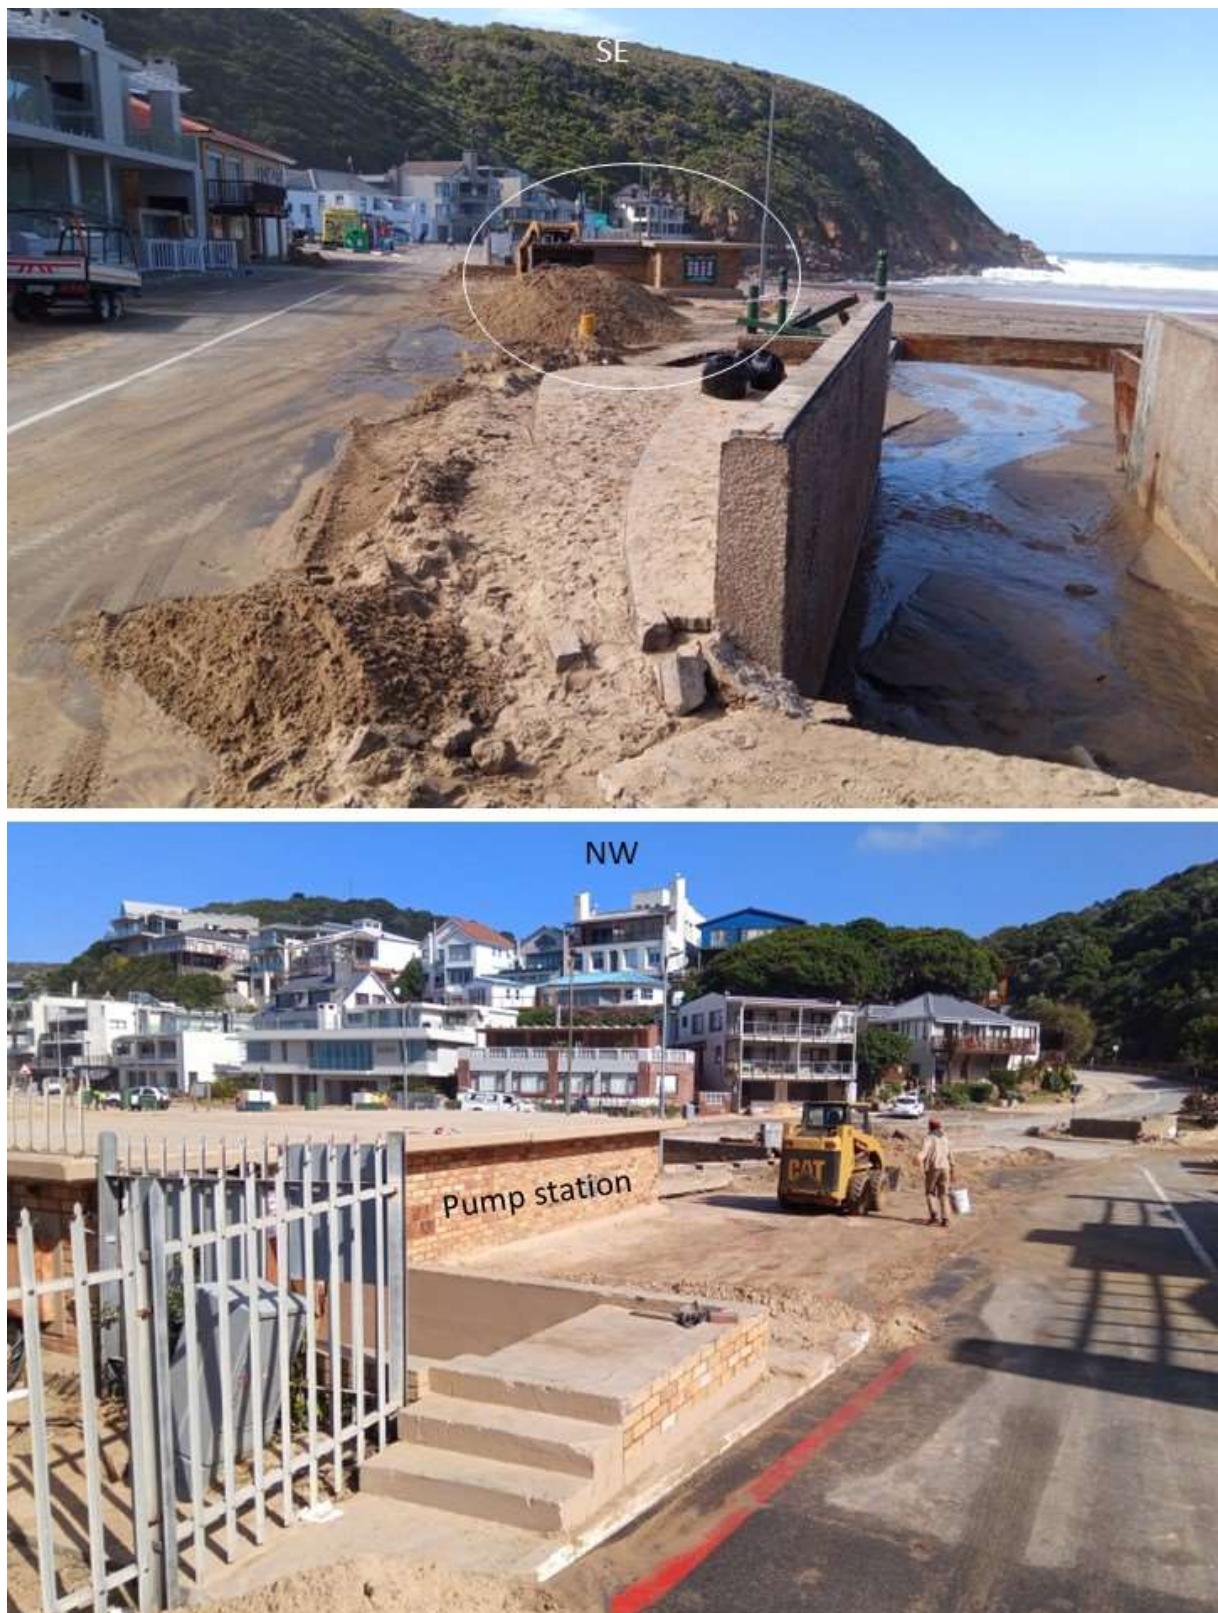
Figure 25. Eastern endpoint at existing pump station SW of Sandstrand Avenue. Existing pipeline route joins Skimmelkrans Lane, visible at right in bottom image. Note clean-up in process after storm & ocean surges on 16 & 17 September 2023.

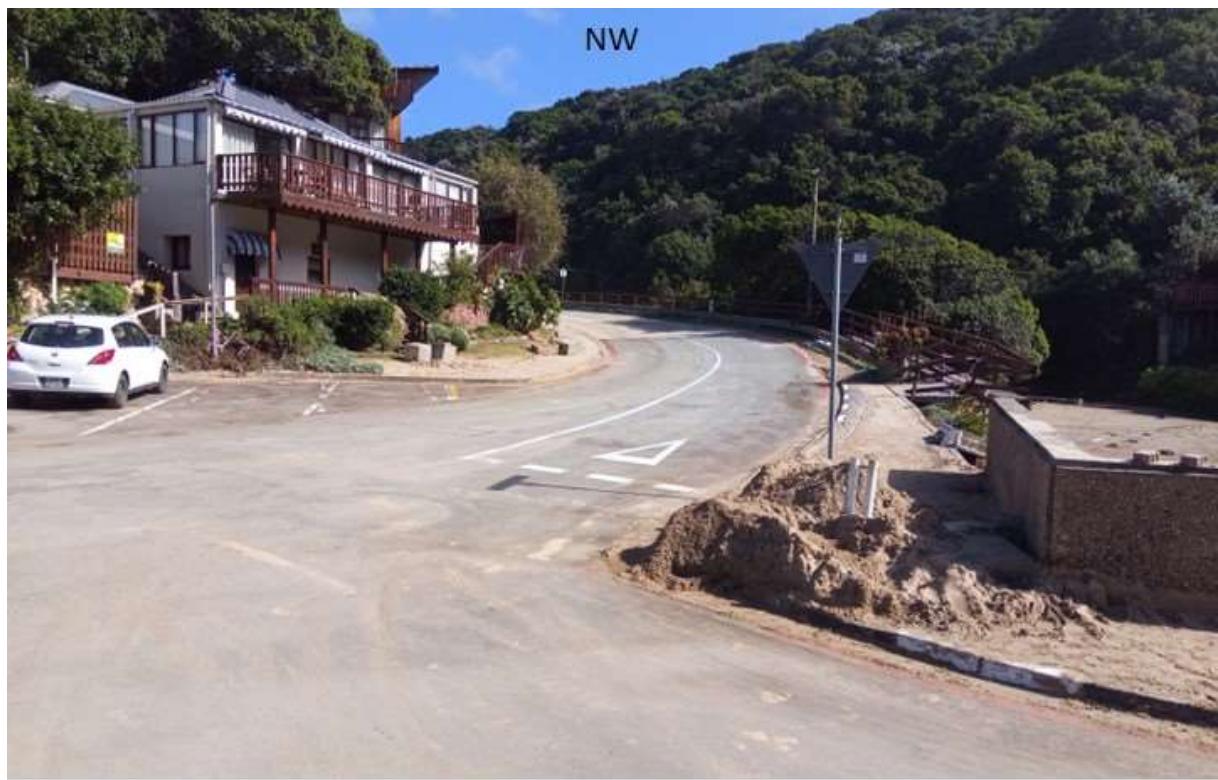
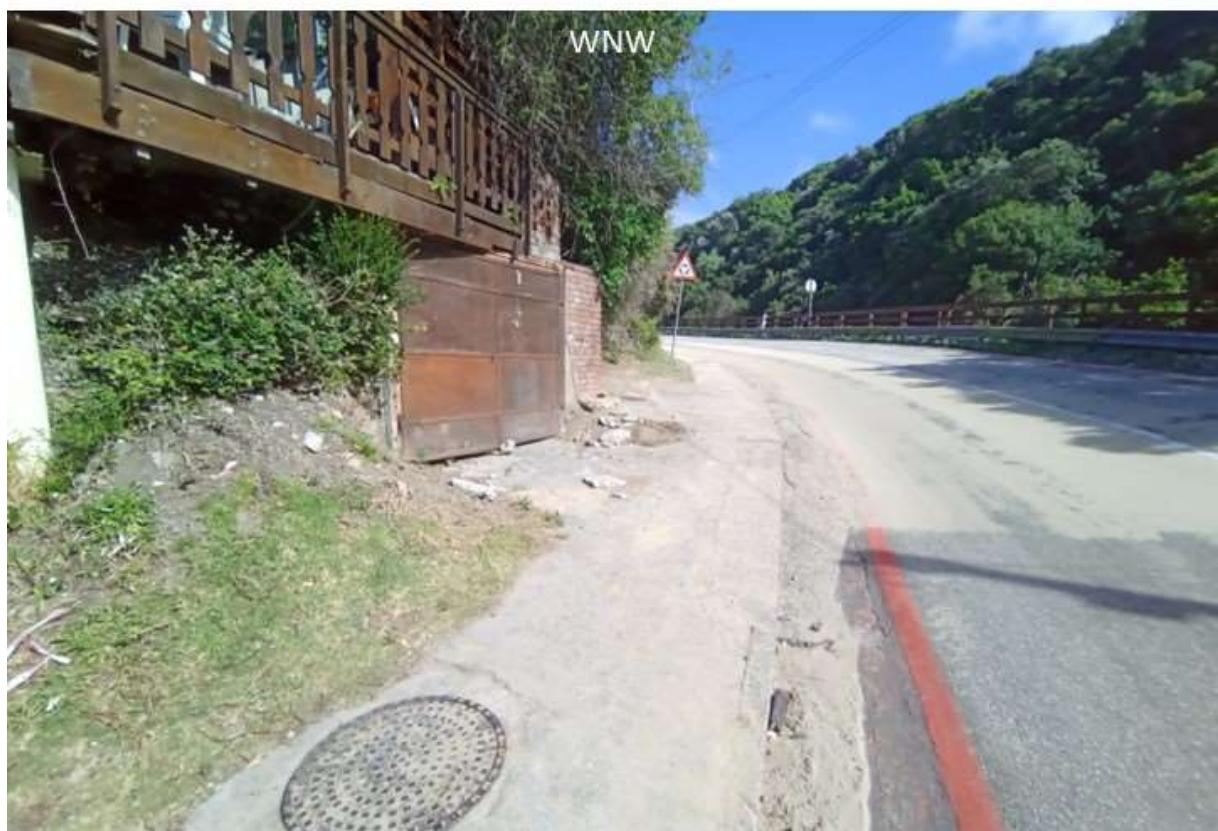
Figure 26. Intersection of Skimmelkrans Lane and Sandstrand Avenue along the existing sewer pipeline route (top). Pipeline route along Skimmelkrans Lane with manhole (bottom).
