# Heritage Statement

## **The Proposed Upgrading of the Herold's Bay Pump Station and Associated Rising Main as well as the Development of New Associated Infrastructure, Herold's Bay, George Municipality, Western Cape Province**

8 October 2023 – Revised 9 April 2024

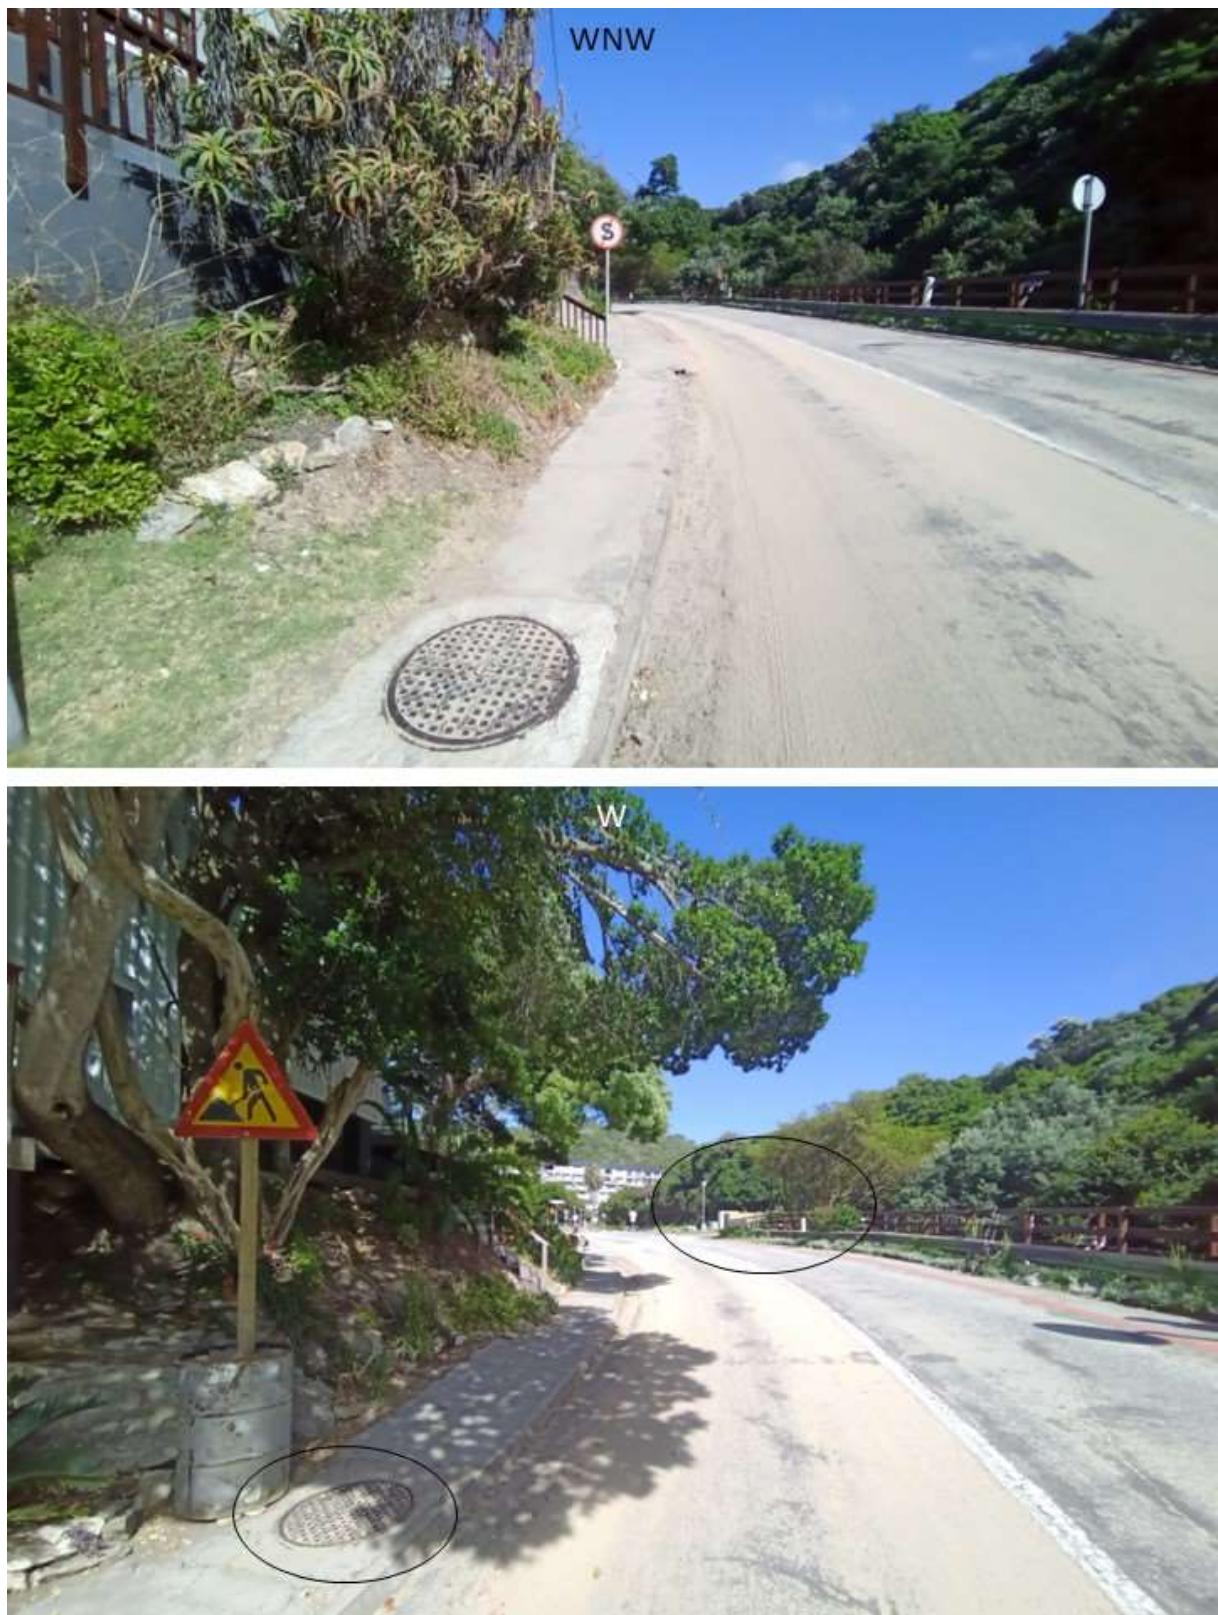
Figure 27. Pipeline route along Skimmelkrans Lane with manholes visible, and the location of Erf 116 – site for new pump station – is indicated with the top black ellipse (bottom image).

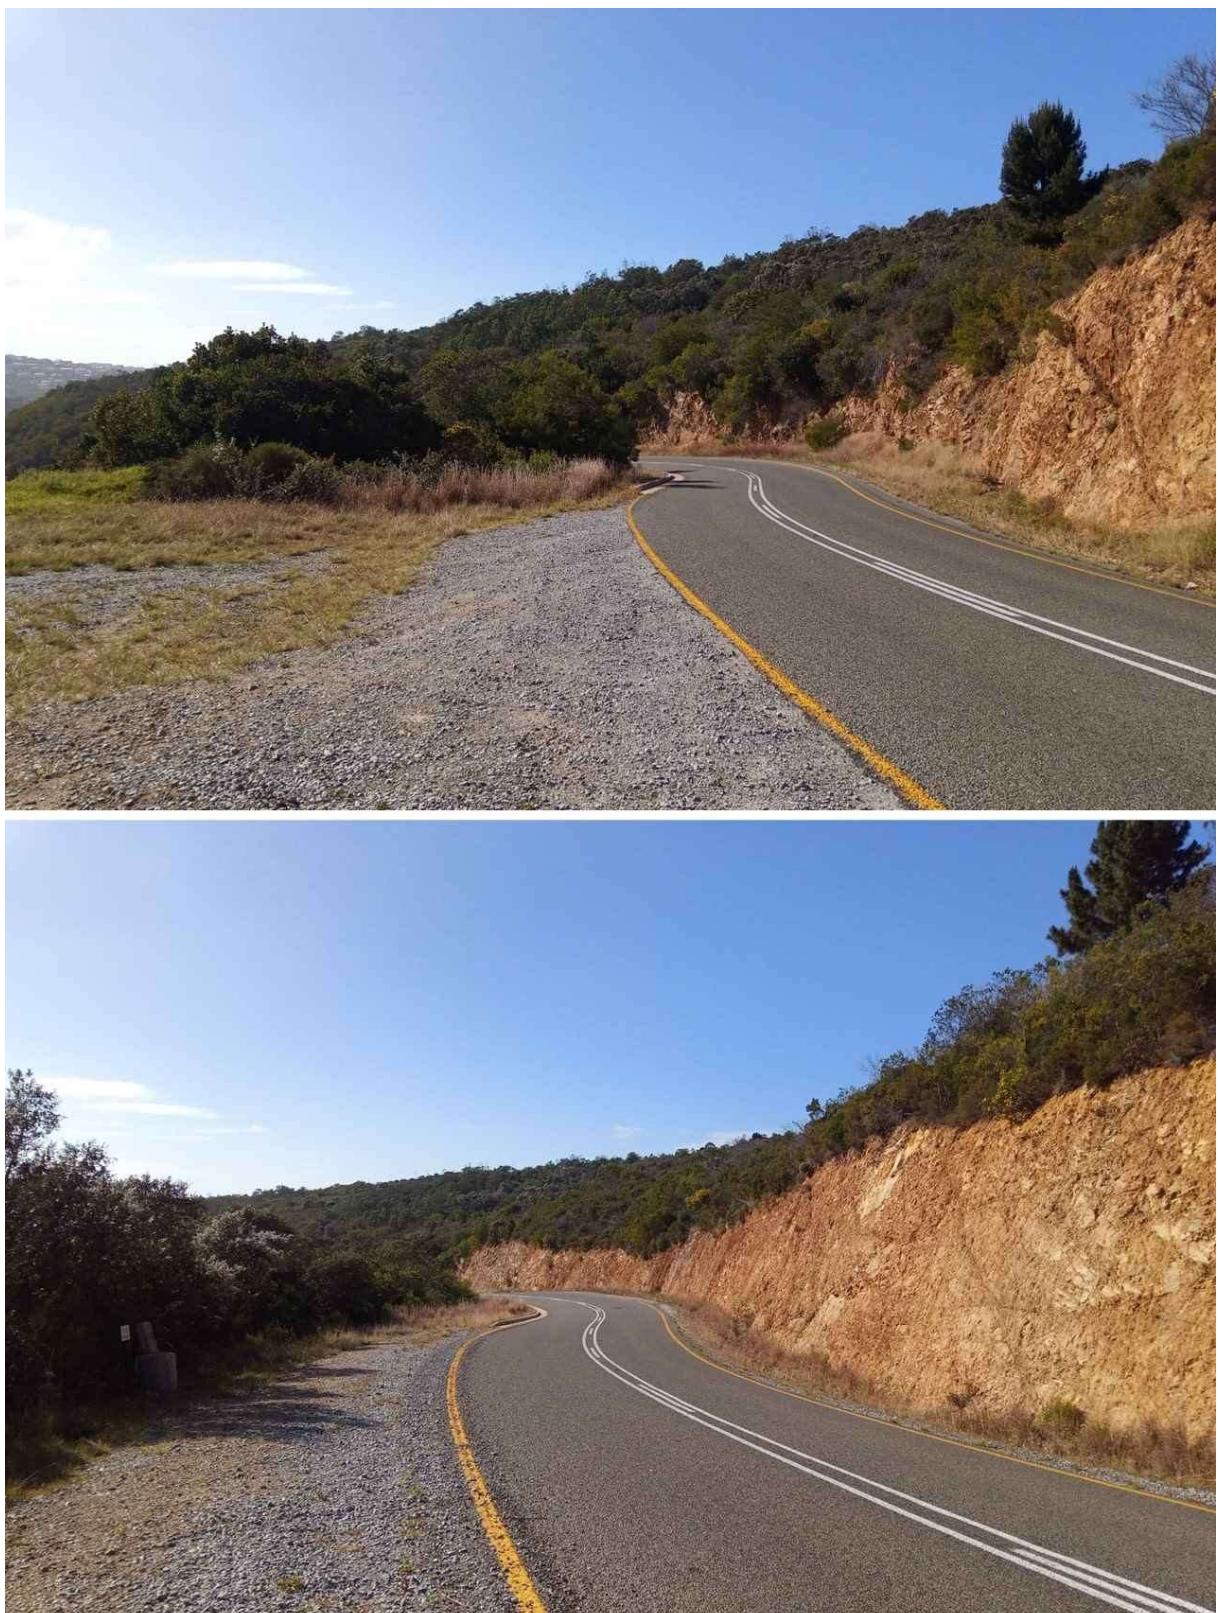
Figure 28. South-Easterly views from the R404 towards the pipeline route running along the top and seaward side of the ridge. Note that the Herold's Bay WWTW is visible from further west along the R404, but that all new additions to the sewer infrastructure in this area will be sub-surface and not visible. The high lying part of Herold's Bay / Dutton's Cove is visible on the left in top image.

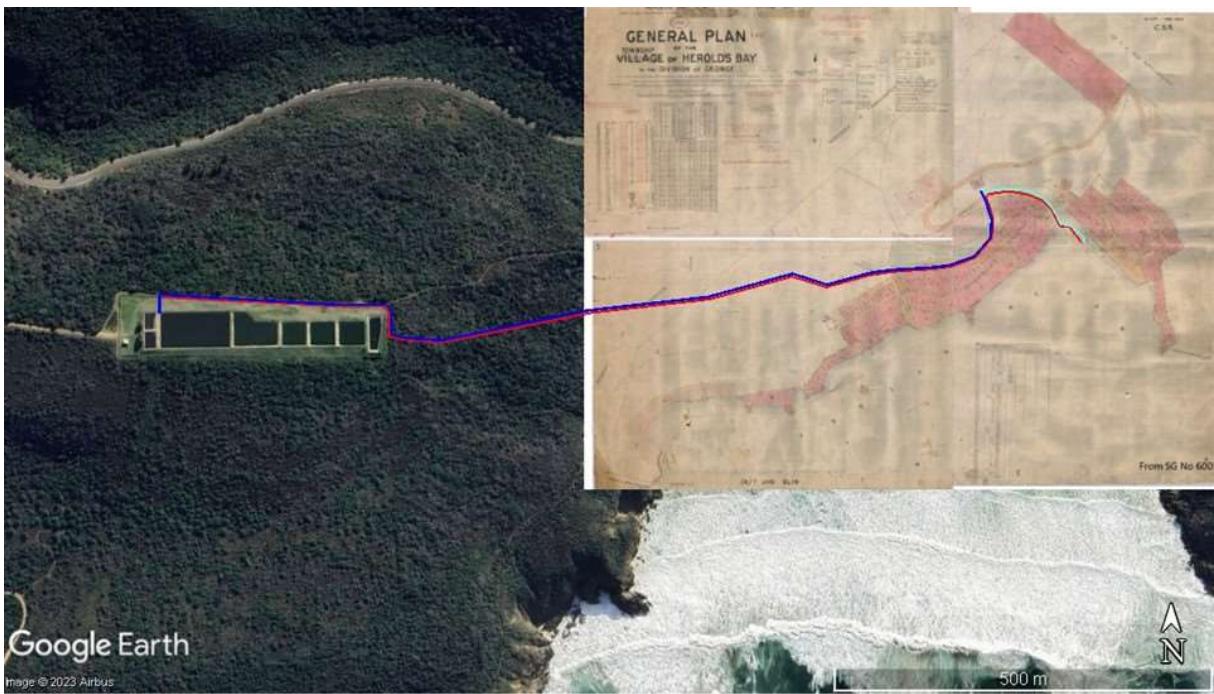
Figure 39. Affected area with SG Diagram 6005/1927 or GP 4178 showing location of proposed development footprint (coloured lines).

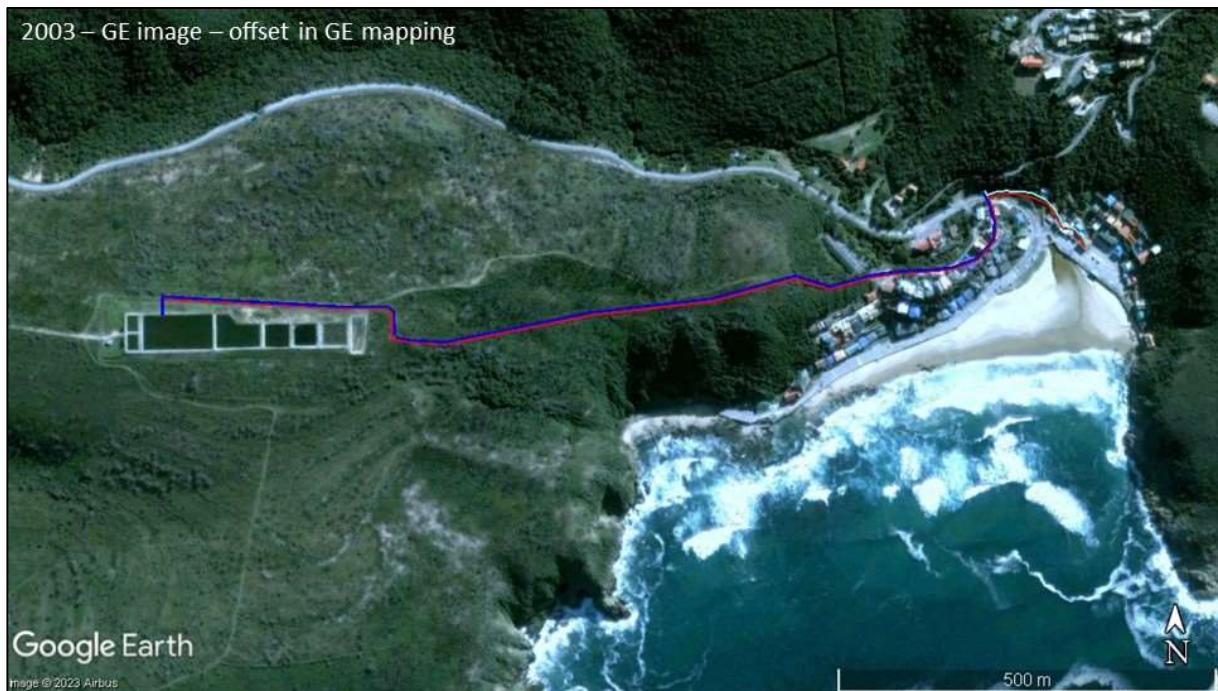
Figure 43. Due to poor quality of historical aerial photographs, the 2003 (top) and 2006 (bottom) are Google Earth images with proposed development footprint (coloured lines). The offset and alignment error seen in 2003 is a Google Earth mapping error. Note “fresh looking” disturbance and exposed ground along sewer pipeline route in 2006.

Unfortunately, the 1936 and 1939 flight/aerial surveys do not cover the study area or Herold's Bay coastline. Aerial photographs shown in Figures 40 through 44 reveal that colonial period impacts and developments are already evident by 1957 – actually begins in late 1800s and early 1900s (De Kock 2016) - and that further developments including the Herold's Bay WWTW and associated sewer pipelines to and along the roads in town are in place by at least 1980 (Figure 42). Although colonial period structures such as the Stella Maris Chapel are older than 60 years and are protected by the NHRA (De Kock 2016), no structures are threatened or will be impacted by the proposed development activities.

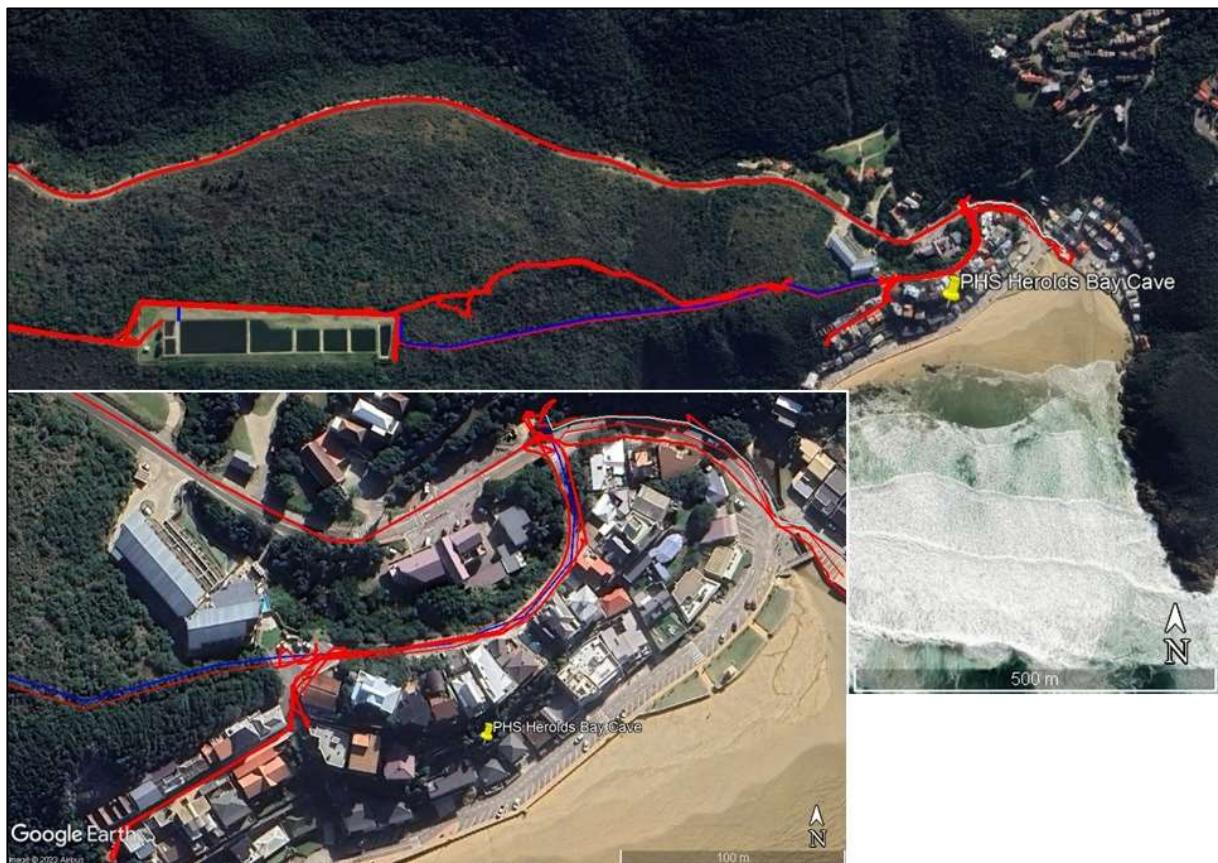
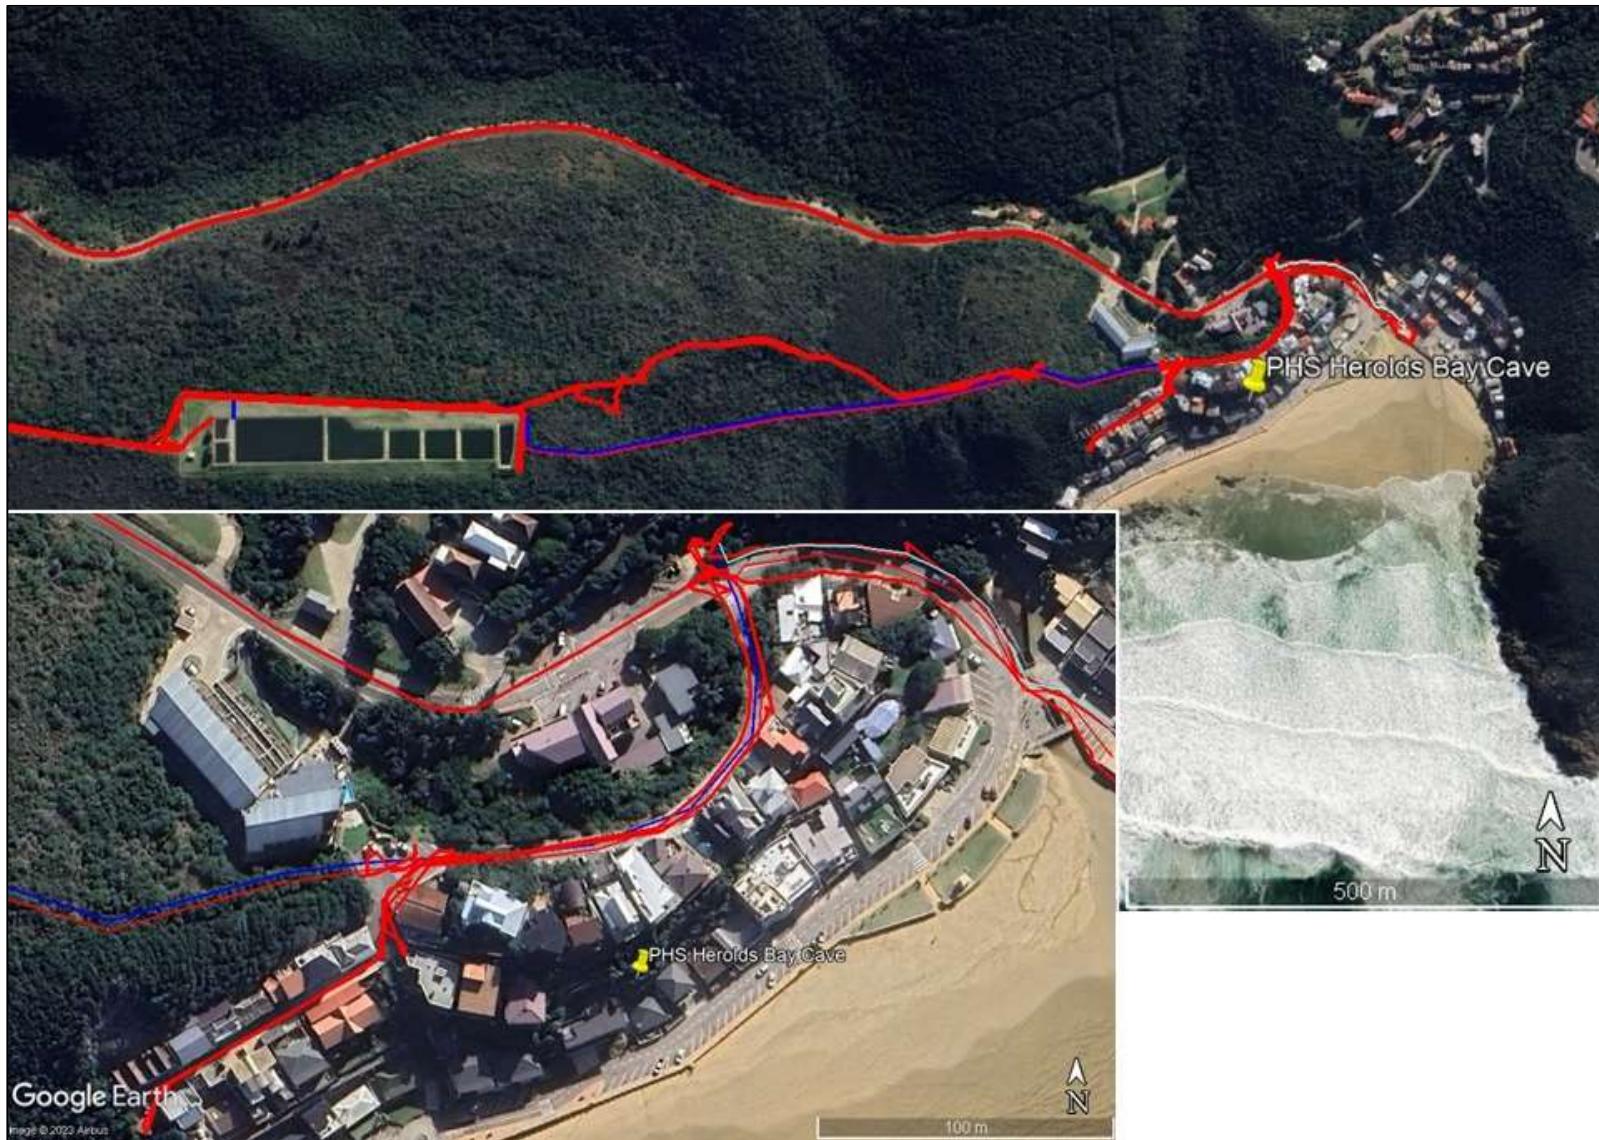
Figure 45: Study area with GPS-fixed survey tracks (red lines). Note stretches along the pipeline route that could not be accessed due to impenetrable vegetation. Inset enlarged to show more detail in Herold's Bay. The Provincial Heritage Site of Herold's Bay Cave on Erf 51 is indicated with the labelled yellow marker. (A4 version below)

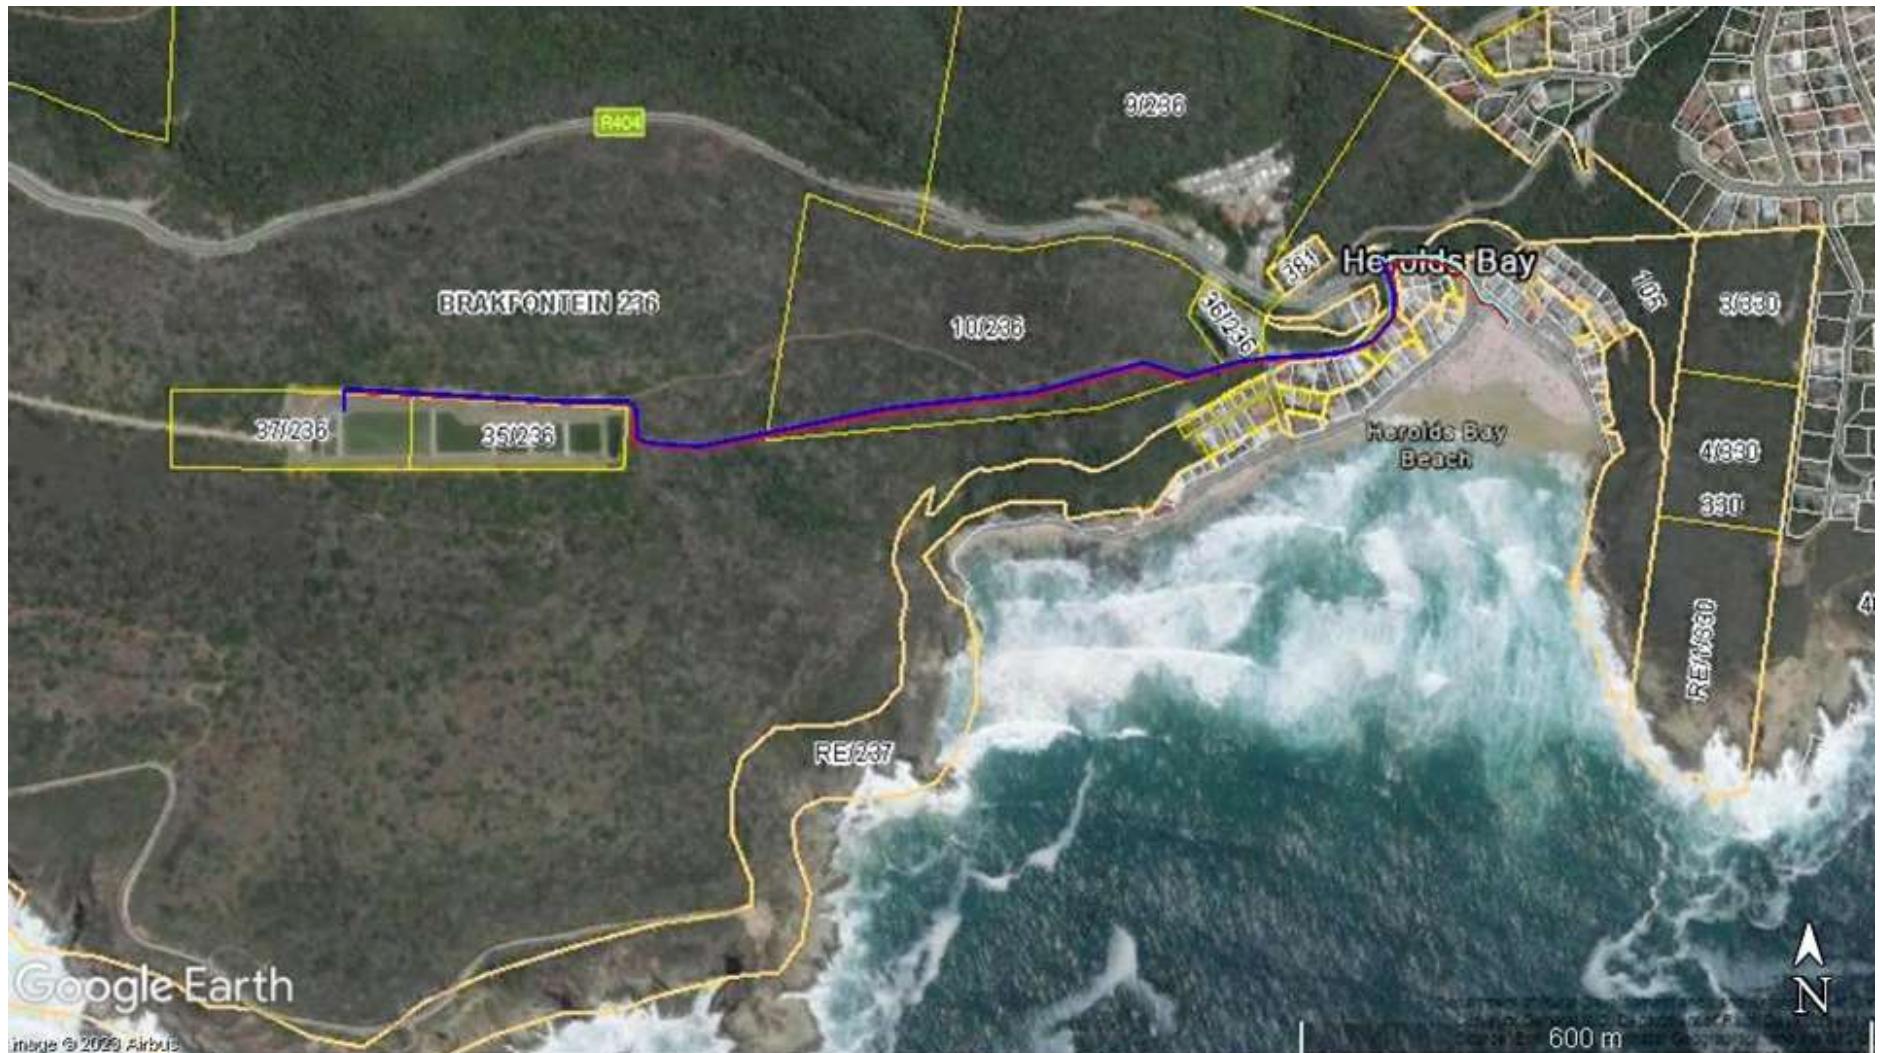
Figure 3. Area enlarged from Figure 1 showing study area (coloured lines), properties and developments. Courtesy of Cape Farm Mapper and Google Earth 2023.

Properties traversed by the activity include Farm 37/236 Brakfontein, Farm 35/236 Brakfontein, RE Farm 236 Brakfontein, Farm 10/236 Brakfontein, RE Farm 237, Erf 110, Spekie Gericke Drive, Erf 116, Erf RE/95 on Sandstrand Avenue, and Erf 113 (Figures 3 & 4 and see labelled markers in Figure 3 in Section D of the accompanying HWC NID application form).

Figures 3 & 4 above show the affected properties and existing developments along the route. Starting at the Herold's Bay WWTW, the linear route falls within the previously disturbed portions of 37/236, 35/236, RE236 and 10/236. Apart from the WWTW, overhead transmission line and a vehicle track leading to a telecommunications mast, this part of the site is heavily overgrown with a mixture of indigenous and exotic vegetation. The route follows the existing sewer pipeline down the steep slope from the telecommunications mast to the top of Spekie Gericke Drive on RE/237 and Erf 110. From here, the route follows existing roads and sewer infrastructure along Spekie Gericke Drive, Skimmelkrans Lane and Sandstrand Avenue where it ends at the existing pump station on Erf RE/95. The new pump station will be built on Erf 116, which is currently an undeveloped erf already transformed and used as an informal car park.

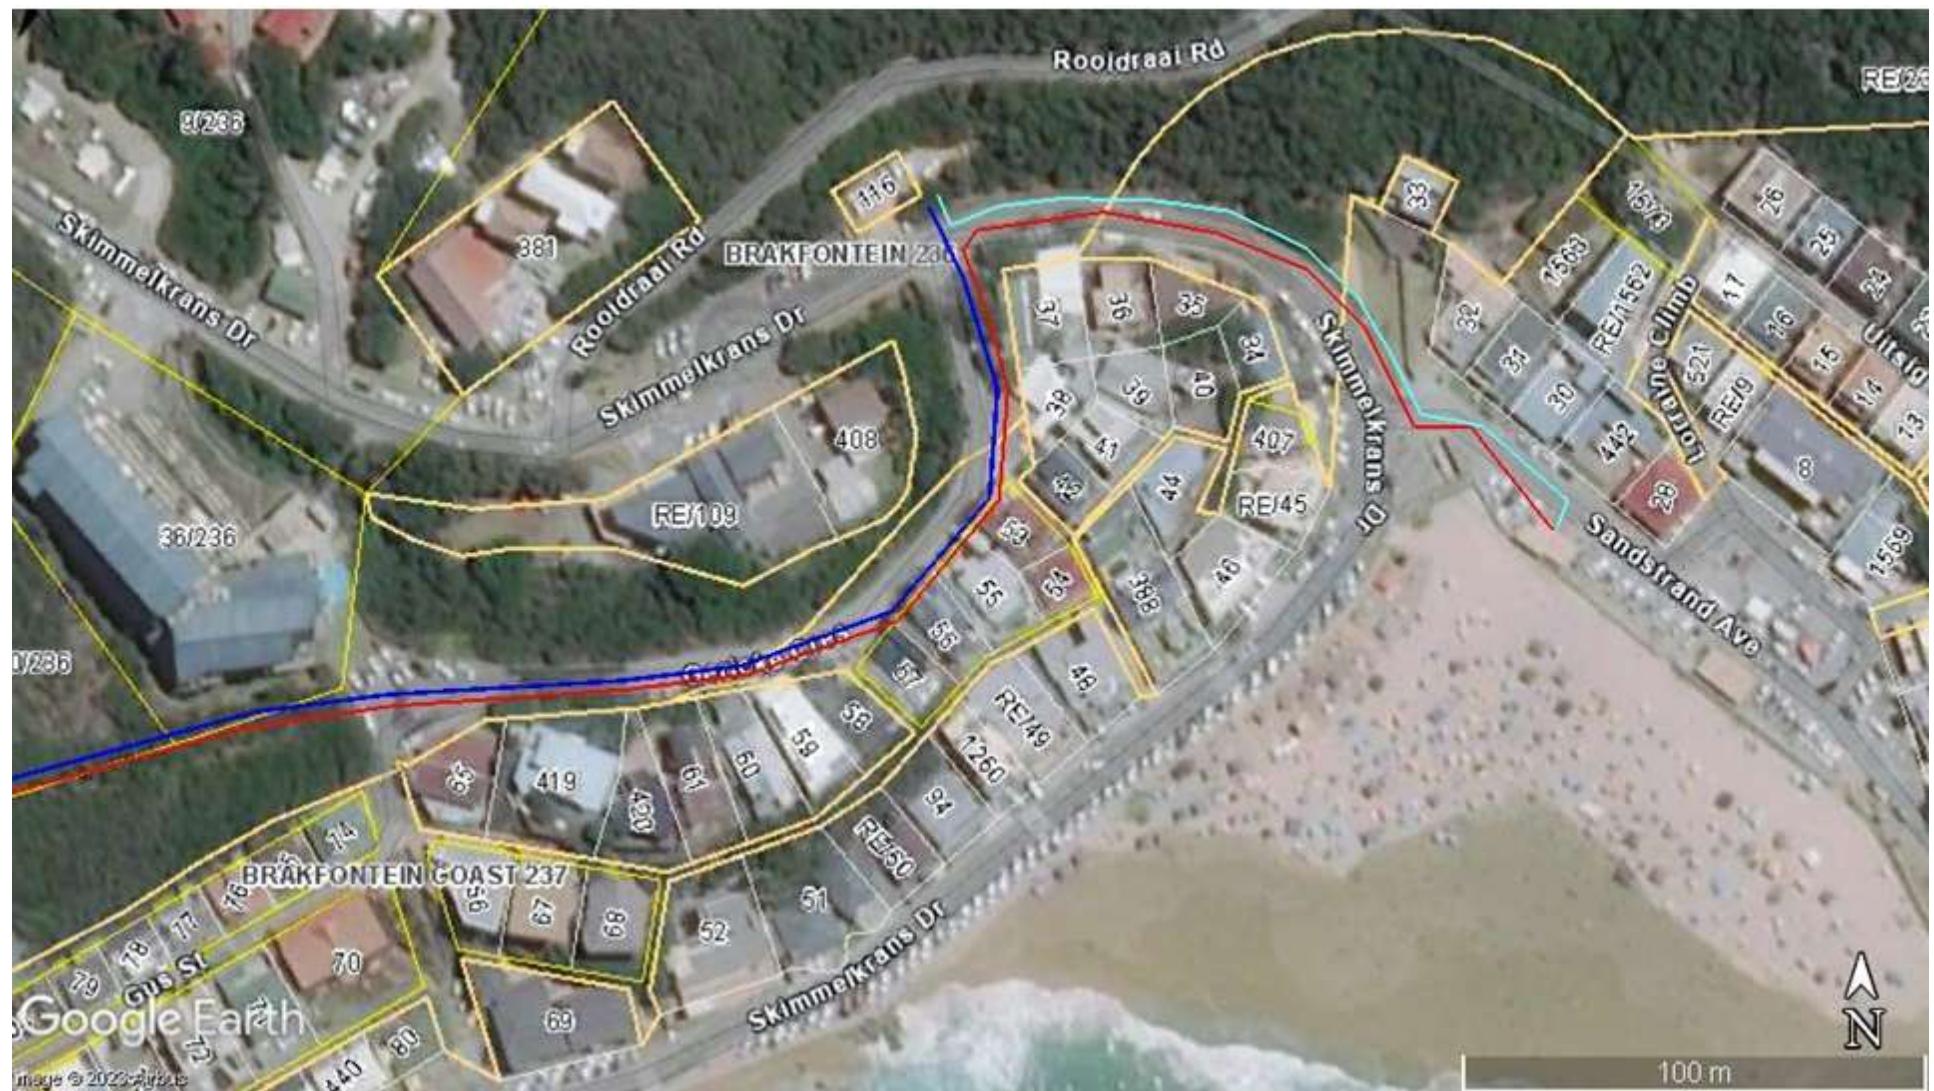
Figure 4. Area enlarged from Figure 3 the study area (coloured lines), properties and developments. Courtesy of Cape Farm Mapper and Google Earth 2023.
