# Maintenance of the Road TR03105 from Ladismith to Calitzdorp (km 0.9 to km 47.63), Western Cape

## Freshwater Assessment

**Prepared For:** Sharples Environmental Services  
**Author:** Dr. J.M. Dabrowski (PhD)  
Confluent Environmental Pty (Ltd)  
7 St. Johns Street,  
Dormehlsdrift,  
George, 6529  
**SACNASP:** Pr. Sci. Nat. (Water Resources) – 114084  
**Date:** 14 November 2025  
**Version:** Draft Final

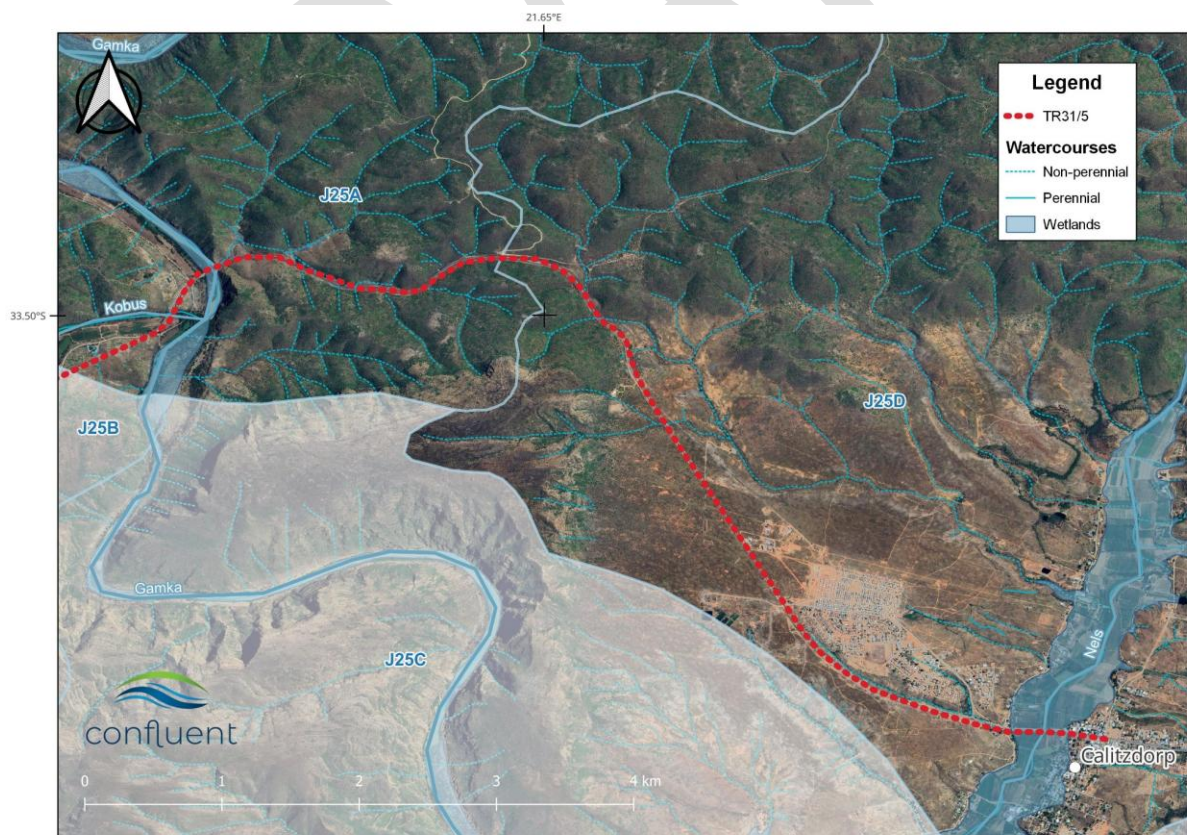
Figure 5: Mapped watercourses in quaternary catchments J25A and J25D.

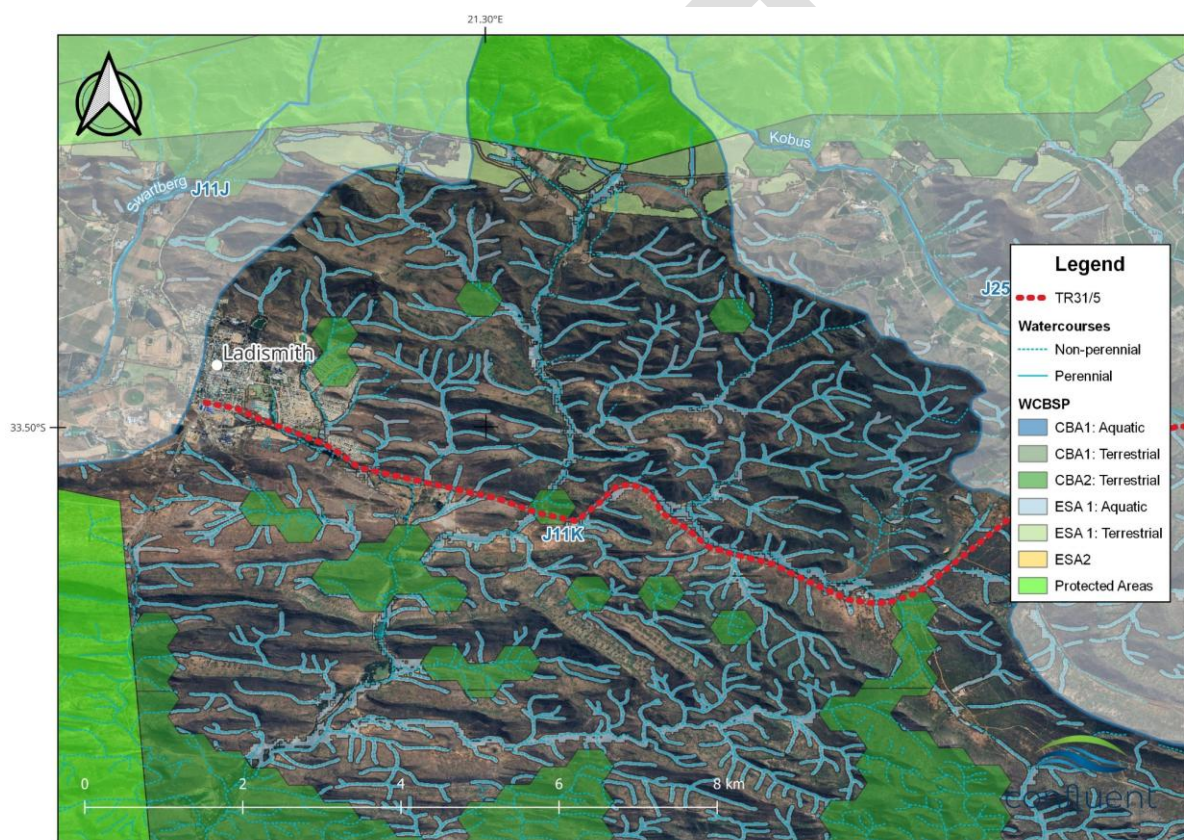
Figure 8: Map of the section of the Western Cape Biodiversity Spatial Plan (WCBSBP) in quaternary catchment J11K.

According to the WCBSP the major perennial rivers (Nels, Huis, Gamka and Nels (at Calitzdorp) crossed by the TR31/5 have been categorized as natural aquatic CBAs (Figure 8 to Figure 10). The Seweweekspoort River and all minor non-perennial rivers crossing the TR31/5 have been categorized as natural ESAs. The definitions and associated management objectives of these biodiversity features are described in Table 2. The management objectives for ESAs allow for some habitat loss provided that the ecological function of these watercourses is not compromised. Low impact activities within CBAs are considered acceptable. Maintenance of existing road infrastructure (including maintenance or extension of culverts) can therefore be considered as an acceptable activity within the context of these objectives.

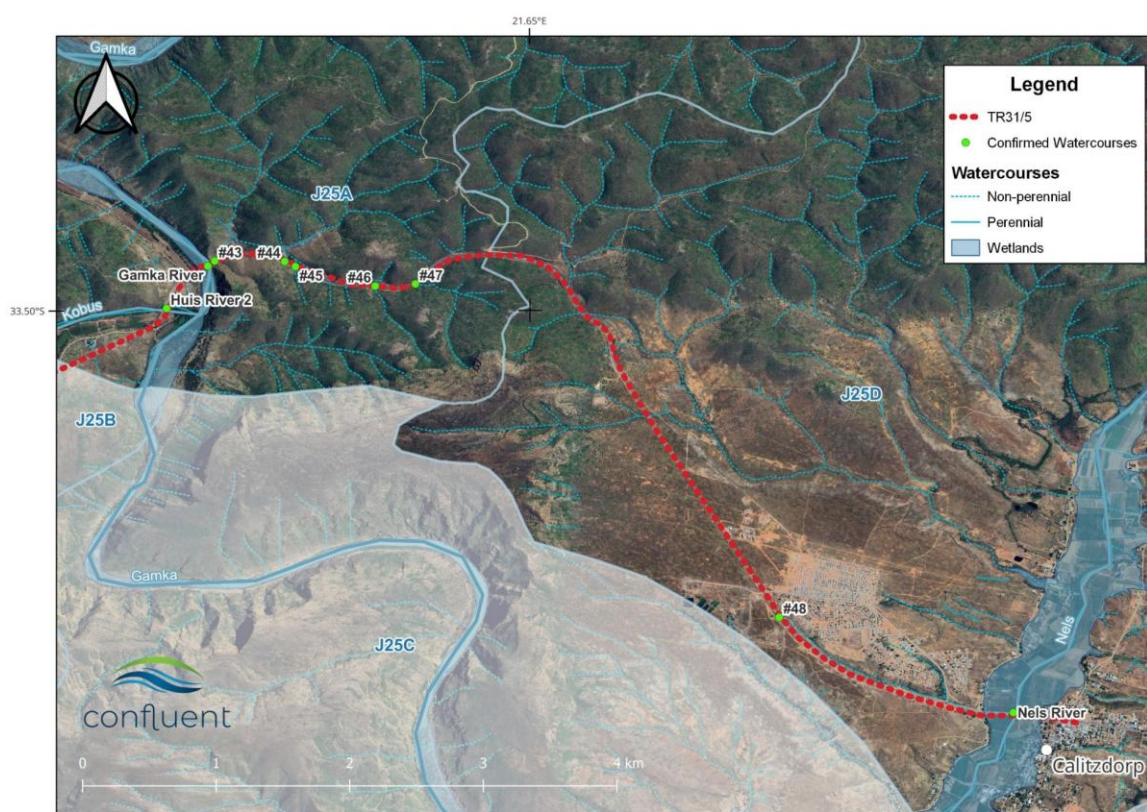
Figure 13: Confirmed watercourses in quaternaries J25A and J25D where maintenance of culverts or bridges could be required.

All watercourses identified in the field cross the TR31/5 road via formalised culverts and ultimately flow into the larger perennial systems draining each of the catchments. Some mapped first order watercourses had been filled in completely during the historical construction of the road and there was no culvert associated with the watercourse. These watercourses were not marked in Figure 11 to Figure 13 as no culvert maintenance would be required on these. Numerous culverts constructed for stormwater drainage were observed along the road. These function purely as conduits to drain stormwater beneath the road surface and are not associated with a watercourse – these have also not been marked in Figure 11 to Figure 13 as they are not considered as natural watercourses

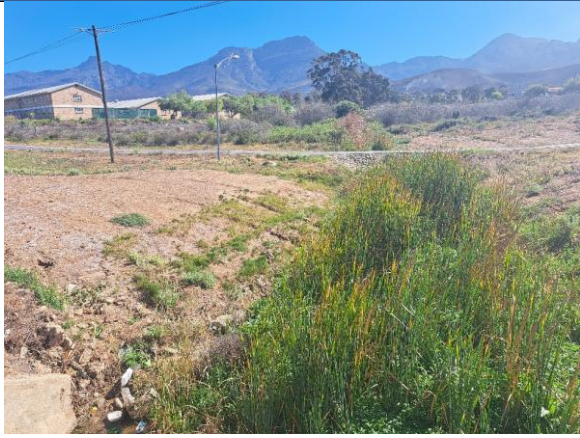
<p><b>Code: #1</b>  <b>Classification:</b> Stream (second order)  <b>Hydroperiod:</b> Non-perennial  <b>Impacts:</b> Urban stormwater runoff, riparian zone invaded by alien tree species, removal of riparian vegetation, crossings impede flow leading to establishment of <i>Typha capensis</i>.  <b>PES:</b> C  <b>EIS:</b> Low</p>
 	<p><b>Code: #2</b>  <b>Classification:</b> Stream (third order)  <b>Hydroperiod:</b> Non-perennial  <b>Impacts:</b> Clearing of riparian vegetation, over grazing within catchment area, small weirs constructed within watercourse channel.  <b>PES:</b> C  <b>EIS:</b> Low</p>
 	<p><b>Code: #3</b>  <b>Classification:</b> Stream (third order)  <b>Hydroperiod:</b> Non-perennial  <b>Impacts:</b> Evidence of erosion in the catchment, leading to high sediment loads (presumably due to over grazing).  <b>PES:</b> B  <b>EIS:</b> Low</p>

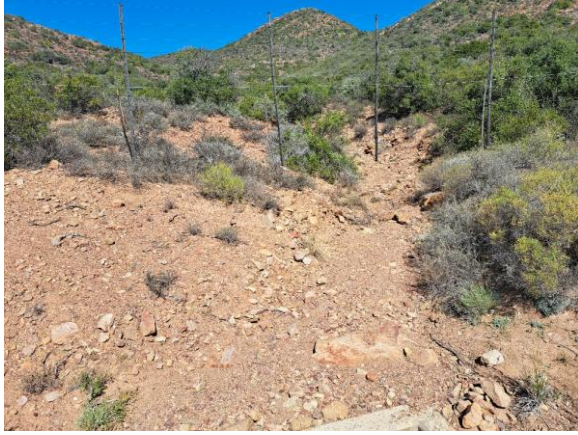
<p><b>Code: #8</b>  <b>Classification:</b> Stream (second order)  <b>Hydroperiod:</b> Non-perennial  <b>Impacts:</b> Minimal impacts apart from minor erosion in catchment area and road crossing.  <b>PES: B</b>  <b>EIS:</b> Low</p>

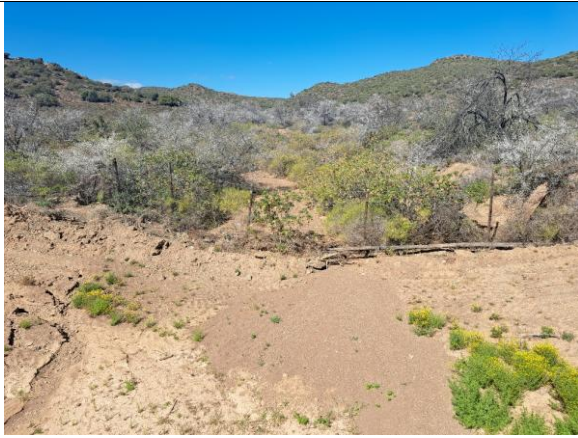
<p><b>Code: #9</b>  <b>Classification:</b> Stream (third order)  <b>Hydroperiod:</b> Non-perennial  <b>Impacts:</b> Erosion of watercourse is prevalent throughout catchment area, presumably due to over-grazing.  <b>PES: C</b>  <b>EIS:</b> Low</p>
<p>No Photo Available</p>	<p><b>Code: #10</b>  <b>Classification:</b> Stream (first order)  <b>Hydroperiod:</b> Non-perennial  <b>Impacts:</b> Poorly defined channel, diverted into agricultural fields.  <b>PES: C</b>  <b>EIS:</b> Low</p>

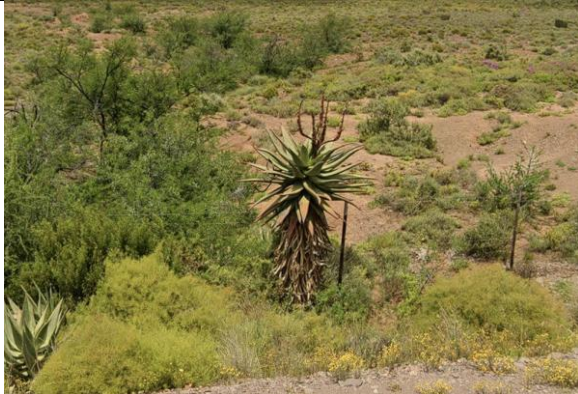
<p><b>Code: #11</b>  <b>Classification:</b> Stream (first order)  <b>Hydroperiod:</b> Non-perennial  <b>Impacts:</b> Poorly defined channel, evidence of erosion in catchment area.  <b>PES: B</b>  <b>EIS:</b> Low</p>

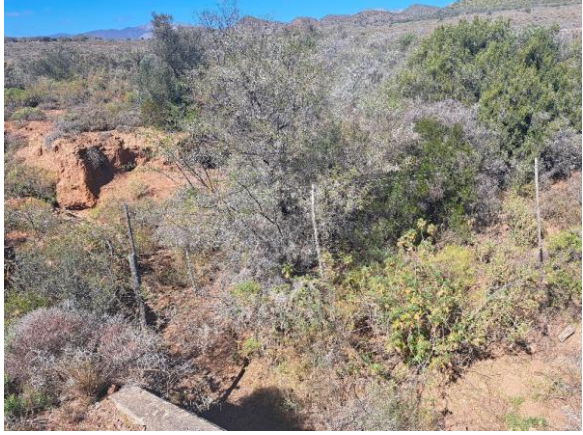
<p><b>Code: #12</b>  <b>Classification:</b> Stream (third order)  <b>Hydroperiod:</b> Non-perennial  <b>Impacts:</b> Widespread erosion in catchment area.  <b>PES: C</b>  <b>EIS: Low</b></p>

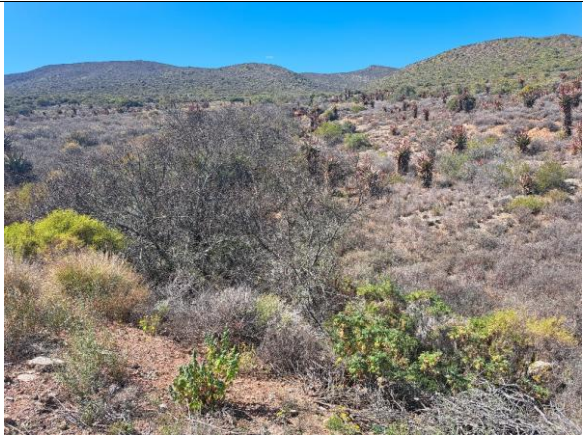
<p><b>Code: #13</b>  <b>Classification:</b> Stream (third order)  <b>Hydroperiod:</b> Non-perennial  <b>Impacts:</b> Heavily eroded channel  <b>PES: C</b>  <b>EIS: Low</b></p>

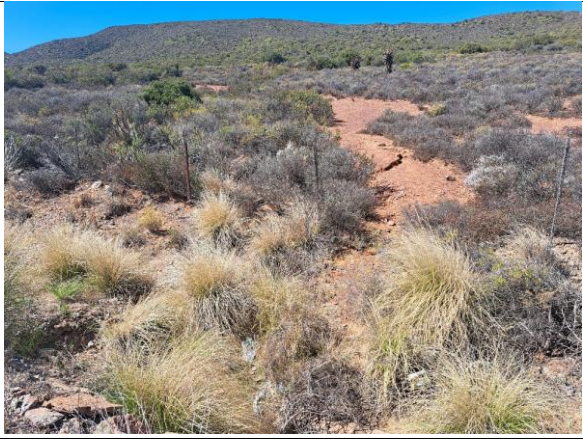
<p><b>Code: #14</b>  <b>Classification:</b> Stream (second order)  <b>Hydroperiod:</b> Non-perennial  <b>Impacts:</b> Poorly defined channel. Instream dam and eroded channel  <b>PES: C</b>  <b>EIS: Low</b></p>

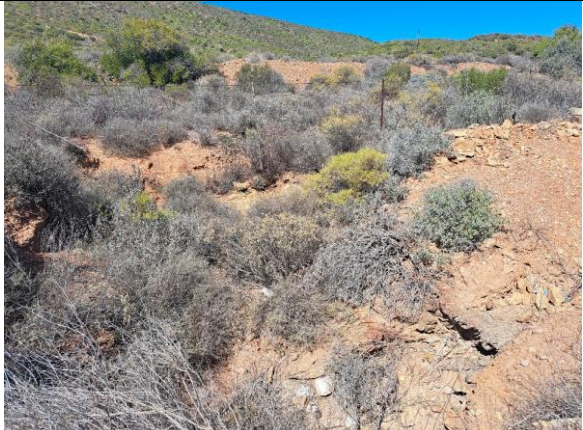
<p><b>Code: #15</b>  <b>Classification:</b> Stream (second order)  <b>Hydroperiod:</b> Non-perennial  <b>Impacts:</b> Poorly defined channel. Instream dam and flow diverted into agricultural furrow  <b>PES: C</b>  <b>EIS: Low</b></p>

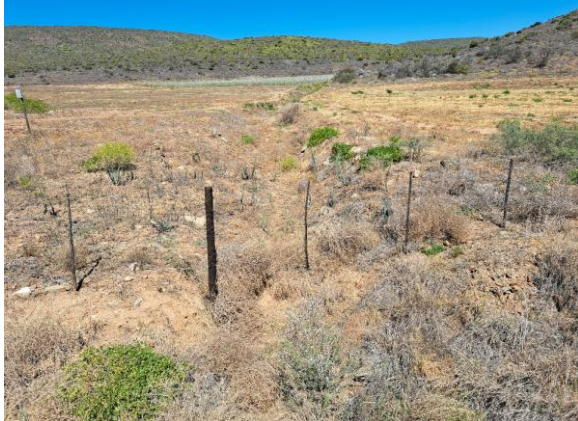
<p><b>Code: #20</b>  <b>Classification:</b> Stream (first order)  <b>Hydroperiod:</b> Non-perennial  <b>Impacts:</b> Heavily impacted by agricultural activities – straightened channel, loss of riparian zone, abstraction of water.  <b>PES: D</b>  <b>EIS: Low</b></p>

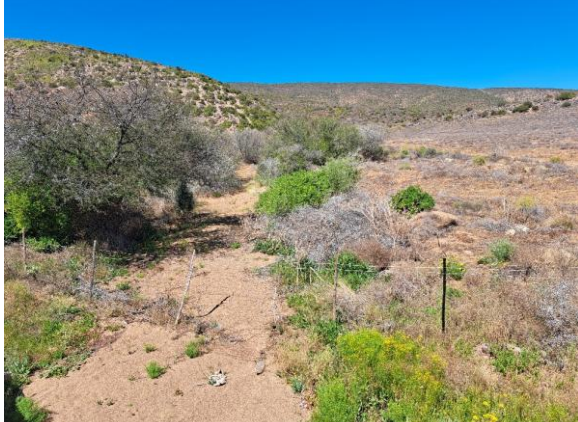
<p><b>Code: #21</b>  <b>Classification:</b> Stream (second order)  <b>Hydroperiod:</b> Non-perennial  <b>Impacts:</b> Large parts of catchment in natural state. Small dams in uppermost catchments area and a large instream dam in lower most reach.  <b>PES: B</b>  <b>EIS: Low</b></p>

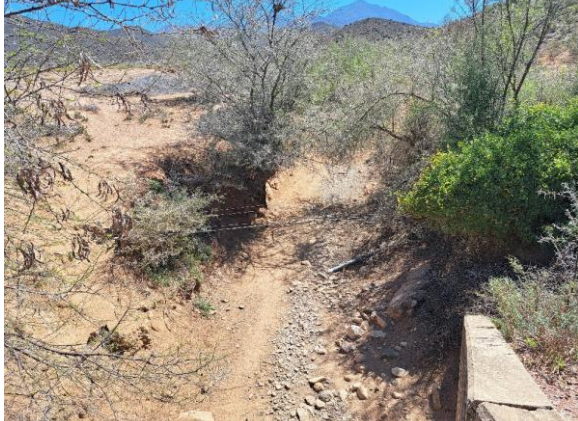
<p><b>Code: #23</b>  <b>Classification:</b> Stream (second order)  <b>Hydroperiod:</b> Non-perennial  <b>Impacts:</b> Large parts of catchment in natural state. Some erosion visible  <b>PES: B</b>  <b>EIS: Low</b></p>

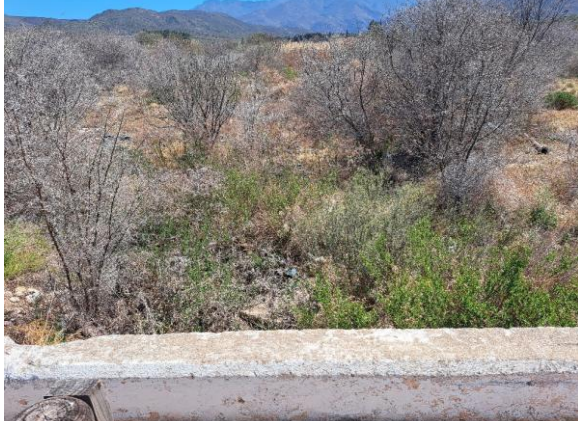
<p><b>Code: #24 (Seweweekspoort River)</b>  <b>Classification:</b> Stream (second order)  <b>Hydroperiod:</b> Non-perennial  <b>Impacts:</b> Side channel of river. Large parts of catchment in natural state. More intensive agriculture in lower most reaches, including instream dams and water abstraction  <b>PES: B</b>  <b>EIS: Low</b></p>

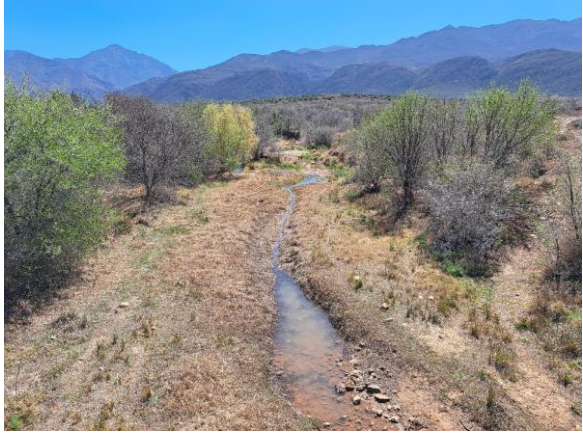
<p><b>Code: #25 (Seweweekspoot River)</b>  <b>Classification:</b> Stream (fifth order)  <b>Hydroperiod:</b> Non-perennial  <b>Impacts:</b> Main channel of river. Large parts of catchment in natural state. More intensive agriculture in lower most reaches, including instream dams and water abstraction  <b>PES:</b> B  <b>EIS:</b> Moderate</p>

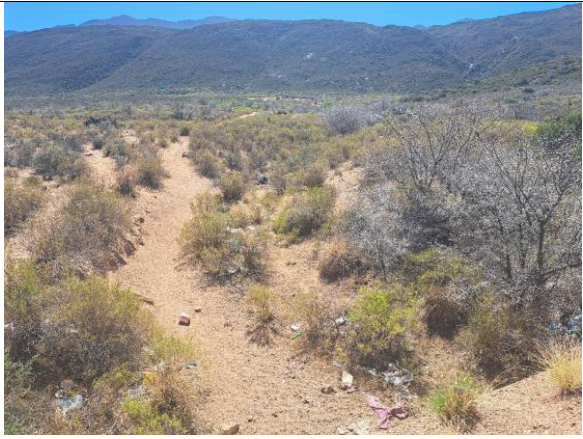
<p><b>Code: #26</b>  <b>Classification:</b> Stream (second order)  <b>Hydroperiod:</b> Non-perennial  <b>Impacts:</b> Downstream of landfill – relatively high levels of litter. Erosion evident – particularly in lower reaches  <b>PES:</b> C  <b>EIS:</b> Low</p>

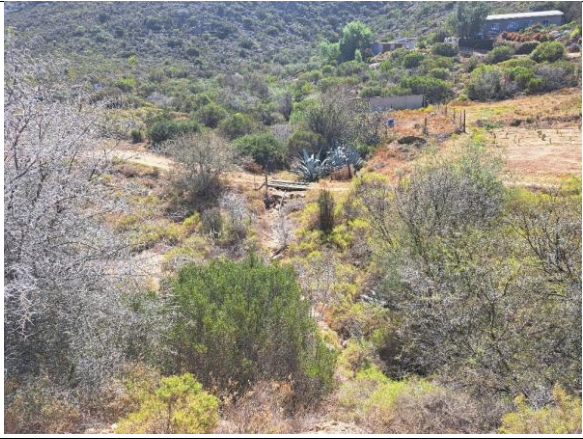
<p><b>Code: #27</b>  <b>Classification:</b> Stream (second order)  <b>Hydroperiod:</b> Non-perennial  <b>Impacts:</b> Channel infilled along lower most reaches  <b>PES:</b> C  <b>EIS:</b> Low</p>

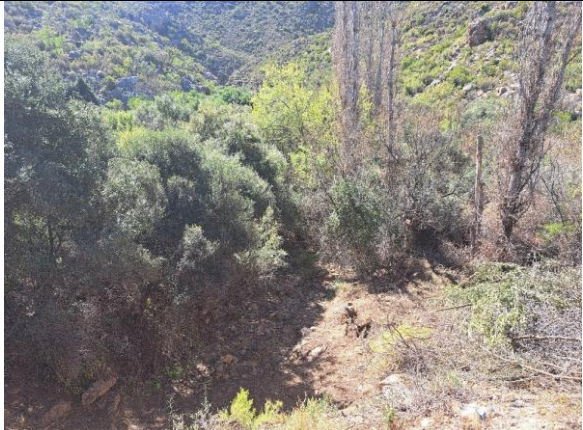
<p><b>Code: #28</b>  <b>Classification:</b> Stream (fourth order)  <b>Hydroperiod:</b> Non-perennial  <b>Impacts:</b> Originates from Swartberg mountains - upper to lower-mid reaches relatively unimpacted, catchment dominated by natural vegetation. Lower reaches impacted by intensive agriculture and alien invaded riparian zone  <b>PES:</b> B  <b>EIS:</b> Low</p>

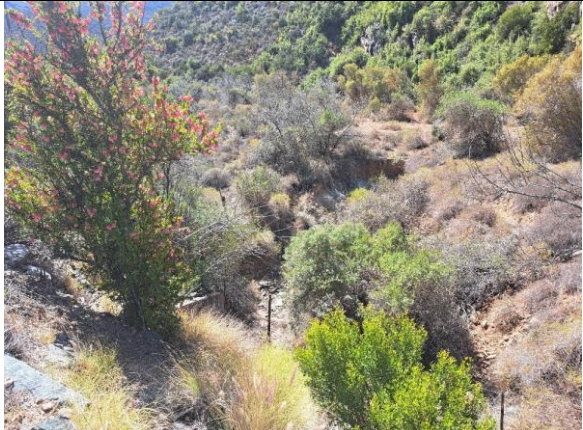
<p><b>Code: #32</b>  <b>Classification:</b> Stream (fourth order)  <b>Hydroperiod:</b> Non-perennial  <b>Impacts:</b> Originates from foothills of Swartberg mountains – largely natural – some first order tributaries infilled by R62, minor erosion of channel.  <b>PES: B</b>  <b>EIS: Low</b></p>

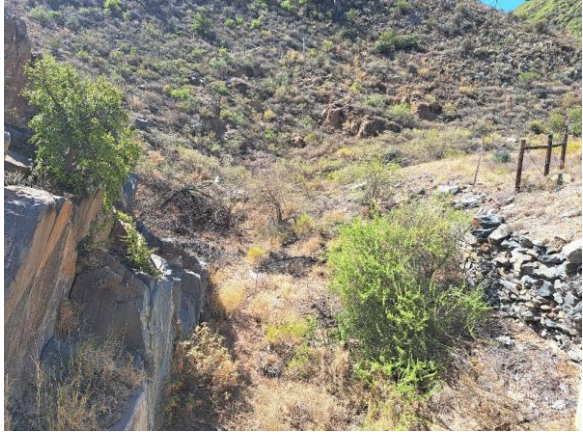
<p><b>Code: #43</b>  <b>Classification:</b> Stream (fourth order)  <b>Hydroperiod:</b> Non-perennial  <b>Impacts:</b> Largely natural. Borrow pit within lower reach of channel..  <b>PES: B</b>  <b>EIS:</b> Low</p>

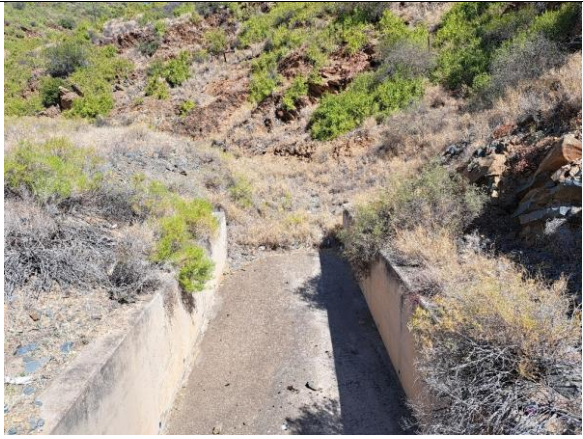
<p><b>Code: #44-45</b>  <b>Classification:</b> Stream (second order)  <b>Hydroperiod:</b> Non-perennial  <b>Impacts:</b> Runs adjacent to R62, crossing via channelled culverts twice. Stream canalised in parts  <b>PES: C</b>  <b>EIS:</b> Low</p>

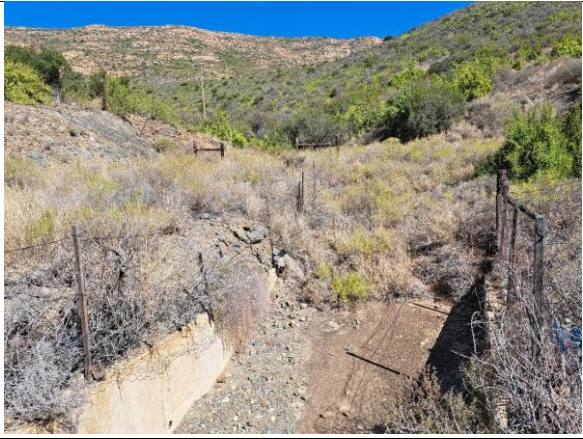
<p><b>Code: #46</b>  <b>Classification:</b> Stream (first order)  <b>Hydroperiod:</b> Non-perennial  <b>Impacts:</b> Poorly defined channel. Unimpacted, near pristine.  <b>PES: A</b>  <b>EIS:</b> Low</p>

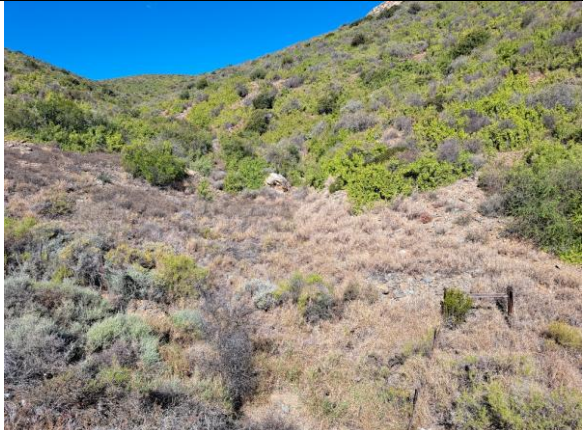
<p><b>Code: #47</b>  <b>Classification:</b> Stream (first order)  <b>Hydroperiod:</b> Non-perennial  <b>Impacts:</b> Poorly defined channel. Unimpacted, near pristine.  <b>PES: A</b>  <b>EIS:</b> Low</p>

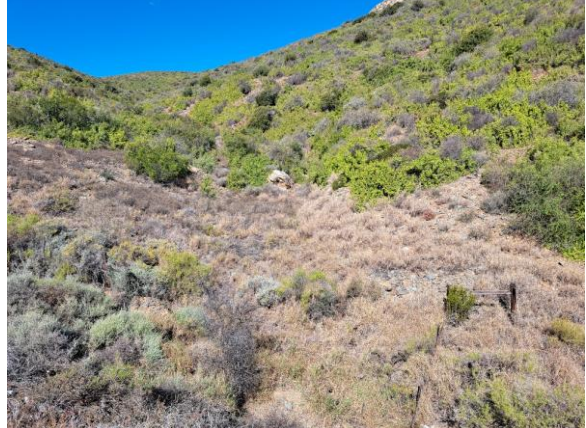
<p><b>Code: #48</b>  <b>Classification:</b> Stream (first order)  <b>Hydroperiod:</b> Non-perennial  <b>Impacts:</b> Poorly defined channel. Unimpacted, near pristine.  <b>PES:</b> A  <b>EIS:</b> Low</p>

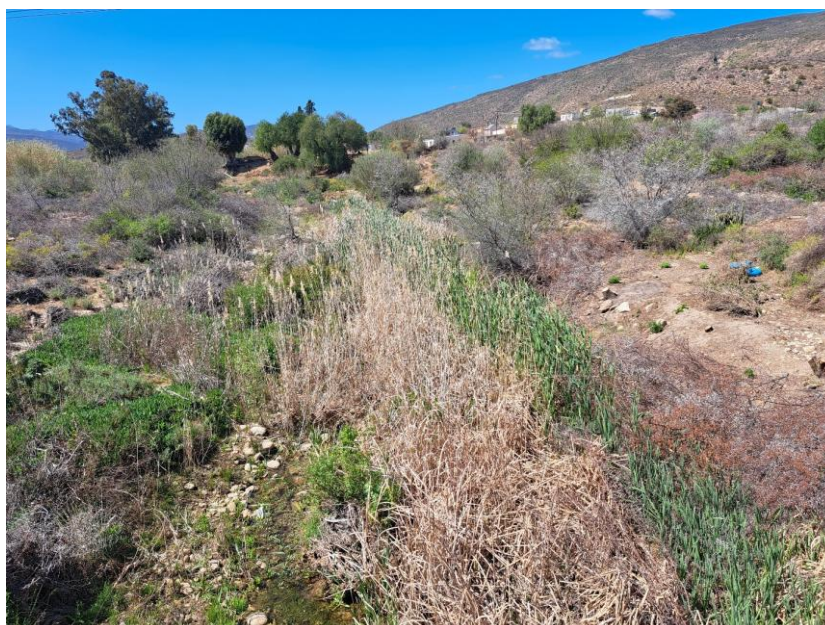
**PES:** Upper-most reaches are pristine while mid to upper and lower most reaches are adjacent to intensive agriculture, with high rates of abstraction for irrigation. Several, relatively large instream dams in tributaries also regulate flows through the river system and flow had been reduced to a trickle at the time of the site visit. Low flows have encouraged growth of instream vegetation (e.g. *Typha capensis* and *Phragmites australis*) in lower gradient reaches. Alien invasive tree species in the riparian zone are synonymous with agricultural activity. Physical habitat along the middle reaches (as the river passes through the narrow, steep gorges of the Paardeberg Mountains) is relatively unimpacted, although regulation of flows in the upper agricultural areas does influence the diversity and quality available of instream aquatic habitat. Here riparian habitat is prominent and is characterised by well vegetated kloofs. Riparian zone is dominated by *Vachelia karroo* and *Salix mucronate*, however, regulated flows in the catchment area have favoured the establishment of reedy species within the channel of the river. The PES is D (Largely Modified).

Figure 14: Photograph of the Nels River from Bridge 2664.

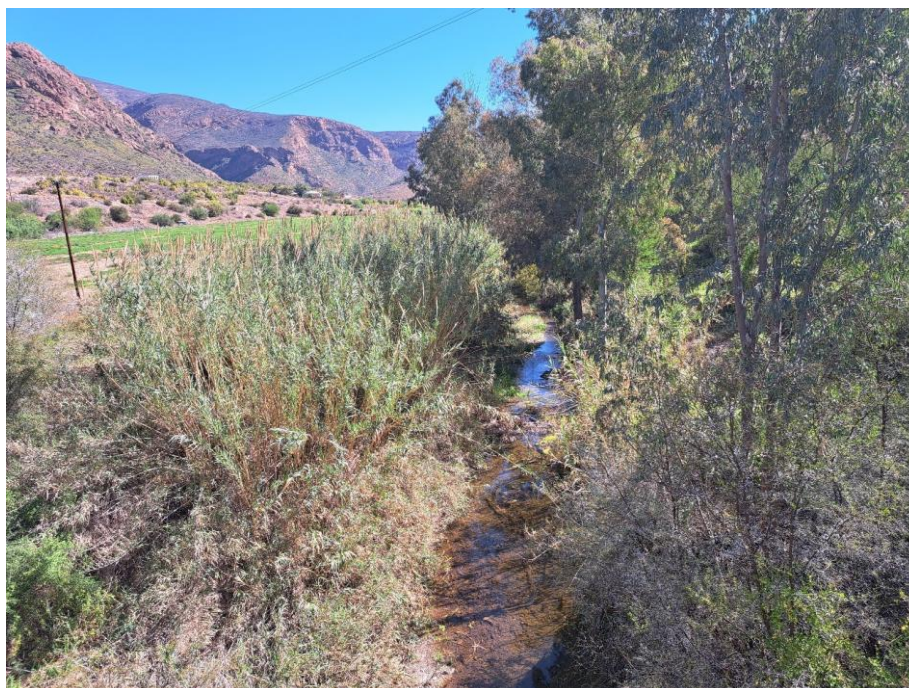
**PES:** This site is situated downstream of an agricultural area and the riparian zone is densely vegetated with alien invasive species (predominantly *Eucalyptus sp.*) – reed beds of invasive *Arundo donax* are also prevalent along the channel. High rates of water abstraction occur to sustain irrigated agriculture. Irrigated agricultural fields are located immediately adjacent to the river, which is poorly buffered against agricultural impacts. The riparian zone is densely vegetated with alien invasive species (predominantly *Eucalyptus sp.*) and the channel and banks are heavily invaded by the invasive *Arundo donax*. The PES is D (Largely Modified)

Figure 16: Photograph of the Huis River from Bridge 4941.

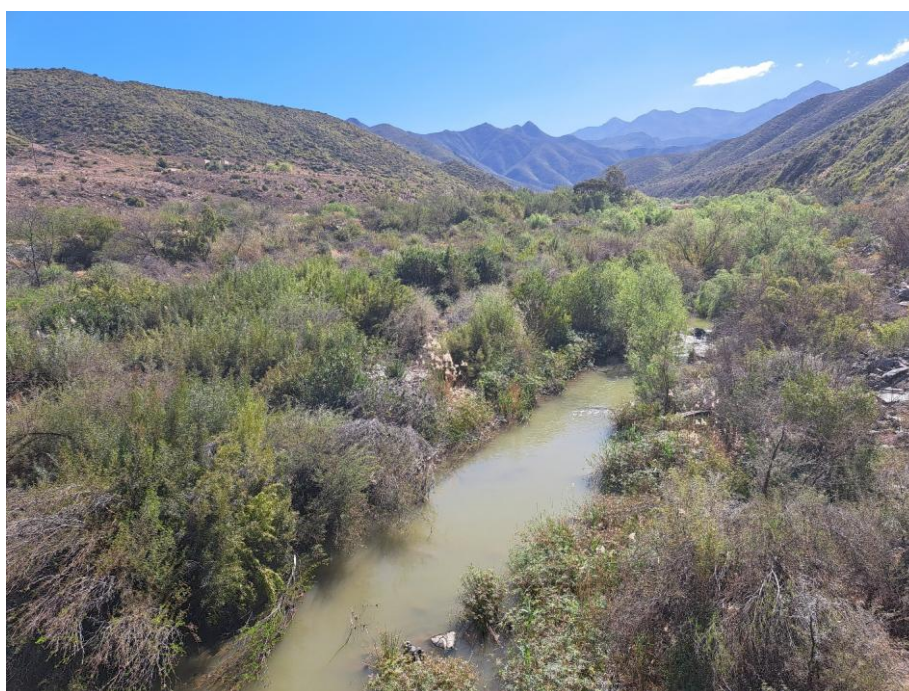
**PES:** Flow through the entire SQC is regulated by the Gamkapoort Dam which was constructed primarily for flood control. Large areas of the SQC run through mountainous areas, that are largely in a natural state. Floodplain areas in the lower reaches of the SQC are cultivated. Overall, impacts are moderate and the PES is C (Moderately Modified).

Figure 17: Photograph of the Gamka River from Bridge 4342.

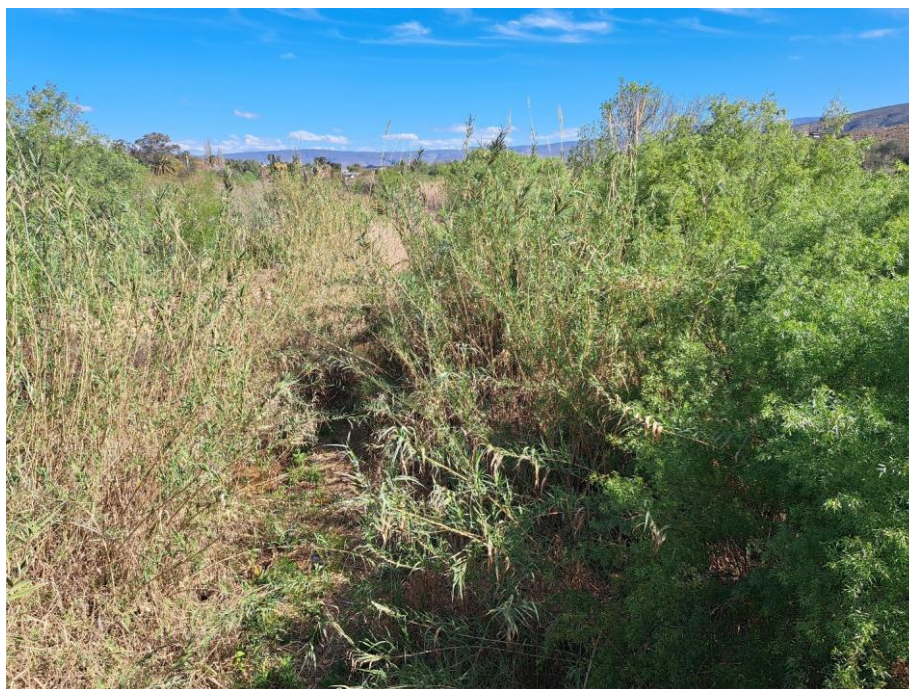
with the Calitzdorp Dam located further upstream, regulate flows through the river and no flow was visible along the river at the time of the site visit. The PES is D (Largely Modified).

Figure 18: Photograph of the Nels River from Bridge 4942.
