Botanical Impact Assessment

Proposed flood damage repairs to the Langenhoven Substation, George

25 July 2025

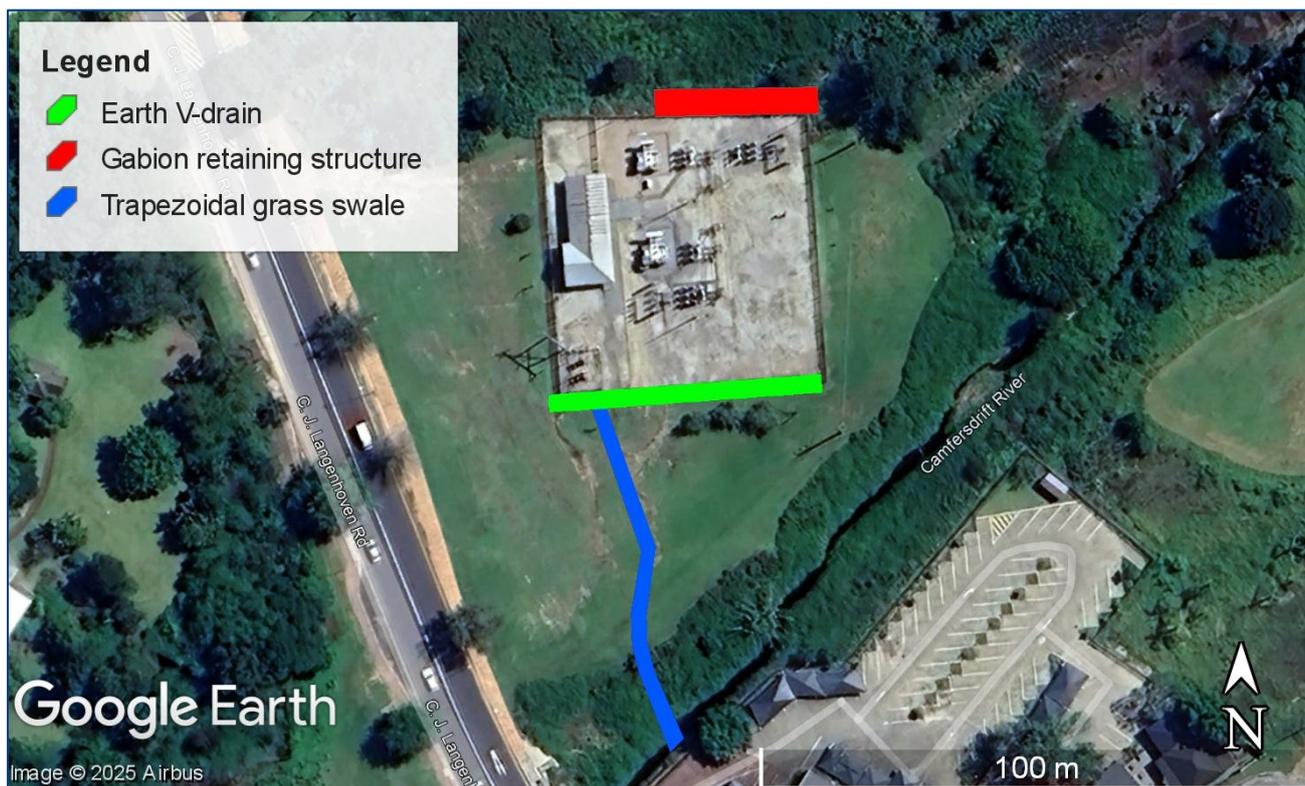
The extent and scope of the proposed repair work include (**Figure 1-2**):

- Construct a gabion retaining structure (consisting of 2×1×1 m gabion baskets) on the northern side of the substation;
- Construct an earth V-drain along the southern edge of the substation; and
- Construct a trapezoidal grass swale with an outlet as close to the river as possible with energy dissipators to protect against erosion. Alternatively, construct a trapezoidal grass swale with a flared swale to spread the water out on the edge of the riverine scrub.

Figure 1-2: Proposed project layout.

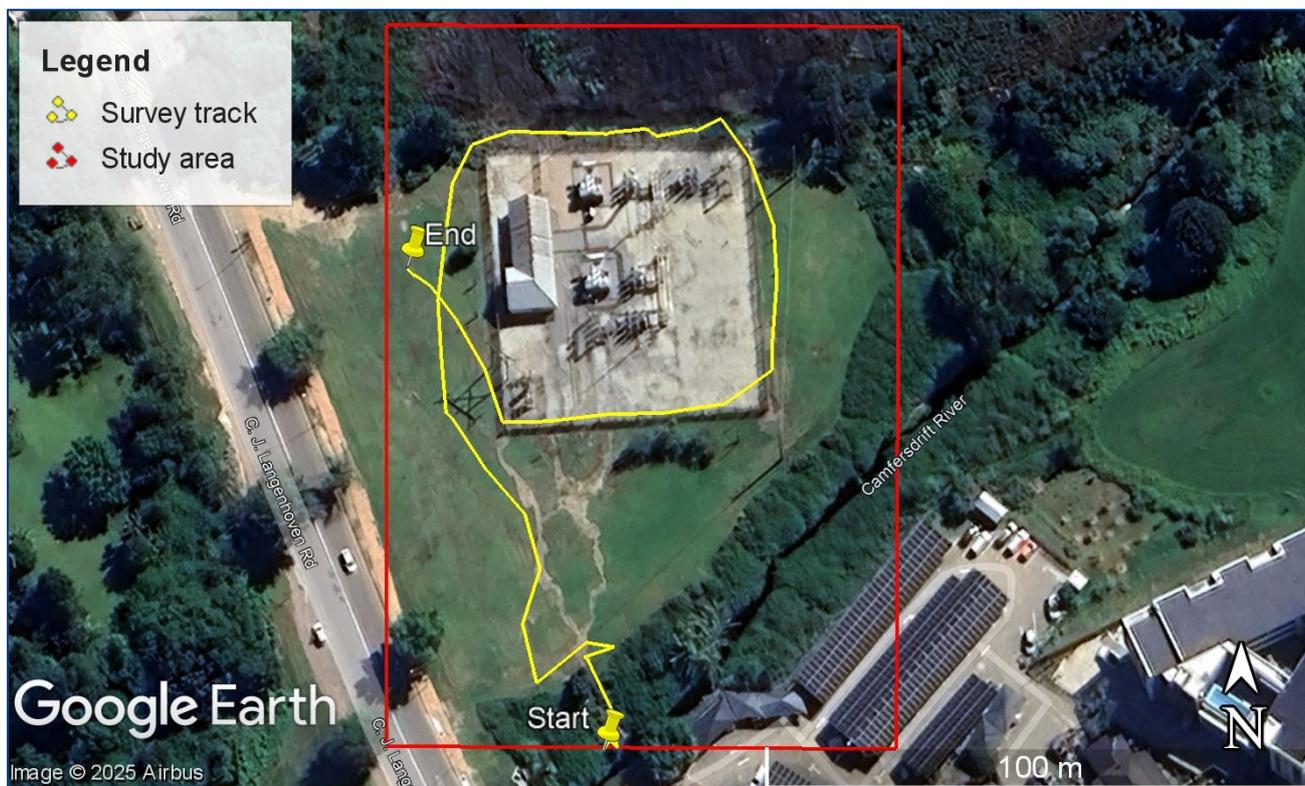
Figure 3-1: Satellite photo showing the survey track on site.

A botanical survey of the site was undertaken on 18 July 2025 by the author. A qualitative assessment of the type and condition of affected vegetation on site, disturbances and presence of alien species, SCC and protected tree species was carried out. The path walked during the survey is shown in **Figure 3-1**. Plant species not identified in the field, were collected and/or photographed and identified at the office and Compton (Kirstenbosch) Herbarium. The 2018 South African Vegetation Map and the latest floristic taxonomic literature and reference books were used for the purpose of this specialist study. Any plants classified as rare or endangered in the Red List of South African Plants online database¹ are highlighted. The assessment follows the relevant national guidelines/protocols for biodiversity assessments as listed in the Government Gazette No. 43110 on 20 March 2020.

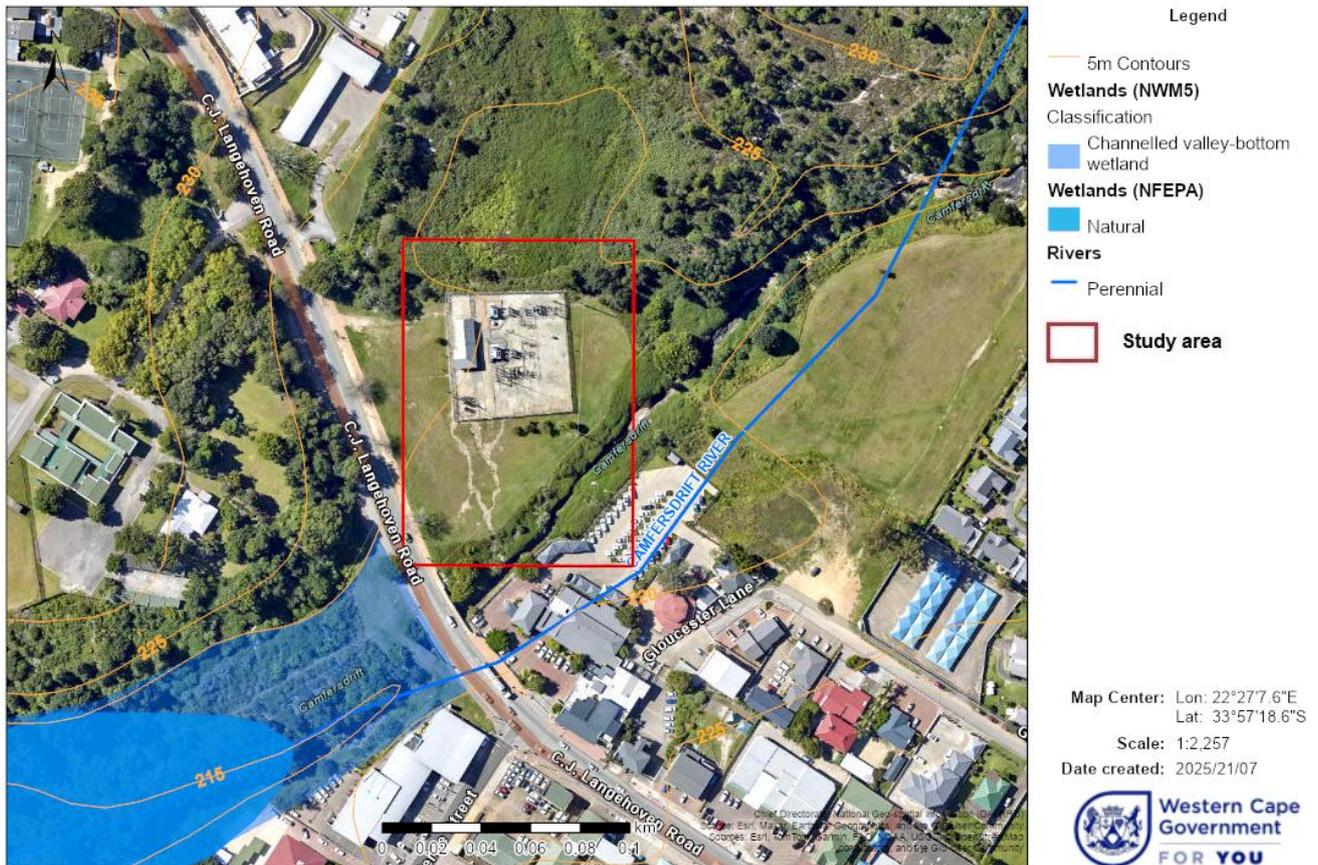
Figure 4-1: Combined topography and hydrology map.

The study site (± 220 masl) is located next to the Camfersdrift River inside George. Apart from the deeply incised river channel, the terrain is relatively flat (**Figure 4-1**). The northern edge of the substation is located on top of an embankment. The site is surrounded by

According to CapeFarmMapper, the only watercourse present on the site is the Camfersdrift River, which cuts across the south-eastern corner (**Figures 4-1 & 4-3**). The site survey also revealed a large impoundment on the northern side of the substation (**Figure 4-4**). Both the river and impoundment are highly modified. The riverine corridor downstream from C.J. Langenhoven Road has been mapped as a NWM5 channelled valley-bottom wetland, as well as a National Freshwater Ecosystem Priority Areas (NFEPA) wetland. The NFEPA project provides strategic spatial priorities for conserving South Africa's freshwater ecosystems and supports sustainable use of water resources. The above riverine corridor and impoundment (artificial) have been included in the Western Cape biodiversity network as aquatic (river) and terrestrial critical biodiversity areas (CBA's).

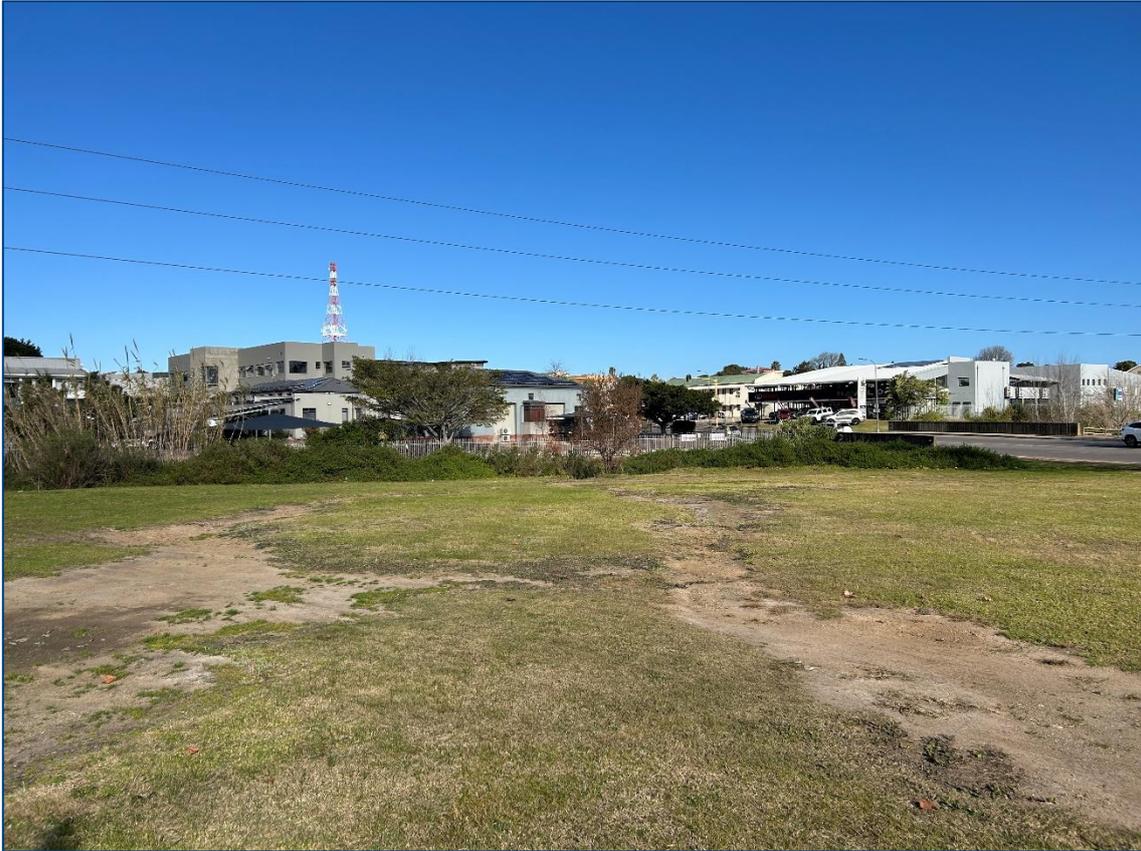
Figure 4-2: View across the southern part of site towards commercial area east of the Camfersdrift River.

open spaces, a residential area, a provincial hospital, commercial/business area and a school. Access to the site is gained from the bypassing C.J. Langenhoven Road. The Outeniqua Mountains form a dramatic backdrop 5 km away to the north. The site itself is covered by grasses/weeds, riverine habitat, an electrical substation and a few planted trees (**Figure 4-2**).

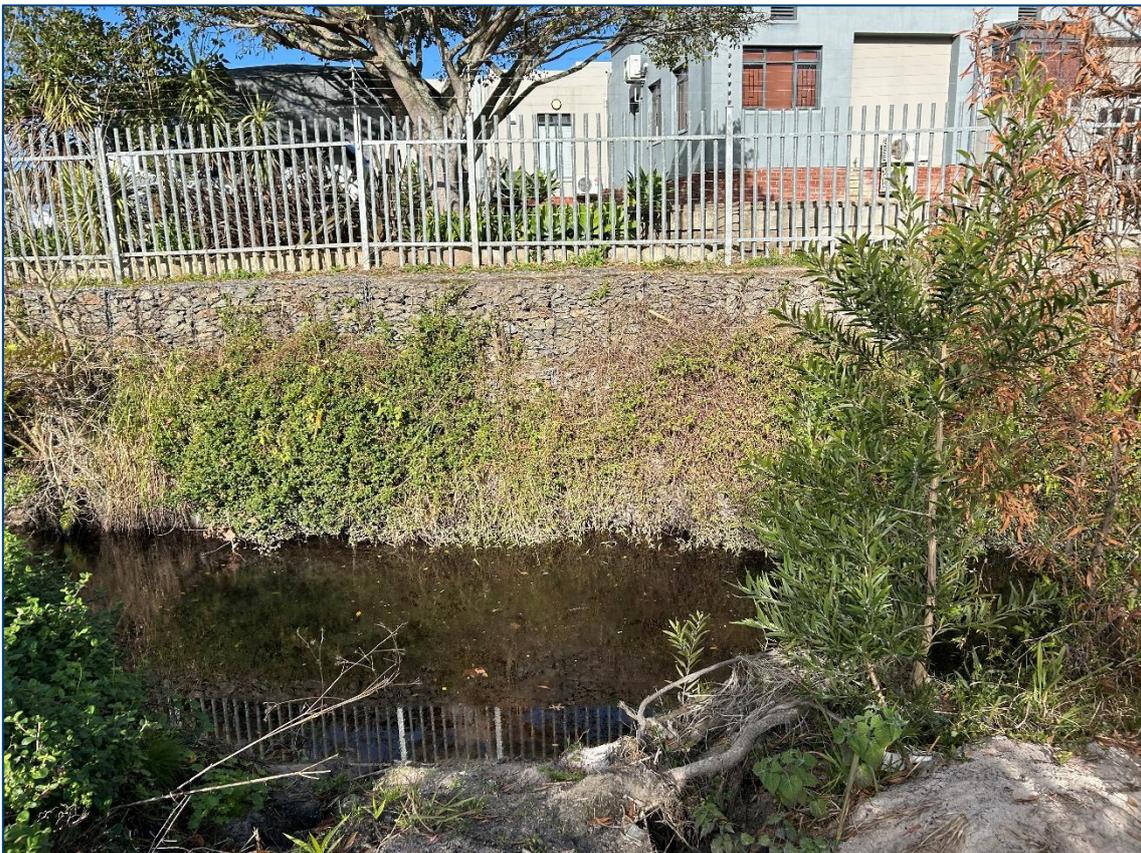
Figure 4-3: Camfersdrift River.

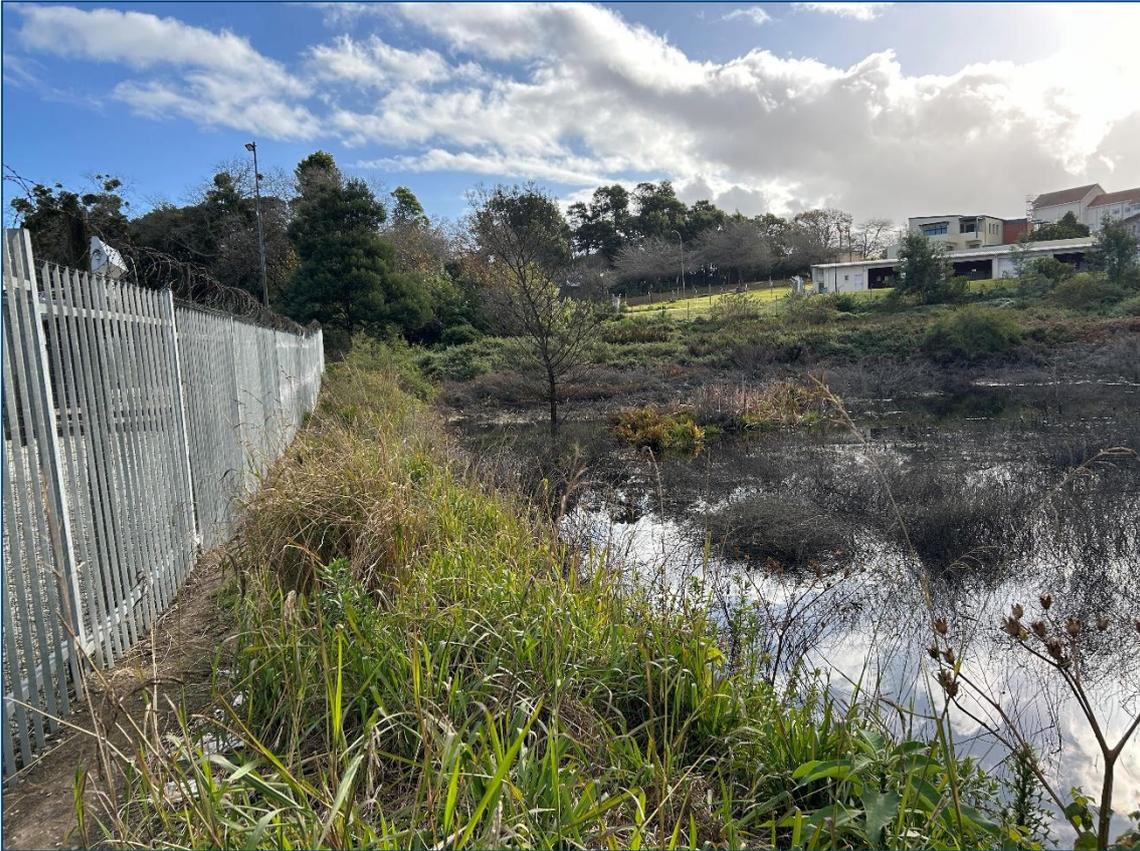
Figure 4-4: Impoundment on northern side of substation.

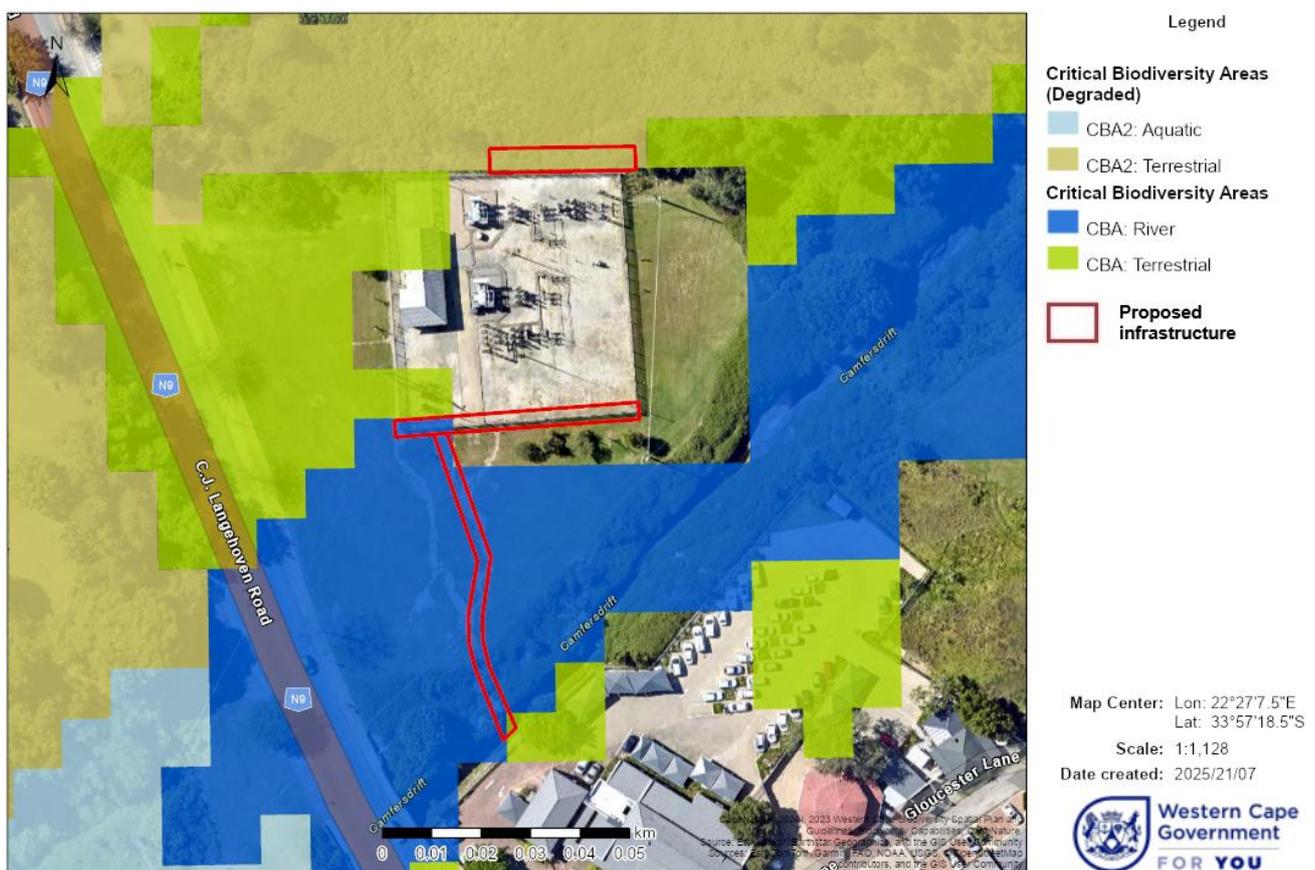
Figure 4-6: Extract of the Western Cape biodiversity network map.

The site falls inside the George biodiversity network (**Figure 4-6**). Being located next to the Camfersdrift River, it includes aquatic and terrestrial critical biodiversity areas (CBA's), as well as a degraded critical biodiversity area (CBA2). These are all aligned with the Camfersdrift River and adjacent tracts of parkland, which act as an ecological corridor linking the Outeniqua Mountains with the coastline. Reasons for the importance of the mapped CBA's include the presence of ecological processes (FEPA river corridor) and water resource protection (Gwaing & South Eastern Coastal Belt). The closest protected area is the Van Kervel Local Authority Nature Reserve, located 1.4 km away to the northeast of the site. The Witfontein Nature Reserve is located ± 3 km away to the north.

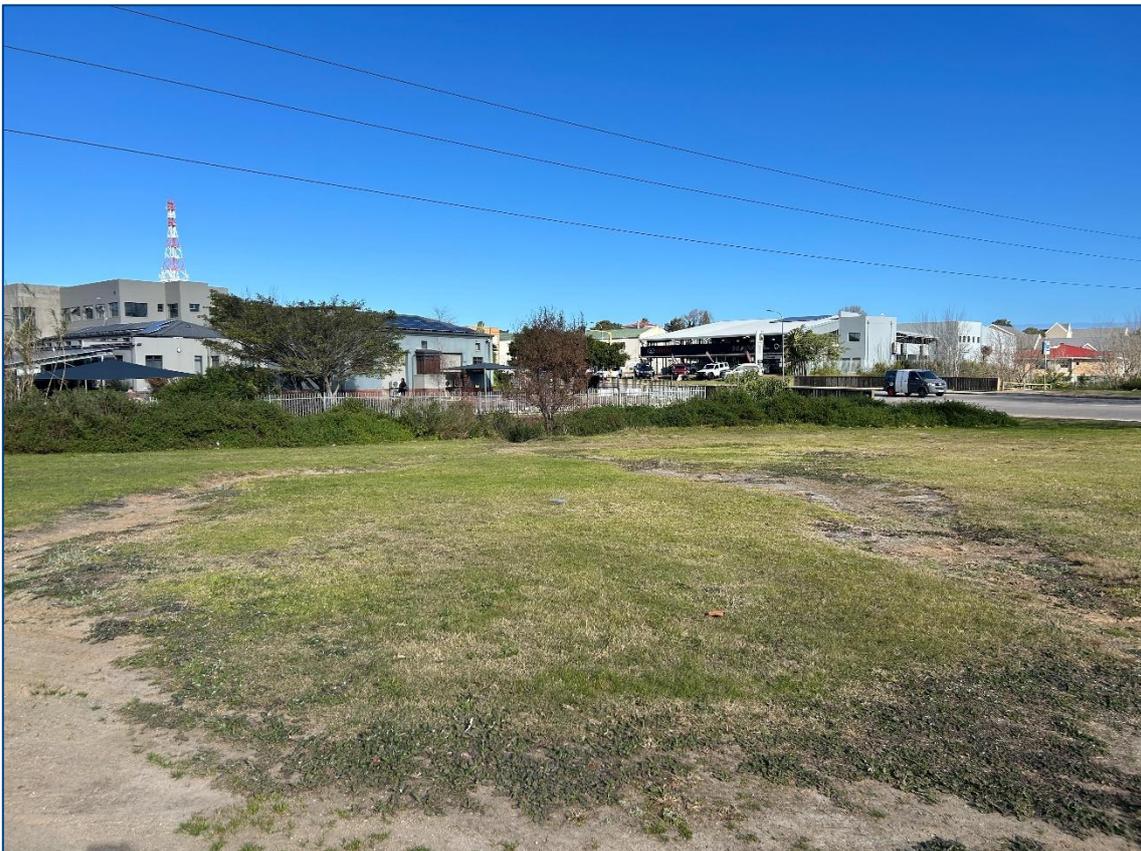
Figure 5-1: Grassy area south of the substation and approximate route for the trapezoidal grass swale.

The area around the substation is highly transformed/modified, comprising a flat grassy area leading to the Camfersdrift River, and an embankment/impoundment on the northern side of substation (**Figures 5-1 to 5-3**). Most of the indigenous species recorded are associated with the riparian habitat next to the Camfersdrift River. However, the latter is also modified by past development activities. No proper fynbos was encountered, only some riparian scrub associated with the river. The quality of the latter is also poor due to a high presence of pioneers and invasive species. The rest of the site, including the embankment, is covered by grasses and weeds. The botanical attributes of the site are presented in **Figure 5-4**.

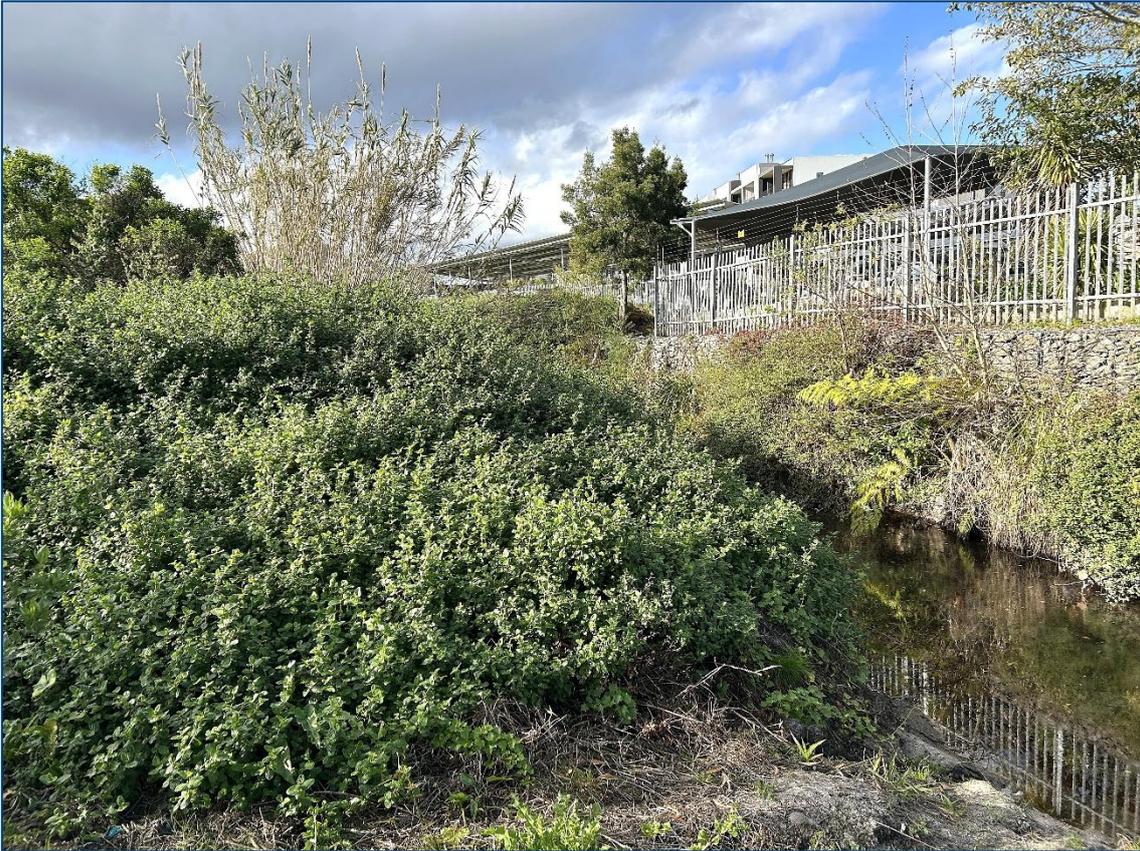
Figure 5-2: Riparian scrub next to the Camfersdrift River. The dominant shrub is *Cliffortia odorata*.

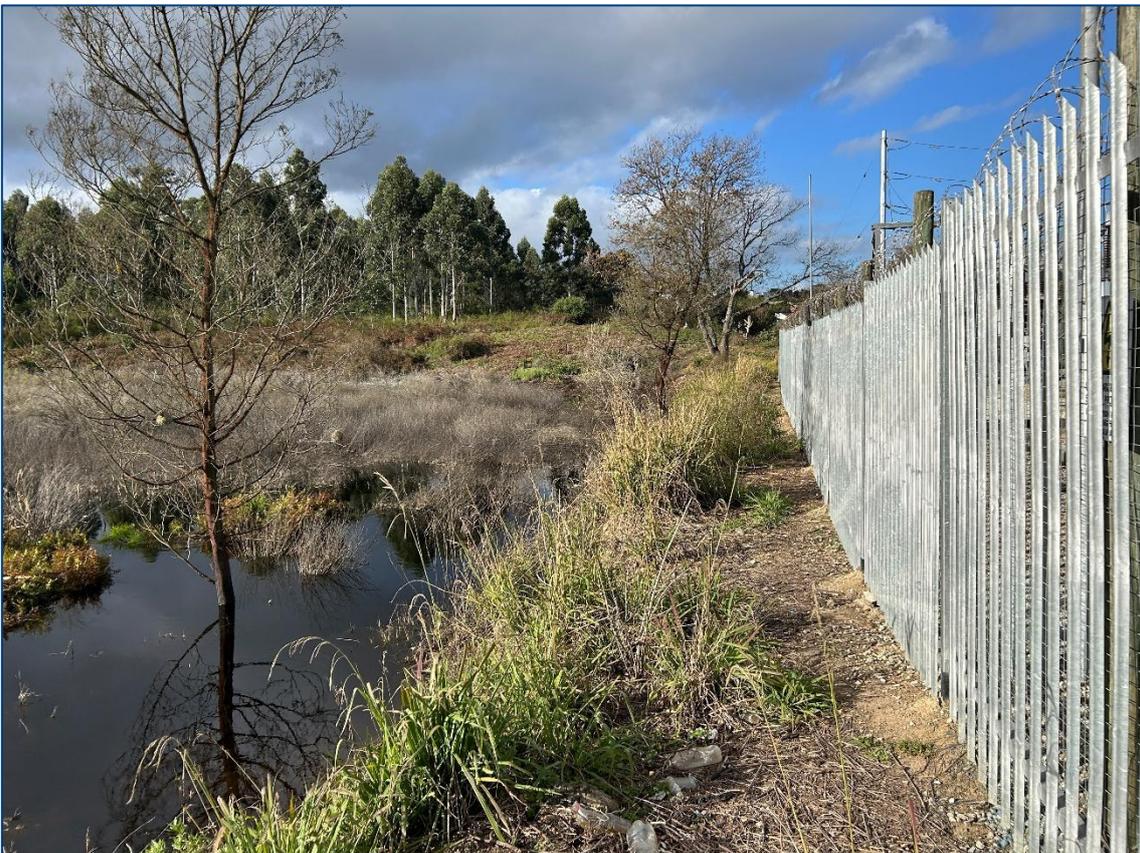
Figure 5-3: Embankment and impoundment on northern side of substation.

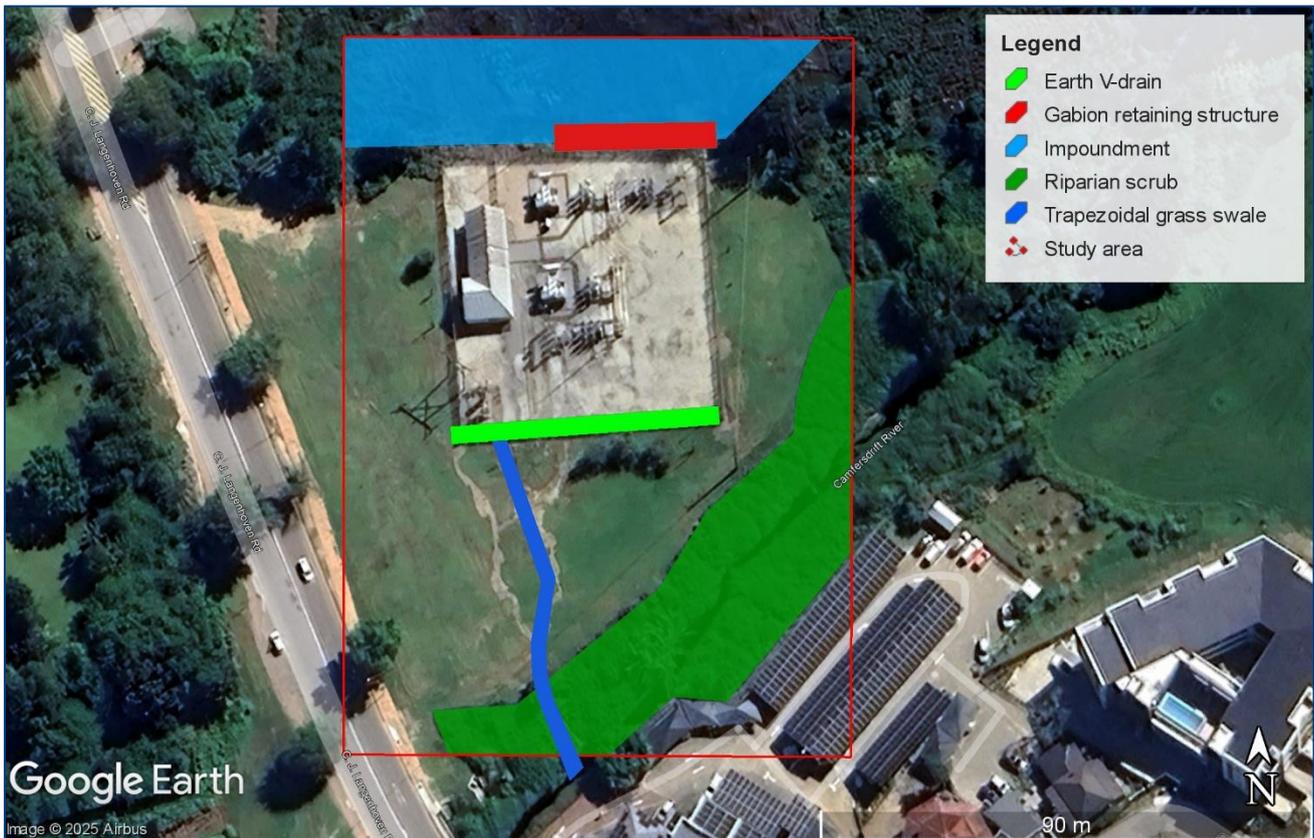
Figure 5-4: Botanical attributes of the site. The untoned areas are highly transformed.

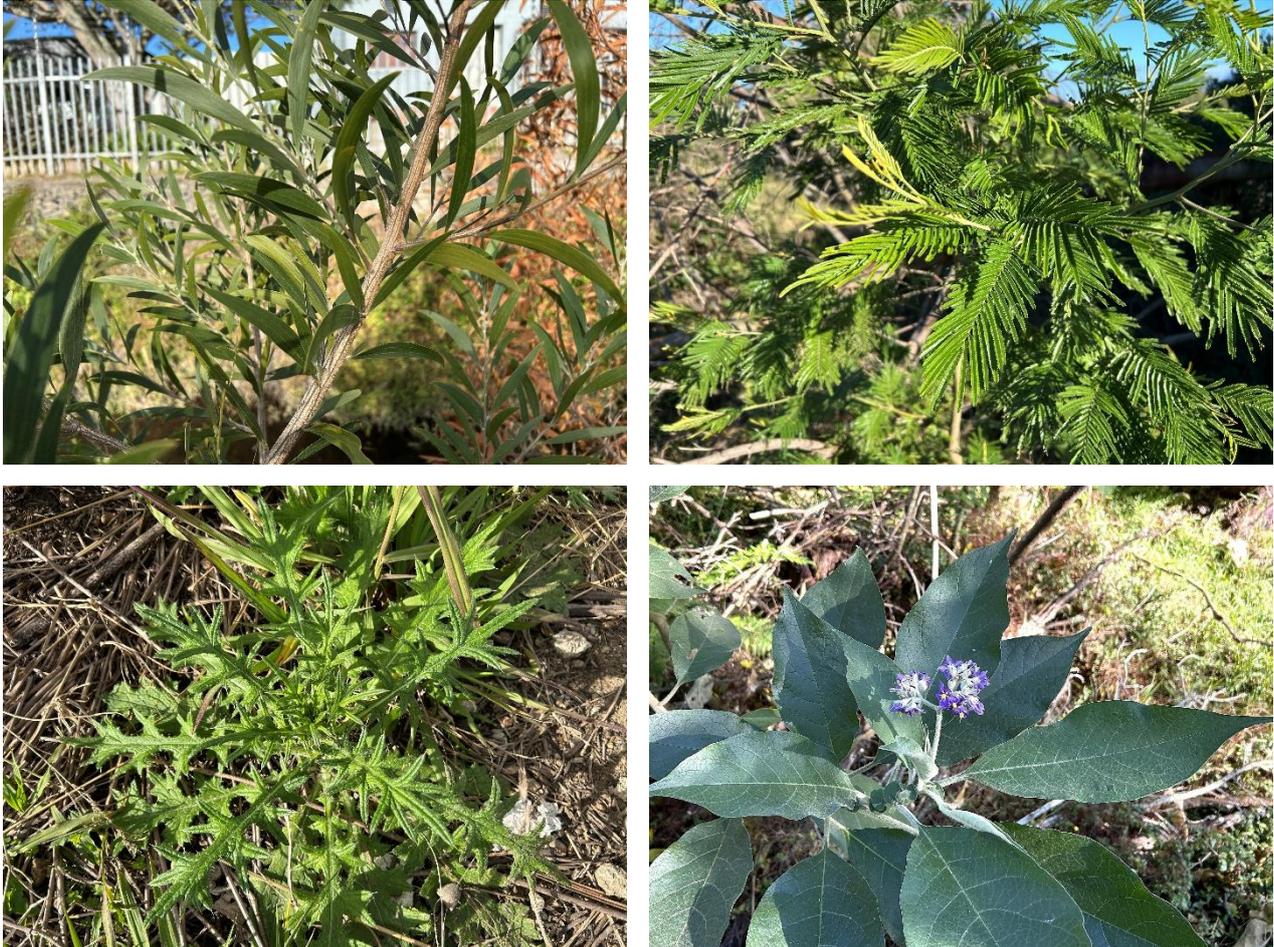
Figure 5-5: Alien species recorded on site, with *Acacia melanoxylon* (top left), *A. mearnsii* (top right), *Cirsium vulgare* (bottom left) and *Solanum mauritianum* (bottom right).

Figure 5-5 shows a few of the alien species. As indicated above, the majority are Category 1b and 2 invaders. In terms of the National Environmental Management: Biodiversity Act

(NEMBA) (Act 10 of 2004) Alien and Invasive Species List (2016), category 1b invasive species require compulsory control as part of an invasive species control programme. Also, the harbouring of category 2 species, such as black wattle and blackwood, is prohibited without a permit. Black wattle, which is indicative of past disturbances, is considered a serious threat to the environment and very difficult to control.
