# ENVIRONMENTAL MANAGEMENT PROGRAMME

PROPOSED CONSTRUCTION OF A MIXED-USE  
 DEVELOPMENT ON ERF 998 AND PORTION 5 OF  
 THE FARM ZANDHOOGTE NO. 139 (PORTION OF  
 RE/139), TERGNIET, MOSSEL BAY LOCAL  
 MUNICIPALITY, WESTERN CAPE

<b>APPLICANT:</b>	3MP Sales and Education Services
<b>ENVIRONMENTAL CONSULTANT:</b>	Sharples Environmental Services cc Michael Jon Bennett
<b>DEA &amp; DP PROJECT REFERENCE:</b>	16/3/3/1/D6/35/0008/26
<b>SES REFERENCE NUMBER:</b>	EMP/MUD/TN/MB/WC/03/26
<b>DATE:</b>	March 2026

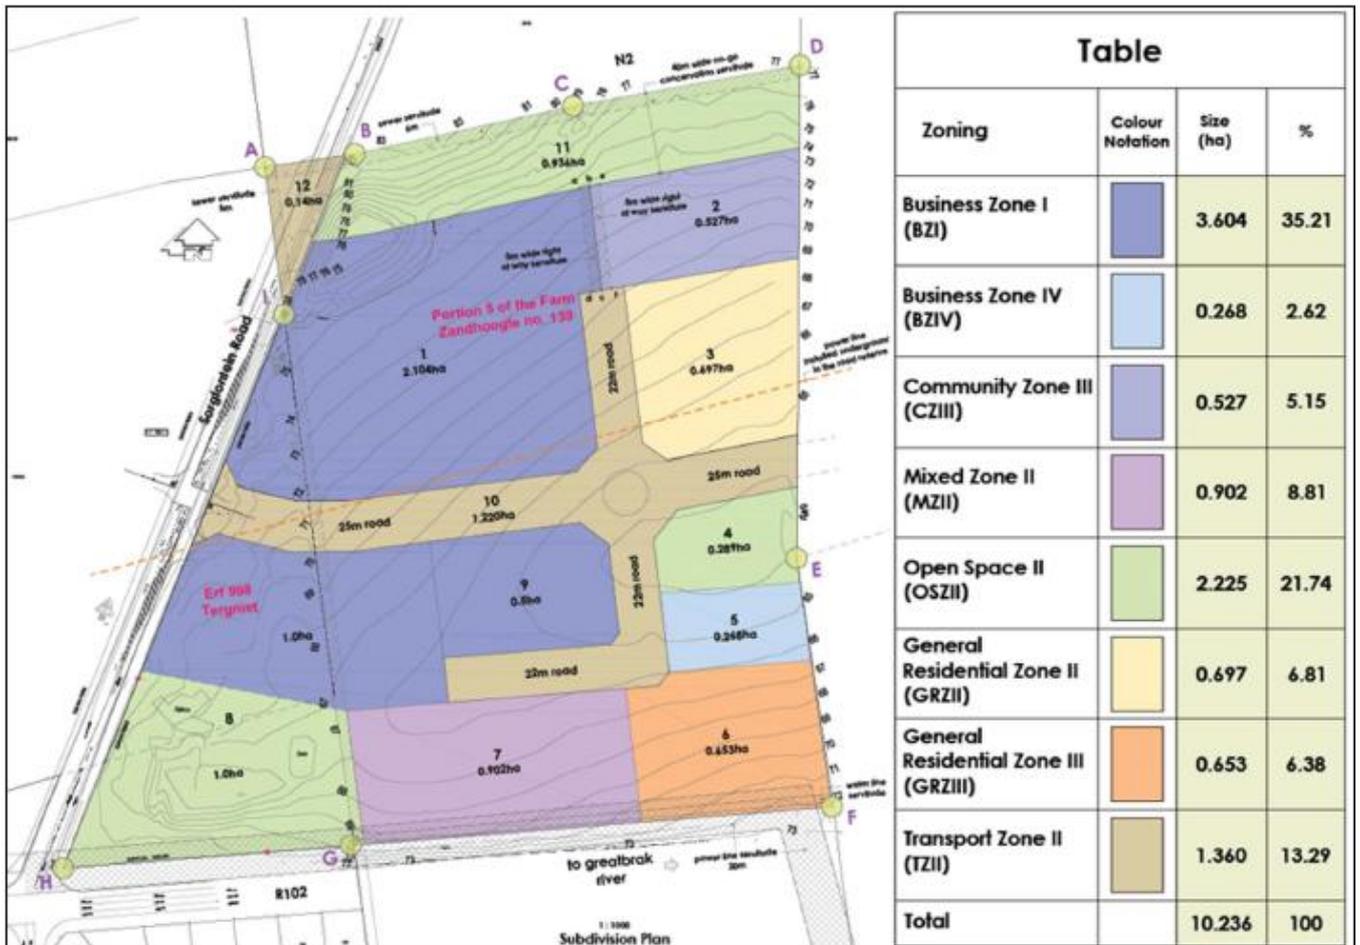
**Figure 1: Site Development Plan**

<b>Zoning</b>	<b>Size (ha)</b>
Business Zone I (BZI)	2.604
Business Zone IV (BZIV)	0.268
Community Zone III (CZIII)	0.527
Mixed Zone II (MZII)	0.902
Open Space II (OSZII)	1.225
General Residential Zone II (GRZII)	0.697
General Residential Zone III (GRZIII)	0.653
Transport Zone II (TZII)	1.360
Mixed Use Zone II (MZII)	0.902
Split zone erf consisting of a portion Business Zone I (BZI) with a size of 1.0 hectare and a portion Open Space Zone II (OSZII) with a size of 1.0 hectare	2.00

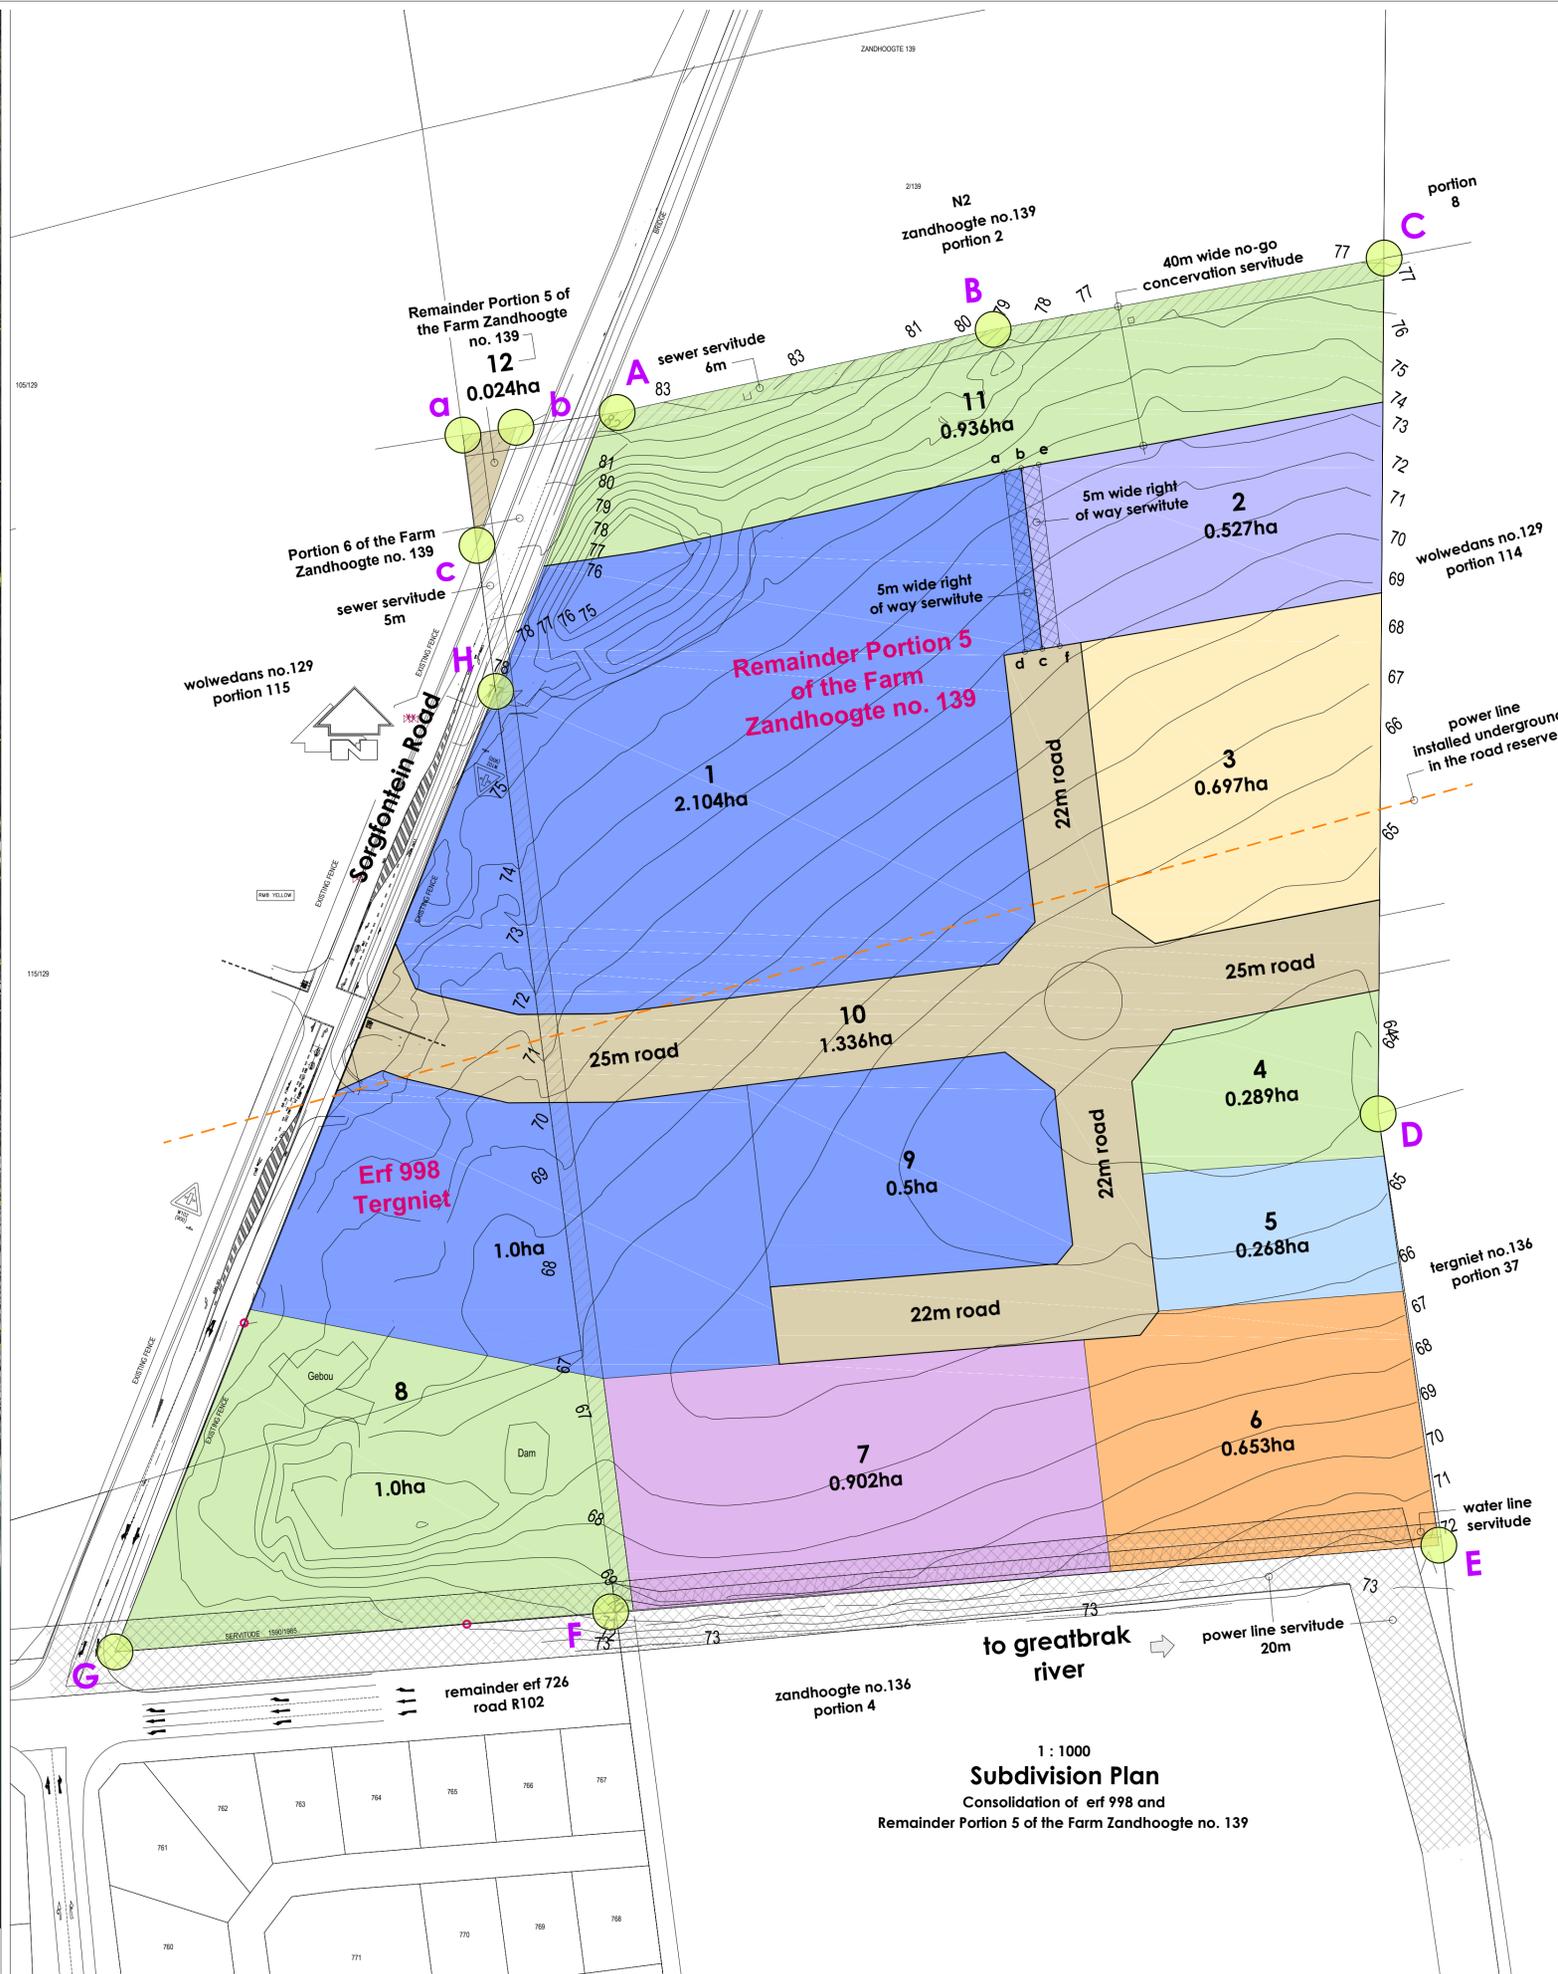
1 : 1000  
**Subdivision Plan**  
 Consolidation of erf 998 and  
 Remainder Portion 5 of the Farm Zandhoogte no. 139

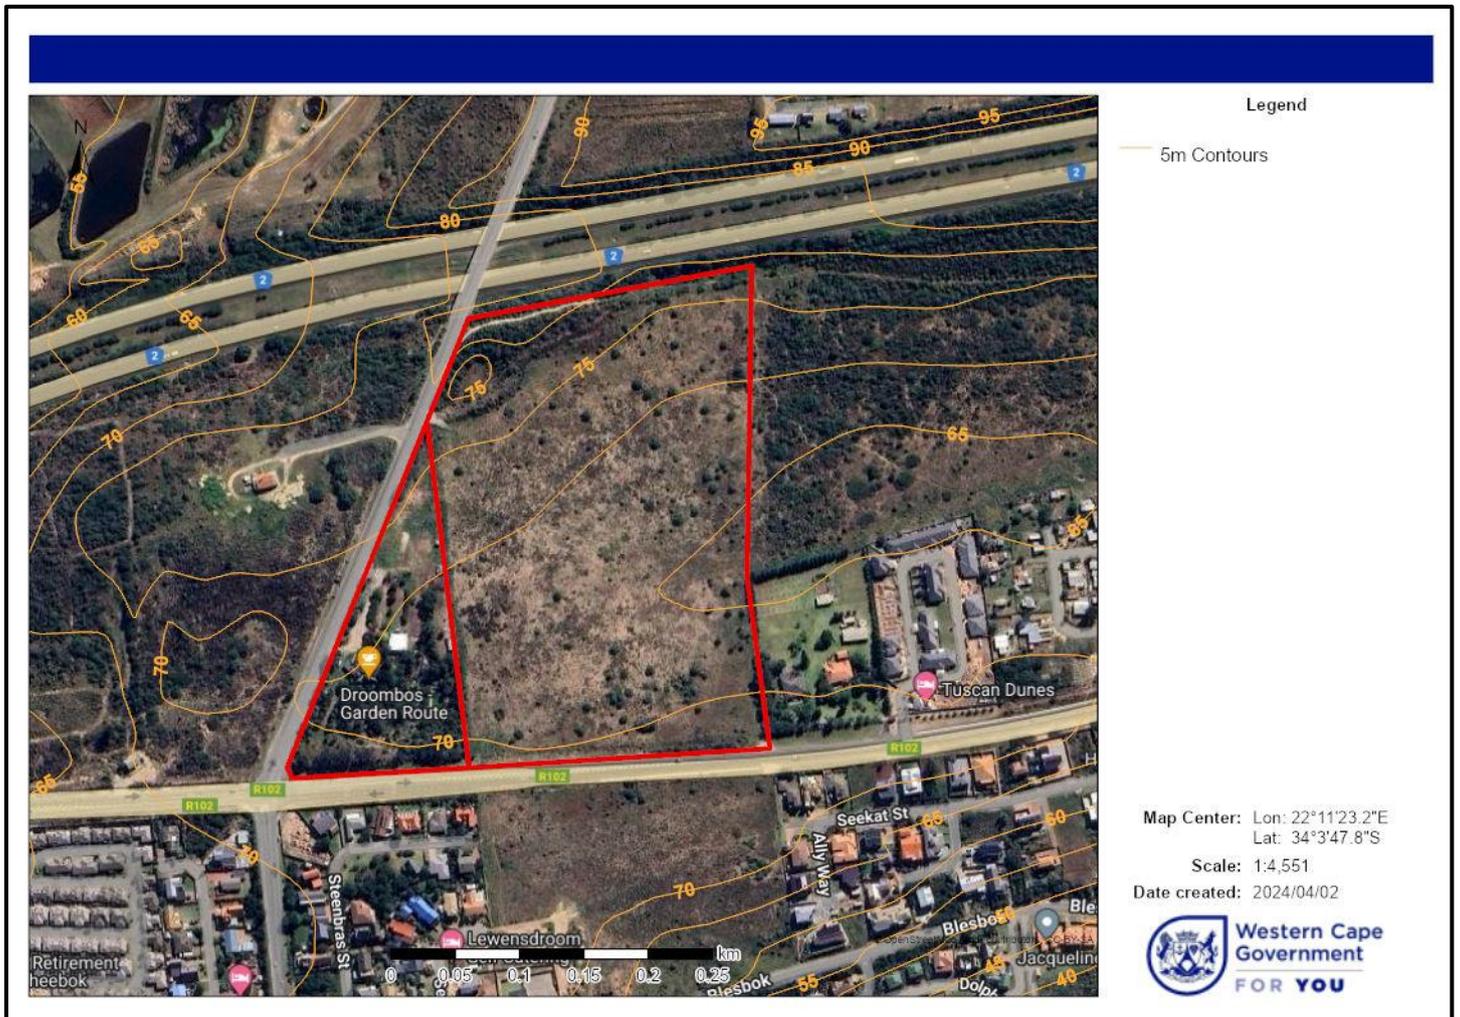
**Figure 3** Topology of the study area showing 5 meter contour lines (Red polygon = Study area; map generated in Cape Farm Mapper version 3, Western Cape Department of Agriculture).

The larger northern part of the site slopes gently south-eastward, with the southern part sloping north-westward to create a slight depression in the southern section (Figure 3).

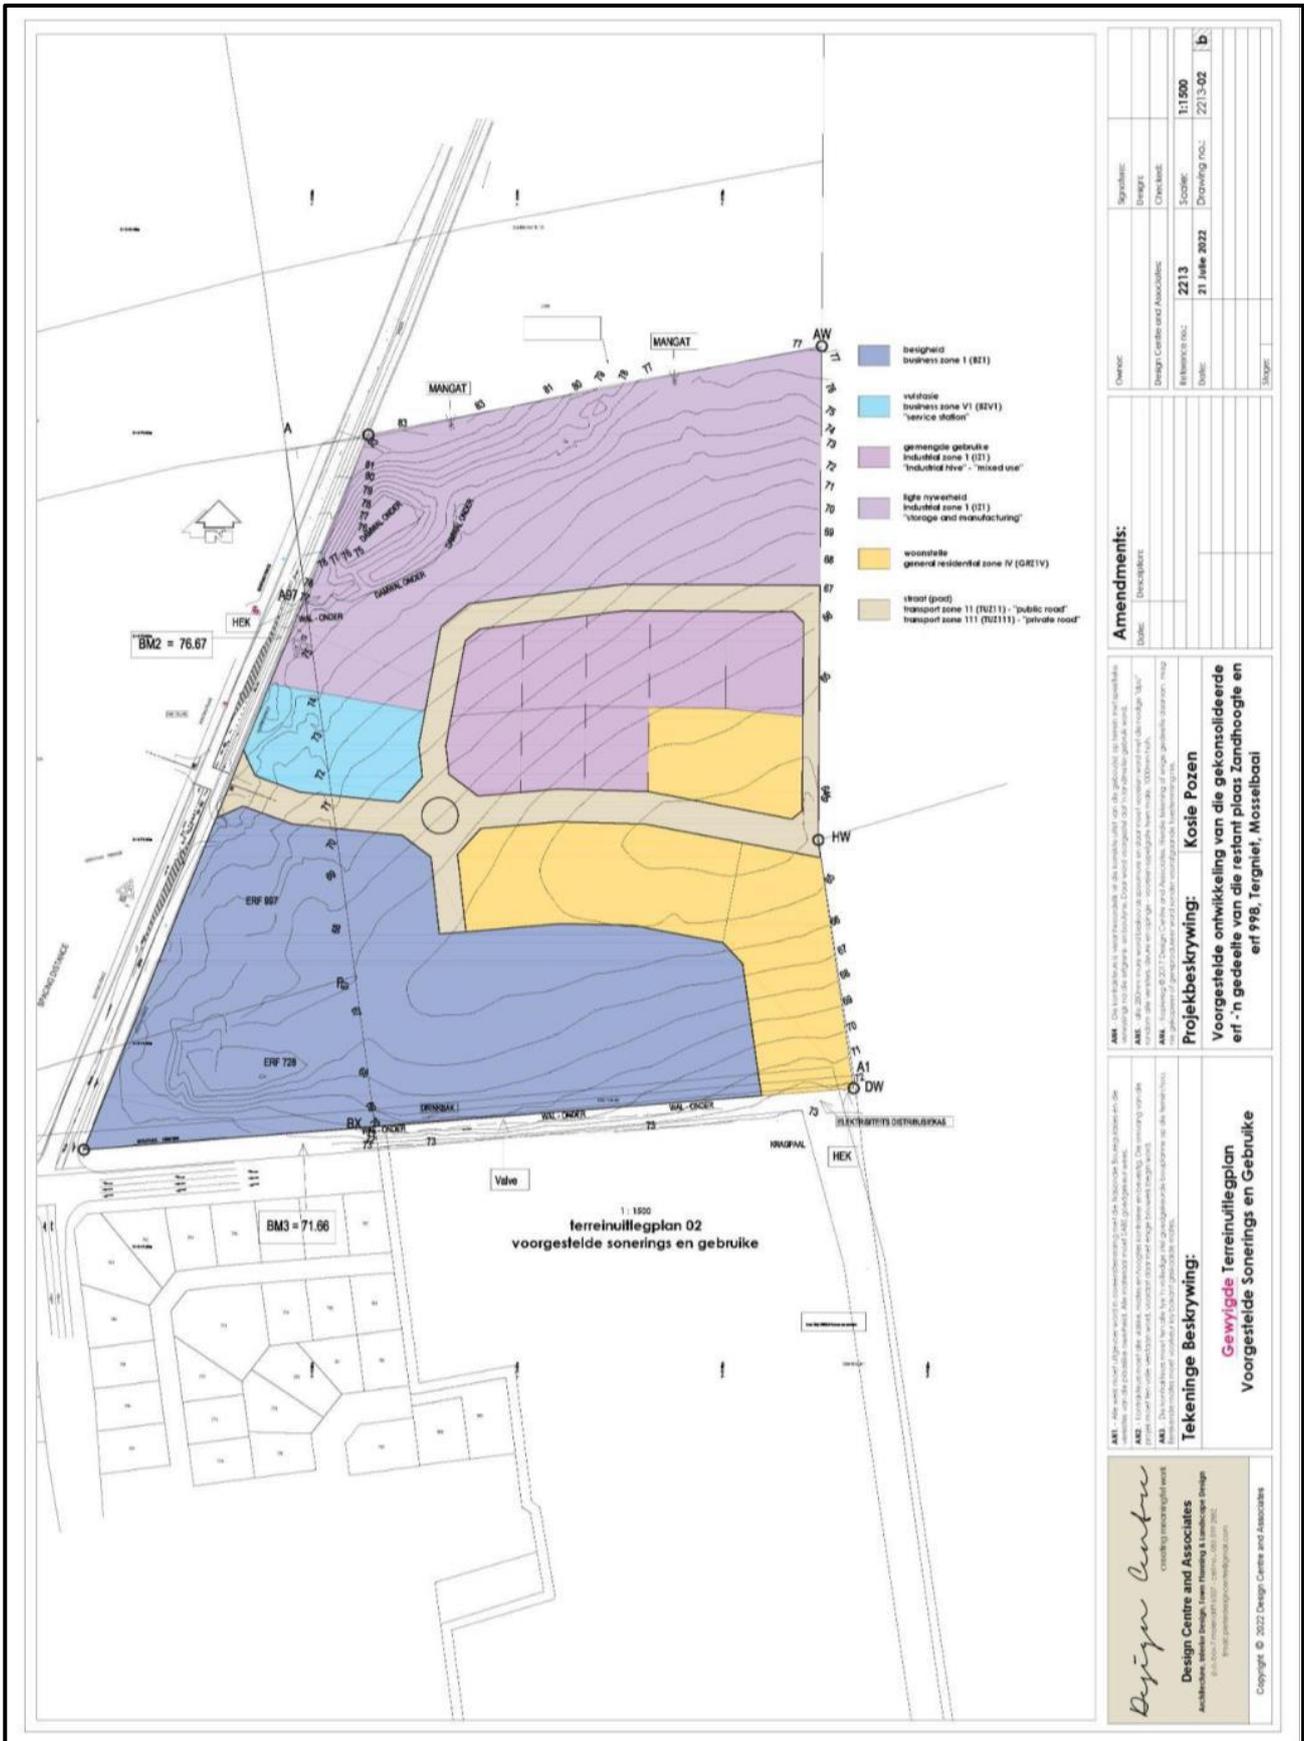
Figure 19 Proposed site development plan (SDP) for the study area under alternative A.

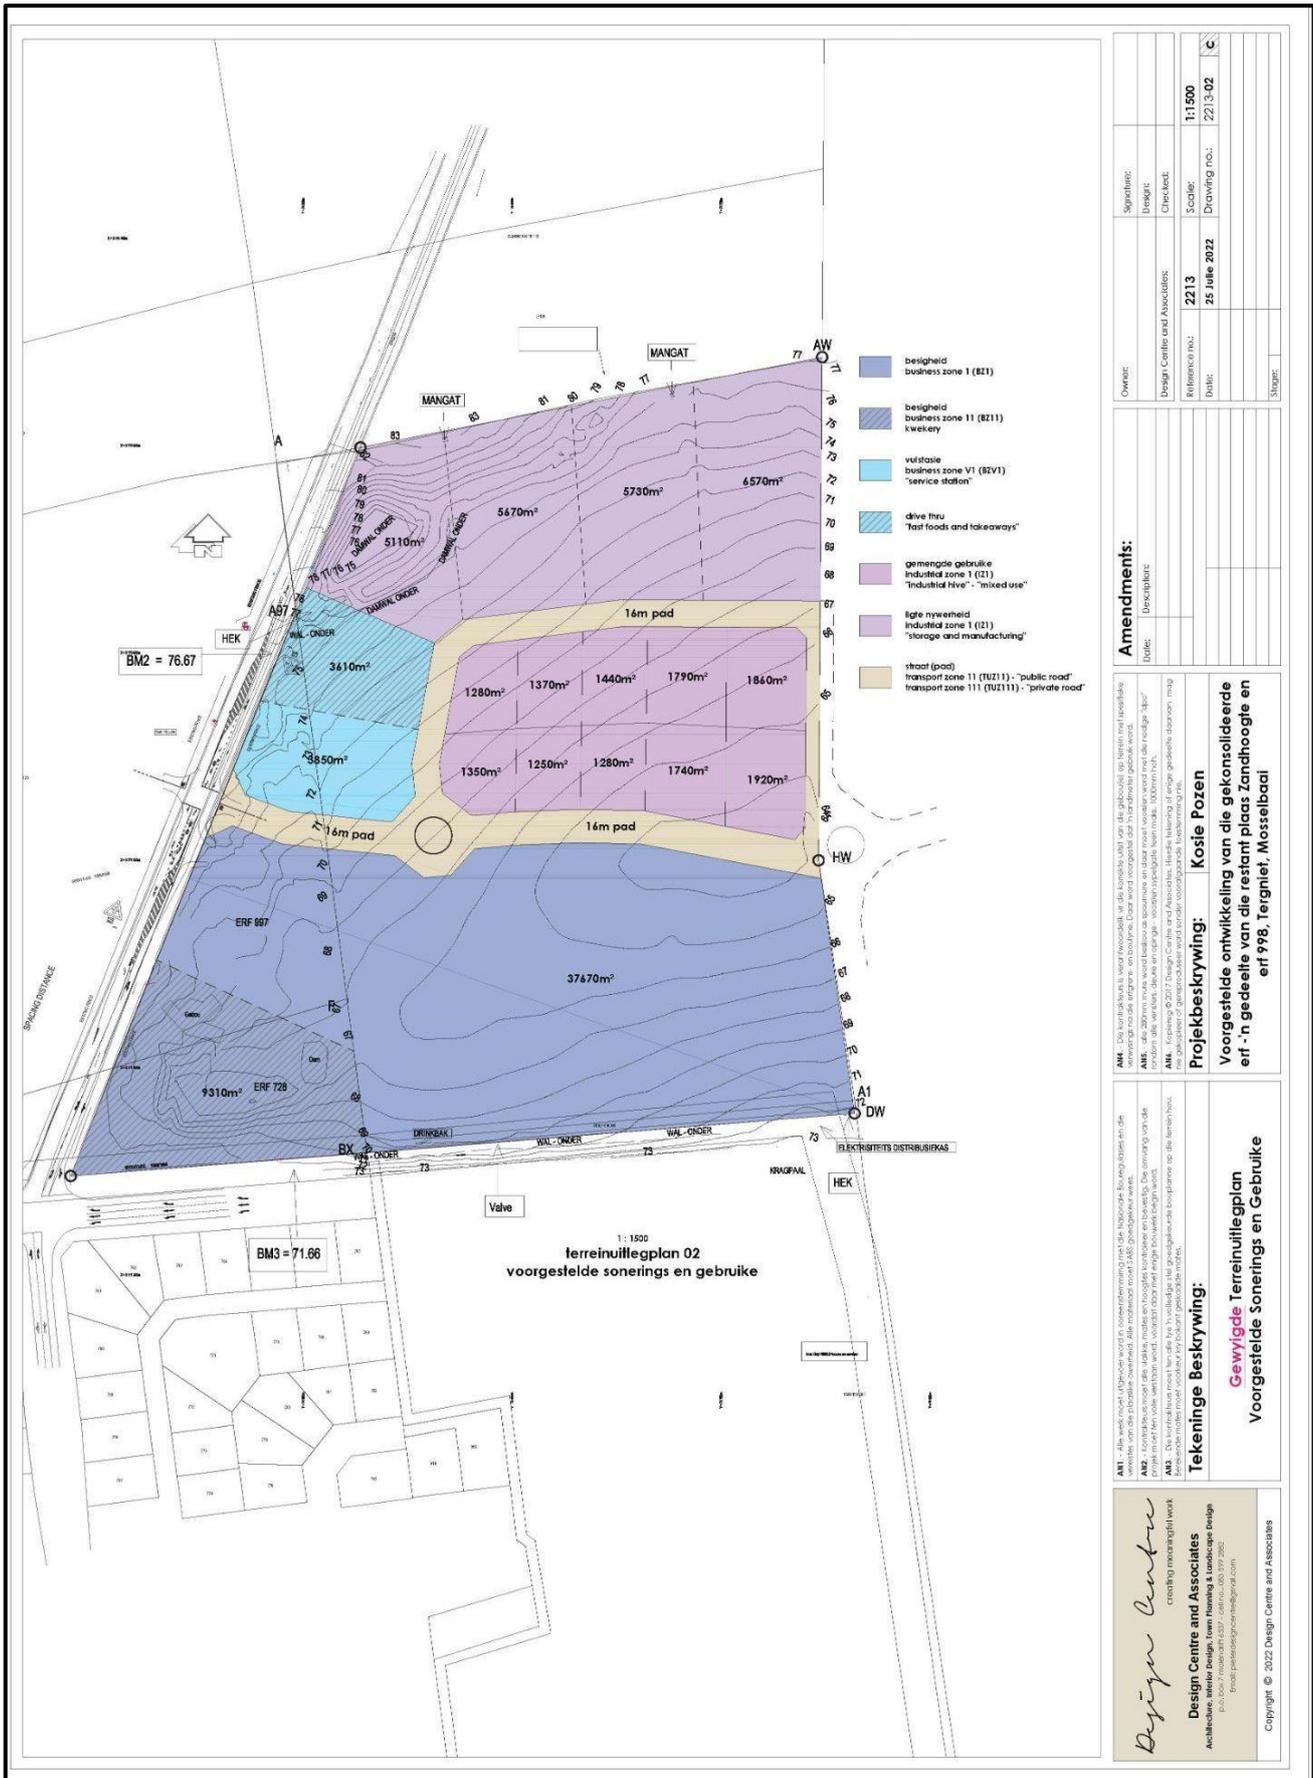
Figure 20 Proposed site development plan (SDP) for the study area under alternative B.
