SITE SPECIFIC ALIEN AND INVASIVE SPECIES MANAGEMENT PROGRAMME

FOR THE PROPOSED FLOOD DAMAGE REPAIRS TO THE LANGENHOVEN SUBSTATION ON THE REMAINDER OF ERF 464 (NEAR THE GEORGE PROVINCIAL HOSPITAL), GEORGE

DATE: 02 March 2026

DEA&DP REF.NO.: 16/3/3/1/D2/20/0009/26

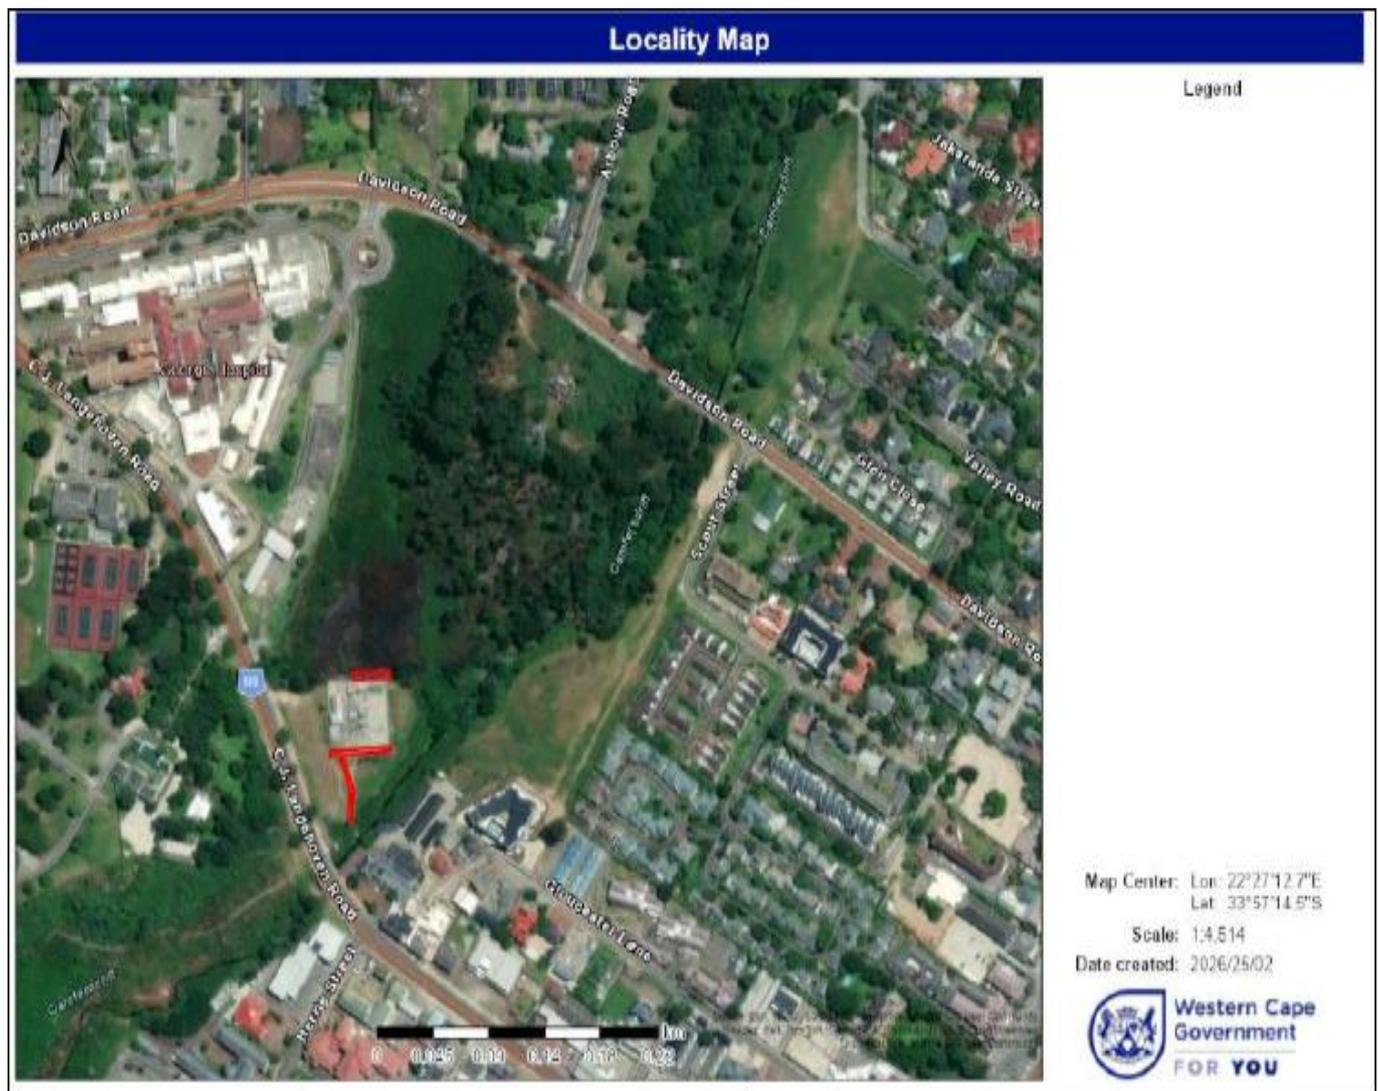
Figure 1: Locality of proposed flood damage repairs.

- Construct a gabion retaining structure (consisting of 2×1×1 m gabion baskets) on the northern side of the substation;
- Construct an earth V-drain along the southern edge of the substation; and
- Construct a trapezoidal grass swale with an outlet as close to the river as possible with energy dissipators to protect against erosion. Alternatively, construct a trapezoidal grass swale with a flared swale to spread the water out on the edge of the riverine scrub.

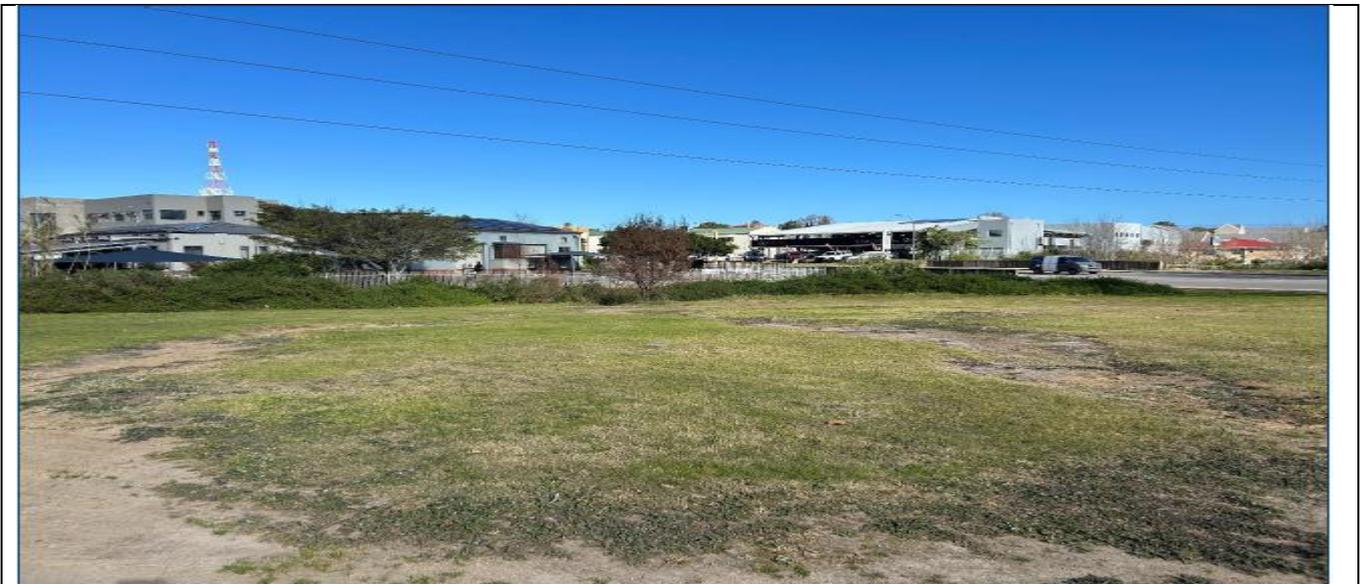
Figure 2: Grassy Area south of the substation and approximate route for the Trapezoidal grass swale

The area around the substation is highly transformed/modified, comprising a flat grassy area leading to the Camfersdrift River, and an embankment/impoundment on the northern side of substation. Most of the indigenous species recorded are associated with the riparian habitat next to the Camfersdrift River. However, the latter is also modified by past development activities. No proper fynbos was encountered, only some riparian scrub associated with the river. The quality of the latter is also poor due to a high presence of pioneers and invasive species. The rest of the site, including the embankment, is covered by grasses and weeds. The botanical attributes of the site are presented in the figures below:

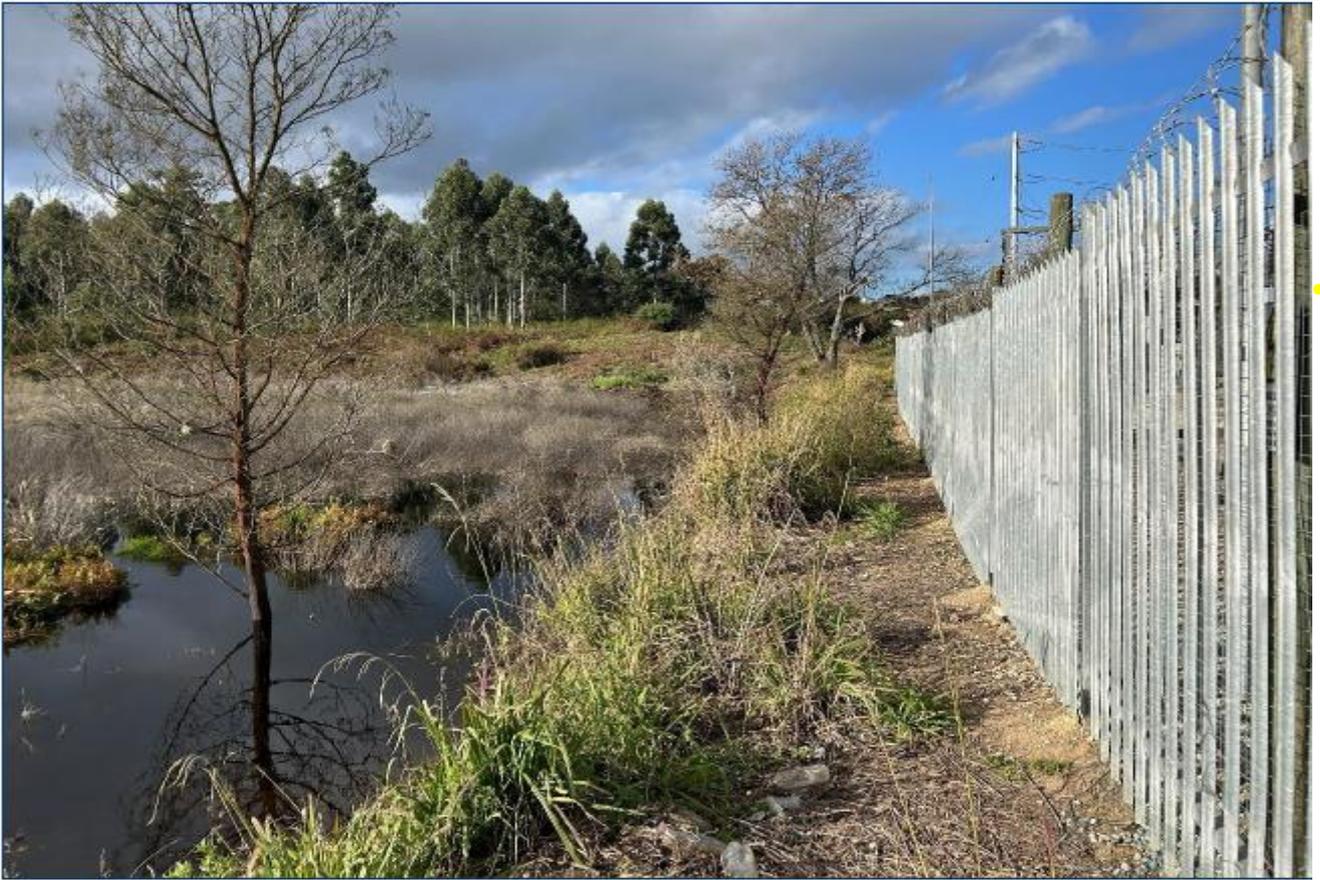
Figure 4: Embankment and impoundment on Northern Side of the Substation

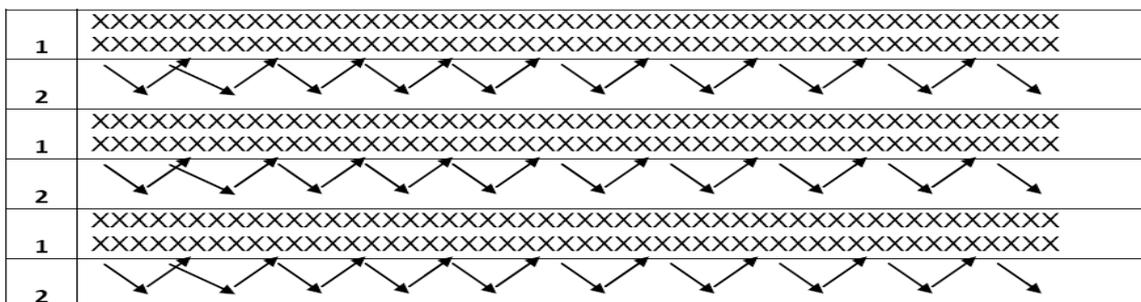
3.4 Team composition

- 6 persons, each being equipped with a lopping shear, bow saw and herbicide applicator, must first sweep through the area in individual lanes 5 metres apart. These persons target all plants less than 8 cm in basal diameter, felling, stacking and applying herbicide. De-branching should only be used to facilitate stacking of larger branches.
- 2 chainsaw operators thereafter follow through these lanes felling all plants more than 8 cm in basal diameter. Two assistants are responsible for stacking and herbicide application.
- For the denser areas, methodology must follow the illustration below. All rows are five metres wide. Swathes labelled 1 must be cut first and the debris placed back into these swathes. Thereafter debris generated in swathes labelled 2, must be placed into swathes labelled 1.

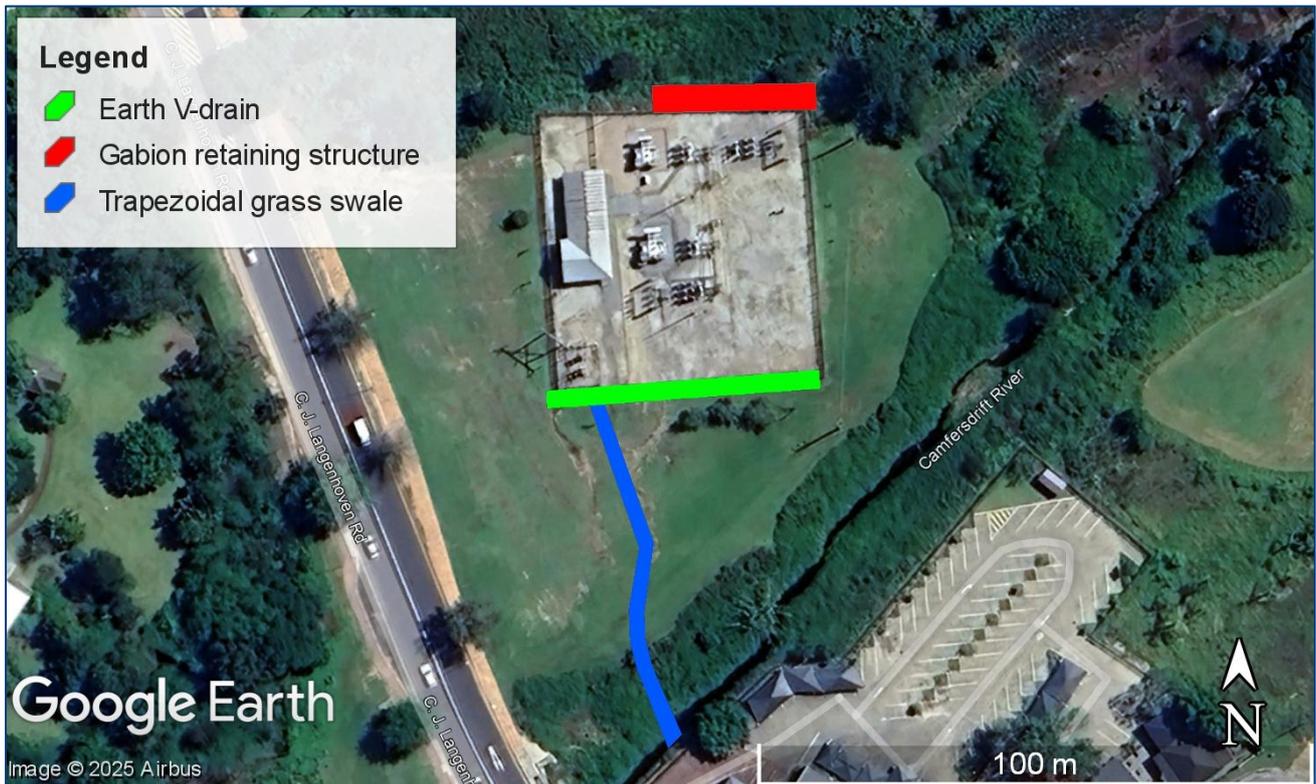
Figure 1-2: Proposed project layout.

The extent and scope of the proposed repair work include (**Figure 1-2**):

- Construct a gabion retaining structure (consisting of 2×1×1 m gabion baskets) on the northern side of the substation;
- Construct an earth V-drain along the southern edge of the substation; and
- Construct a trapezoidal grass swale with an outlet as close to the river as possible with energy dissipators to protect against erosion. Alternatively, construct a trapezoidal grass swale with a flared swale to spread the water out on the edge of the riverine scrub.
