Proposed Residential Development on Portion 1 of Farm 331 and Portion 4 of Farm Rheeboksfontein 142, Mid-Brak, Western Cape.

Aquatic Compliance Statement

Date: 24 November 2025

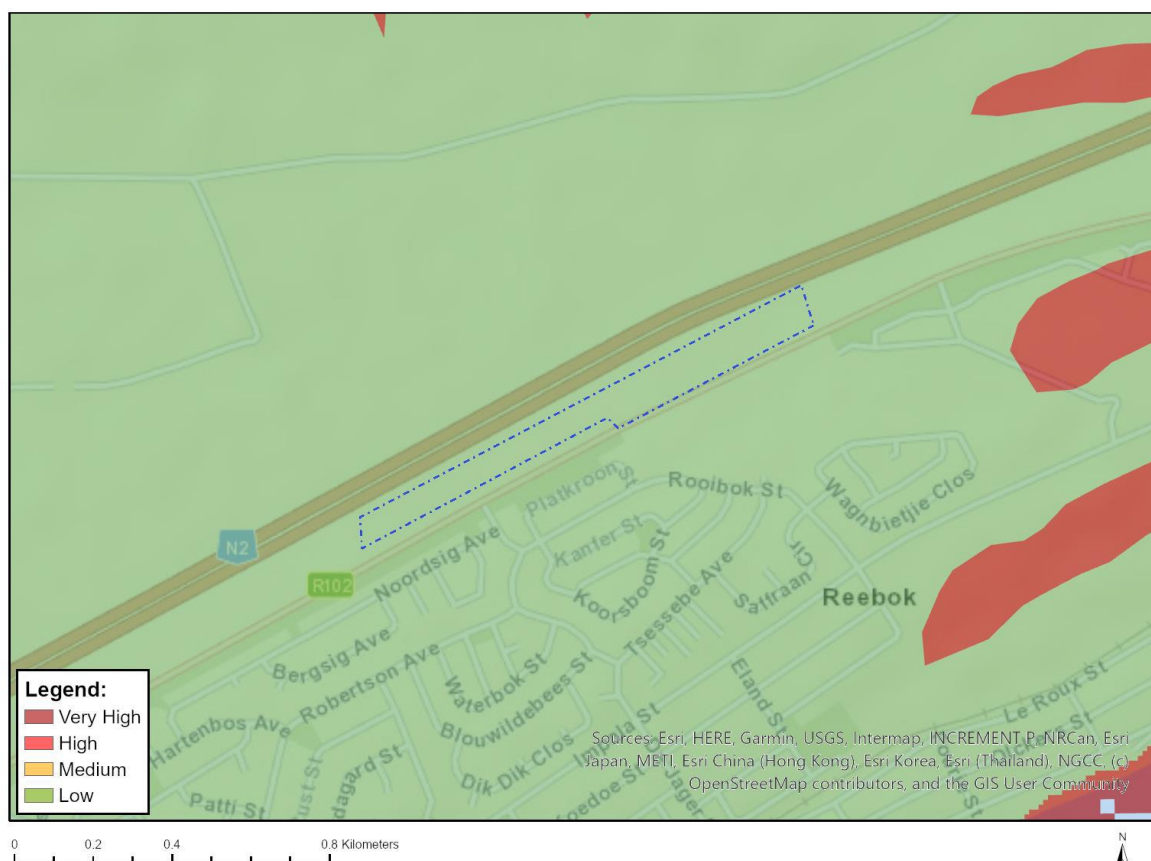
The screening tool classified the site as being of **Low** aquatic biodiversity (Figure 2). According to the protocol, a site sensitivity verification must be undertaken to confirm the sensitivity of the site as indicated by the screening tool.

Figure 2: Results of the DFFE Screening Tool, which indicate Low Sensitivity for the Aquatic Biodiversity theme for Portion 1 of Farm 331 and Portion 4 of Farm Rheebofsfontein 142.

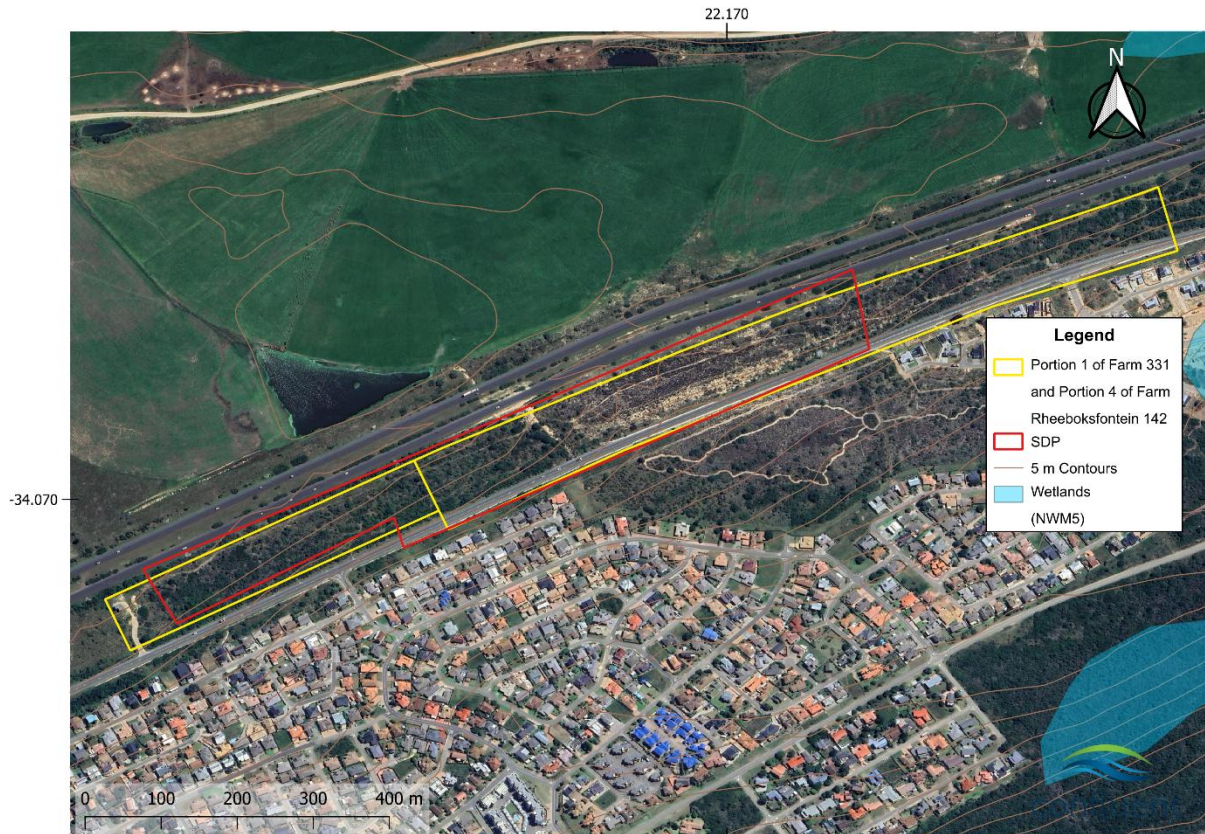
The property falls within Primary Catchment K (Kromme) area and in quaternary catchment K10F (Figure 3). According to geospatial data sources, no watercourses are present, adjacent to or within the property boundaries (Figure 4). No aquatic features have been included in the Western Cape Biodiversity Spatial Plan (WCBSP) covering the property. A terrestrial Critical Biodiversity Area 1 (CBA 1 - terrestrial) is mapped to extend across the entire property, with some small areas mapped as terrestrial Critical Biodiversity Area 2 (CBA 2 - terrestrial) (Figure 5).

Figure 4: Location of the property in relation to mapped watercourses.

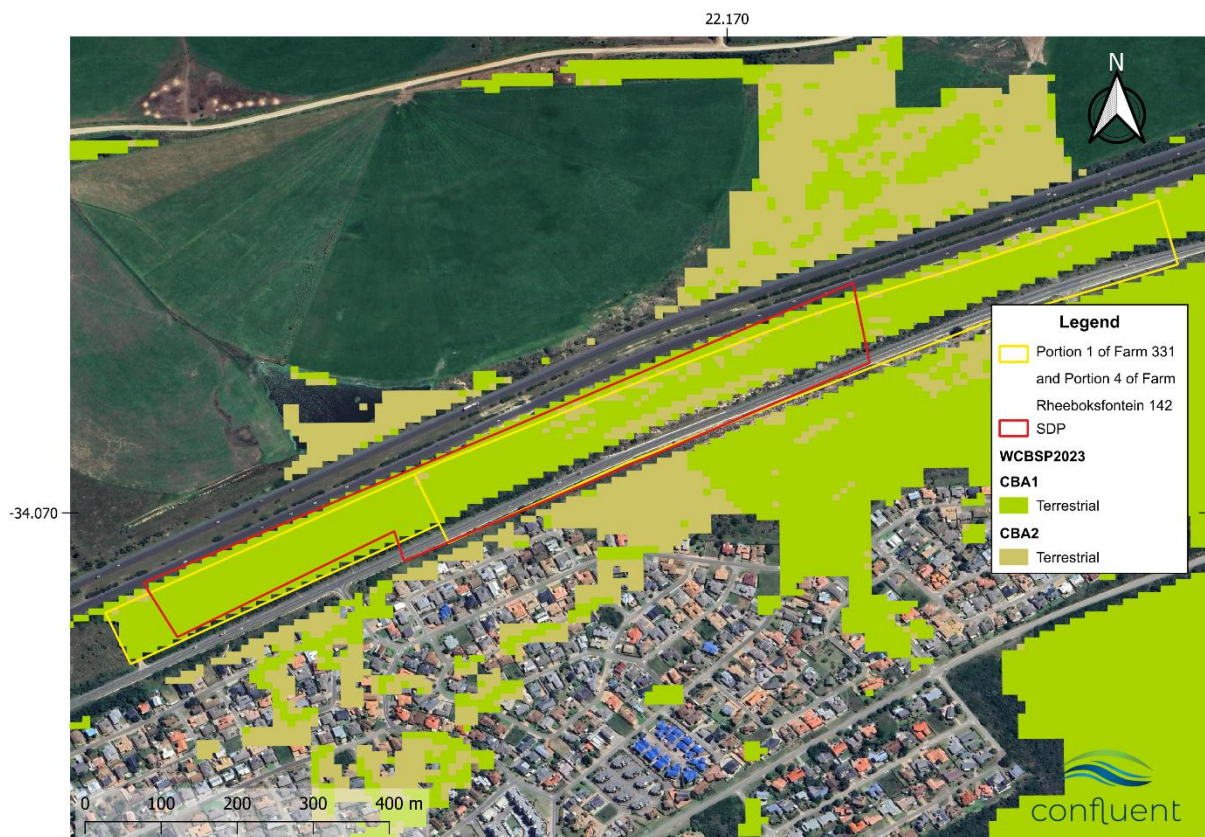
Figure 5: Map of the property relative to the Western Cape Biodiversity Spatial Plan (WCBSP).

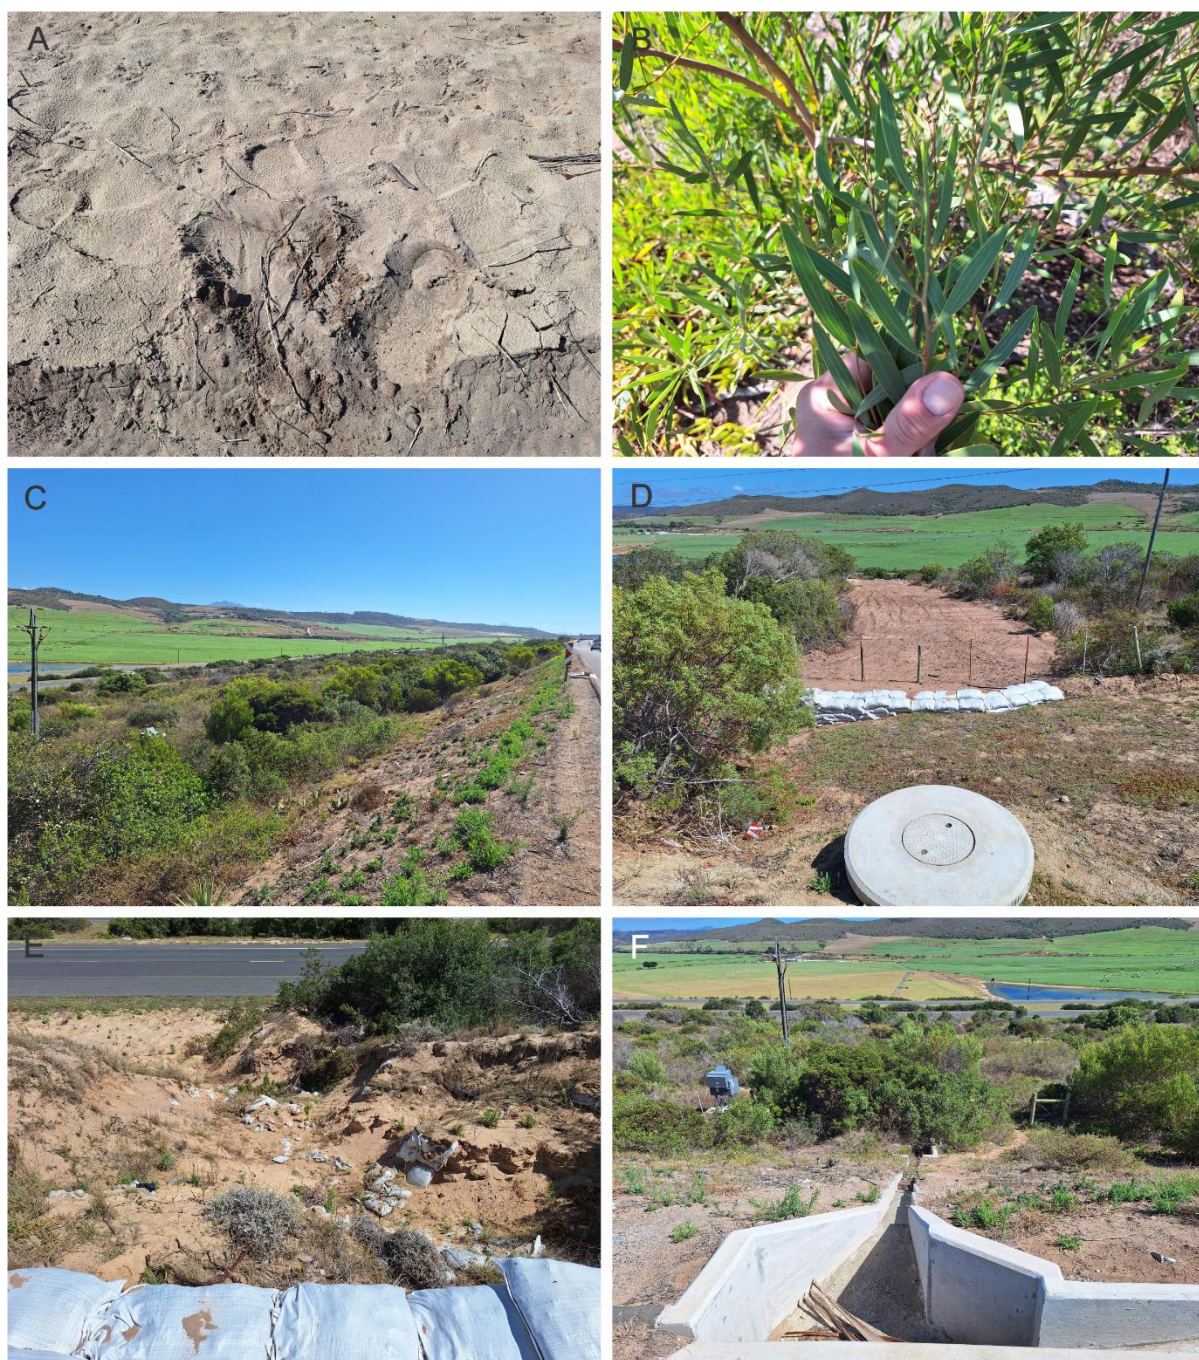
The site visit was conducted on the 7th of November 2025, during which time the entire extent of the proposed development footprint was traversed on foot. The terrain of the property is relatively flat, with the eastern side sloping gently towards the north. A relatively steep slope is present along the southern boundary of the property, sloping down from the R102 towards the property (northwards). The soil on the property is very sandy (Figure 7: A) and does not show any signs of water retention. The property was largely covered by indigenous vegetation with some invasives that included, but were not limited to, Rooikraans (*Acacia cyclops*; Figure 7: B) and Goosefoot (*Chenopodium* sp). The vegetation on the property is Thicket, and includes, but is not limited to; *Searsia lucida*, *Carpobrotus* sp., *Sideroxylon inerme* (milkwood tree), *Pittosporum viridiflorum* (Cape Cheesewood), *Grewia occidentalis*, *Osteospermum moniliferum*, and *Helichrysum patulum* (Figure 7: C). A noticeable vegetation change occurs in the approximate centre of the property, with this section being dominated by *Thamnochortus* sp. for approximately 436 m, before changing back to the previously described vegetation characteristic. No hydro-geomorphological landscape features (depressions, confined valleys, channels etc.) indicating the presence of a watercourse (i.e. stream, river or wetland) are present within or near the property.

It should be noted that stormwater management is an aspect that must be carefully considered, as there is a large eroded section present in the centre of the SDP, visible from satellite imagery and confirmed during the site visit (Figure 7: D and E). It was apparent that efforts were made to address the problem by building a sandbag wall on the south (upslope) and north (downslope) of the property and filling in the eroded area. However, prominent erosion is present, cutting underneath and existing concrete channel on either side of the downslope point of the eroded area, adjacent to the N2. This erosion is most likely caused by stormwater from the R102 that discharges onto the property. It should be noted that multiple culverts from the R102 and the developed area south of the property discharge onto the property (Figure 7: F).

Figure 7: Photographs of the property, including very sandy soil on the property (A), Rooikraans present on the property (B), vegetation on the property (C), upslope of erosion area (D), erosion still present and expanding, downslope of erosion area (E) and a culvert draining onto the property (F).

A key impact related to the development is the generation of large volumes of stormwater associated with an increased area of impermeable surfaces created by the development. Taking the current erosion into account, the addition of harden surfaces on the property will exacerbate the current erosion area as well as create additional erosion areas on the property.

It is therefore important that stormwater generated on-site should be managed according to Sustainable Drainage System (SuDS) principles. This requires that as much stormwater as possible should be attenuated within the development footprint. For example, the City of Cape Town guideline is that developments must provide for 24-hour extended detention of the 1-year return interval 24-hour storm event. In this respect, the following measures, *inter alia*, should be considered: (City of Cape Town stormwater management plan).

- Rainwater harvesting tanks must be installed where possible;
- Use of swales and detention ponds to attenuate stormwater runoff, encourage infiltration and reduce the speed, energy and volumes at which stormwater is discharged from the;
- Use of permeable paving to encourage infiltration into the soil, if the parking in front of the filling station is to be paved; and
- Use of retention ponds and artificial wetlands to capture stormwater runoff, prevent its discharge from the site and attenuate pollutants.

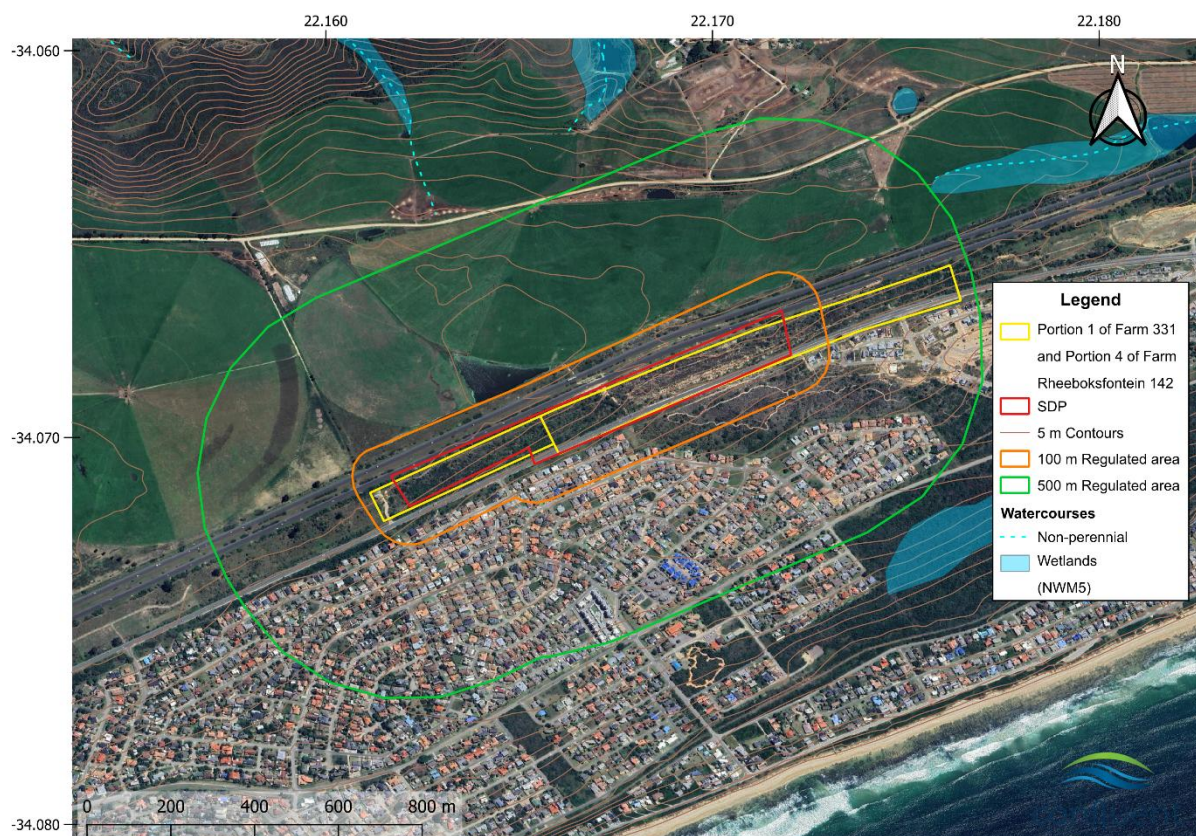
Given the information obtained from the desktop study and the observation during the site visit, the aquatic biodiversity sensitivity is considered to be **Low** as no watercourse is present on the property. In terms of legislation pertaining to the NWA, the development falls outside of the regulated area of any watercourses (Figure 8) and will therefore not require any water use authorisation in terms of **Section 21 (c) and (i)** of the NWA.

Figure 8: Map indicating the 100 m and 500 m regulated areas relative to the SDP on the property.

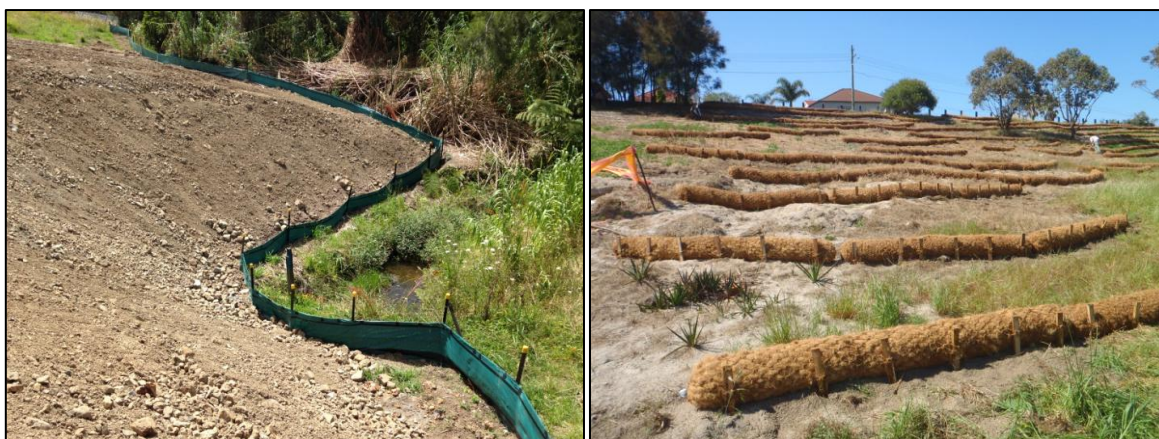
- Ensure that construction activities do not cause any preferential flow paths and concentrated surface runoff during rainfall events.
- Clearly demarcate the construction area and ensure that heavy machinery does not compact soil or disturb vegetation outside of these demarcated areas.
- Reduce transport of sediment through use of structures such as silt fences and biodegradable coir logs placed along a contour below the development footprint (Figure 9).

Figure 9: Examples of silt fences (left) and coir logs (right) used to trap sediment mobilised from steep slopes.
