# Heritage Statement

**Proposed Culvert Replacements, DR1633 km 3.35 and Site 8  
DR1602 km 8.5, Jonkersberg Area, Varings River, Mossel Bay  
Municipality, Garden Route District, Western Cape Province**

21 February 2024  
Revised with inputs on the 27<sup>th</sup> of February 2025

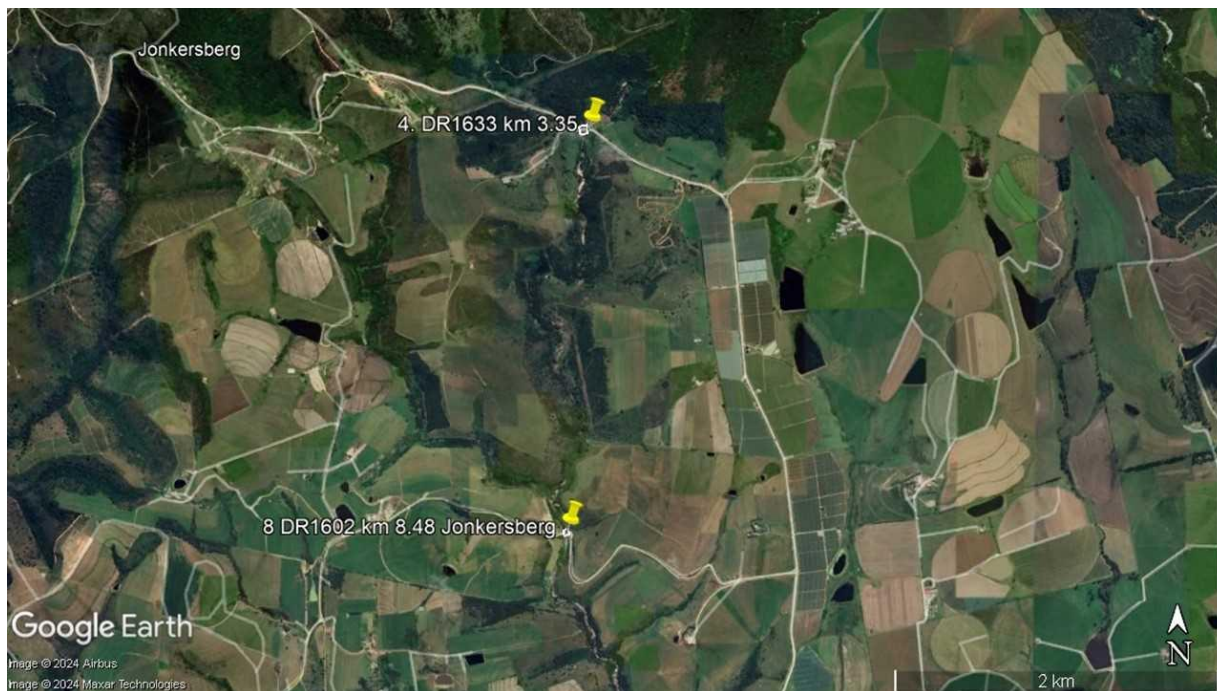
Figure 2. Enlarged from Figure 1 showing Sites 4 & 8 (labelled yellow marker) in the Jonkersberg area, Western Cape. Courtesy of Cape Google Earth 2022. (A4 version below)

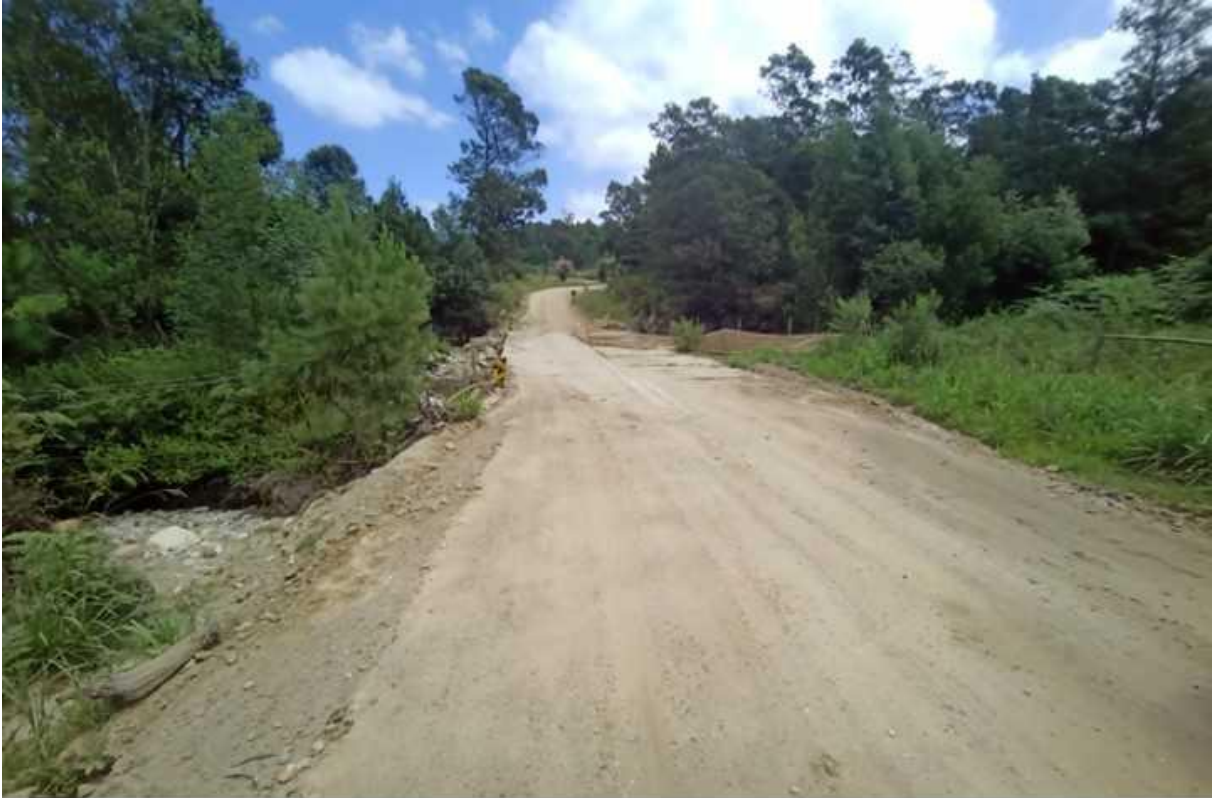
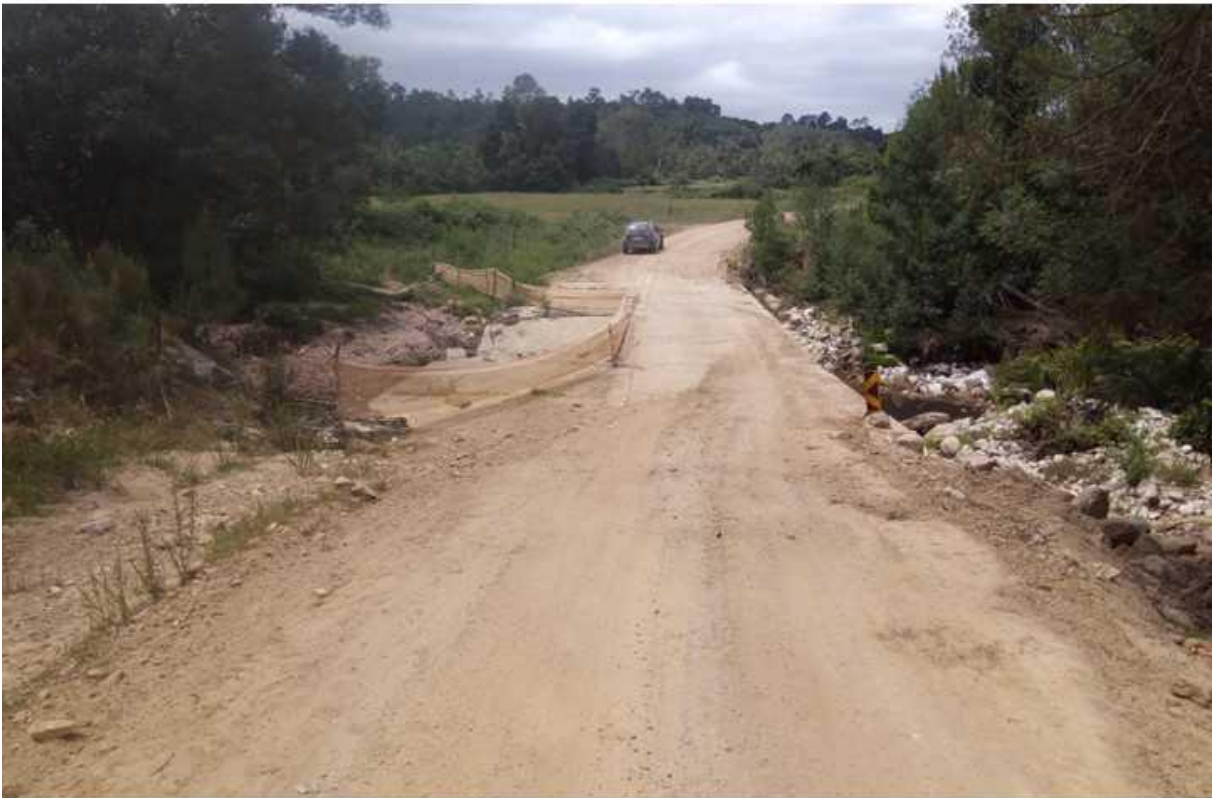
Figure 4. Site 4 and immediate surroundings viewed from the East (top) and viewed from the West (bottom).

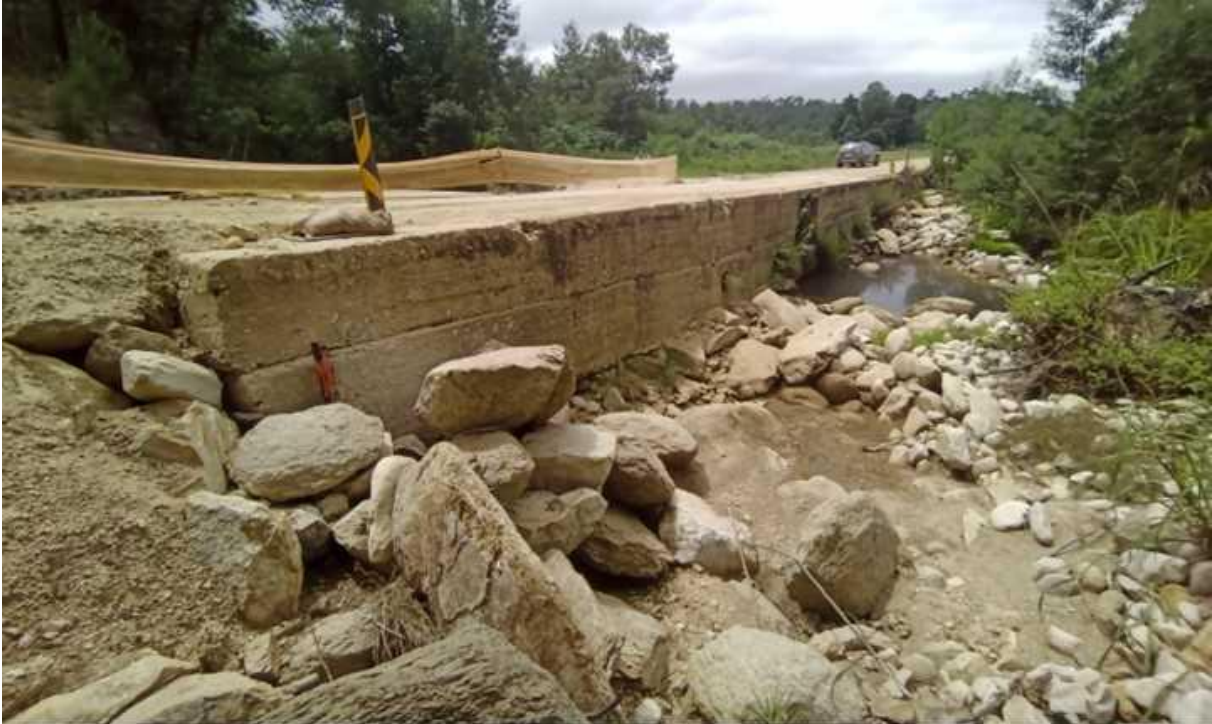
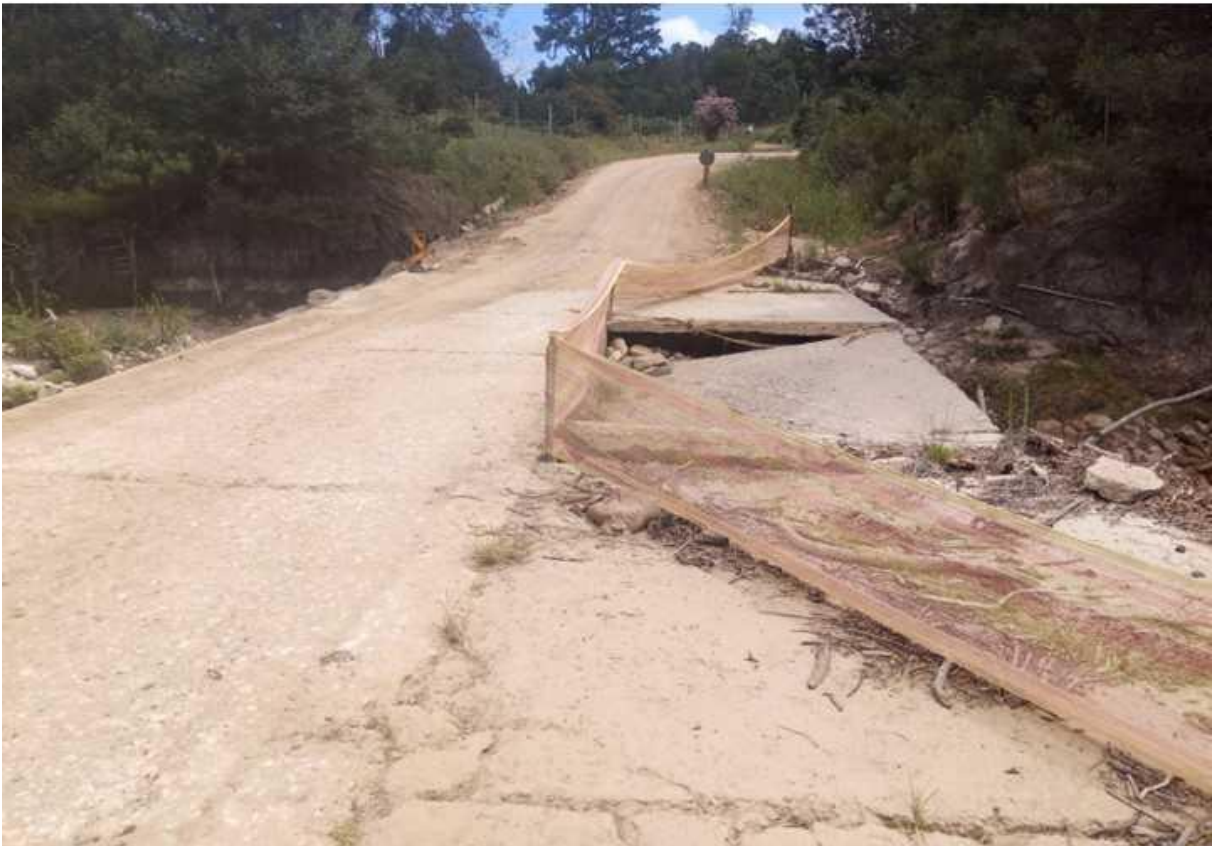
Figure 5. Site 4 - showing the causeway, flood damage, and immediate surroundings viewed from the West (top) and viewed from the East (bottom).

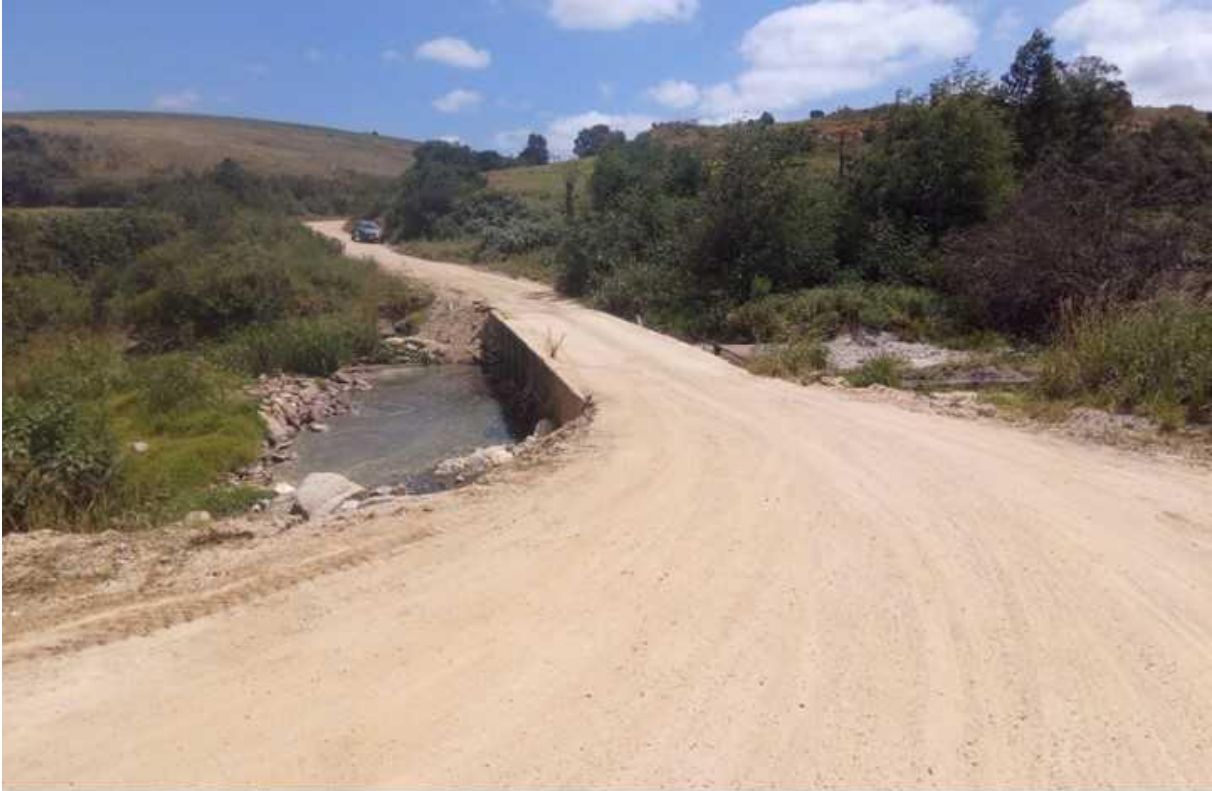
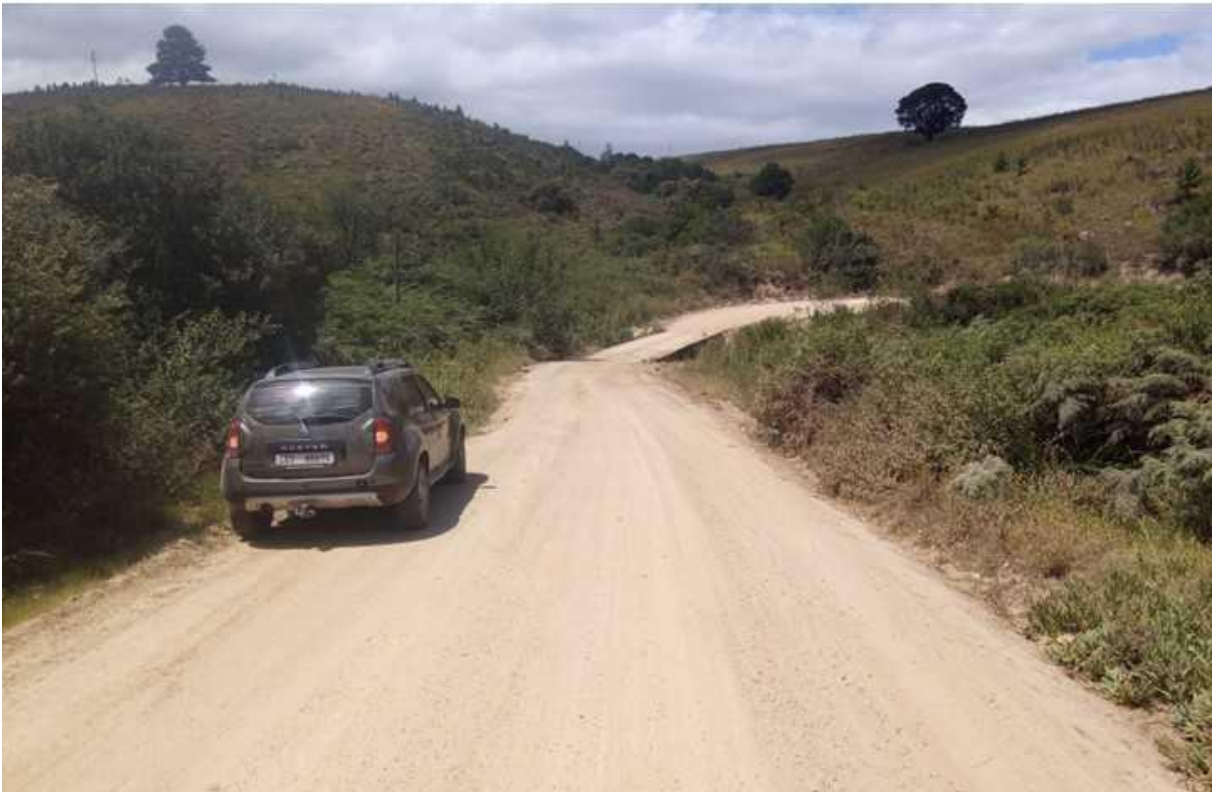
Figure 6. Site 8 and immediate surroundings viewed from the East (top) and viewed from the West (bottom).

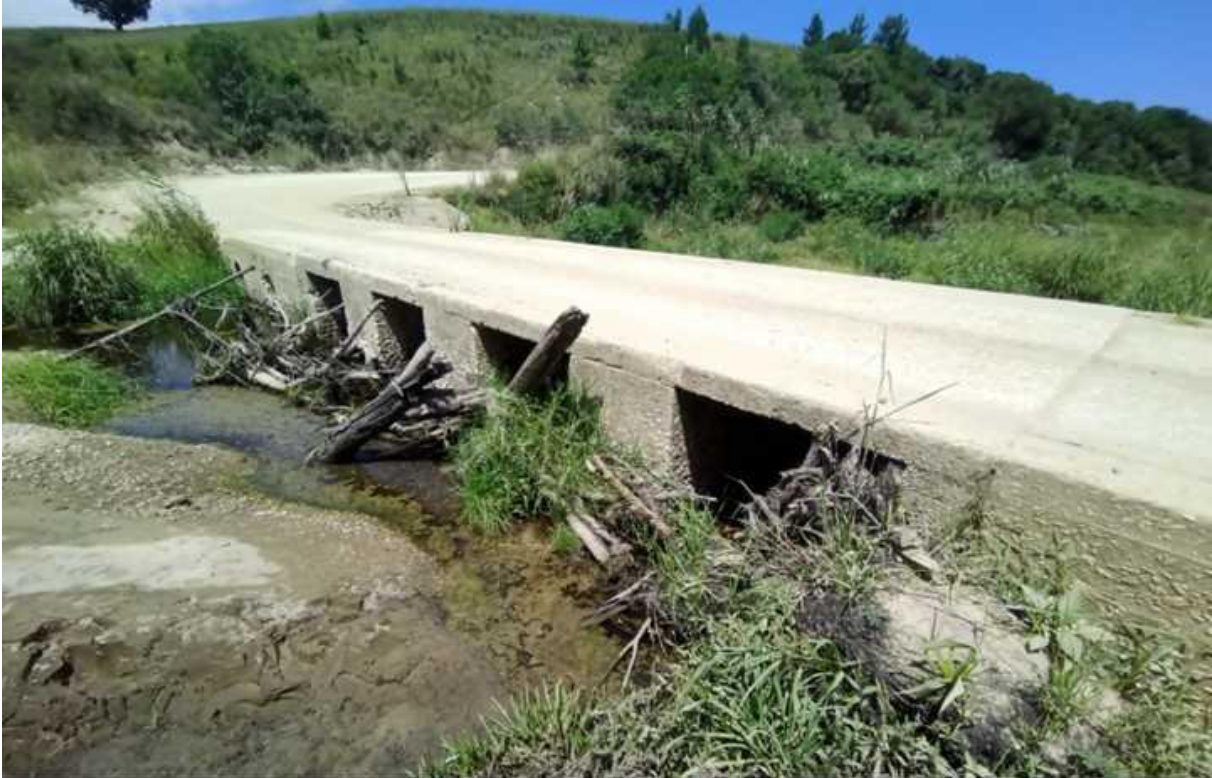
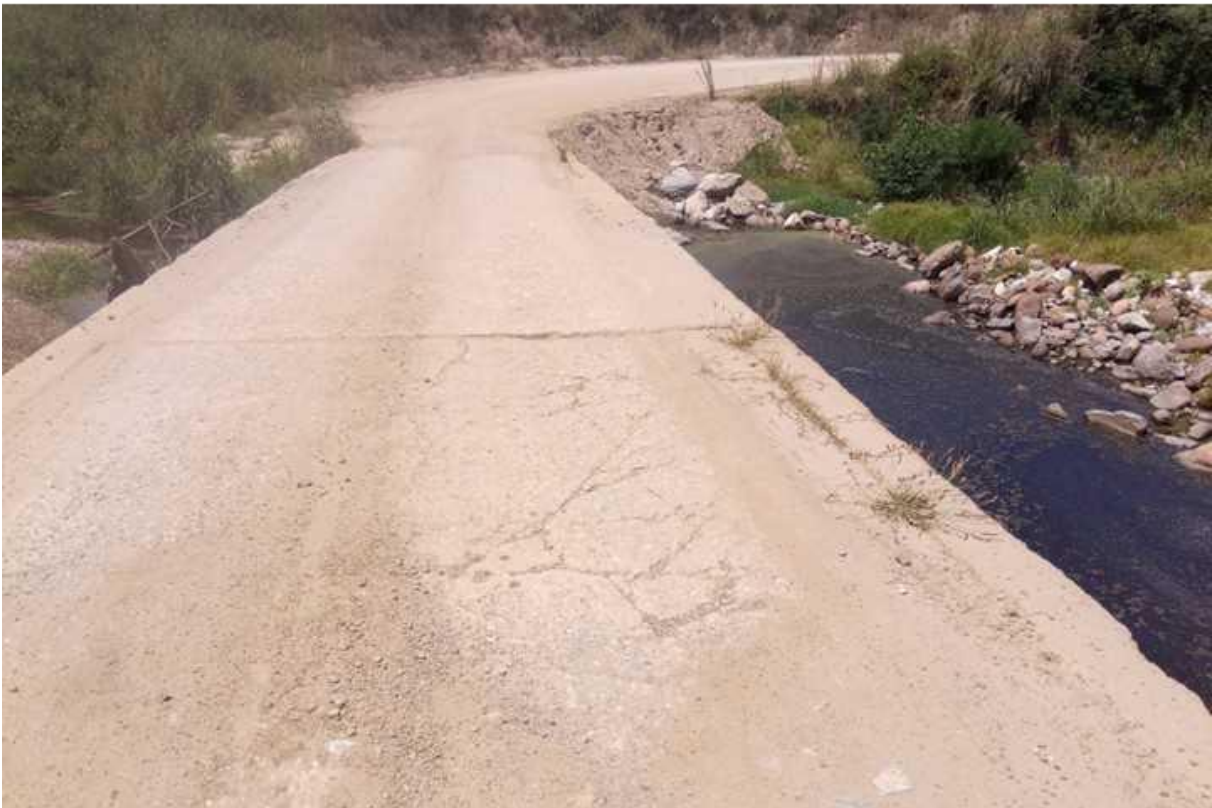
Figure 7. Site 8 - showing the causeway and damage.

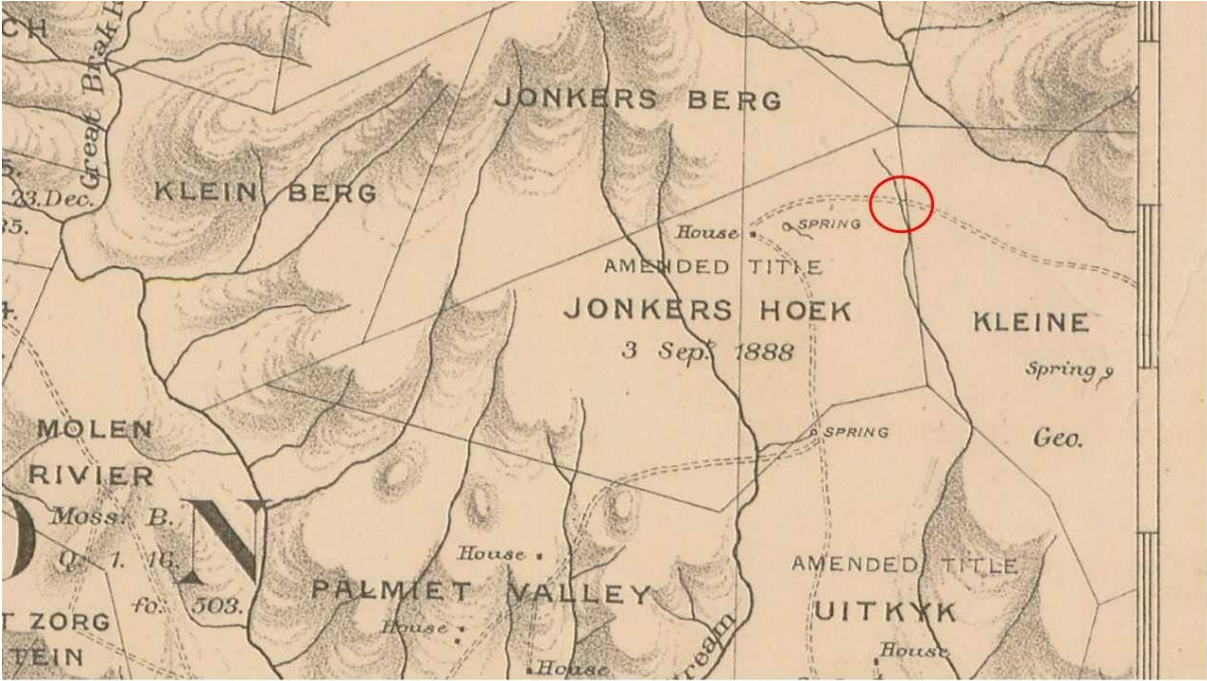
Because the proposed activities do not trigger the NHRA nor the need for a NID application to HWC, historic aerial photographs were not obtained or consulted for this report. A cursory examination of the 1880 – 1890 SG mapping of Oudtshoorn shows an old road at Site 4, but

no other heritage-related structures or features are indicated at either of the sites nor in their immediate surroundings (Figure 8). Given the above, no information pertaining to colonial period ownership and land use of Sites 4 and 8 are presented here as the affected areas have been road reserves for some time.

Figure 8. Enlarged portion of Oudtshoorn Map 1880-1890 (NGSI - DALRR) showing Site 4 with red circle. Note old road at Site 4.

The road and causeway at Site 4 is certainly older than 60 years (Figure 8) while those at Site 8 are likely older than 60 years, but neither have any structural features of heritage value. Given the existing transport infrastructure at both sites, any archaeological or palaeontological resources that may have occurred in the affected area are disturbed by human-related activities, imported sediments, and damage from water erosion. No archaeological or heritage resources of colonial or pre-colonial origin were identified within the study area or in its immediate vicinity. No fossil-bearing sediments were seen.

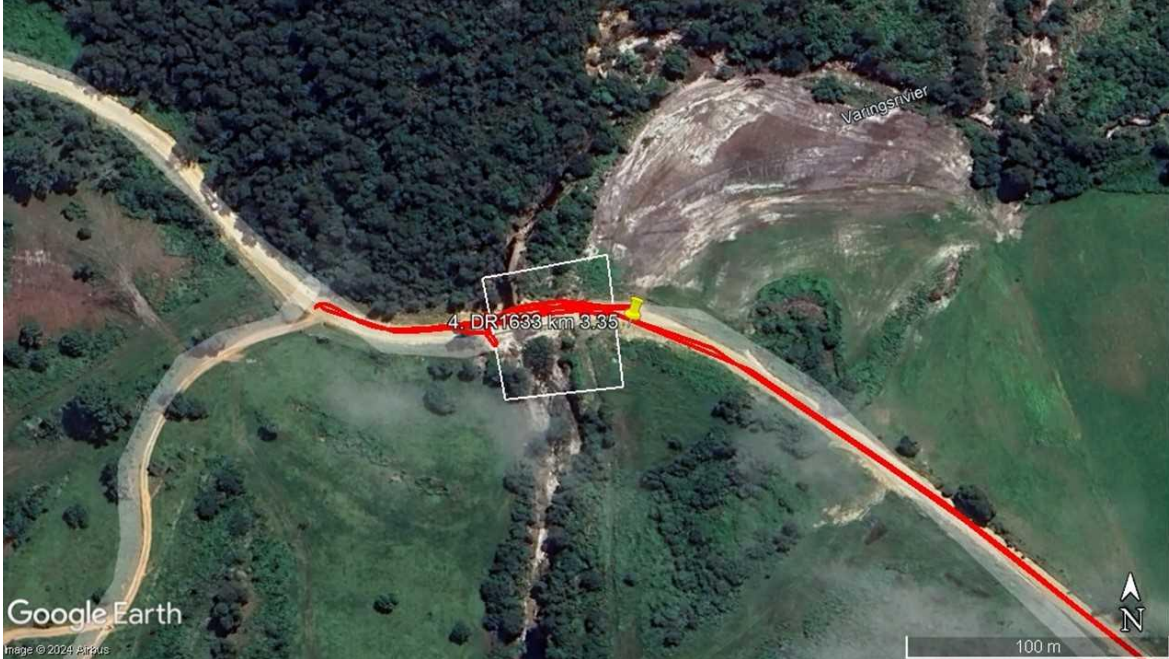
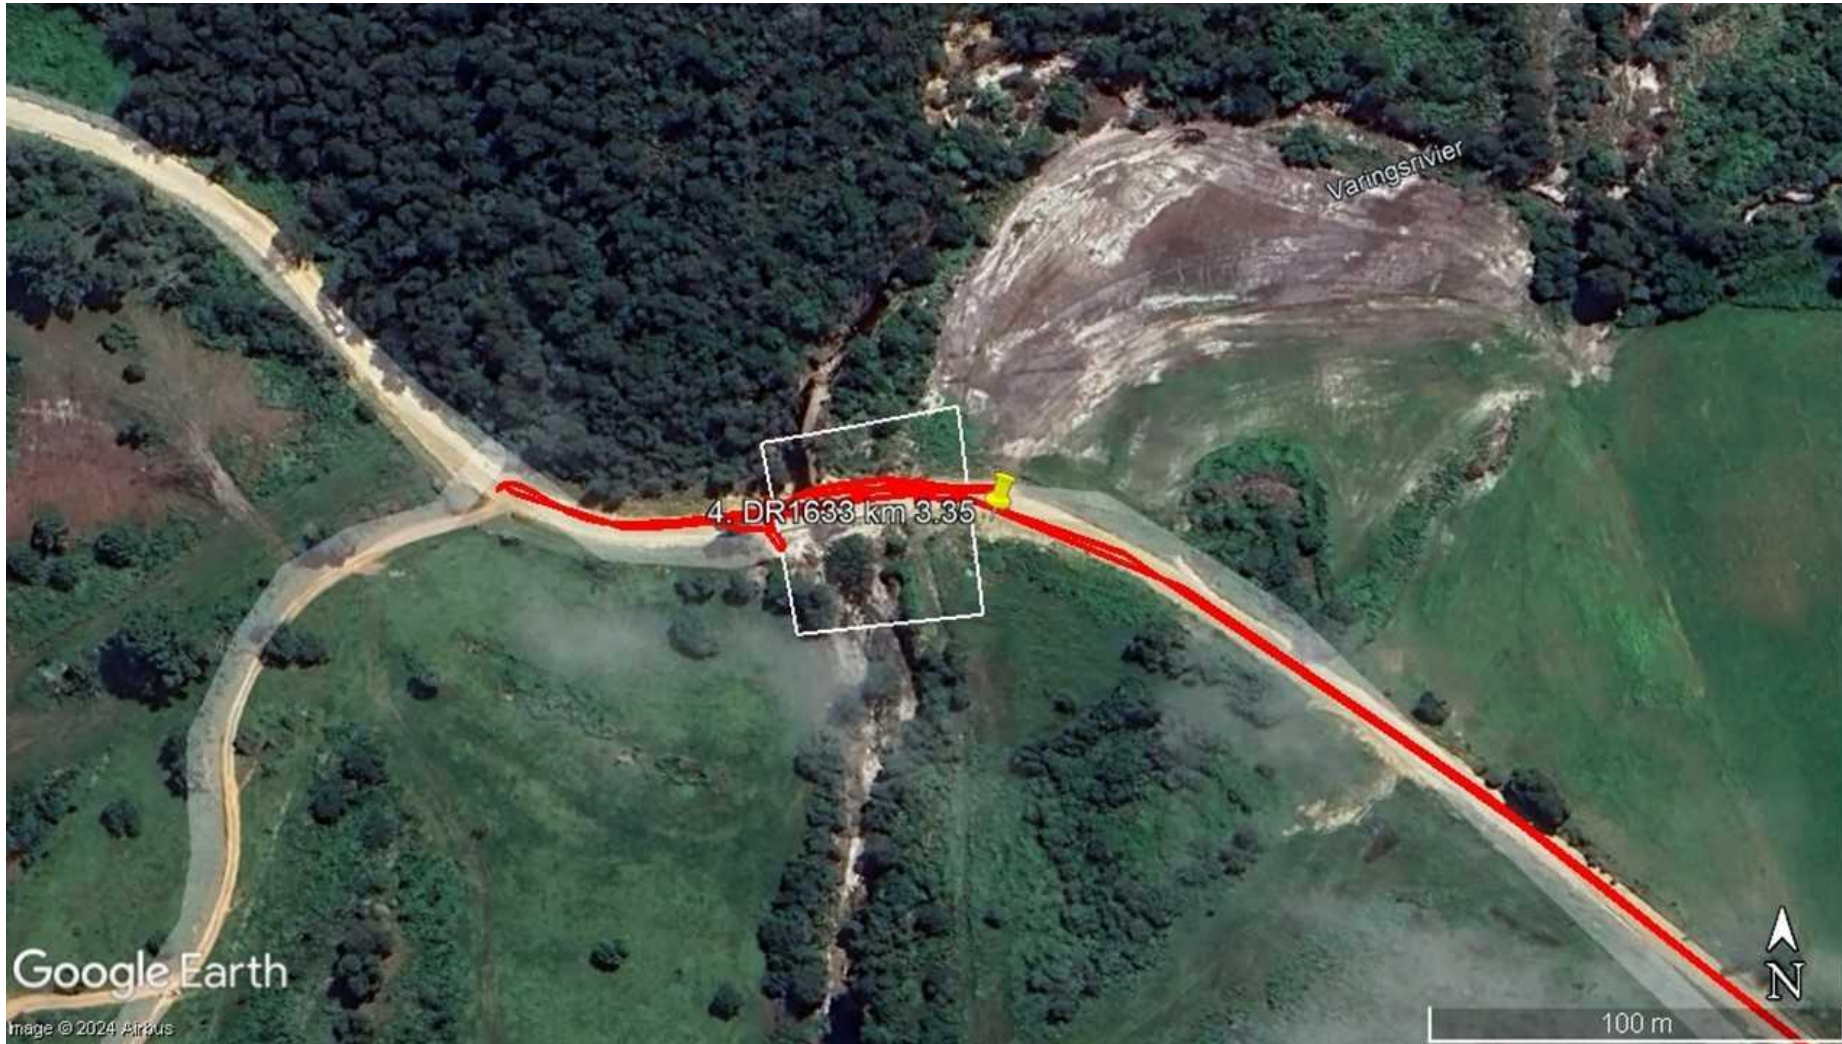
Survey tracks and observations were fixed with a handheld Garmin Etrex 30x GPS to record the investigated areas (Figures 9 and 10). A high quality, comprehensive digital photographic record was made with a DooGee S86 mobile phone, including location data for photographs. All GPS and photographic data are available on request.

Figure 9. Site 4 (yellow marker and white rectangle) with GPS-fixed survey tracks (red lines). (A4 version below).

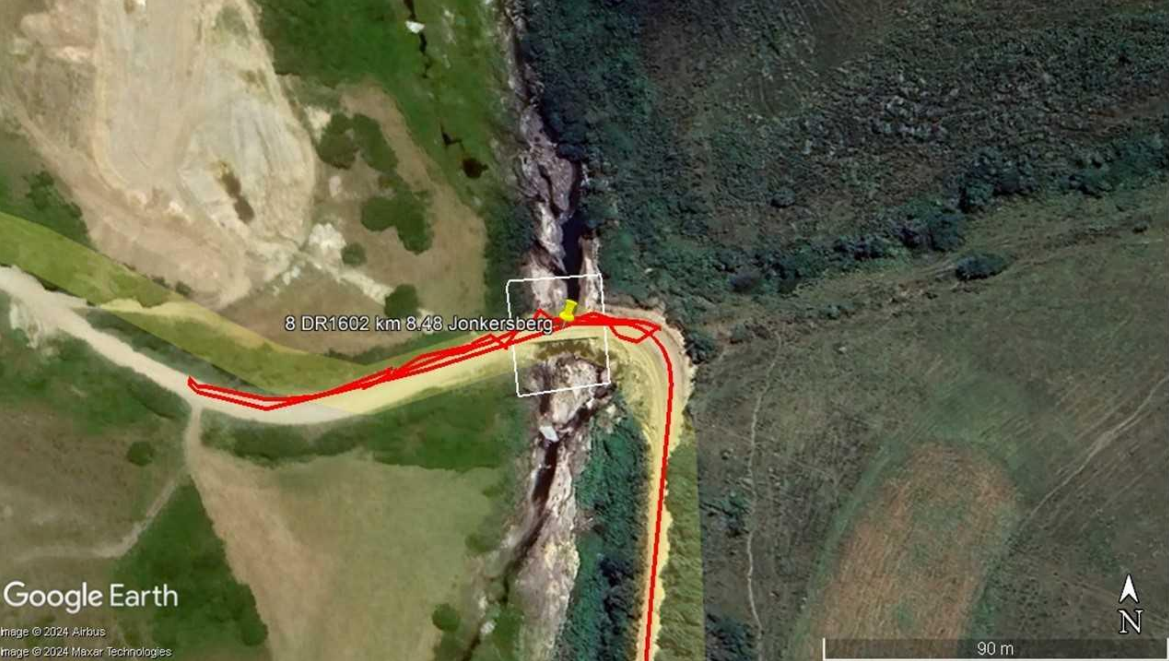
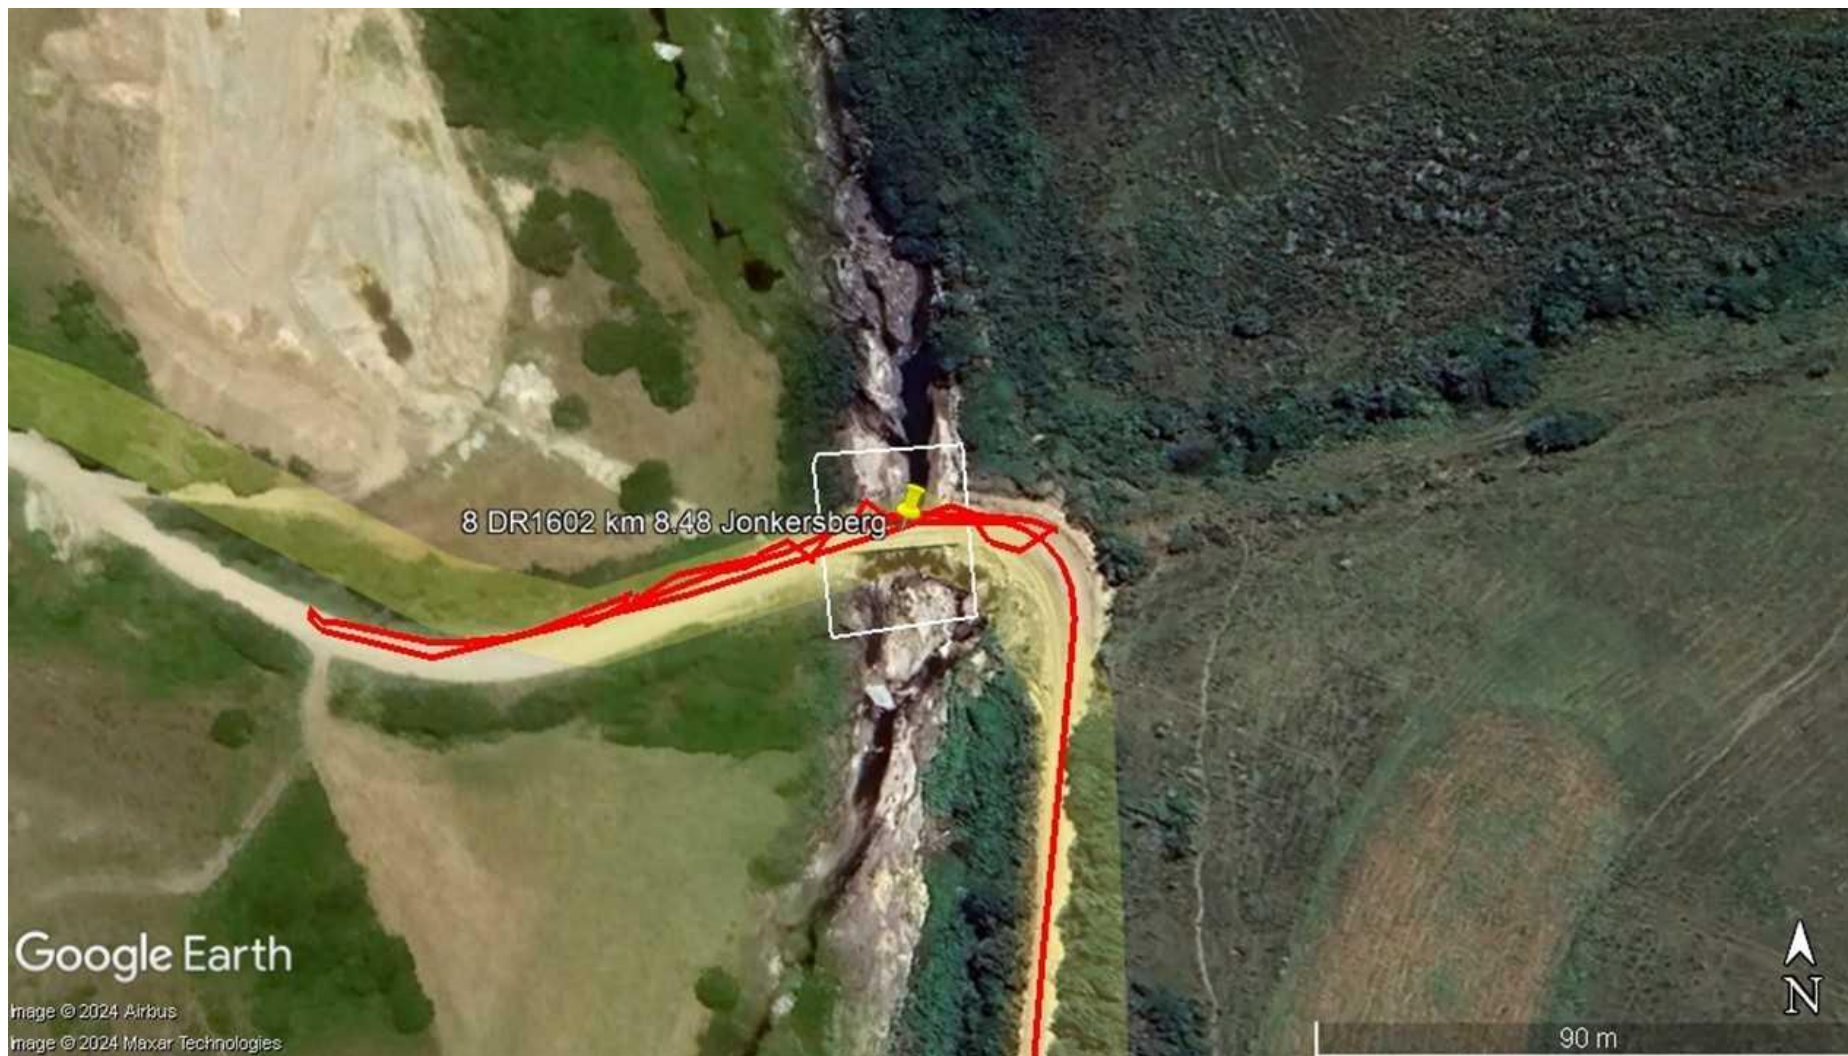
Figure 10. Site 8 (yellow marker and white rectangle) with GPS-fixed survey tracks (red lines). (A4 version below).

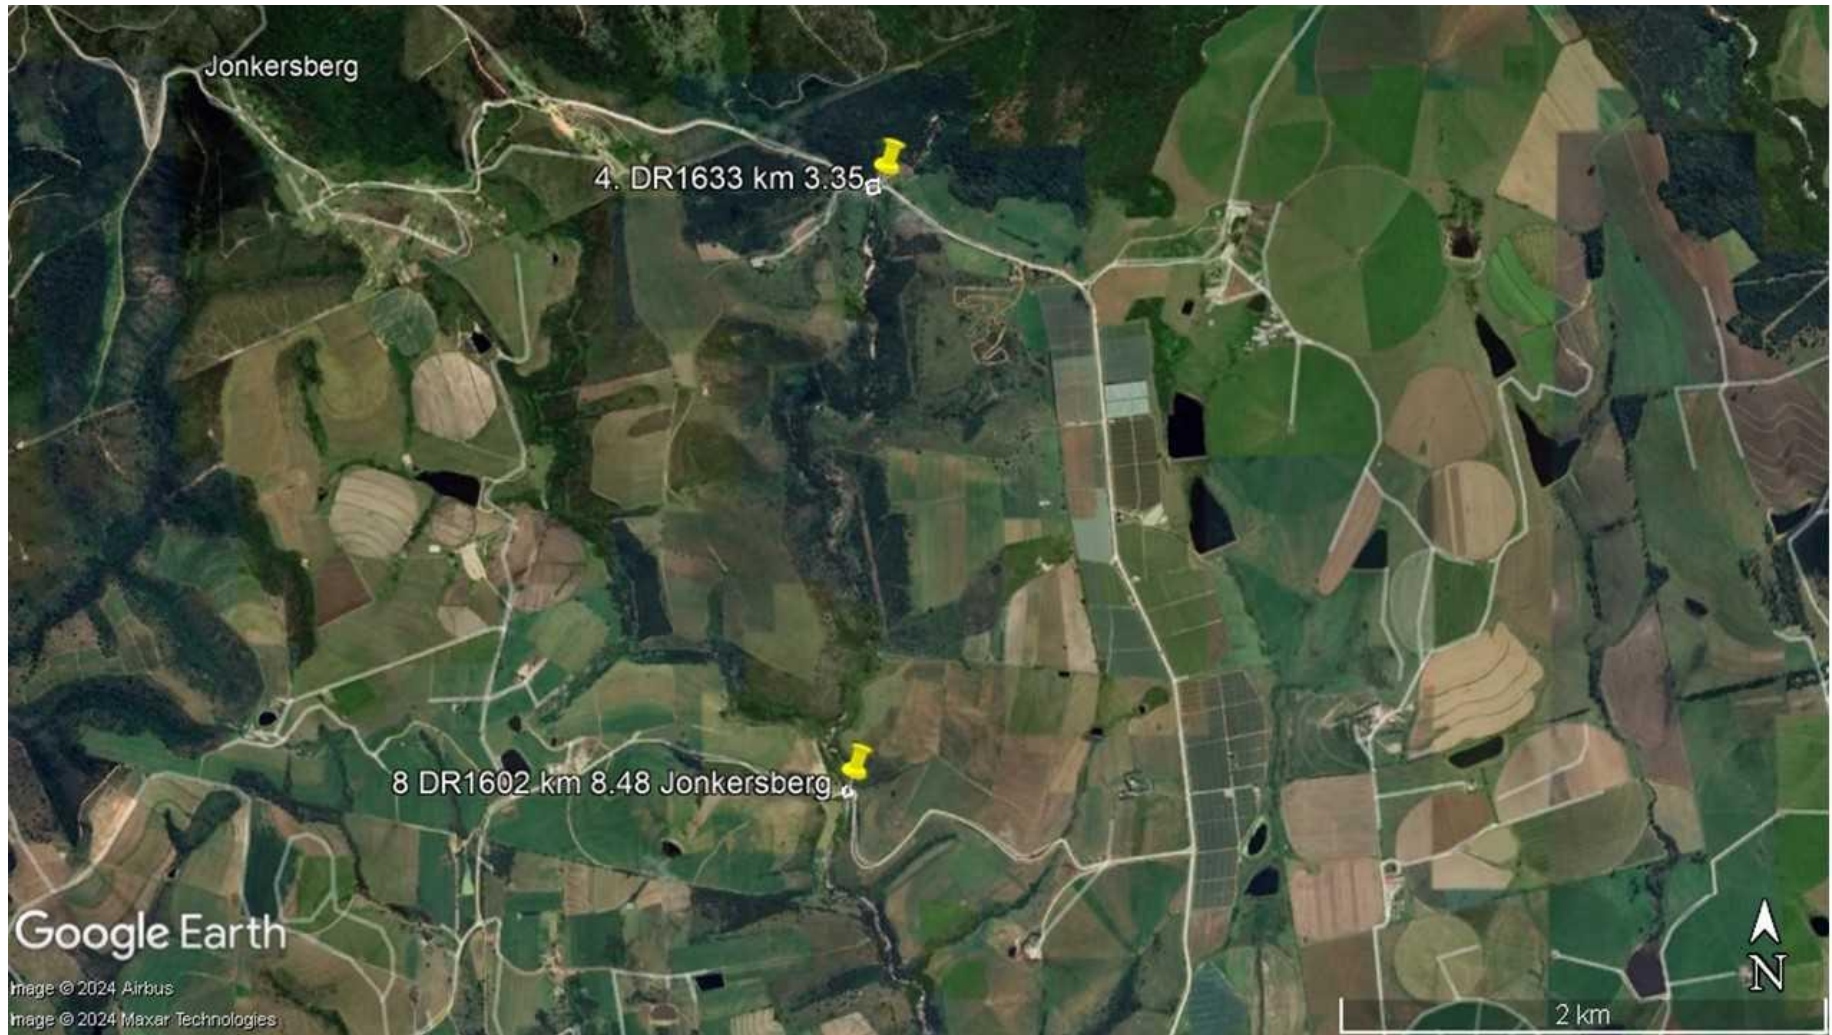
Figure 2. Enlarged from Figure 1 showing Sites 4 & 8 (labelled yellow marker) in the Jonkersberg area, Western Cape. Courtesy of Cape Google Earth 2022.
