EXTERNAL ENVIRONMENTAL AUDIT - THEMBALETHU PUMP STATION NO. 06 AND NEW RISING MAIN

PREPARED FOR:
SES Environmental Services

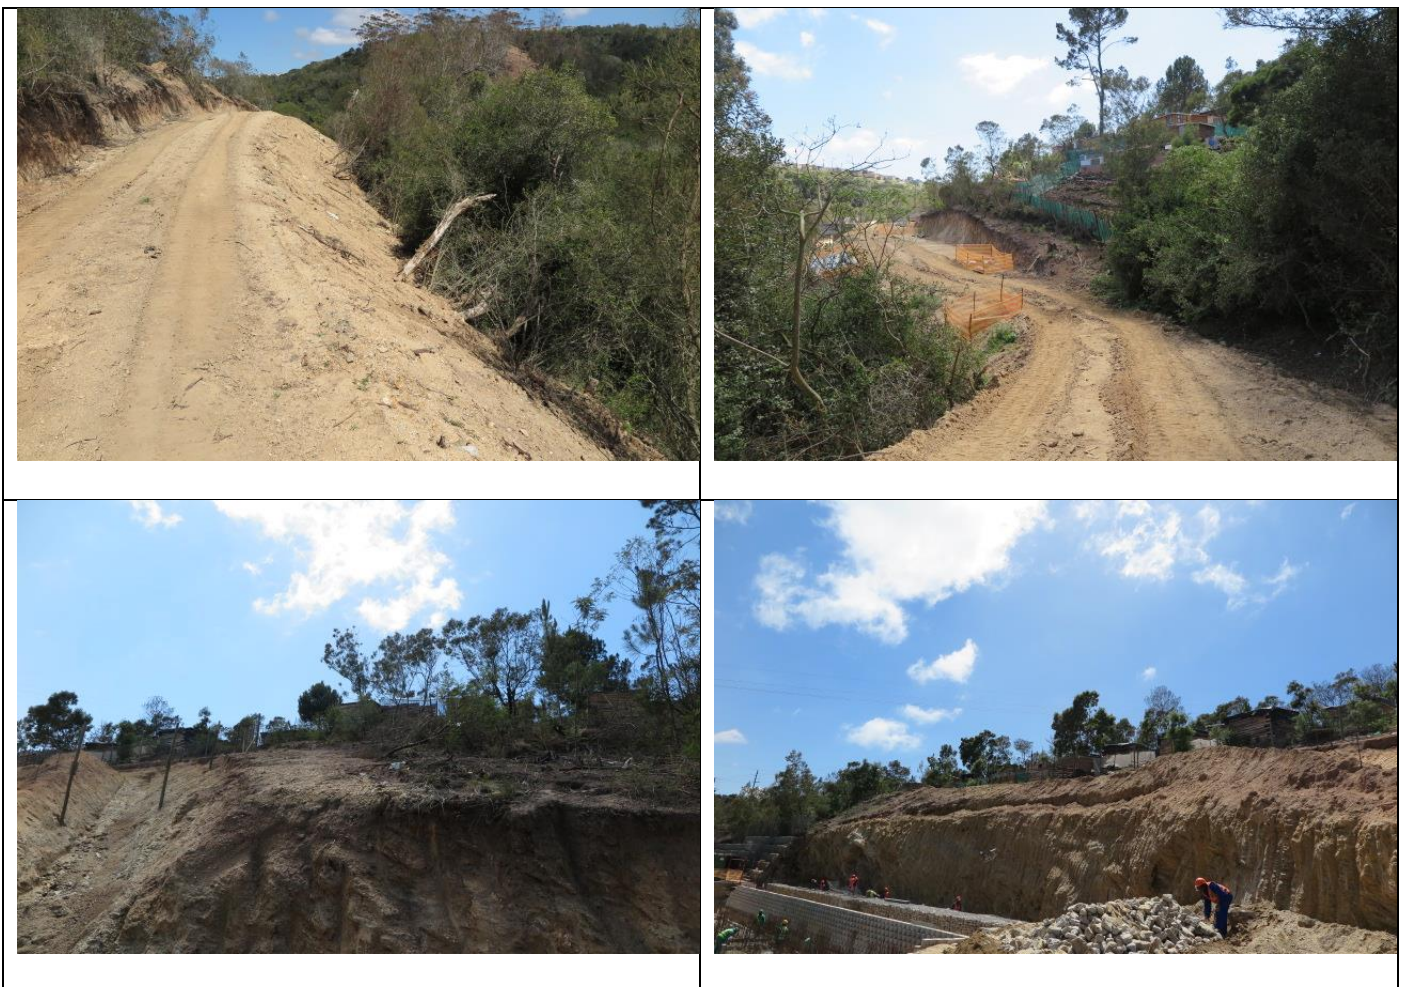
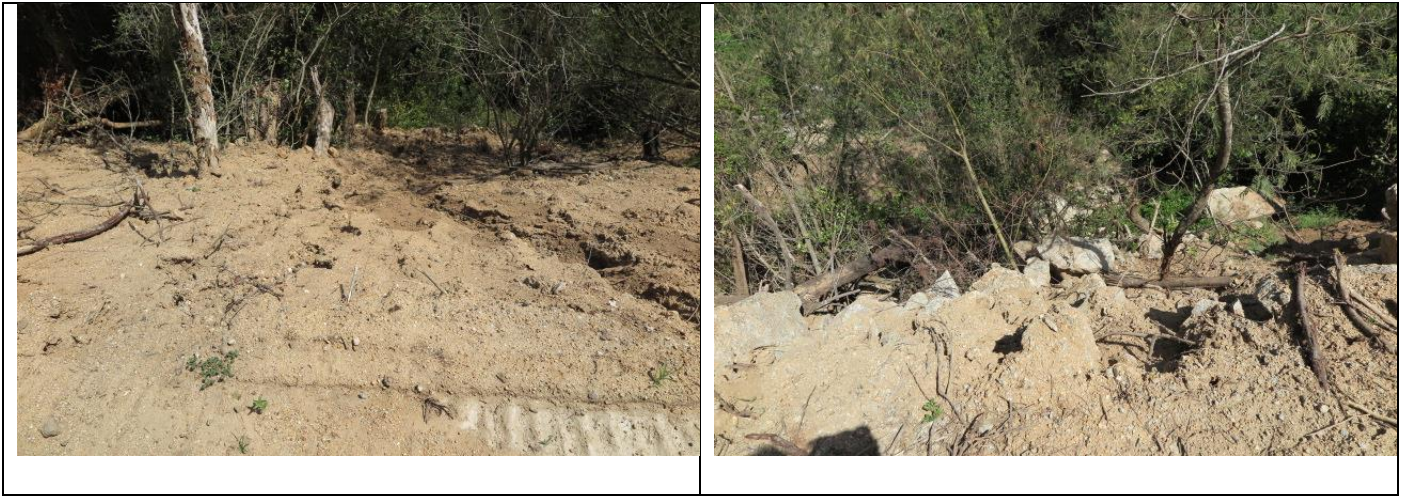
During the audit site inspection, the auditor noticed that cut slopes were very steep in places and that the exposed material had not been stabilised. This poses a risk of slopes collapsing, landslides and damage to adjacent structures and dwellings. The auditor strongly recommends that the Engineer be requested to provide an opinion on the stability and inherent safety of these slopes. Where necessary, corrective measures must be implemented as a matter of urgency. The following photographs serve to illustrate the issue:

The last two images above show erosion gullies starting to form on the un-stabilised cut slopes.

The findings relating to alien vegetation clearing, erosion control and slope stabilisation are highly significant from an environmental perspective and the resultant risks posed to both the local residents and the receiving environment require urgent attention. The cut slopes very steep in places and that the exposed material had not been stabilised at the time of the audit. This poses a risk of slopes collapsing, landslides and damage to adjacent structures and dwellings. The auditor strongly recommends that the Engineer be requested to provide an opinion on the stability and inherent safety of these slopes. Where necessary, corrective measures must be implemented as a matter of urgency.

Areas that are identified as being prone to erosion must be suitably protected with for e.g. silt fencing and/or sand bags during the earthworks / construction period.	Extensive evidence of erosion starting to take place was found during the audit site visit. Please see photographic evidence in Section 6.3.	Non-compliant	Erosion prevention measures must be implemented urgently.
During construction, the Contractor shall protect all areas susceptible to erosion by installing necessary temporary and permanent drainage works.	Extensive evidence of erosion starting to take place was found during the audit site visit. Please see photographic evidence in Section 6.3.	Non-compliant	Erosion prevention measures must be implemented urgently.

Any erosion channels within the construction site, or new ones that develop during construction on steep slopes must be backfilled, compacted and restored to an acceptable condition. Regular monitoring for erosion along the access track. Erosion problems should be rectified on a regular basis. Culverts and pipe bridges should be inspected on a regular basis for erosion and rectified where necessary.	There are several erosion runnels in evidence along the pipeline route. Please see photographic evidence in Section 6.3.	Non-compliant	Erosion prevention measures must be implemented urgently.
Stabilisation of cleared areas to prevent and control erosion and/or sedimentation shall be actively managed. retaining cut slopes with the installation of permanent retaining wall structures, brush-cut packing, mulch or chip cover, straw stabilising, planting of vegetation (refer to Section 6.19 below), soil binders and anti-erosion compounds, mechanical cover or packing structures (including the use of geofabric, log/pole fencing) & installation of biddum or shade cloth silt screens.	Extensive evidence of erosion starting to take place was found during the audit site visit. Steep slopes are left bare and unstabilised, which could lead to severe erosion and possibly even landslides. Please see photographic evidence in Section 6.3.	Non-compliant	Erosion prevention measures must be implemented urgently.

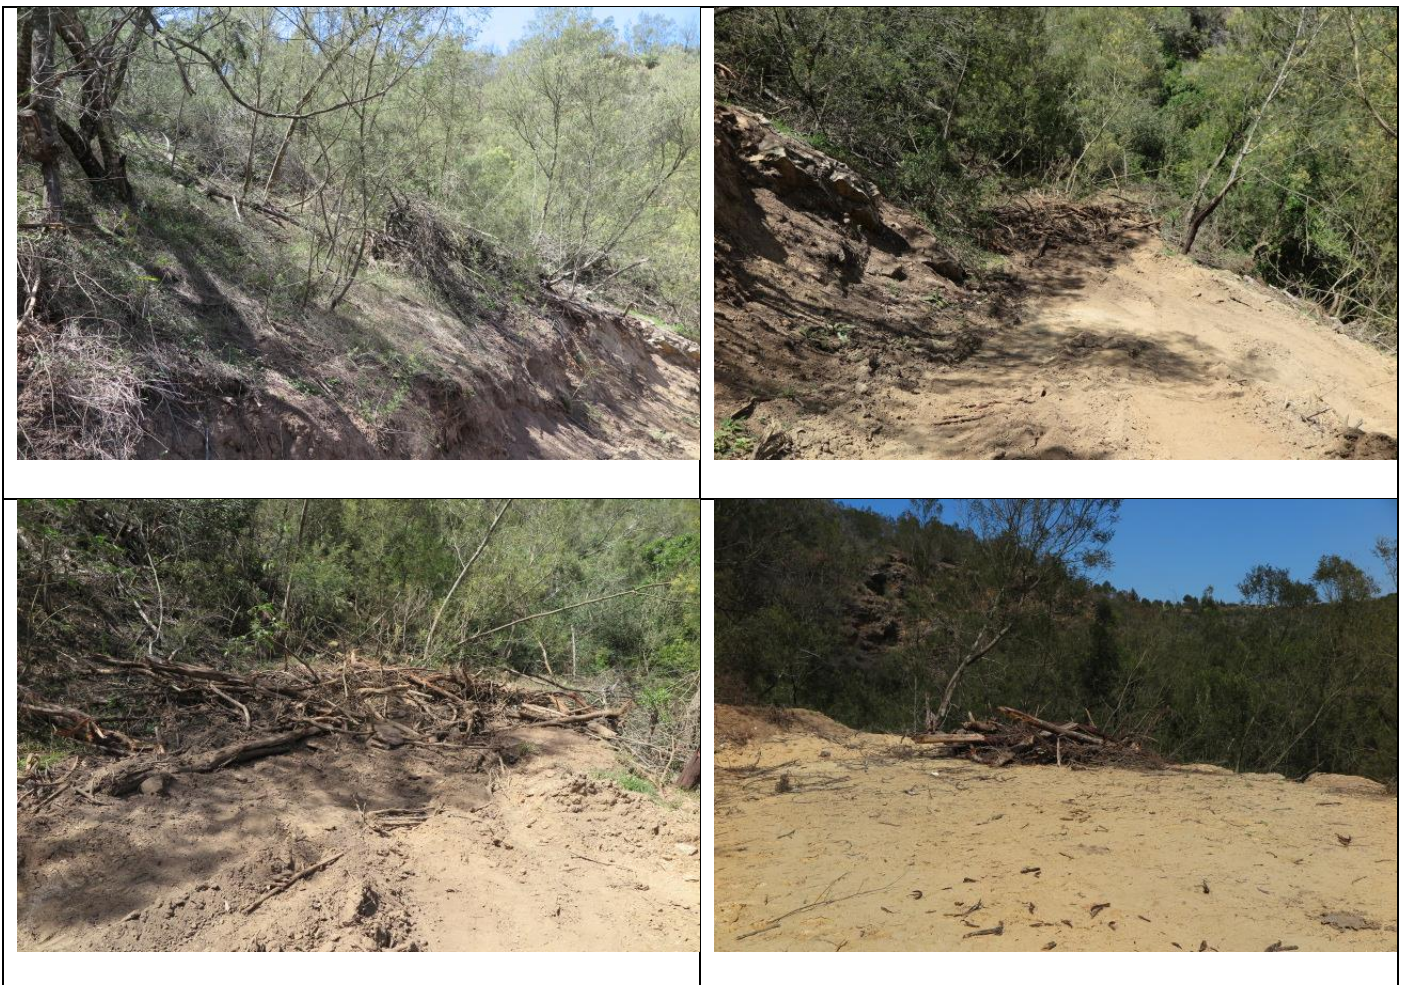
Cut vegetation management is another source of concern. Various instances were noted where cut vegetation had simply been stacked or stockpiled and not been removed from site. This increases the fire load in the area significantly. The following photographs serve as illustration of the problem.

Cut vegetation management is another source of concern. Various instances were noted where cut vegetation had simply been stacked or stockpiled and not been removed from site. This increases the fire load in the area significantly. These stockpiles must be removed to a composting facility.
