## SECTION 24G DIRECTIVE

**DIRECTIVE IN TERMS OF SECTION 24G (1) OF THE NATIONAL ENVIRONMENTAL MANAGEMENT ACT 107 OF 1998 ("NEMA"): THE UNLAWFUL COMMENCEMENT OF EROSION REPAIRS AND THE REHABILITATION AT THE STORMWATER OUTLET, OUTENIQUA WASTEWATER TREATMENT WORKS ON THE REMAINDER OF ERF 325, GEORGE.**

## Annexure A:

Photographs taken on 28 May 2024 of the unlawful commencement of erosion repairs and the rehabilitation at the stormwater outlet, Outeniqua Wastewater Treatment Works ("OWWTW") on the Remainder of Erf 325, George.

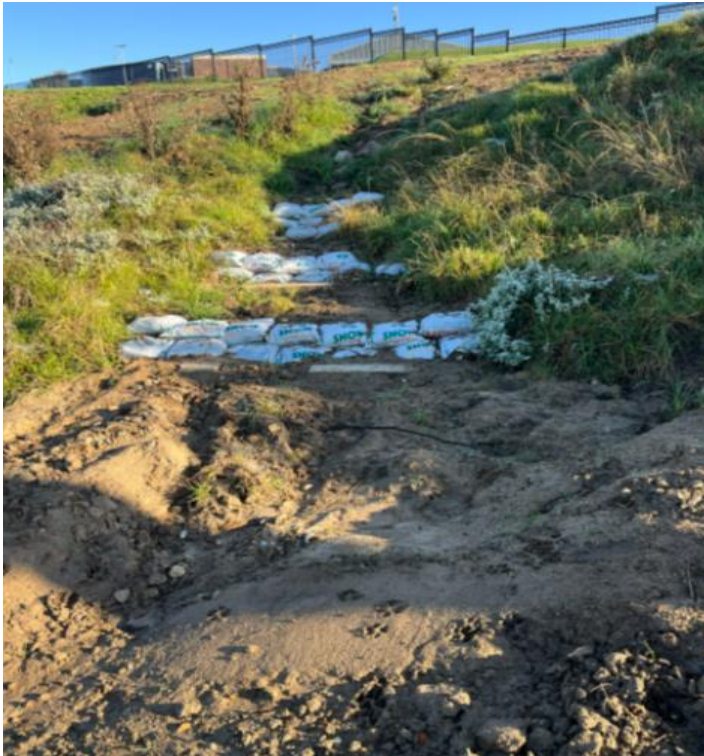
**Figure 1:** High-lying temporarily diverted stormwater outlet route with erosion gulleys formed above the access road. Sandbags used to impede surface flow energy. Northerly view from existing access road.

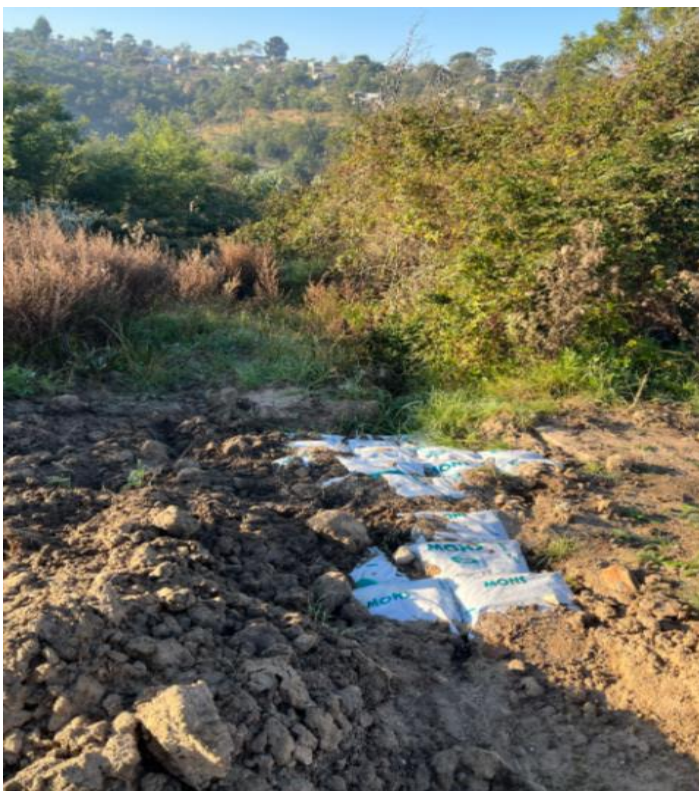
**Figure 2:** lower-lying temporary diverted stormwater outlet route with erosion gulleys formed below the access road. Sandbags used to impede surface flow energy. Southern view from existing access road.

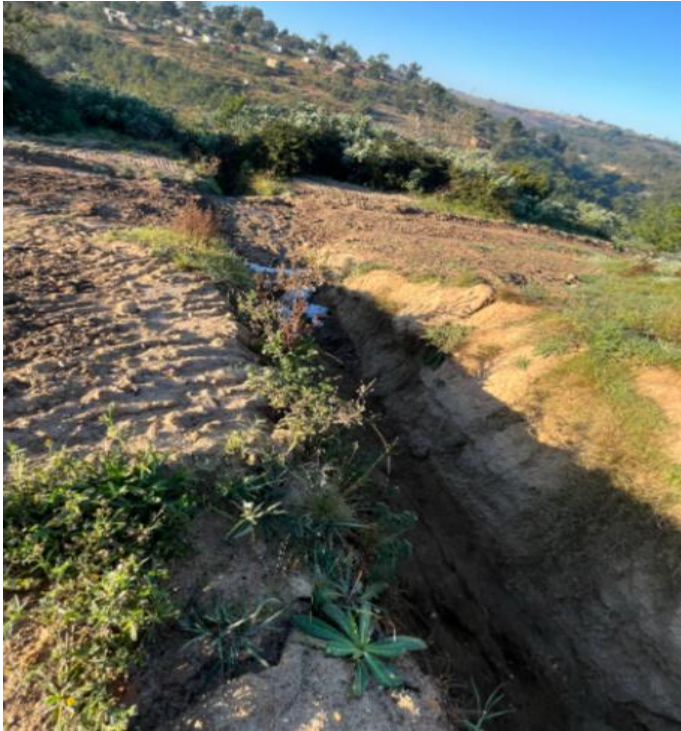
**Figure 3:** Top view of diverted stormwater outlet route with erosion gully formed – sediment runoff downstream. The estimated depth of existing erosion gully is approximately 2 – 2.5m deep.

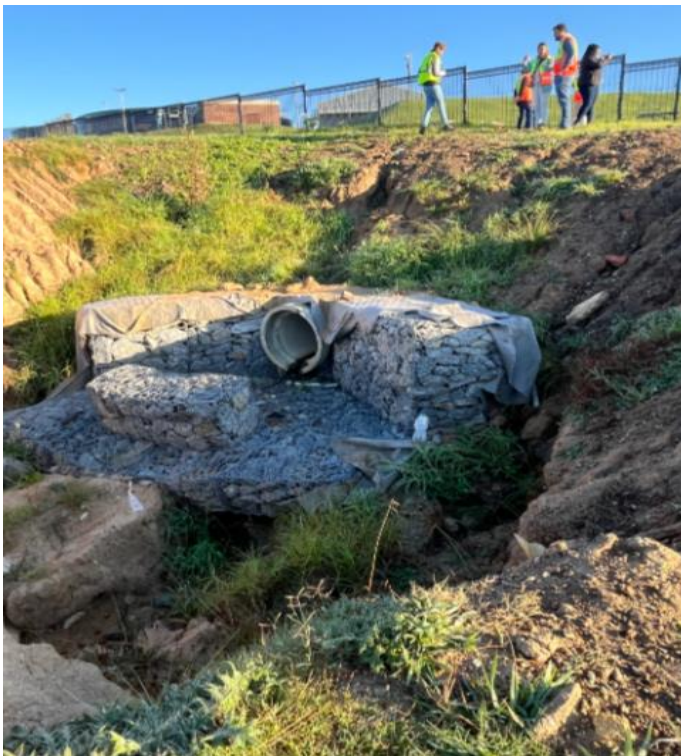
**Figure 4:** Top view of diverted stormwater outlet route with erosion gulleys formed. The estimated depth of existing erosion gully is approximately 2 – 2.5m deep.

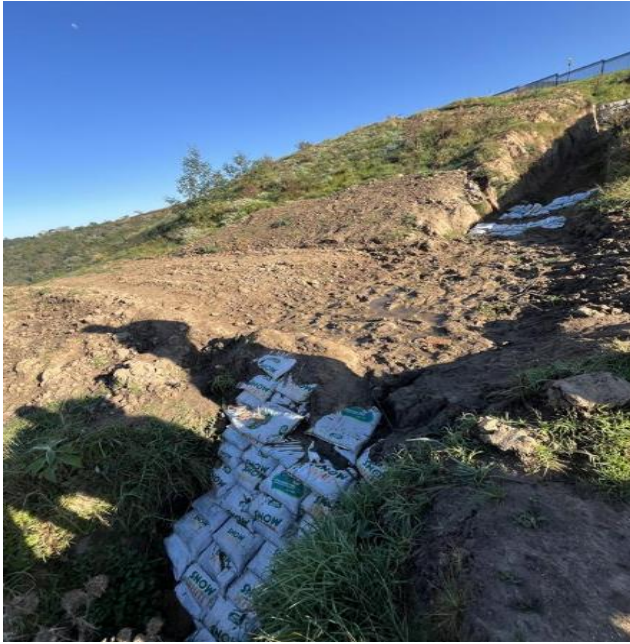
**Figure 5:** Angle from downstream of diverted stormwater outlet route with erosion gully formed. Access road traversing flow path. The estimated depth of existing erosion gully is approximately 2 – 2.5m deep.

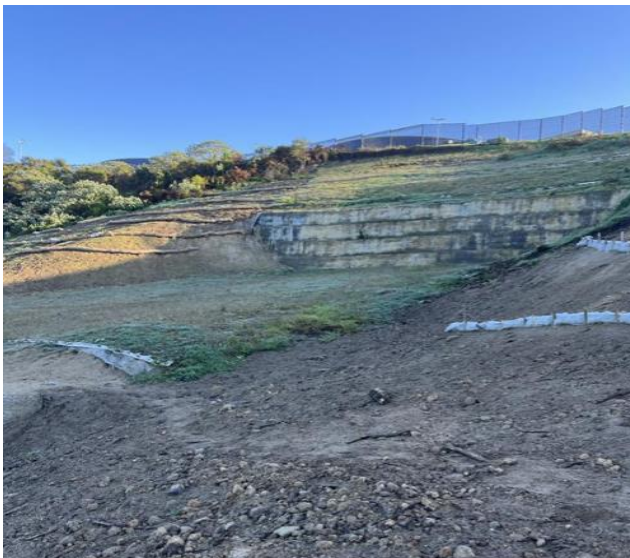
**Figure 6:** Unlawful rehabilitation works in main erosion donga where main stormwater outlet was positioned.

Northerly view of unlawful rehabilitation works undertaken at eroded area (donga) caused by the main stormwater outlet pipe.

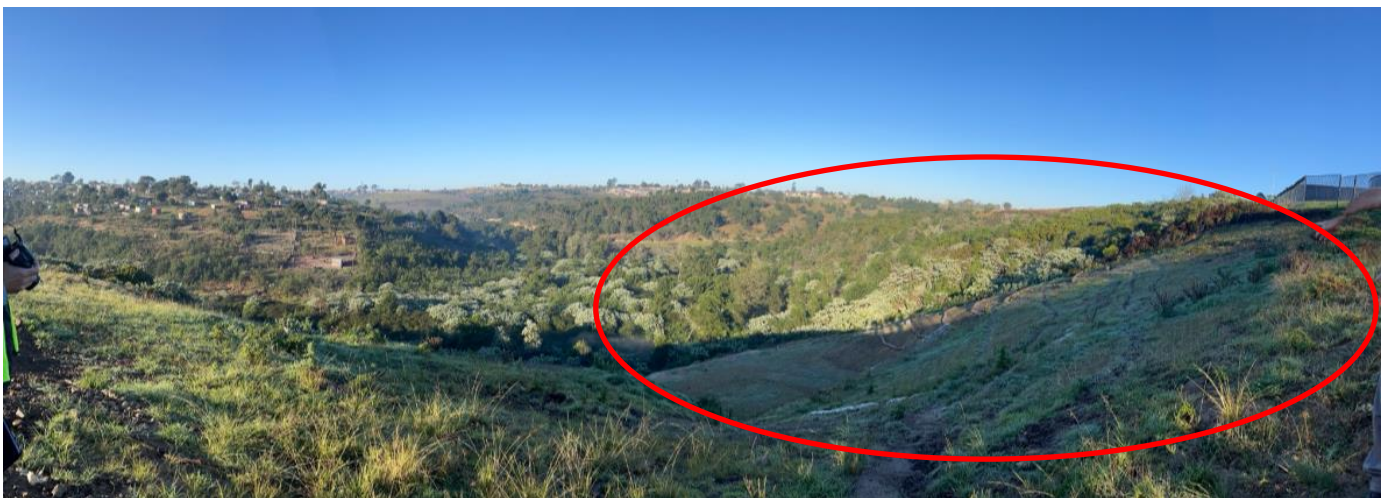
**Figure 7:** View of unlawful rehabilitation works undertaken at eroded area caused by the main stormwater outlet pipe (circled in red).
