## ENVIRONMENTAL MONITORING REPORT 3: FINAL REPORT

## THE OUTENIQUA WASTEWATER TREATMENT WORKS (WWTW), GEORGE EROSION REPAIR

**SITE INSPECTIONS AT OUTENIQUA WASTEWATER TREATMENT WORKS, GEORGE, IN  
COMPLIANCE WITH THE REHABILITATION PLAN AND DIRECTIVE ISSUED**

**ENVIRONMENTAL MONITORING REPORT NO 3: FINAL REPORT**

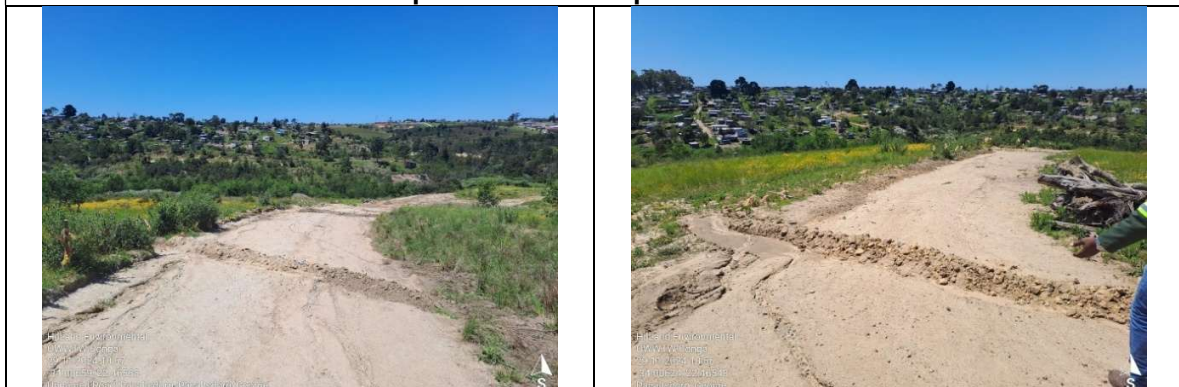
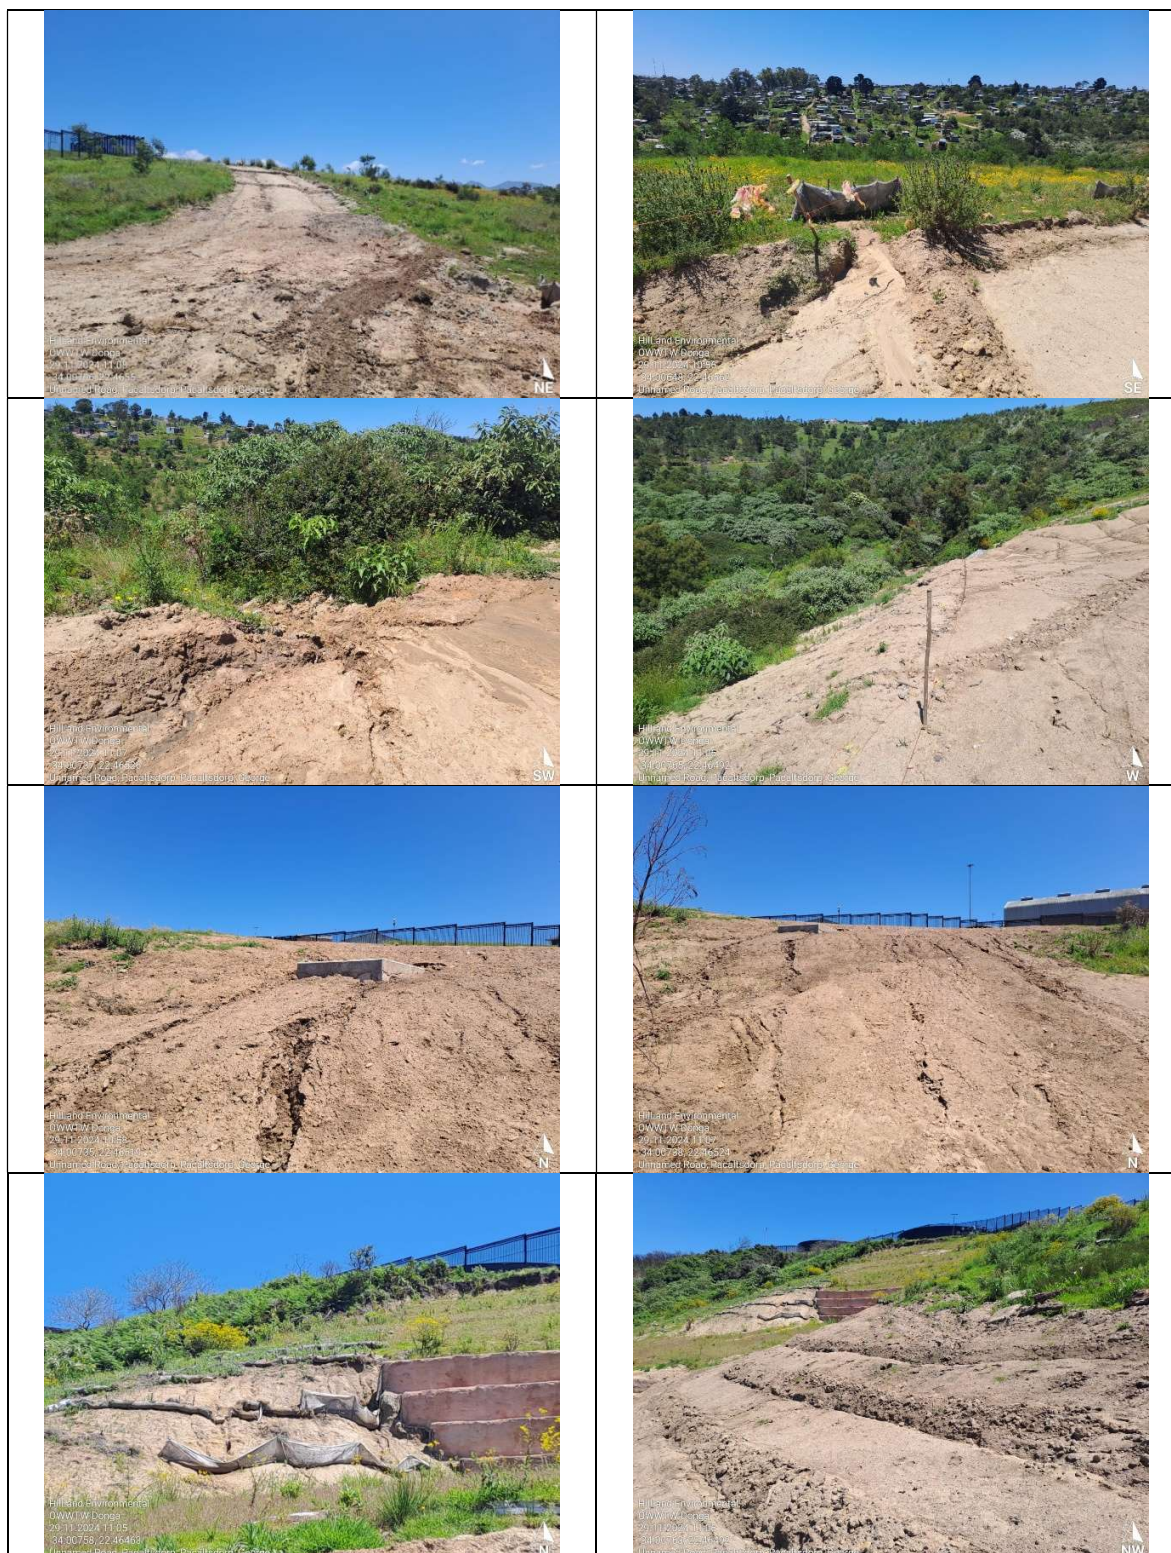
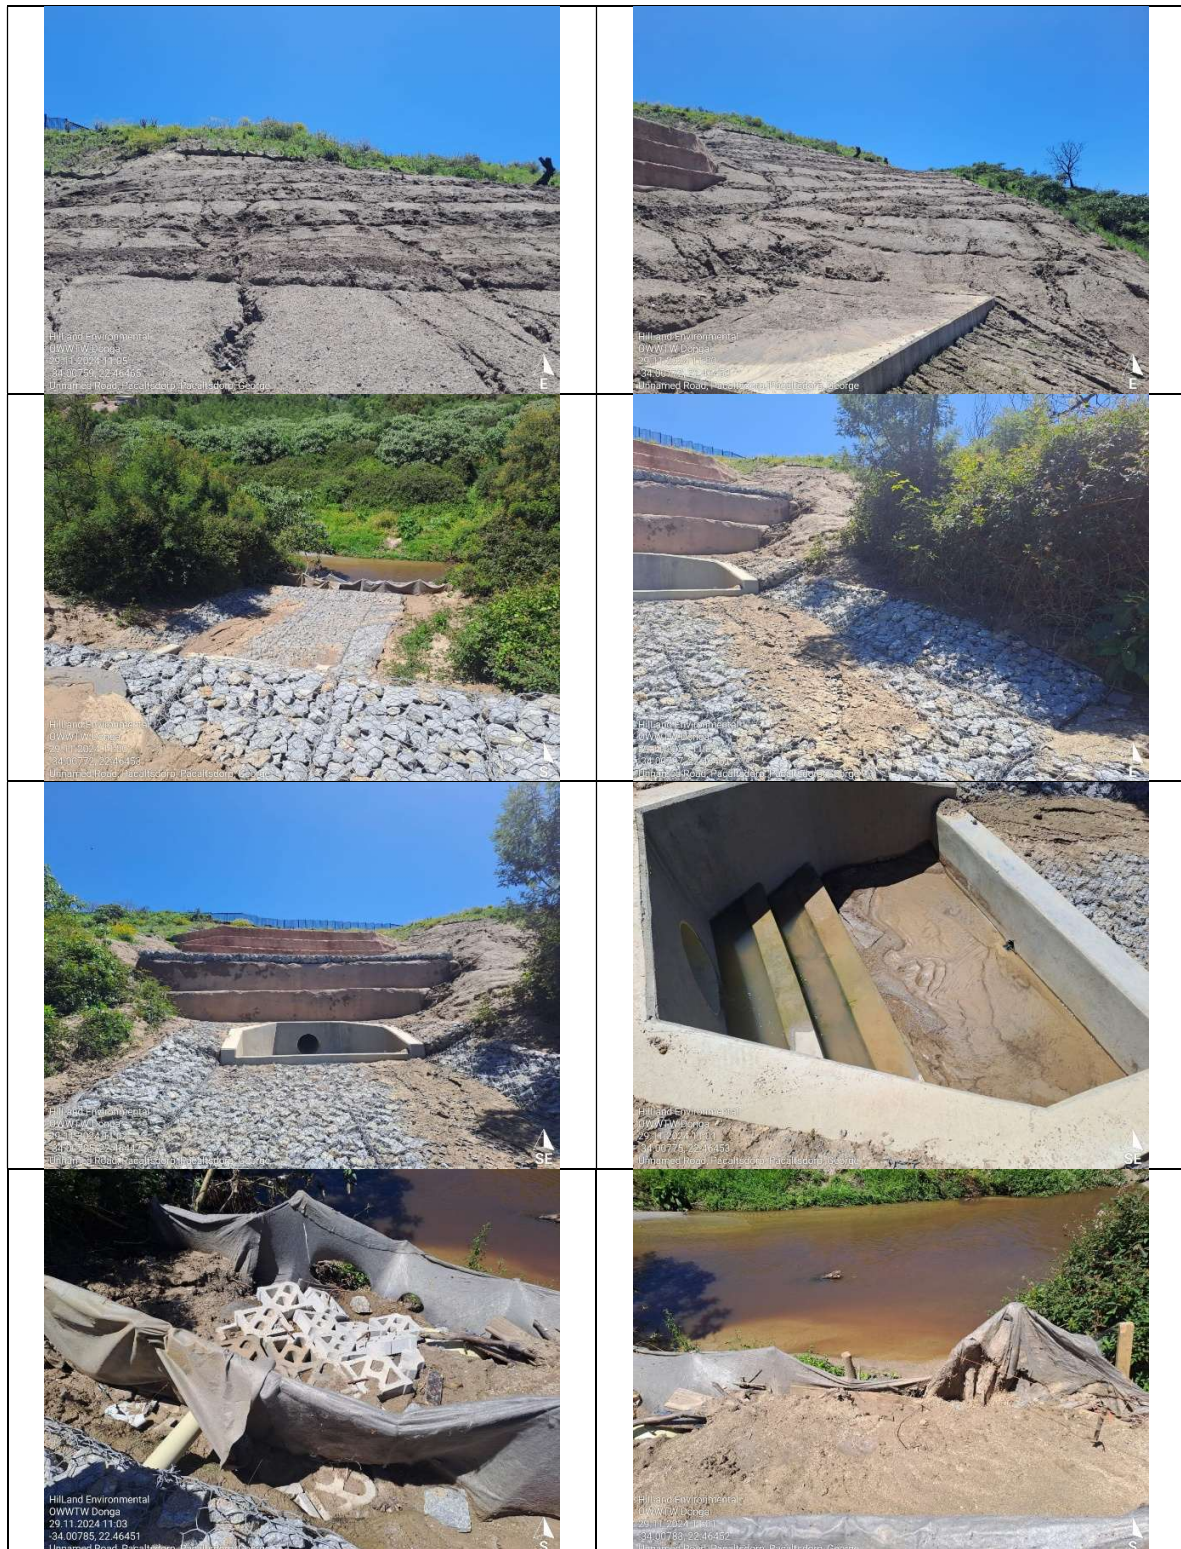
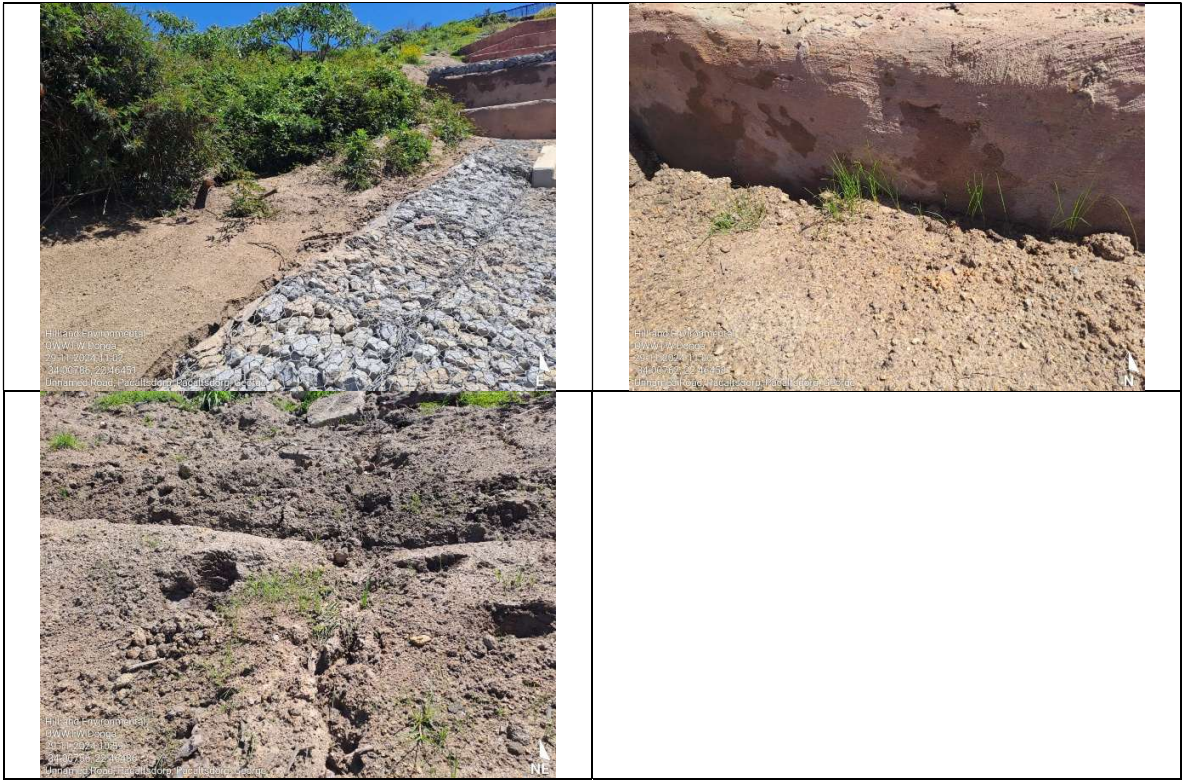
**29 November 2024 - ECO inspection for completion of the Directive works**

The stormwater outlet headwall and gabion structure were completed within the timeframes of the Directive.

Final shaping was completed.

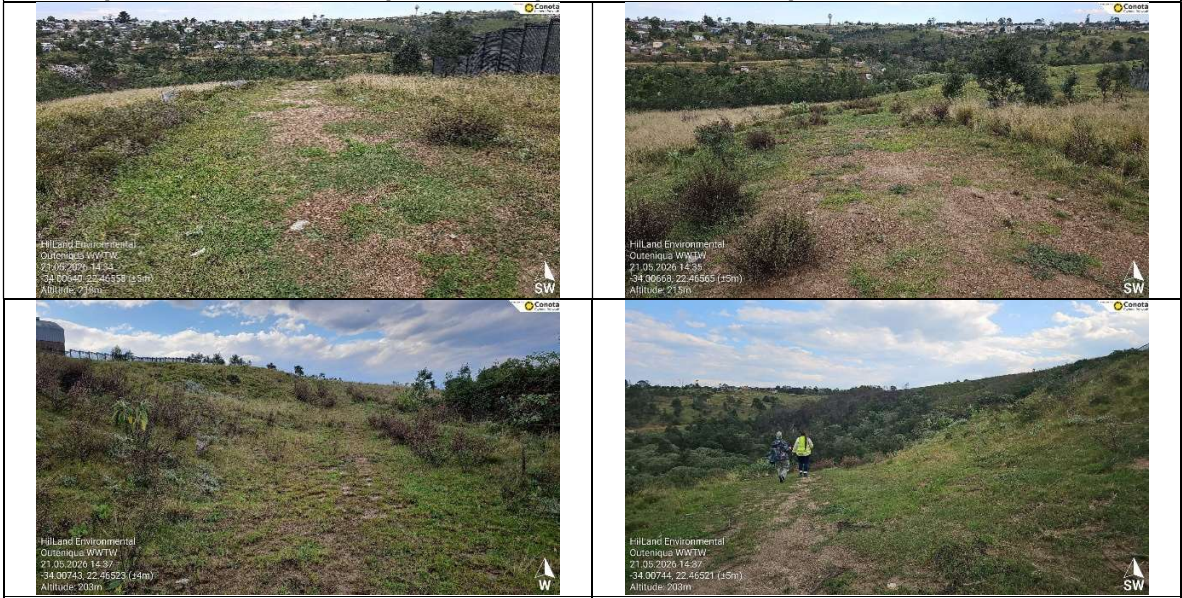
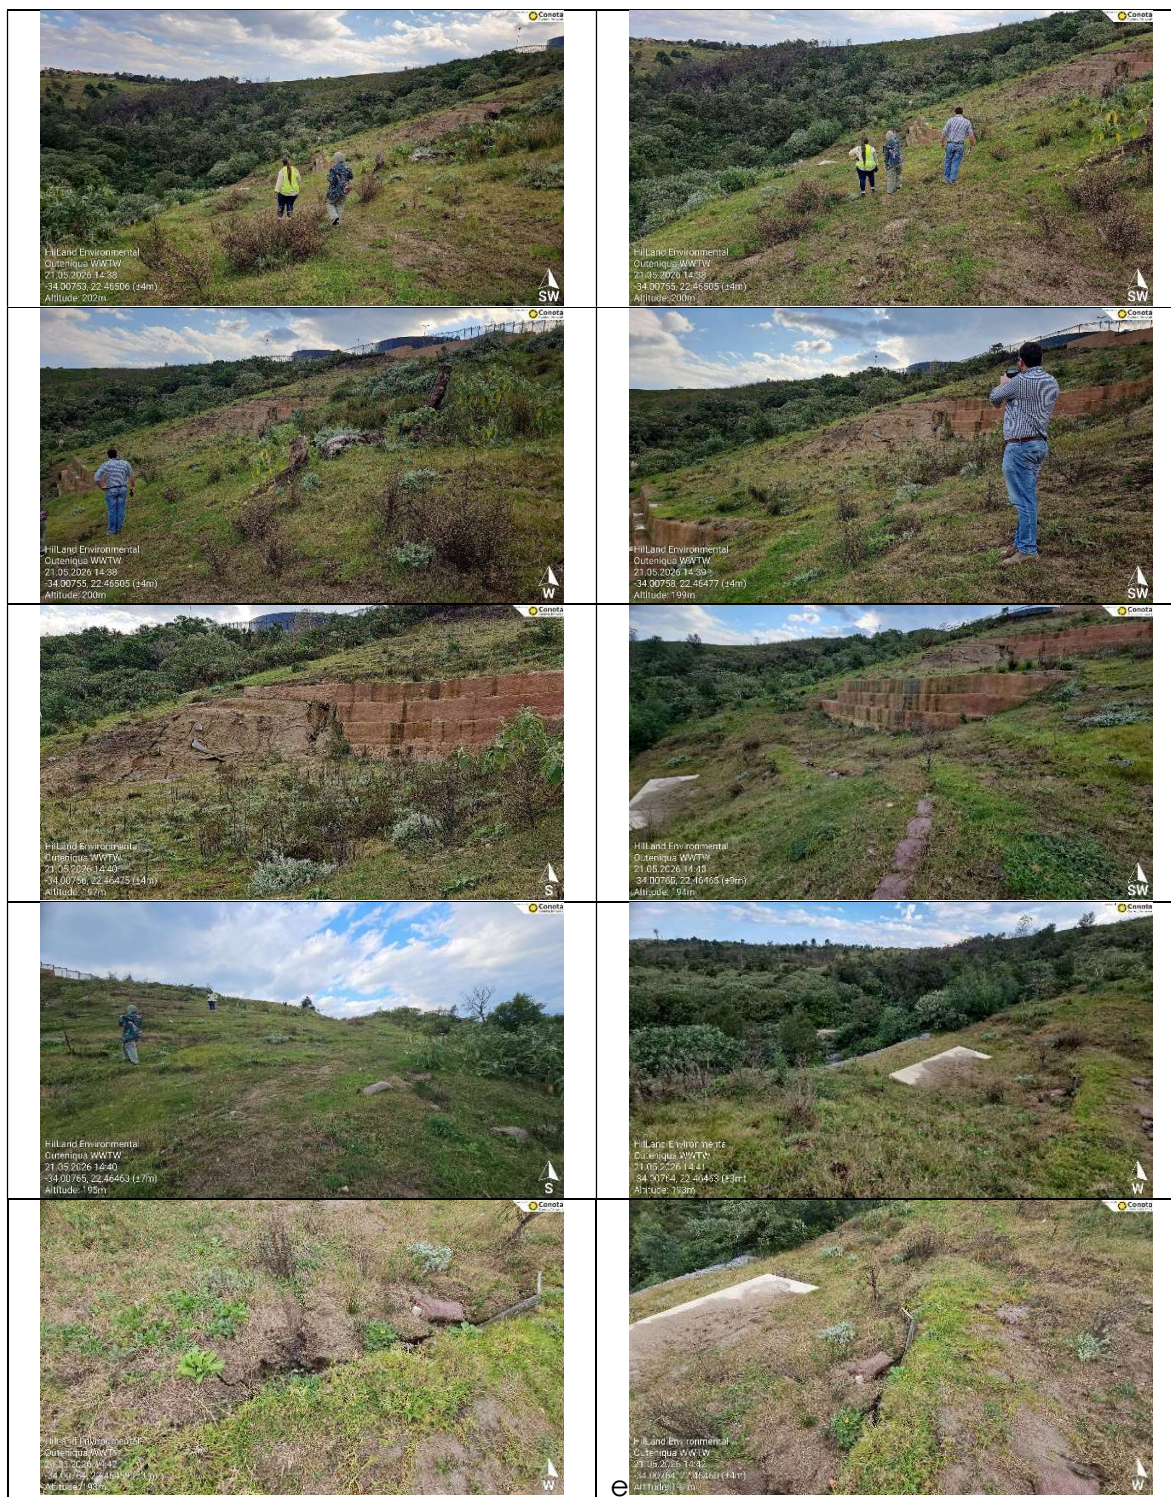
**21 May 2026 – DEADP compliance inspection – after May 2026 storm event.**

- **Ongoing. The bed and banks of the river appeared in good condition following the storm events inspections of early May 2026 and June 2026.**

The post construction rehabilitation and maintenance have been successful, with only minimal repair works required due to runoff / erosion after the significant storm events of May and June 2026.

The stormwater system functioned well and there is no erosion at the riverbank.

Alien infestation is evident in the working area and will require regular maintenance to hand pull seedlings every 6 months.
