**Aquatic specialist inputs to proposed erosion control measures for road OP06914 on Swartvlei Lake, Sedgefield.**

**Prepared by: Dr. Jackie Dabrowski of Confluent Environmental (Pty) Ltd**

**For: Garden Route District Municipality**

**April 2021, updated June 2021**

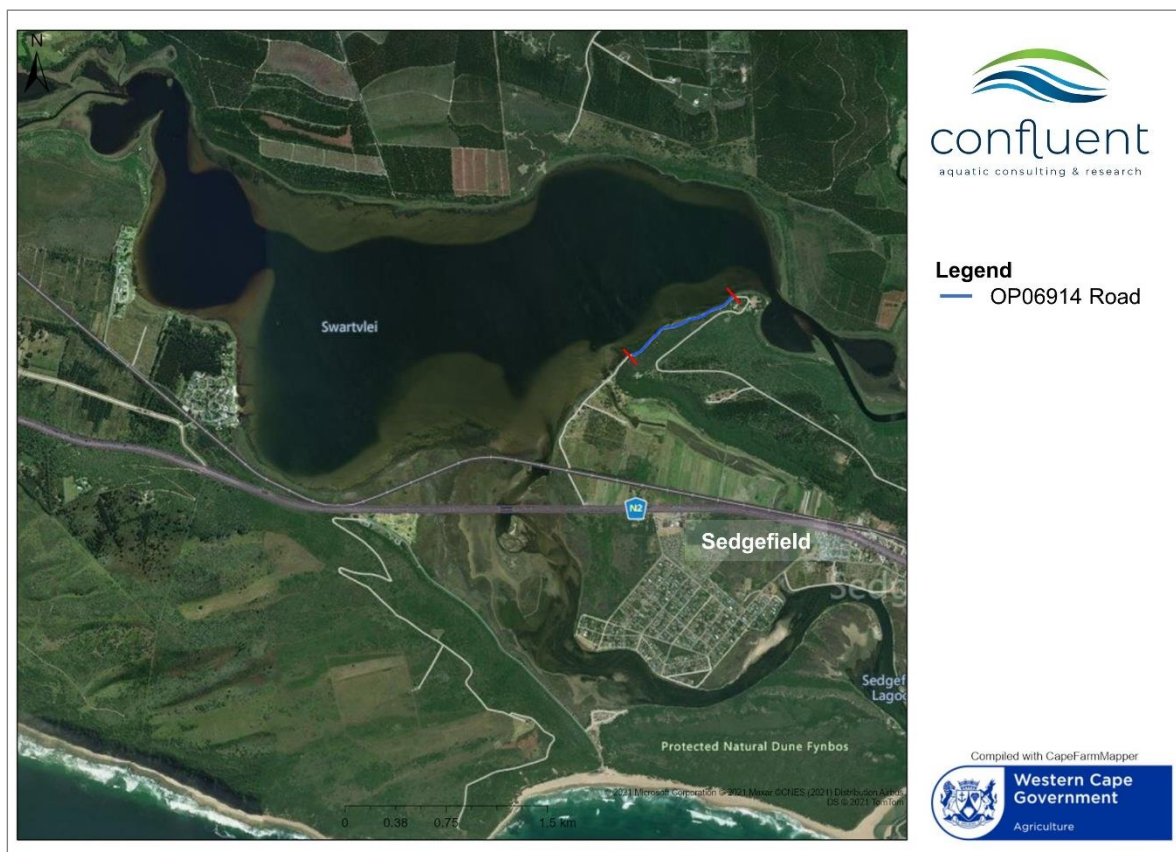
Figure 1. Map depicting the layout of the area and the eroded section of road OP06914.

Erosion at the site was previously controlled by packing sandbags adjacent to the road edge. During the site visit broken bags were observed and they were not providing any level of protection from wave action. The eroding road edge has resulted in the road narrowing, and in some places, vehicles need to travel dangerously close to the eroded edge.

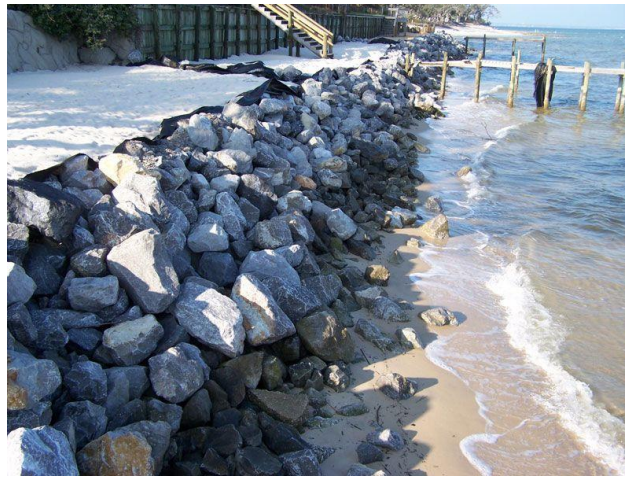
The GRDM have proposed to place riprap along eroded areas and other areas of high risk to erosion (Figure 2). The specific locations were not identified but would be located between km 1.5 and km 2.1 measured from the turnoff from the N2 highway. This would involve the placement of sloping rock along the road edge into the water and is considered a hard technique.

Figure 2. Example of riprap proposed by the GRDM (image supplied by GRDM).

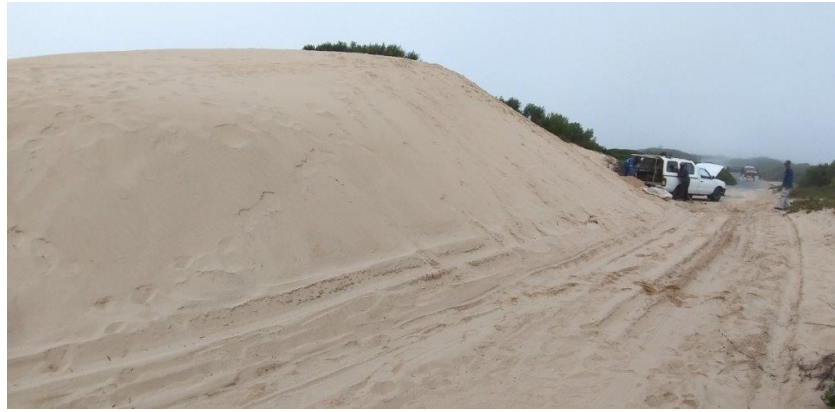
Figure 3. Photo of beach sand on the road 6817 in Groot Brak that needs to be removed.

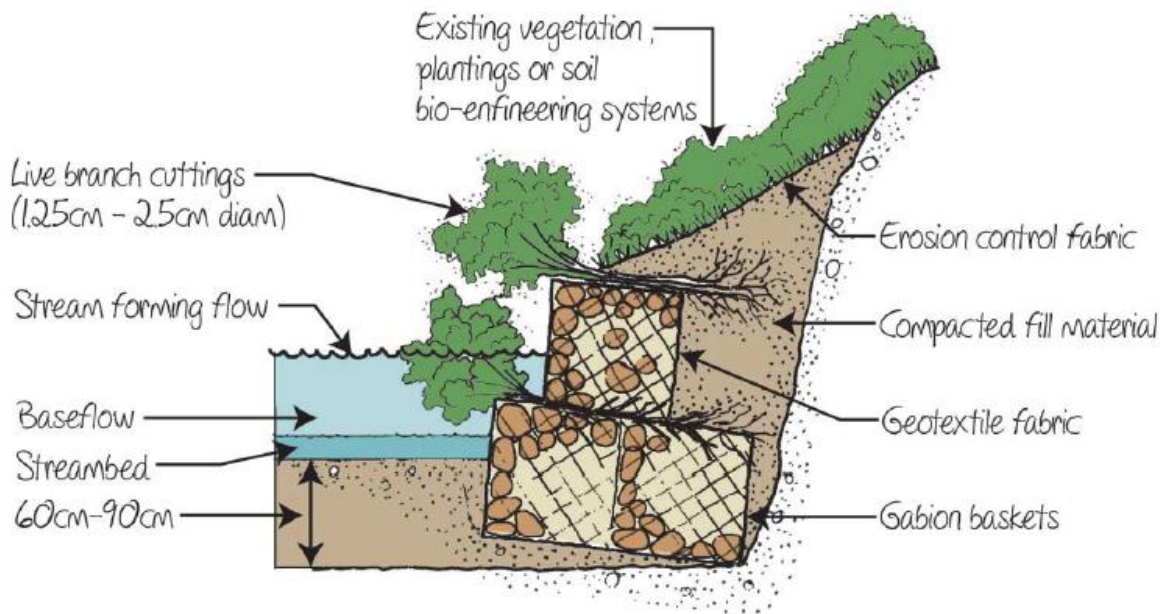
Figure 4. Cross section of a gabion retaining wall with vegetation planted through it (Day *et al.*, 2016).

The long-term recommendation is to install a retaining wall constructed of gabions for steeper, more vertical edges of the road to support the road material. This would be interplanted with vegetation to create a more natural and aesthetically pleasing look. This intervention would not be needed along the full length of the road, just where the road material needs support. This would be in the vicinity of Kms 1.4 and 1.78 (Figure 11). A similar concept to that depicted in Figure 4 would be followed.

- Gabions should have a slight 'step' with the lowest step buried into the sand with about 200 mm emerging from the top (See Figure 4). This should allow planted vegetation access to sufficient water to survive.
- Rock-filled gabions should be filled with sand from the site (sand excavated to install the lowest step) and covered in hessian to ensure the plants establish before the hessian rots away. In other words, the gabion basket is lined with hessian which is then filled with rocks and sand.
- Suitable plants would be *Phragmites australis* reeds which are abundant at the site and elsewhere at Swartvlei Lake.
