Section A

Koo river bridge

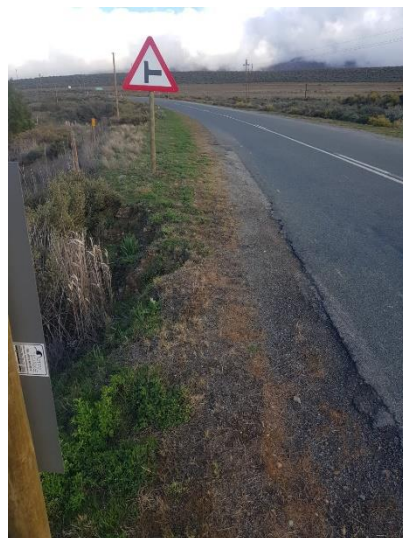
Image 10: Disturbed and erosion area near the Koo River Bridge.

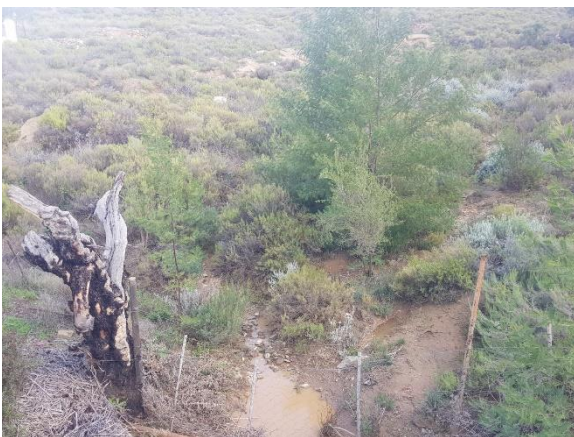
Image 14: Fence line near to Major Culvert C10507.

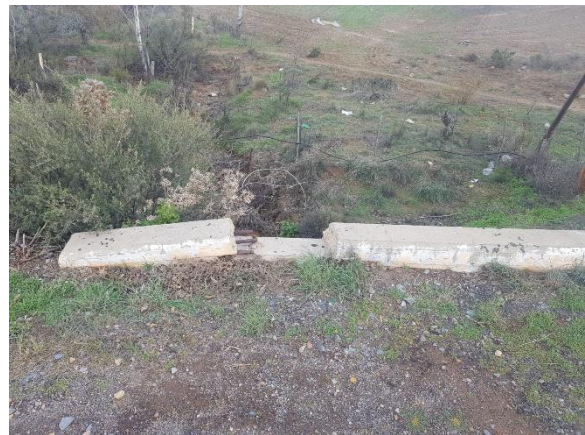
Image 21: Damaged infrastructure on Major Culvert C10508.

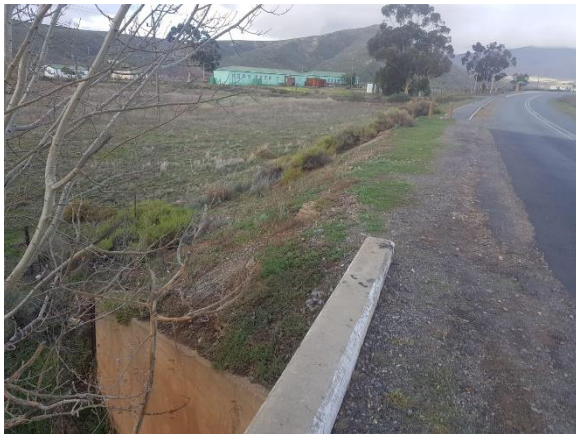
Image 26: Disturbed area adjacent to Major Culvert C10508.

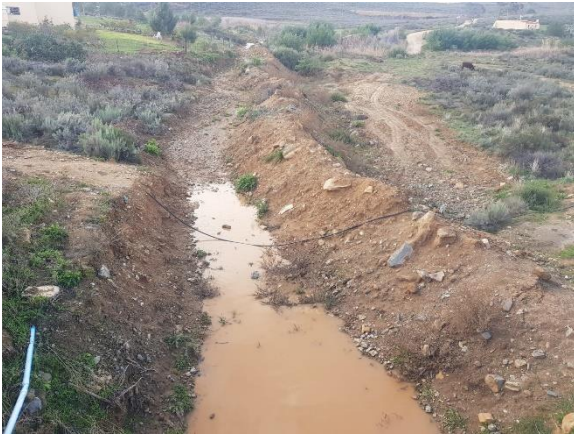
Image 28: Watercourse with disturbed adjacent areas.

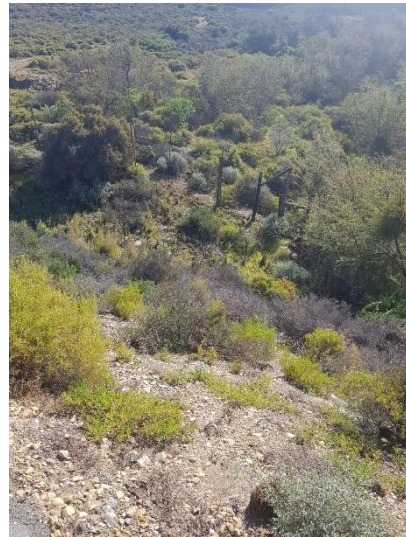
Image 134: Adjacent topography showing a steep gradient.

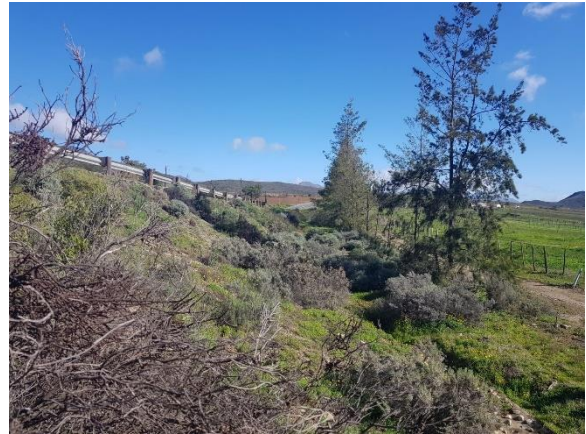
Image 138: Adjacent topography showing a steep gradient.

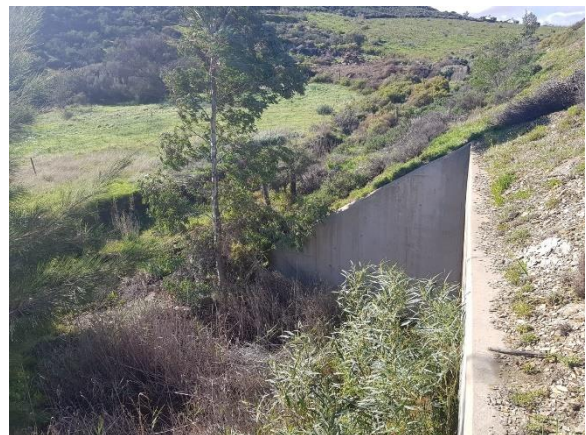
Image 140: Adjacent topography showing a steep gradient.

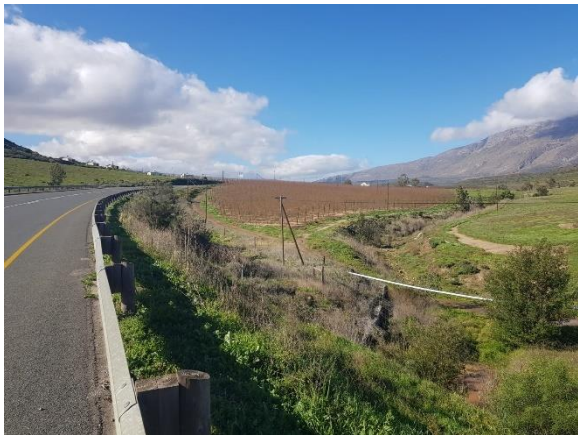
Image 145: Adjacent topography showing a steep gradient.

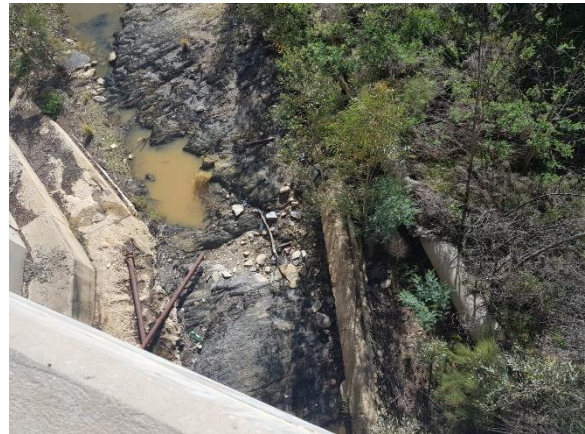
Image 149: Concrete pillar within flow path.
