**Section 24G Application for the Unauthorised
Construction of a Road and Clearance of Vegetation at
Farms Portion 1, Platte Kloof 131 and Remainder Holle
Kloof 91 within the George Local Municipality,
Western Cape Province**

Botanical Compliance Statement

Prepared for Sharples Environmental Consultants

June 2022; October 2022

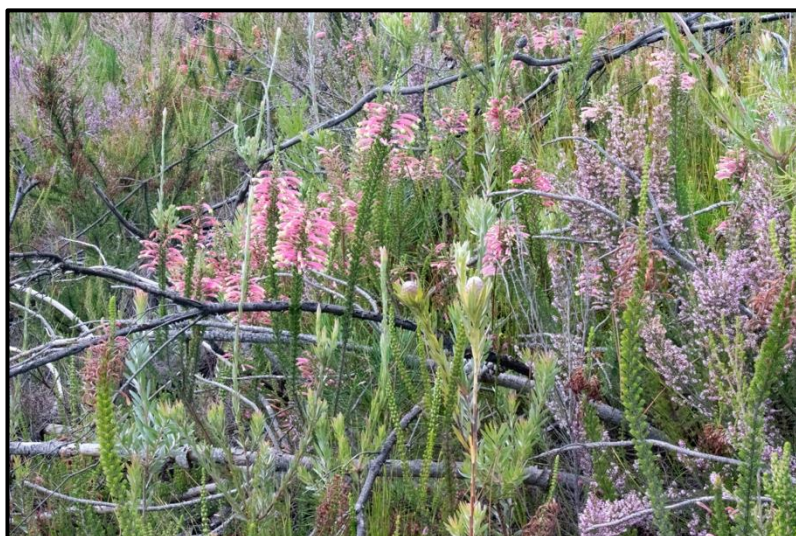
Figure 25. *Erica densifolia*,
Erica uberiflora,
Leucadendron uliginosum
subsp. *uliginosum* growing
amongst fallen pine branches.

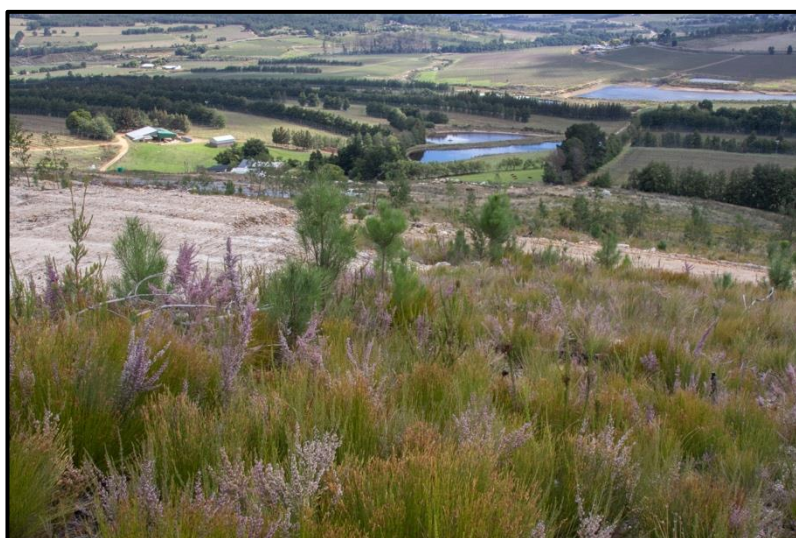
Figure 27. View northwest
with low fynbos in the
foreground and the small
platform to the left.

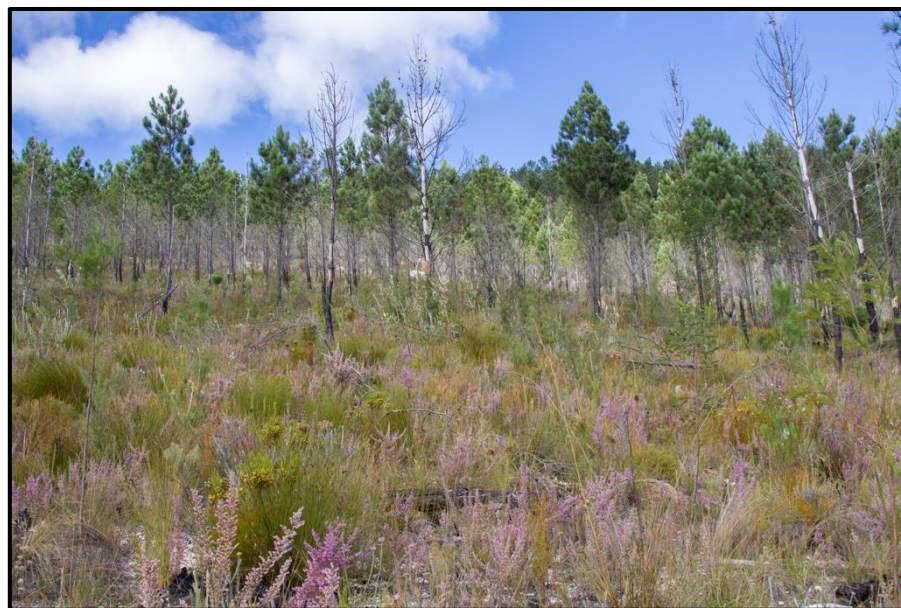
The two main alien invasive species occurring in the vegetation around the house platform and along the sides of the access road are *Pinus radiata* (Monterey Pine) (Figures 30—32) and *Acacia mearnsii* (Black Wattle) (Figure 32). A third species, *Hakea sericea* (Silky Hakea), is also present but with lower abundance (Figure 31). These species have a serious negative impact on indigenous vegetation and must be cleared. The pine trees have been present for some time, judging by their size, and apart from being scorched by the fire four years ago, most of them have survived. The fire also stimulated the germination and growth of the silky hakea, black wattle and pine (Figure 32).

Figure 30. Uninvaded low fynbos in the foreground with tall *Pinus radiata* trees that survived the last fire in the background.

Apart from the remediation that is the central issue of this investigation, every effort must be made to control the growth and spread of the above alien invasive plant species. In fact, it is a legal requirement for landowners to keep their property free of these aggressive invaders.

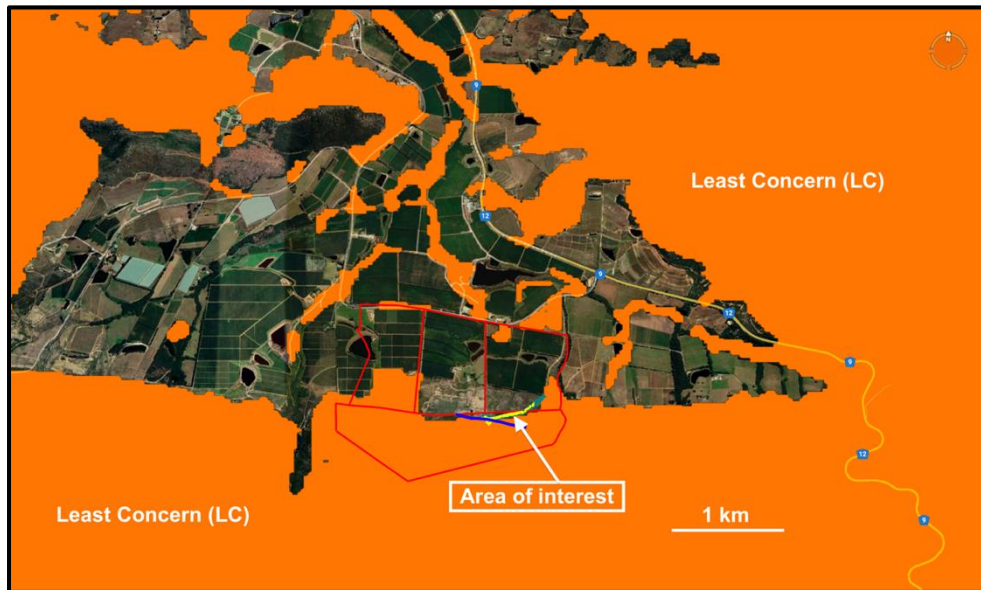
According to the National List of Threatened Terrestrial Ecosystems (Government Gazette, 2011), South Outeniqua Sandstone Fynbos was classified with a conservation status of Least Concern (since it was not listed). That has not changed in the most recent appraisal in 2021 (Figure 33) of what is now called Red List Ecosystems (RLE) (SANBI, 2021). The area of interest is in a habitat type with a low risk of loss and negative impacts due to anthropogenic activities, since it is well conserved in the mountain catchments of the Outeniqua Mountain Range.

Figure 33. The RLE map superimposed on Google Earth Pro TM showing that the area of interest is in an ecosystem of Least Concern (LC).

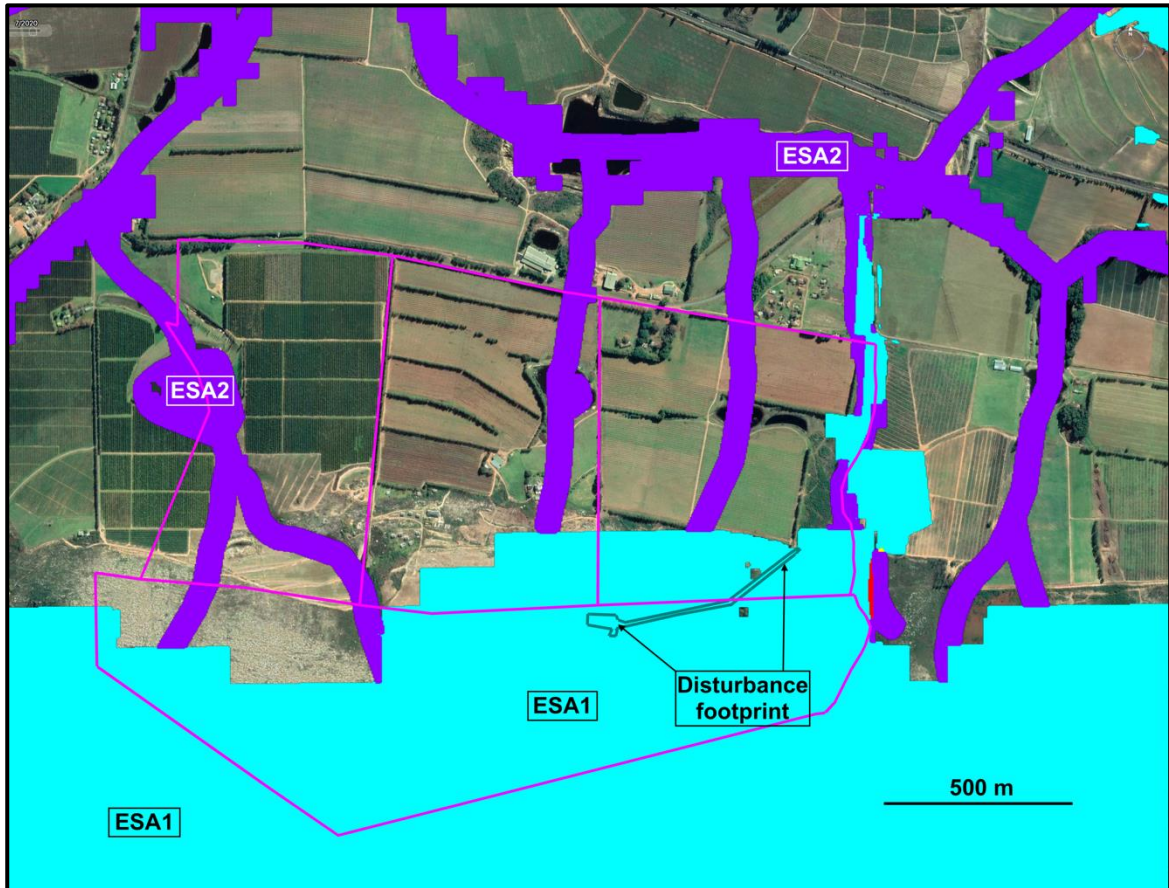
An overlay on Google Earth TM imagery of the map of Critical Biodiversity Areas from the Western Cape Biodiversity Plan [WCBSP] (Pence, 2017; Pool-Stanvliet *et al.* 2017) is presented in Figure 34. The 'disturbance footprint' falls in an Ecological Support Area 1. The definition of Ecological Support Areas is given below (see text box) as defined by Pool-Stanvliet *et al.* (2017). Note that the ESA2 definition below is not strictly correct since the ESA2 areas in Figure 34 are watercourses with their azonal habitat characteristics.

Figure 34. The WCBSP map for the area of interest showing that the 'disturbance footprint' is in a ESA1.

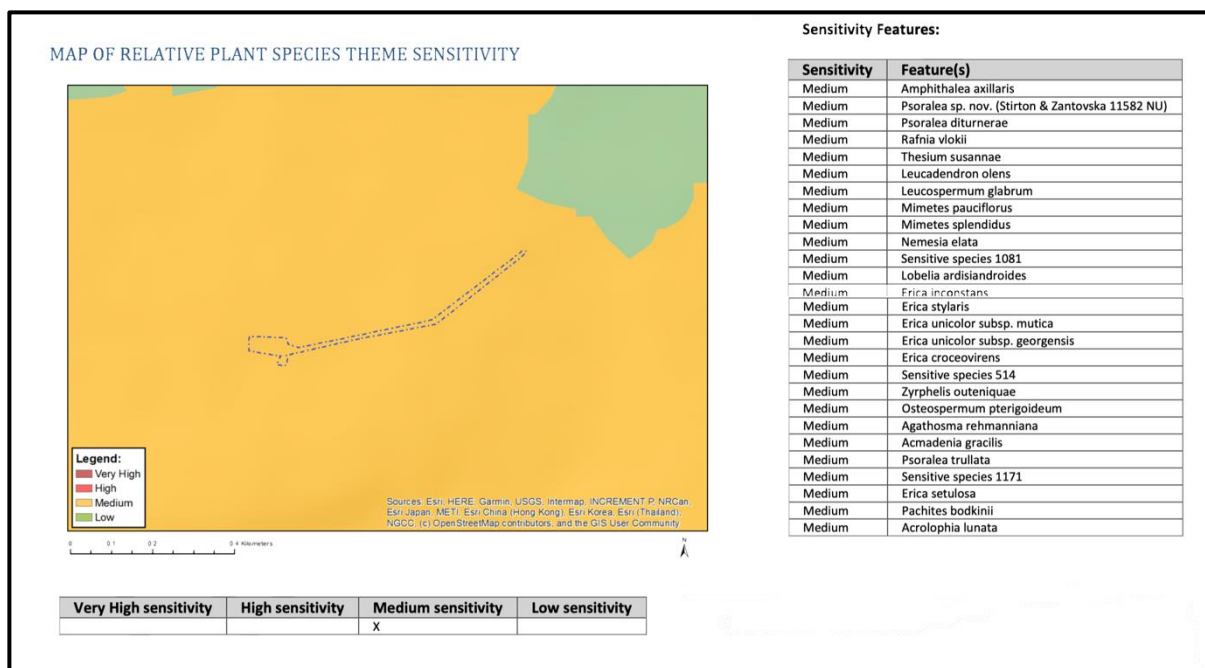
A mandatory requirement of specialists is to apply the National Web-based Environmental Screening Tool to any area that is assessed. The screening tool was thus applied to the 'footprint' of the disturbed 'house platform' and access road at Portion 1 of Platte Kloof 131. The outcome of the screening tool for the Relative Plant Species Theme Sensitivity is **Medium** (Figure 35). In addition, none of the 'sensitive species' listed in Figure 35 were recorded.

Figure 35. The output map from the National Web-based Screening Tool for Plant Sensitivity, with a list of sensitive plant species.

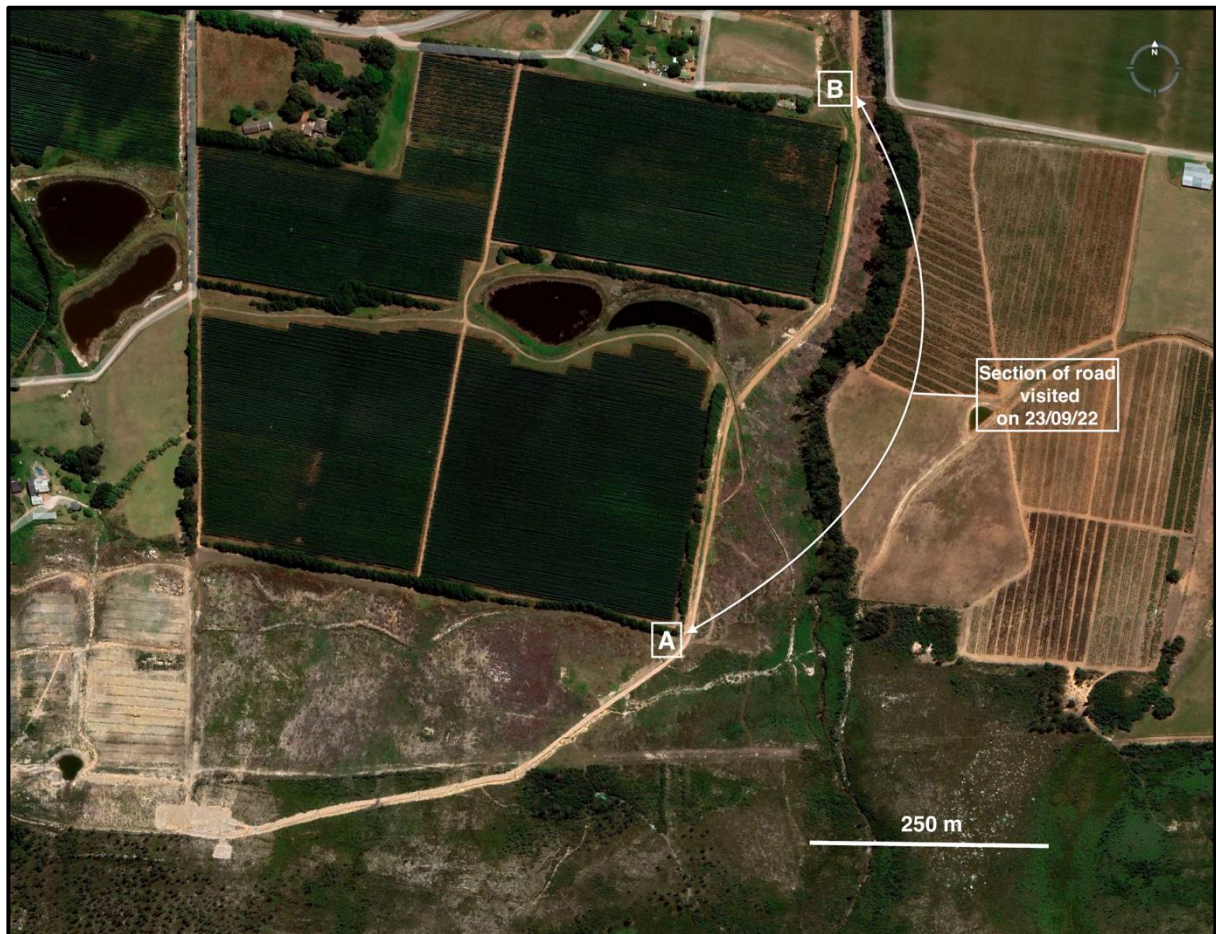
Figure A1. Aerial image (Google Earth TM) with annotations indicating the section of the access road that was surveyed in September 2022.

The section of the access road to Portion 1 Platte Kloof 131, George that was not surveyed in April 2022 is the lower section adjacent to the hops orchards on the neighbouring farm, Remainder Holle Kloof 91. The road was surveyed by walking from the upper Point A to the lower Point B in Figure A1, taking note of the vegetation and general habitat condition.

It is safe to say that there is no intact indigenous plant community anywhere adjacent to the section of road investigated. The environment is extremely disturbed and generally invaded by alien black wattle (*Acacia mearnsii*) and Kikuyu grass (*Pennisetum clandestinum*). A pine plantation was formerly present on the east side of the road, but it was burnt in the last severe fires in the area and the burnt trees have been felled. Opportunistic *Seriphium plumosum* (slangbos), grasses and other ruderal species have established in the burnt area (Figure A2).

It is strongly recommended that the alien invasive black wattle saplings should be cleared as soon as possible before they become large, and the exercise becomes unwieldy and costly.
