RE: Milkwood Updated SDP

Our Reference: AFP240047-PR-MILKWOOD-R00

**MILKWOOD MANOR REVETMENT: COASTAL ENGINEERING ASSESSMENT****1. INTRODUCTION**

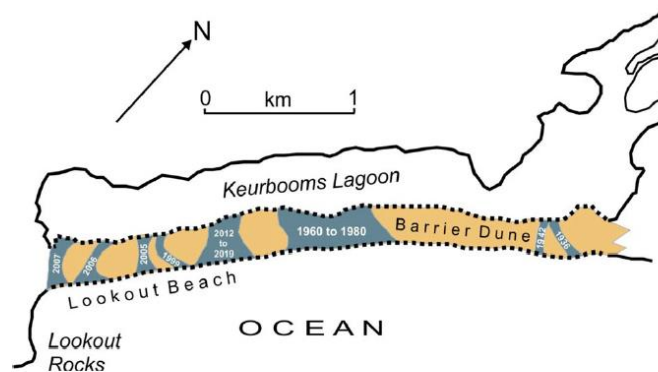
Fig. 2 The Keurbooms Lagoon and associated Barrier Dune. The approximate positions of the mouth over the given years are shown by the dark blue areas on the barrier dune (Duvenhage and Morant 1984; Illenberger 2003; Schumann 2015)

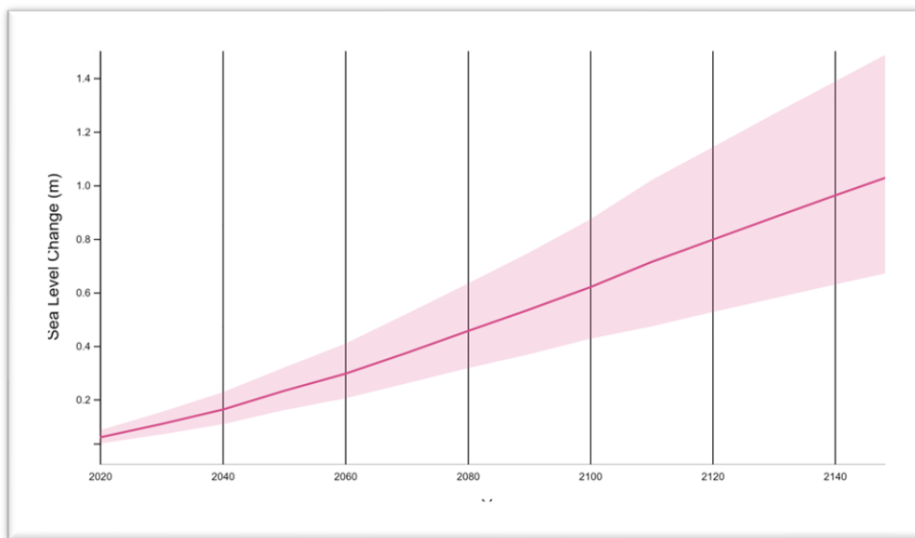
**Figure 3.3.1 Projected Sea Level Rise for SSP2-4.5 scenario**

The impact of climate change will therefore lead to more severe conditions at the site. This will be experienced as higher flooding levels and increased wave heights on the seaward portion of the revetment with resultant higher levels of overtopping and flooding behind the revetment.

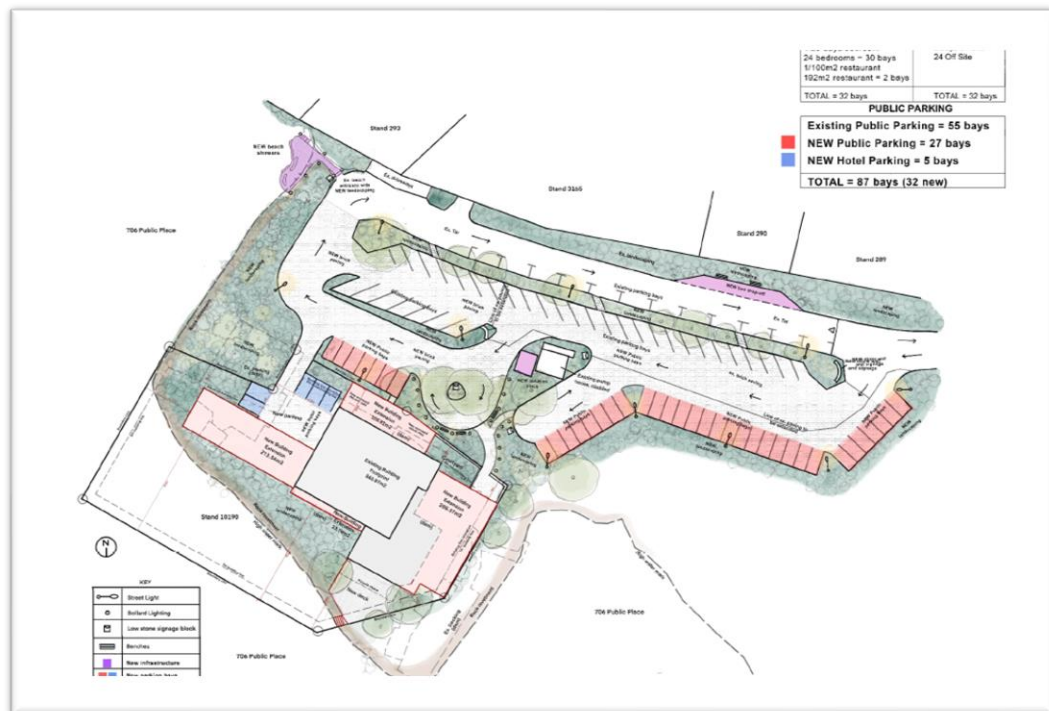
**Figure 3.4.1 Proposed site development plan**
