## Cape Environmental Assessment Practitioners (Pty) Ltd

### **MOLEN CLOSE RIVER REHABILITATION** **Environmental Control (ECO) Report – May / June 2023**

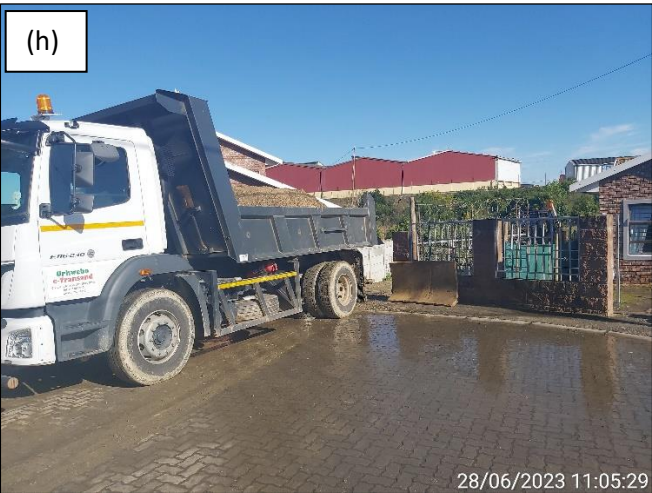
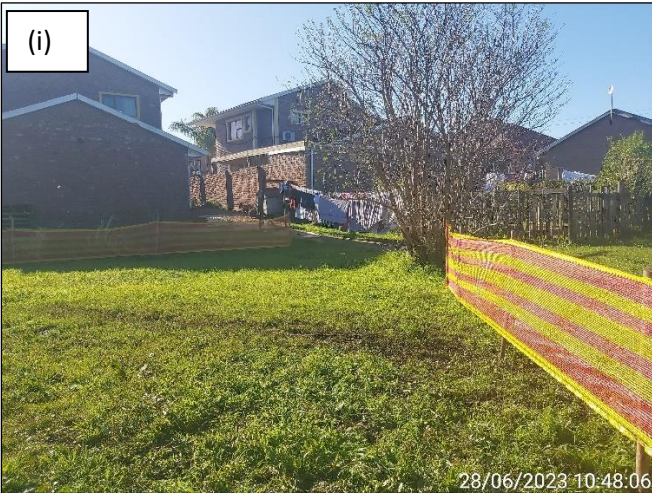
- Silt fences are in place (*photographs a & b*).
- One toilet & bin are on-site (*photograph c*).
- The contractor has commenced with Section 1 (*photograph d - g*).
- A lot of storm water still enters Erf 21151. Reminded the contractor to place sandbags on the sidewalk to direct storm water into the municipal system (*photograph h*).
- A portion of the demarcation is not closed properly (*photograph i*). Asked the contractor to close the demarcation.
- First induction with the contractor's team working within the watercourse. The contractor told the ECO that a few local workers from rosemoor will also help with the gabions. He will inform the ECO once they are on-site so that the ECO can do an induction with them as well.
