# **PROPOSED PREEKSTOEL BEACH ESTATE**

## **ENVIRONMENTAL MAINTENANCE MANAGEMENT PLAN FOR THE REHABILITATION OF THE FRONTAL DUNE SYSTEM ON ERF 2341 STILL BAY EAST**

### **SHORT-TERM ENVIRONMENTAL MAINTENANCE MANAGEMENT PLAN**

**Date: May 2024**

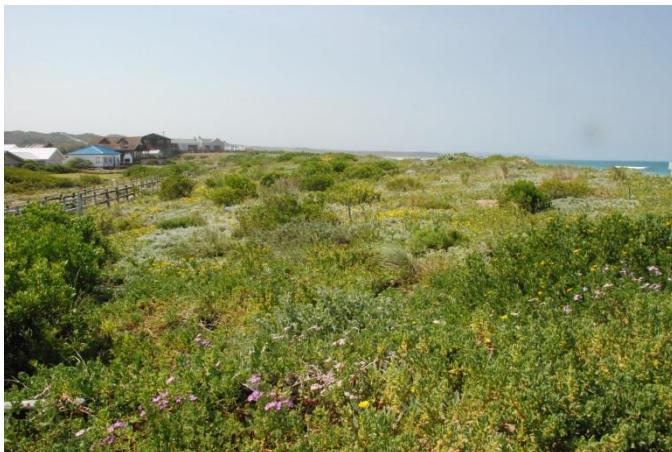
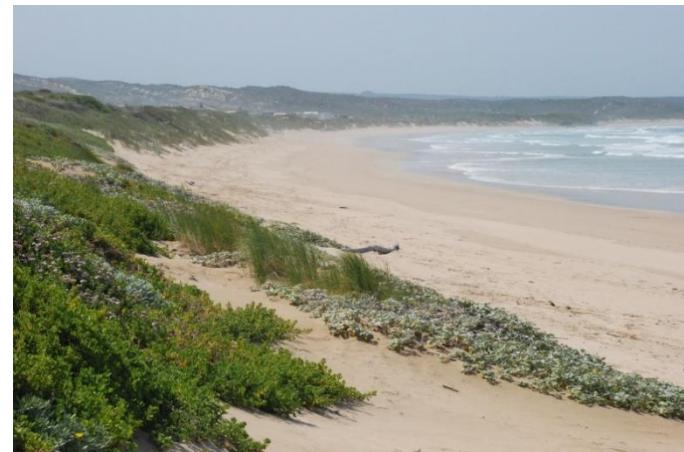
**Photos 16a and 16b:** These photos were taken at Lappiesbaai, Still Bay East where a dune rehabilitation programme was undertaken by the CSIR to stabilise the frontal dune system. The Strandveld plants of this programme are still irrigated by the Hessequa Municipality. Note the flat dune profile.

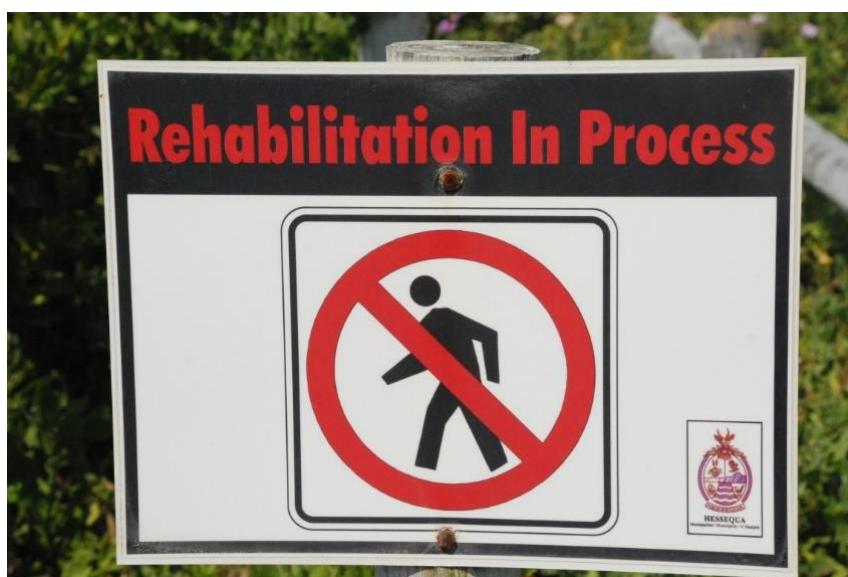
**Photo 17:** An example of a sign board placed on the Lappiesbaai frontal dune system, Still Bay East.

The whole frontal dune should be cordoned off so that the public does not have access to the area being rehabilitated. Permanent sign boards should be erected indicating that dune "rehabilitation is in progress" and that people are not allowed in the area (**Photo 17**).

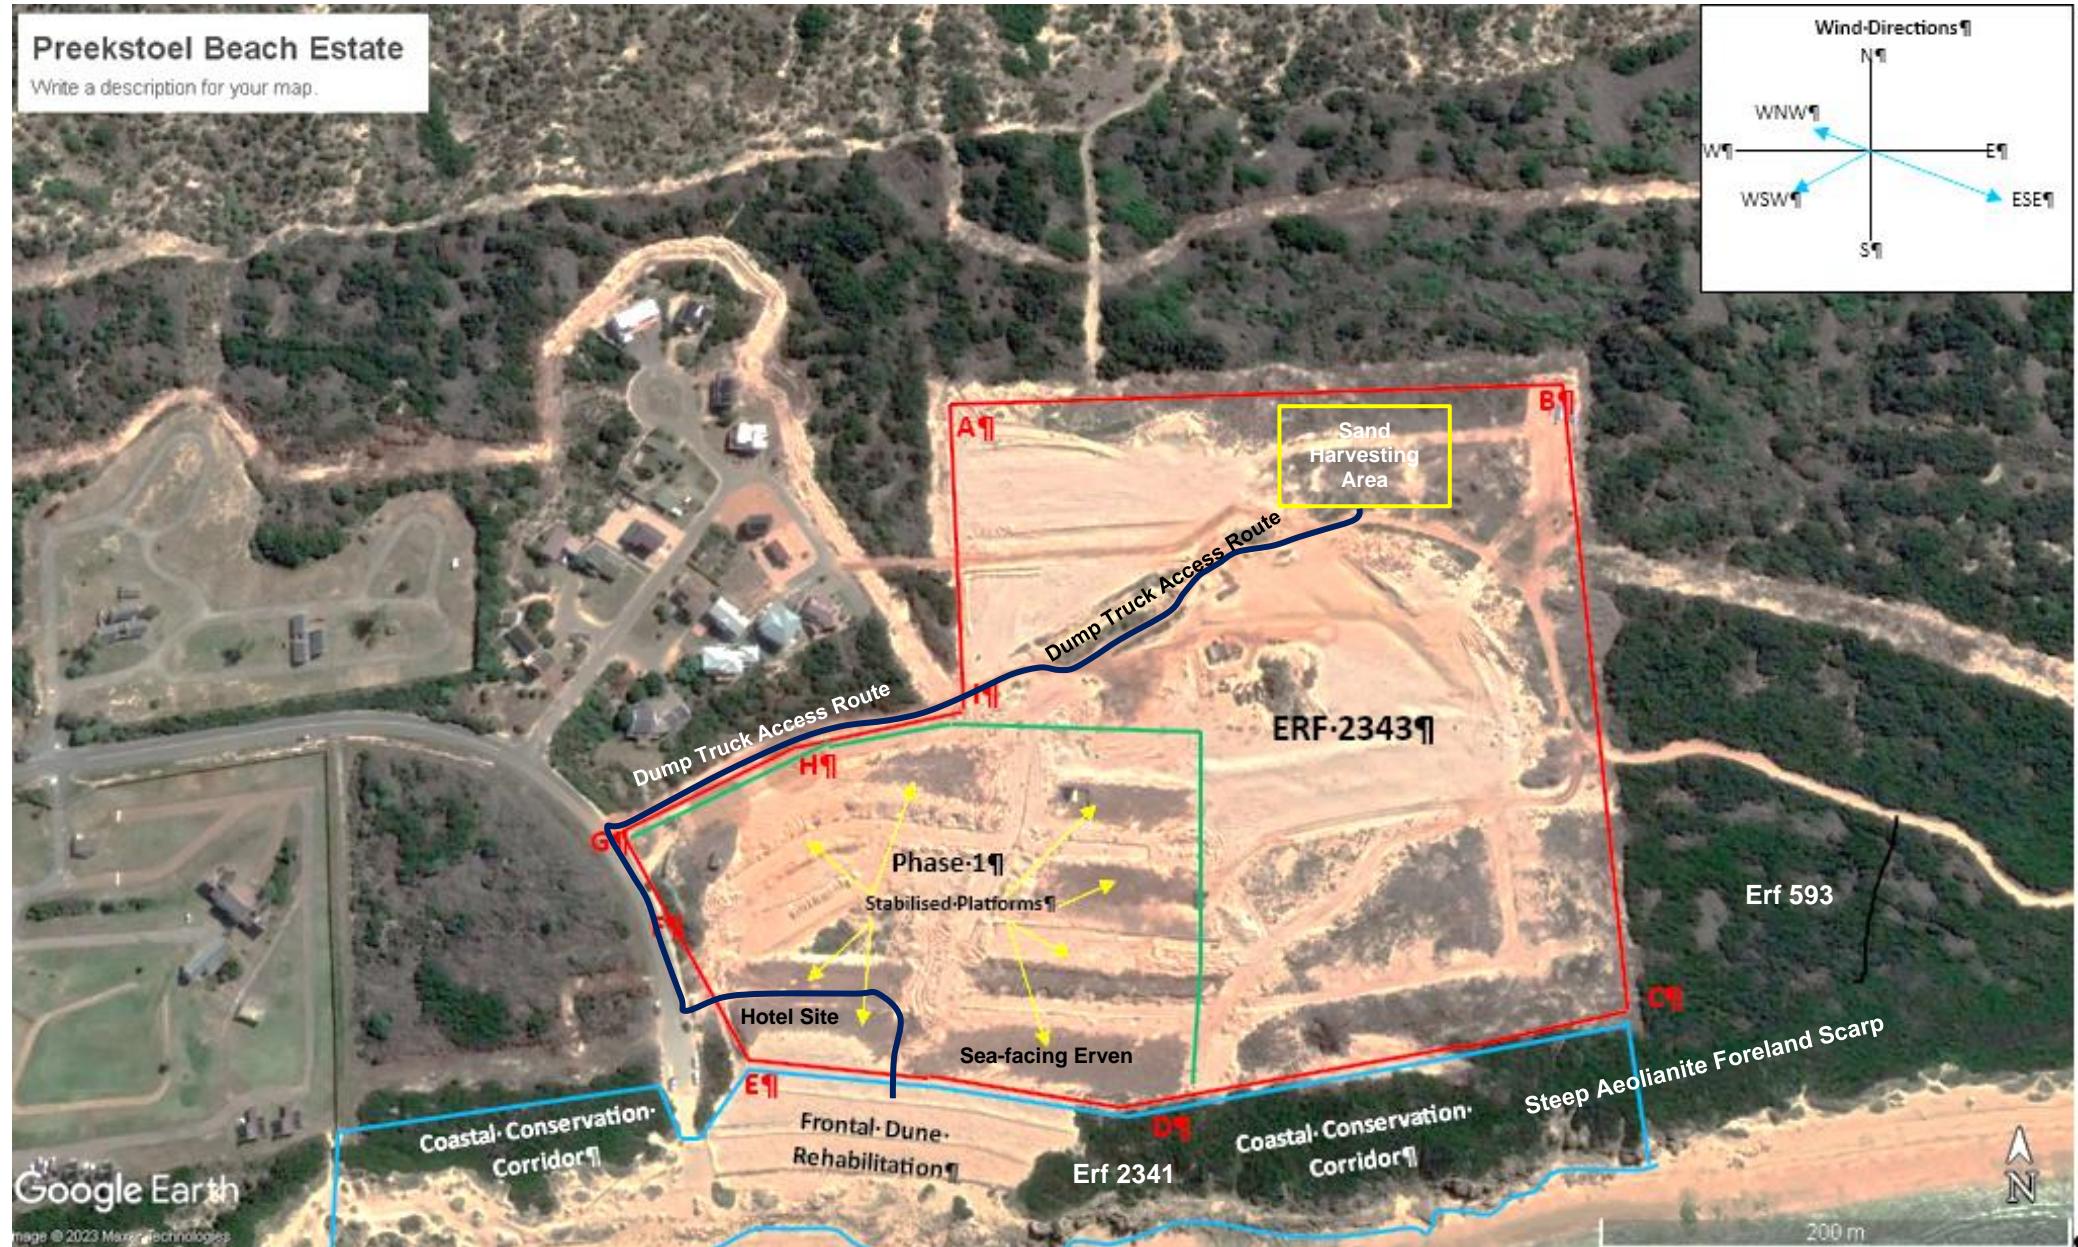
**FIGURE 1:** Preekstoel Beach Estate, showing the stabilised building platforms, the transformed Frontal Dune System, the Sand Harvesting Area, the Dump Truck Access Route to the frontal dune and the Coastal Conservation Corridor (Erf 2341).

The approximately 4 500m<sup>3</sup> of sand to be used in the rehabilitation of the transformed frontal dune will be obtained from the unconsolidated windblown dune sand occurring within the northeast sector of the development site (**Figure 1**). This sand is ideal for the rehabilitation of the frontal dune as it is derived from sea sand blown into the interior of the area when sea levels were lower than they are today. Such sand contains weathered seashells and is geologically identical to the recent sands forming the frontal dune system. Since the sand is being obtained from the site of the development, no authorisation is required for its use as filling on the frontal dune system.

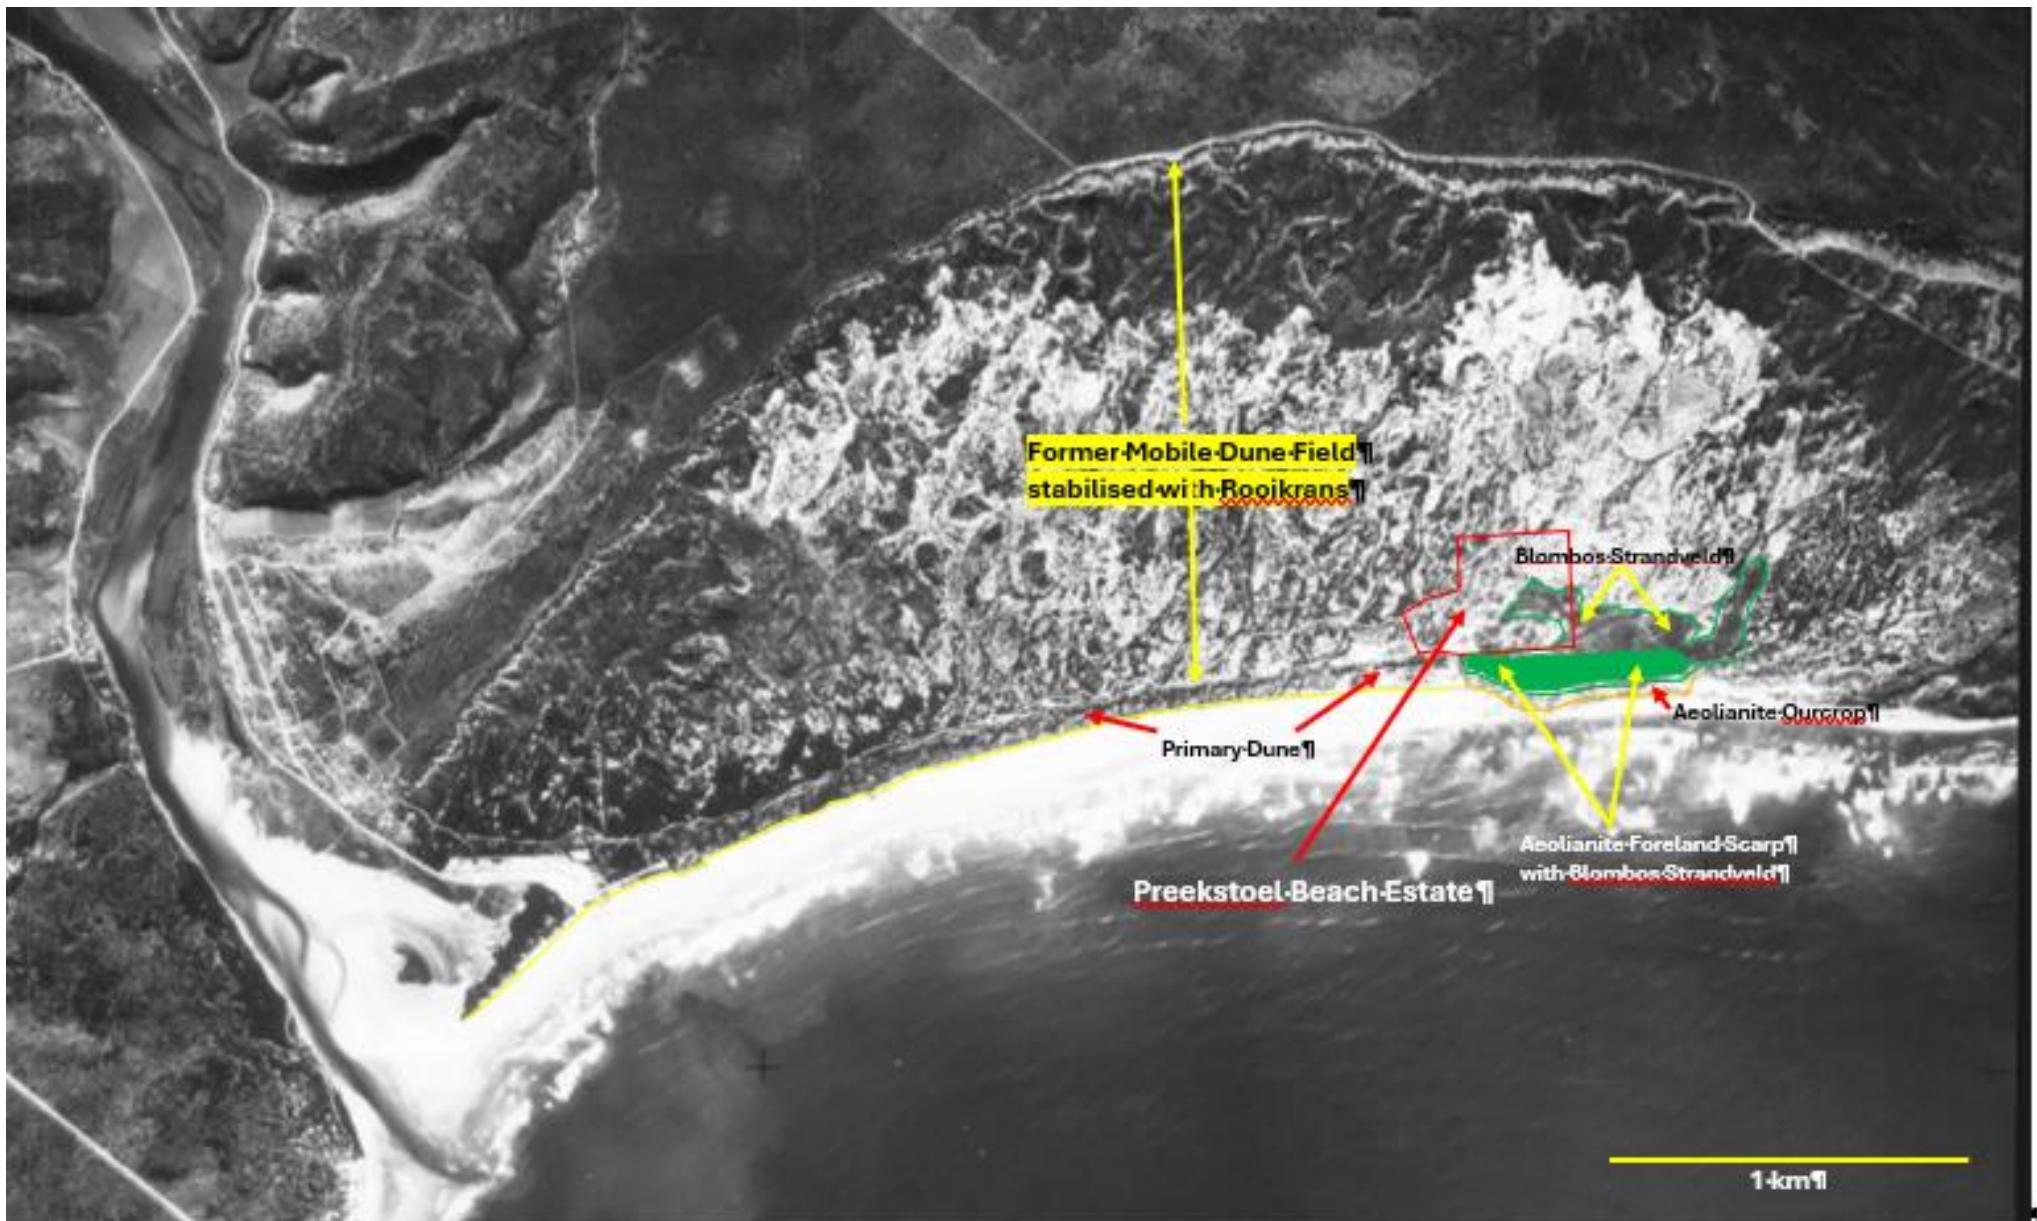
**FIGURE 2:** Aerial photo of the mobile dune field that was stabilised with **rooikrans** seedlings from 1928 to 1950's (photo taken on 3 April 1954). Note the remnant outlier of **Blombos-strandveld** (within green polygon) which today only occurs on the steep aeolianite foreland scarp. The back-dune area has been completely inundated by **rooikrans**. Note the artificial created primary dune along the coast. Also, note the darker grey/black tone of the back-dune area which shows the more prolific growth of **rooikrans**.

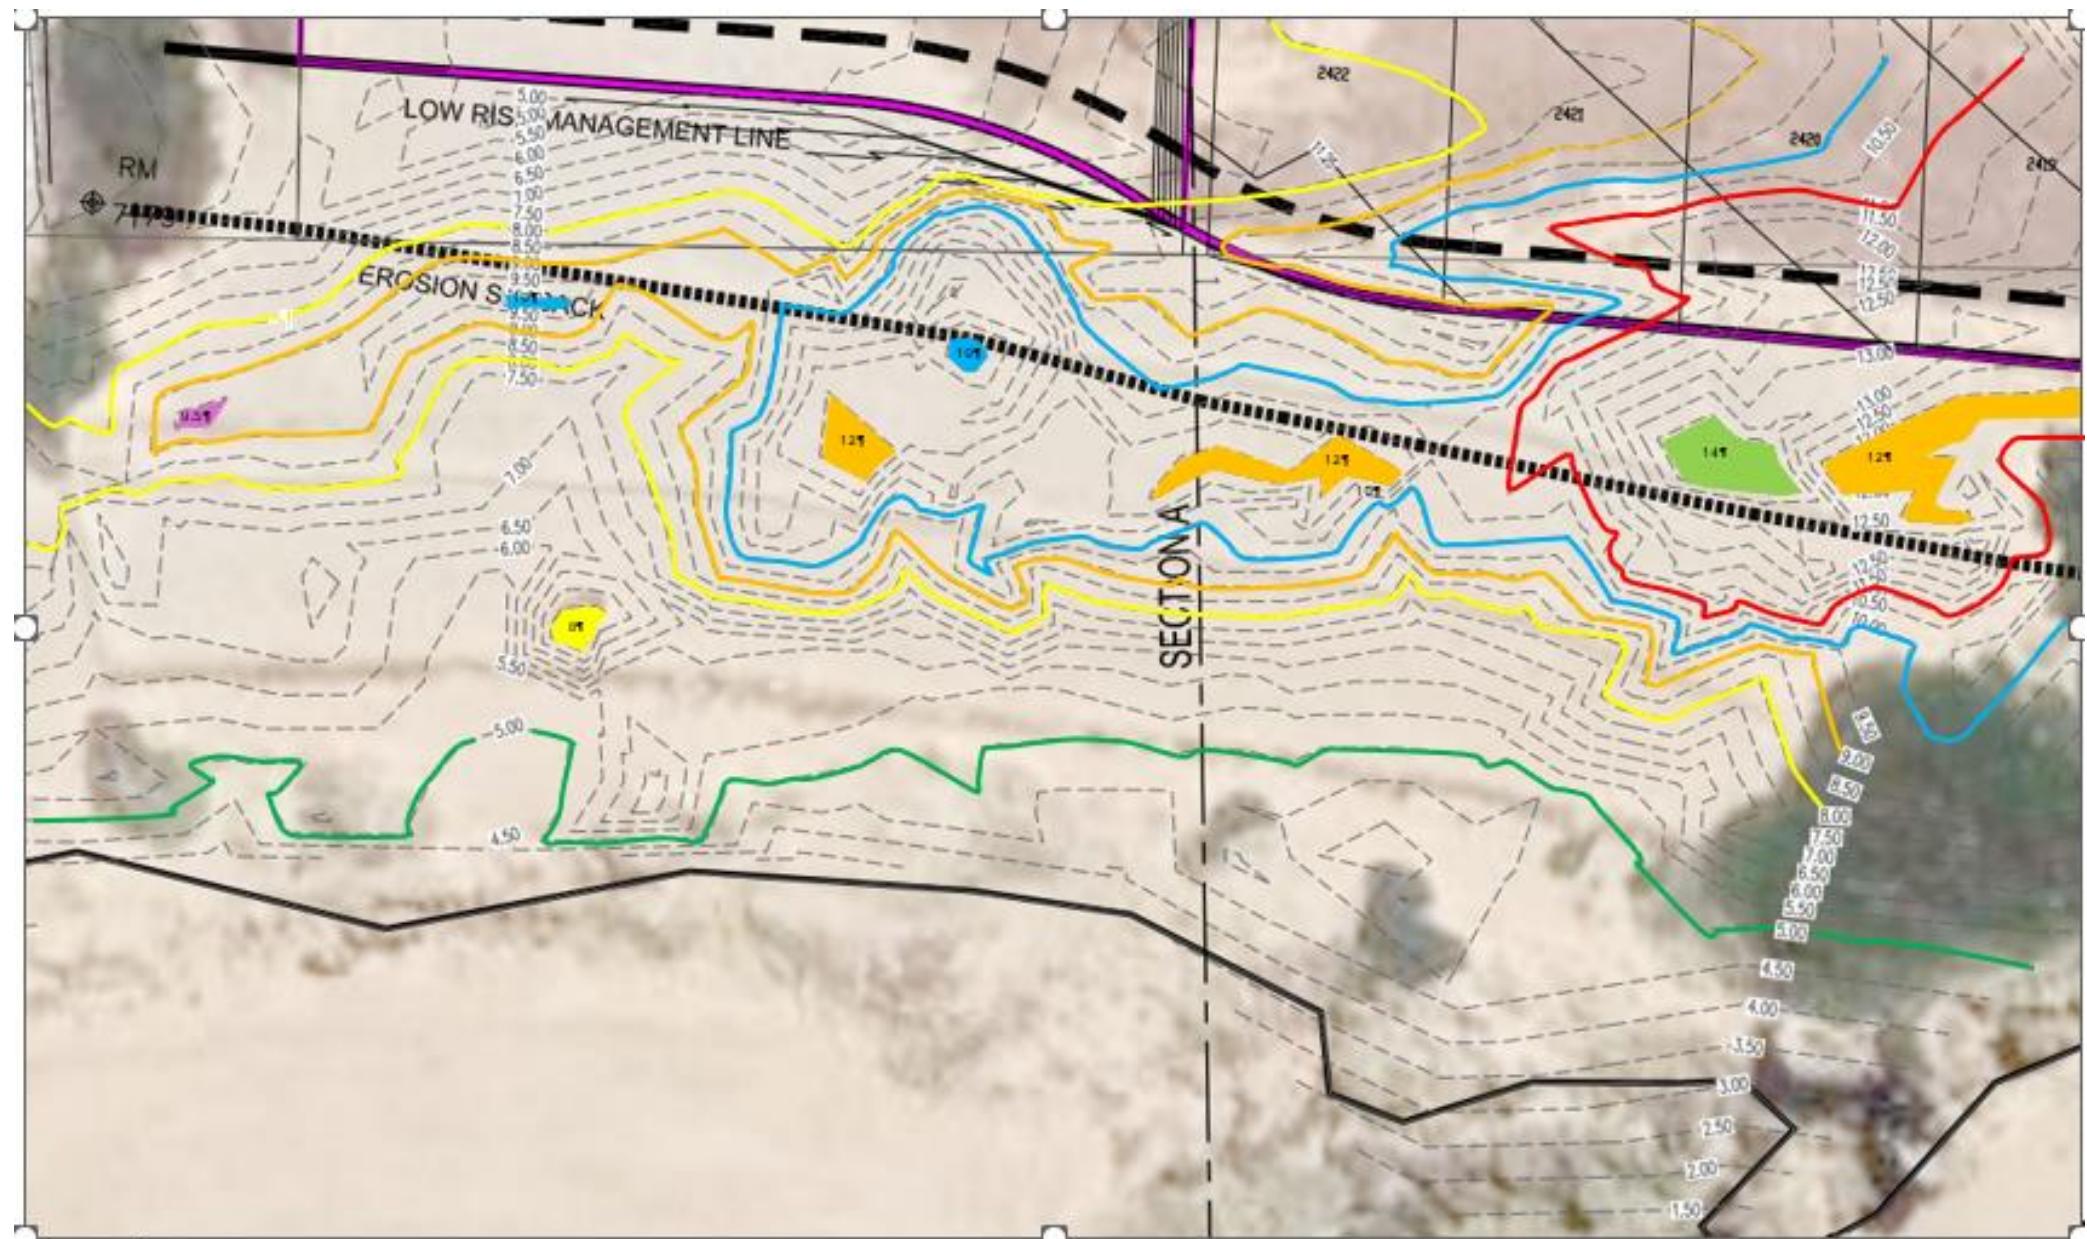
Figure 6: Depicts the surveyed contours of the frontal dune system (June 2012), with the highlighted 10m (blue) and 11m (red) contours, and the orange polygons (12m) and the green polygon (14m). Note the blow-out scars that are shown on the contour plan. ¶

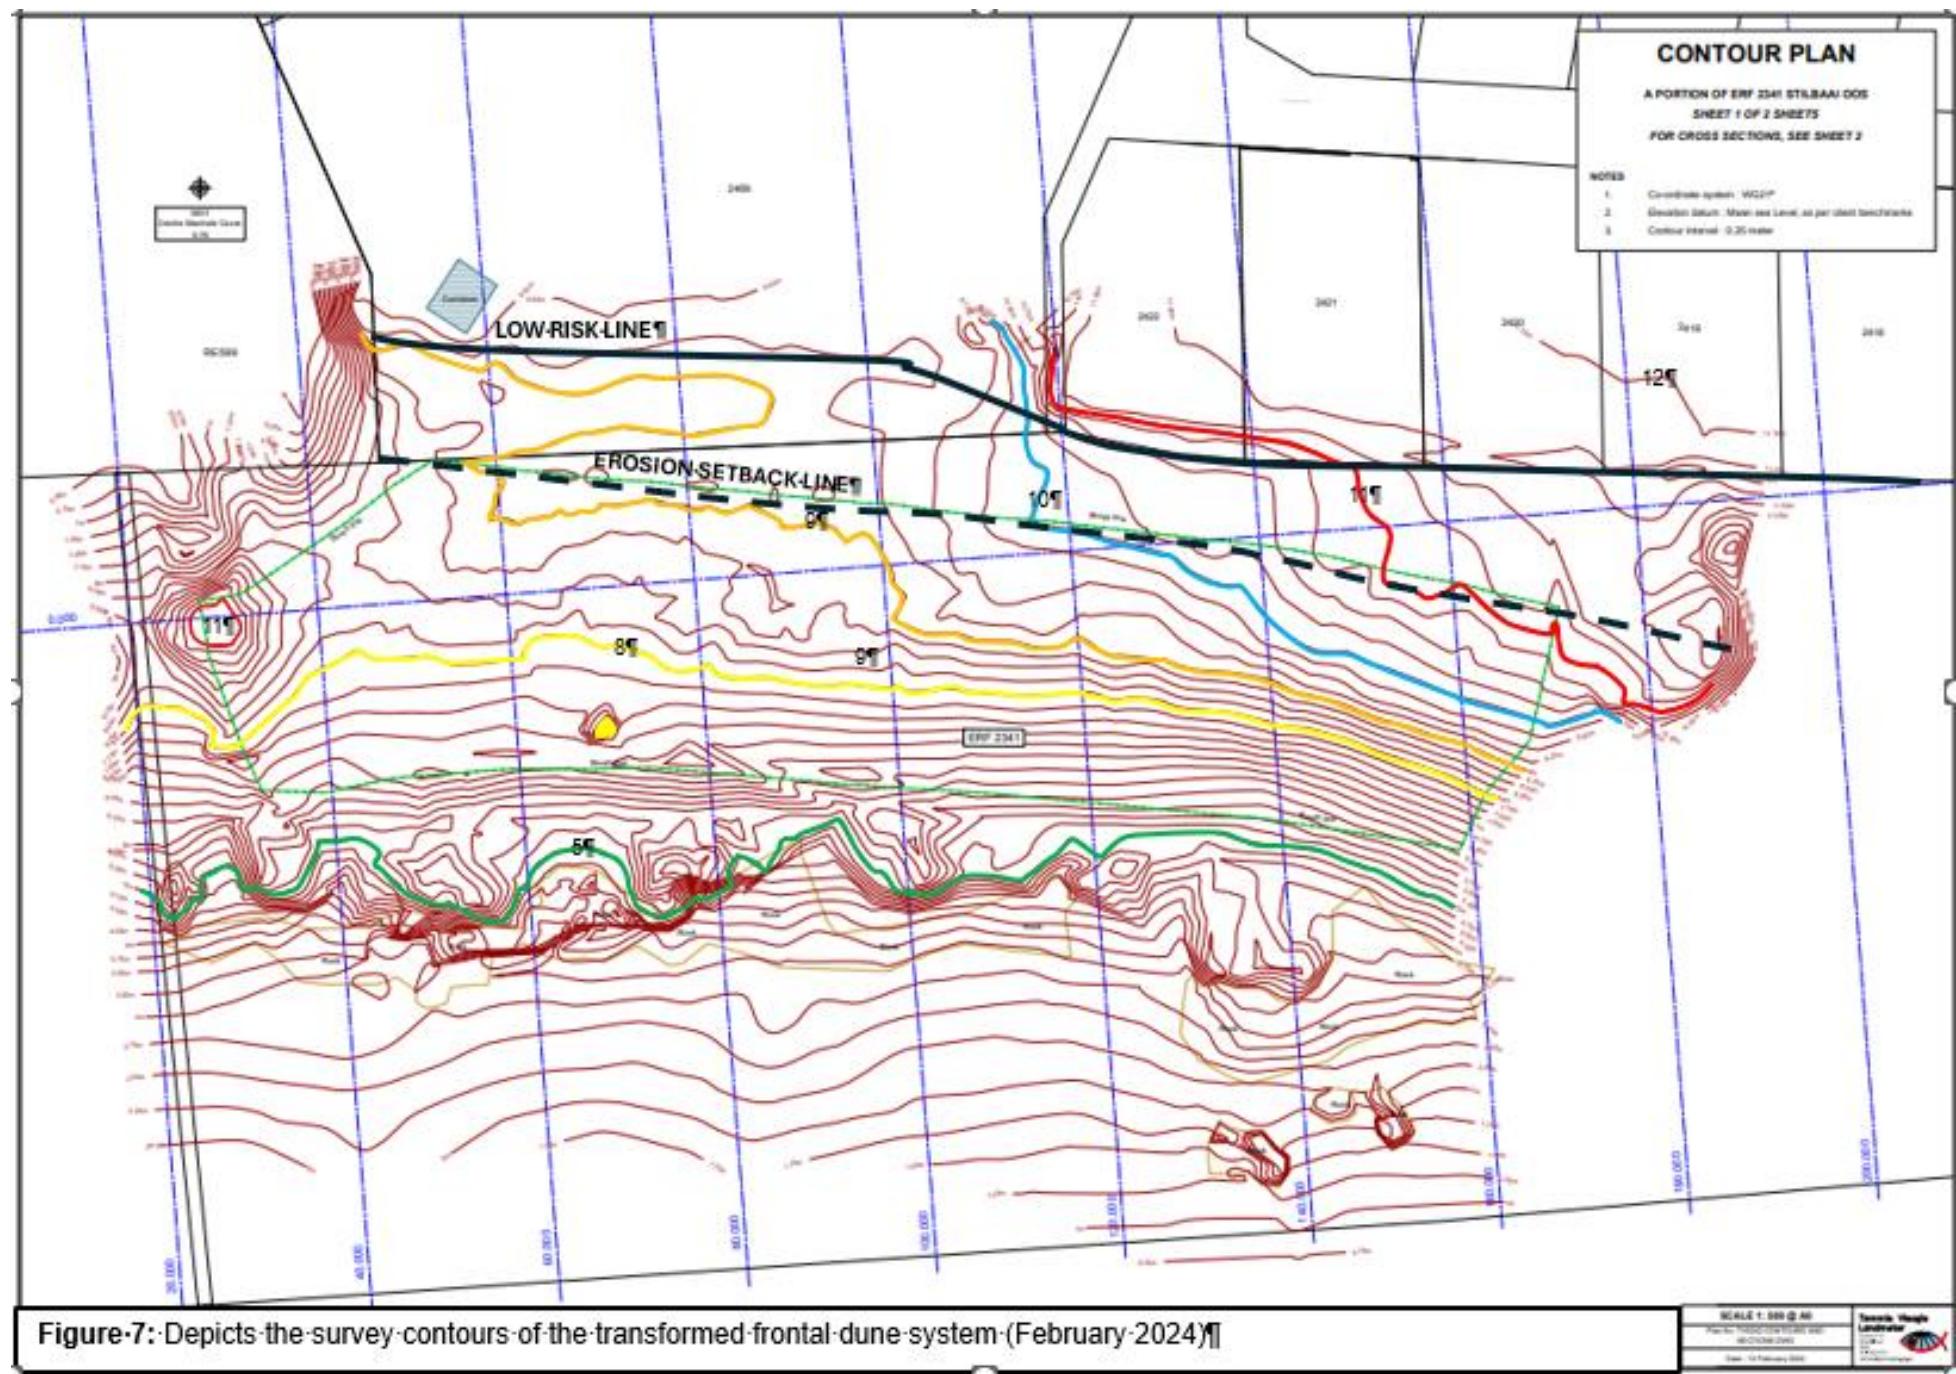
The Environmental Maintenance Management Plan for the Rehabilitation of the Frontal Dune System on Erf 2341: Short-Term Rehabilitation (i.e. the Dune MMP) dated February 2024, was not approved by the DEADP: Directorate: Environmental Law Enforcement (2 May 2024). DEADP requested that it be revised and resubmitted for approval as they believe that the 12m and 14m high dunes running east west within the eastern sector of the central frontal dune system of Erf 2341 should be replaced (**Figure 6**). This east west dune was flattened during the rehabilitation of the frontal dune system in 2022 and the sand was used for the infilling of the blow-outs on the frontal dune system(**Figure 7**).

Figure 7: Depicts the survey contours of the transformed frontal dune system (February 2024) ||

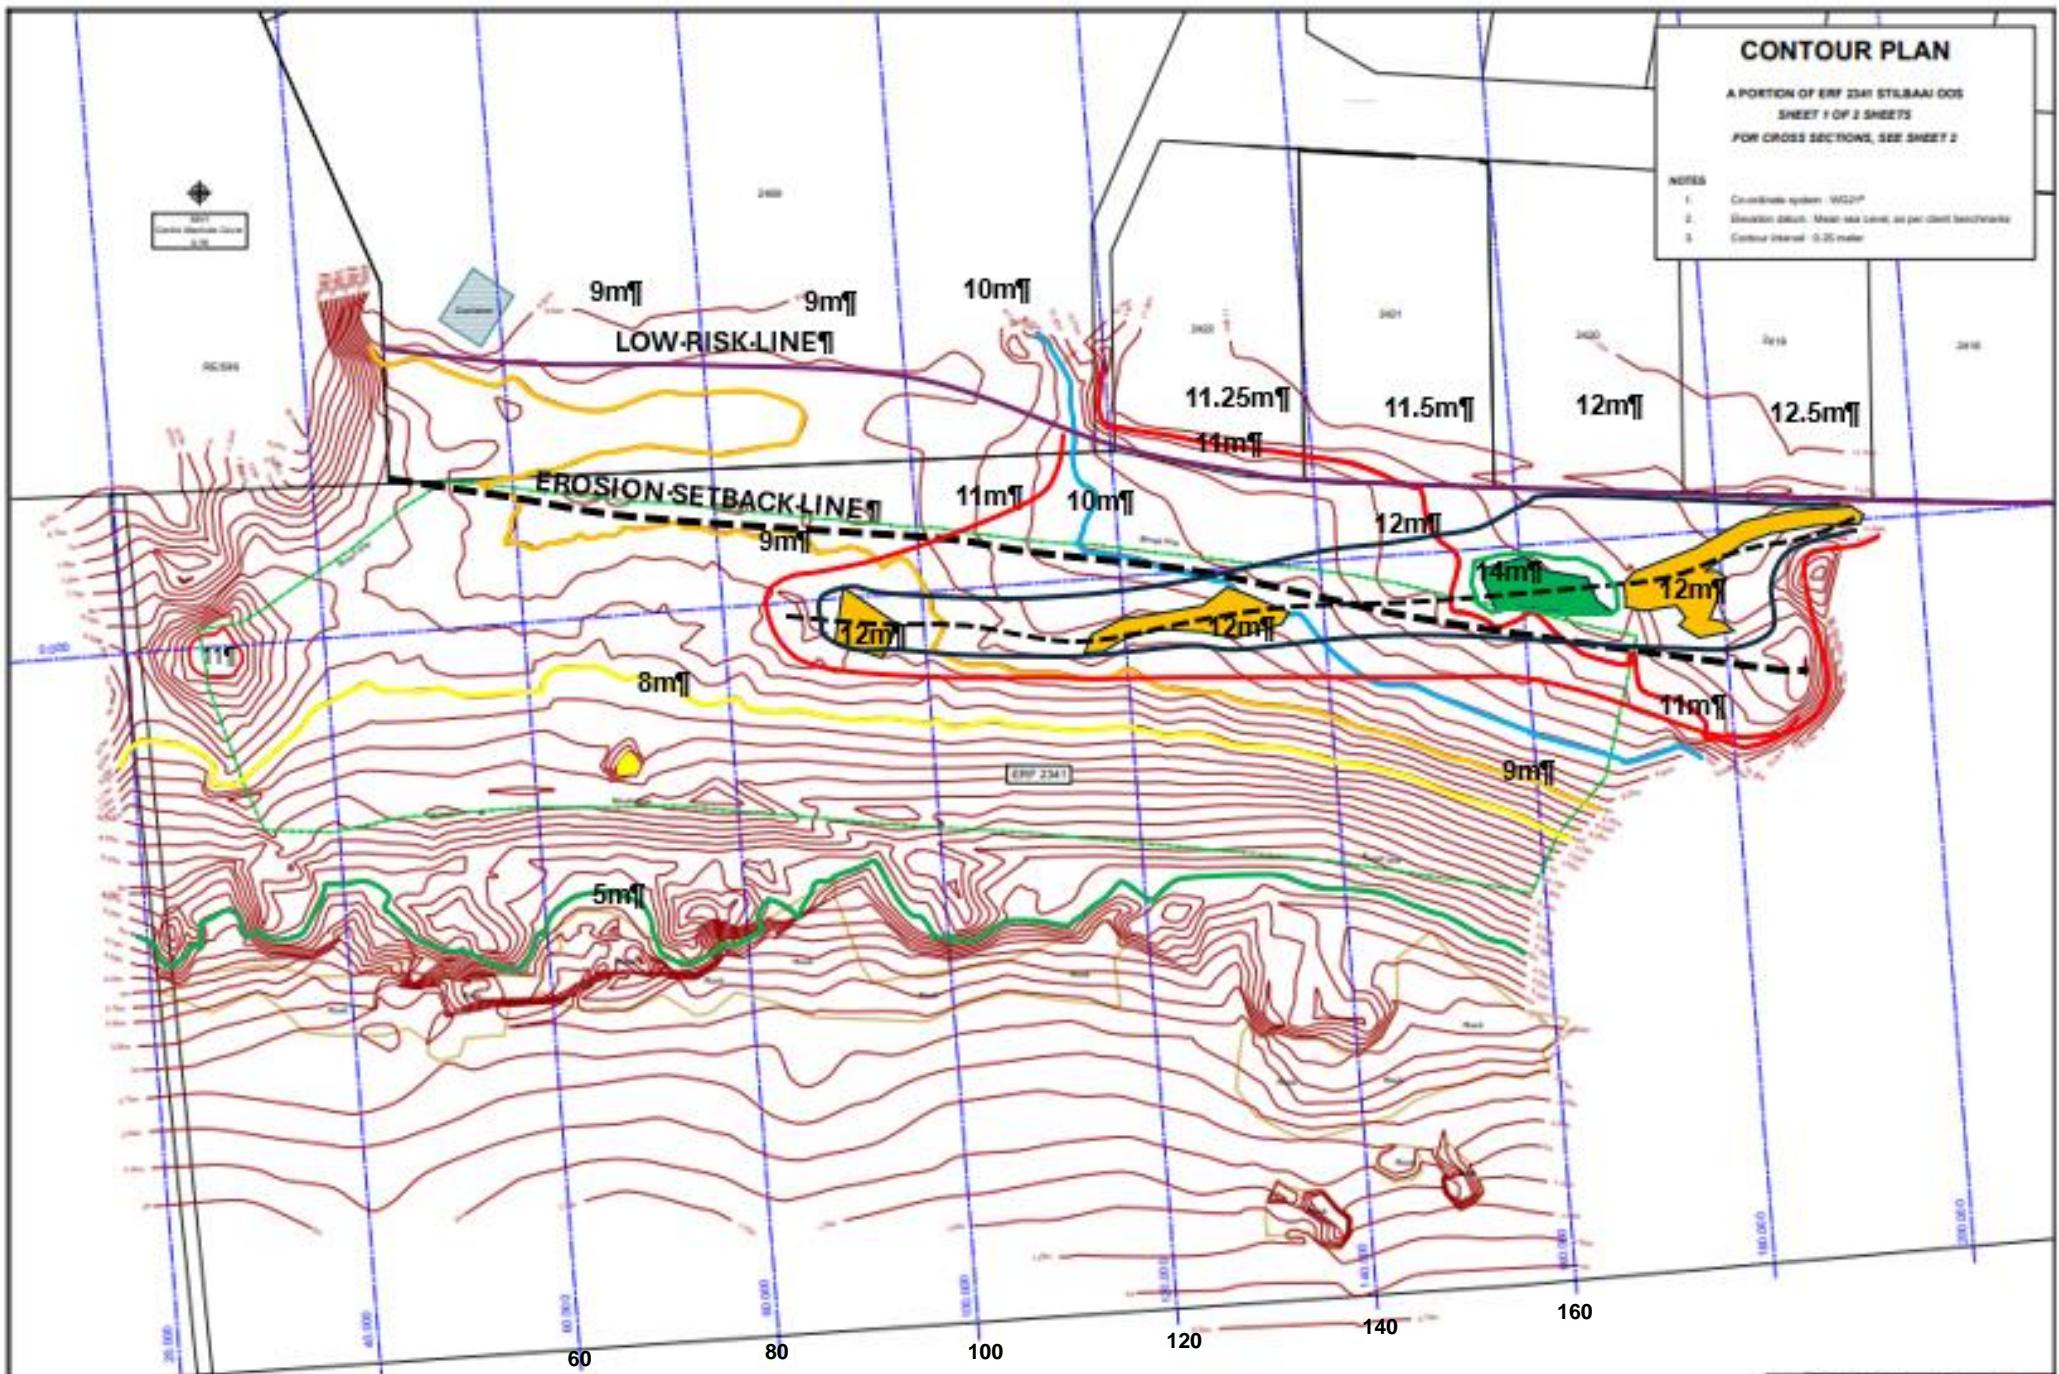
Based on the DEADP's request that the east-west trending dune be replaced, the dune high points mapped in 2012 were superimposed onto the contour plan of the transformed dune system (**Figure 8**). The proposed 10m, 12m and 14m contours were superimposed on the 2024 contour plan depicting where the east-west trending dune will be reconstructed.

Figure 8: Depicts the transformed frontal dune system (February 2024) and the superimposed east-west dune from 2012 survey.

- Demarcate the area that needs to be rehabilitated by adding more dune sand to recreate the profile of the previously existing east-west dune with its 14m and 12m peaks (**Figure 8**).
- Remove the three irrigation pipelines from the rehabilitated frontal dune area.
- Remove the strand plants within the area that will be affected by the placement of more dune sand. The sand is to be obtained from the northeast corner of the development site (**Figure 1**).

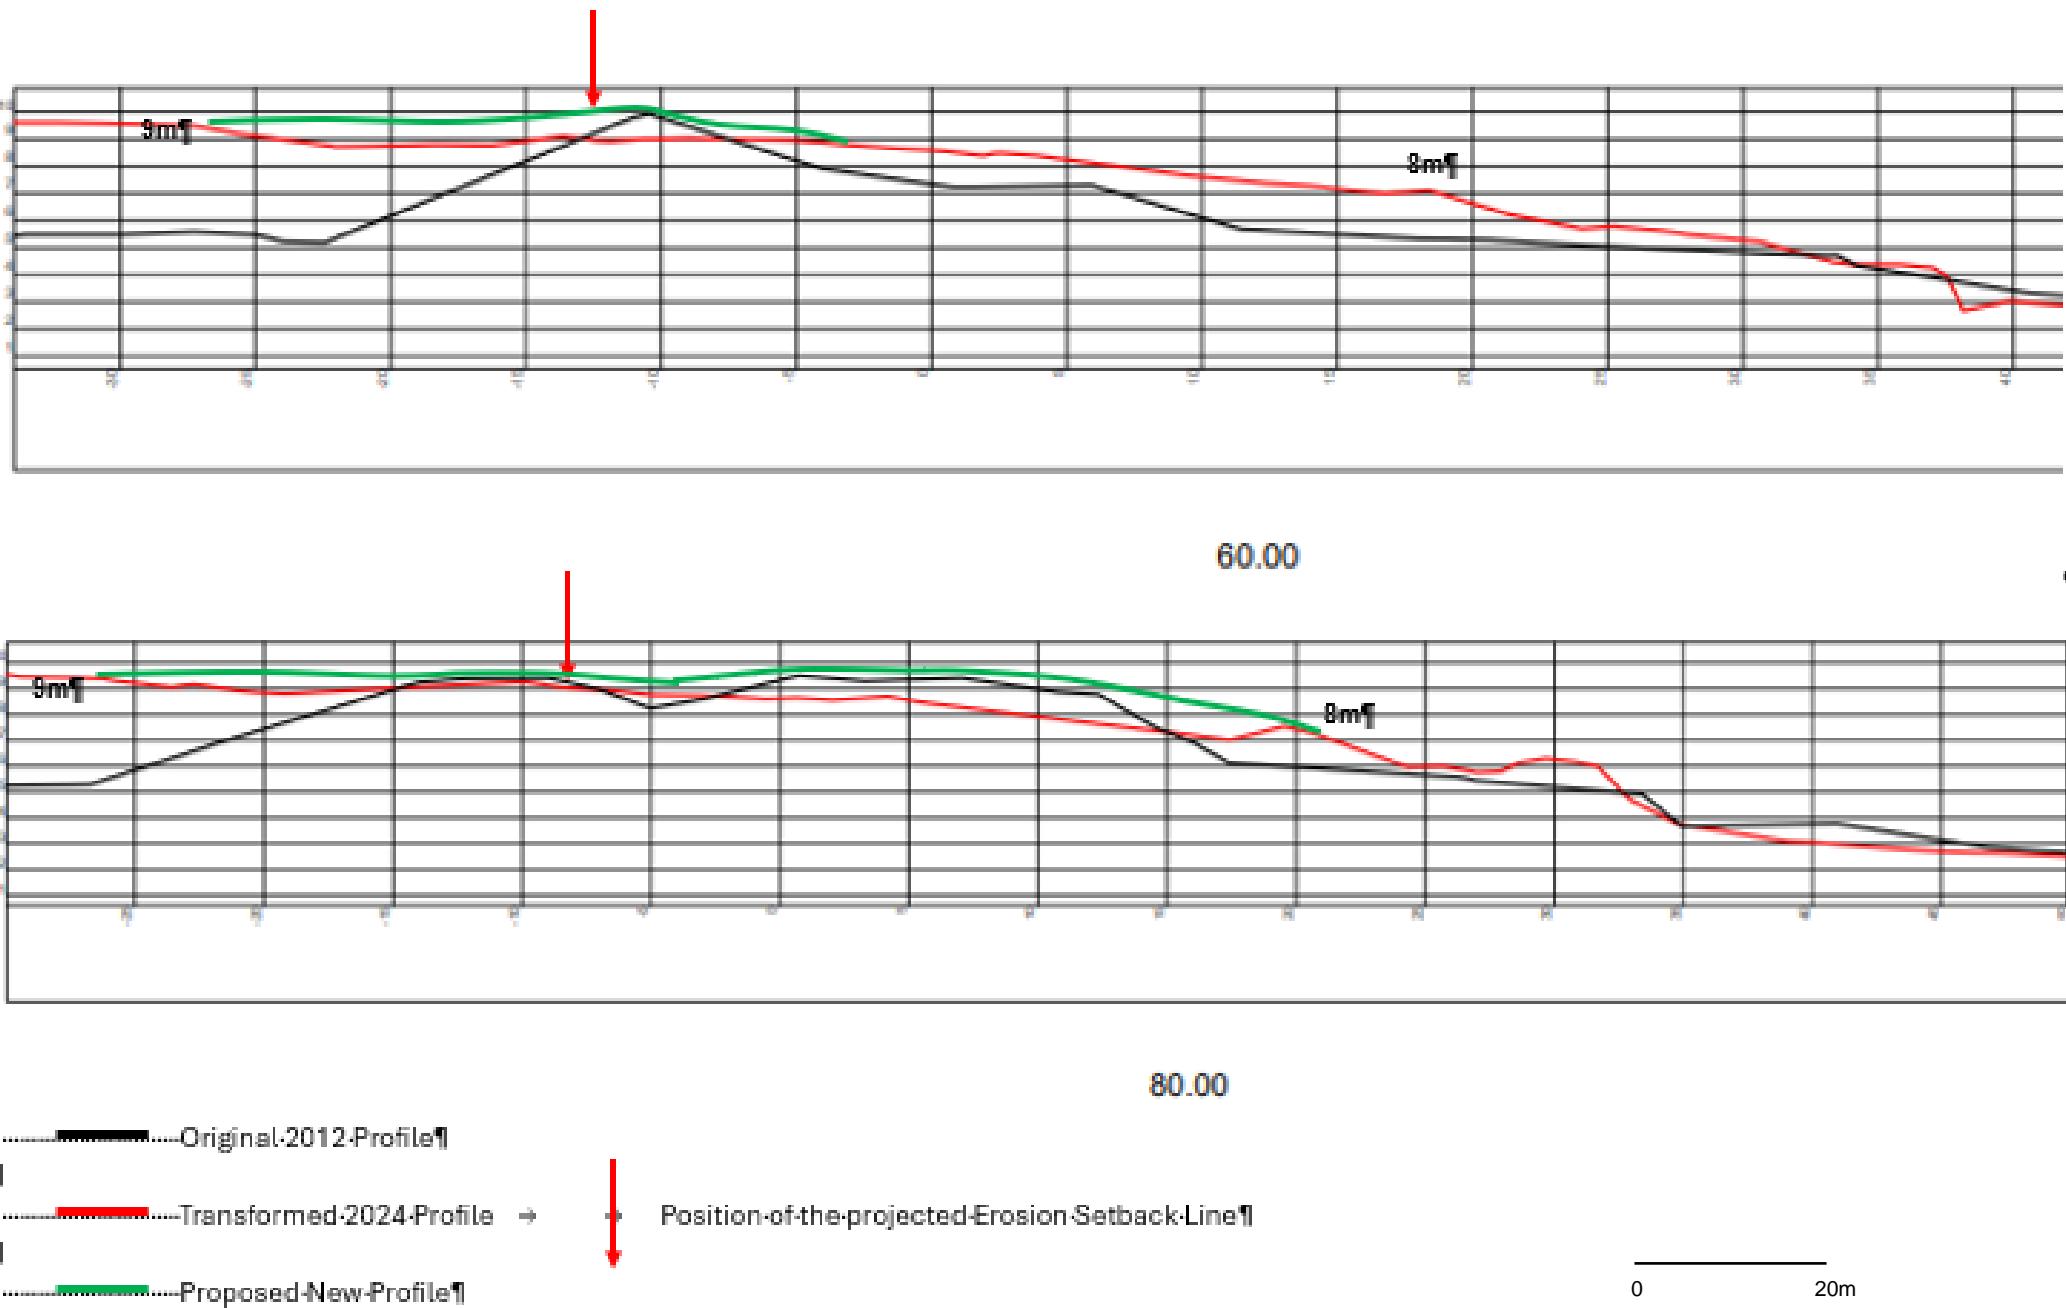
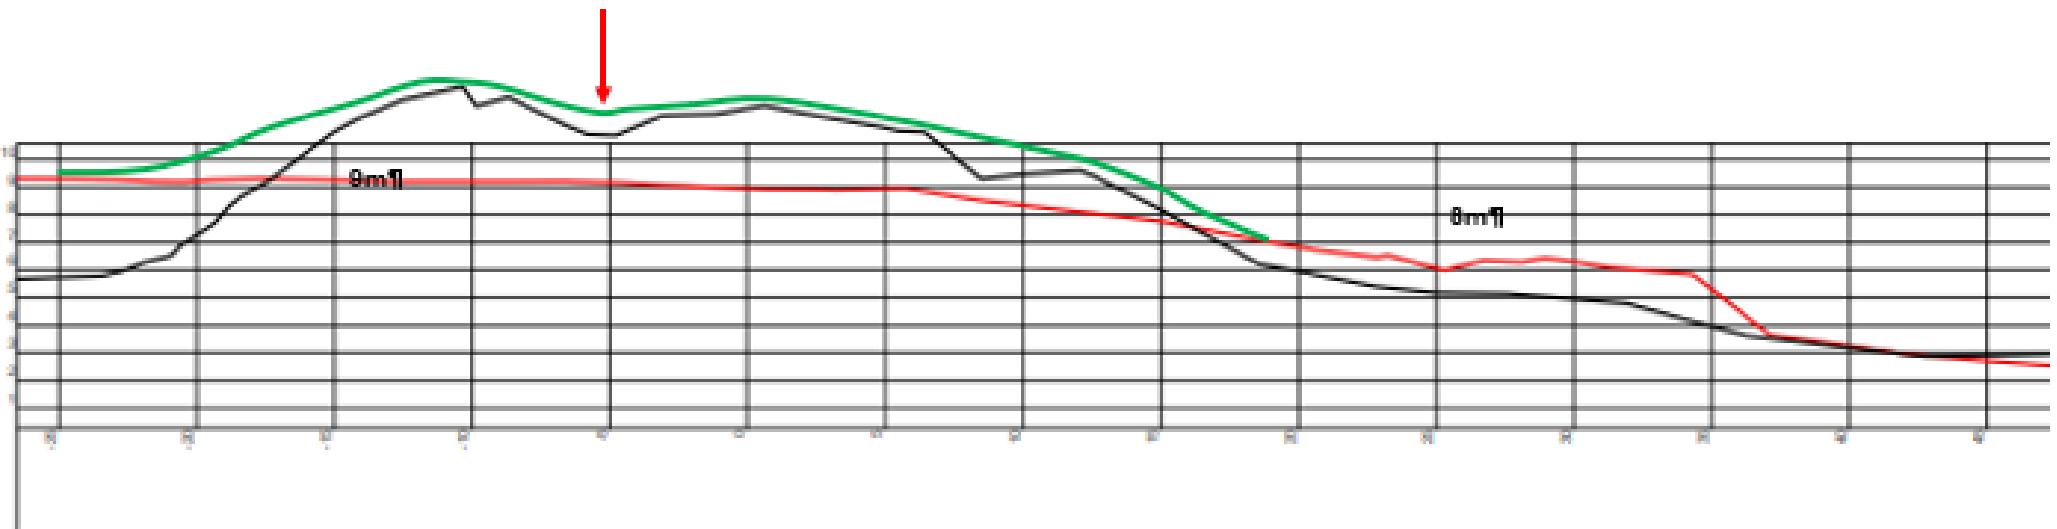
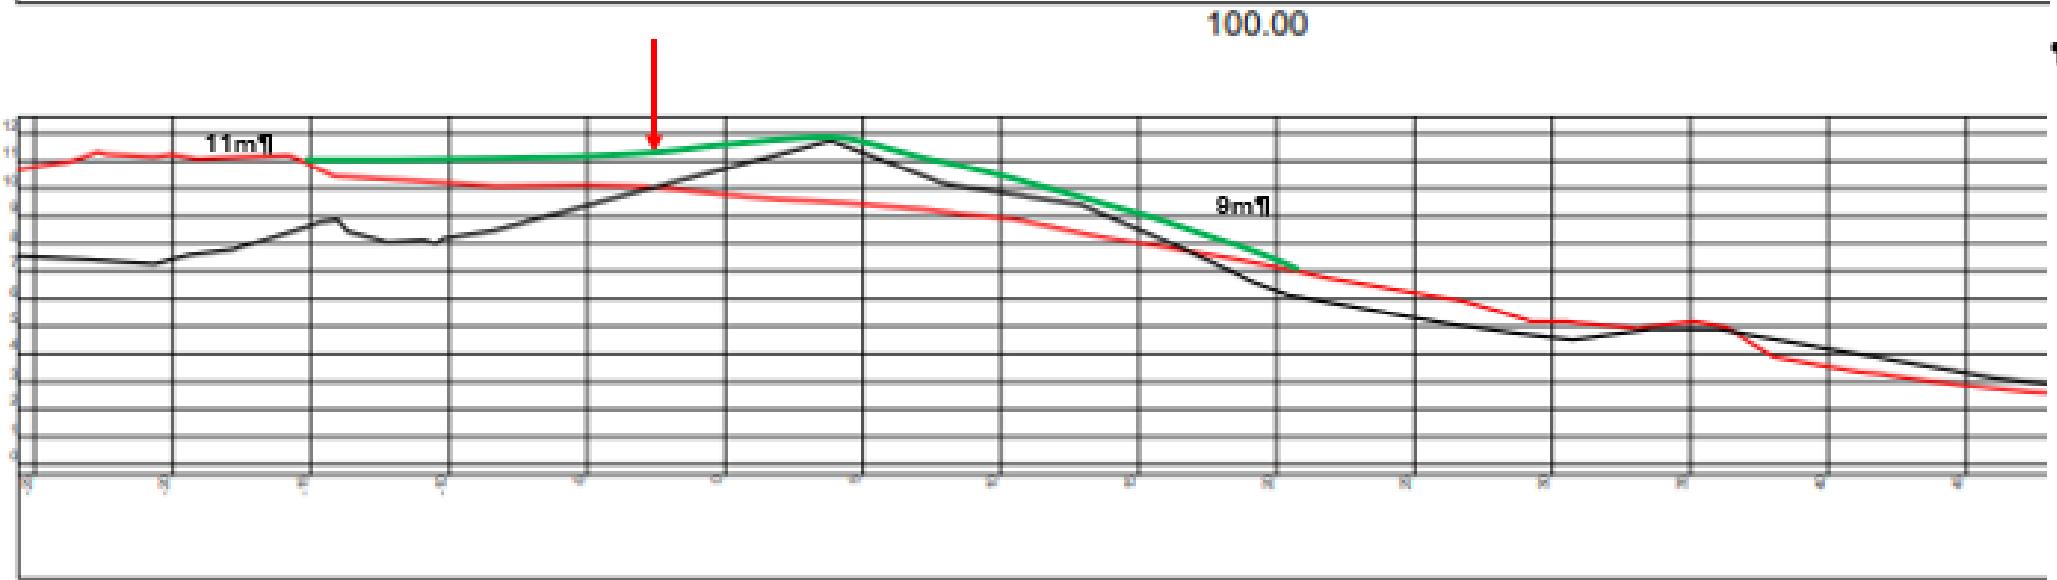
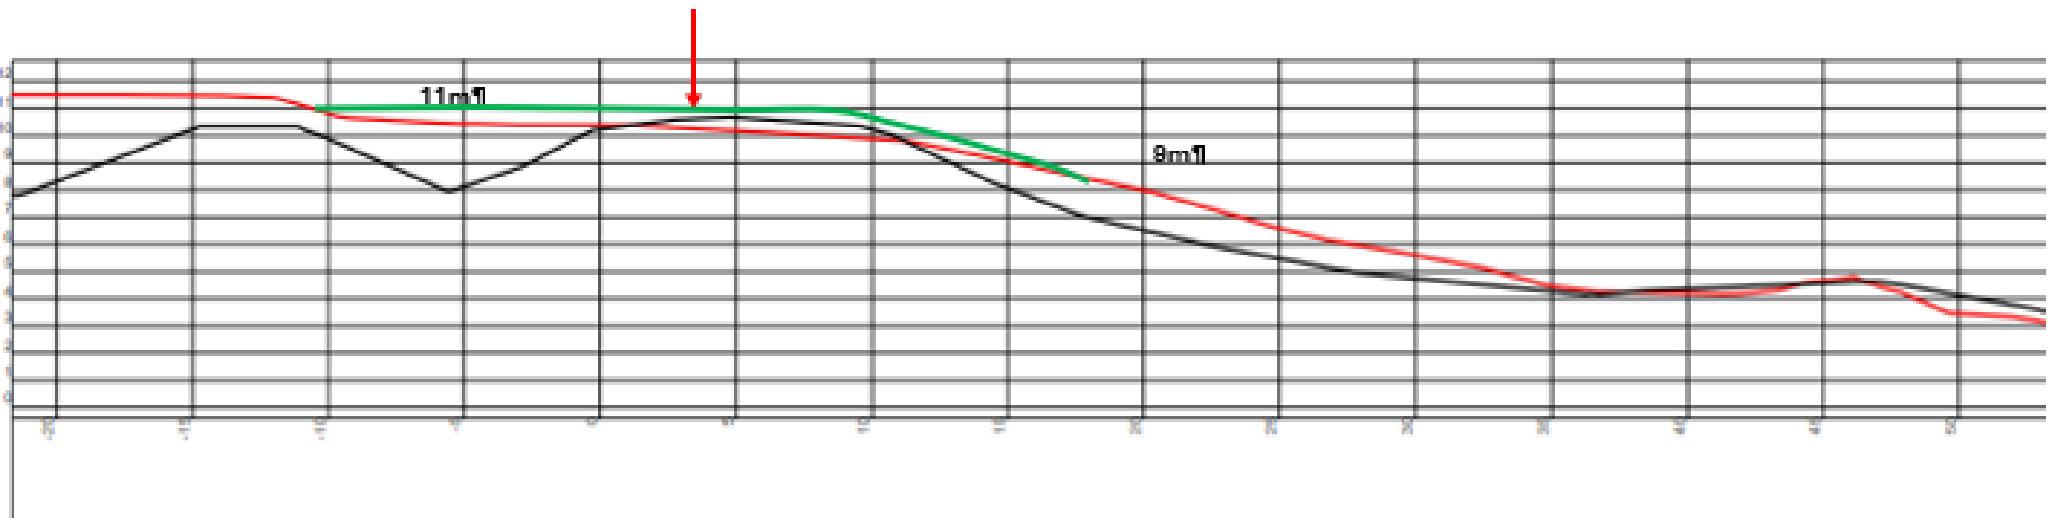
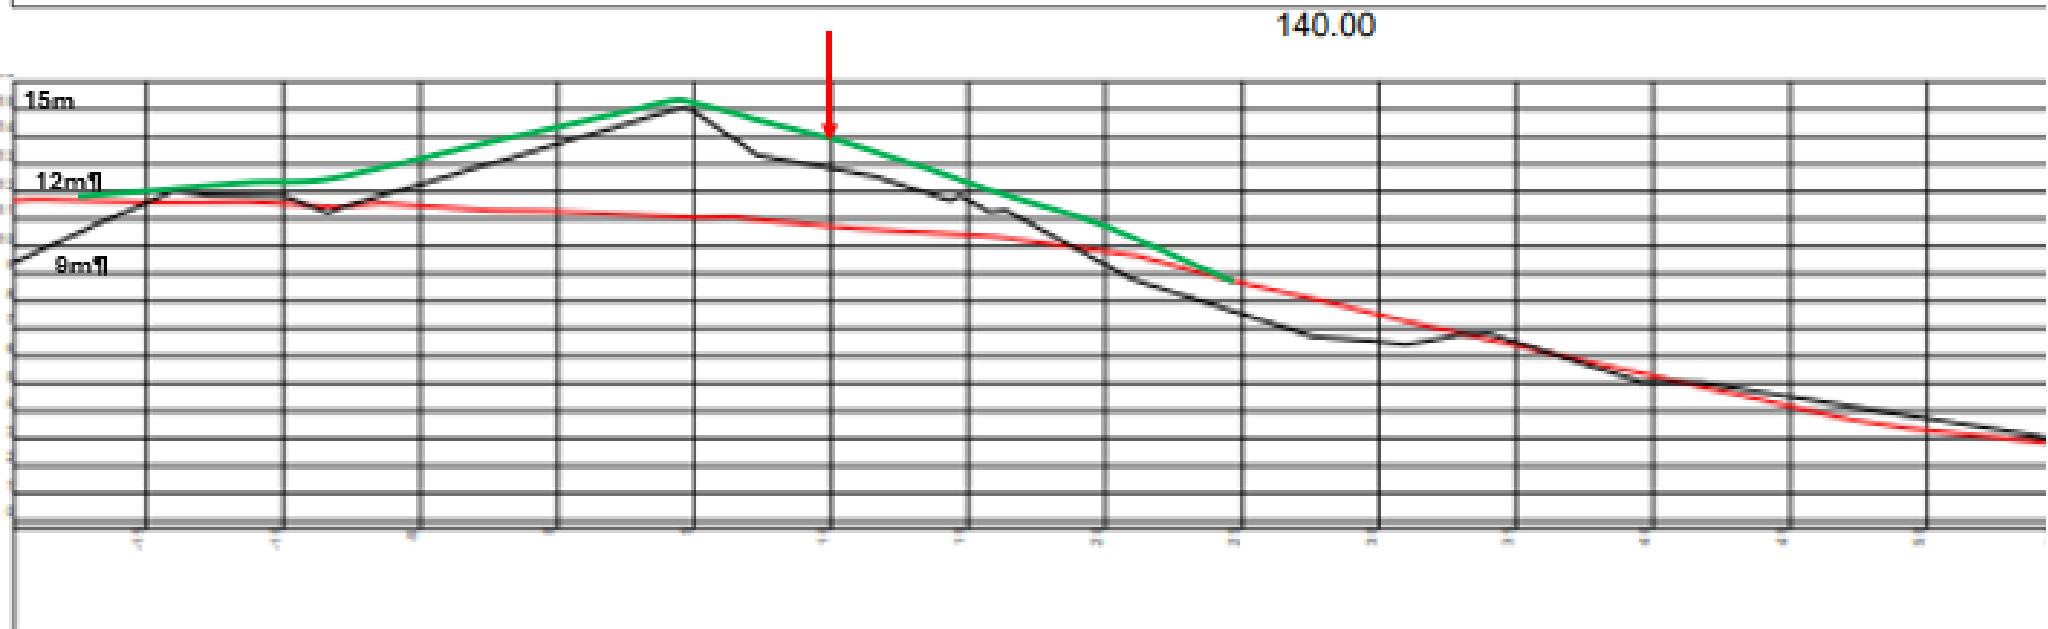
X-Sections through the original frontal dune system (2012) and for the transformed frontal dune system (2024) have been drawn every 20m along the longitudinal profile of the dune (refer to **Figures 9 a, b and c**). The X-section profiles show the original dune profile as surveyed in 2012 (black line), the transformed profile of August 2022 (red line), and the proposed profile once about 4 500m<sup>3</sup> of sand has been added to the frontal dune system (green line).

**FIGURE 9a:** Depicts the transformed frontal dune system (February 2024) & the superimposed east-west dune from the 2012 survey

**FIGURE 9b:** Depicts the transformed frontal dune system (February 2024) & the superimposed east-west dune from the 2012 survey
