# **PROPOSED PREEKSTOEL BEACH ESTATE**

## **ENVIRONMENTAL MAINTENANCE MANAGEMENT PLAN FOR THE REHABILITATION OF THE FRONTAL DUNE SYSTEM ON ERF 2341 STILL BAY EAST**

### **SHORT-TERM ENVIRONMENTAL MAINTENANCE MANAGEMENT PLAN**

**Date: May 2024**

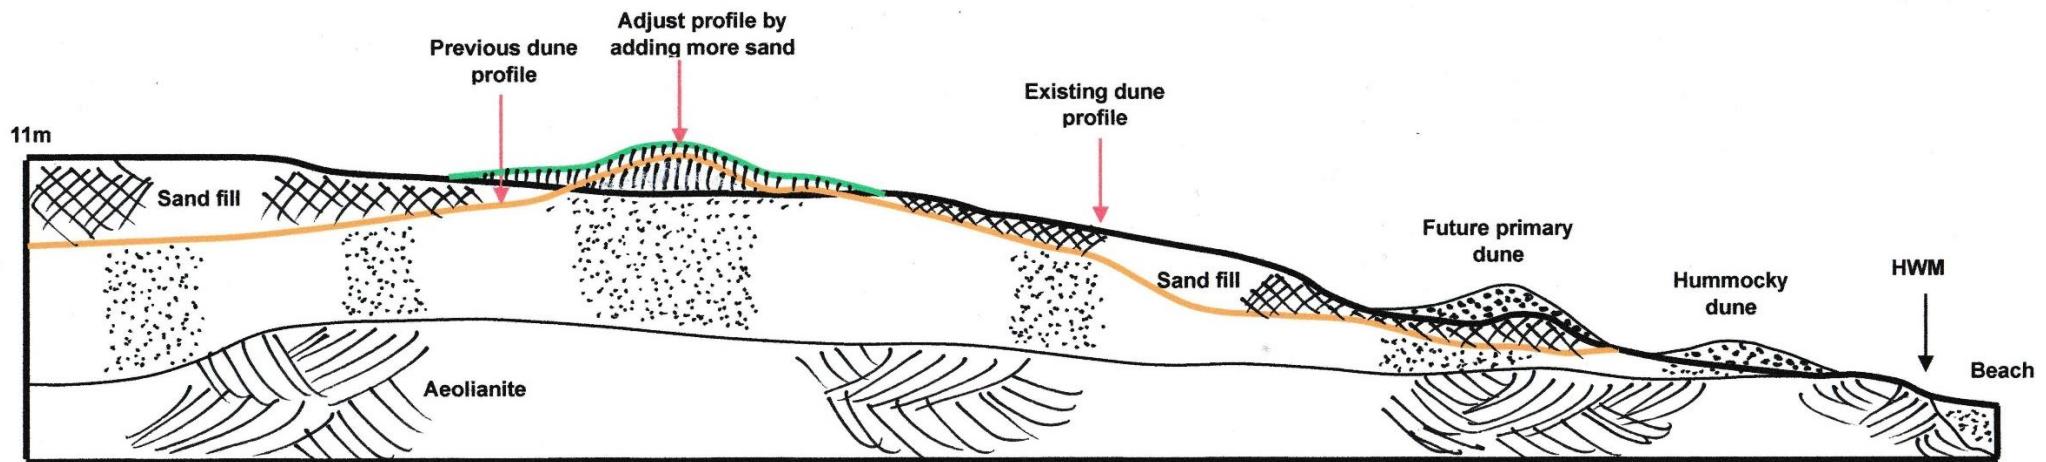
Once the strand and strandveld vegetation has grown back, it is envisaged that with time (say in the next 10-15 years), a more robust hummocky dune system will be formed at the toe of the frontal dune and a primary dune would also have been developed by sand accumulation blown off the hummocky dunes by the dune vegetation. A generalised X-section of what the dune profile could look like in the next 10-15 years is given in **Figure 10**.

**FIGURE 10:** Generalised X-Section through the Frontal Dune System of Preekstoel Beach Estate, showing the previous dune profile before transformation (as drawn from the contour survey of June 2012), the dune profile after transformation (2024), the proposed adjusted dune profile and the anticipated profile in the next 10-15 years.
