**Western Cape Government: DTPW Road Programme Management
Contract C1157.02: Flood Damage Repairs to Structures in the
Garden Route Area**

Incident Report

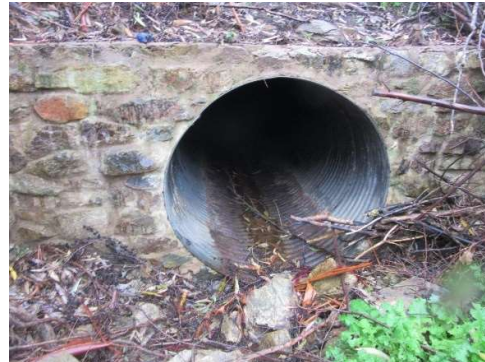
Head fall and culvert inlet

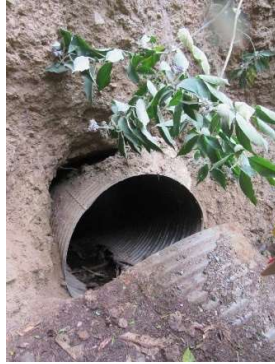
Downstream section of the Armco culvert washed away and collapsed due to erosion

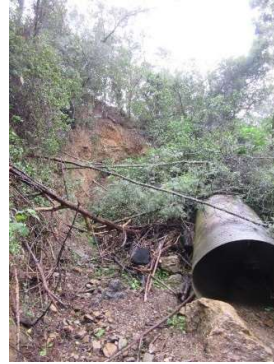
Downstream section of the Armco culvert washed away and collapsed due to erosion

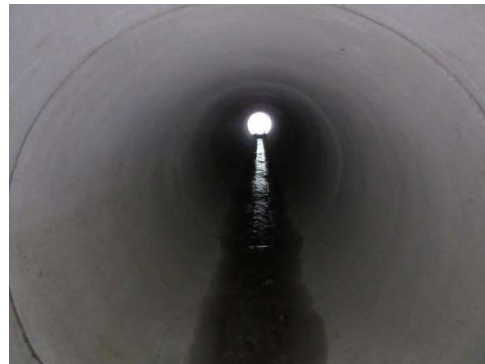
Inside newly installed pipe culvert

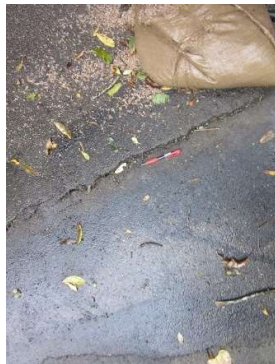
Close-up view of road slip

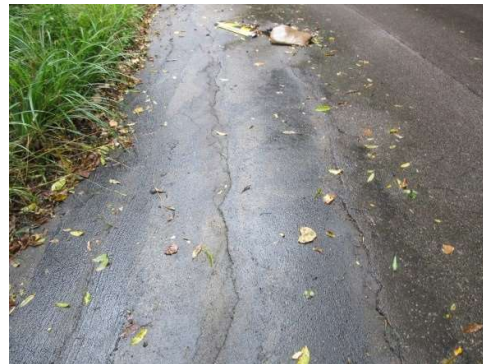
Close-up view of road slip

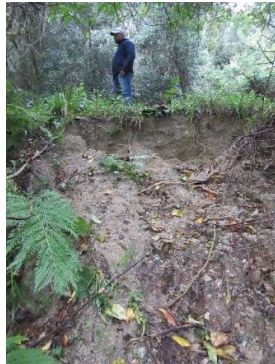
2.2m high rock wall on the edge of the road

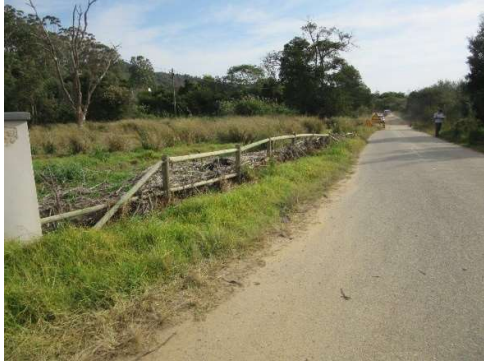
Road DR1791 at km 1.59; upstream on LHS. Debris from previous flood trapped against fence.

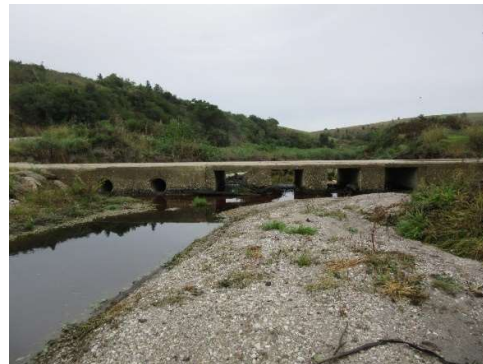
Upstream – looking towards culvert

Construct a new causeway with adequately sized openings (visual estimate of 3 cells 6m wide x 1.5m high). A 6.2m road width between guide blocks is recommended unless the detail design of the safe turning circle and sweep of trailers determine that a wider structure locally at the side of the sharp bend is required.

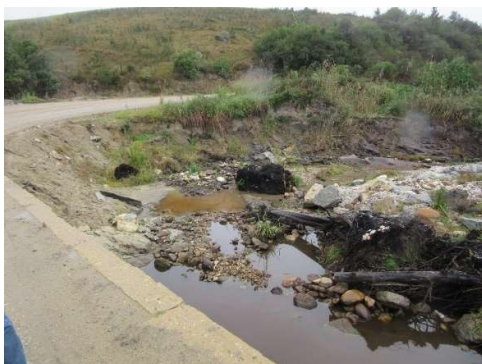
Downstream – looking away from culvert

During the November 2021 flood the George side approach road was washed away for a length of 15m. This portion of road has been repaired and widened

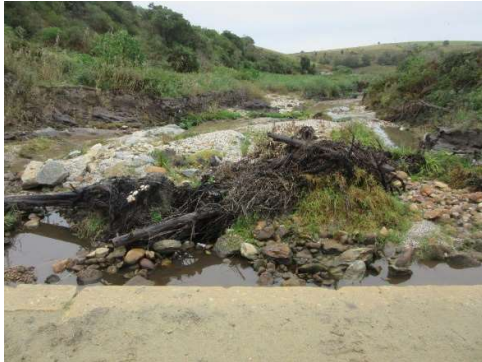
Downstream – looking away from culvert

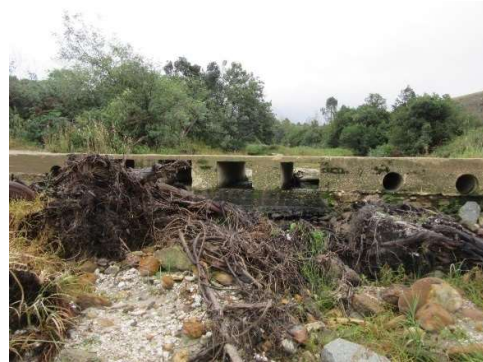
Downstream – looking towards culvert

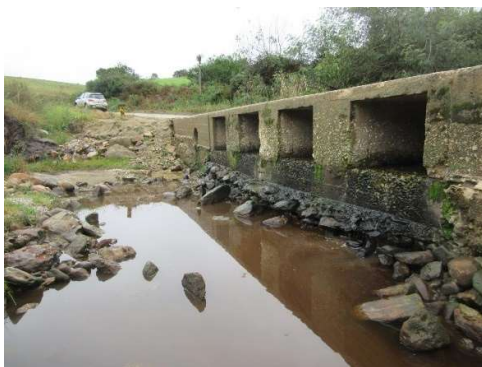
Downstream – looking towards culvert

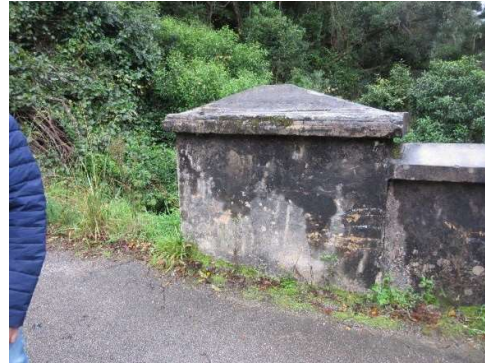
Image of existing end-block on opposite side of the bridge

Replace missing end-block (of the same geometric dimensions) with a reinforced concrete structure.

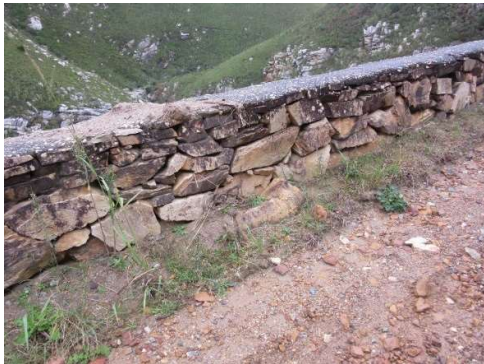
Image of existing dry-stack balustrade wall in Montagu Pass on road DR1640
