## ENVIRONMENTAL MANAGEMENT & MAINTENANCE MANAGEMENT PLAN including REHABILITATION

**For the works already undertaken as part of the erosion repairs, works to be completed and rehabilitation at the stormwater outlet at the Outeniqua Waste Water Treatment Works (WWTW),  
George**

| <b>Hilland reference</b> | GEO23/1251/07 |
| <b>Date</b> | December 2023 |

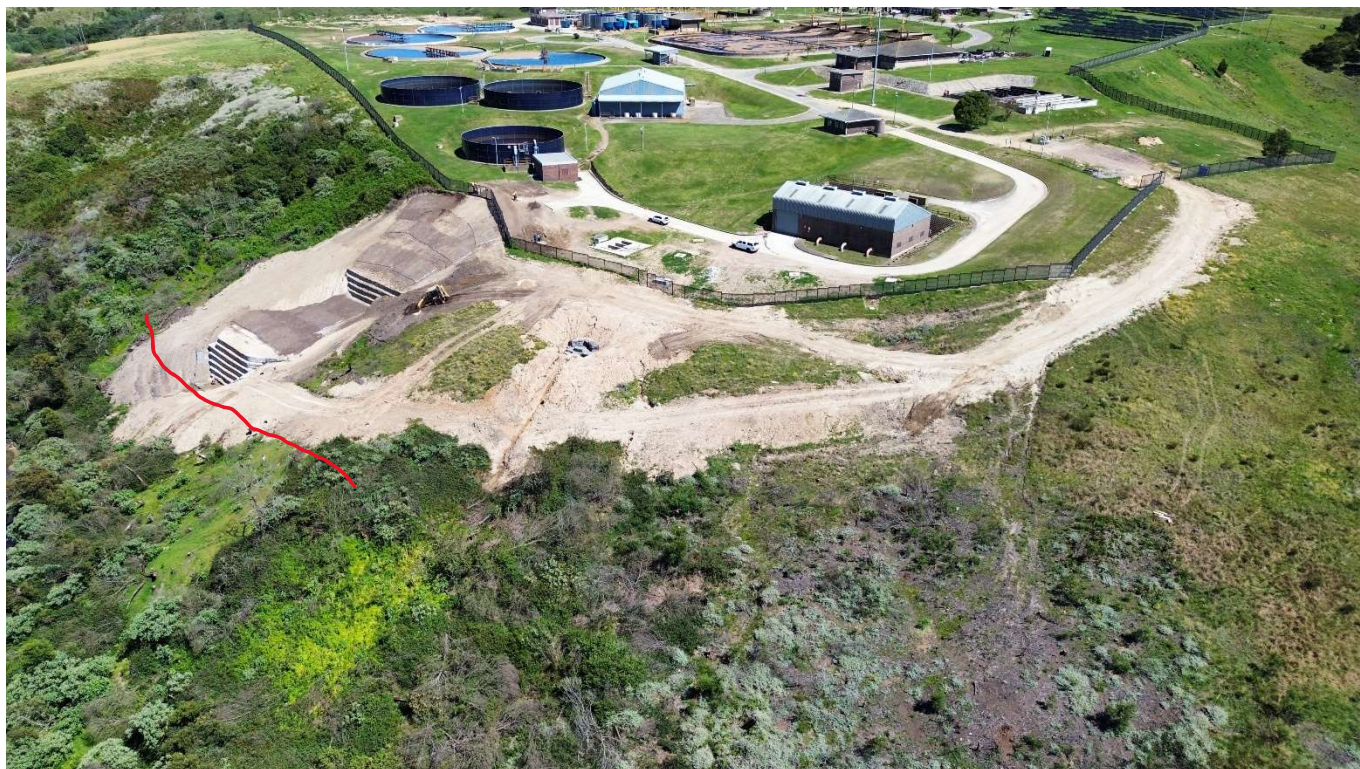
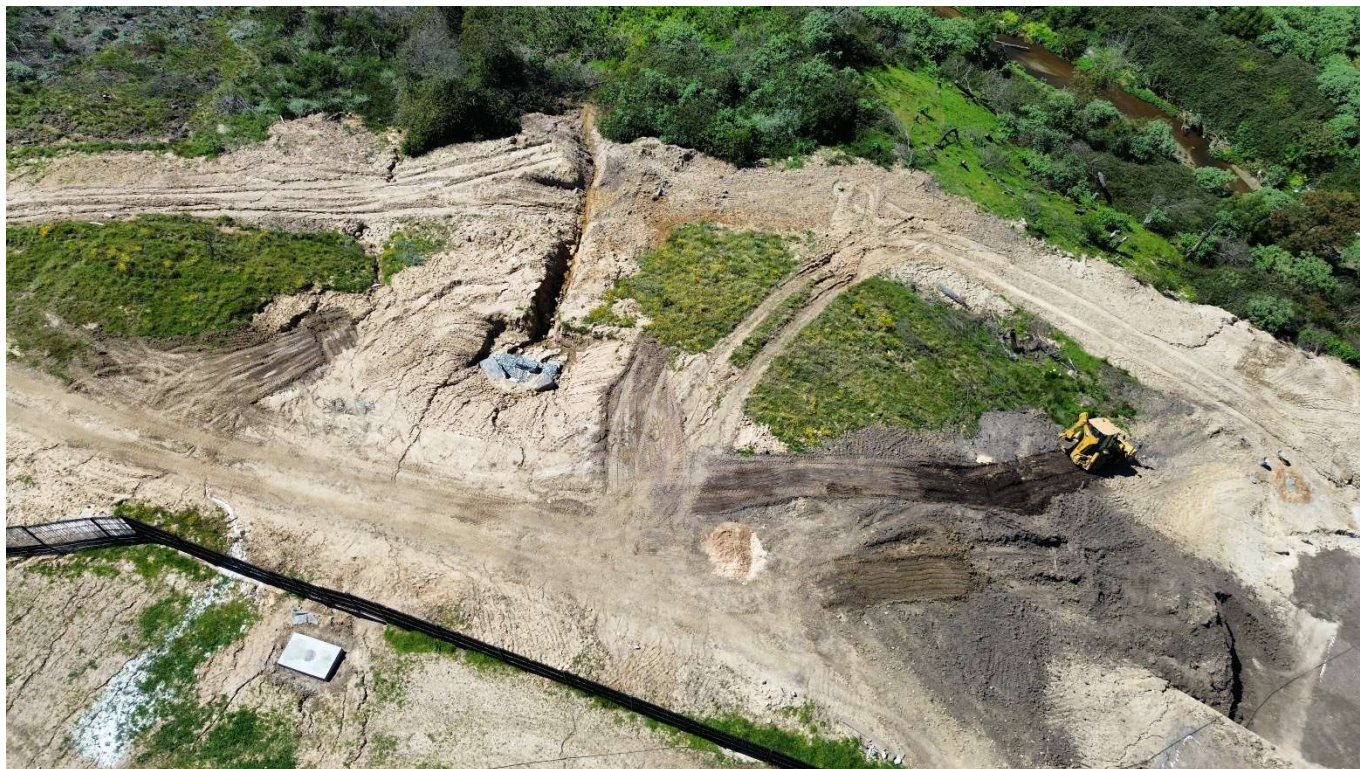
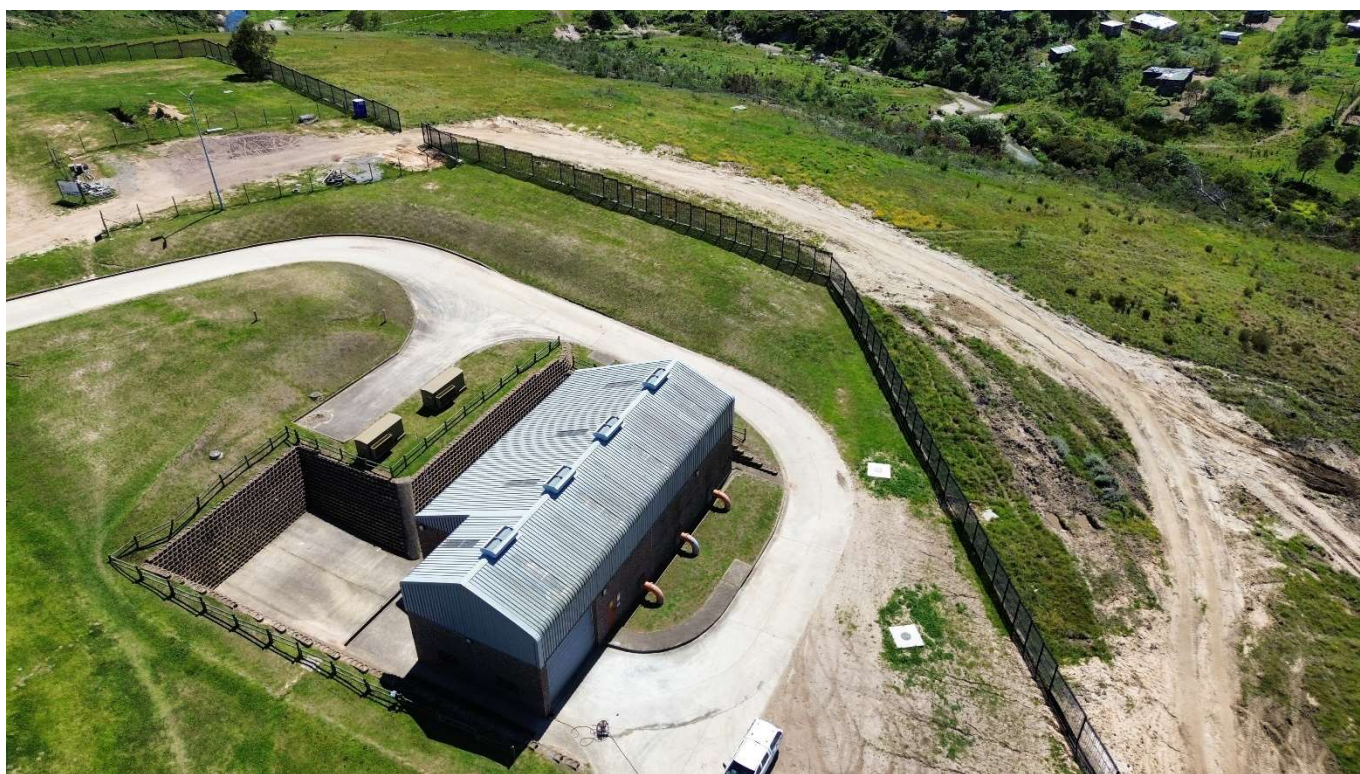
**Yellow arrow** - over spill of material into the 32m riparian zone which will all need to be removed as part of the rehabilitation plan.

**Red line** - Approximate position of the 32m riparian buffer line

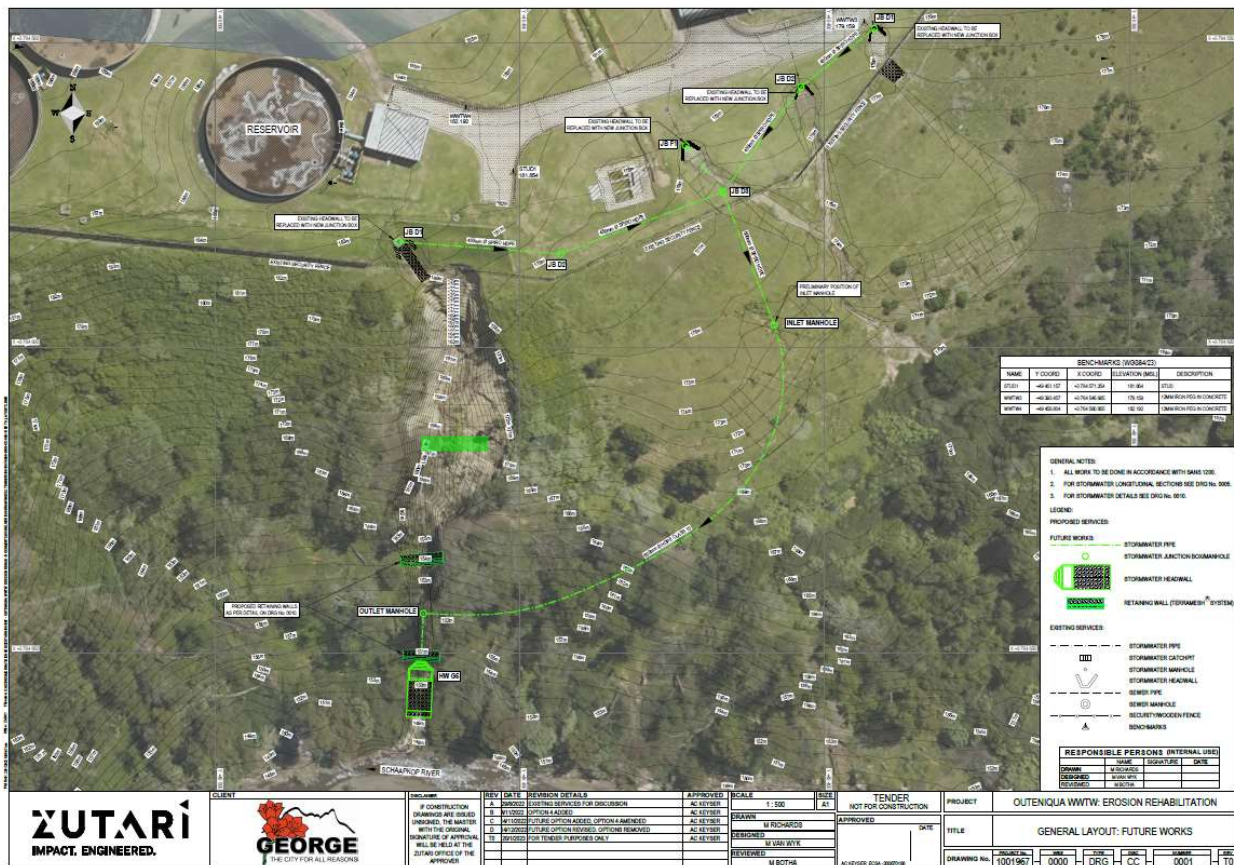
Engineering site plan (Zutari, 2023) note the approximate location of the additional gabion steps installed within the donga during construction (green highlight)

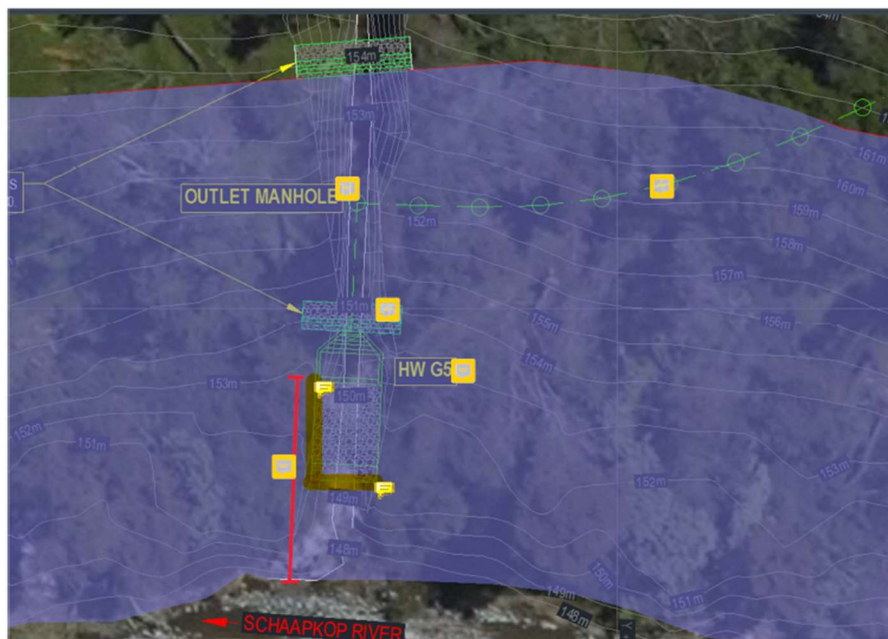
**Plan showing the section of the pipeline route that will be installed within 32m of the watercourse and the gabion structure and outlet that have yet to be constructed – all within 32m of the edge of the watercourse**

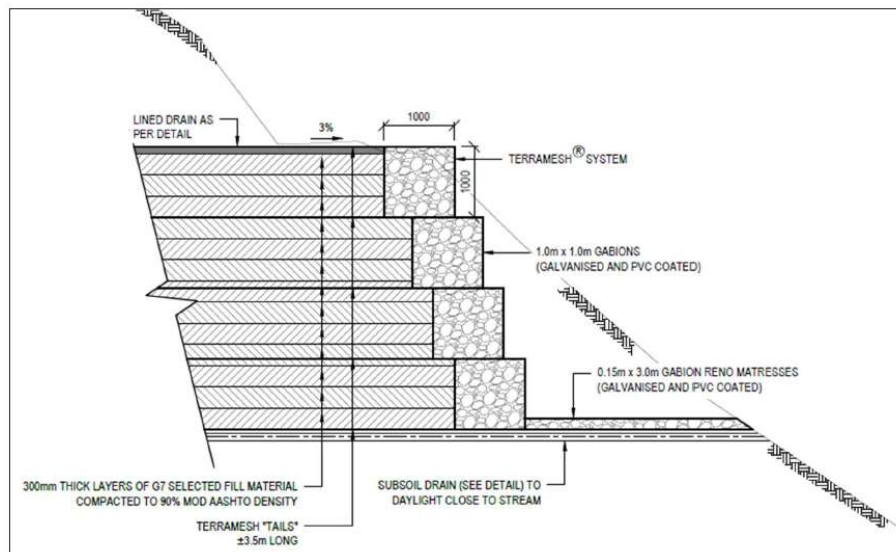
At the 55m contour level (15m from the watercourse) a secondary gabion wall will be constructed. It will be founded on an erosion protected layer (reno-mattress) which extends beyond the footprint of the structure on the down-slope side. Erosion protection will extend at least 3m beyond the toe of the structure.

The retaining wall will consist of approximately 8m and 4m high gabions with a 3.5m long 'tails' to be founded on 0.3m high reno mattress.

**Schematic representation of the retaining wall (Zutari, 2023)**

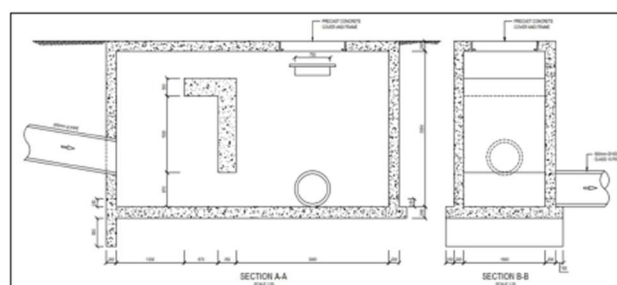
**Figure 17: Details of outlet manhole/energy breaker**

**Details of the outlet manhole / energy breaker still to be constructed (Zutari, December 2023)**

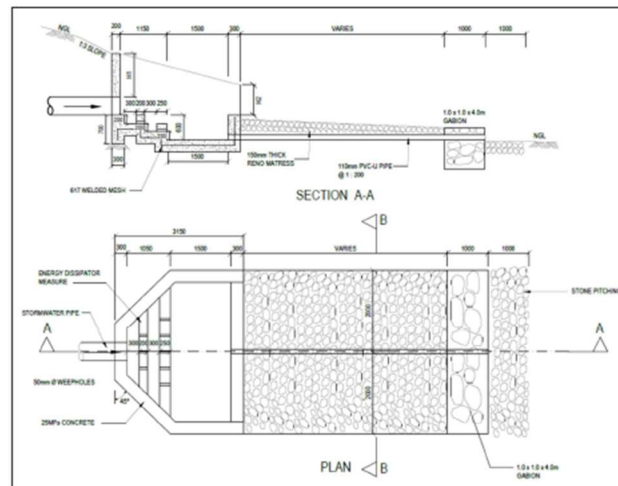
Figure 18: Detail of proposed silt retention and energy dissipator headwall

**Detail of the proposed silt retention and energy dissipator headwall still to be constructed (Zutari, December 2023)**

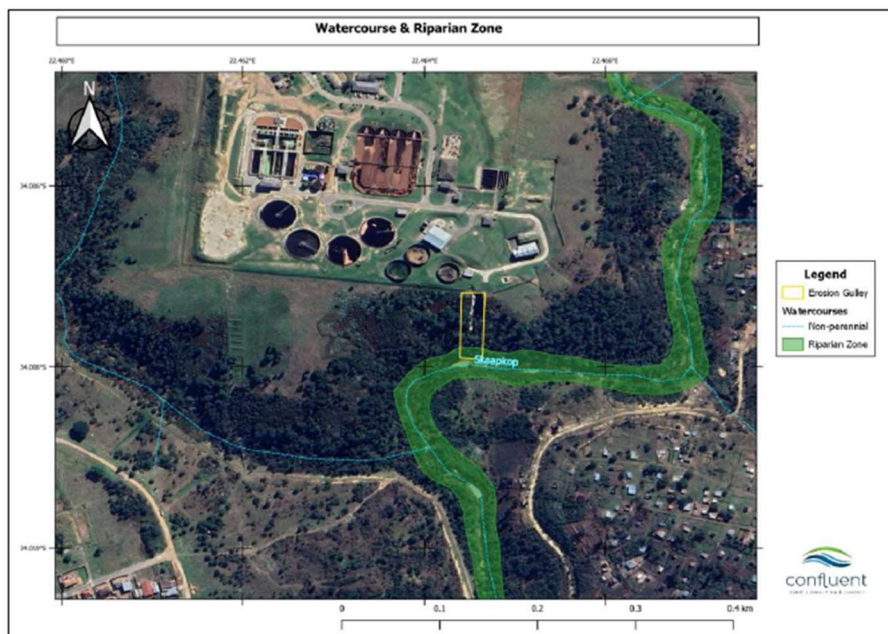
Figure 14: Map indicating the delineated extent of the riparian zone of the Skaapkop River.

The specialist assessment confirmed that the Skaapkop River is heavily modified from its natural condition and the Present Ecological State (PES) has been determined as D (Largely modified). There is an indication of a high silt load below the erosion gully in the form of noticeable sand banks immediately downstream of the erosion source, sedimentation is however high due to erosion within the entire catchment area. The riparian zone is heavily invaded by alien species.
