RE: Milkwood Manor Updated SDP and Conceptual Pack

Renovation of Milkwood Manor House and Expansion of the Public Car Park at Lookout Beach, Plettenberg Bay.

Aquatic Biodiversity – Specialist Assessment

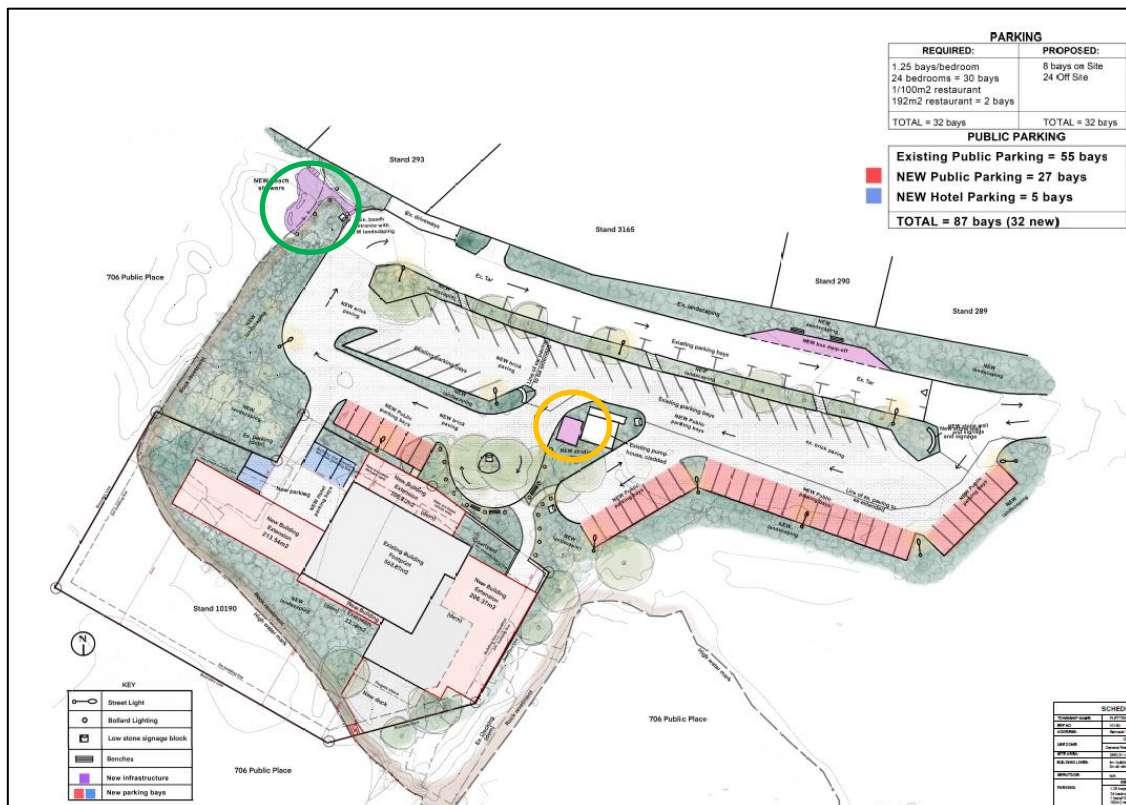
Figure 2: Preferred SDP (beach showers circled in green and ablution block circled in orange).

Expansions to the existing manor house will take place within the existing footprint of the developed portion of the property (i.e. within the perimeter of the rock revetment) and will not encroach further into any estuarine habitat. Two alternatives were provided. The preferred site development plan (SDP - Figure 2) has a reduced footprint of the south-western extension, bringing the building further back from the coast. The ablution block is situated further away from the Lookout Beach, next to an existing pump house. The alternative SDP (Figure 3) has a larger building footprint for the south-western extension and places the ablution block on the western perimeter of the car park, closer to the Lookout Beach. The expansion of the car park is identical for both SDPs and will extend into an undeveloped area of the EFZ (Figure 4).

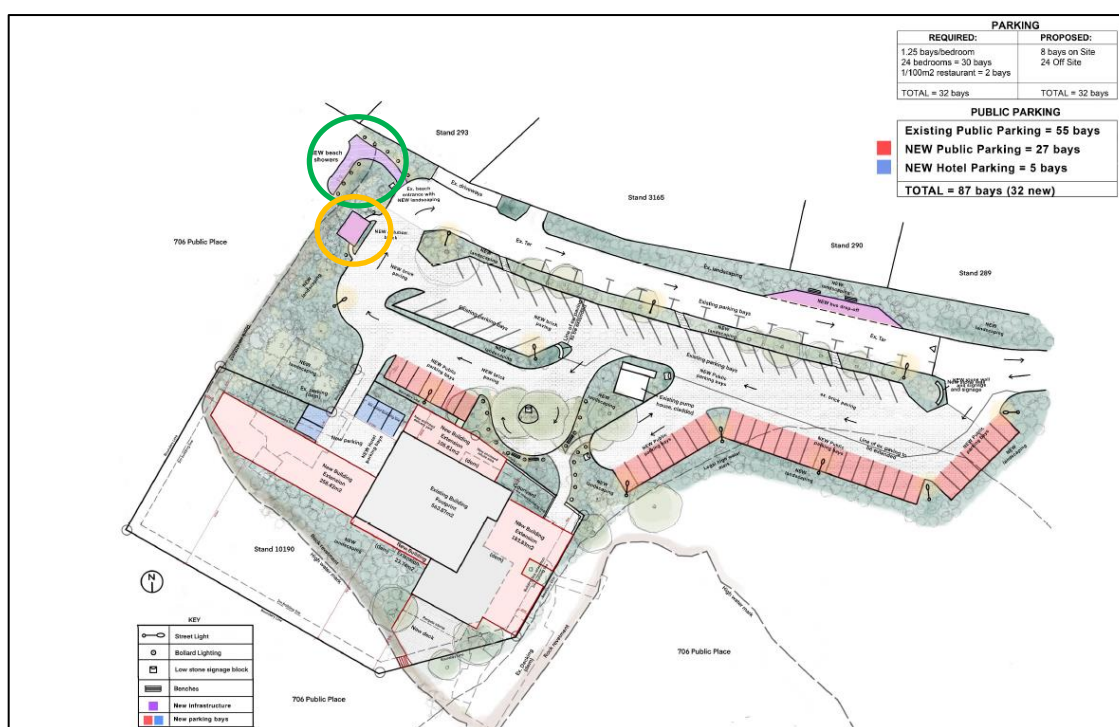
Figure 3: Alternative SDP (beach showers circled in green and ablution block circled in orange).

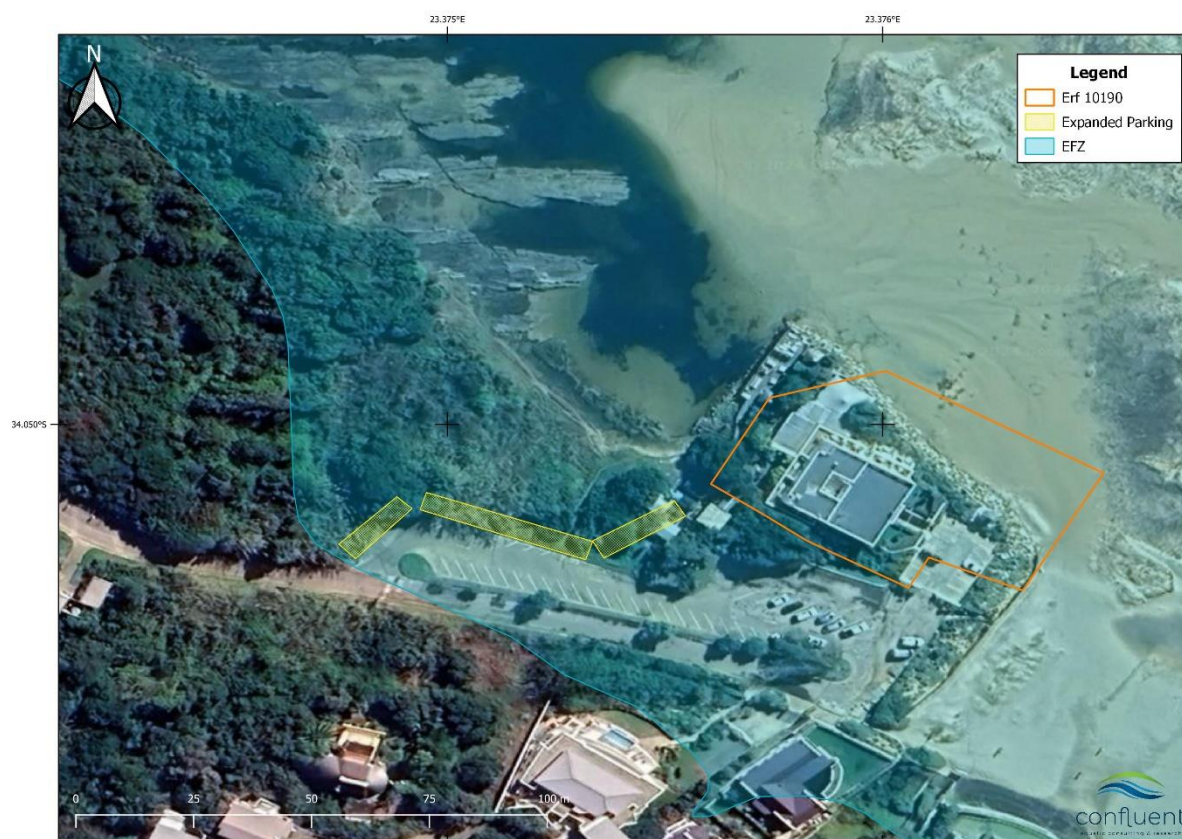
Figure 4: Map indicating the expanded car park areas relative to the mapped Keurbooms EFZ.

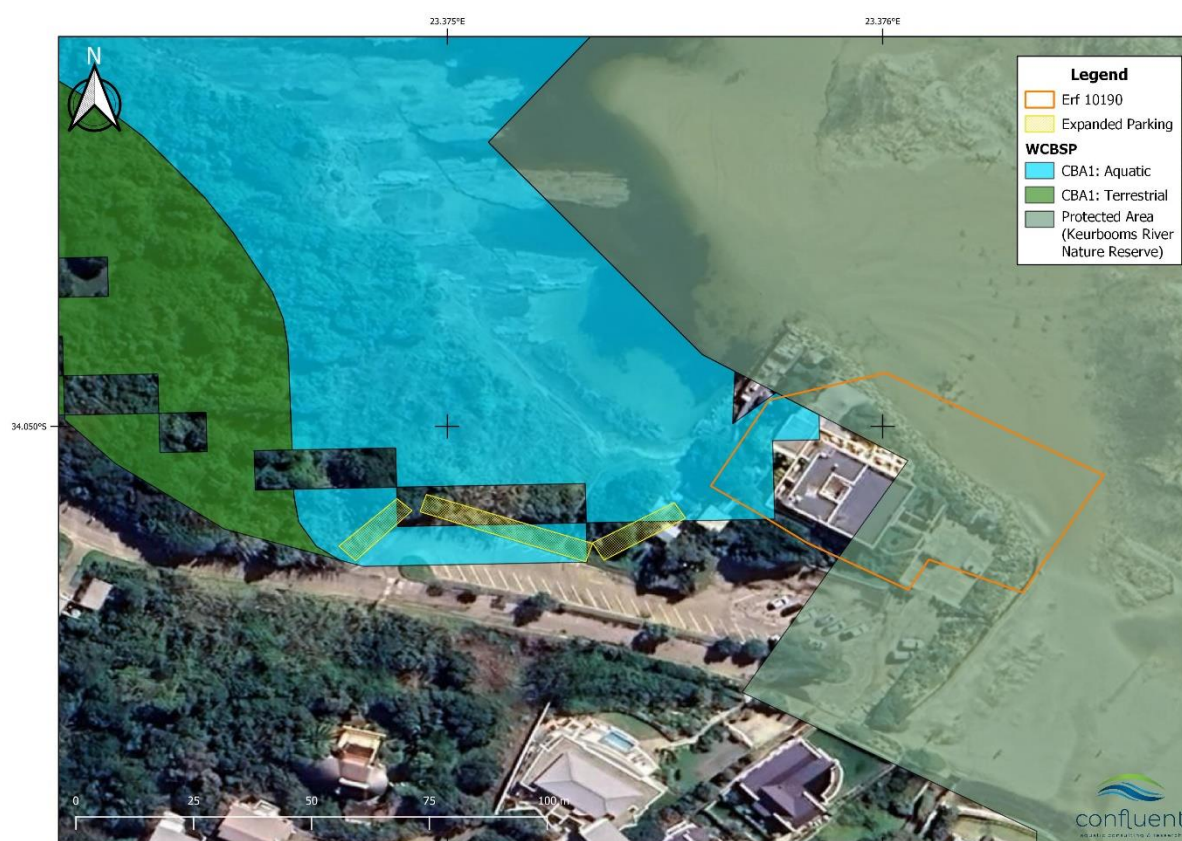
Figure 8: Map indicating the area of development in relation to the Western Cape Spatial Biodiversity Plan (WCBSP).

According to the Western Cape Spatial Biodiversity Plan, portions of the Milkwood Manor property and the area to be covered by the expanded car park fall within an aquatic Critical Biodiversity Area 1 (CBA1) (Figure 8). It is also important to note that the part of the Milkwood Manor property does fall within and is immediately adjacent to a Protected Area (Keurbooms River Nature Reserve). Management objectives associated with CBAs are provided in Table 3 and expansion of the car park is not aligned to these objectives. Inclusion of a part of the existing Milkwood Manor House as a CBA is not an accurate representation of habitat on site and is most likely a result of coarse-scale mapping conducted during development of the WCBSP.

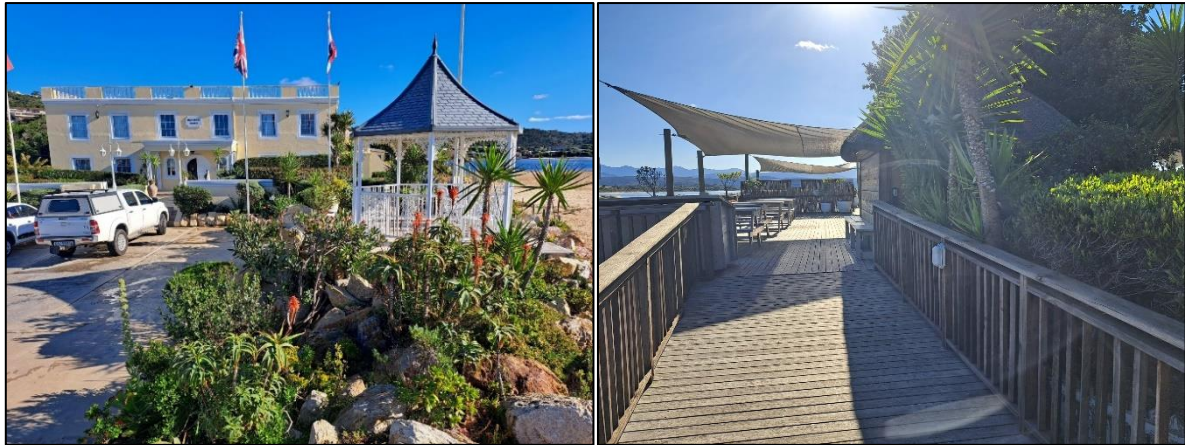
Figure 9: View of the manor house from the top of the rock revetment (left) and wooden decks (right).

Renovations at the manor house and expansion of the public car park will occur in very close proximity to the estuary but is limited to the existing developed area of the property that is contained within the rock revetment border. This area is presently covered by buildings, car park, landscaped rock gardens (Figure 9) and outdoor dining and recreational areas (i.e. raised decks overlooking the estuary). The renovations will therefore not result in any additional loss of area of estuarine (or coastal) habitat.

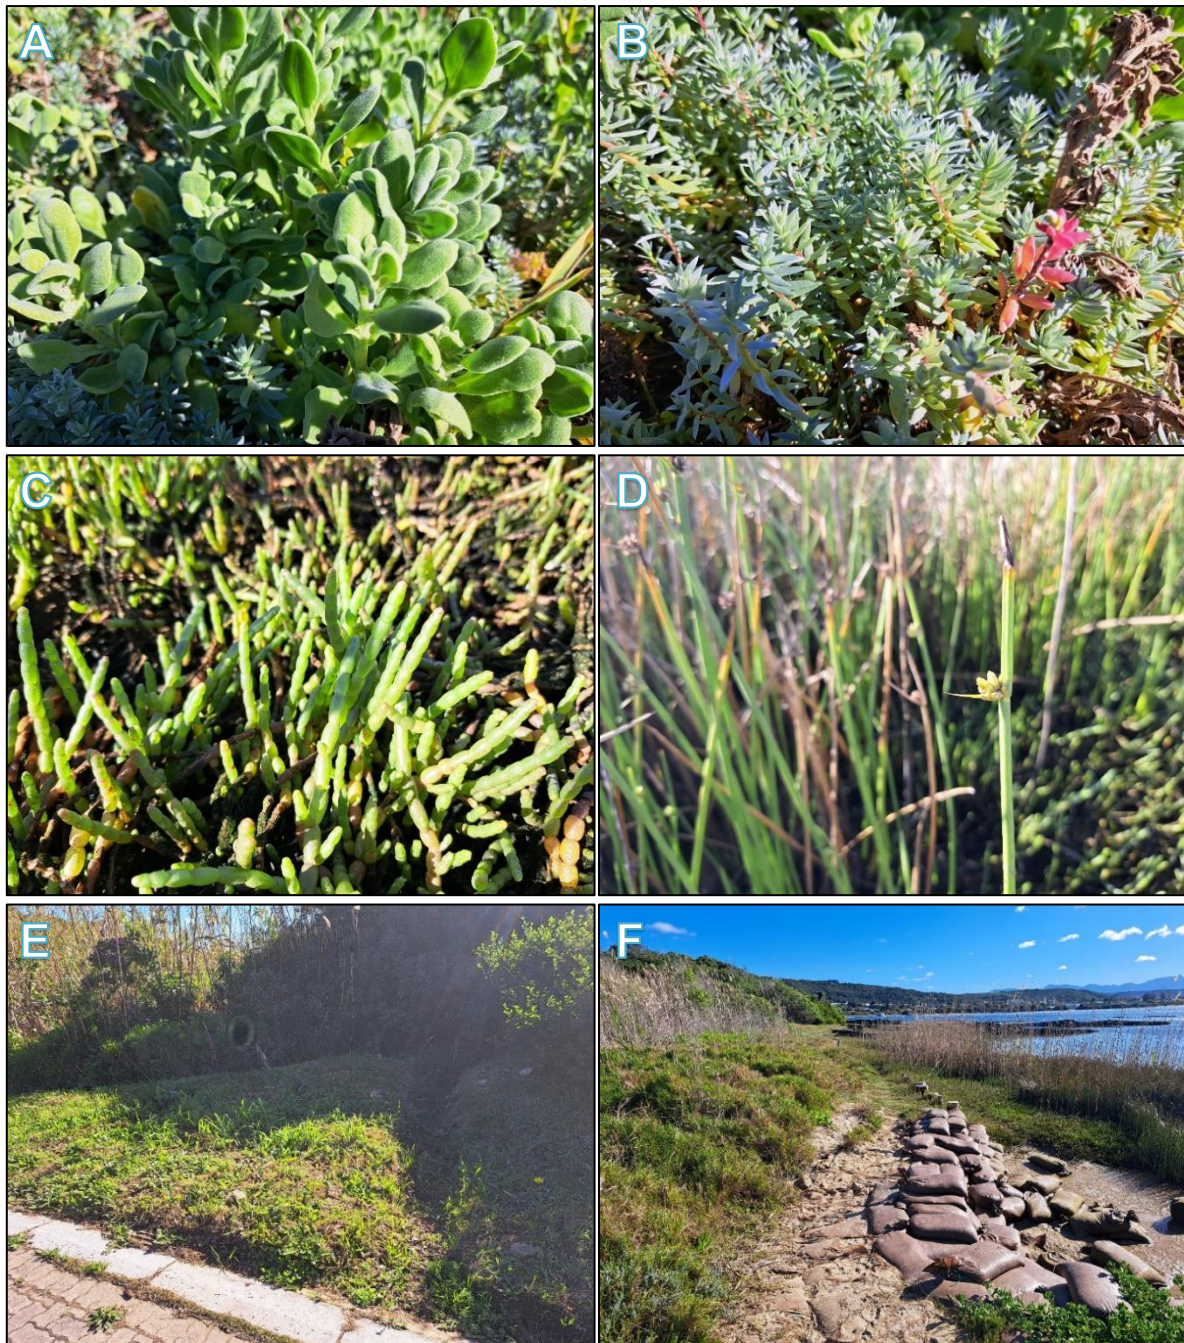
Figure 11: Photographs of plant species in the inter-tidal salt marsh, including *Tetragonia decumbens* (A); *Chenolea diffusa* (B); *Salicornia* sp (C); and *Cyperus laevigatus* (D); stormwater channels extending from the car park into the EFZ (E); and sandbags placed to protect the banks of the estuary (F).

The narrow shoreline of the estuary is further to the north and is characterised by typical salt marsh species (Figure 11). A single-track footpath runs through the salt marsh habitat, long the shoreline. This habitat falls well outside of the proposed car park expansion area. Rocky outcrops extend from the western shoreline and open water in the estuary is dominated by extensive patches of *Zostera capensis*. Stormwater runoff is directed from the car park into this patch and appears to have caused a small area of erosion along the shoreline, which is currently being stabilised using sand-bags.

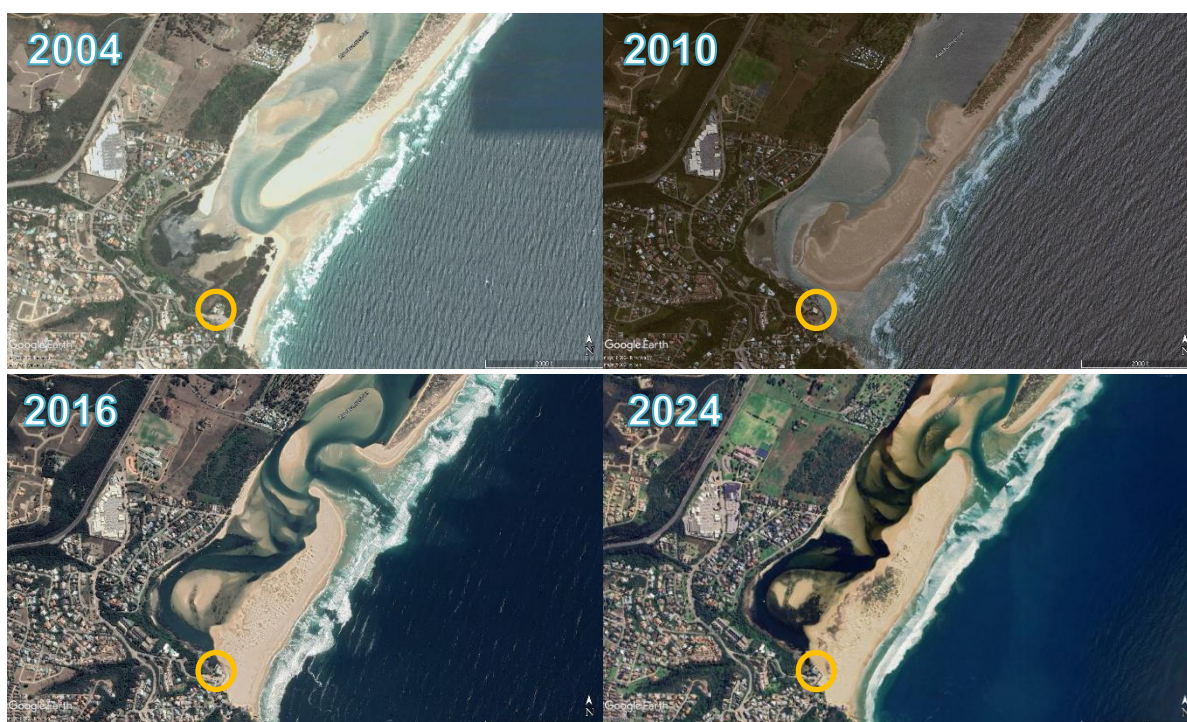
Figure 12: Google Earth images showing movement of the position of the estuary mouth.

As is typical of permanently open estuaries, the mouth of the Keurbooms Estuary has shifted over time (Figure 12). Historically the mouth opened at its present location (2004). Coastal dunes to the south of the mouth were well vegetated, right up to the perimeter of the Milkwood Manor property. Flooding resulted in the mouth shifting further south (2010), immediately adjacent to the Milkwood Manor property. Coastal vegetation was washed away by the flooding, resulting in the formation of a large unvegetated sandbank. By 2016 the mouth had shifted further north, back to its original position. A coastal dune/sand bank area has re-

established immediately north of the property. This area remains largely unvegetated, although there are signs that vegetation is starting to re-establish (2024).

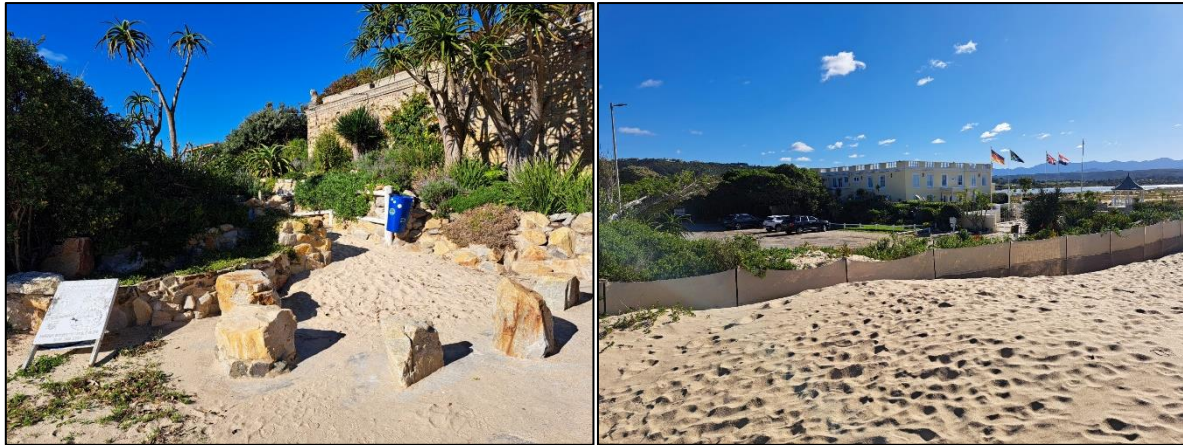
Figure 13: Photographs showing the access point to Lookout Beach (left) and the proposed location of the beach showers (right).

Construction of public beach showers is planned at the public access point to the Lookout Beach. While this area falls within the EFZ of the estuary, habitat is definitely coastal, consisting of beach sand, well above the tidal mark. The area is not vegetated and no aquatic estuarine biota (dependant on tidal exchange) inhabit the area. The area experiences high volumes of pedestrian traffic and is unlikely to be an important nesting, roosting or feeding area for coastal bird species.
