MOLEN CLOSE RIVER REHABILITATION **Environmental Control (ECO) Report – July 2023**

- Daily Environmental Site Inspections (03 July 2023 – 31 July 2023).

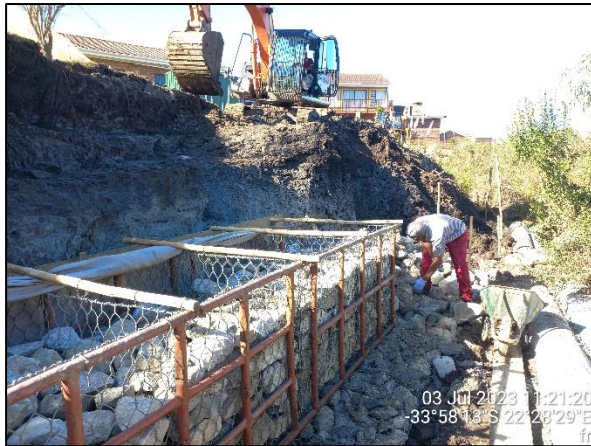
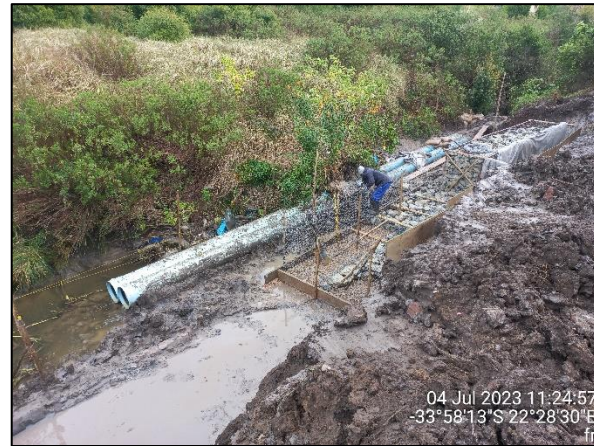
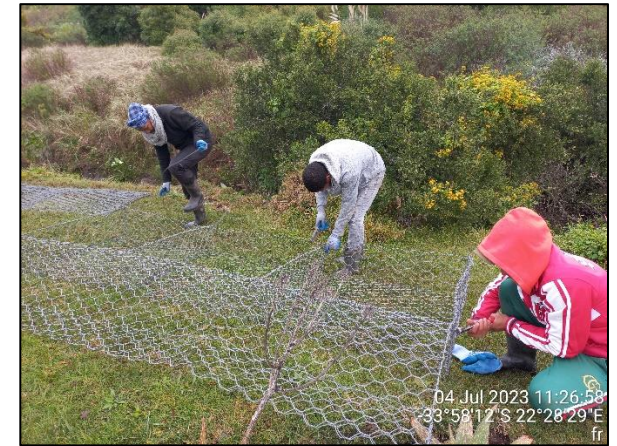
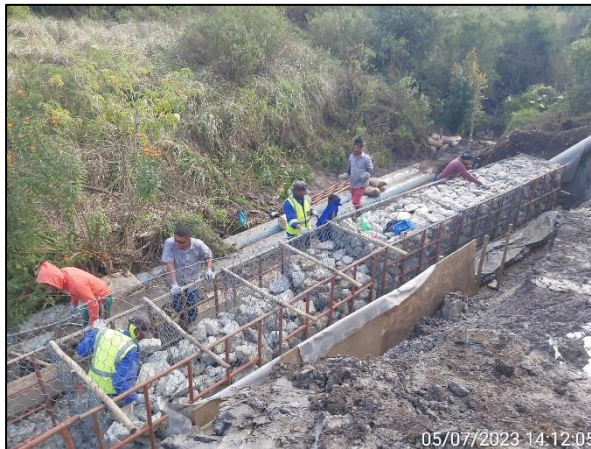
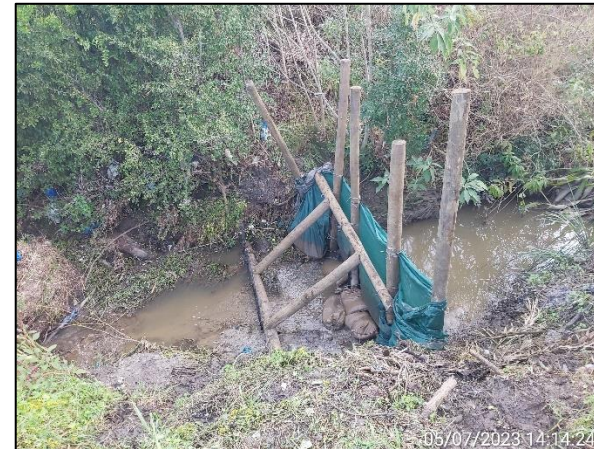
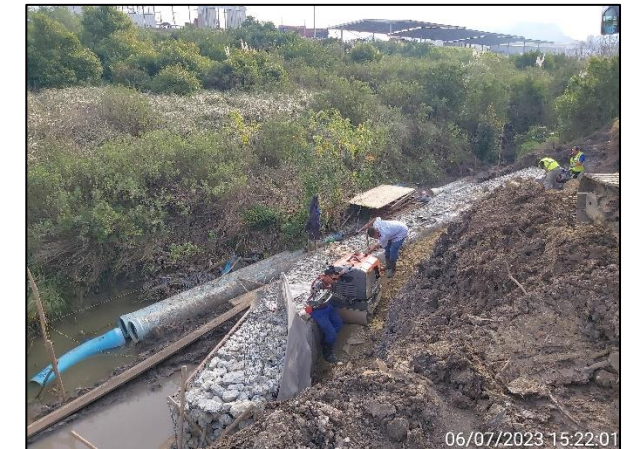
- Kindly refer to below photographs on the progress being made at Molen Close. Additional photographs are available on request.
