Renovation of Milkwood Manor House and Expansion of the Public Car Park at Lookout Beach, Plettenberg Bay.

Aquatic Biodiversity – Specialist Assessment

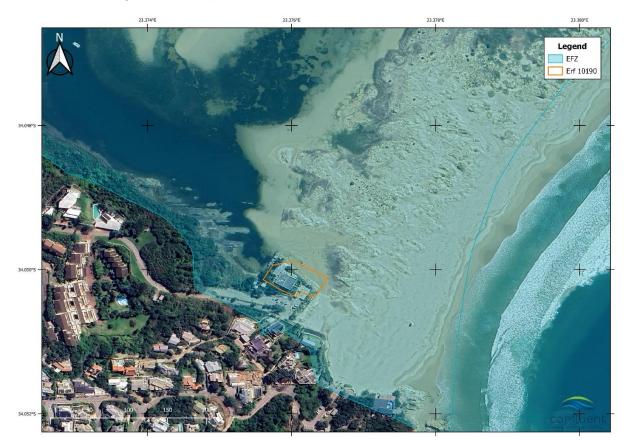
Figure 1: Map indicating the property boundary relative to the Keurbooms Estuarine Functional Zone.

The Milkwood Manor House is situated at the south-western-most extent of the Keurbooms Estuary, at the transition between estuarine and coastal dune habitat (Figure 1). The north-western corner of the property remains undeveloped and extends into the estuary. The perimeter of the developed portion of the property is protected from tidal action and flooding by a rock revetment which extends around the entire the perimeter of the property. The public parking is located to the south of the property and provides access to the popular Lookout Beach to the west. The entire property and adjacent public parking is located with the Keurbooms Estuarine Functional Zone (EFZ).

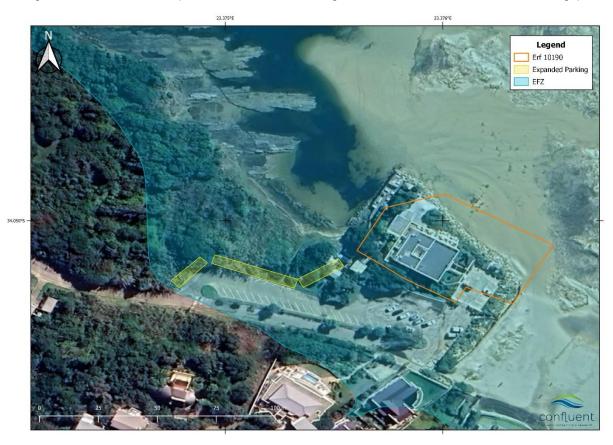
Figure 4: Map indicating the expanded car park areas relative to the mapped Keurbooms EFZ.

Expansions to the existing manor house will take place within the existing footprint of the developed portion of the property (i.e. within the perimeter of the rock revetment) and will not encroach further into any estuarine habitat. Two alternatives were provided. The preferred site development plan (SDP - Figure 2) has a reduced footprint of the south-western extension, bringing the building further back from the coast. The ablution block is situated further away from the Lookout Beach, next to an existing pump house. The alternative SDP (Figure 3) has a larger building footprint for the south-western extension and places the ablution block on the western perimeter of the car park, closer to the Lookout Beach. The expansion of the car park is identical for both SDPs and will extend into an undeveloped area of the EFZ (Figure 4).

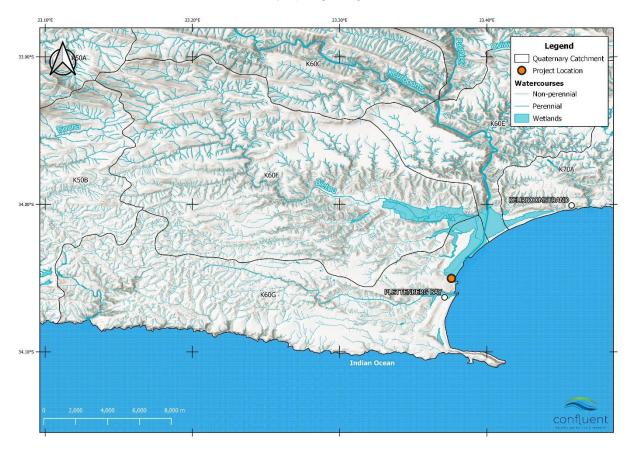
Figure 6: Figure illustrating the location of the project area in relation to quaternary catchment K60G.

The affected portion of the Keurbooms Estuary falls in quaternary catchment K60G (Figure 6) which covers the entire catchment of the Piesangs River and the lower most reaches of the Bietou and Keurbooms estuaries. The estuary falls within level 22.02 of the Southern Coastal Belt ecoregion, which is characterised by moderately undulating plains of moderate relief with altitude ranging from 0 to 500 m above mean sea level. Mean annual precipitation for the catchment area is relatively high (between 300 and 700 mm per annum), and occurs year-round, with peaks in late winter and early spring (August to October).

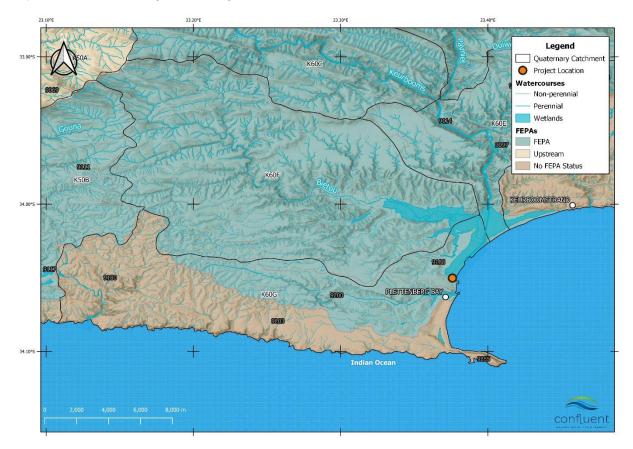
Figure 7: Map illustrating the loaction of the project area in relation to FEPA sub-quaternary catchments.

The property falls within sub-quaternary catchment (SQC) 9188, which, according to the National Freshwater Ecosystem Priority Atlas (NFEPA, Nel et al., 2011), has been classified as a Freshwater Ecosystem Priority Area (FEPA) (Figure 7). River FEPAs achieve biodiversity targets for river ecosystems and threatened/near-threatened fish species and were identified in rivers that are currently in a good condition (A or B ecological category). Their FEPA status indicates that they should remain in a good condition in order to contribute to national biodiversity goals and support sustainable use of water resources (Nel et al., 2011).

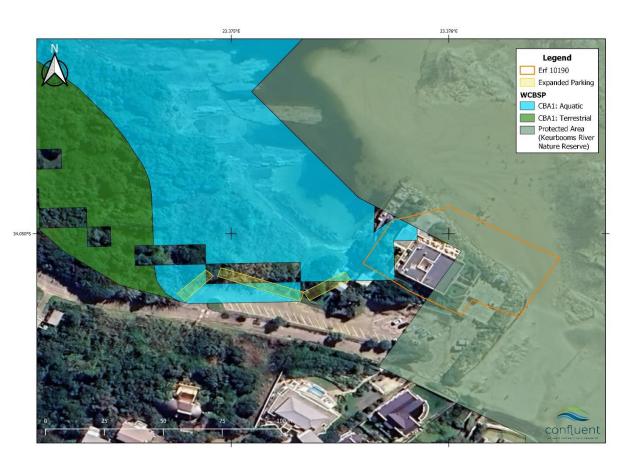
Figure 8: Map indicating the area of development in relation to the Western Cape Spatial Biodiversity Plan (WCBSP).

According to the Western Cape Spatial Biodiversity Plan, portions of the Milkwood Manor property and the area to be covered by the expanded car park fall within an aquatic Critical Biodiversity Area 1 (CBA1) (Figure 8). It is also important to note that the part of the Milkwood Manor property does fall within and is immediately adjacent to a Protected Area (Keurbooms River Nature Reserve). Management objectives associated with CBAs are provided in Table 3 and expansion of the car park is not aligned to these objectives. Inclusion of a part of the existing Milkwood Manor House as a CBA is not an accurate representation of habitat on site and is most likely a result of coarse-scale mapping conducted during development of the WCBSP.

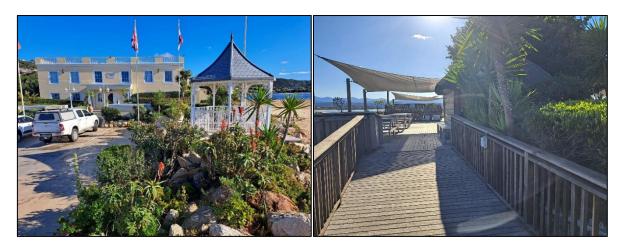
Figure 9: View of the manor house from the top of the rock revetment (left) and wooden decks (right).

Renovations at the manor house and expansion of the public car park will occur in very close proximity to the estuary but is limited to the existing developed area of the property that is contained within the rock revetment border. This area is presently covered by buildings, car park, landscaped rock gardens (Figure 9) and outdoor dining and recreational areas (i.e. raised decks overlooking the estuary). The renovations will therefore not result in any additional loss of area of estuarine (or coastal) habitat.

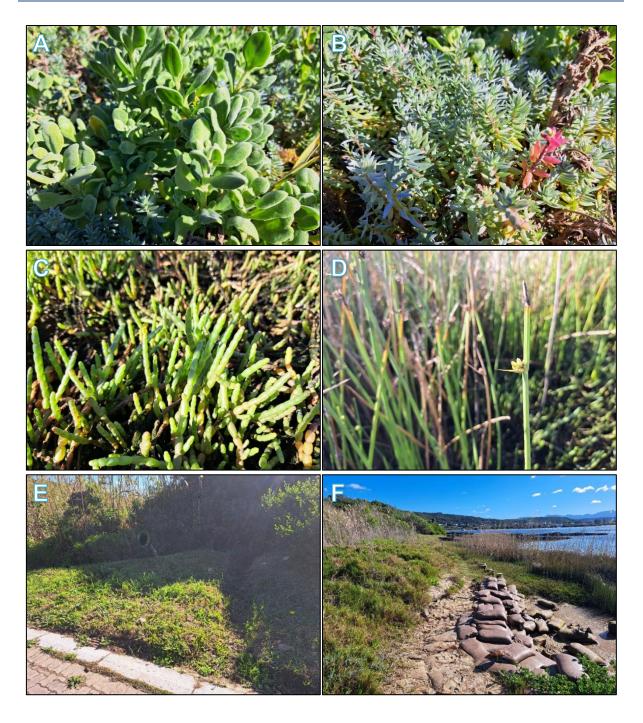
Figure 11: Photographs of plant species in the inter-tidal salt marsh, including Tetragonia decumbens (A); Chenolea diffusa (B); Salicornia sp (C); and Cyperus laevigatus (D); stormwater channels extending from the car park into the EFZ (E); and sandbags placed to protect the banks of the estuary (F).

The narrow shoreline of the estuary is further to the north and is characterised by typical salt marsh species (Figure 11). A single-track footpath runs through the salt marsh habitat, long the shoreline. This habitat falls well outside of the proposed car park expansion area. Rocky outcrops extend from the western shoreline and open water in the estuary is dominated by extensive patches of *Zostera capenis*. Stormwater runoff is directed from the car park into this patch and appears to have caused a small area of erosion along the shoreline, which is currently being stabilised using sand-bags.

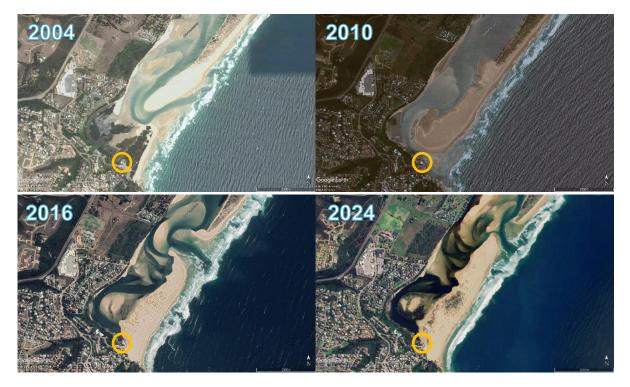
Figure 12: Google Earth images showing movement of the position of the estuary mouth.

As is typical of permanently open estuaries, the mouth of the Keurbooms Estuary has shifted over time (Figure 12). Historically the mouth opened at its present location (2004). Coastal dunes to the south of the mouth were well vegetated, right up to the perimeter of the Milkwood Manor property. Flooding resulted in the mouth shifting further south (2010), immediately adjacent to the Milkwood Manor property. Coastal vegetation was washed away by the flooding, resulting in the formation of a large unvegetated sandbank. By 2016 the mouth had shifted further north, back to its original position. A coastal dune/sand bank area has re-

established immediately north of the property. This area remains largely unvegetated, although there are signs that vegetation is starting to re-establish (2024).

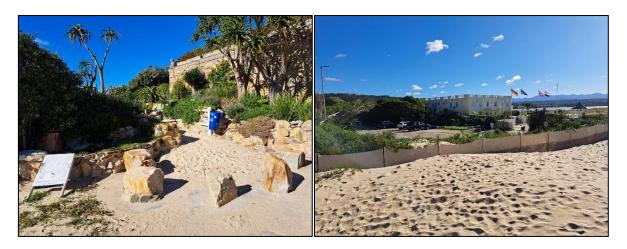
Figure 13: Photographs showing the access point to Lookout Beach (left) and the proposed location of the beach showers (right).

Construction of public beach showers is planned at the public access point to the Lookout Beach. While this area falls within the EFZ of the estuary, habitat is definitely coastal, consisting of beach sand, well above the tidal mark. The area is not vegetated and no aquatic estuarine biota (dependent on tidal exchange) inhabit the area. The area experiences high volumes of pedestrian traffic and is unlikely to be an important nesting, roosting or feeding area for coastal bird species.
