Western Cape Government: DTPW Road Programme Management Contract C1157.02: Flood Damage Repairs to Structures in the Garden Route Area

Incident Report

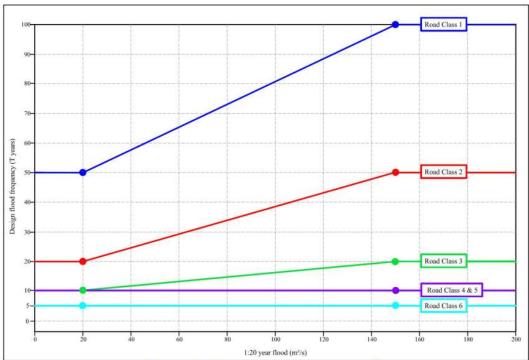
Figure 8.2: Design flood frequency estimate (Revised in 6th edition)

The hydraulic design will be based on the Sanral Drainage Manual 6th edition. The design flood return period will be determined by the Class of road and the size of the flood based on a 20-year return period based on Figure 8.2.

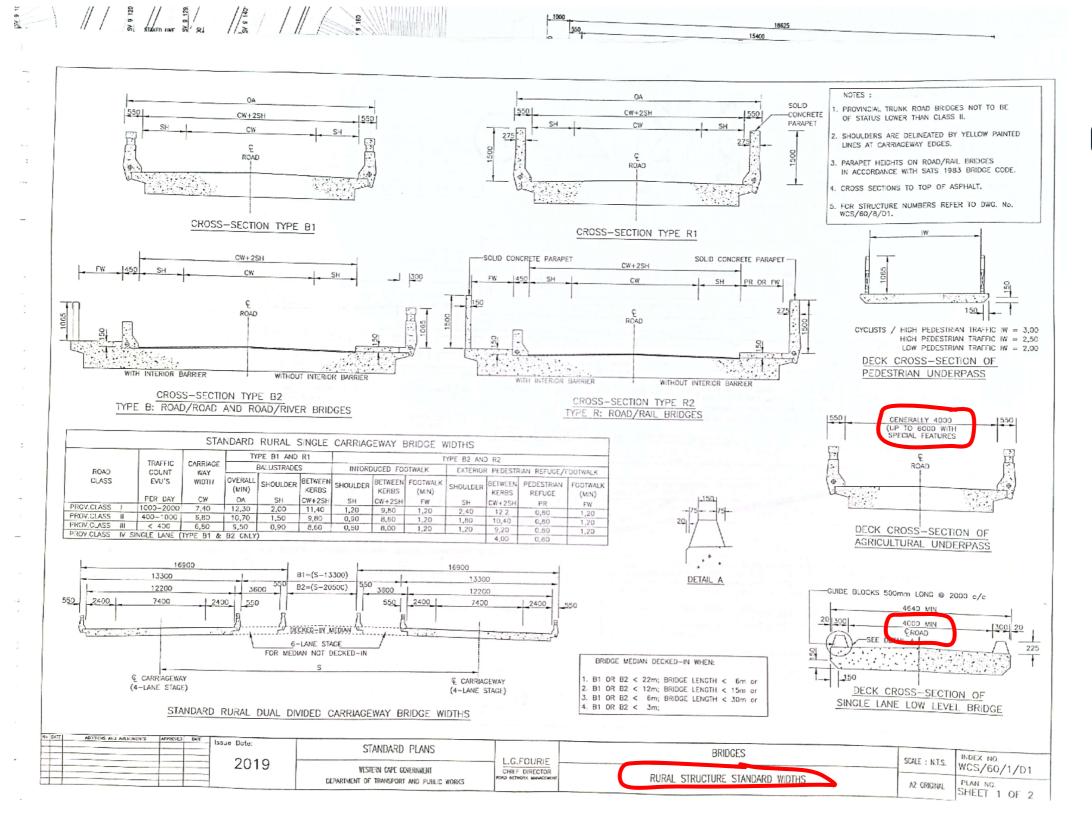
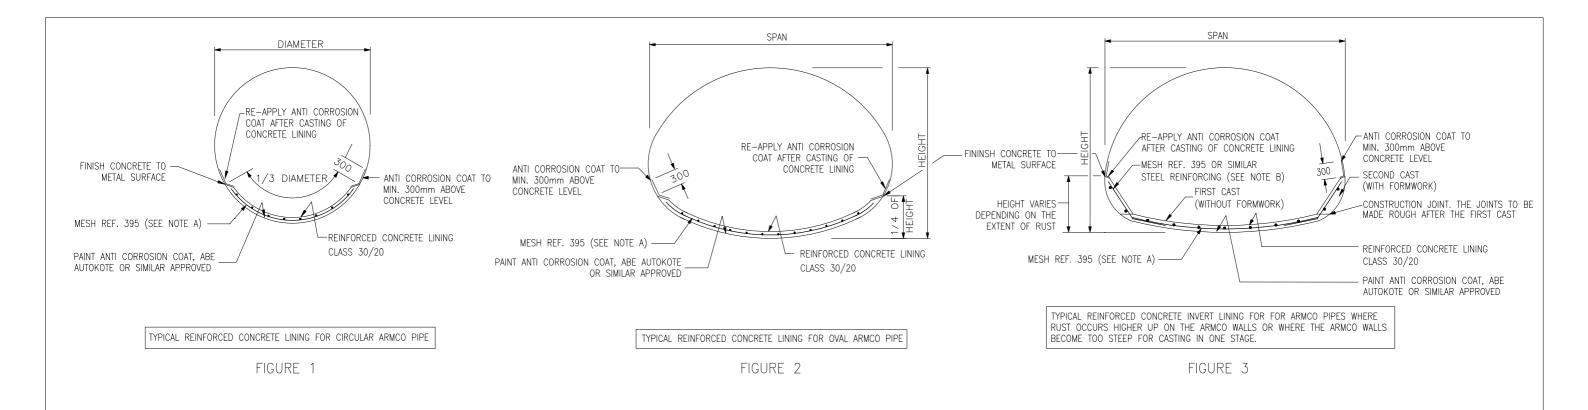
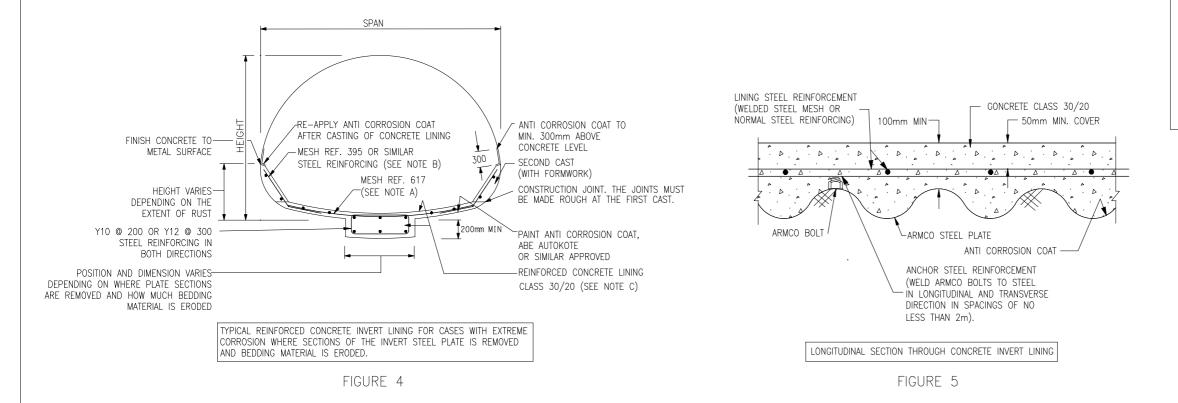
APPENDIX D: WCG DTPW STANDARD DRAWINGS

- A. THE STEEL MESH TO BE BENT ON SITE TO SUIT THE ARMCO DIMENSIONS. IN CASES WHERE THE STEEL MESH CANNOT BE BENT TO THE ARMCO DIMENSIONS, THEN NORMAL STEEL REINFORCEMENT BARS TO BE USED EQUIVALENT TO THAT OF THE PRESCRIBED STEEL MESH.
- B. THE REINFORCEMENT STEEL TO BE ANCHORED TO THE ARMCO BY MEANS OF WELDING ANCHOR STEEL TO THE EXISTING ARMCO BOLTS (SEE FIGURE 5). IN THE TRANSVERSE DIRECTION THE REINFORCEMENT MUST BE ANCHORED INTO THE FLOOR SECTION (FIRST CAST) BY 500mm MINIMUM.
- C. THE FLOOR SLAB TO BE CAST IN SECTIONS WHERE BEDDING MATERIAL IS REPLACED WITH CONCRETE (FIGURE 4).

- 1. Repair Armco culvert to the WCG Standard drawing no. WSC/60/9/D1 (See Appendix D)
- 2. Replace the Armco culvert
 - a. By excavating the culvert and laying a new concrete pipe
 - Jacking a concrete pipe over the existing Armco and subsequently removing the Armco culvert.

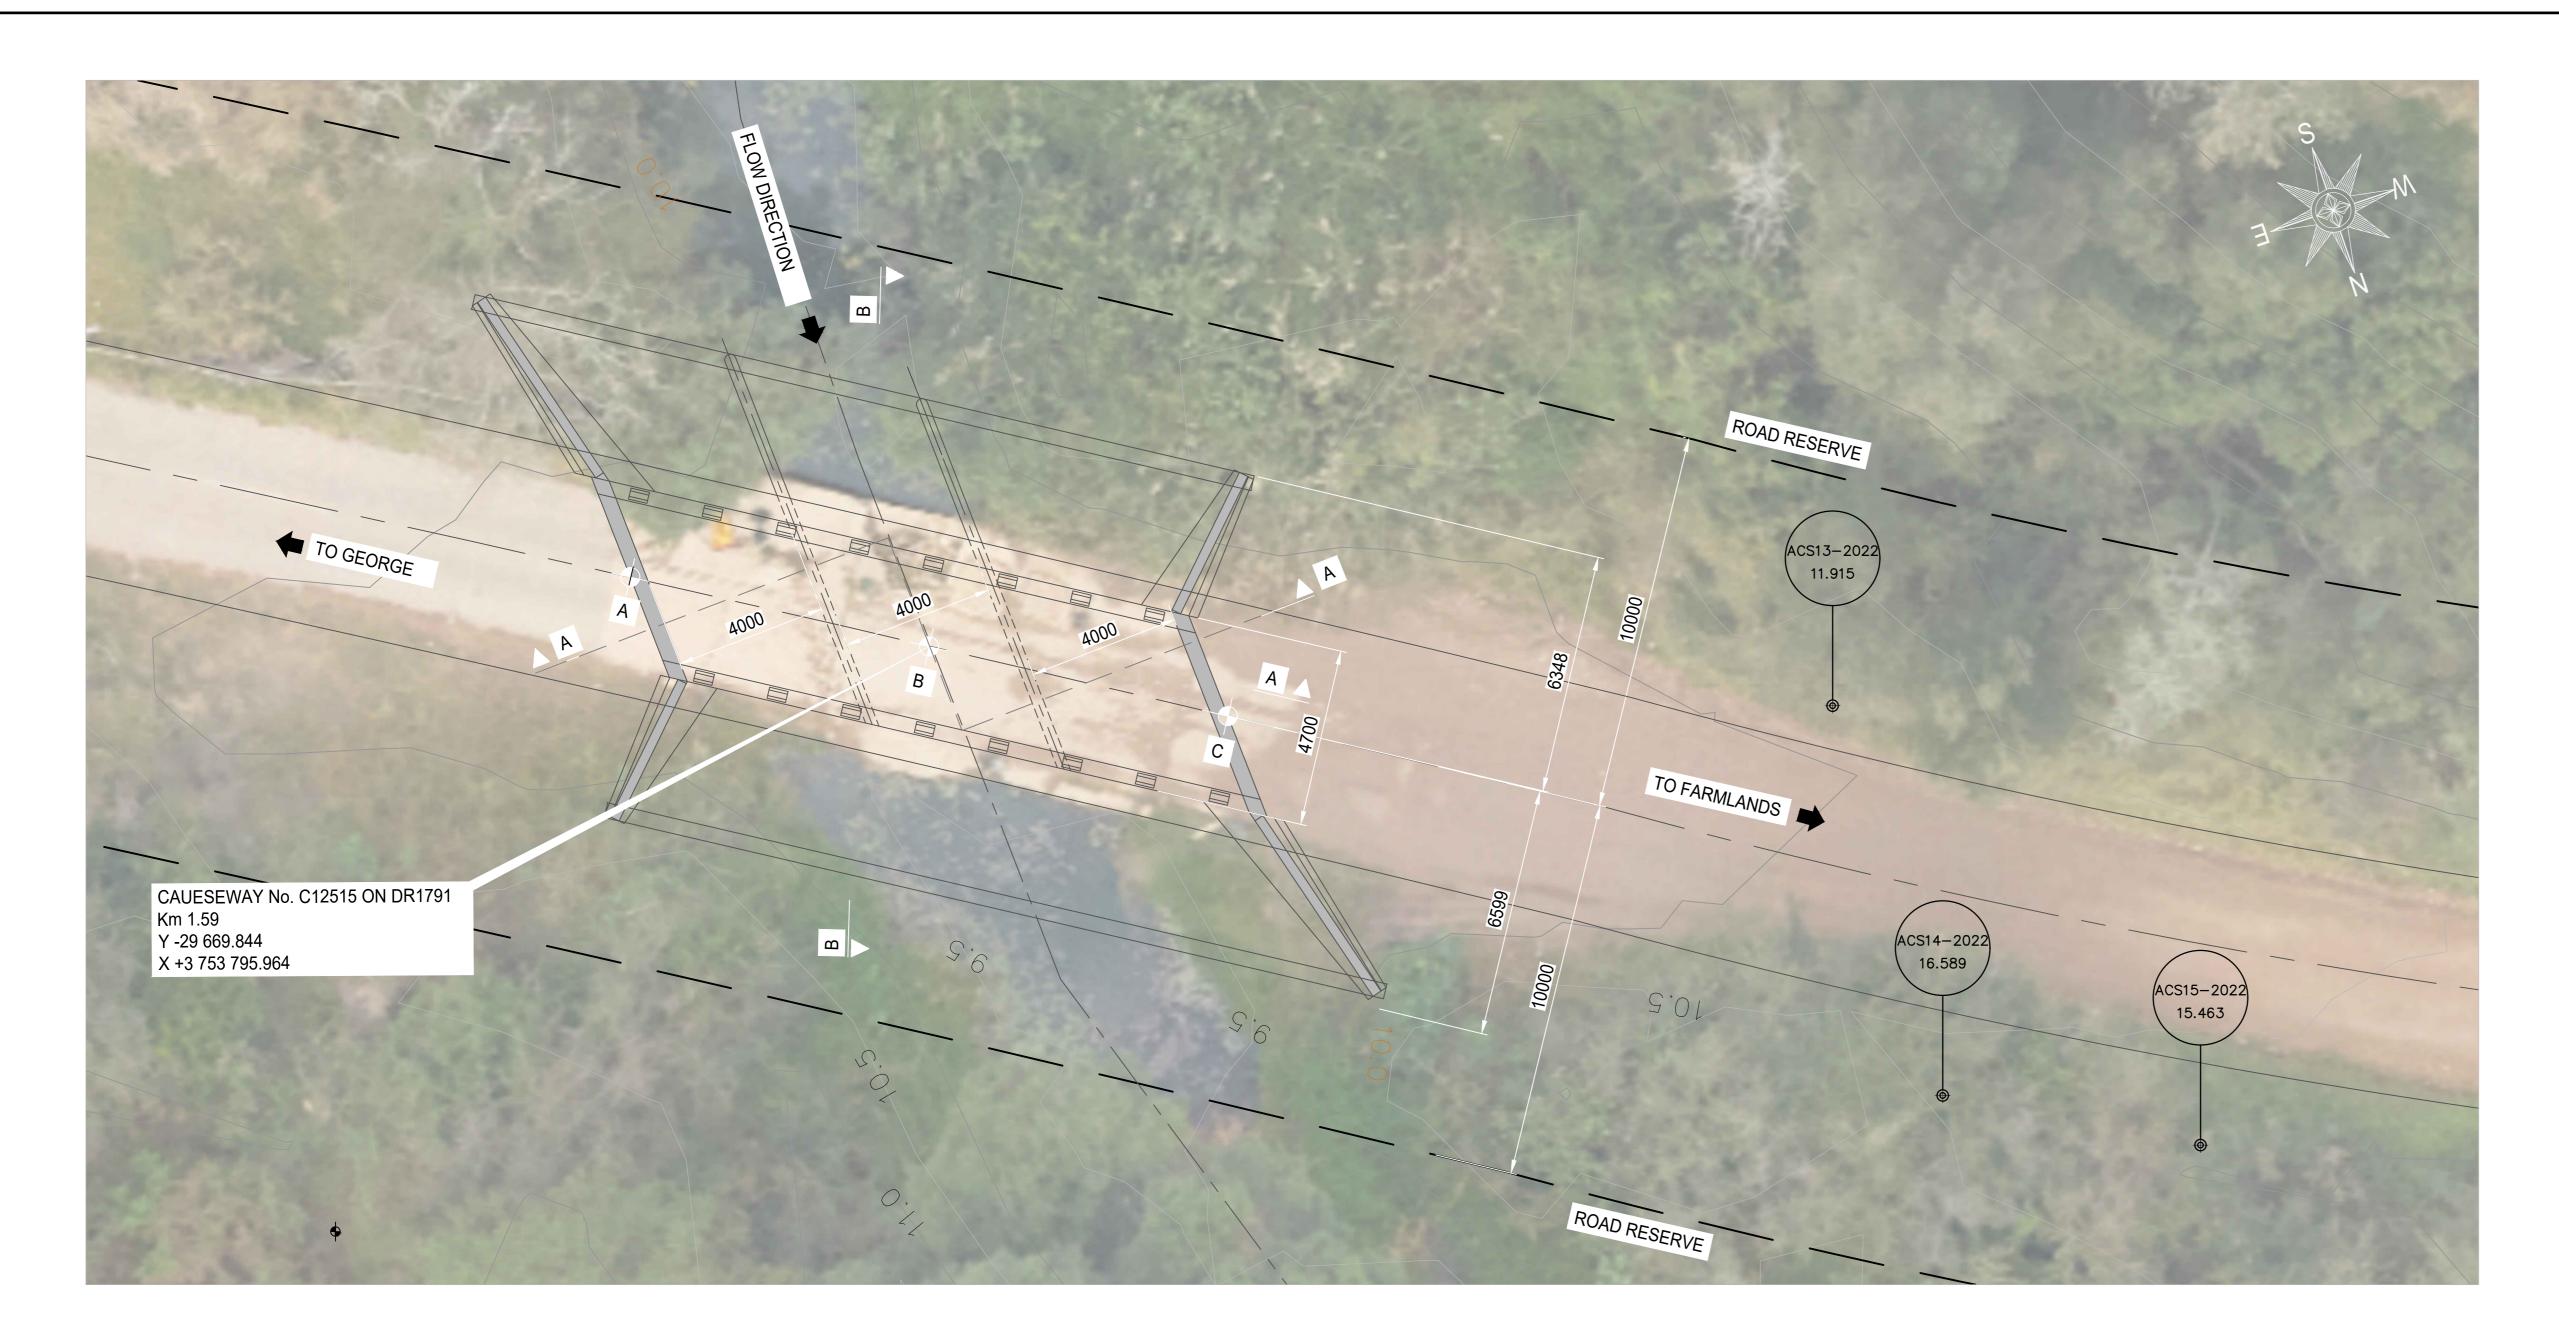
PLAN ON CAUSEWAY
SCALE 1:100

CALICEWAY No 40545 on DD4704 of King 4 50 over DITOU DIVED NEAD OTOFDAD		ISCALE ASSIDMIN I	ORIGI PAPER
CAUSEWAY No 12515 on DR1791 at Km 1.59 over BITOU RIVER NEAR STOFPAD	CONTRACT NO. C1157.02	WCG STRUCTURE C12515/01	PLA
GENERAL ARRANGEMENT	CONSULTANTS DWG NO. H361596-00000-220-270-1791-0001	WCG INDEX NO. A99/131	VE

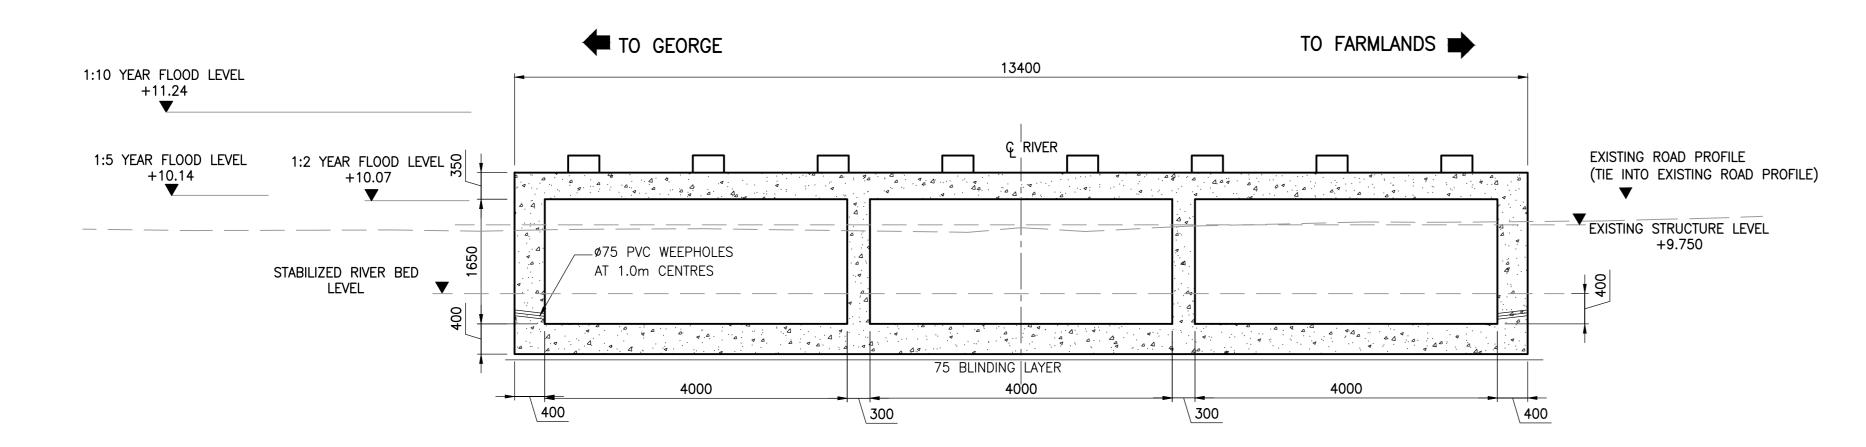
ROAD CROSS SECTION A—A

SCALE 1:50

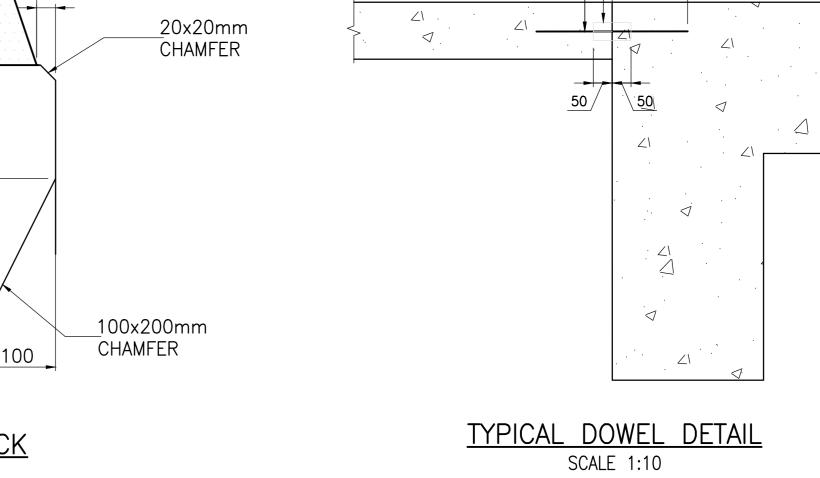
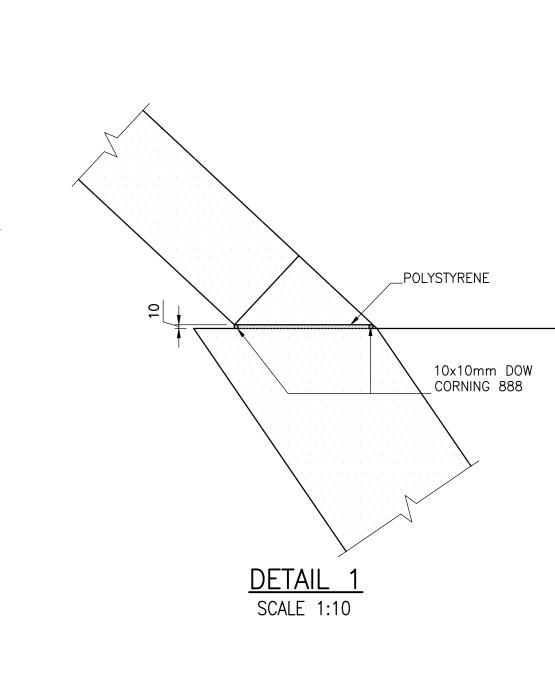
WRAP IN 100mm DENSO TAPE —

DOWEL BAR — 200

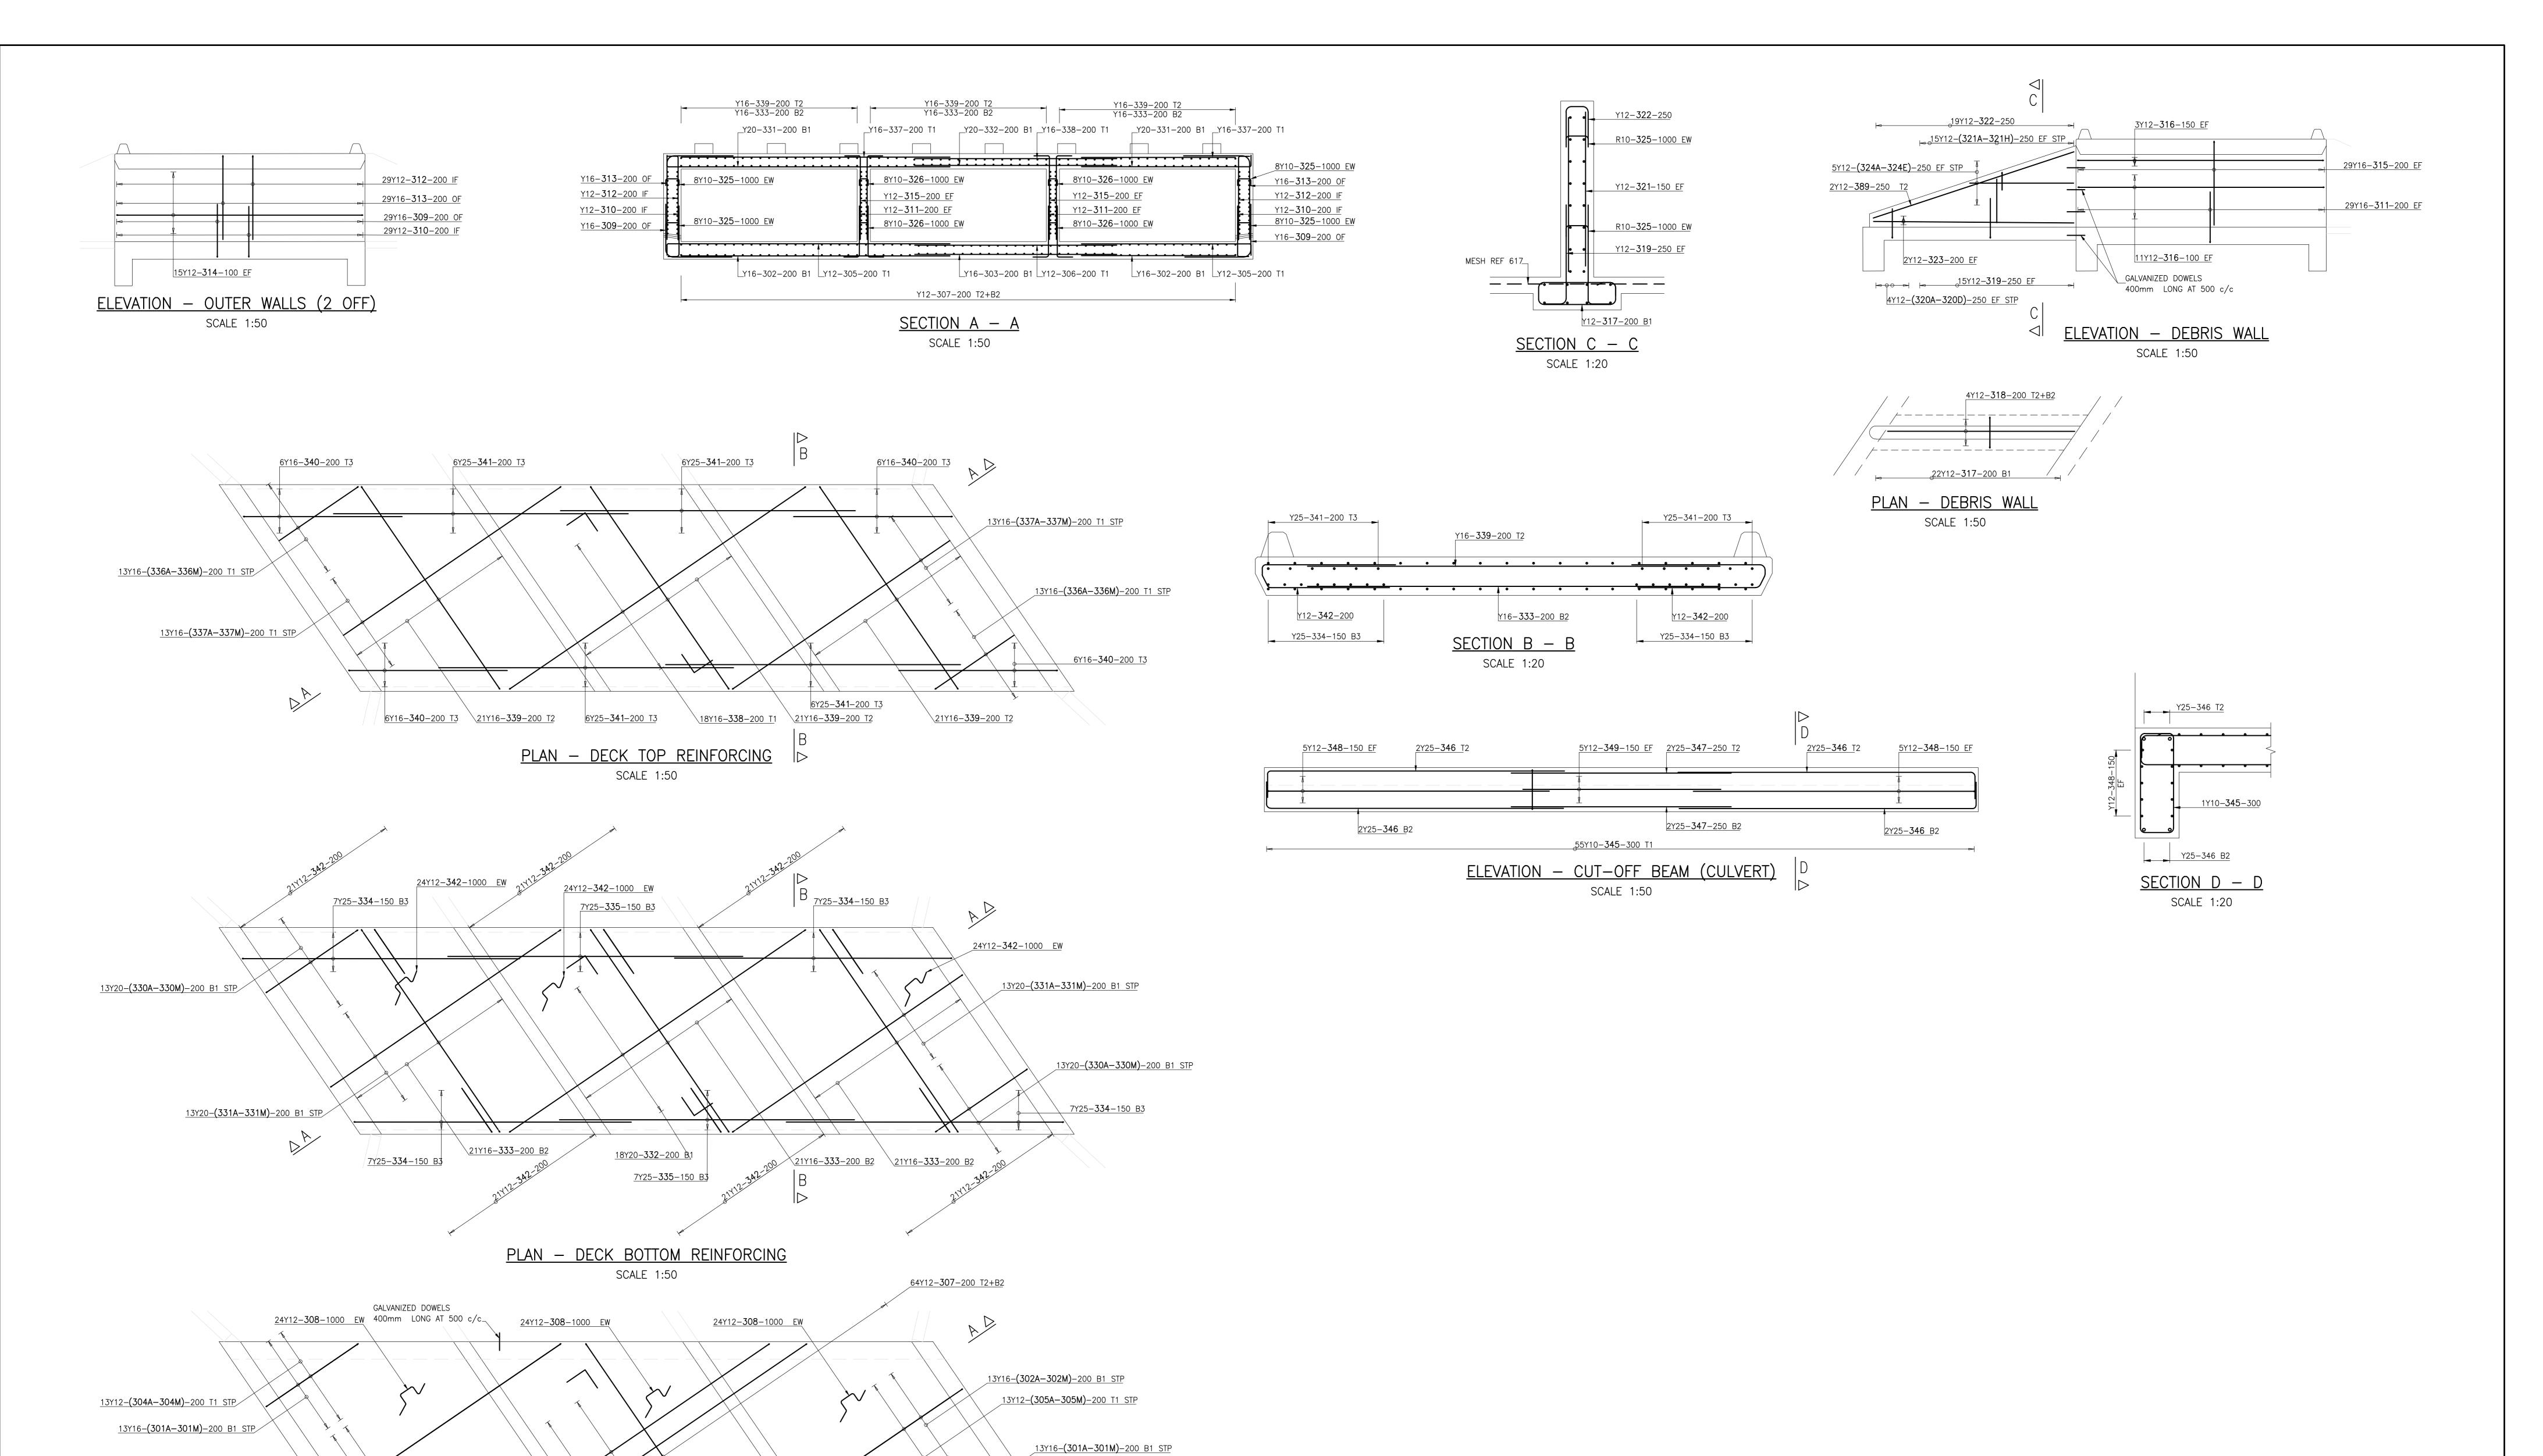
CAUSEWAY No 12515 on DR1791 at Km 1.59 over BITOU RIVER NEAR STOFPAD	P.R.E's FILE NO. DOI16/6/4/1/4/C1157.02	SCALE SHEETS OF	ORIGINAL PAPER SIZE	
CAUSEWAT NO 12313 OII DR1791 at Kill 1.33 OVEL BITOO KIVER NEAR STOFFAD	CONTRACT NO. C1157.02	WCG STRUCTURE PLAN C12515/04		
REINFORCEMENT DETAILS CELLULAR STRUCTURE	CONSULTANTS DWG NO. H361596-00000-238-272-1791-0001	WCG INDEX NO. A99/134	VER VB

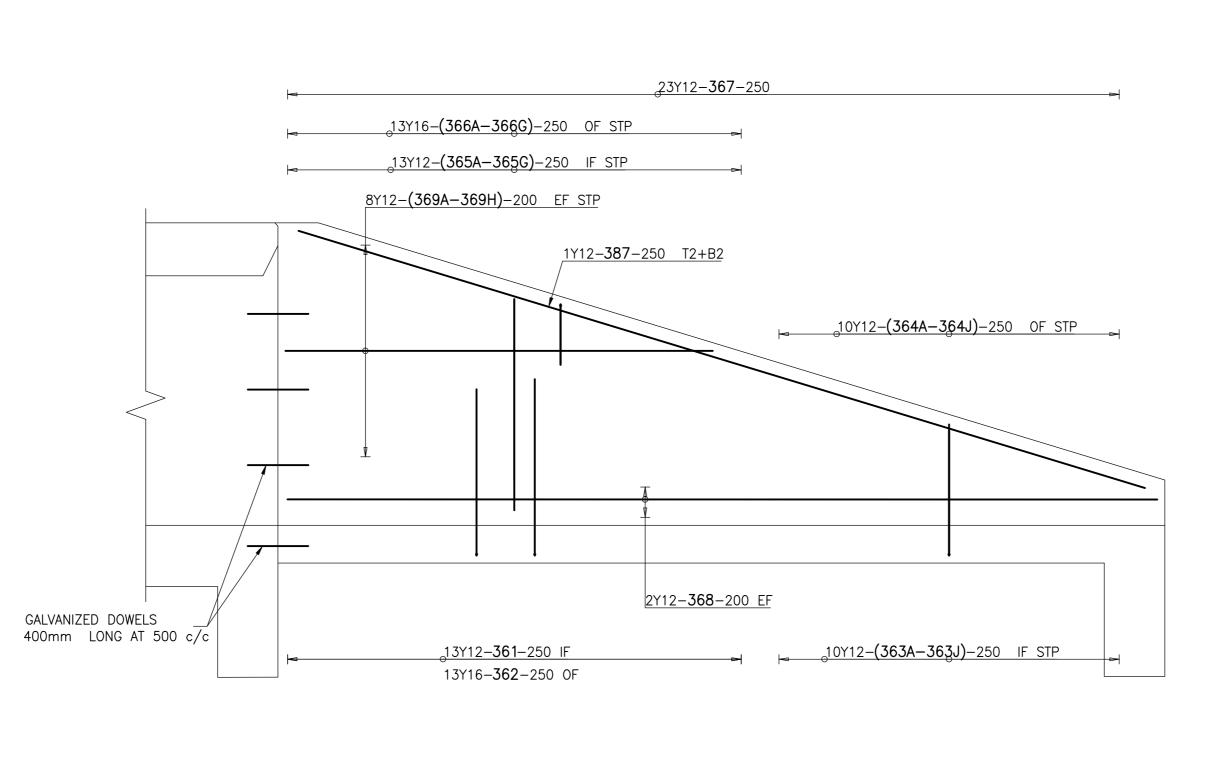
ELEVATION — WINGWALLS 1 AND 4 SCALE 1:25

P.R.E's FILE NO.	SCALE	ORIGINAL PAPER SIZE	
CAUSEWAY No 12515 on DR1791 at Km 1.59 over BITOU RIVER NEAR STOFPAD	DOI16/6/4/1/4/C1157.02	SHEETS OF	A0	
CAUSEVVAT NU 12313 UII DR 1731 AL RIII 1.33 OVEL BITOU RIVER NEAR STUFFAD	CONTRACT NO. C1157.02	WCG STRUCTURE PLA C12515/05		
REINFORCEMENT DETAILS WING WALLS	CONSULTANTS DWG NO. H361596-00000-238-272-1791-0002	WCG INDEX NO. A99/135	VER VB
