# SITE SENSITIVITY VERIFICATION REPORT

PERIODIC MAINTENANCE OF  
TR03105 FROM  
LADISMITH TO CALITZDORP (KM 0.9  
TO KM 47.63)  
WESTERN CAPE

**DATE:** 09 March 2026

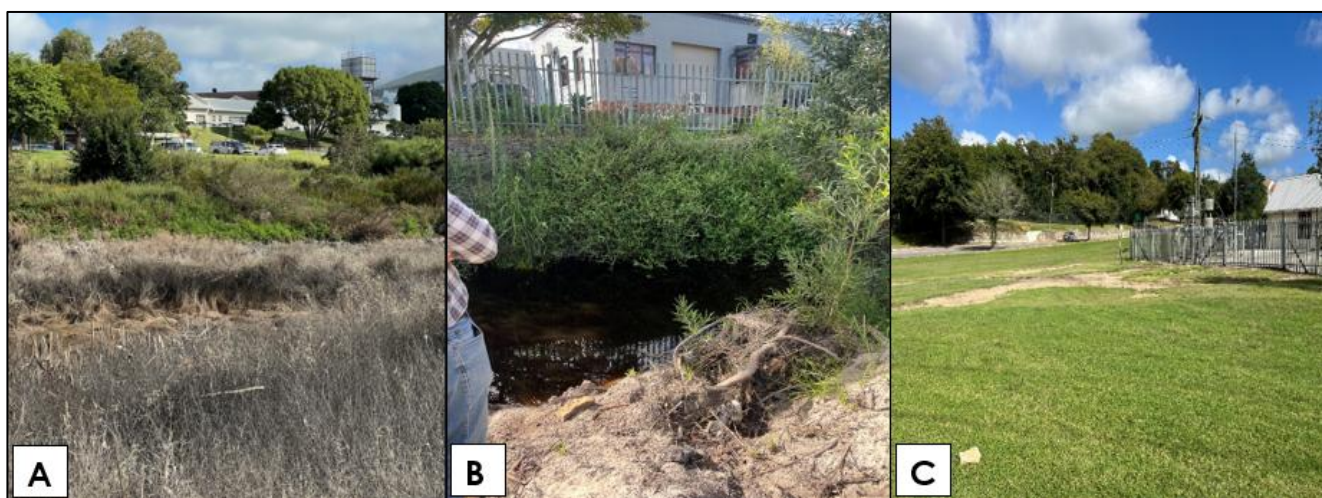
Figure 12: Visibility of proposed works

The screening tool report recommended that a visual assessment be undertaken. We disagree; there is no need as the proposal is to repair damages and install protection measures to the site. The look of gabion retaining structures, a swale and earth v-drain is well known.

As seen from Figure 12A, the vegetation north of the proposed gabion structures is dense which will make the structures well hidden. As seen from Figure 12B, the outlet or flared swale will be partially visible to the building to the south as there is vegetation along the gate across the river. As seen from Figure 12C, the swale and earth v-drain will be visible to pedestrians and drivers using Langenhoven Road. The visual impact of the proposed repair works is therefore Low, and no study will be conducted.
