APPENDIX 3

MAINTENANCE MANAGEMENT PLAN FOR CLEARING ALIEN INVASIVE VEGETATION ON THE PREEKSTOEL COASTAL ESTATE PROPERTY, INCLUDING ERF 593

Revision September 2023

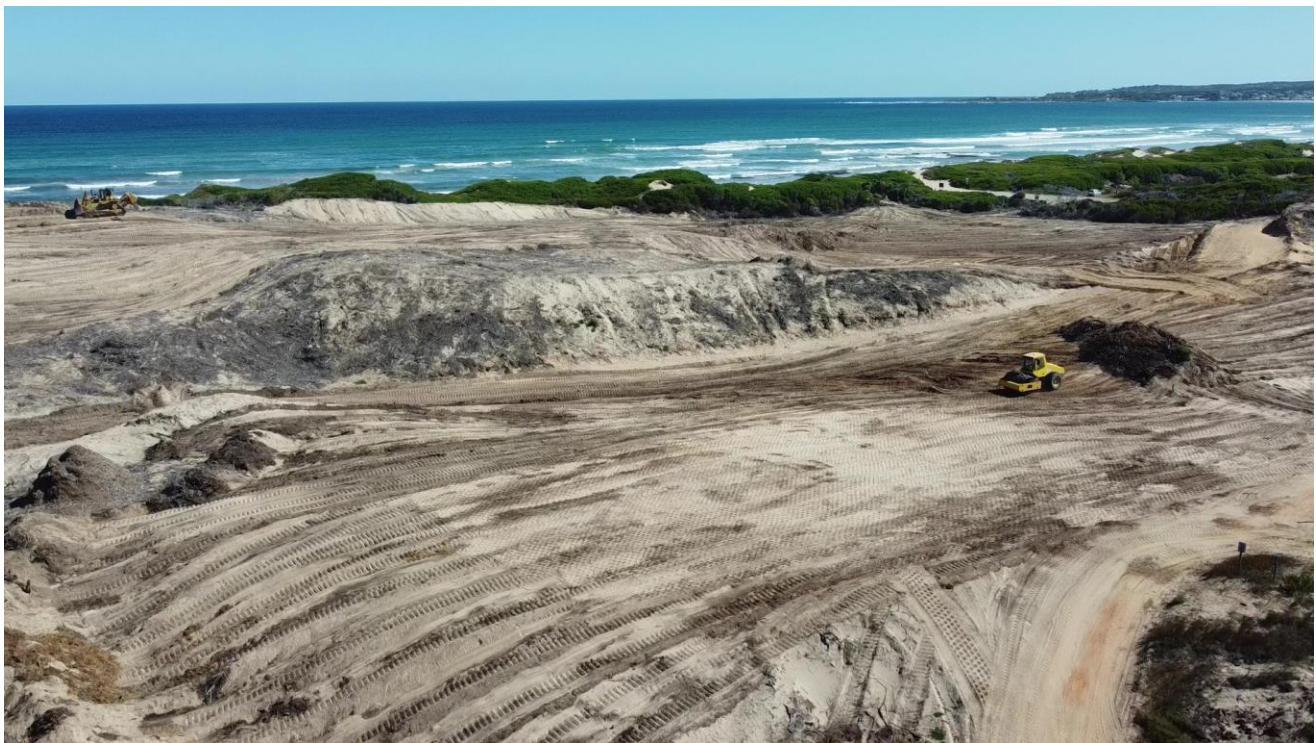
The cover of alien infestation on the northern portion of Erf 1028 is dense and equally so on Erf 399 (now known as Erf 2343). According to the botanist, these erven comprise 75-80% rooikrans. Erf 593 is also densely populated with rooikrans with some areas where rooikrans has been previously removed by CapeNature and contains some locally indigenous Strandveld species. Since the botanist indicated that there was very little locally indigenous vegetation of Erf 2343, and that there were no areas of concern on this property, the botanist indicated that the most efficient way of clearing the rooikrans on these two erven was by use of a bulldozer. The rooikrans and the upper leaf litter, including the seed bank was also removed by bulldozer (**Photo 1**).

Photo 1: Shows the site has been cleared by bulldozer and the topsoil layer comprising leaf litter and seed.

The removed rooikrans was worked with a frontend loader to shake out the sand. It was then stored on site and chipped with an industrial sized chipper. The mulch was saved in various large mounds across the site (**Photo 2**). The leaf litter with the seed bank and very little topsoil was removed to the future site of the Private Open Space (POS), in the middle of the development site (**Photo 3**). Following the removal of rooikrans, the mass earthworks was undertaken to produce stabilized building platforms for Phase 1 of the development.

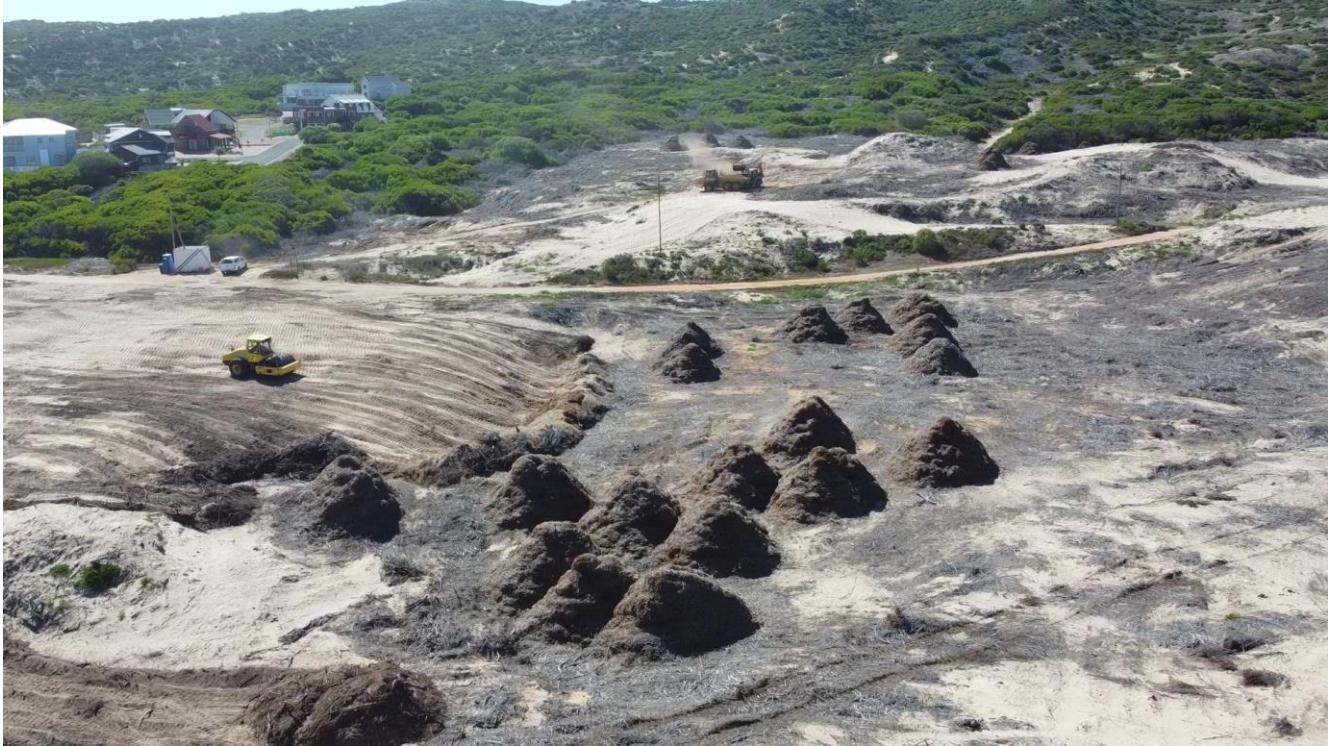
Photo 2: Shows the mounds of woodchips on the property

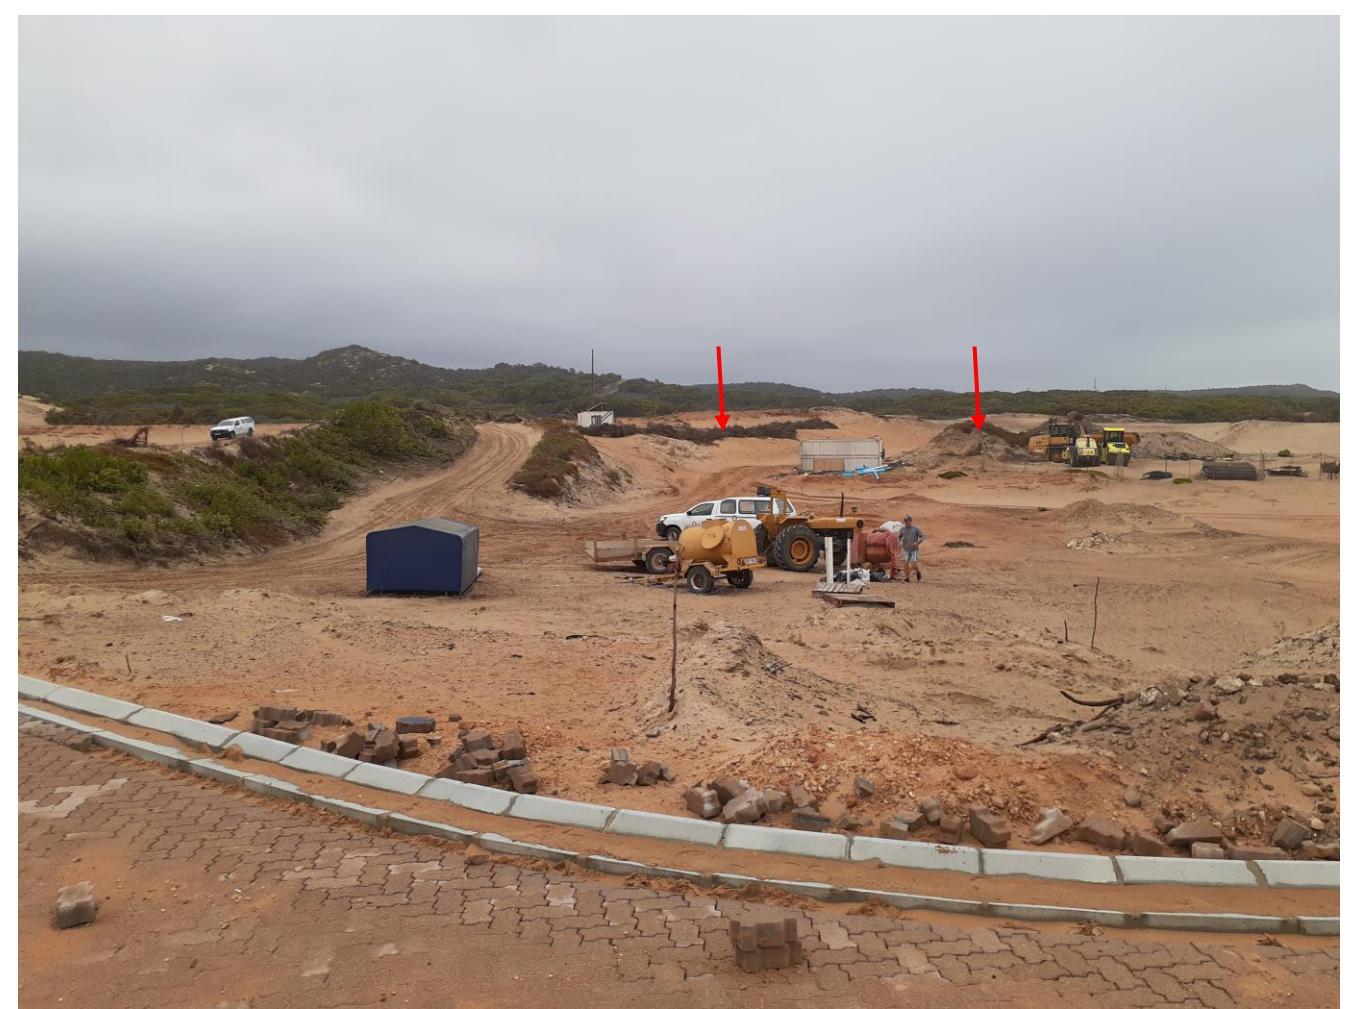
Photo 3: Shows the heaps of topsoil, leaf litter and rooikrans seed heaped up on the development site (arrows)

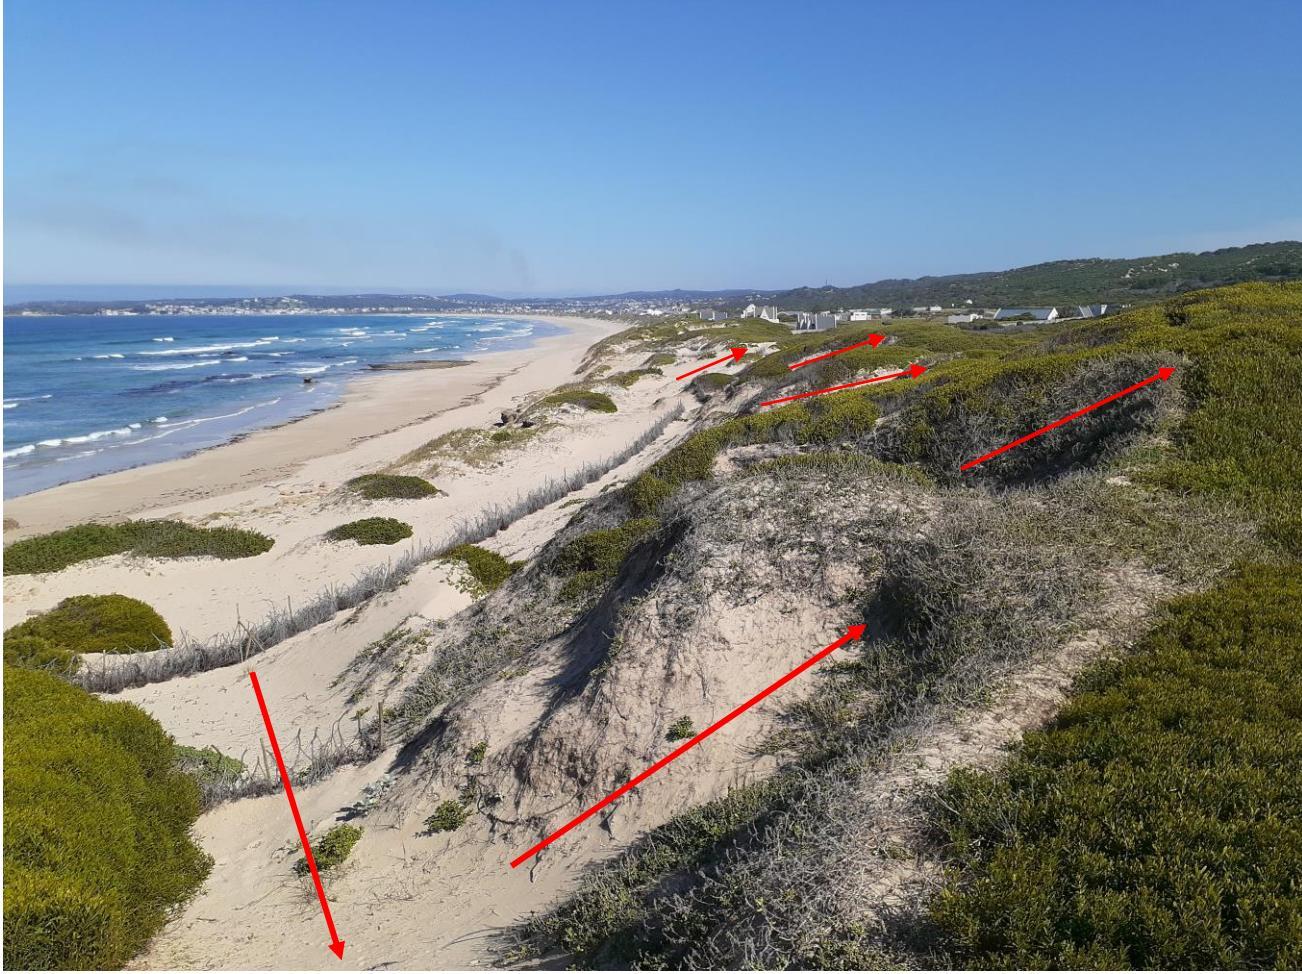
In terms of the rehabilitation of the frontal dune system, brushwood fences were constructed along the base of the back dune area (**Photo 4**) to prevent more sand being blown onto the top of these dunes and into the dune slack to the north, and to trap sand being blown off the beach and onto and off the hummocky dunes.

Photo 4: Shows the brushwood fence along the toe of the high back dune of the frontal dune system. Note the large blow-outs (arrows) with sand blowing into the dune slack inundated with rooikrans.

Brushwood fences were also erected within the large blow-outs to trap windblown sand (**Photo 4**). This system of sand traps collected about 30m³ in just under a year of being deployed. Whilst the use of brushwood fences have worked well in other coastal areas, such as Cape Agulhas-Struisbaai coastline, it has not worked at Still Bay East.

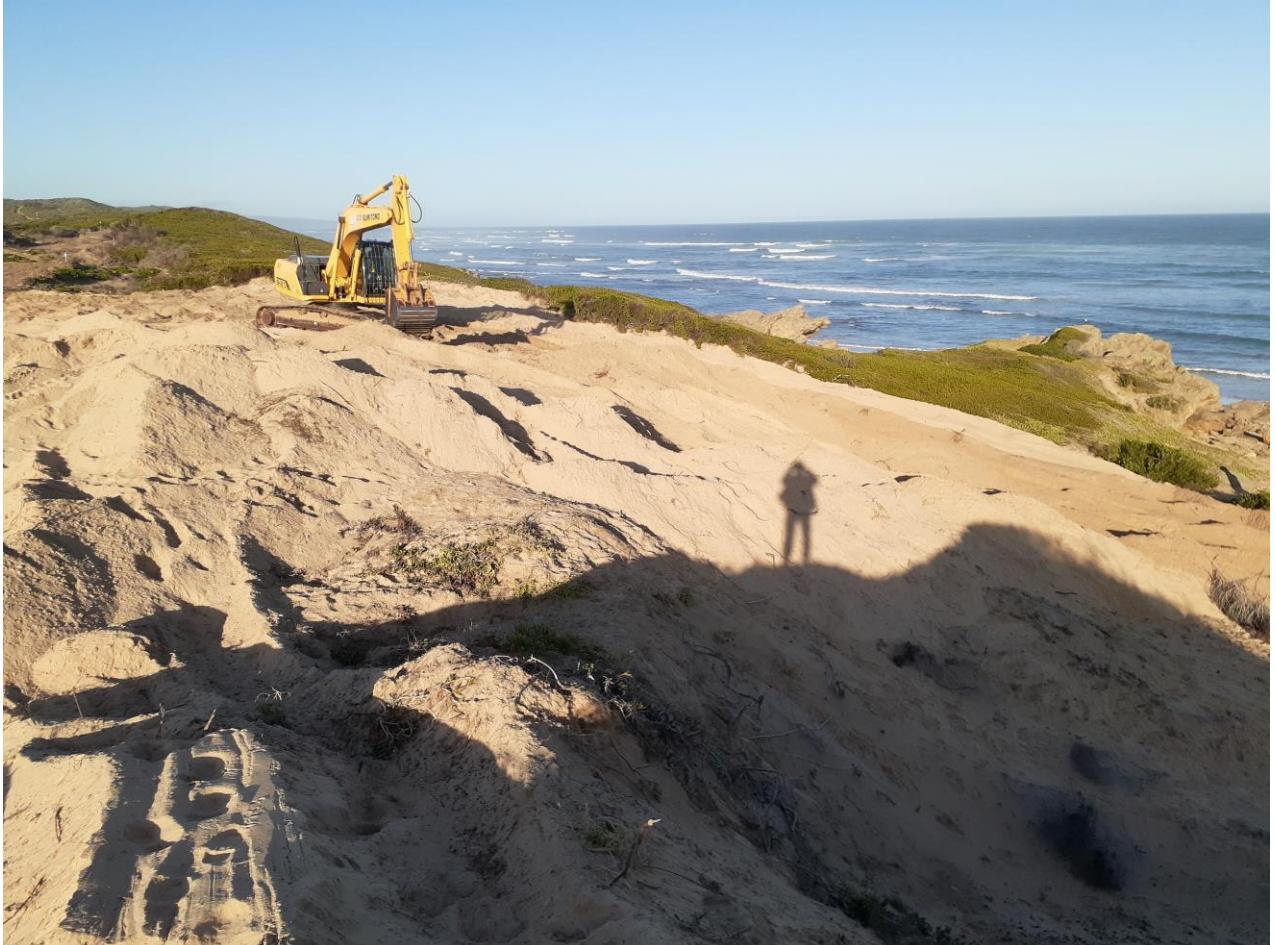
latter methodology was then also used for the Preekstoel frontal dune system (**Photo 5**). The rooikrans in the back dune area was also removed by an excavator, the most efficient way of removing rooikrans from the back dune area and moving sand over a relatively small area (approximately 10 260 m²).

Photo 5: Shows the movement of sand trapped in the back due area by dense rooikrans by excavator towards the hummocky dunes above the high water mark.

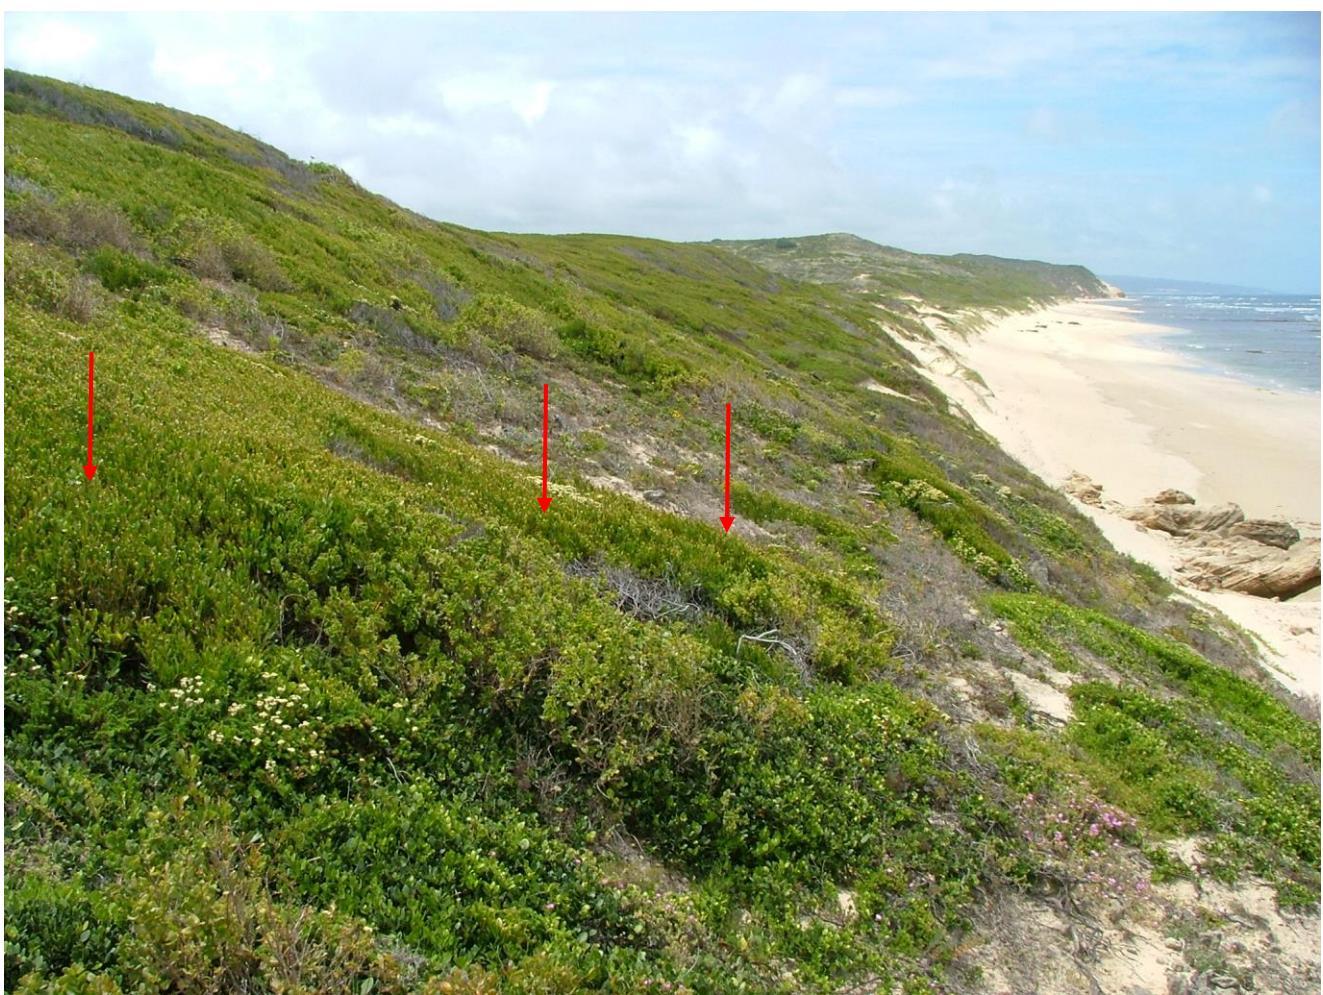
The steep foreland scarp contained about 60-65% locally indigenous Strandveld and the rest was invaded by rooikrans. The Strandveld species found on the steep foreland scarp comprise *Chrysanthemoides monilifera* (bietou), *Maytenus procumbens, Searsia crenata* (dune crowberry), *Searsia glauca, Diospyros dichrophylla* (bladder nut), *Euclea racemose, Pterocelastrus tricuspidatus* (kershout), *Sideroxylon inerme* (milkwood), and *Tarchonanthus littoralis* (camphor tree).

Photo 6: shows the steep aeolianite foreland scarp with a covering of locally indigenous Blombos Strandveld and invasive rooikrans (arrows). Note the "hedging" effect of the vegetation caused by salt laded strong winds.

In terms of the removal of rooikrans from the steep, stable foreland scarp, and to reduce the impact of wind erosion, it was recommended that the rooikrans growing in between the locally indigenous Strandveld plants (**Photo 6**) on this sensitive dune system, would be to remove individual rooikrans plants by hand, using a long handled pair of shears. The rooikrans must be cut as low down as possible. Fortunately, these rooikrans plants do not carry many seed pods, if at all. Each rooikrans plant must be removed from this dune system and chipped if need be. Care must also be taken not to damage the indigenous plants when moving in and out of the dune area. In-planting of hardy, locally indigenous Strandveld must be undertaken in the gaps provided by the removed rooikrans. Such planting must only take place once the first good winter rains have fallen as it will be near impossible to keep these new plants watered, and hope that follow-up rains will maintain a high moisture level in the upper dune sand layer during winter and into spring.

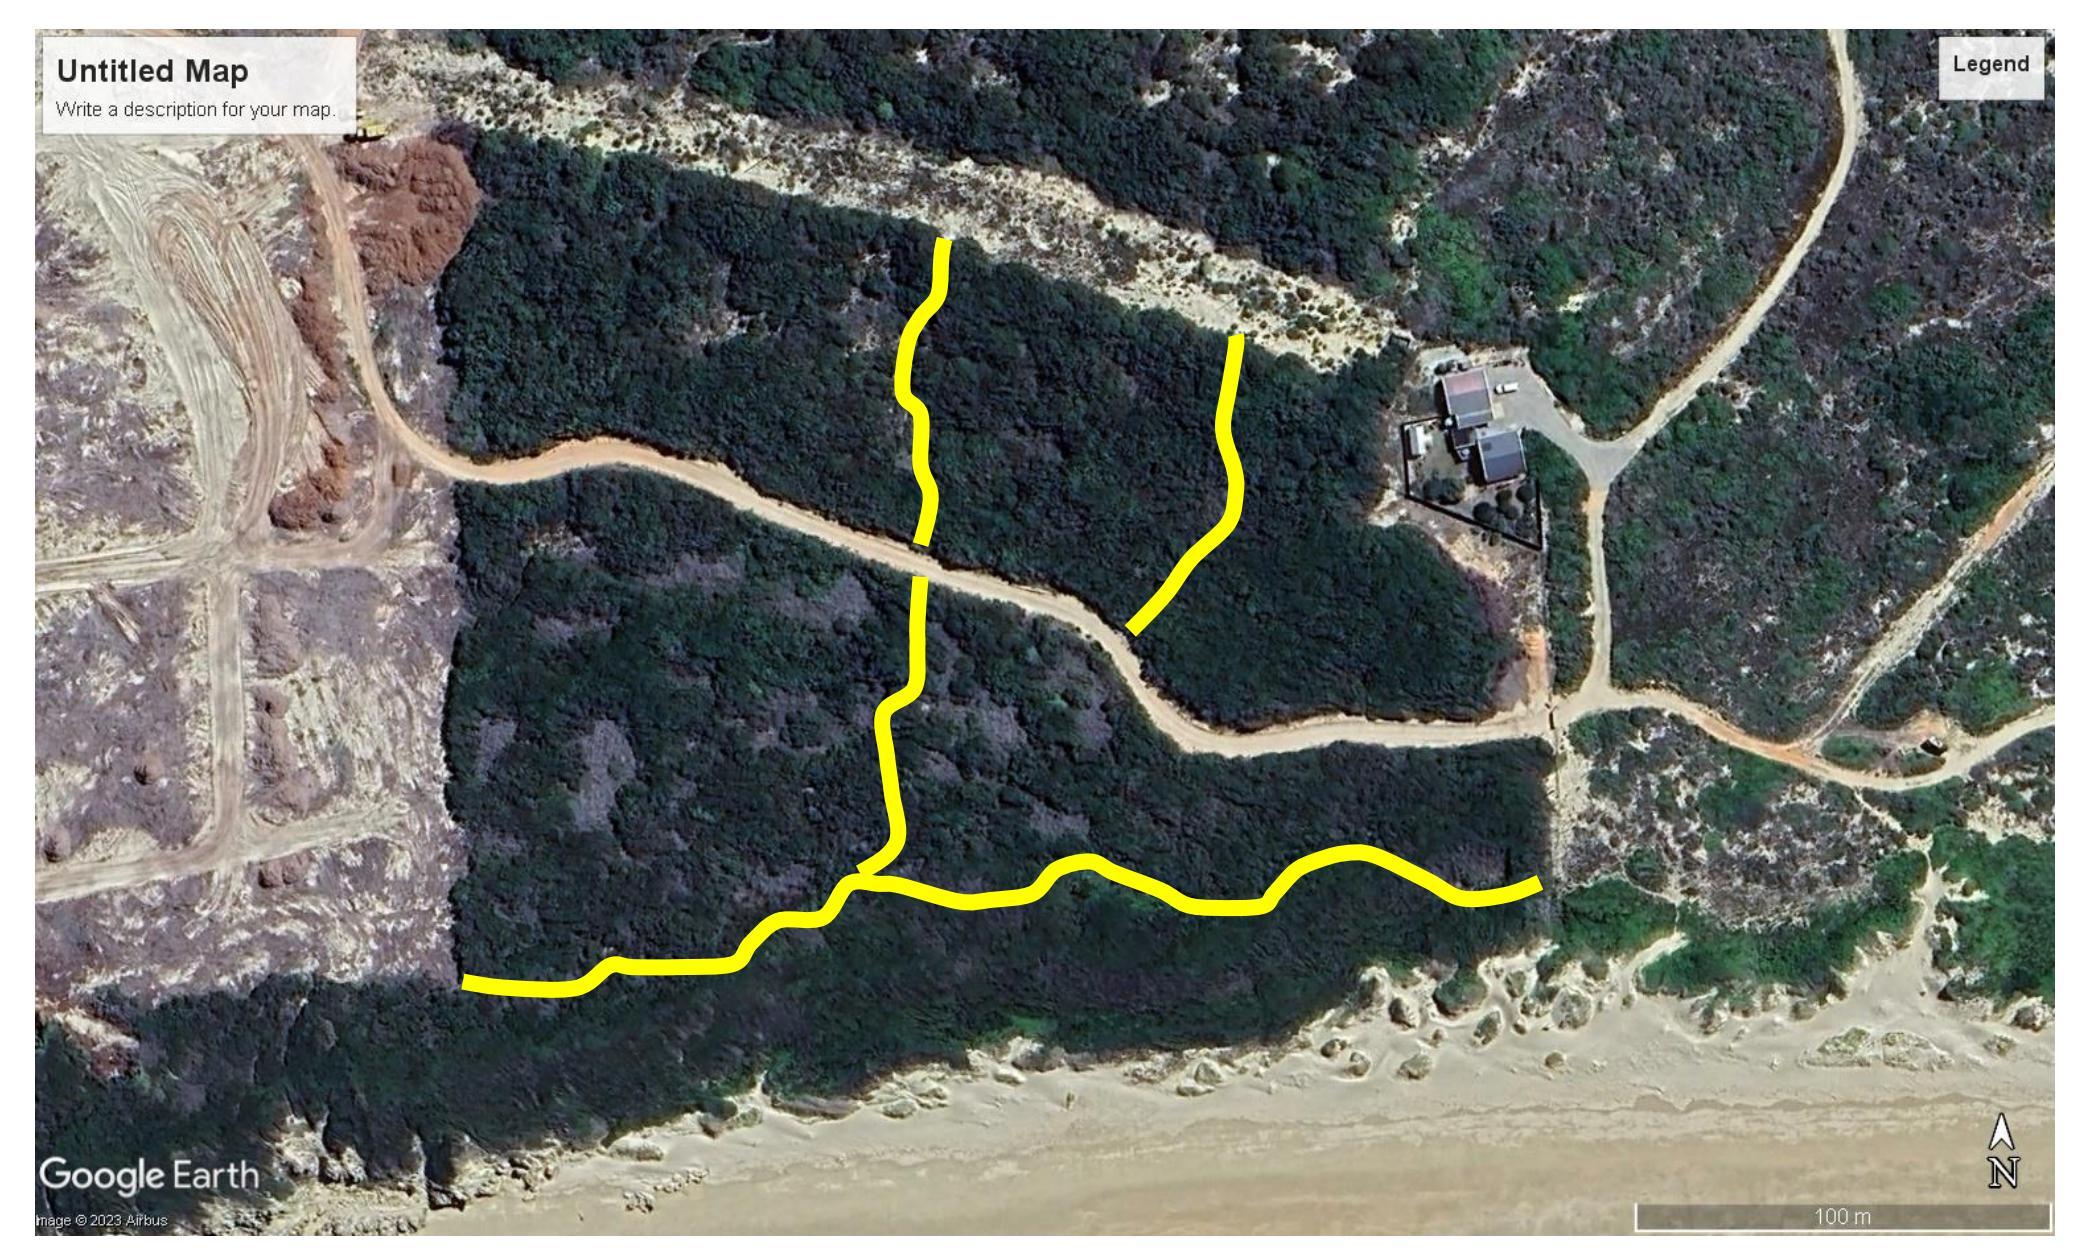
FIGURE 1: Shows the eastern portion of Erf 593 that needs to be cleared of its dense stands of Rooikrans (Acacia cyclops)

The rooikrans within the remainder of Erf 593 will be cleared by hand using chain saws. **Figure 1** below shows the pathways to be cleared first in a swath about 3m wide. The cut rooikrans shrubs will be removed to the nearest road for stockpiling before being removed to the cleared area of the development site to the west for chipping.

Given that the removed rooikrans shrubs will have seedpods on them, the leave component of the shrub will be separated from the stems. These stems will then be chipped. Once these pathways have been cut, the interior of the blocks will be cleared. The leaf component of shrubs will be stockpiled on the development site for later burning in small piles. The necessary permits for burning the residue leaves will be obtained.
