## **ECO CHECKLIST FOR THE CONSTRUCTION OF THE PACKAGE SEWAGE PLANT AND HOUSES ON THE PREEKSTOEL BEACH ESTATE, STILL BAY EAST, WESTERN CAPE**

**File 1012 : Construction ECO Checklist No.: 2**

**Date: 20 March 2024**

ECO Checklist the Construction of the Sewage Package Plant and Housing on the Preekstoel Beach Estate, Still Bay East, Western Cape

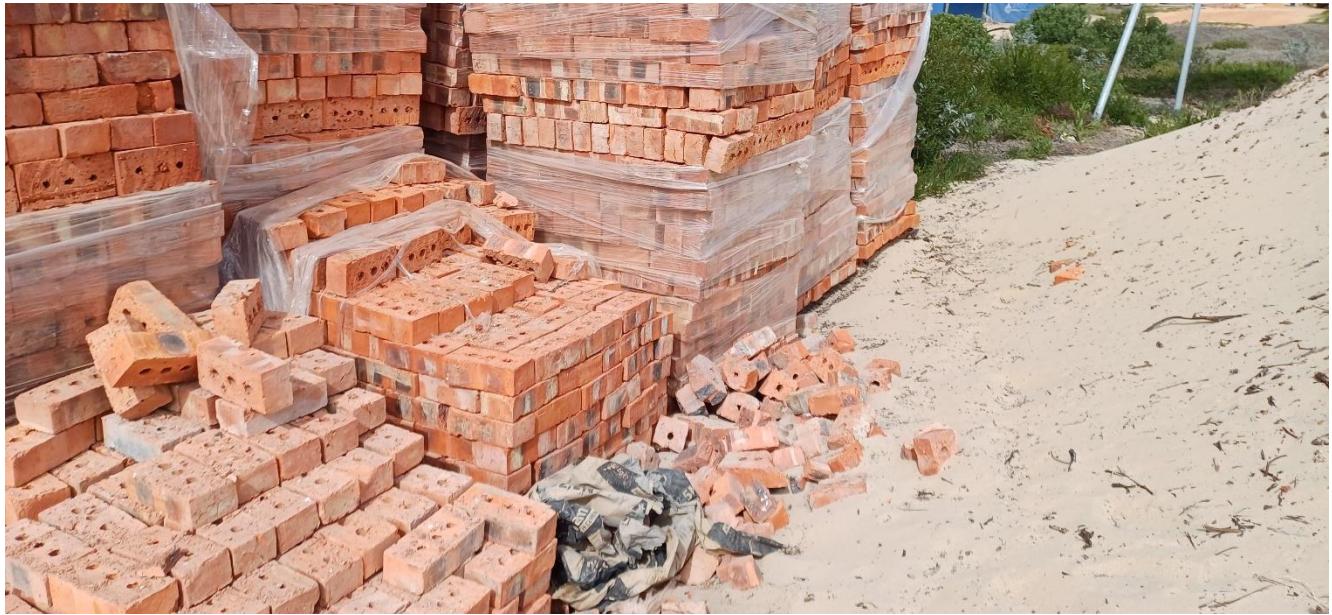
**Photo 1:** The building materials on the site of the first house are stored in a non-sensitive area, and in a neat condition. The building site supervisor was reminded to store plastic wrapping and used cement bags in a lidded bin for later removal from site.

Storage of construction materials, concrete mixing areas, rubble storage and litter management on building sites	1. Construction material (precast concrete components of the package sewage plant, concrete and mortar raw materials) must be stored in designated areas in a neat and orderly manner.	Area for construction material has been designated by the Site Agent and to be in secured area out of the way of access routes. ECO to monitor compliance.	C	The storage areas have been vetted by the Site Agent and ECO and are out of the way. These storage areas are in a neat and tidy state ( <b>Photos 1, 2 and 3</b> ).

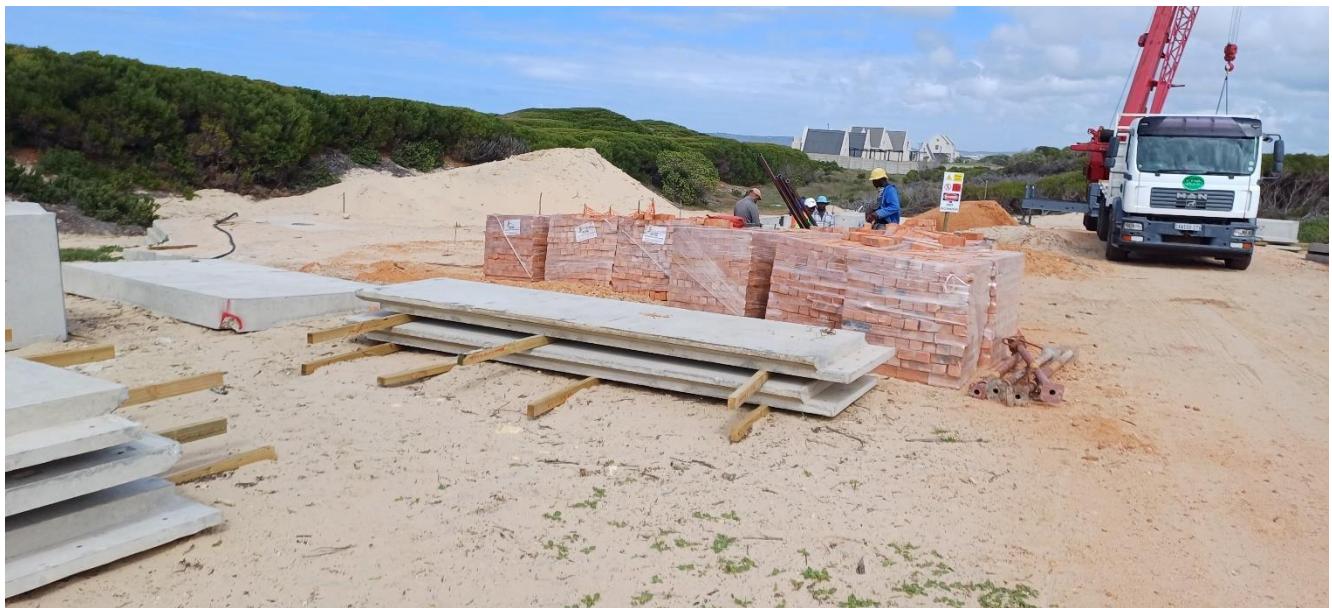
**Photo 2:** Shows the FluidCo site of the package sewage plant's site. The building materials and the pre-cast concrete panels are stored out of the way and in a neat manner. The last of the panels were off-loaded on 13 March 2024.

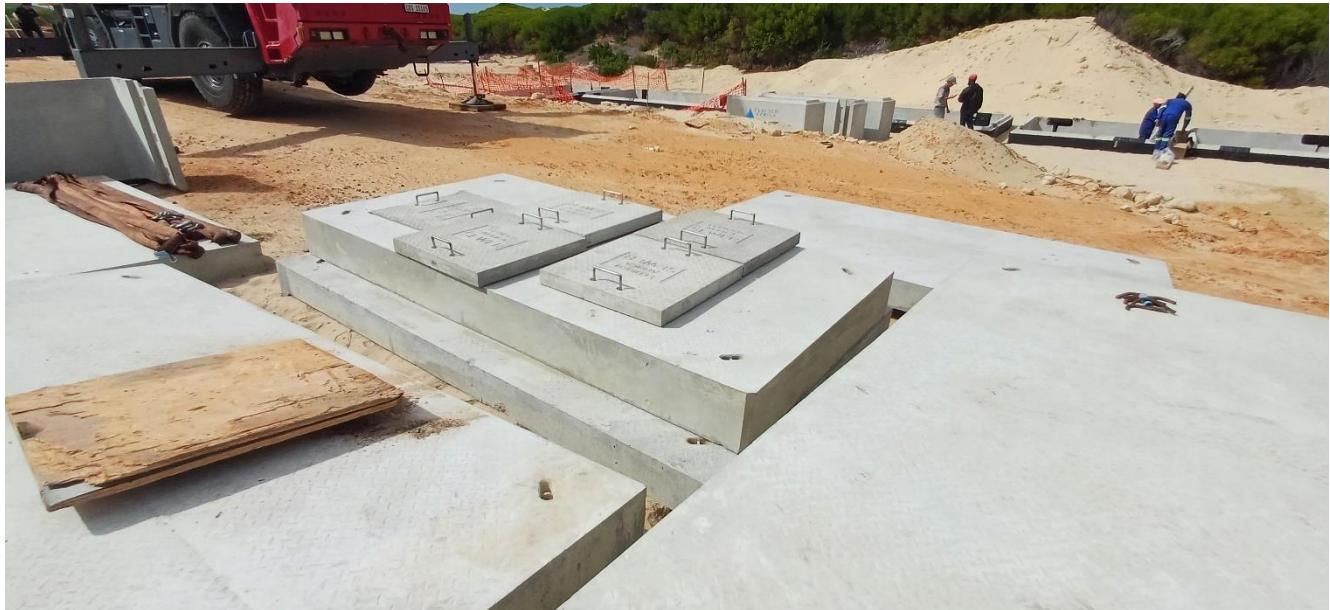
**Photo 3:** The pre-cast concrete components of the package sewage plant are neatly stored on site.

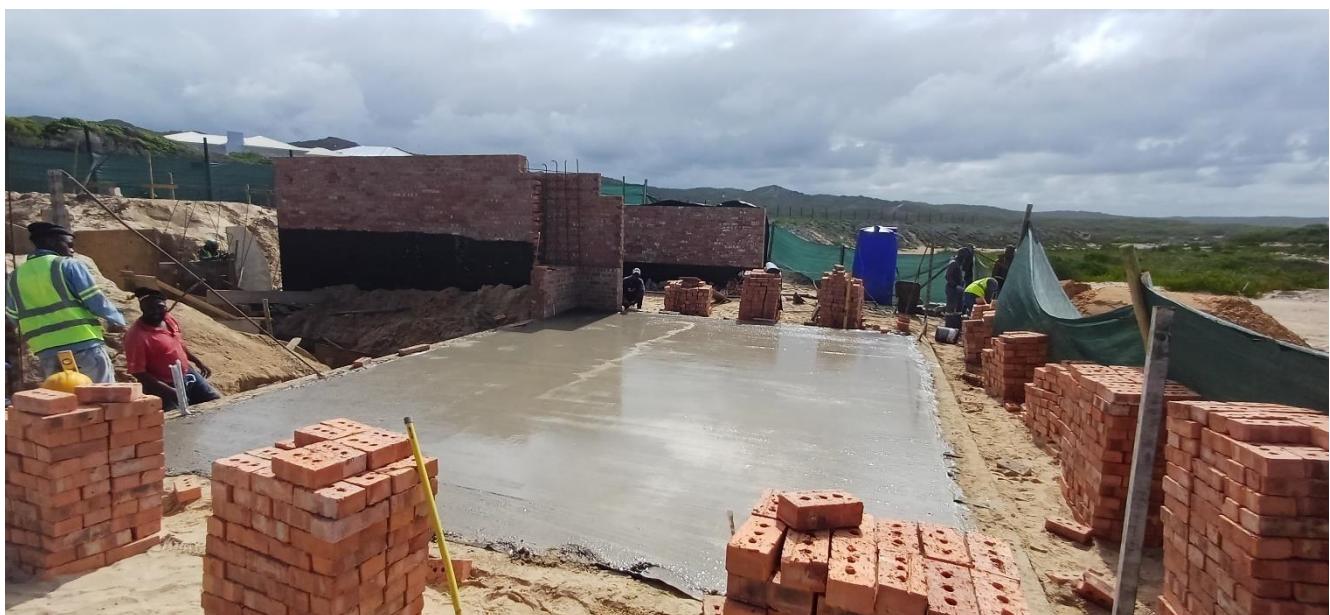
**Photo 4:** Ready-mixed concrete was used to cast the floor of the double garage on Erf 2457. Note the retaining walls of the main house in the background. The cavity in these walls will also be filled with ready-mixed concrete.

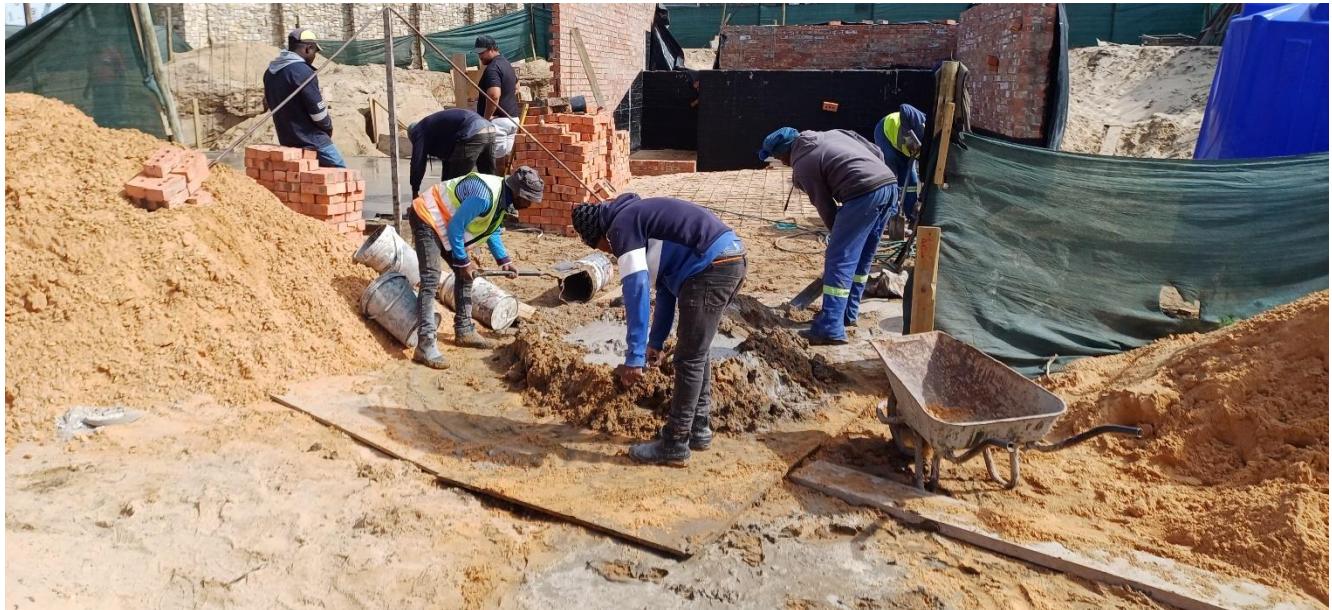
**Photo 5:** Mortar is being mixed on mortar boards on site for the building of walls and retaining walls.

ENVIRONMENTAL ASPECTS (PROJECT ACTIVITY)	REQUIRED ACTIONS	TARGET AND RESPONSIBILITY	COMPLIANCE	ECO COMMENTS
<b>Storage of construction materials, concrete mixing areas, rubble storage and litter management on building sites (continued.)</b>	<p>2. Contractor to store building rubble in a suitable designated area, with rubble removed from site on a weekly basis.</p> <p>3. The building contractor must indicate the dumping area for all spoil from the site. Trucks removing spoil must remain on designated access roads.</p> <p>4. All other solid waste and litter to be kept in appropriate containers with lids and removed from the site on a weekly basis to a licensed waste disposal facility. The burning of solid waste and paper on site will not be allowed. Recyclable waste (e.g. paper, glass, tin, plastic) should be recycled if possible.</p> <p>5. Concrete mixing must be restricted to a designated area on site and cement residues to be removed from site as soon as possible. At least one wastewater catch pits must be constructed for the capture of concrete residues from cleaning of the cement mixer. Residues are to be removed from site from time to time.</p>	<p>The area for any building rubble storage to be designated by the Site Agent. Contractor to remove any builder's rubble on weekly basis. ECO to monitor compliance.</p> <p>Site Agent to assess spoil dumping area, and to monitor condition of access roads.</p> <p>Contractor to remove solid waste on a weekly basis. Site Agent and ECO to monitor compliance. Waste skips are to be used where necessary on building sites.</p> <p>Site Agent and ECO to monitor compliance. Contractor to remove cement residues from each logical phase of construction.</p> <p>No concrete is currently being mixed on site and ready-mix concrete is being used.</p>	<span style="background-color: #90EE90; color: black; padding: 2px 5px;">C</span> <span style="background-color: #FFD966; color: black; padding: 2px 5px;">PC</span> <span style="background-color: #90EE90; color: black; padding: 2px 5px;">C</span>	<p>No building rubble is being generated during the current phase of works.</p> <p>Given that construction of houses has just begun, there is currently no building rubble being generated on site. Waste skips are to be used by the building contractors.</p> <p>Litter such as plastic wrapping on brick pallets, used cement bags and general domestic litter (plastic bags, lunch paper, cooldrink bottles are to be collected on a daily basis and placed in a lidded bin (refer to <b>Photo 1</b>).</p> <p>OIG Fencing mixed concrete for their fencing poles on an area designated for a road, i.e. non-sensitive designated area. Ready-mixed concrete is being used during the current phase of works on site for foundations of buildings (<b>Photo 4</b>). Mortar is being mixed on site on shutter boards for building walls and retaining walls (<b>Photo 5</b>).</p>

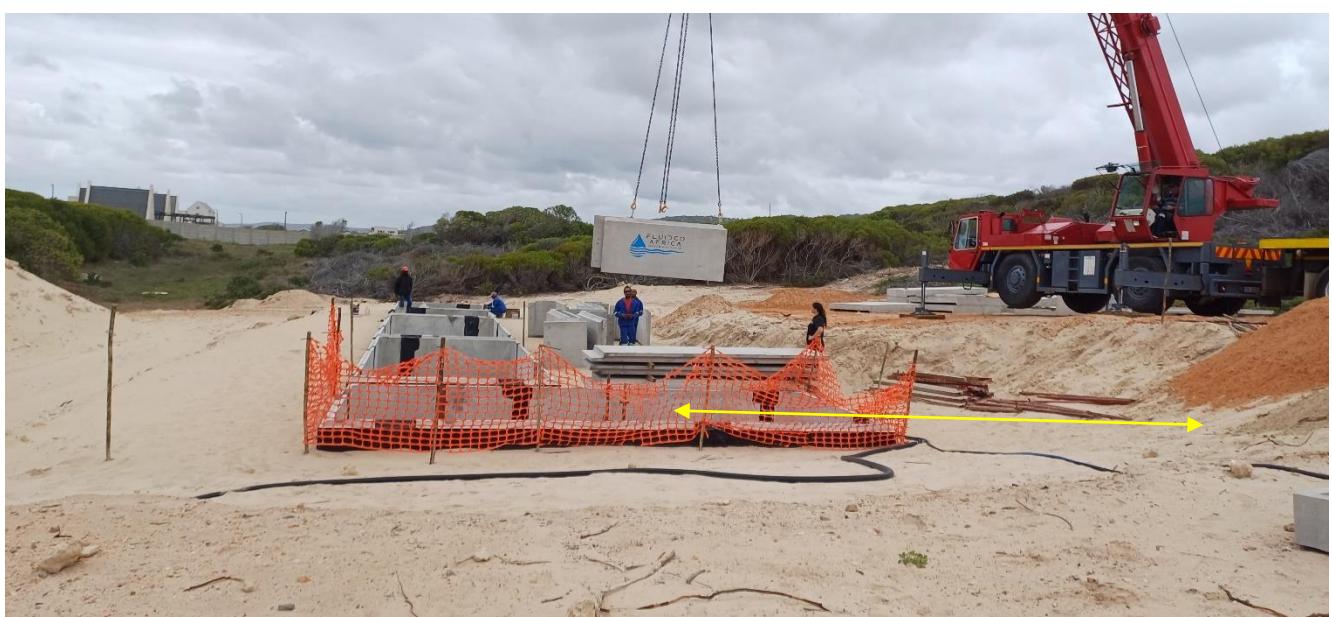
**Photo 6:** The last of the pre-cast concrete panels were off-loaded on site on 13 March 2024. These panels will form the last row of panels to be placed on top of the package sewage plant. The crane was off-loaded from a low-bed truck with a full tank of diesel.

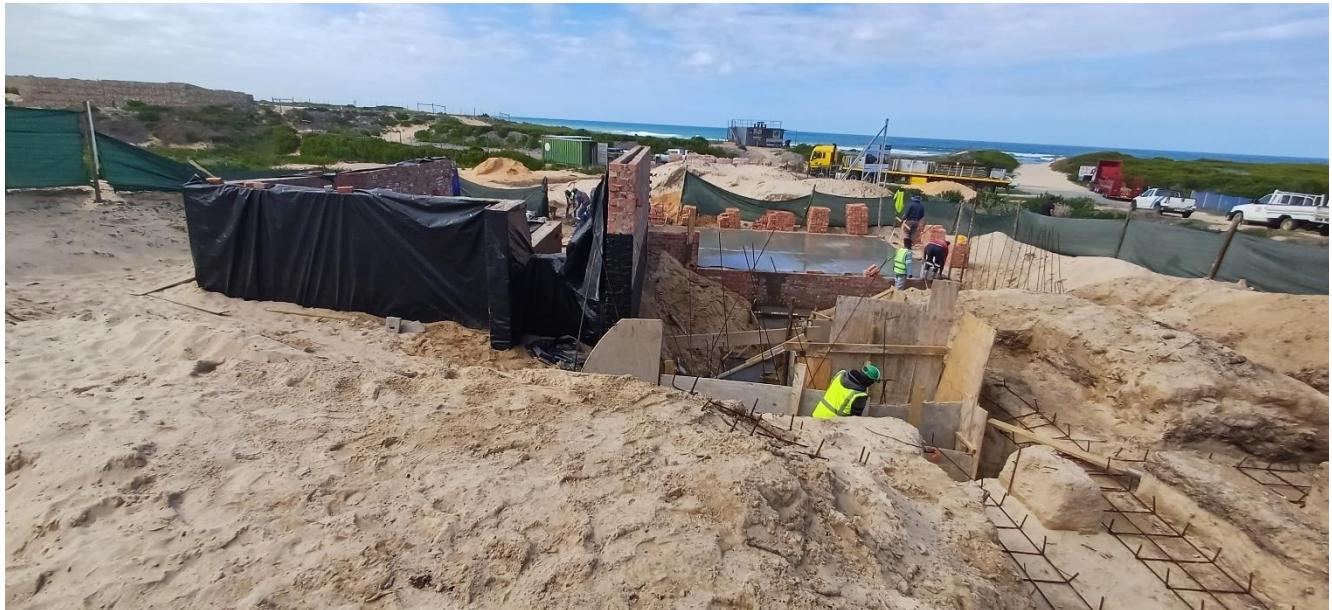
**Photo 7:** Shutter boards were required to hold back sand from falling into deeply excavated foundations for the house on Erf 2457.
