ECO CHECKLIST FOR THE CONSTRUCTION OF THE PACKAGE SEWAGE PLANT AND HOUSES ON THE PREEKSTOEL BEACH ESTATE, STILL BAY EAST, WESTERN CAPE

File 1012 : Construction ECO Checklist No.: 4

Date: 4 June 2024

ECO CHECKLIST # 4

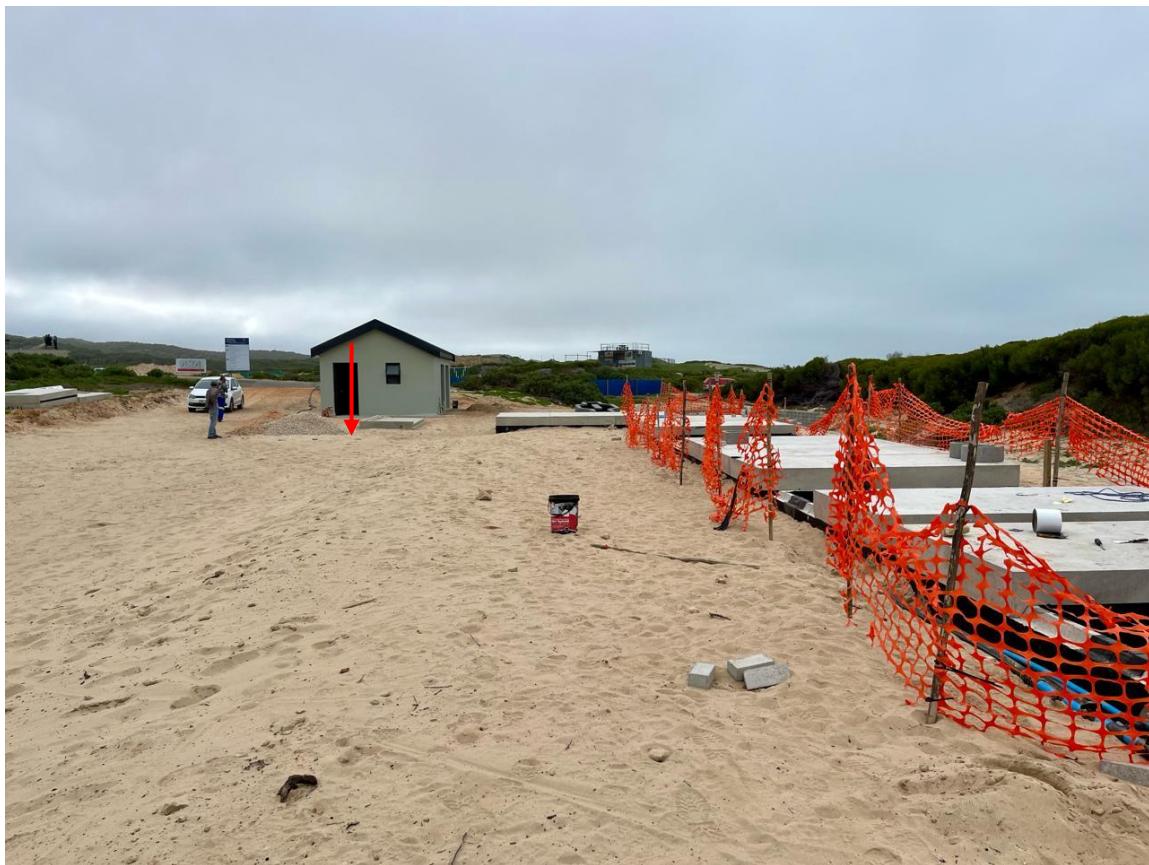
Photo 1: The control room has been completed. Some lids still to be put onto package sewage plant.

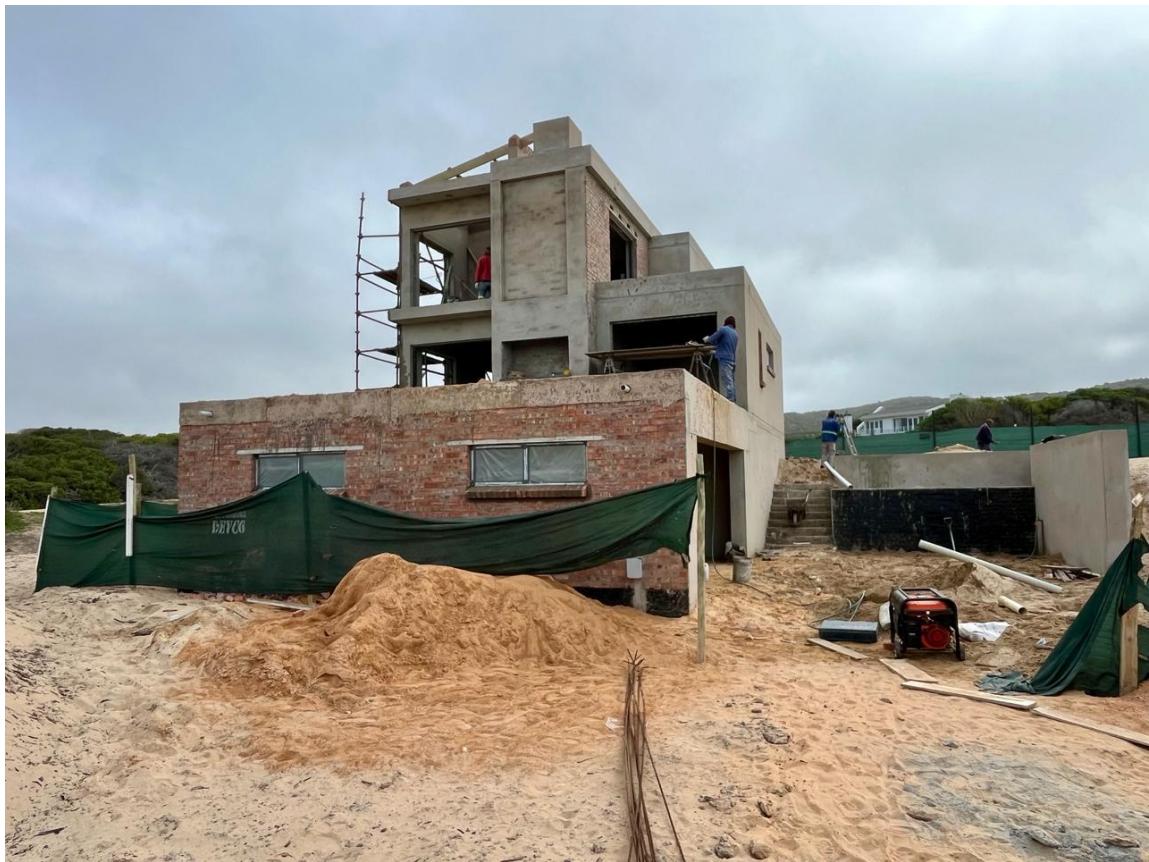
Photo 2: The main construction of house on Stand 33/Erf 2457 is nearing completion. Some outside walls still need to be plastered and clad with natural limestone blocks.

ENVIRONMENTAL ASPECTS (PROJECT ACTIVITY)	REQUIRED ACTIONS	TARGET AND RESPONSIBILITY	COMPLIANCE	ECO COMMENTS
Storage of construction materials, concrete mixing areas, rubble storage and litter management on building sites (continued.)	2. Contractor to store building rubble in a suitable designated area, with rubble removed from site on a weekly basis.	The area for any building rubble storage to be designated by the Site Agent. Contractor to remove any builder's rubble on weekly basis. ECO to monitor compliance.	C	Building rubble is being generated on both sites associated with the construction of the control room for the sewage package plant and the first house (Stand 33). Such waste was removed from site. The package sewage plant is all but completed (Photo 1). The house on Stand 33 is also nearing completion (Photos 2 and 3). It is recommended that waste skips are used on Stand 44 (Photo 4).

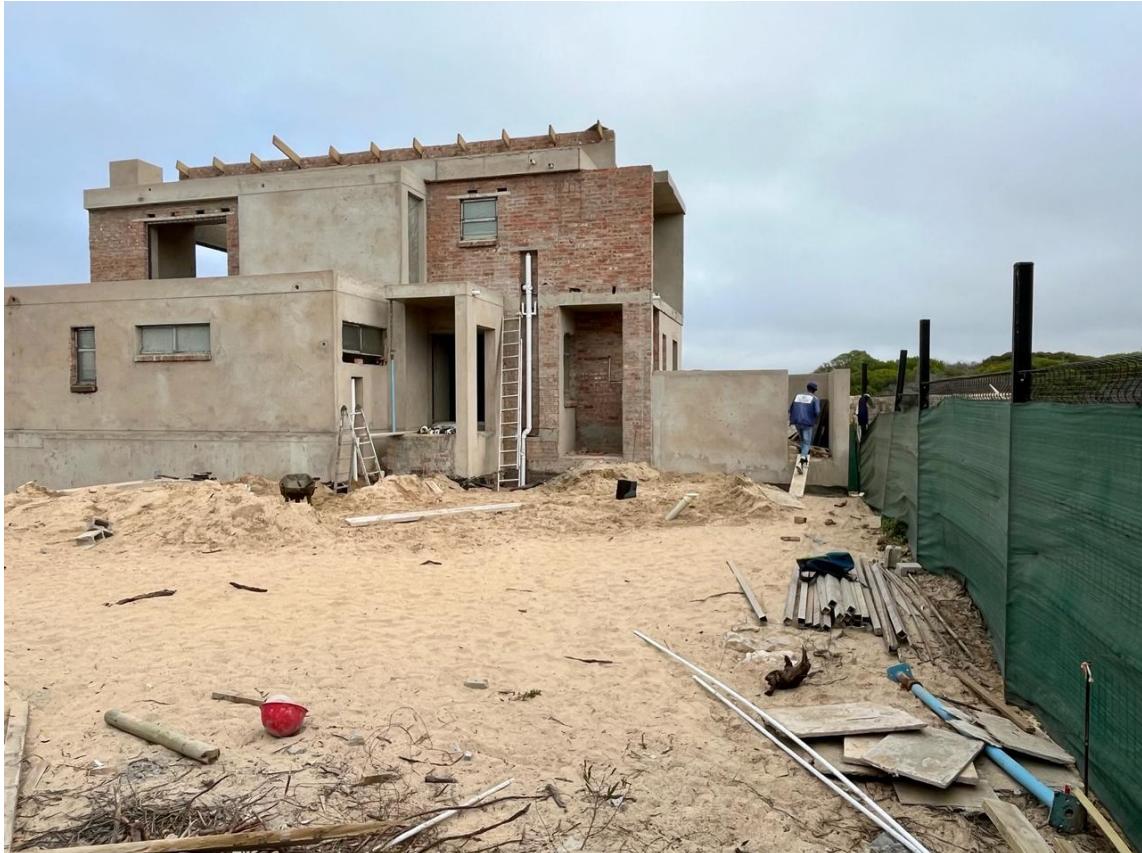
Photo 3: The roof is being constructed. Shutter boards and scaffolding are neatly packed on the inside of the erf.

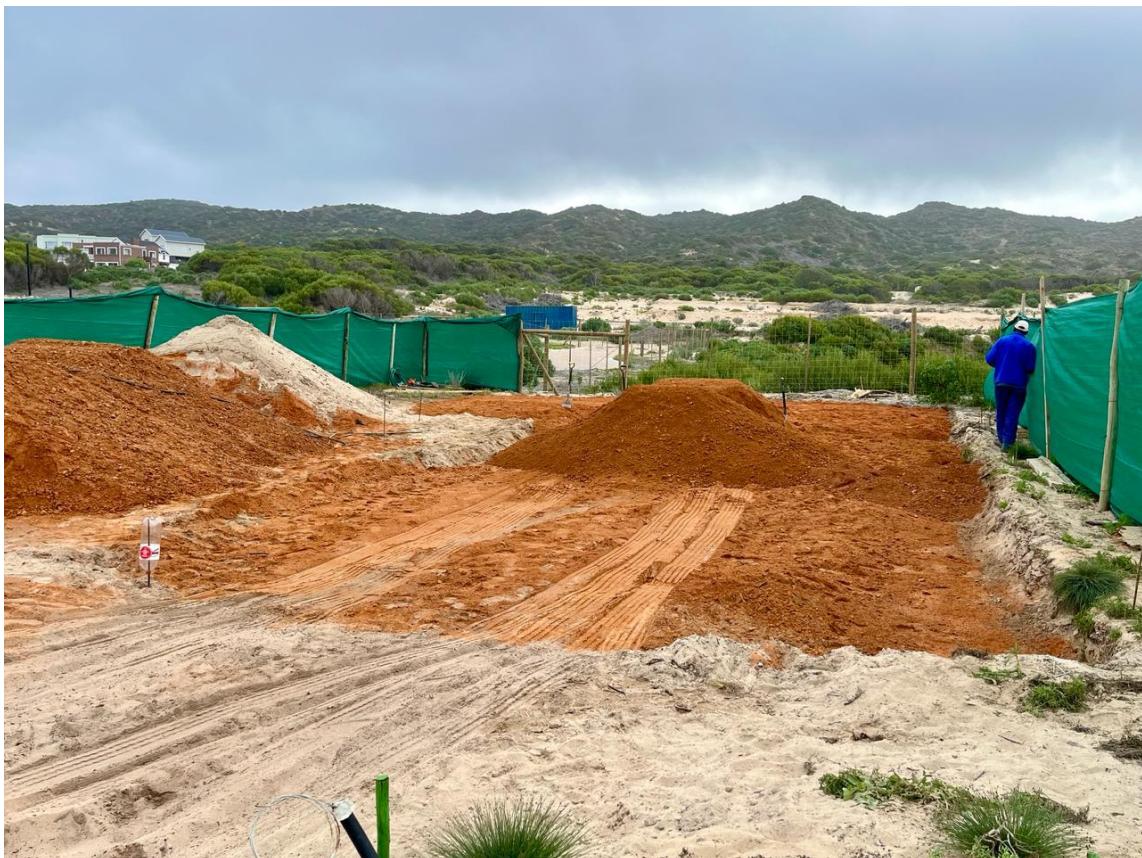
Photo 4: Construction work has started on Stand 44/Erf 2382 by Southshore Devco, with the excavation of sand from the building platform. G7 material is being placed within the excavated building platform, which will be compacted, for creating a stabilized raft foundation. The shade cloth is being erected on the boundary of the erf.
