Upgrading of Existing Bulk Sewage Pipeline and Stormwater Outlets, Rosemoor, George, Western Cape.

Aquatic Biodiversity – Specialist Assessment

Prepared For: Sharples Environmental Services

Date: 9 March 2026

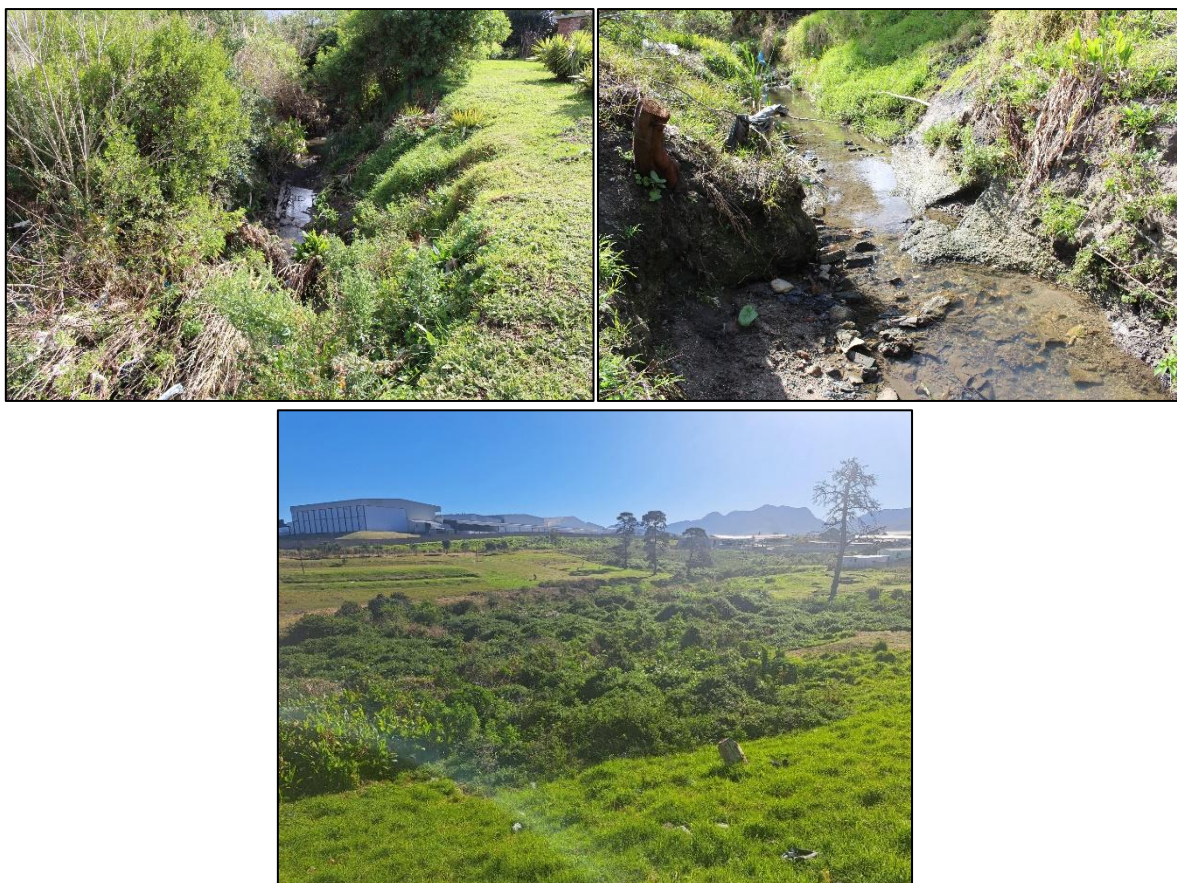
river reach – on both sides of the channel. The eastern tributary is mapped as a non-perennial drainage line, but the site visit confirmed the presence of a seep wetland along the adjacent slopes – similar to the seep wetland along the Meul River. The formation of seep wetlands along the gentle slopes of valleys is consistent with the soil type in George (i.e. a coarsely textured A horizon overlying a relatively impervious clay enriched B horizon). The seep wetland features are sustained primarily by lateral sub-surface flow which is prevented from penetrating the deeper impervious B horizon and expresses near the surface as it travels down the relatively gentle slopes. The gentle slopes allow water to be retained in the soil profile for an extended period of time, leading to seasonally saturated conditions and the establishment of wetland vegetation. Further downstream (far below project area of interest below the N2 highway), the gradient of these slopes becomes steeper and water is retained in the soil profile for a shorter duration, and wetland habitat is replaced by woody vegetation typical of a riverine riparian zone. The most likely original reference configuration of the aquatic features is a seep wetland which would have historically fed a non-perennial river channel abutting the wetland. Over time this channel has become severely modified due to stormwater inputs from the urban catchment area. A more accurate delineation of the wetland seep is provided in Figure 9 and includes wetland seep habitat along the eastern tributary of the Meul River. Alien invasive species are not prolific within the seep wetland but do occur throughout and, amongst others, include *Cenchrus clandestinus* (kikuyu grass), *Solanum mauritanium*, *Acaia mearnsii* and *Rubus sp.*. In some areas, where invasion is more dense, the woody structure contributes to confining high flows to the channel, exacerbating channel incision.

Figure 7: Photographs showing the steeply incised riverine channel of the Meul River (top right and left) and a section of the wetland seep along the slopes of the river (bottom).

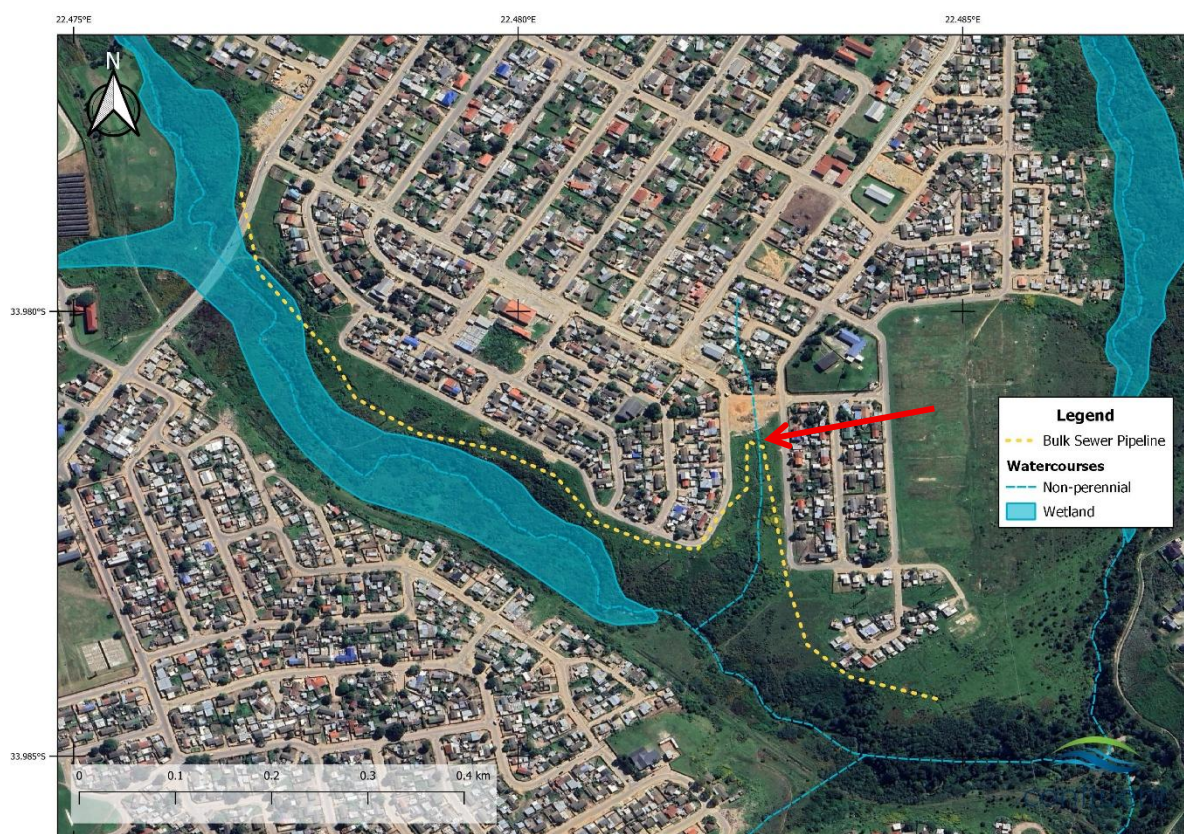
Figure 10: Map showing the delineated extent of seep wetlands along the Meul River and its eastern tributary. The pipeline crosses a stormwater channel at the position indicated by the red arrow.

As highlighted in Figure 10, the pipeline and stormwater outlets are located immediately adjacent to or intersect with delineated wetland habitat. There is therefore potential for construction activities to impact the wetland and mitigation measures must be implemented in order to avoid and/or minimize these impacts. Given its hydrological connection to the larger Meul River system, recommended mitigation measures are also applicable to the stormwater channel indicated in Figure 10.

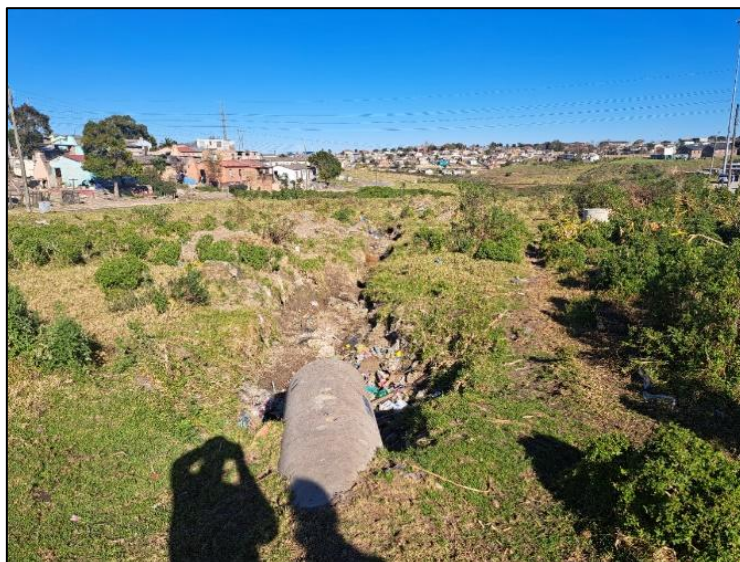
The pipeline is mapped to cross a non-perennial watercourse (Figure 2). The site inspection revealed a narrow, incised channel that originates from a stormwater outlet and traverses a gently sloping plain (Figure 11). The outlet discharges onto the gently sloping plain with no defined valley or topography that would favour the formation of a natural drainage line/stream, and it is clear that the channel has been formed due to erosion caused by stormwater discharge. Wetland vegetation has colonised this channel (mainly *Typha capensis*) and as with other stormwater outlets in the area, levels of litter and dumping were high. The pipeline crosses the channel approximately 20 m downstream from the stormwater outlet. For the purposes of this assessment the channel is considered a man-made stormwater channel and does not provide habitat for aquatic biodiversity.

Figure 11: Channel that will be crossed by the upgraded bulk sewer pipeline.

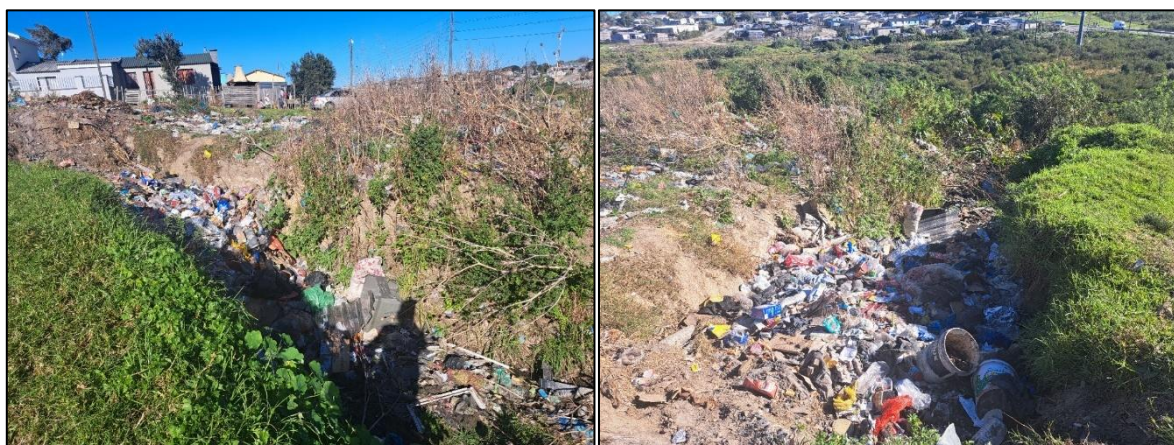
All stormwater outlets are located at the top of a relatively wide, gently sloping valley. The wetland seep is located along the slopes (up to 50 m in width) and is dominated by *C. odorata* and invaded by *C. clandestinus* on the margins. All outlets discharge relatively high up onto the slope and have no erosion protection. Eroded gulleys are therefore present at many of these outlets (Figure 12), which drain down towards the wetland. While all outlets are located outside of the delineated area of the wetland, there is a strong likelihood that, if left in their current state, the erosion gulleys could eventually extend into the wetland. Significant

quantities of solid waste and litter have been dumped into most of these gulleys, which act as a source of solid waste pollution to the wetland and Meul River.

Figure 12: Example of an erosion gully at a stormwater outlet that has become an informal dumping site.

up onto the unprotected slope and have caused several erosion gullies that extend into wetland seep vegetation along the banks. Significant quantities of solid waste and litter have been dumped into these gullies, which acts as source of solid waste pollution to the wetland and Meul River.

Lack of erosion protection at stormwater outlets that discharge relatively high up on slopes has caused extensive erosion gullies that extend into wetland habitat along the Meul River. Given the management objectives for SWSAs, it is important that the proposed upgrades are undertaken at all sites so as to alleviate erosion problems. Upgrades are likely to result in a Low Negative construction phase impact (assuming implementation of mitigation measures). For the operational phase the upgraded stormwater outlets will incorporate energy dissipation and erosion control structures which will result in improved mitigation of stormwater discharge into the Meul River system and can be considered a positive impact relative to the No-Go scenario, which will result in continued erosion of wetland habitat below the outlets. It is

therefore recommended that authorisation for the upgrade of stormwater infrastructure in Rosemoor be granted. In terms of the NWA, the upgrades will require a General Authorisation.
