Section A

Koo river bridge

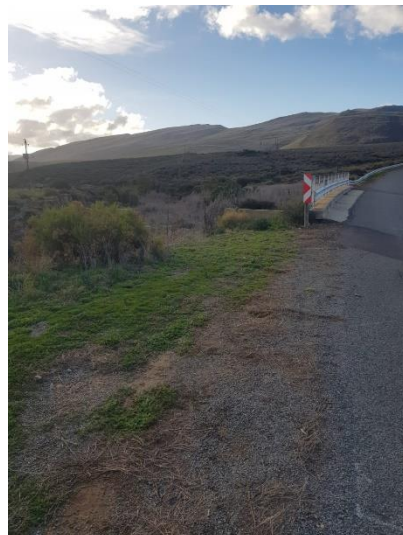
Image 8: Disturbed area near the Koo River Bridge.

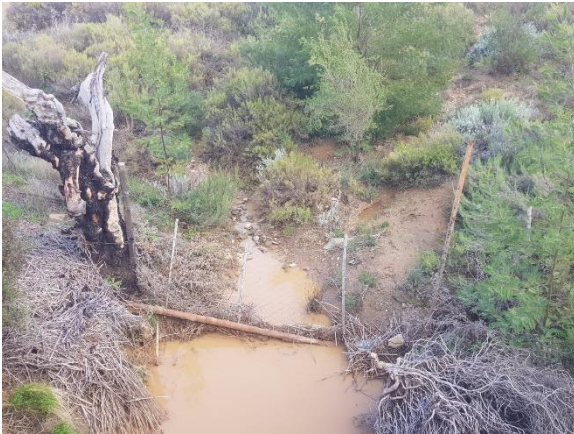
Image 12: Watercourse bed and adjacent vegetation.

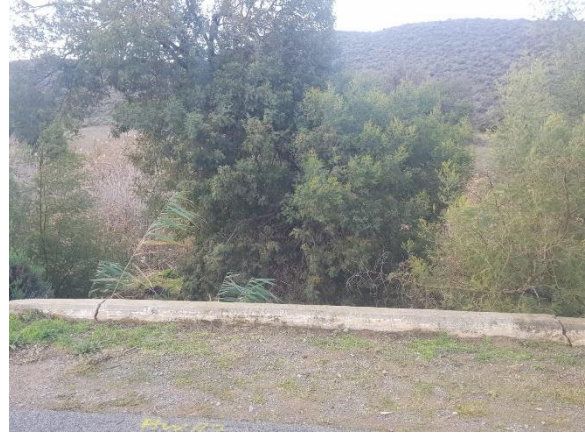
Image 17: Large tree within the watercourse.

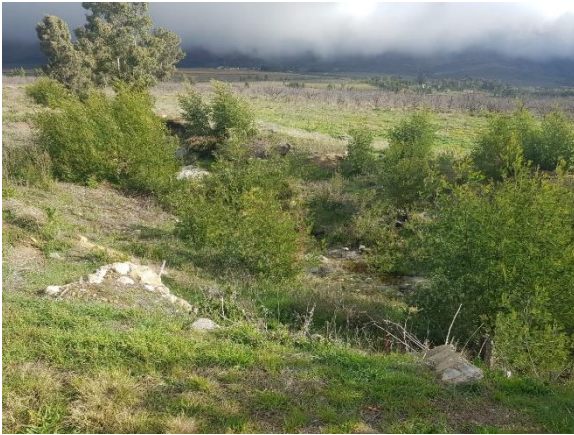
Image 34: Alien vegetation adjacent to the watercourse.

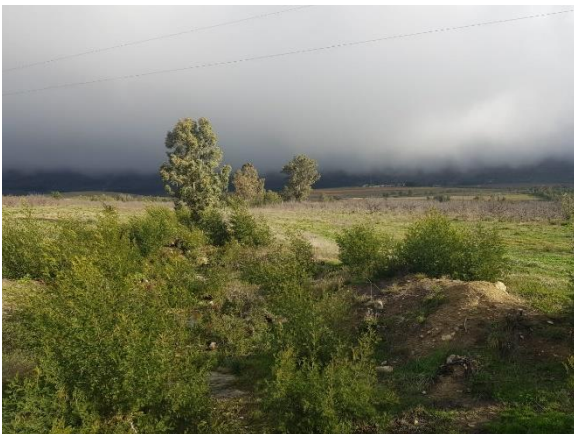
Image 38: Watercourse with alien vegetation.

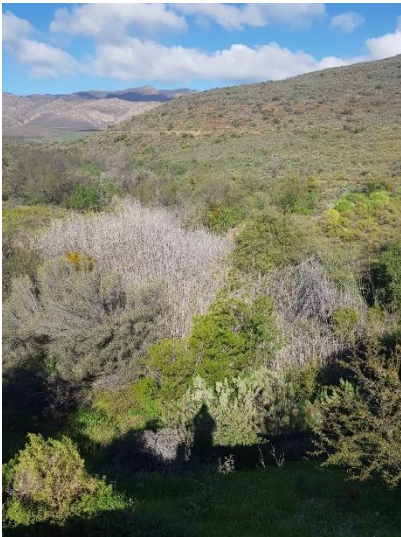
Image 133: Adjacent riverine vegetation.

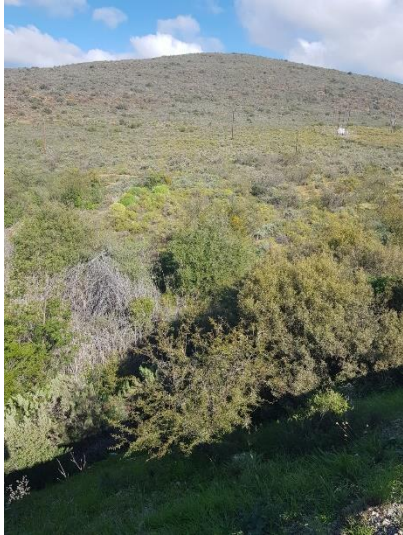
Image 135: Dense vegetation adjacent to the watercourse.

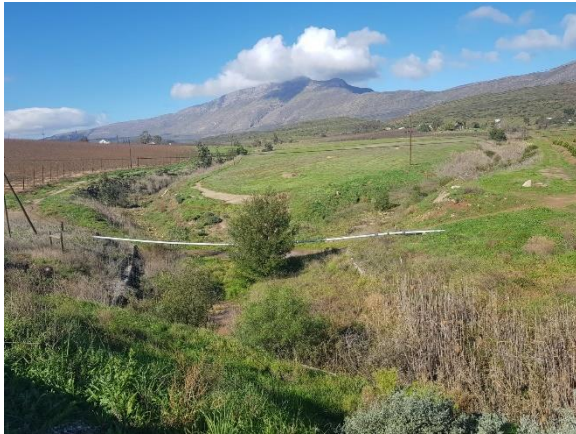
Image 137: Eastern flow path.

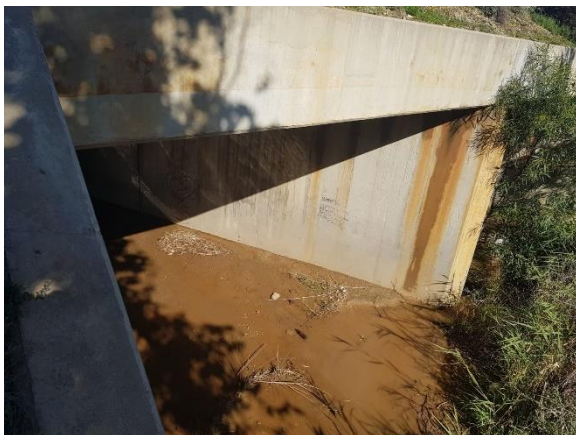
Image 139: Riverbed of the watercourse.

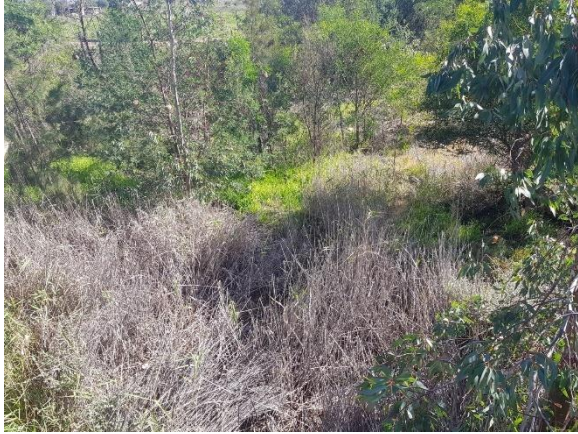
Image 141: Adjacent riverine vegetation.

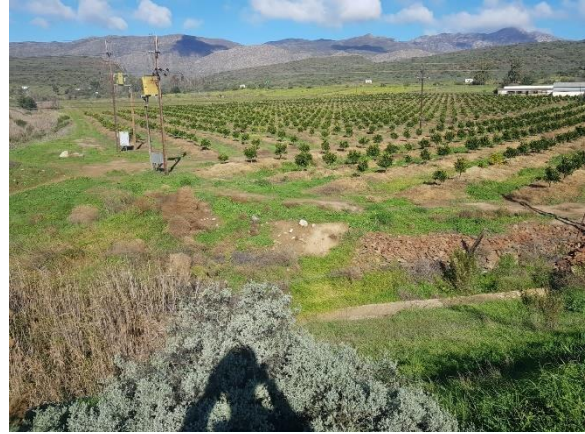
Image 142: Nearby agricultural activities.

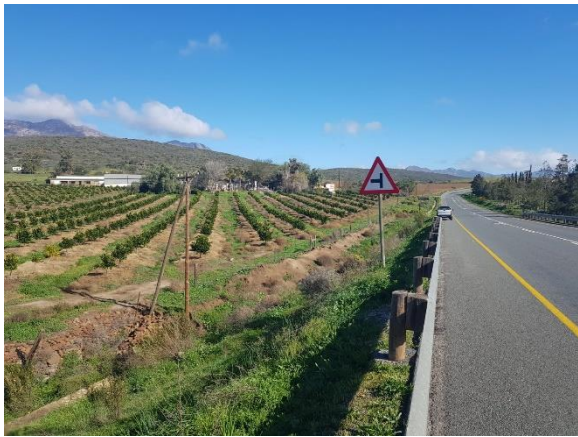
Image 143: Nearby agricultural activities.

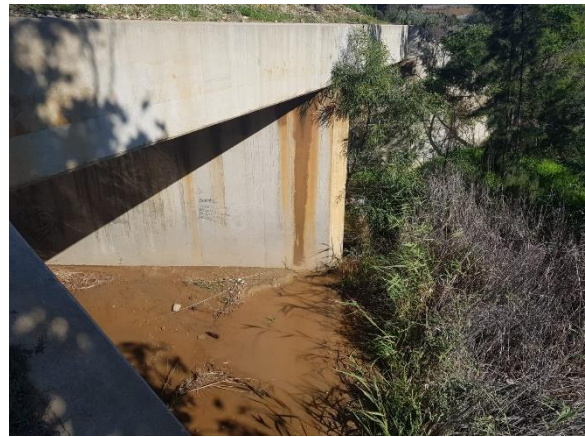
Image 144: Western flow path.

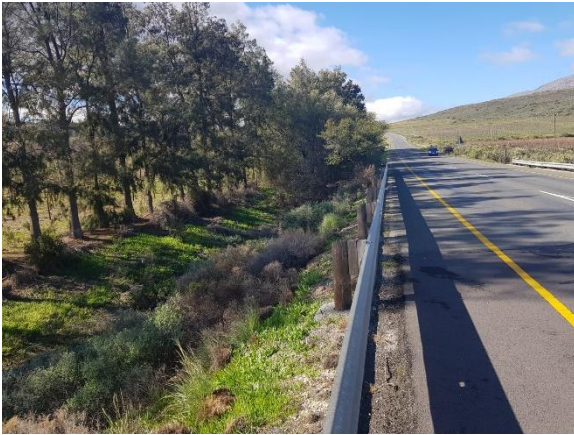
Image 146: Adjacent topography.

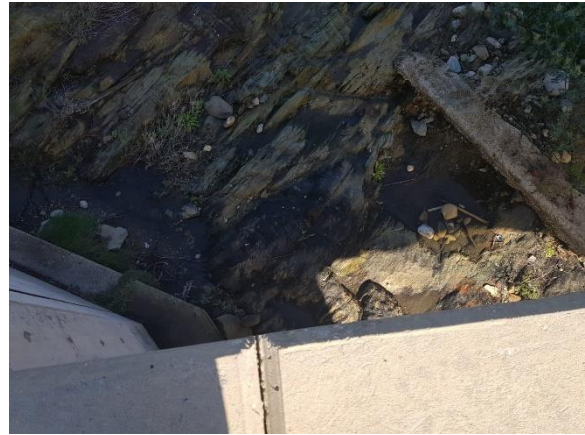
Image 147: Bed rock exposed within riverbed.

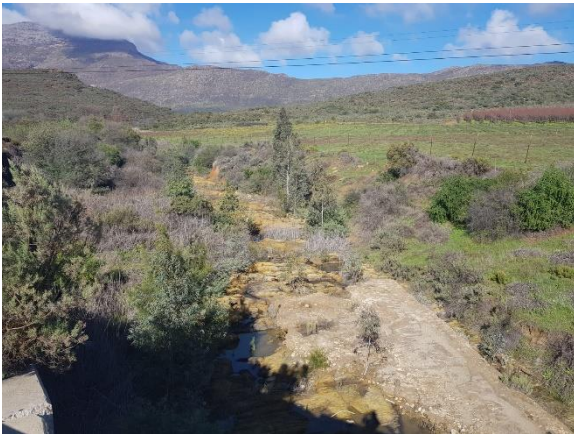
Image 148: Eastern flow path.

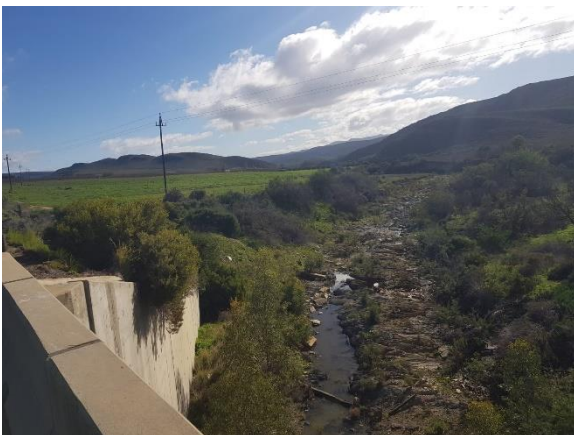
Image 150: Flow path and adjacent riverine vegetation.

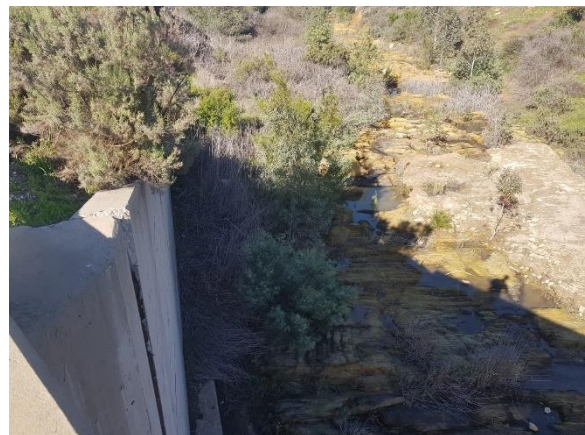
Image 151: Eastern flow path and aquatic vegetation.
